**UNITED STATES ENVIRONMENTAL PROTECTION AGENCY**  
**REGION 5**  
**25063 CENTER RIDGE ROAD**  
**WESTLAKE, OHIO 44145**

**SUBJECT:** CLEAN WATER ACT INSPECTION REPORT  
Village of Arlington WWTP, 18377 Township Road 71,  
Arlington, Hancock County, Ohio, 45814

**Inspection Type:** Clean Water Act (CWA) National Pollutant Discharge Elimination System (NPDES) Compliance Evaluation Inspection

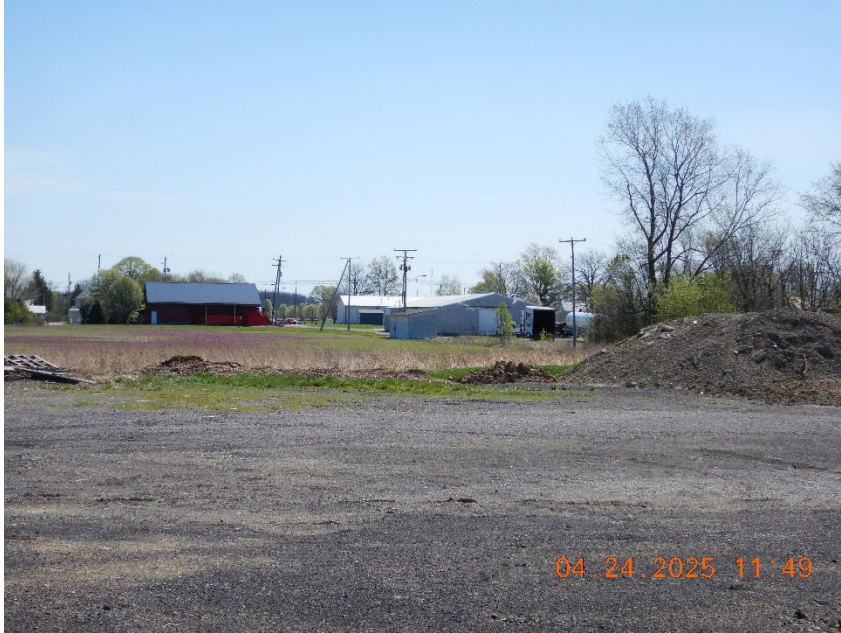
**1:** DSCN4324

**Description:** View from WWTP looking towards the Main Pump House (gray building at center of photograph) that houses the main lift station for the plant. The lift station is designed with a comminutor that grinds any solids and debris in the influent flows.

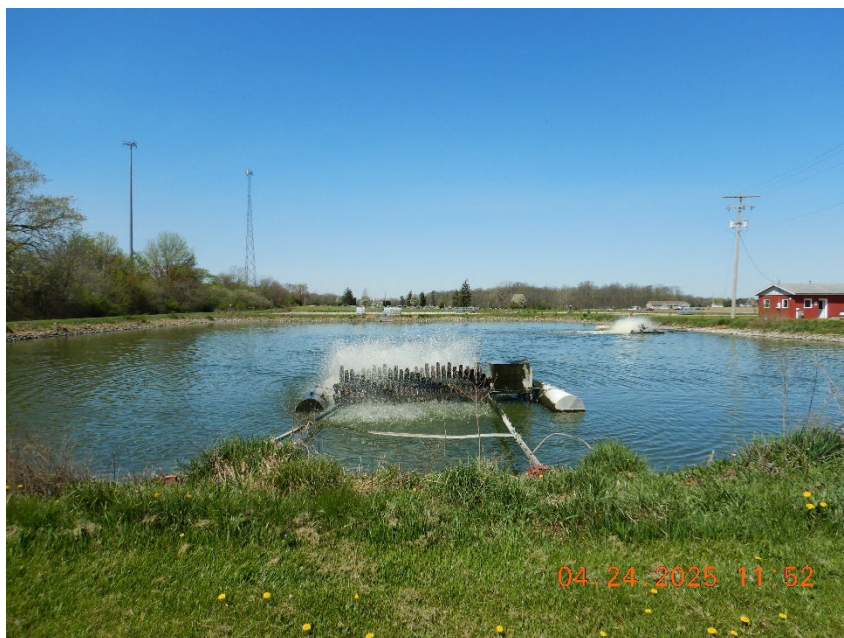
**2:** DSCN4325

- Cells 1, 2 and 3: Observations of the three cells found no evidence of excessive scum build-up, grease, foam, or floating sludge in the cells (Photographs 2, 3, 4 and 6). In addition, there was no observable evidence of leakage through the berms, animal burrowing activity, or rooted, woody plant growth around any of three cells. The two rotor brush aerators in Cell 1 were operational. The torpedo-style aerator in Cell 2 was not operational. An electrician service appointment for the torpedo-style aerator had been previously scheduled for 4/25/2024. All 3 cells initially looked to have a normal

coloring when looking across the water surface; however, upon closer examination, all three cells were observed to have a greenish discoloration (Photographs 2, 3 and 4).

**Description:** Two S&N Airoflo 2600 Series rotor brush aerators are located in Cell 1.

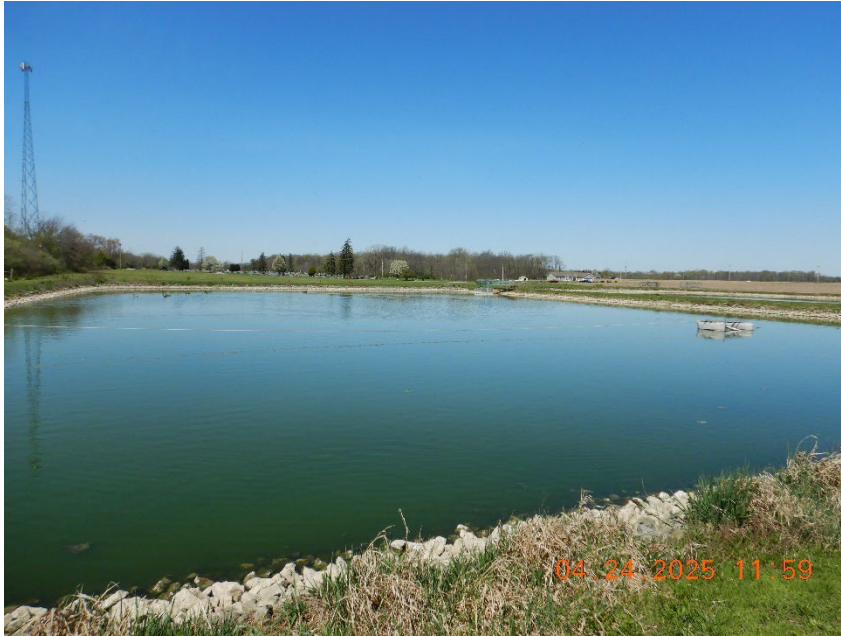
**3:** DSCN4326

- c. The single 5-horsepower aerator in Cell 2 (Photograph 3) was not operational at the time of the inspection. According to Mr. Childs, a recent power surge caused an electrical issue which took the aerator offline. The facility already had a service appointment with an electrician scheduled for 4/25/2024 to repair the electrical issue.

**Description:** A single torpedo-style aerator (5 horsepower) is deployed near the northeast corner of Cell 2. The Cell 2 aerator was offline at time of inspection due to a previous power surge. Electrician service appointment for aerator was already scheduled to occur on 4/25/2024.

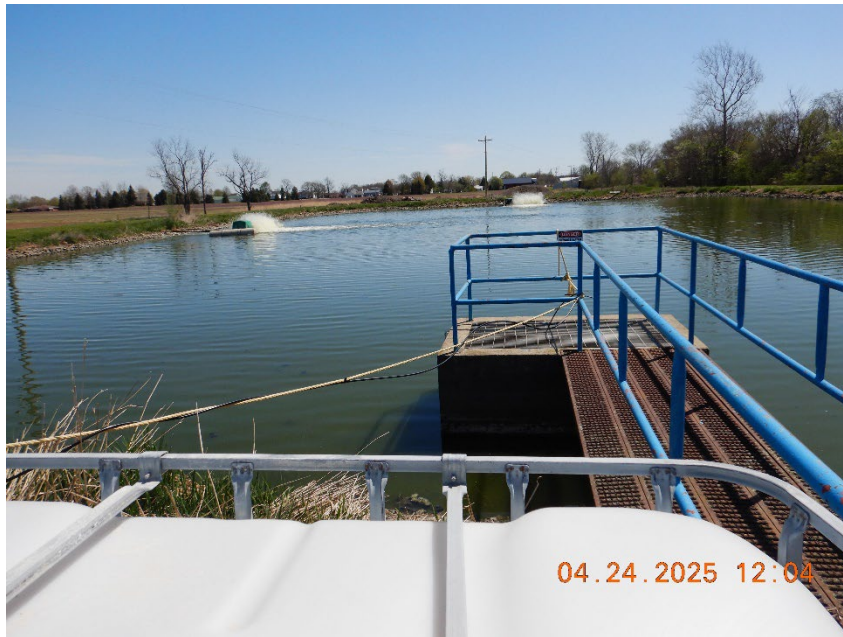
**4:** DSCN4327

**Description:** Location along the west bank of Cell 1 where Brennfloc RE 5000 flocculant is added at the gravity overflow from Cell 1 into Cell 2 to aid in phosphorus and total suspended solids control. Nature's Pond 4-In-One Plumbing, Septic & Sewage (bio-enzymatic additive) is also added at this location as a sludge reduction additive.

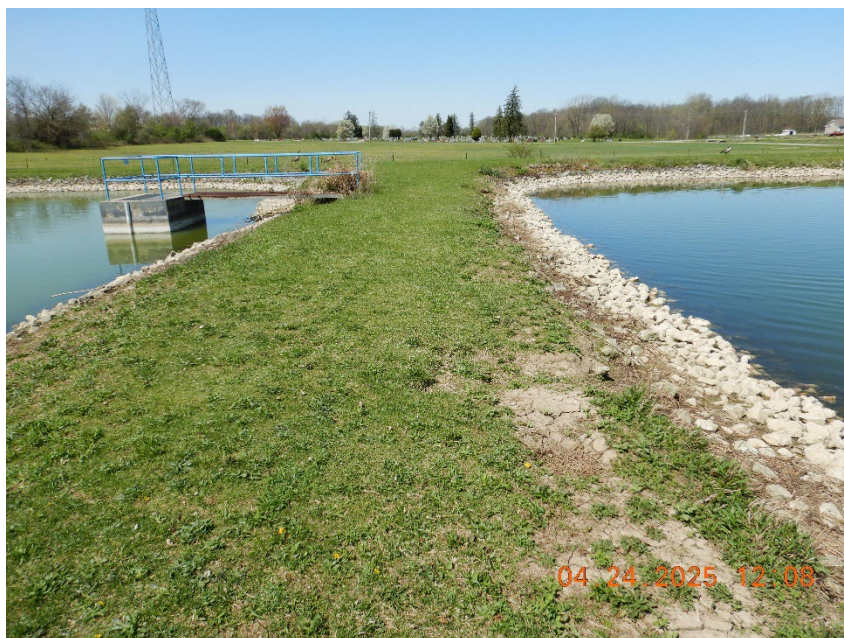
**5:** DSCN4328

- d. U.S.EPA observed areas of minor erosion on the top edge of the southern berm for Cell 3 in bare areas with loss of grass cover (Photograph 5). Erosion appears to be impacted by previous and current nesting activities with incubating eggs from Canadian Geese on site.

**Description:** EPA observed loss of grass cover and erosion along the top of the southern berm of Cell 3, between Cell 2 and Cell 3.

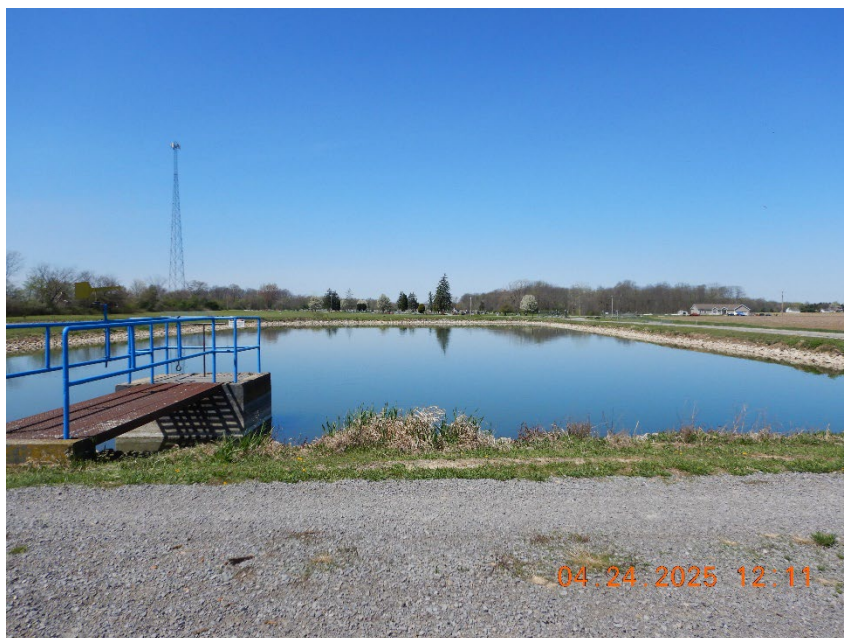
**6:** DSCN4329

**Description:** Overview of Cell 3.

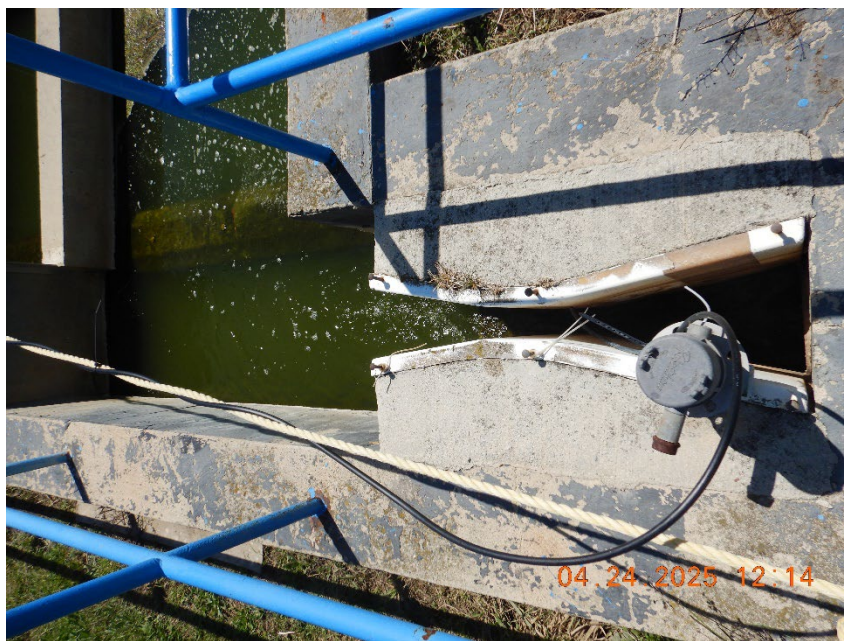
7: DSCN4330

**Description:** When required May through October, the facility drips sodium hypochlorite directly into the inlet to the first contact chamber for the Chlorination/Dechlorination Unit.

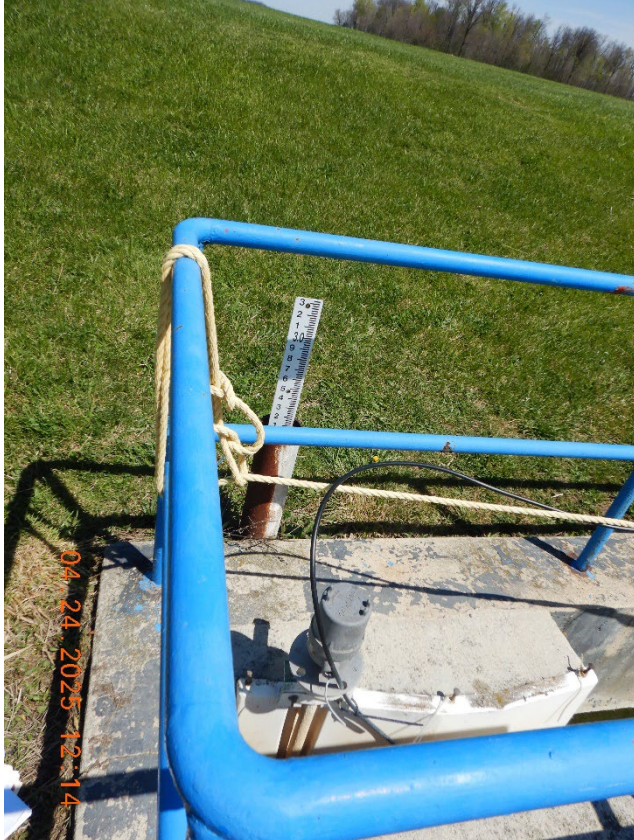
**8:** DSCN4331

Flow from Cell 3 was observed entering the northwest corner of the chlorination/dechlorination unit through a parshall flume. Facility operators use a hand-held measuring gauge that is not permanently affixed to the flume sidewall to measure the height of the flow which is then converted to an estimated daily flow rate that is reported on the daily DMRs for the Outfall 001. After the flume, flow enters the chlorination/dechlorination unit and travels through multiple chlorine contact chambers to the final chamber where dechlorination occurs in the northeast corner of the unit. U.S. EPA observed grass clippings floating on the surface of the water in the chambers of the chlorination/dechlorination unit. Significant growth of organic material, on the overflow baffles for the chambers was also observed.

- a. Facility personnel are determining the estimated daily effluent flow rate with a measuring gauge that is manually placed at the end of the diverging section of the Parshall flume to measure the height of flow. This measurement is then compared to a flume flow chart which converts the height measurement to an estimated instantaneous flow rate. The primary point of head measurement for a Parshall flume should be in the converging section, upstream from the throat, at a distance of two-thirds the length of the sidewall measured from the back of the throat.

**Description:** The measuring gauge for the Parshall flume at the influent to the Chlorination /Dechlorination Unit is not permanently affixed to the flume sidewall. The measuring gauge is stored in a vertical pipe adjacent to the flume.

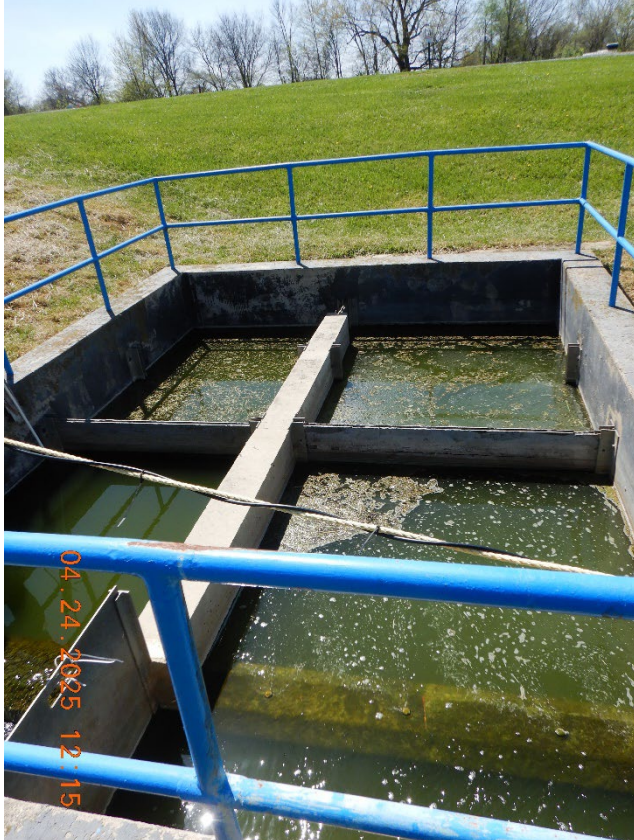
9: DSCN4332

- e. U.S. EPA observed grass clippings floating in the chambers of the chlorination/dechlorination unit (Photograph 9). U.S. EPA also observed that the overflow baffles

in the chambers were covered with significant growth of organic material, possibly moss and algae. (Photographs 9 and 10). The effluent water in the final chamber of the chlorination/dechlorination unit appeared green in color.

**Description:** Chlorination/Dechlorination Unit consists of four overflow baffles and three underflow baffles. EPA observed accumulated grass clippings floating on the surface of the water within three of the chambers of the Chlorination/Dechlorination Unit. Concrete overflow baffles were observed to have significant organic growth covering the tops of the baffles.

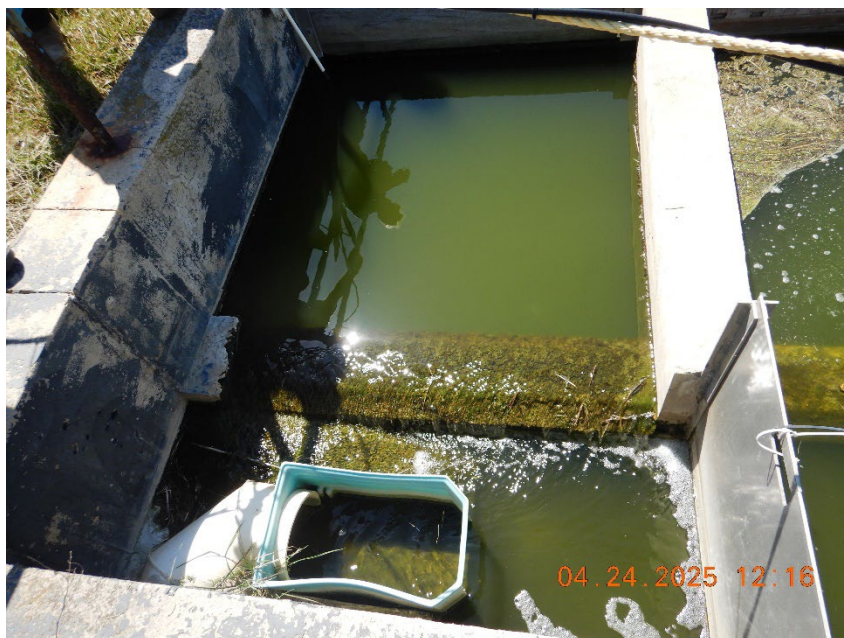
**10:** DSCN4333

**Description:** View of the dechlorination chamber. From May through October, sodium thiosulfate is dripped into this final chamber to dechlorinate the flow before it is discharged from the Chlorination/Dechlorination Unit to the final outfall. The white plastic tubing for adding sodium thiosulfate can be seen in the upper left corner of the photograph. The outlet from the dechlorination chamber is the white PVC pipe in the lower left corner of the photograph.

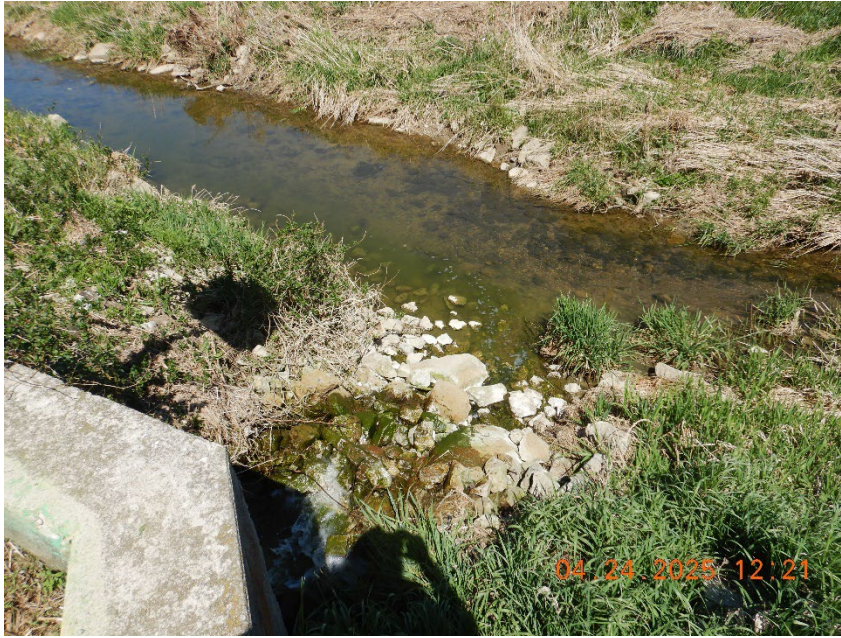
**11:** DSCN4334

- Outfall 001/Receiving Stream: U.S. EPA did not observe any floating solids, oil sheen, or foam in the effluent discharging from Outfall 001 or in the receiving water and there was no noxious odor detected at the outfall (Photograph 11). However, the effluent discharge from Outfall 001 was observed to have a green discoloration. The green discoloration from the effluent was observed to extend from Outfall 001, downstream in the receiving water (Photograph 11). However, the discoloration was not present in the receiving stream at the downstream sampling location (road crossing at Fellowship Road adjacent to driveway entrance to WWTP). The green discoloration was not observed in the receiving waters, immediately upstream of Outfall 001 (Photograph 12). U.S. EPA and facility representatives drove to the upstream receiving water sampling location located near the village park at a road crossing over Buck Run Creek. At the time of the inspection there was no observed discoloration or floating debris at this upstream sampling location.

6. NPDES Permit No. OH0053171 Part III. 2. C. states "The effluent shall, at all times, be free of substances: In amounts that will alter the natural color or odor of the receiving water to such degree as to create a nuisance;..."
  - a. The effluent discharge from Outfall 001 was observed to have a green discoloration. The green discoloration from the effluent was observed to extend from Outfall 001, downstream in the receiving water. The discoloration was not present in the receiving waters at the downstream sampling location (road crossing over Buck Run Creek, just north of the WWTP driveway entrance), approximately 900 feet west of Outfall 001.

**Description:** Outfall 001 discharge into Buck Run Creek. EPA observed a green discoloration from organic matter coating the rip rap rocks below the Outfall 001 outlet and a plume of green discoloration within the receiving waters where flow from Outfall 001 enters the waterway. U.S. EPA noted that at the downstream sampling location at the Fellowship Road overpass, the discoloration was no longer present in the receiving waters.

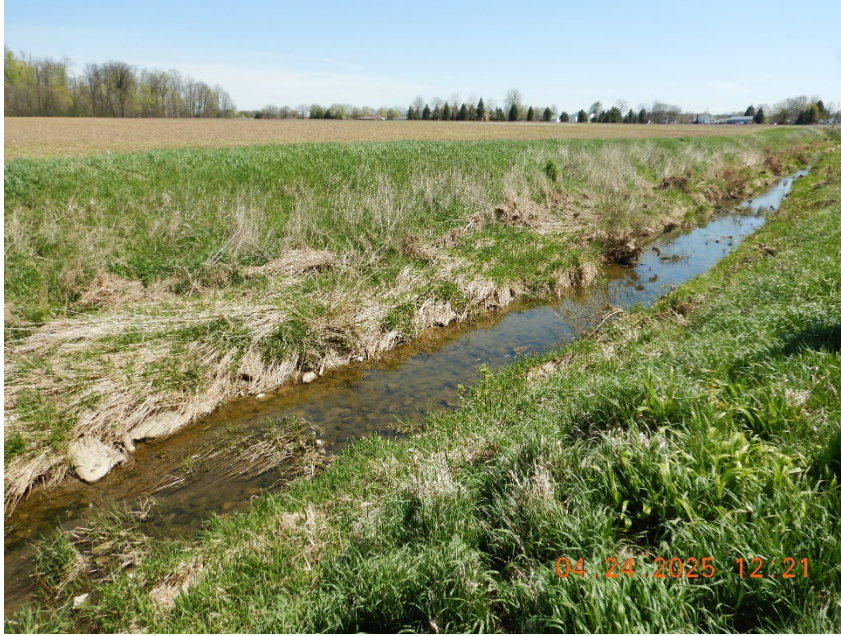
**12:** DSCN4335

**Description:** View of Buck Run Creek upstream of Outfall 001. No discoloration present.
