**UNITED STATES ENVIRONMENTAL PROTECTION AGENCY, REGION 2**  
**CARIBBEAN ENVIRONMENTAL PROTECTION DIVISION**  
**MULTIMEDIA PERMITS AND COMPLIANCE BRANCH**

**NPDES Stormwater Inspection**  
**Industrial Site**

**CHITOLIE TRUCKING SERVICE, LLC**

Inspection Date: March 30, 2023

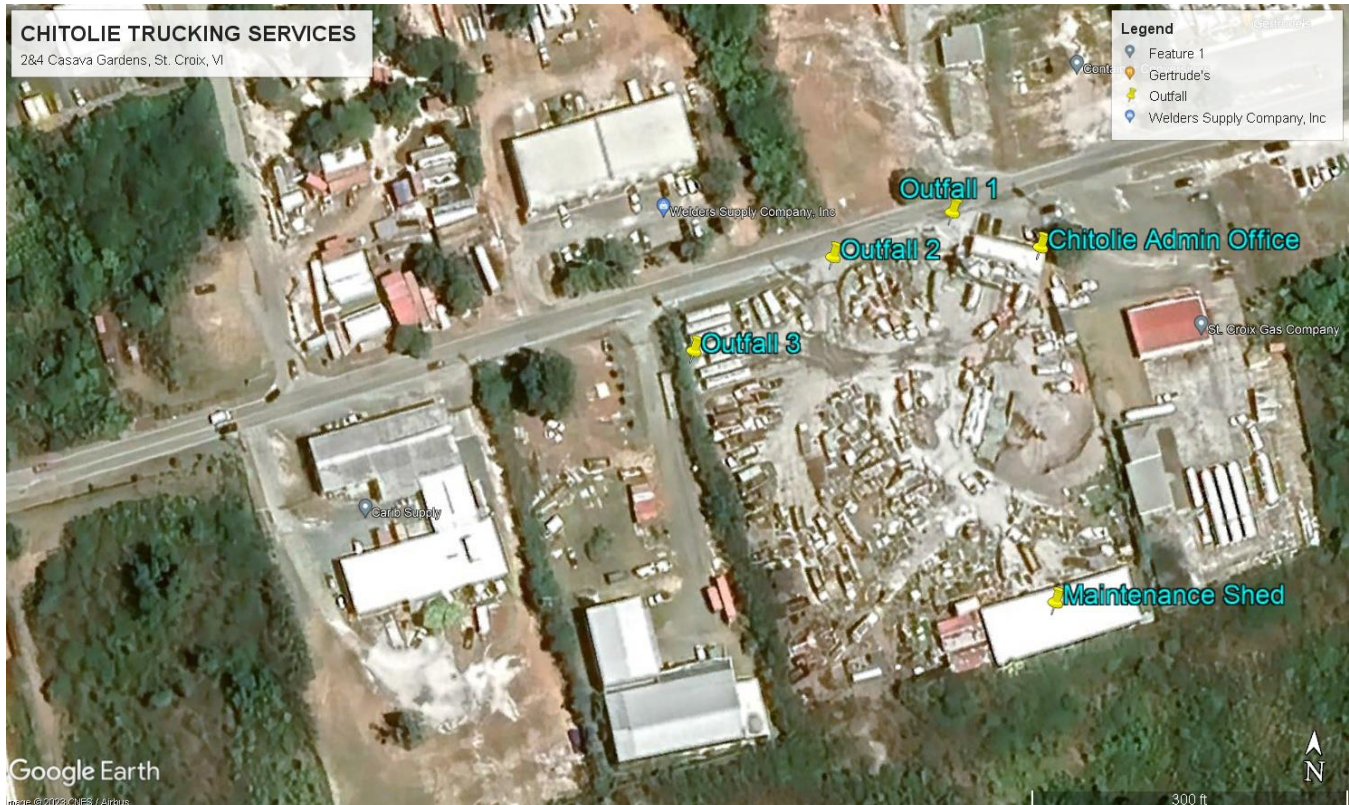
**Figure 1**  
**Chitolie Trucking Service, Christiansted, St. Croix, VI**

Chitolie Trucking Service, LLC (“Chitolie”) is a trucking service provider conducting a variety delivery and/or removal of materials operations ranging from fuel delivery to removal of debris from construction sites throughout the District of St. Croix, United States Virgin Islands (“USVI”). Chitolie’s facility is located at No. 2&4 Casava Gardens, Christiansted, St. Croix, VI 00802 (the “Facility”). An aerial photograph of the Facility<sup>1,2</sup> is featured as **Figure 1** (below) of this Inspection Report.

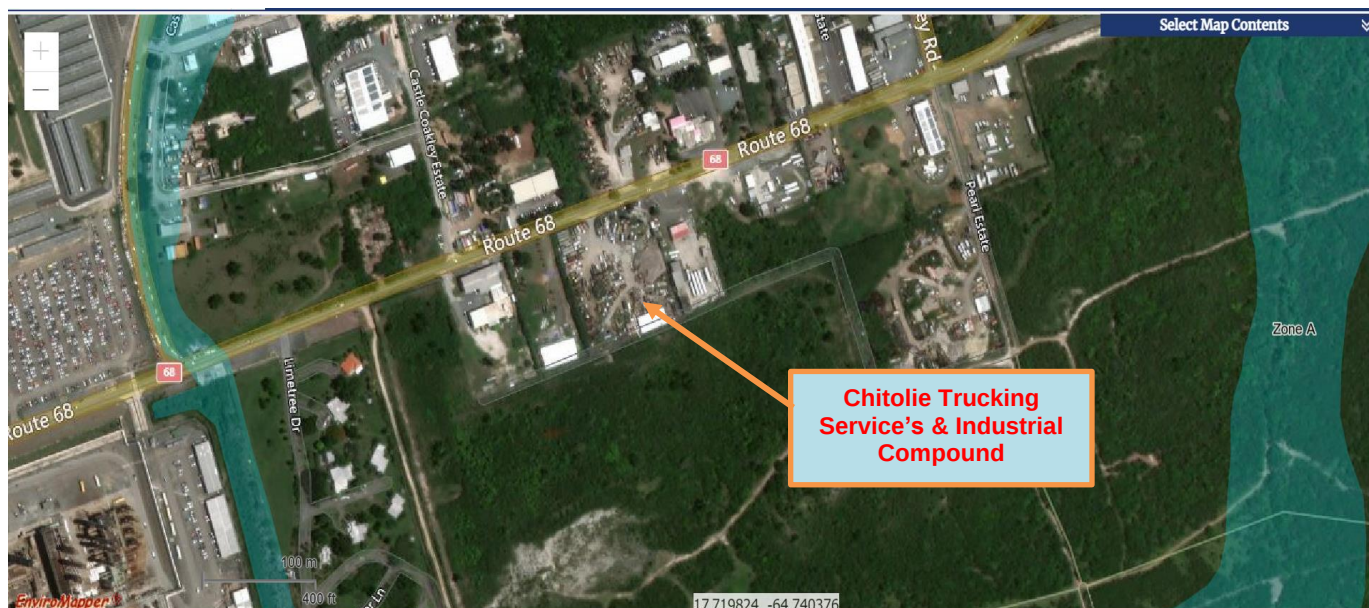
**Figure 2**

The Facility is situated in an industrial zone along the south-central coastal region of St. Croix watershed that drains into the Cane Garden Bay (Caribbean Sea). An aerial view of location of the Facility and immediate surroundings are depicted in satellite imagery of the reference watershed area featured in **Figure 2**, (Source: <https://nepassisttool.epa.gov/nepassist/nepamap.aspx>) on the next page.

**Chitolie Trucking Service's Facility situated within the south-central section of the St. Croix Watershed**
