## Clean Water Act Section 404: Site Visit/Case Development

| Site Name | John L Conner, Jr., Site 14, Hogpen Slough | | | | |

| Inspection Purpose | Initial site visit | | |

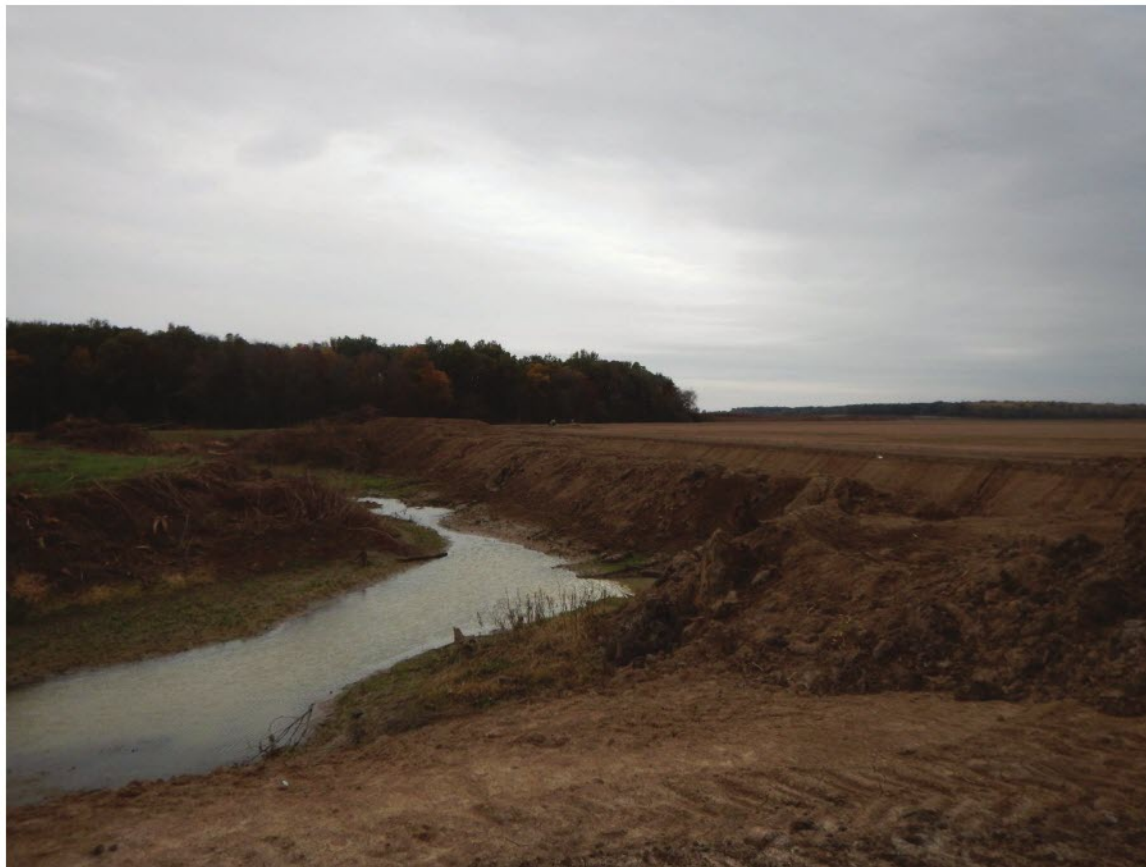
Photo No. 1

| Photo File Name | Date and Time of Photo | Photographer | Description |
|---|---|---|---|
| DSCN6168 | 11/09/2023, 10:50 AM | Chelsey Sherwood | Showing Hogpen Slough from river right facing downstream. Note vegetation completely removed along right bank below the Ordinary High Water Mark; the bank erosion; and sedimentation in the stream. Picture taken facing south. |

| We let Mr. Fitts and Mr. Langston know our concerns and that a permit is required for discharging fill material into the stream. | | | |

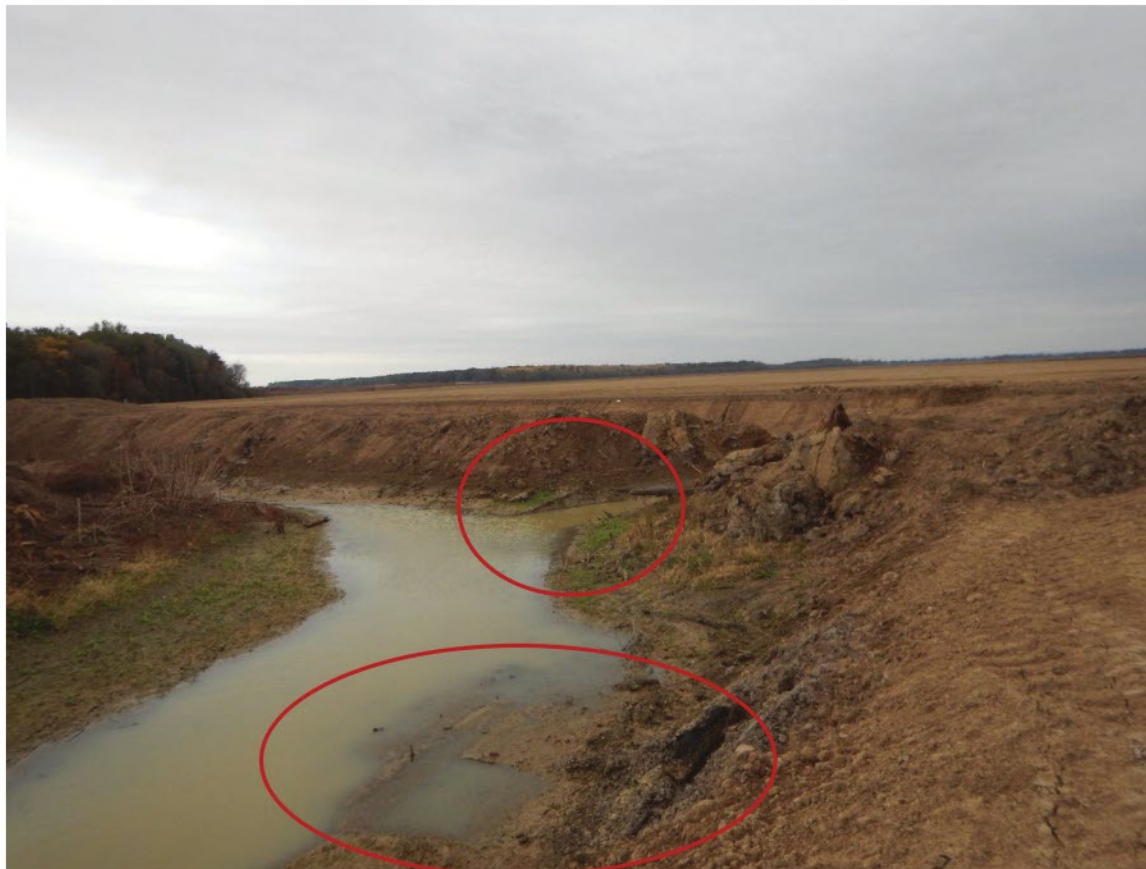
Photo No. 2

| Photo File Name | Date and Time of Photo | Photographer | Description |
|---|---|---|---|
| DSCN6169 | 11/09/2023, 10:50 AM | Chelsey Sherwood | Circled in red is showing where ditch now flows into Hogpen Slough. Note the turbidity and water coloration difference where the ditch confluences with Hogpen Slough. Also, note vegetation completely removed along river right bank below Ordinary High Water Mark; the bank erosion; and sedimentation in the stream. Picture taken facing southwest. |

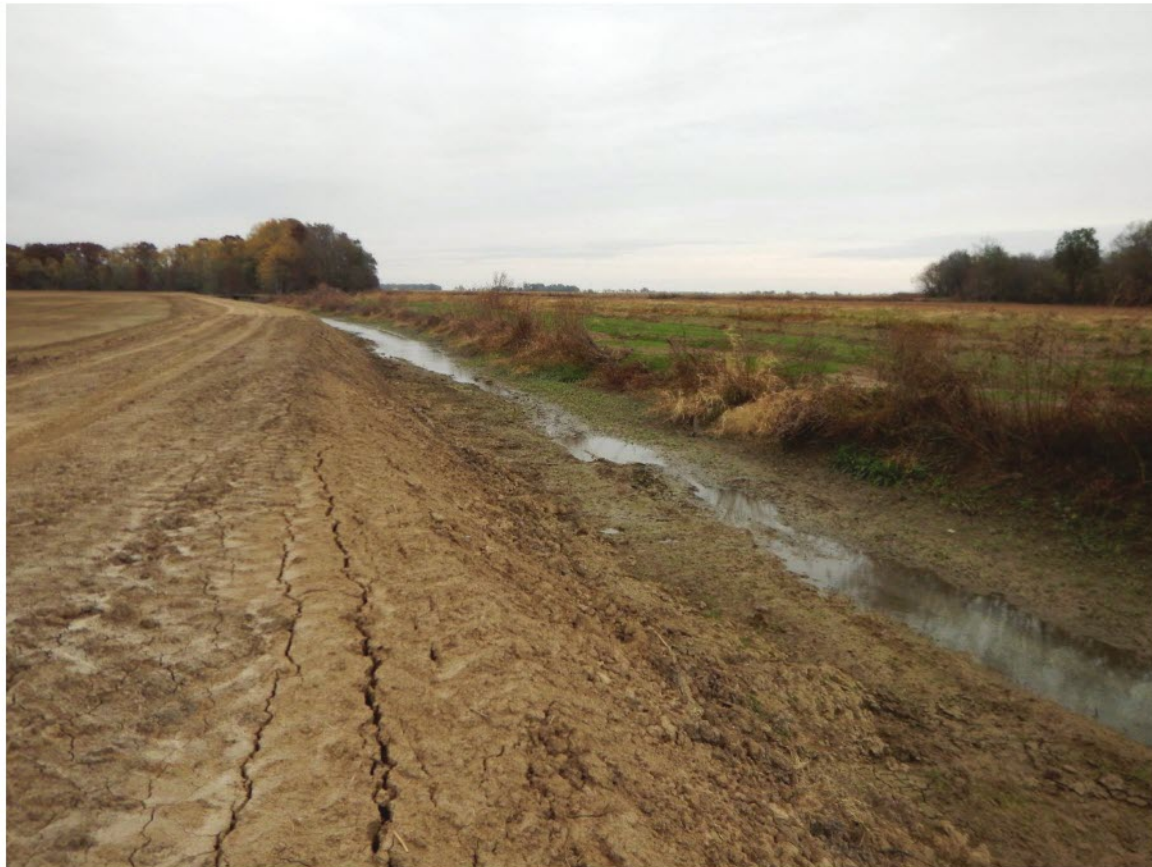
Photo No. 3

| Photo File Name | Date and Time of Photo | Photographer | Description |
|---|---|---|---|
| DSCN6170 | 11/09/2023, 10:51 AM | Chelsey Sherwood | Showing Hogpen Slough from river right facing upstream. Note vegetation completely removed below Ordinary High Water Mark along river right bank and the road built up along the stream. Also, note the sloughing of the road into the stream and the sedimentation in the stream bed impeding flow. Picture taken facing northeast. |

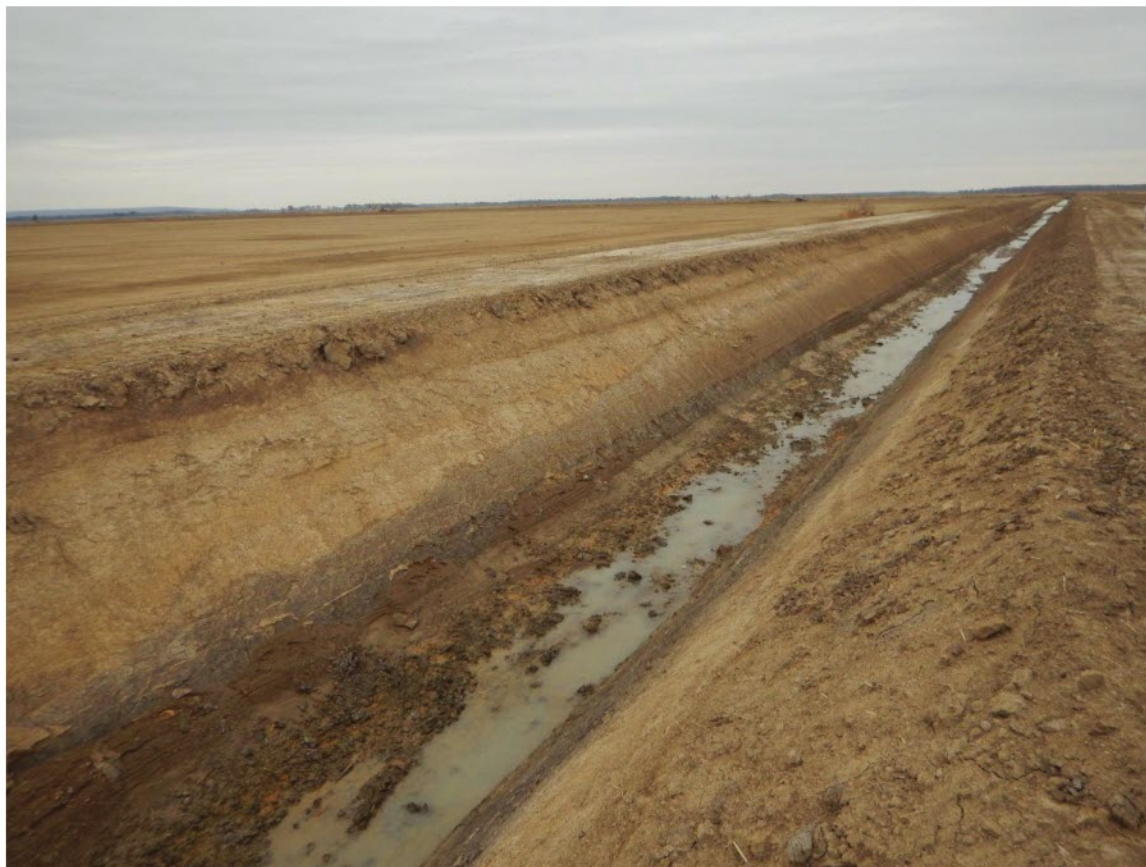
Photo No. 4

| Photo File Name | Date and Time of Photo | Photographer | Description |
|---|---|---|---|
| DSCN6171 | 11/09/2023, 10:52 AM | Chelsey Sherwood | Showing upstream of ditch about 12 feet deep. Picture taken facing north. |

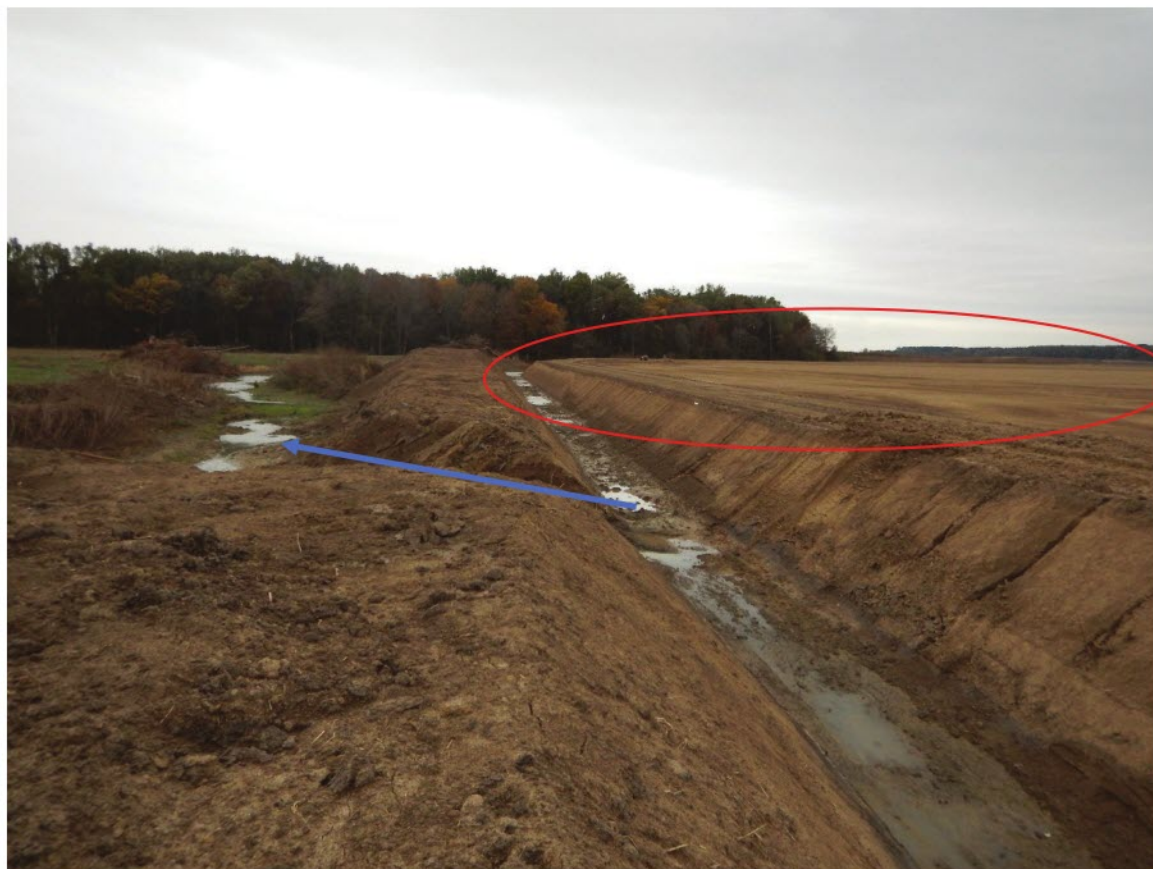
Photo No. 5

| A 404 permit was not obtained for discharge of fill material. The tributary on the northwest side of Hogpen Slough has been completely filled and a ditch has also been dug out connecting to Hogpen Slough on the north side. The riparian zone on river right has been completely removed below the Ordinary High Water Mark and the road has been built up that runs parallel to Hogpen Slough. We also observed several areas where the road is sloughing off and the bank is eroding into the stream. There are concerns with impacts to water quality and flow impairment due to increased bank erosion and sedimentation. Refer to maps and photos for details. Note in the USA NAIP Imagery the remnant stream channel of the tributary to Hogpen Slough that has now been filled. | | | |

| Photo File Name | Date and Time of Photo | Photographer | Description |
|---|---|---|---|
| DSCN6172 | 11/09/2023, 10:52 AM | Chelsey Sherwood | Showing downstream of ditch. Note the red circle shows area where tributary to Hogpen Slough should be, but has been filled. The blue arrow shows where the ditch is now connecting to Hogpen Slough. Picture taken facing south. |

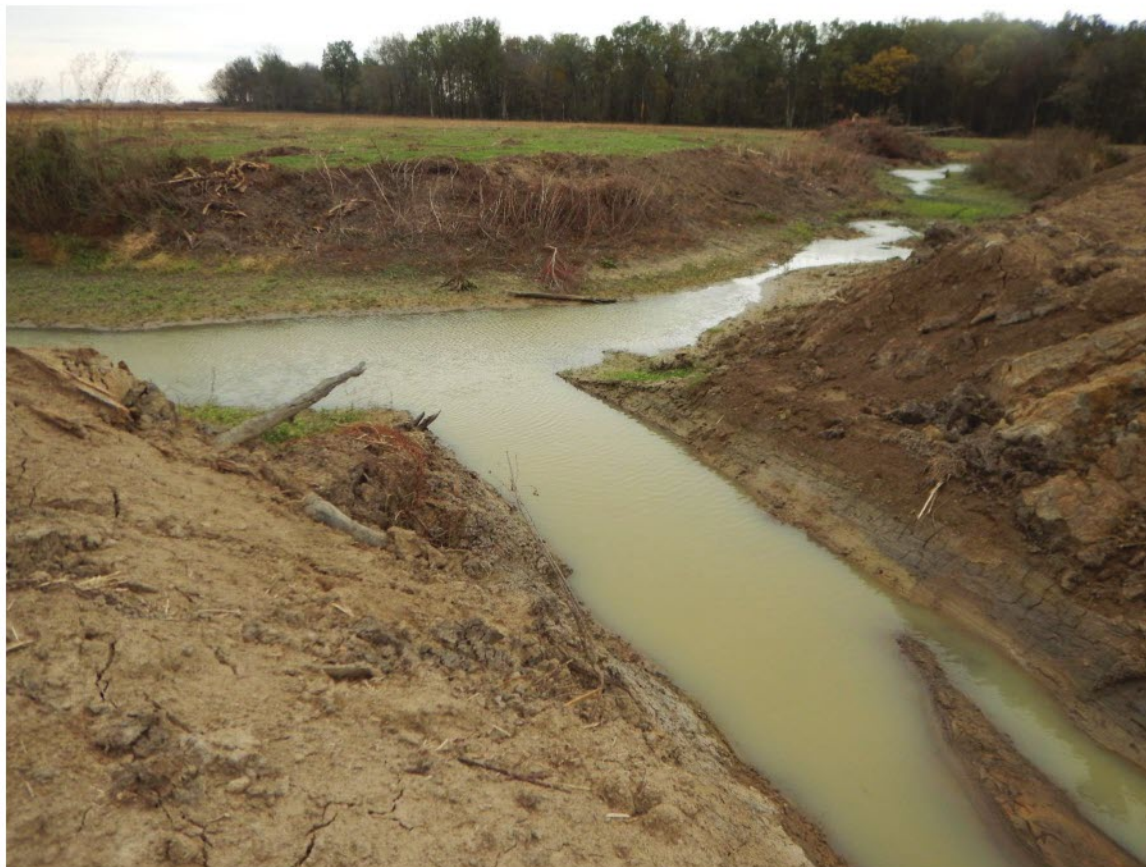
Photo No. 6

| Photo File Name | Date and Time of Photo | Photographer | Description |
|---|---|---|---|
| DSCN6173 | 11/09/2023, 10:54 AM | Chelsey Sherwood | Showing confluence of connection from ditch to Hogpen Slough. Note turbidity and sloughing of banks. Picture taken facing southeast. |

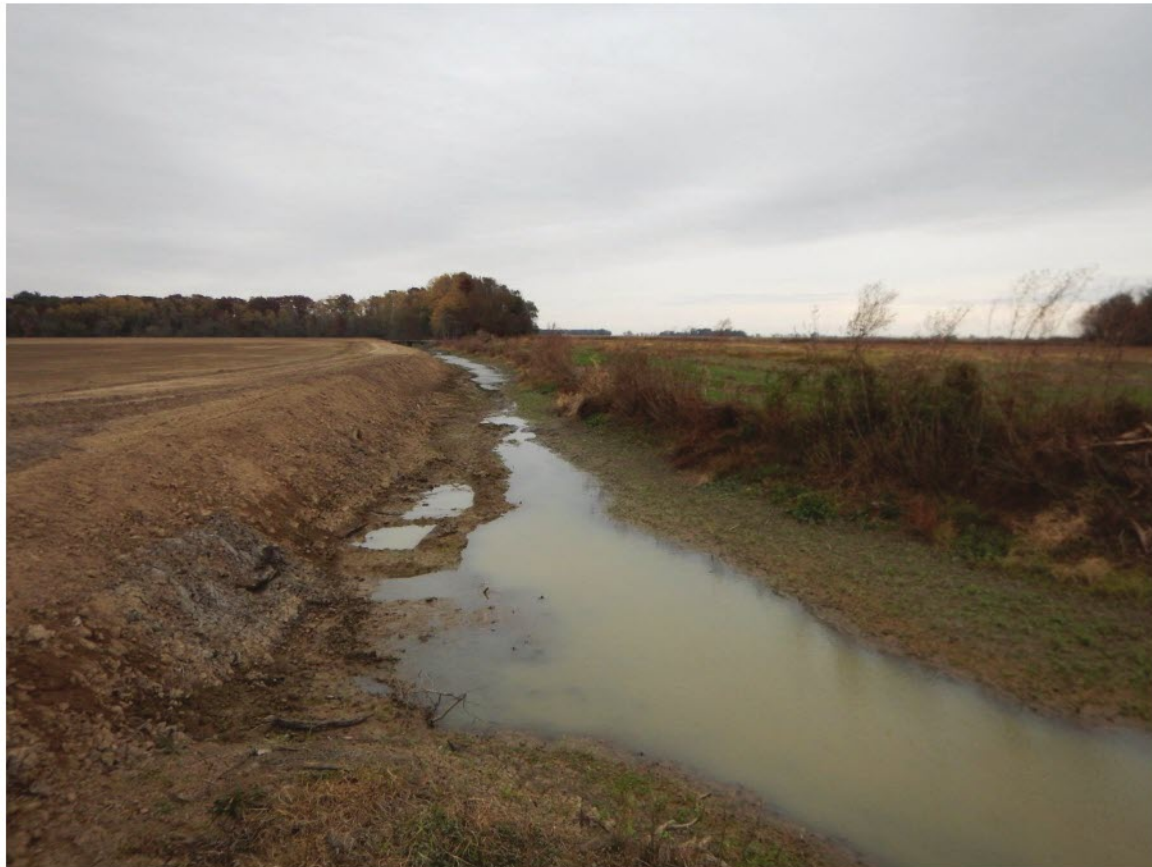
Photo No. 7

| Photo File Name | Date and Time of Photo | Photographer | Description |
|---|---|---|---|
| DSCN6174 | 11/09/2023, 11:01 AM | Chelsey Sherwood | Showing upstream of Hogpen Slough from confluence of ditch. Note vegetation completely removed below Ordinary High Water Mark along river right bank and the road built up along the stream. Also, note the sloughing of the road into the stream and the sedimentation in the stream bed impeding flow. Picture taken facing northeast. |
