## **RCRA Inspection Report**

Safety-Kleen Systems, Inc.  
125 Sommerville Park Road  
Raleigh, NC 27603

July 13, 2023, 8:55am

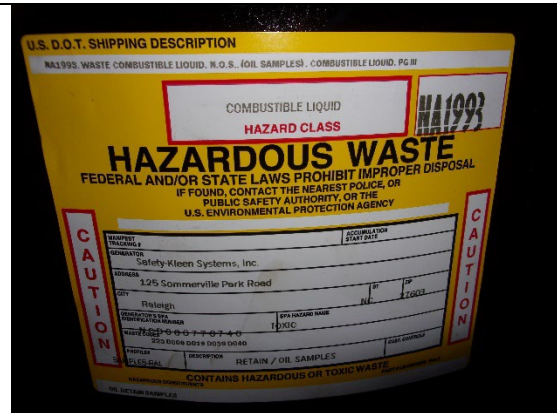
SK manages a permitted storage area in the West Drum Storage Room for managing immersion cleaner wastes, aqueous parts washer solvent, Perchloroethylene waste, new project and empty containers that is generated by various processes such as received waste from generators, cleaning washer parts, etc. The inspectors observed one 55-gallon container in this area. The container was equipped with a latching lid, which was closed (Figure 2). The container was marked as “SAMPLES-RAL”, labeled D008, D018, D039, D040 hazardous waste “Retain/Oil Samples,” and identified with an indication of the hazards of the contents (Figure 1).

Figure 1: 9:38 AM West Drum Storage Room  
One 55-gallon container with hazardous waste label, and indication of the hazards of the contents.

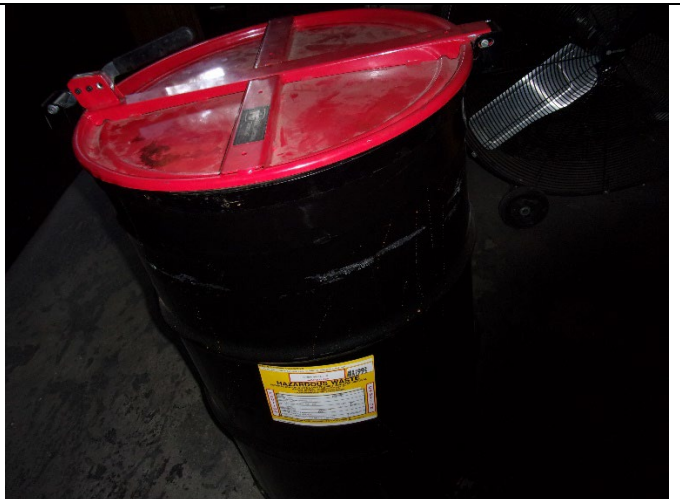
Figure 2: 9:38 AM West Drum Storage Room  
One 55-gallon container with hazardous waste label, and indication of the hazards of the contents.

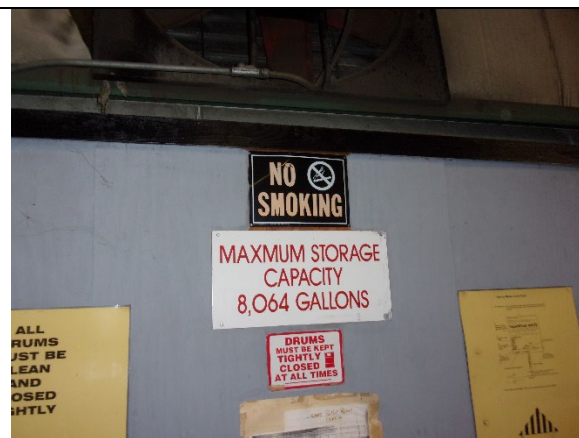
Inspectors observed a no smoking sign within the permitted storage area (Figure 3).

Figure 3: 9:43 AM West Drum Storage Room  
No smoking sign in permitted storage room.

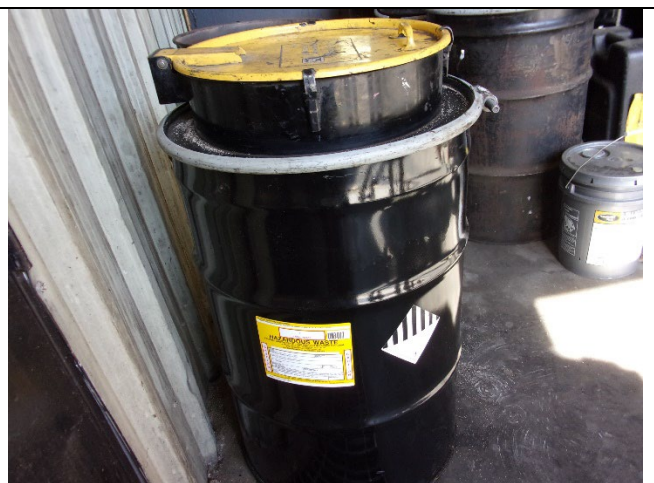
Figure 4: 9:51 AM Clean Mineral Spirits Area  
One 55-gallon container with hazardous waste label, and indication of the hazards of the contents.

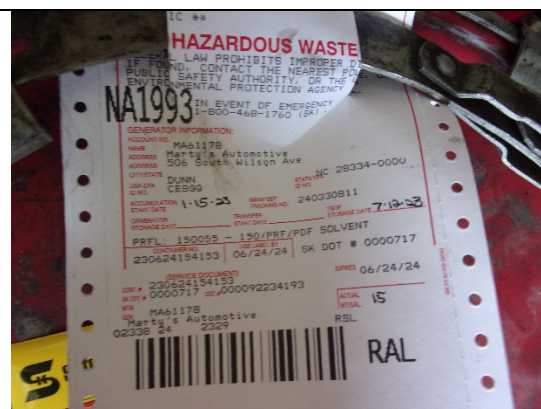
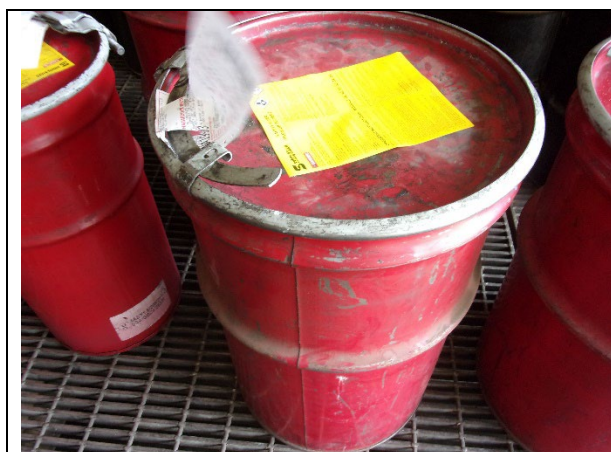
Inspectors also observed one 35-gallon container to be emptied into the drum washer unit where it is sent to Tank No.3 in their tank farm (Figures 6 and 7). The container was labeled hazardous waste and included an accumulation/storage start date.

Figure 6: 9:57 AM Return and Fill Station  
One 35-gallon container with hazardous waste label, and indication of the hazards of the contents.

Figure 7: 9:57 AM Return and Fill Station  
One 35-gallon container with hazardous waste label, and indication of the hazards of the contents.

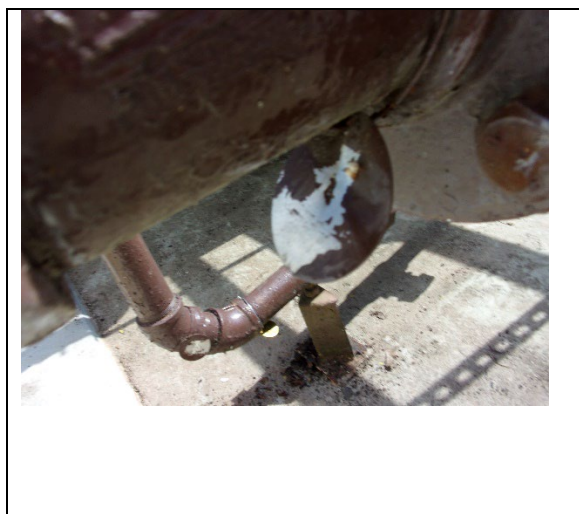
Inspectors observed tag numbers 1, 4, 6, 13, and 14 for Tank No. 3 (Figures 11 through 14). The tags observed were weathered and partially illegible. Inspectors recommended facility personnel to replace the tags.

**Pursuant to 15A NCAC 13A .0107(a) [40 C.F.R. § 262.17(a)(2)], which incorporates 15A NCAC 13A .0110(t) [40 C.F.R. Part 265, Subpart BB], and is a condition of the LQG Permit Exemption, a generator accumulating hazardous waste in tanks must comply with the RCRA Subpart BB organic air emission standards for equipment leaks, including, but not limited to, each piece of equipment to which this subpart applies shall be marked in such a manner that it can be distinguished readily from other pieces of equipment. 15A NCAC 13A .0109 [40 C.F.R. § 264.1050(d)].**

| <p>Figure 11: 10:02 AM Tank Farm<br/>Tag number partially illegible.</p> | <p>Figure 12: 10:02 AM Tank Farm<br/>Tag #6 weathered and partially illegible.</p> |

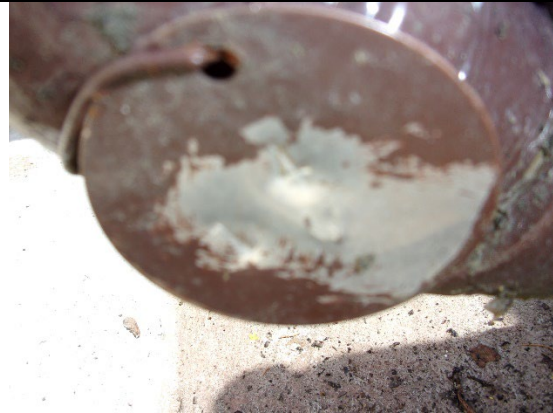
Figure 13: 10:04 AM Tank Farm  
Tag #4 partially illegible.

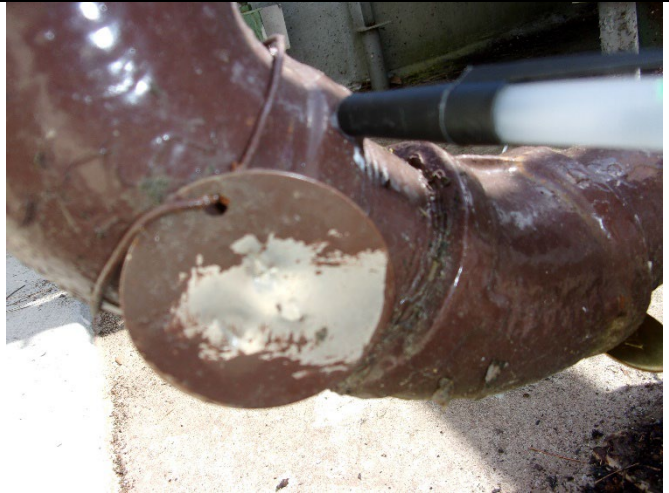
Figure 14: 10:04 AM Tank Farm  
Tag #4 partially illegible.

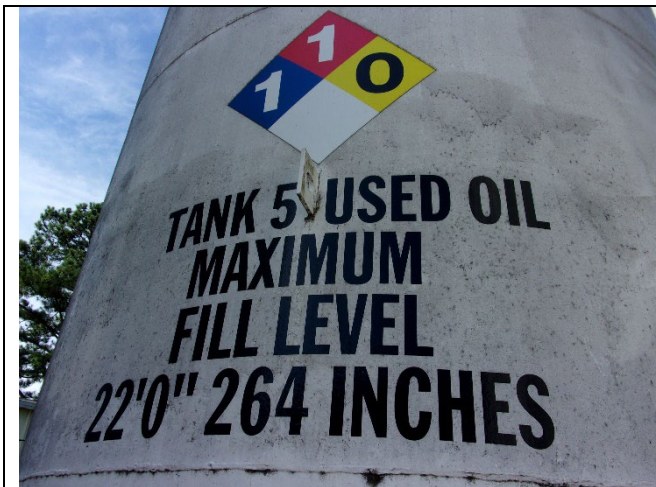
Inspectors observed Tank No.5 labeled Used Oil (Figure 15). Tank No. 1 and 4 were also labeled Used Oil.

Figure 15: 10:06 AM Tank Farm  
Tank #5 labeled Used Oil.

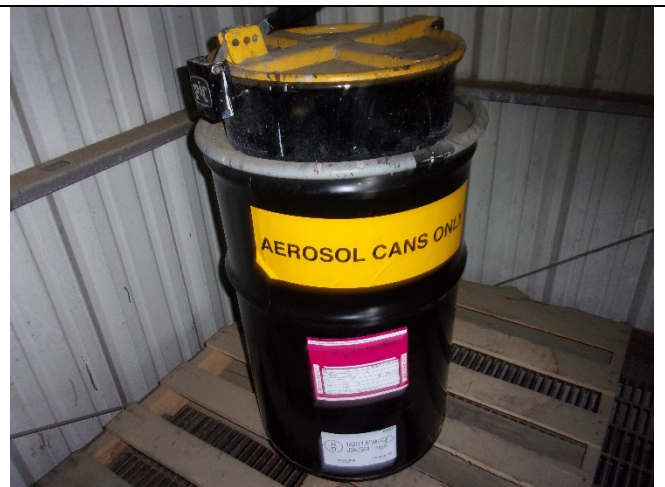
SK manages universal waste aerosol cans in this area (Figure 16). The inspectors observed one 55-gallon container of universal waste aerosol cans in this area during the inspection. The container was closed and marked with an accumulation start date, was labeled universal waste aerosol cans. The date observed on the container was July 9, 2023.

Figure 16: 10:20 AM 10-Day Transfer Area/90-Day Area  
One 55-gallon container labeled Universal Waste Aerosol Cans.
