**UNITED STATES ENVIRONMENTAL PROTECTION AGENCY**

**Subject:** Reconnaissance and Sampling Inspection Report  
Clean Water Act – National Pollutant Discharge Elimination System (NPDES)  
City of Lynn, MA

- A. Facility Name:* Lynn Water and Sewer Commission
- B. Facility Location:* 400 Parkland Avenue, Lynn, MA 01905
- C. Facility Contact:* Daniel F. O'Neill, Executive Director  
(781)596-2400, doneill@lynnwatersewer.org
- D. NPDES Permit ID:* MAR041044 (MS4)

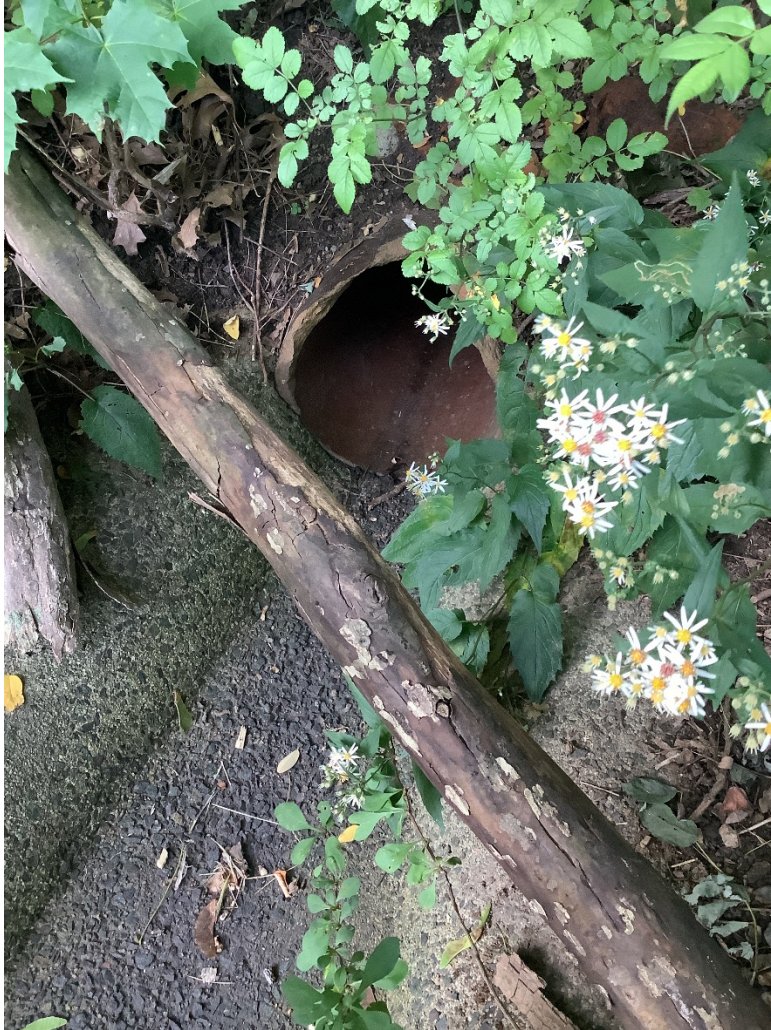
**1. SluicePond1:** One of three outfalls located on Sluice Pond along a retaining wall adjacent to the Knights of Columbus property along Lynnfield Street. Dry at the time of recon inspection. Not visited during sampling inspection.

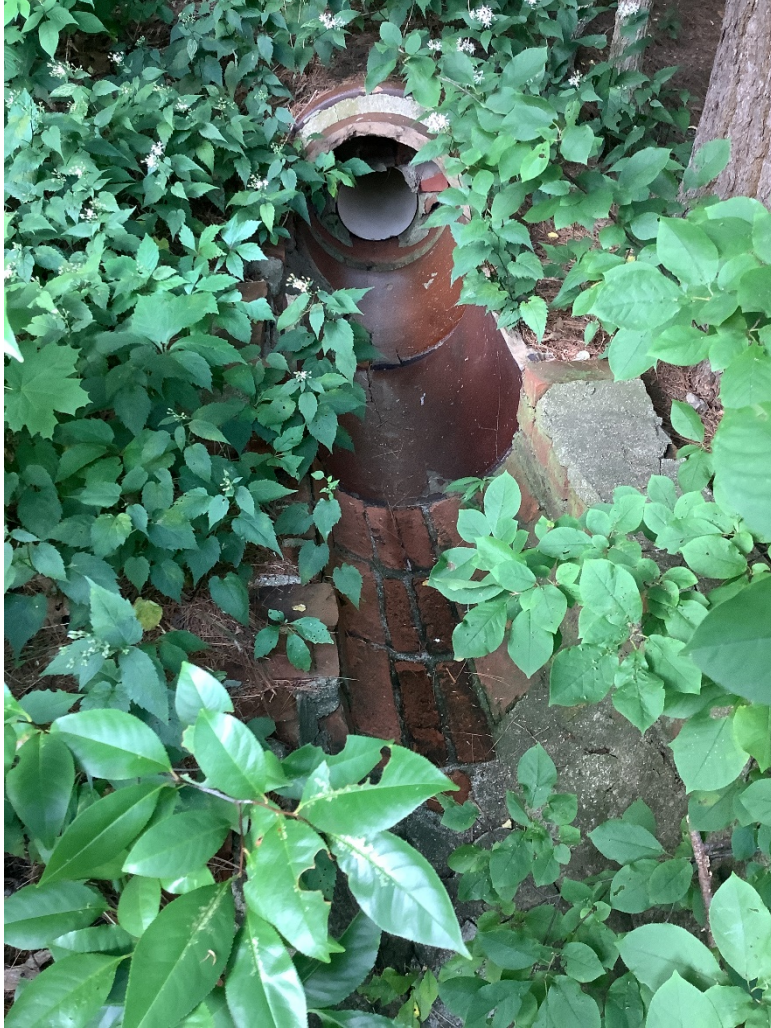
**2. SluicePond2:** One of three outfalls located on Sluice Pond along a retaining wall adjacent to the Knights of Columbus property along Lynnfield Street. Dry at the time of recon inspection. Not visited during sampling inspection.

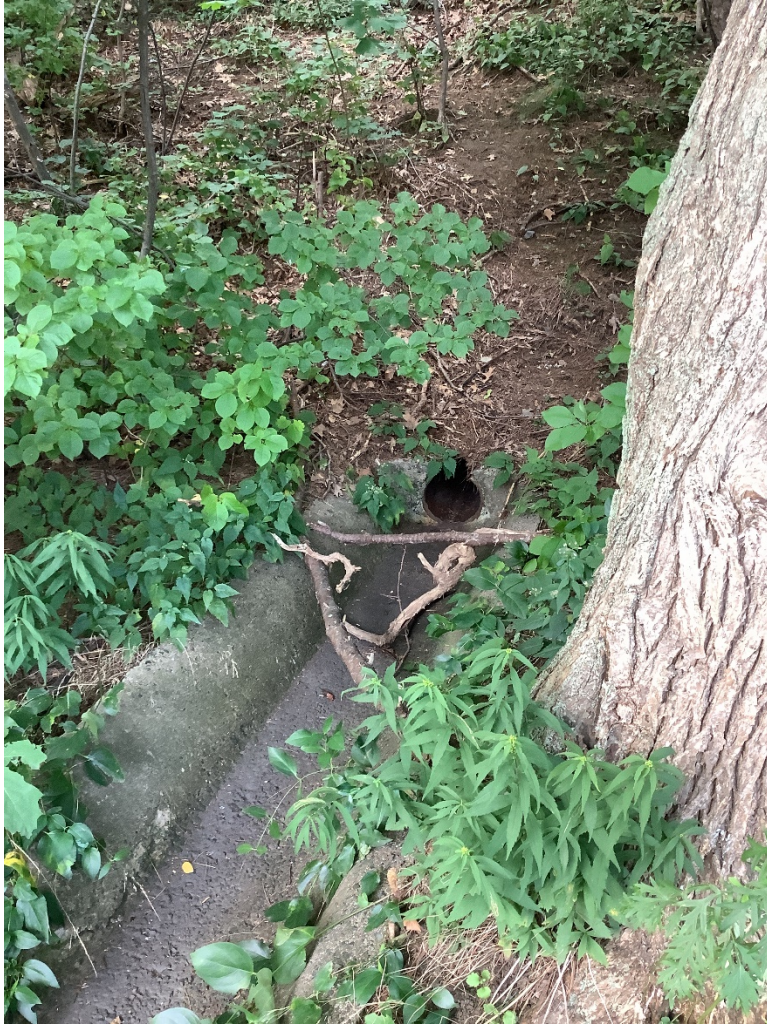
**3. SluicePond3:** One of three outfalls located on Sluice Pond along a retaining wall adjacent to the Knights of Columbus property along Lynnfield Street. Dry at the time of recon inspection. Not visited during sampling inspection.

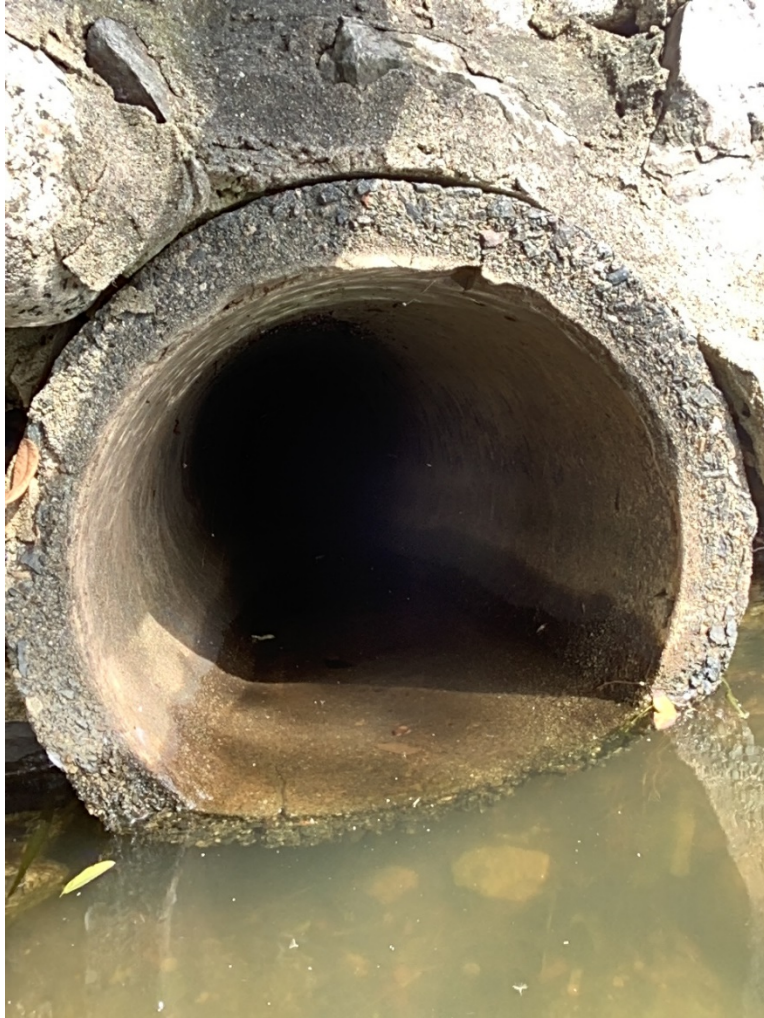
**4. CarterN:** the northmost outfall on Flax Pond along Carter Road. Height of pond caused water to backfill into the pipe, but discharge flow did not appear to be occurring. Not visited during sampling inspection.

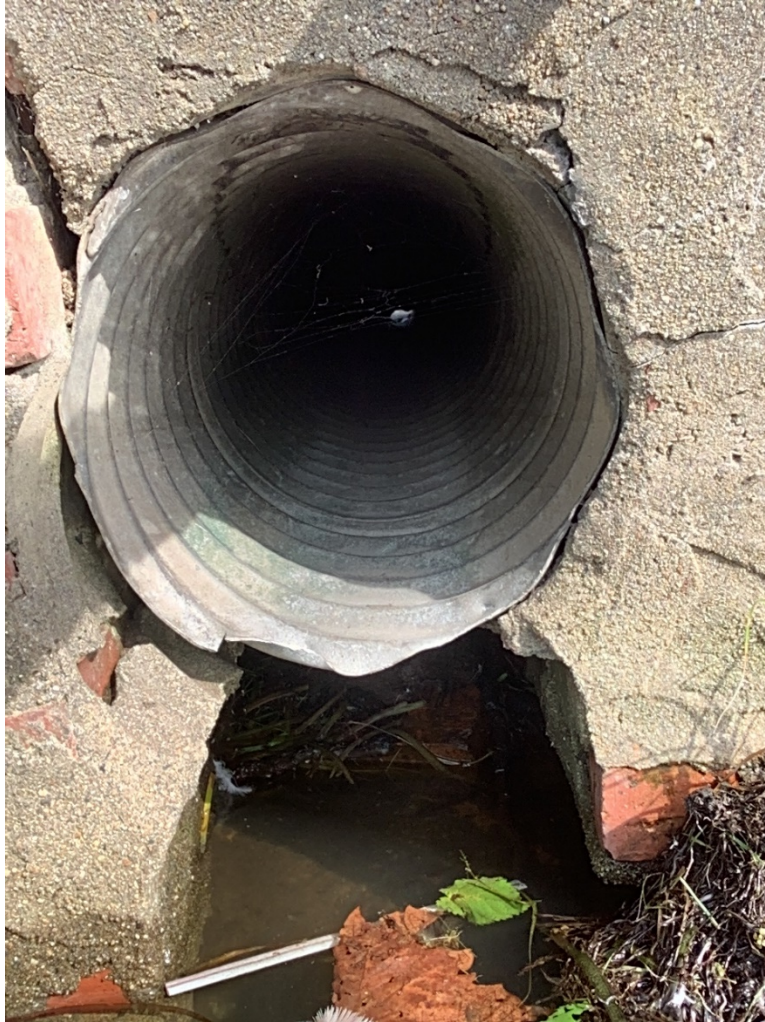
**5. CarterS:** the southmost outfall on Flax Pond along Carter Road. Dry at the time of recon inspection. Not visited during sampling inspection.

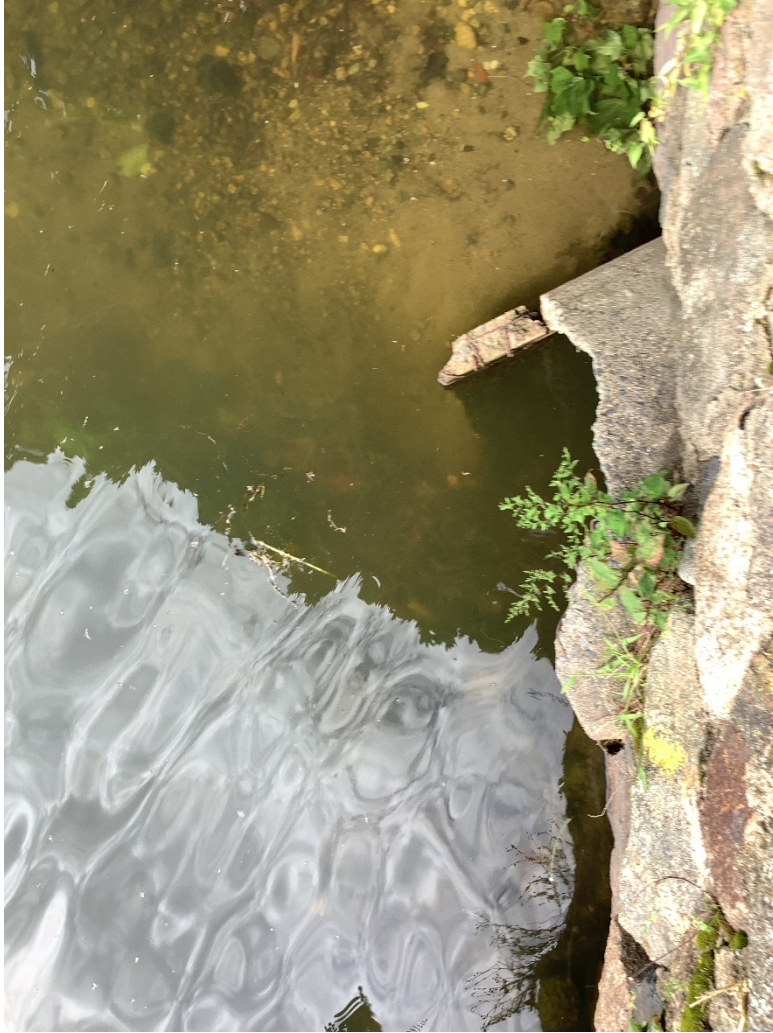
**6. LV Ave W:** Outfall on Flax Pond near 91 Lake View Avenue. Height of pond caused water to backfill into pipe, but discharge flow did not appear to be occurring. Not visited during sampling inspection.

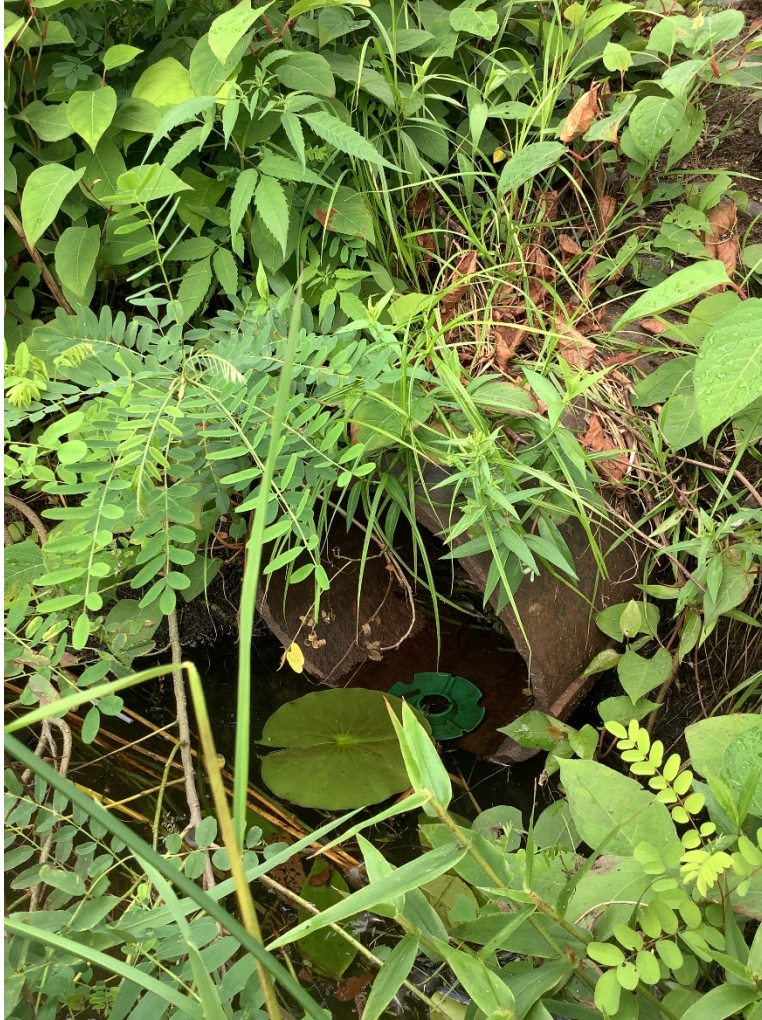
**7. 51LV Ave:** Outfall on Flax Pond located near 51 Lake View Avenue. Dry at the time of recon inspection. Not visited during sampling inspection.

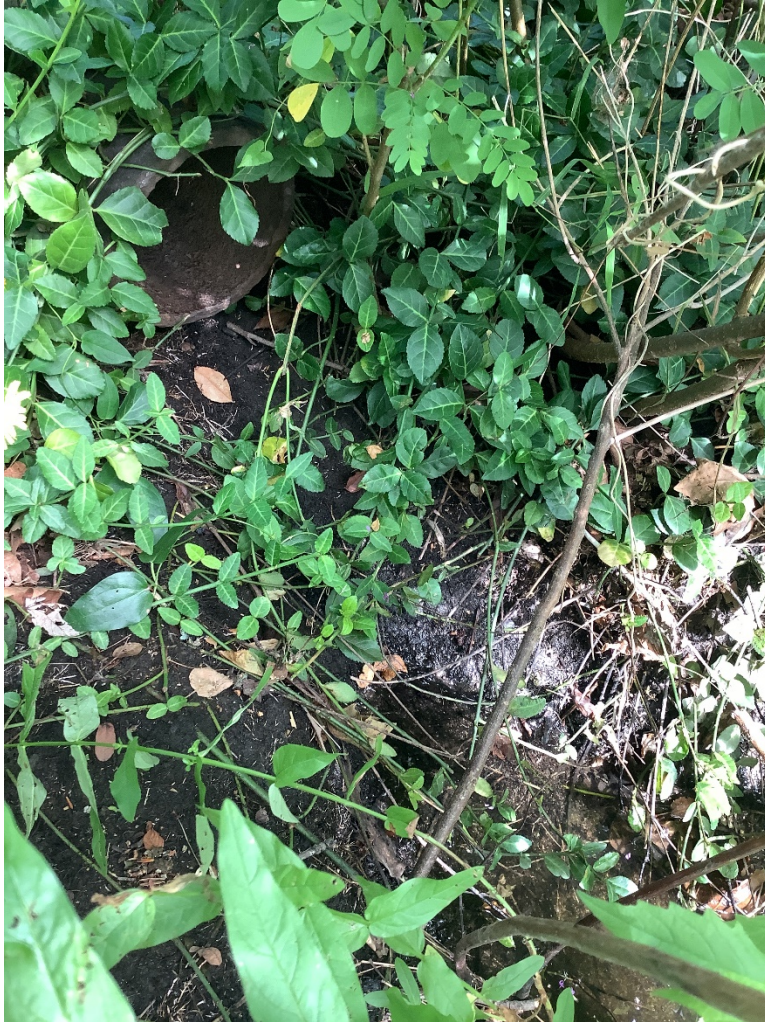
**8. Verona:** Outfall on Flax Pond located near the Verona and Lake View Avenue rotary. Dry at the time of the recon inspection. Not visited during sampling inspection.

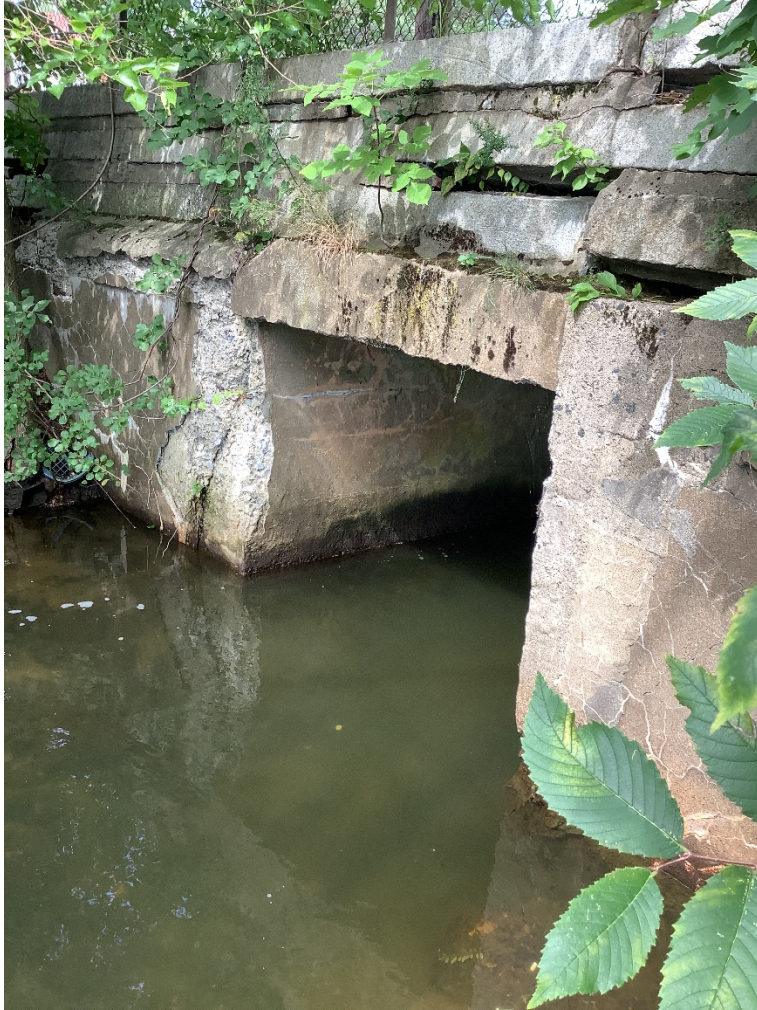
- **Magnolia**: A concrete box culvert located on the northwest end of Flax Pond adjacent to 100 Magnolia Avenue.
- **GenEdBr**: A single outfall located on the Saugus River on the northeast side of the General Edwards Bridge at the Willis Fishing Pier.
- **Heritage**: Several outfalls and CSOs located at the northwest corner of Lynn Heritage State Park on Lynn Harbor.

**9. Magnolia:** Outflow of Sluice Pond into Flax Pond, located adjacent to 100 Magnolia Avenue. Due to time constraints during the sampling inspection, no sample was collected at this location.

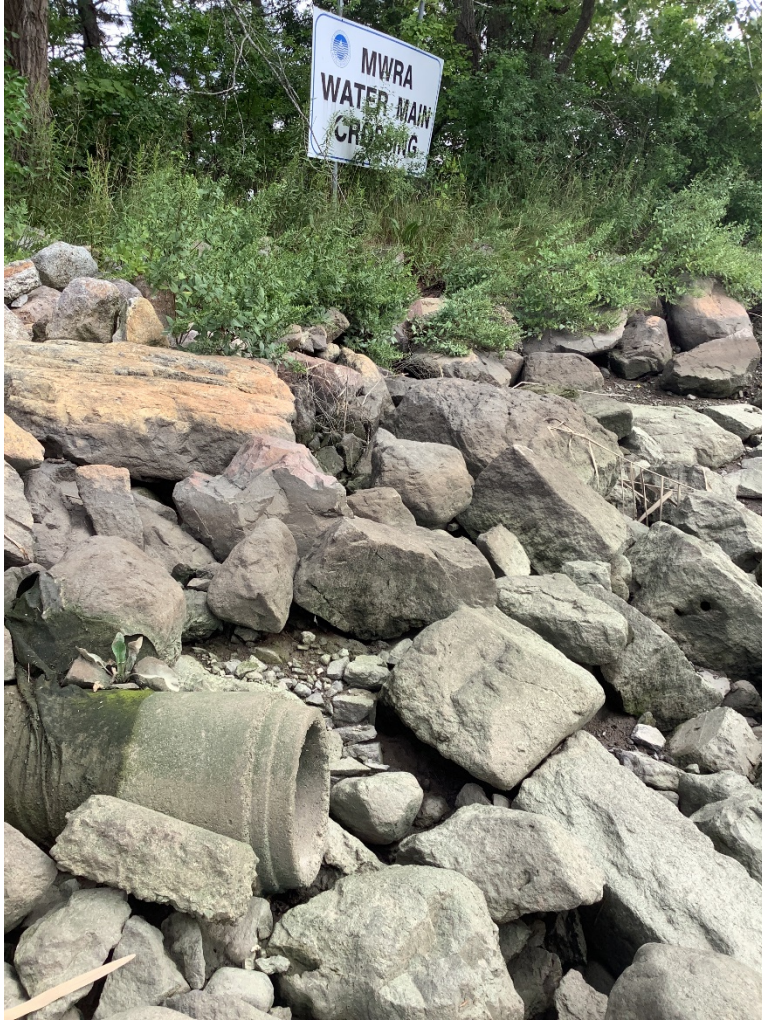
**10. 826Lincoln:** Outfall on the Saugus River located on the northeast corner of the Lincoln Avenue Bridge. Dry at the time of the recon inspection. Not visited during the sampling inspection.

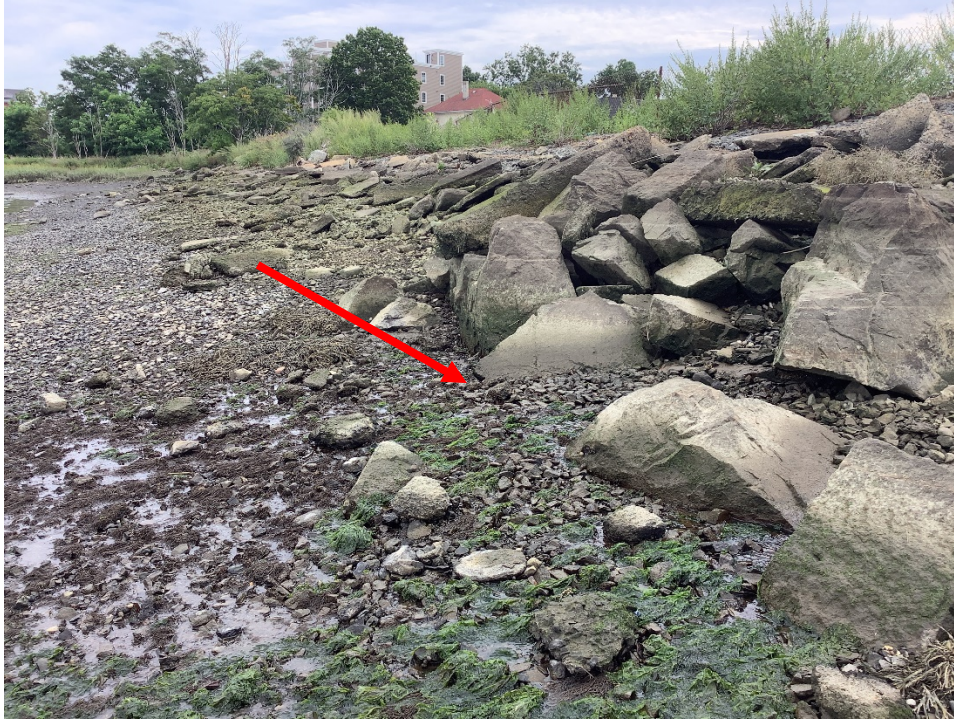
- **Bates**: Asset located along the beach north of the baseball field at the end of Bates St. Asset construction and material could not be determined as it appeared to be collapsed under a large pile of concrete material. Discharge flow was visible, and it appeared to be flowing

from under the rubble at approximately 1-2 gpm into the Saugus River. Sample was collected from a small pool where the flow appeared to be occurring.

**11. Bates:** Collapsed outfall on the beach to the north of the baseball field at the end of Bates St. Sample point indicated by a red arrow.

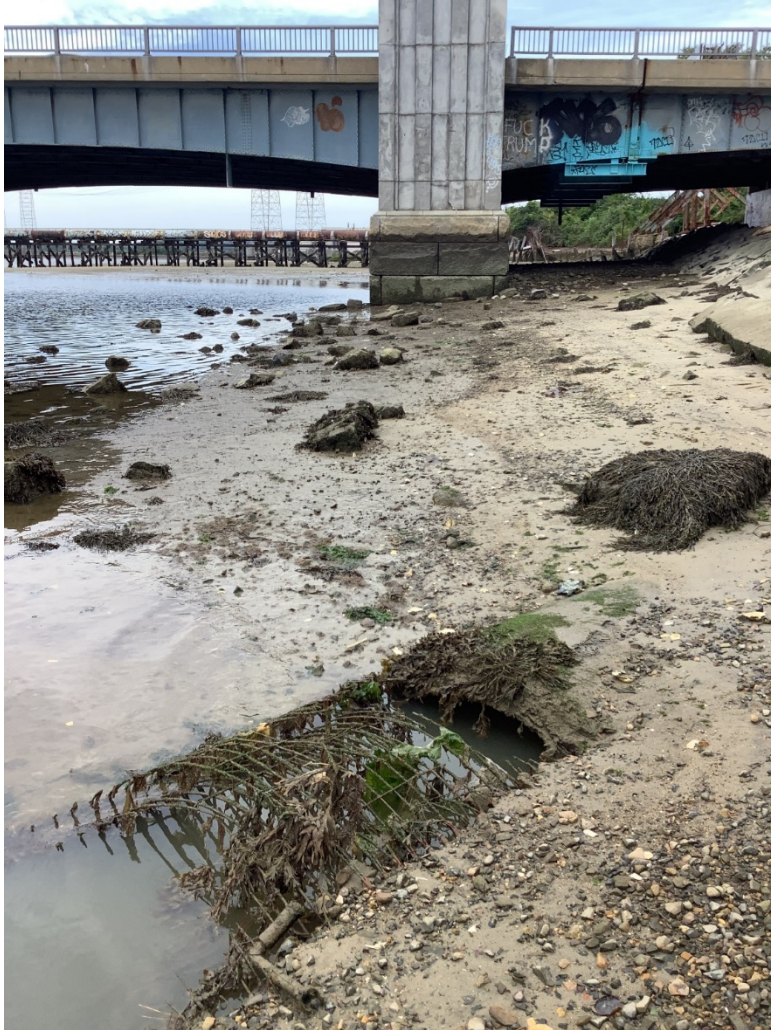
**12. GenEdBr:** Outfall on the Saugus River located on the northeast corner of the General Edwards Bridge, at the Willis Fishing Pier. Due to tidal activity, the outfall was submerged during the sampling inspection, so no sample was collected here.

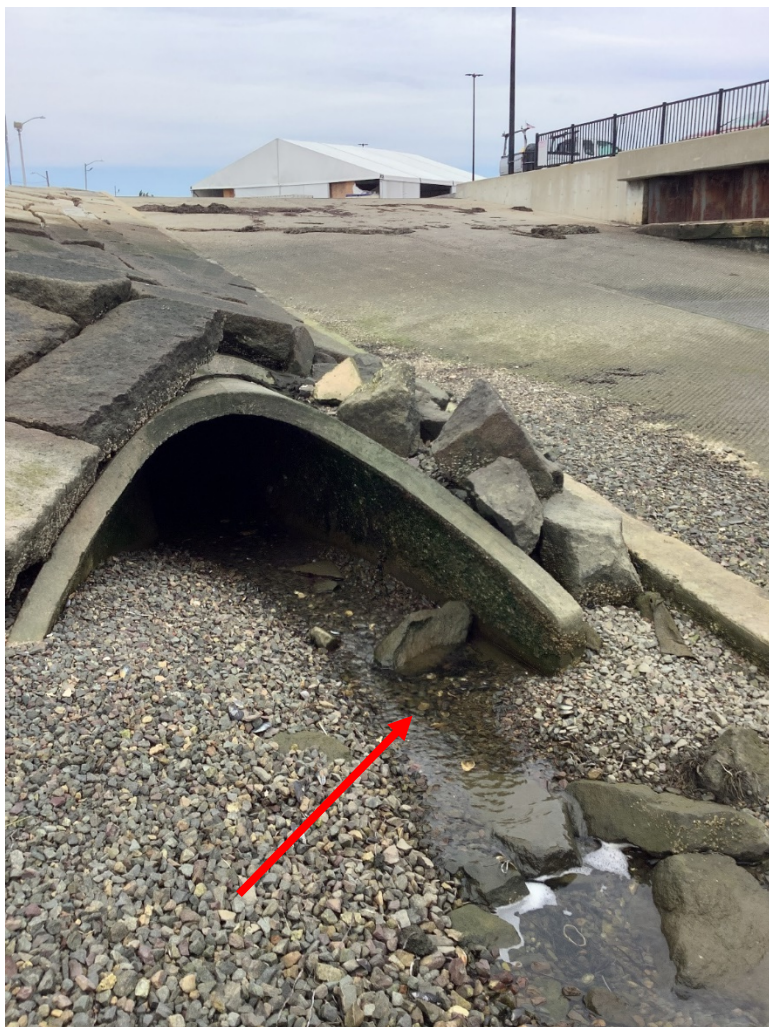
- **Blossom**: A singular elliptical concrete outfall approximately 36" in diameter located at the west side of the end of Blossom Street boat ramp. Discharge flow was approximately 5 gallons per minute (gpm) into Lynn Harbor. A slight musty odor was detected and grey staining on the rocks was observed. Sample was collected approximately 6 inches downstream from the mouth of the outfall.

**13. Blossom:** Outfall located on the west side of the Blossom Street boat ramp. Sample point indicated by a red arrow.

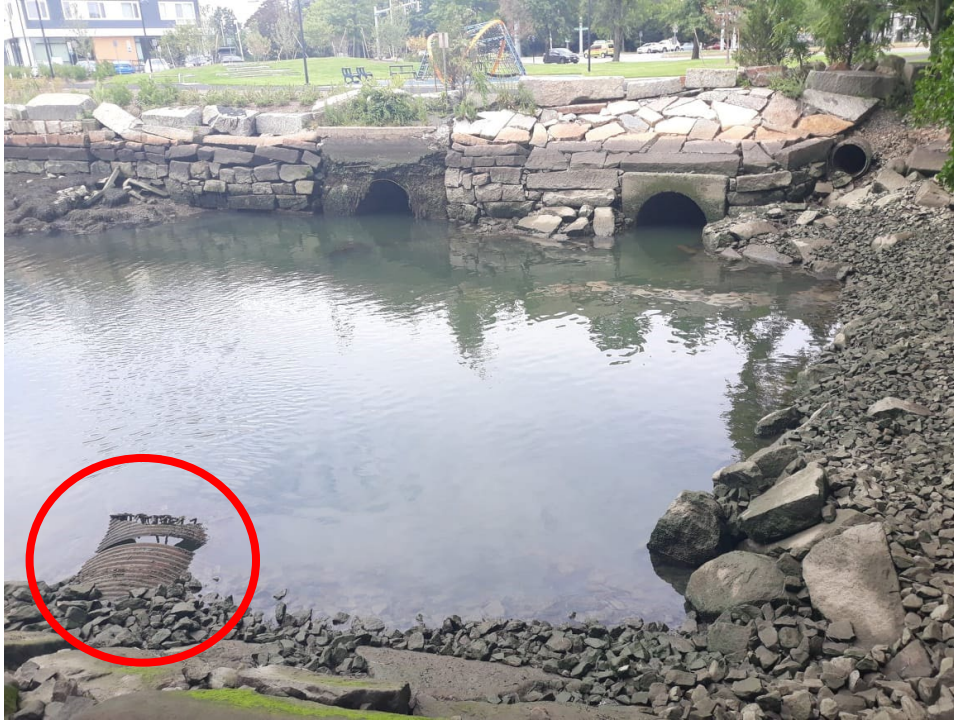
**14. Heritage:** Outfall in bottom right corner (red circle) appeared to be flowing during the recon inspection. During the sampling inspection, the outfall was submerged due to tidal activity with no apparent discharge flow, so no sample was collected.

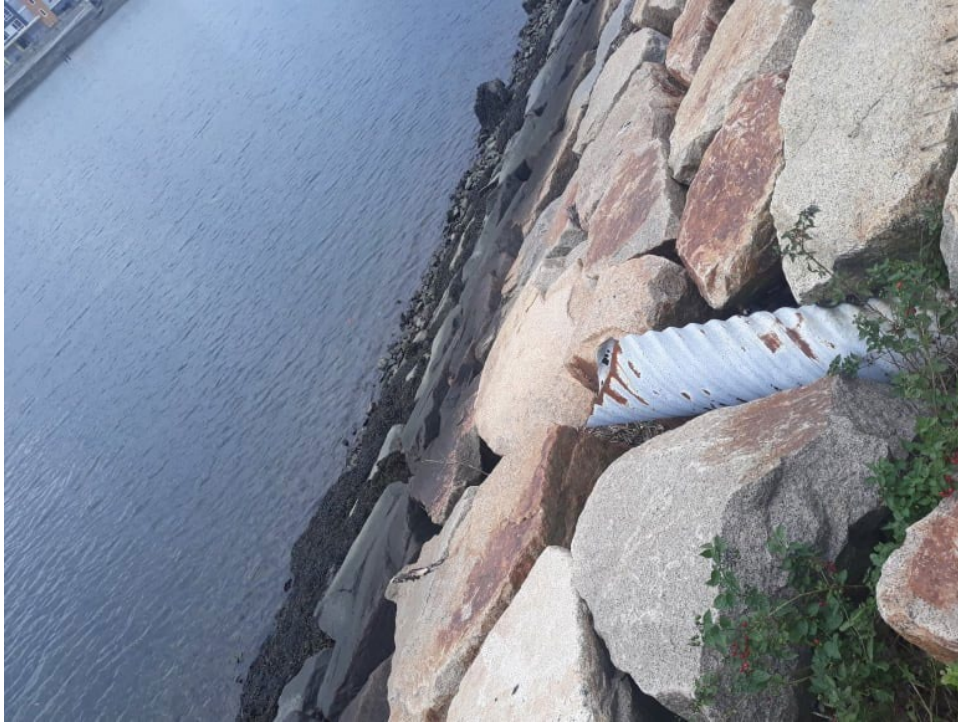
**15. Lynnway1:** One of three outfalls located along the walkway along the Lynn Hertiage Stage Park. Dry at the time of the recon inspection. Not visited during the sampling inspection.

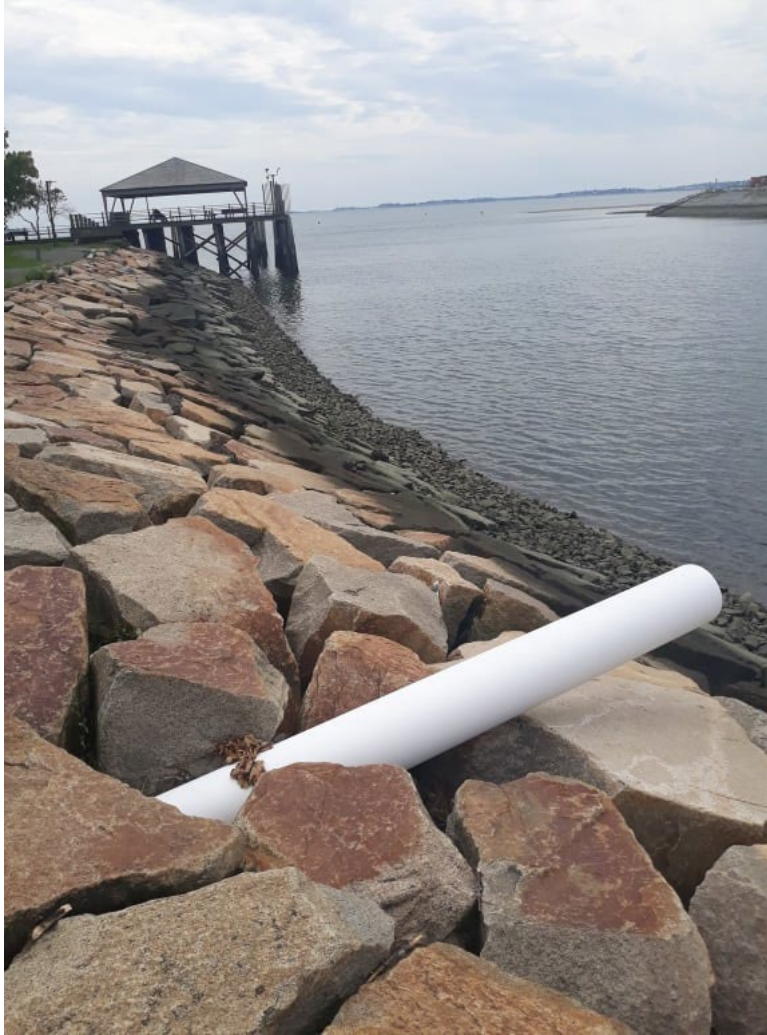
**16. Lynnway2:** One of three outfalls located along the walkway along the Lynn Hertiage Stage Park. Dry at the time of the recon inspection. Not visited during the sampling inspection.

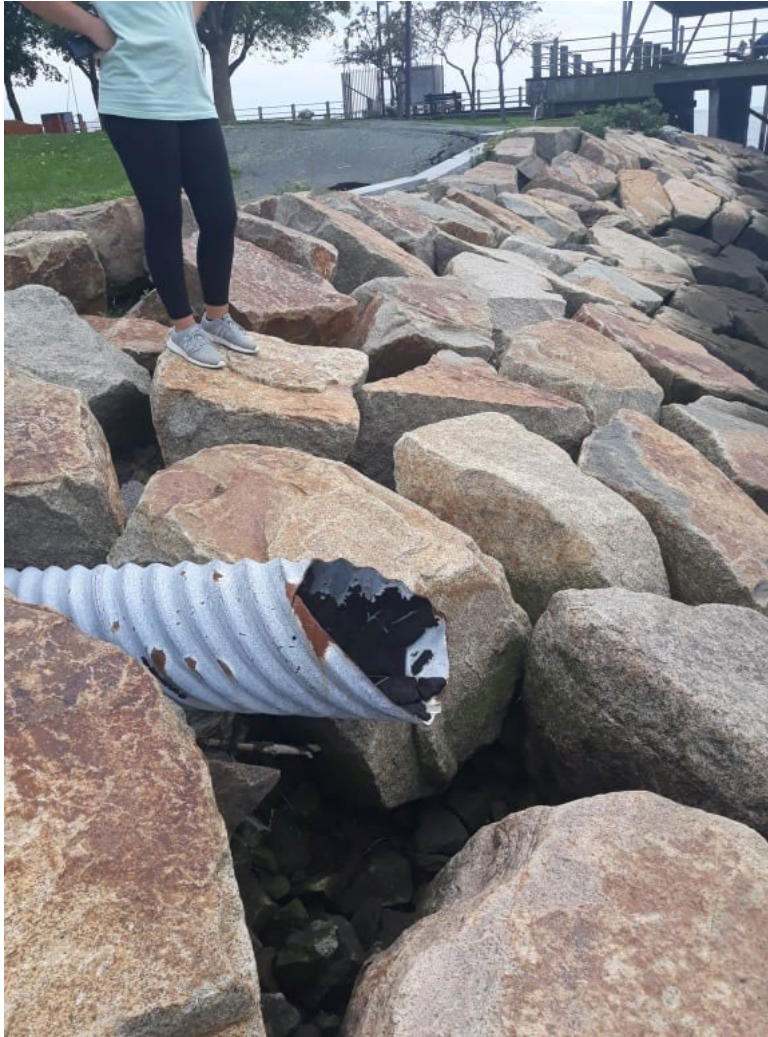
**17. Lynnway3:** One of three outfalls located along the walkway along the Lynn Hertiage Stage Park. Dry at the time of the recon inspection. Not visited during the sampling inspection.

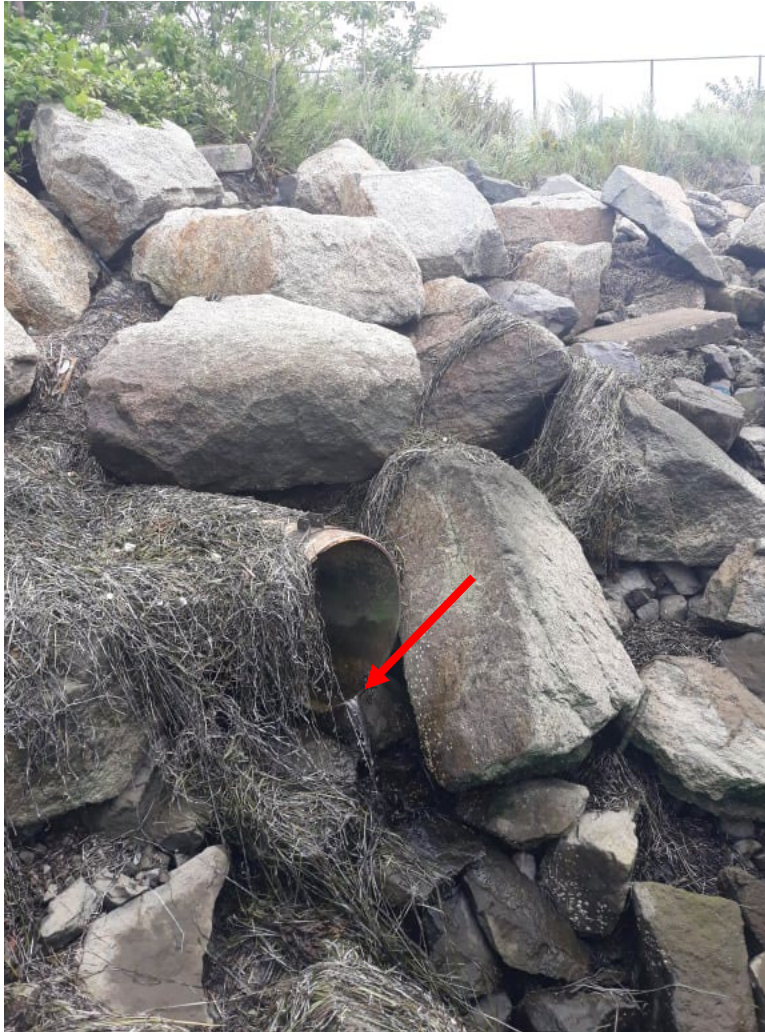
- **Surfside**: A singular circular steel outfall approximately 30" in diameter located on the southeast side of the apartment complex at 50 Lynnway. Discharge flow was approximately 2-3 gpm into Lynn Harbor. Brown algae growth was observed inside the pipe. Sample was collected at the mouth of the outfall.

**18. Surfside:** Outfall located on the southeast side of the Ocean Shores apartment complex. Sample point indicated by a red arrow.

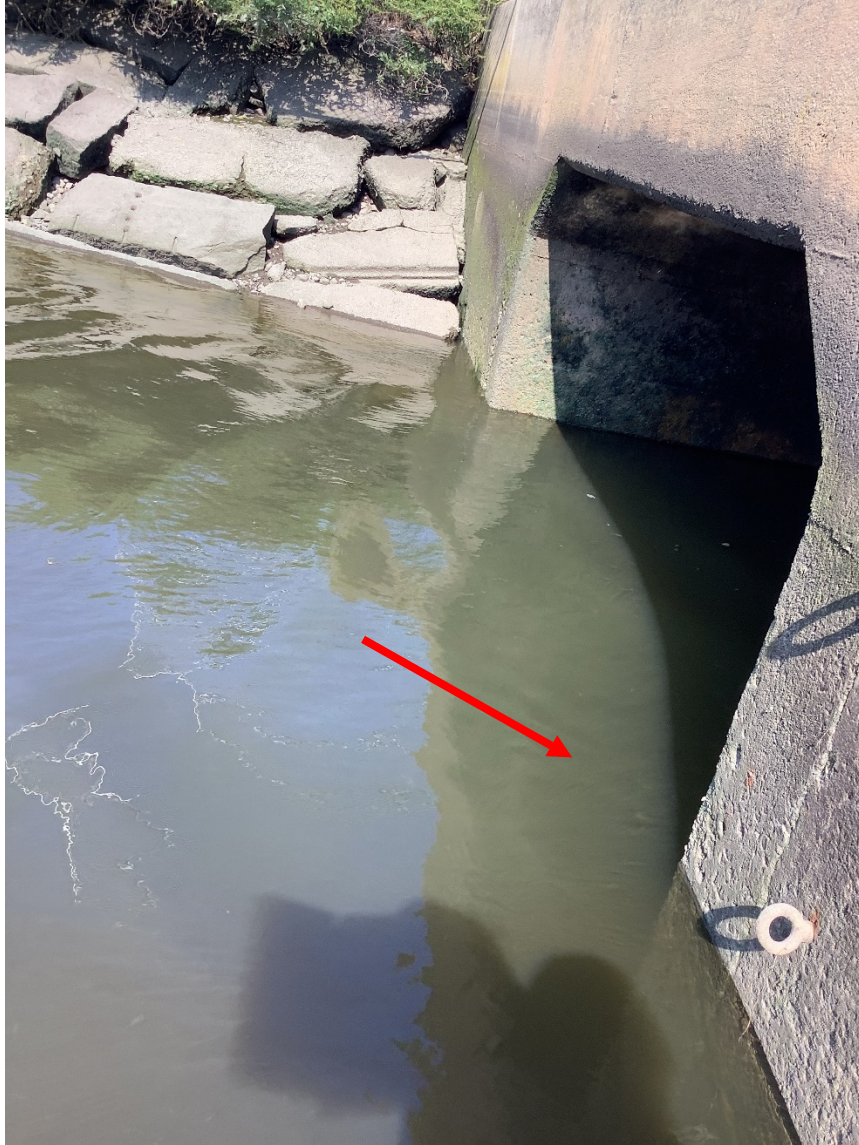
- **Strawb**: A single concrete box culvert of the Strawberry Brook outflow, approximately 7 ft by 9ft located along Summer Street that discharges into the Saugus River. Discharge flow could not be estimated, as it was an open stream. Some white suds were observed floating from inside the culvert upstream. Sample was collected at the mouth of the culvert.

**19. Strawb:** Box culvert outfall for Strawberry Brook, located along Summer Street, flowing into the Saugus River. Sample point is indicated by a red arrow.

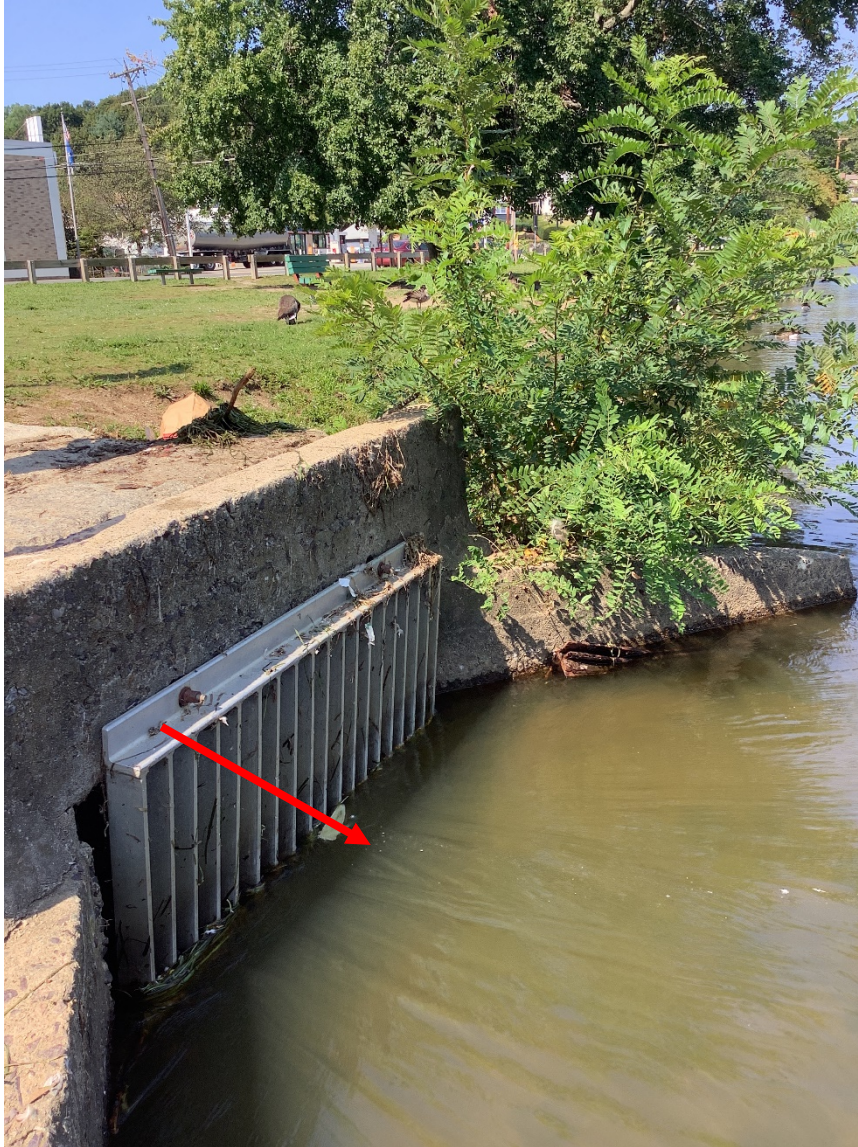
- **FlaxOut**: A singular reinforced concrete box culvert with steel grate approximately 6' by 4' located along Chestnut Street adjacent to the Flax Pond Playground. The asset discharges flow from Flax Pond. Sample was collected at the mouth of the culvert upstream of the gate.

**20. FlaxOut:** Outlet structure of Flax Pond adjacent to the playground located along Chestnut Street. Sample point is indicated by a red arrow.
