**UNITED STATES ENVIRONMENTAL PROTECTION AGENCY, REGION 2**  
**CARIBBEAN ENVIRONMENTAL PROTECTION DIVISION**  
**MULTIMEDIA PERMITS AND COMPLIANCE BRANCH**

**Industrial Site**  
**NPDES Stormwater Reconnaissance Inspection**

**CHITOLIE TRUCKING SERVICE, LLC**

Inspection Date: November 2, 2022

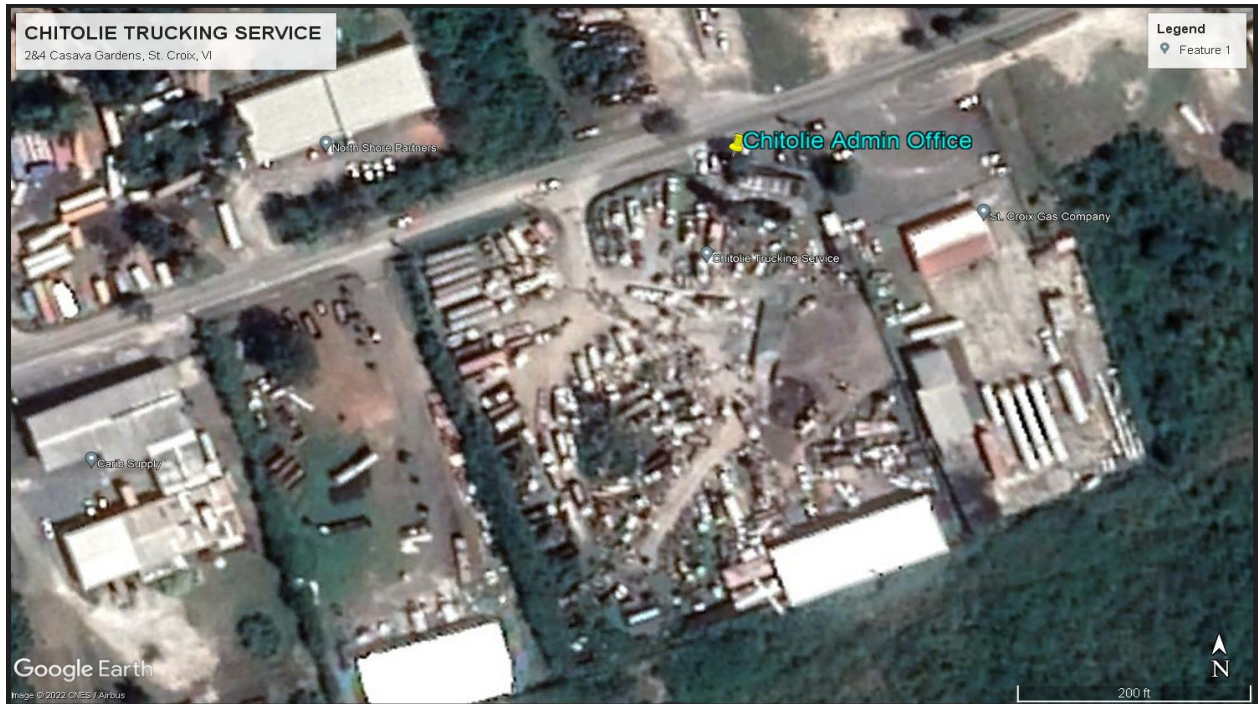
**Figure 1**  
**Chitolie Trucking Service, Christiansted, St. Croix, VI**

Chitolie Trucking Service and Industrial Compound (“Chitolie” or the “Facility”) is a trucking service provider, conducting a variety delivery and/or removal of materials operations ranging from fuel delivery to removal of debris from construction sites throughout the District of St. Croix, United States Virgin Islands (“USVI”). The Facility is located at No. 2&4 Casava Gardens, Christiansted, St. Croix, VI 00802. An aerial photograph of the Facility<sup>2</sup> is featured as **Figure 1** (below) of this Inspection Report.

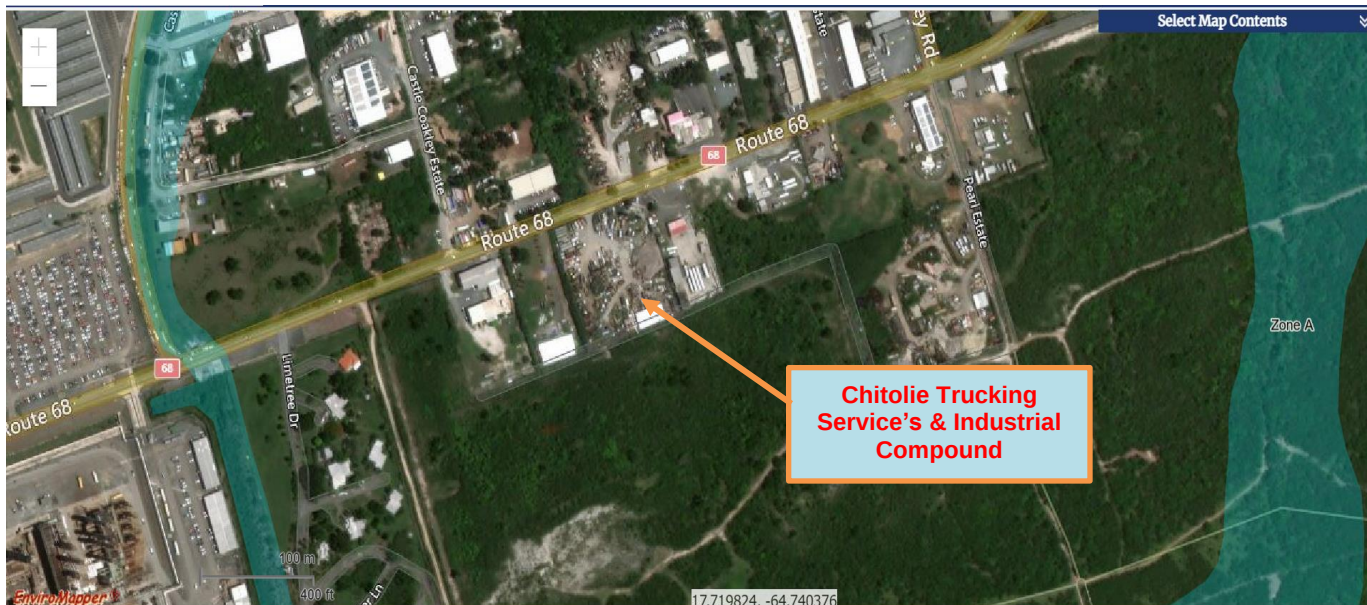
**Figure 2**

The Facility is situated in an industrial zone along the south-central coastal region of St. Croix watershed that drains into the Cane Garden Bay (Caribbean Sea). An aerial view of location of the Facility and immediate surroundings are depicted in satellite imagery of the reference watershed area featured in **Figure 2**, (Source: <https://nepassisttool.epa.gov/nepassist/nepamap.aspx>) on the next page.

**Chitolie Trucking Service's Facility situated within the south-central section of the St. Croix Watershed**
