## Region 6 - Enforcement & Compliance Assurance Division

### INSPECTION REPORT

| Company Name: | <b>J &amp; B Oil, LLC</b> | |
| Facility Name: | <b>TC Patton Tank Battery</b> | |

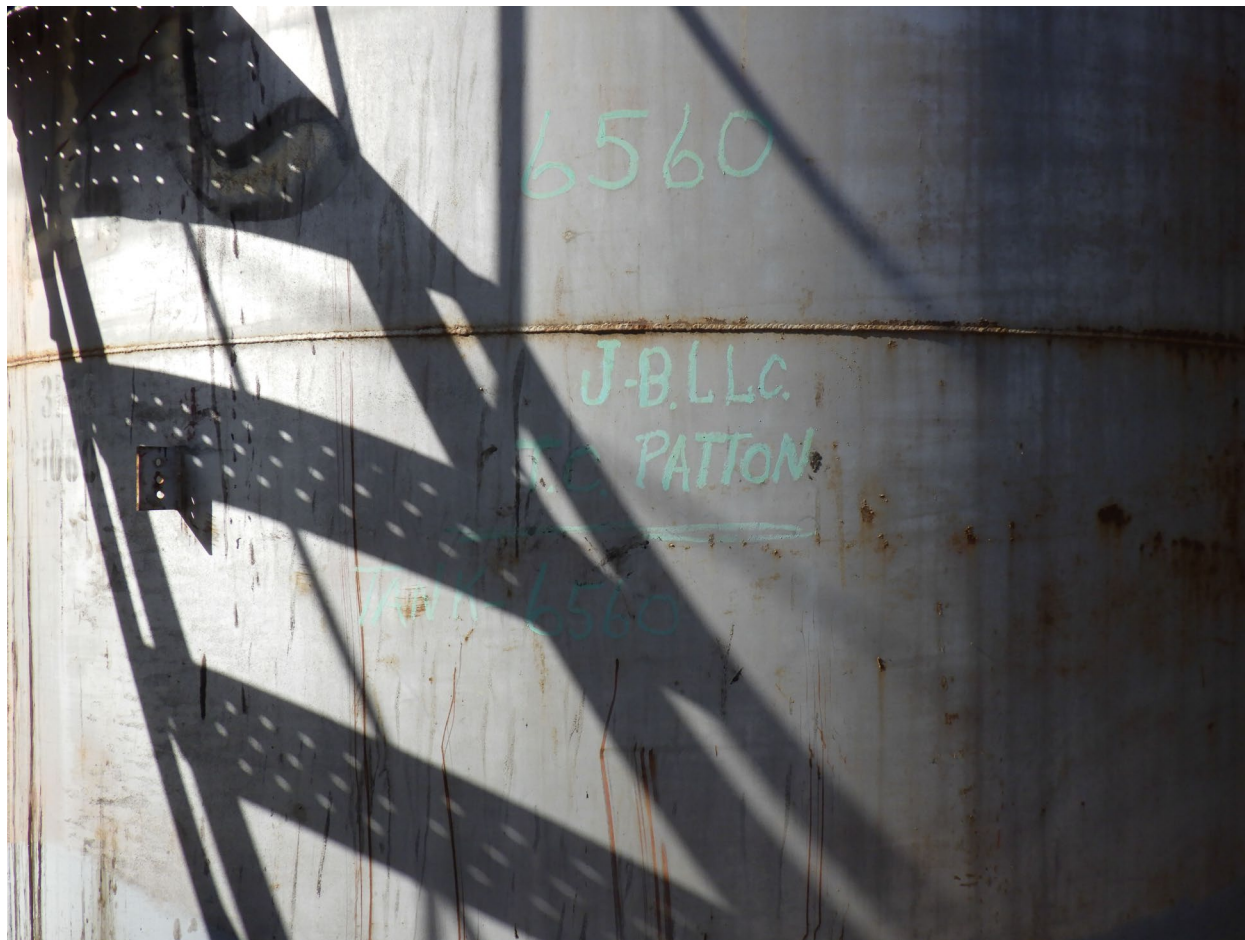
Photo No. 1

**Description:** This photo was taken looking SW showing the facility information on the tank.

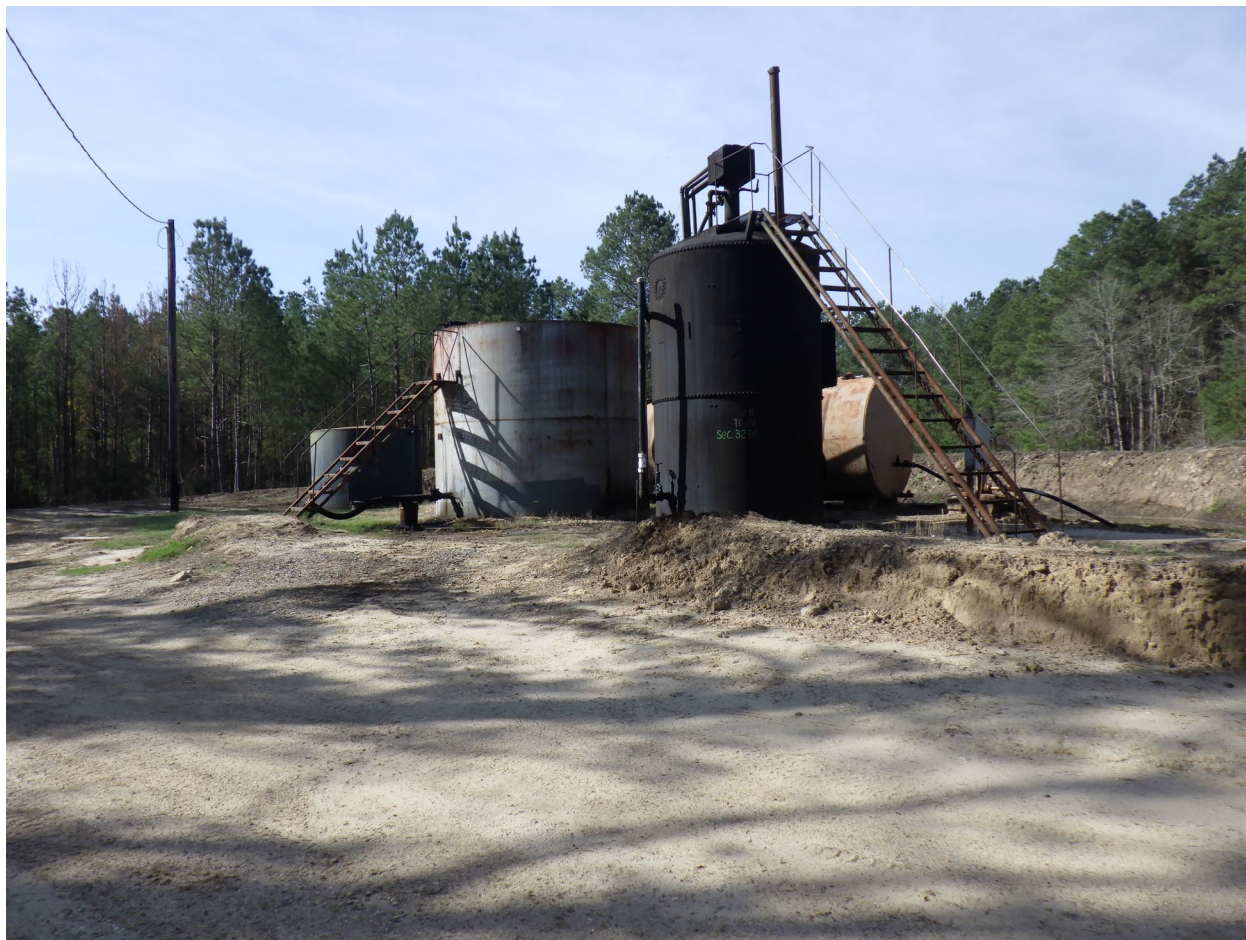
Photo No. 2

I observed the facility sign, secondary containment, oil separators, pipes, and tanks located at the facility, see Appendix 1 (photo log), photo No. 1 and No. 2. For additional GPS location and photo metadata, see Appendix 1.

**Description:** This photo was taken looking SW showing an overview of the facility.

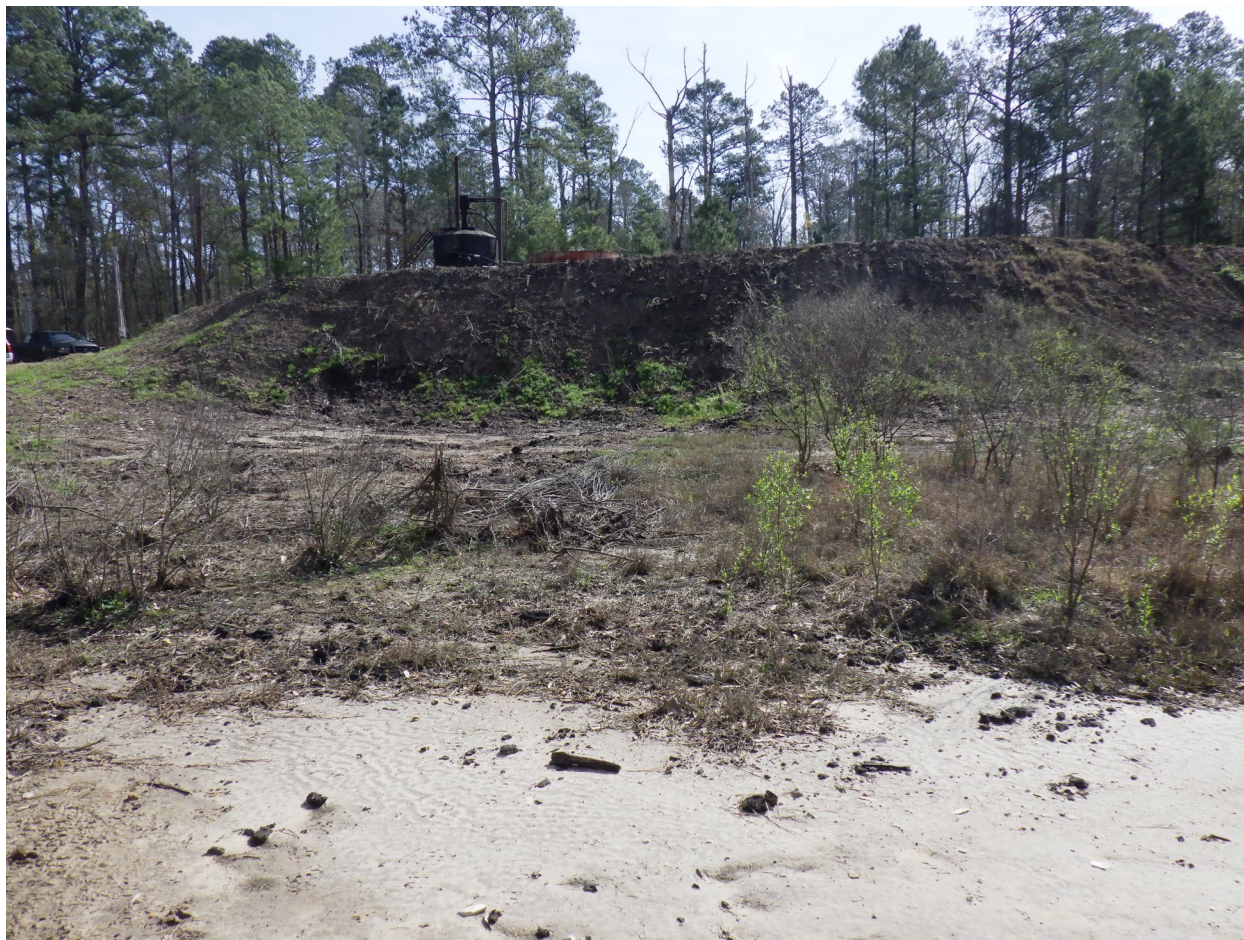
Photo No. 3

I observed the contaminated flowpath, dead vegetation, and salt crystals on top of the soil on the backside (W) of the facility, see photo No. 3 and No. 4.

No closing conference was held due to no J & B Oil, LLC staff being present during the inspection. Areas of concern at the time of the inspection include the contaminated flowpath to the unnamed tributary and the elevated TDS levels in Wolf Creek.

**Description:** This photo was taken looking ENE along the back side of the facility outside of secondary containment showing impacted flow path and dead vegetation.

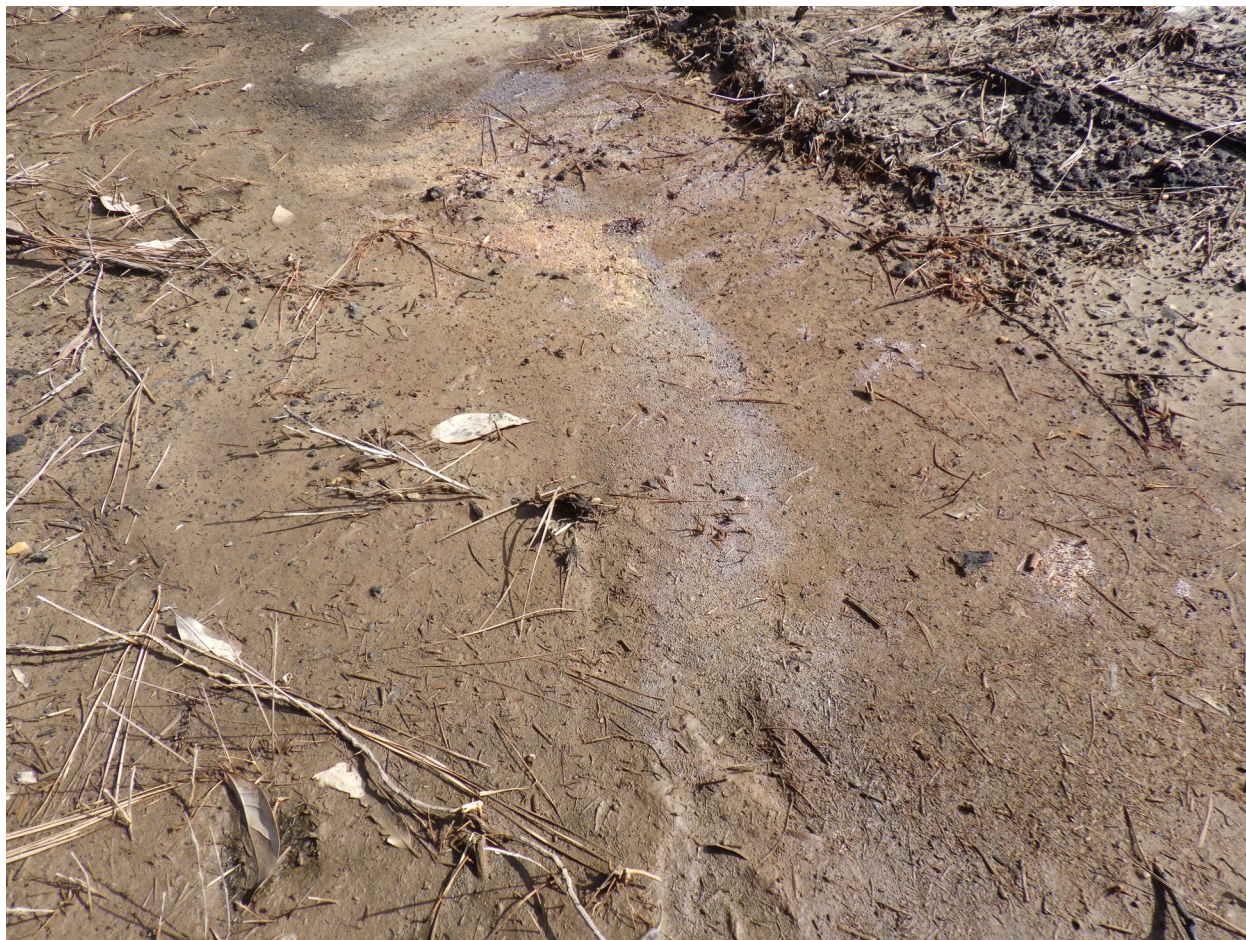
Photo No. 4

**Description:** This photo was taken looking NE showing crystalized salt on top of the soil on the flowpath by the facility.

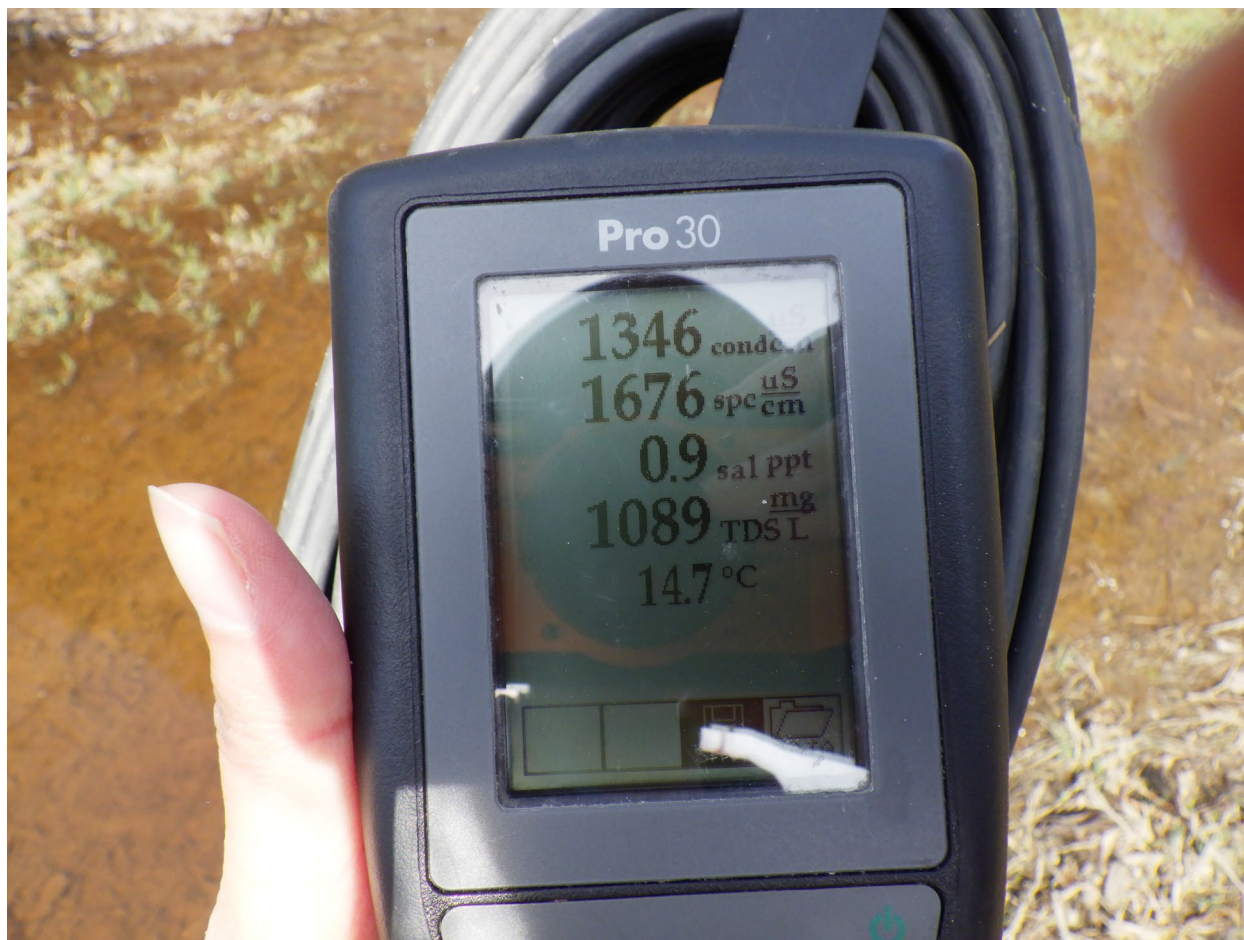
Photo No. 5

I observed a Total Dissolved Solids (TDS) reading of 1,089 mg/L as well as stream characteristics on the backside (W) of the facility in the unnamed tributary that connects to Wolf Creek, see photo No. 5 through photo No. 7.

**Description:** This photo was taken showing a Total Dissolved Solids (TDS) reading of 1,089 mg/L at the point of entry (POE) into an unnamed tributary of Wolf Creek.

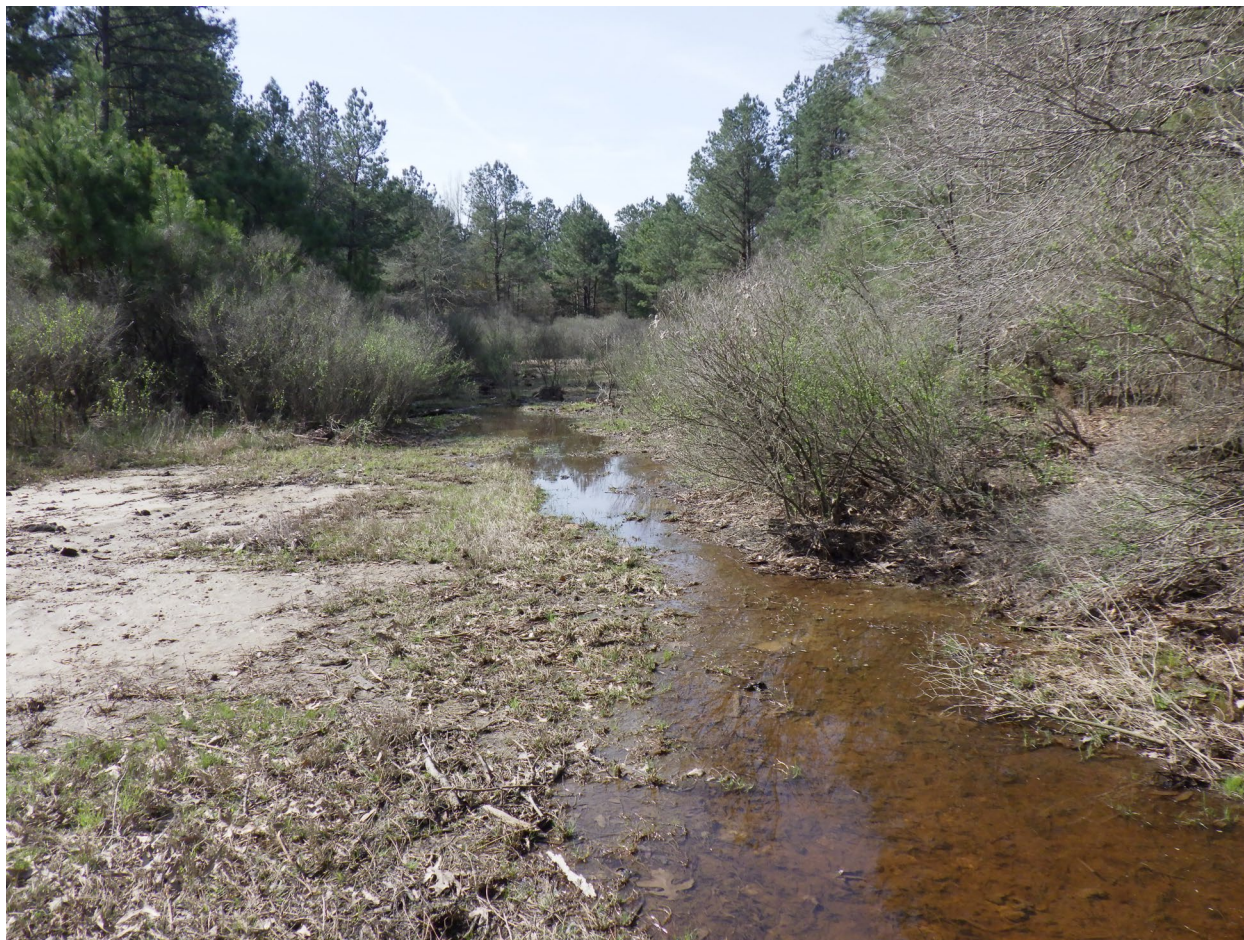
Photo No. 6

**Description:** This photo was taken looking downstream (S) from the TDS reading on Photo No. 5 showing stream characteristics of the unnamed tributary of Wolf Creek.

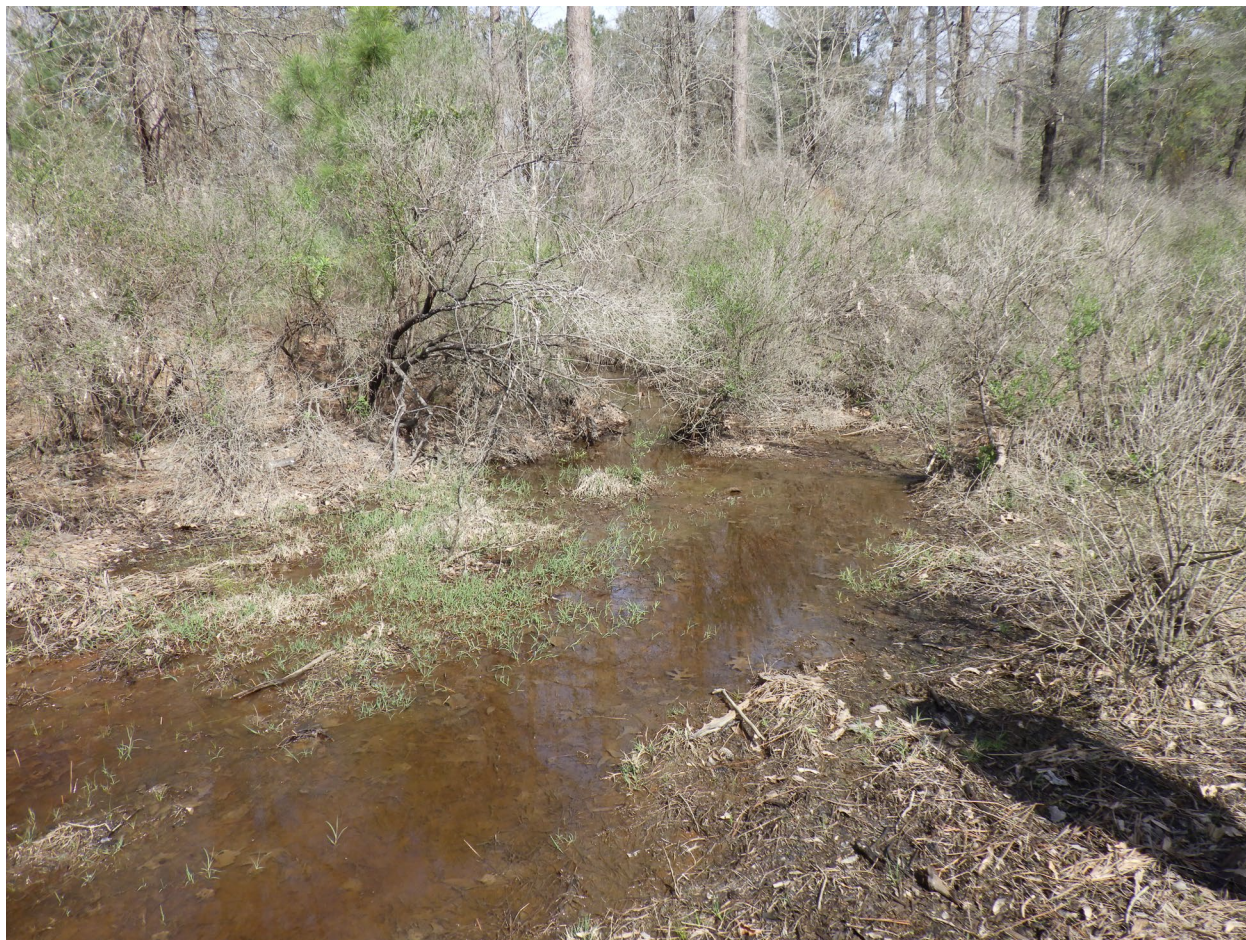
Photo No. 7

**Description:** This photo was taken looking upstream (N) from the TDS reading on Photo No. 5 showing stream characteristics of the unnamed tributary of Wolf Creek.

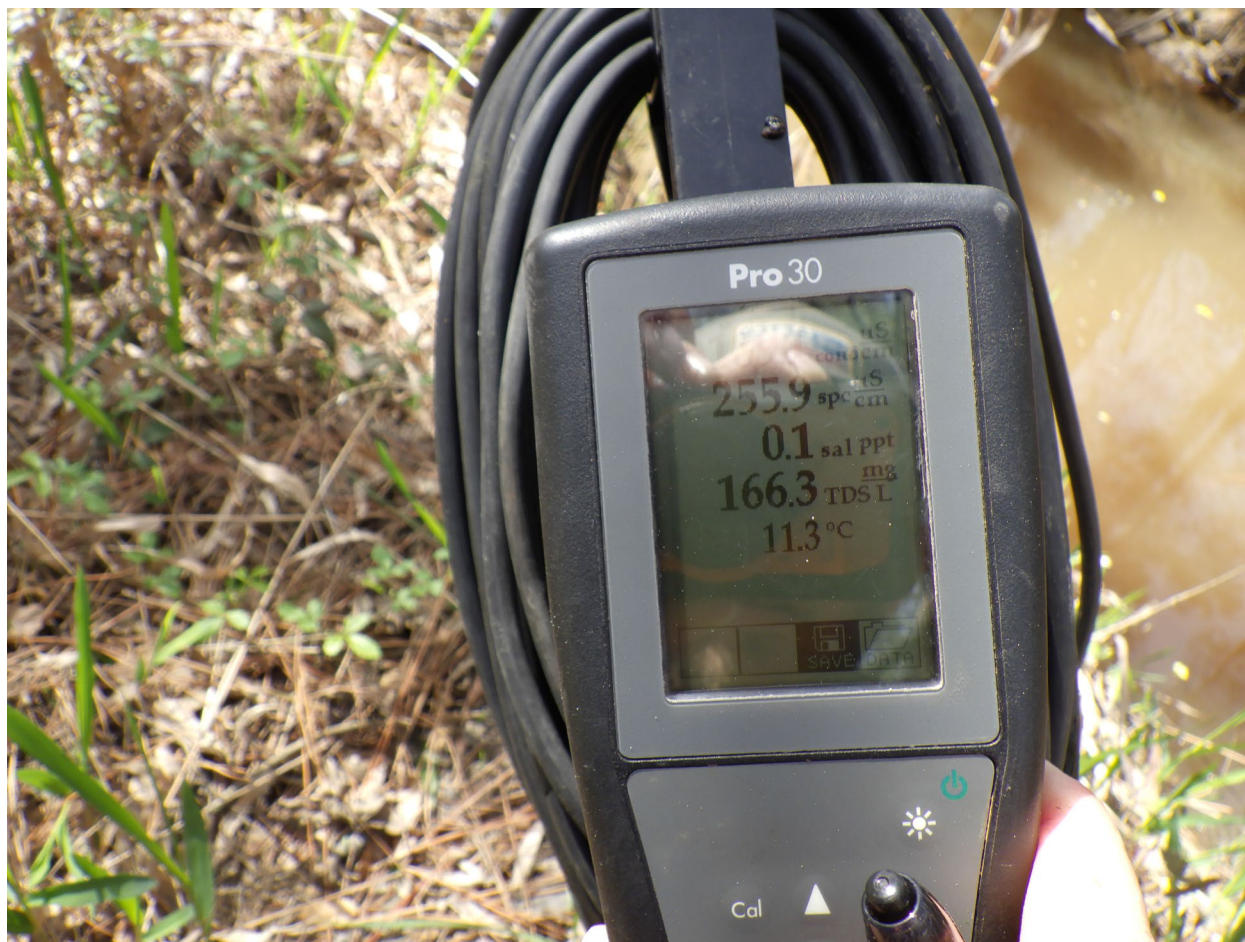
Photo No. 8

I observed a TDS reading of 166.3 mg/L upstream from the point of entry (POE) into Wolf Creek. I also observed the POE from the unnamed tributary to Wolf Creek as well as stream characteristics, see photo No. 8 through photo No. 10.

**Description:** This photo was taken showing the background TDS reading of 166.3 mg/L upstream from the POE into Wolf Creek.

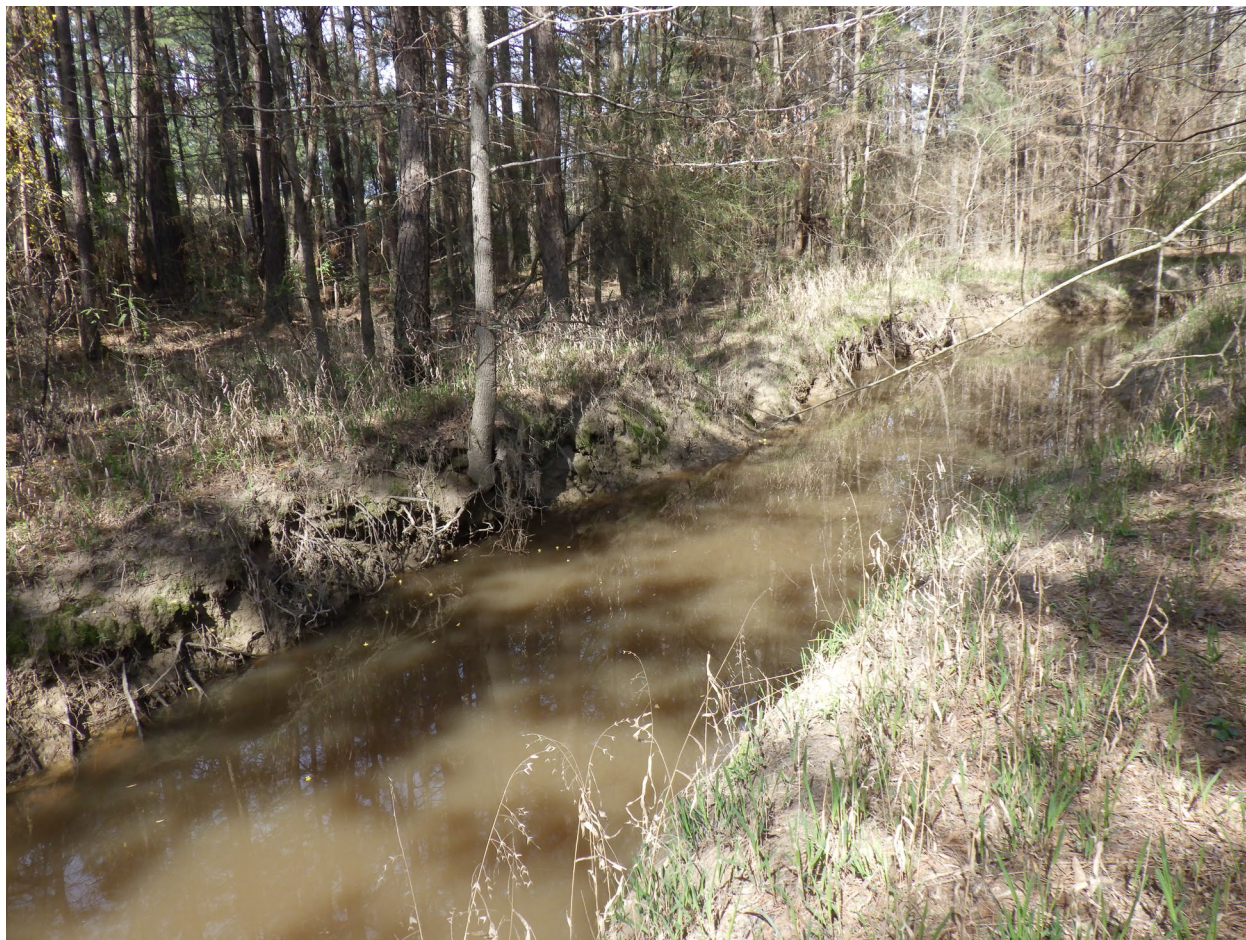
Photo No. 9

**Description:** This photo was taken looking upstream (NW) from the TDS reading on Photo No. 8 showing stream characteristics of Wolf Creek.

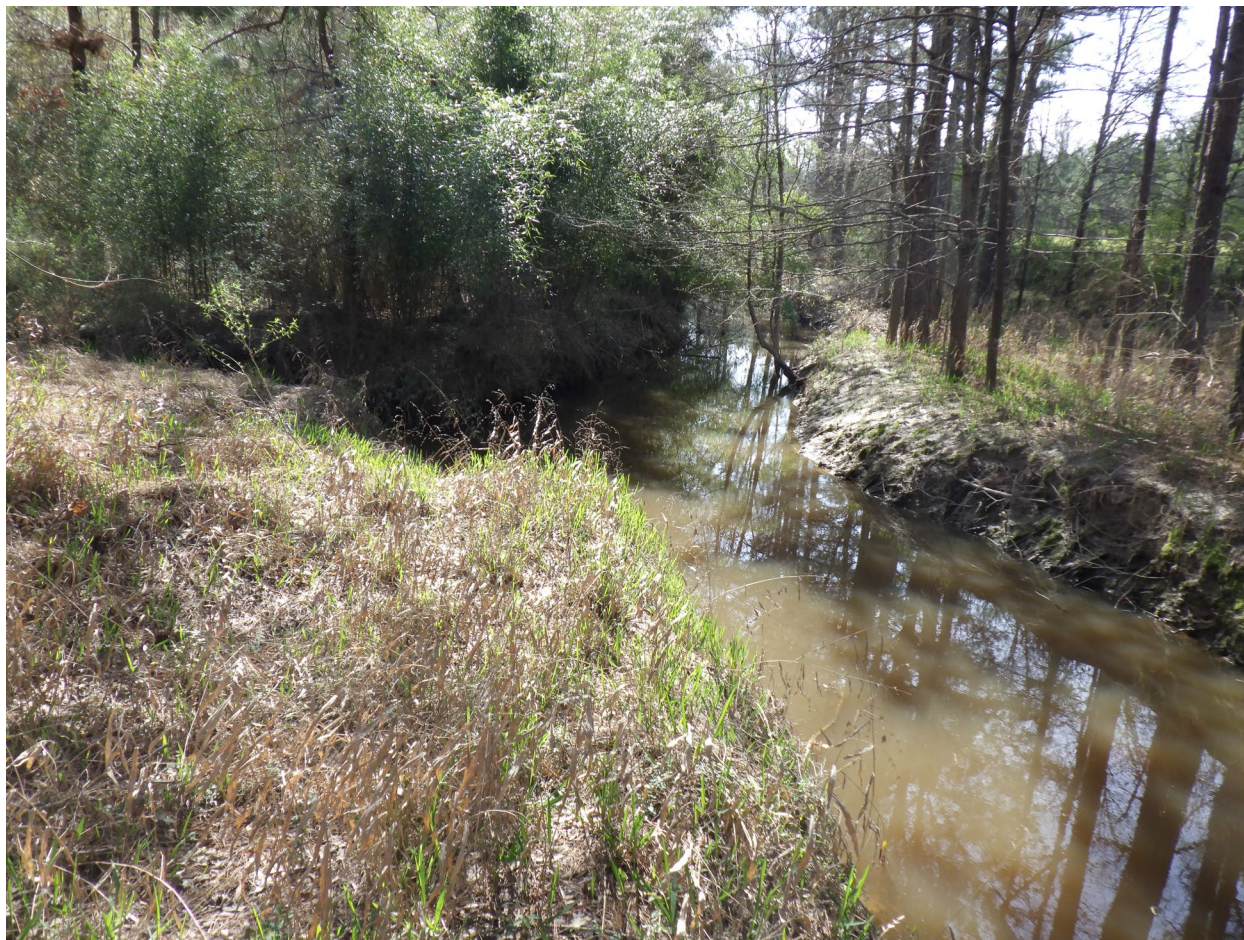
Photo No. 10

**Description:** This photo was taken looking downstream (S) from the TDS reading on Photo No. 8 showing stream characteristics of the unnamed tributary of Wolf Creek as well as the POE on the left side of the picture.

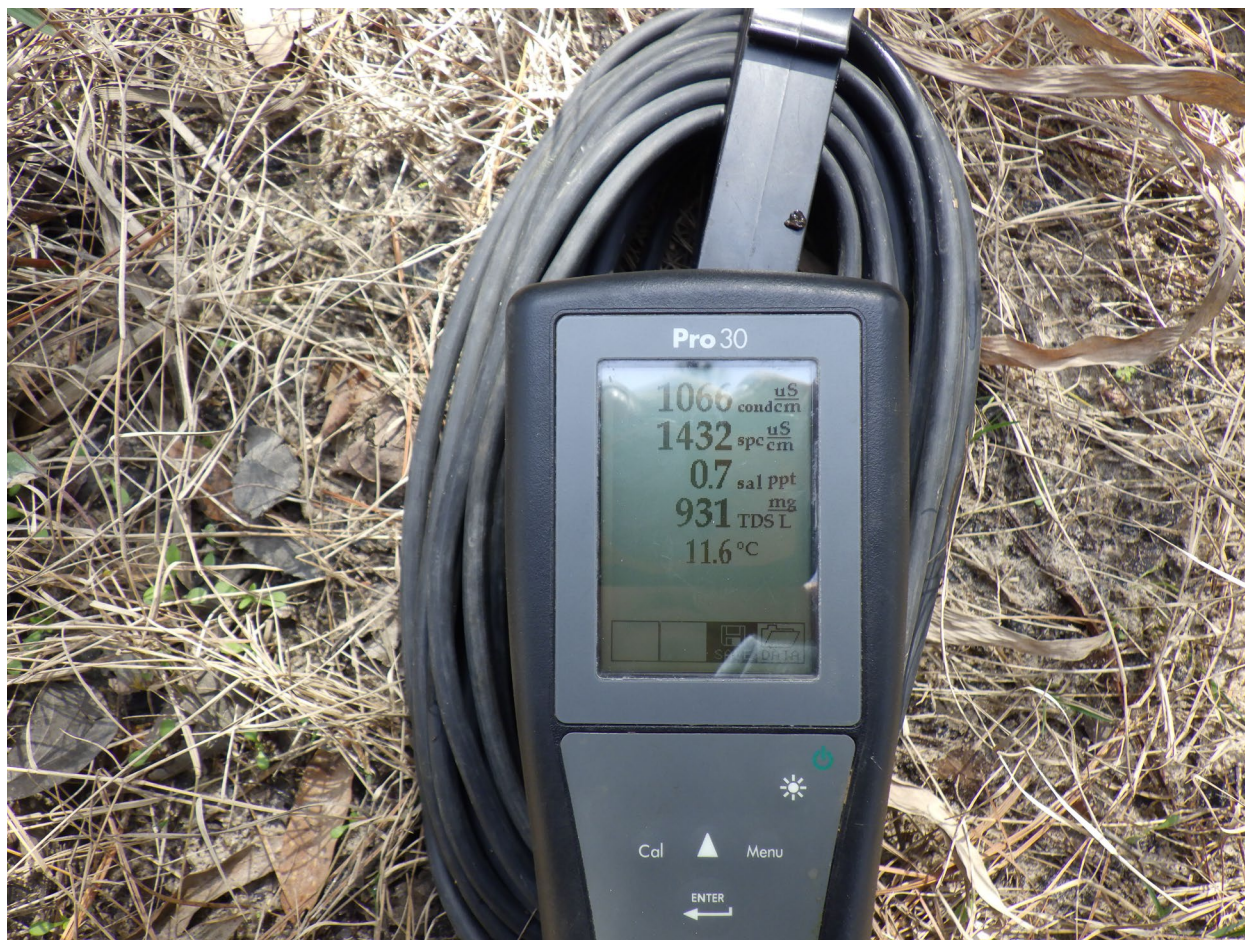
Photo No. 11

At the POE, I observed a TDS reading of 931 mg/L in Wolf Creek, see photo No. 11.

**Description:** This photo was taken showing a TDS reading of 931 mg/L at the POE into Wolf Creek.

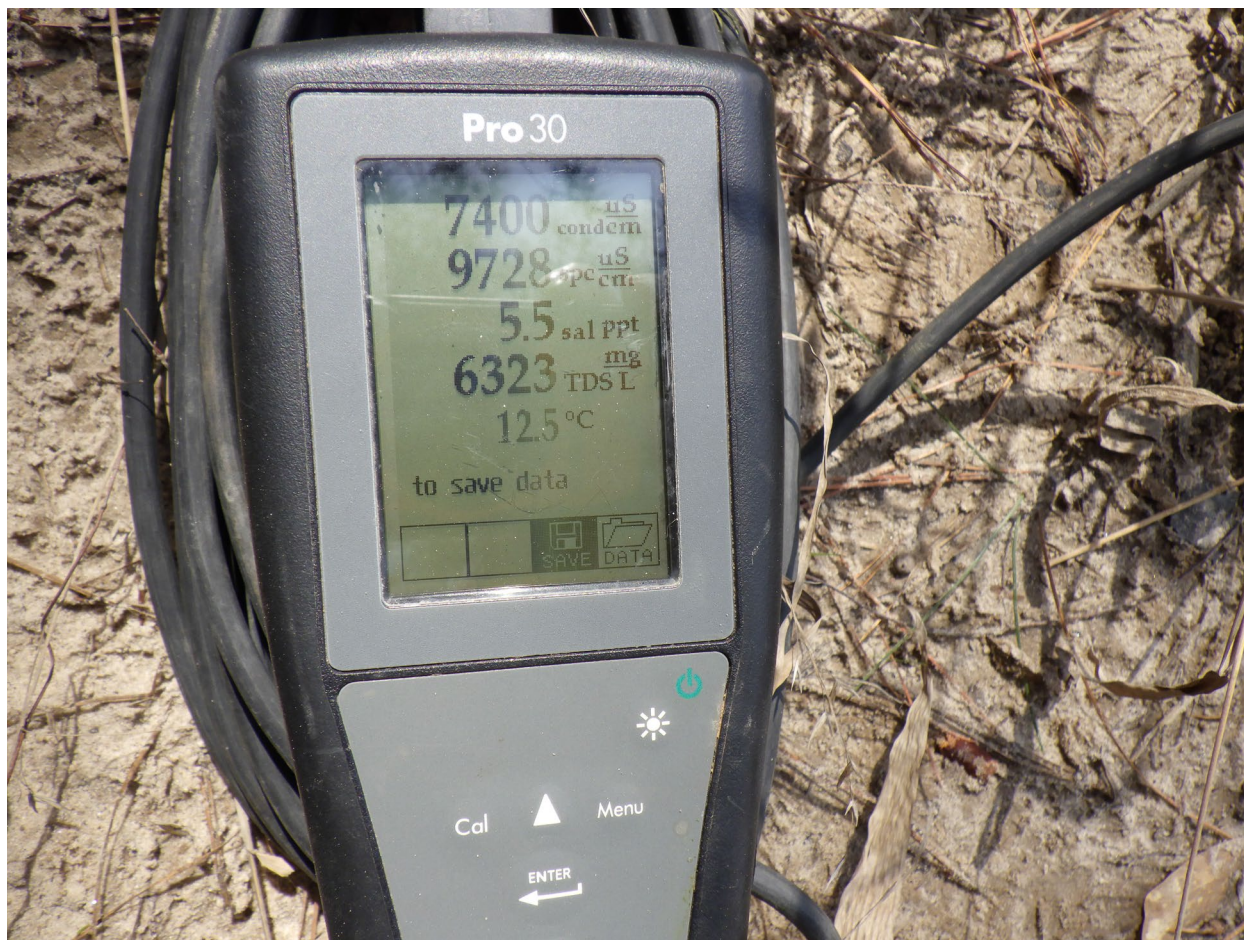
Photo No. 12

Downstream from the POE, I observed a TDS reading of 6,323 mg/L on the east side of the Highway 7 bridge as well as stream characteristics, see photo No. 12 through photo No. 14

**Description:** This photo was taken showing a TDS reading of 6,323 mg/L in a deep pool where Wolf Creek bends.

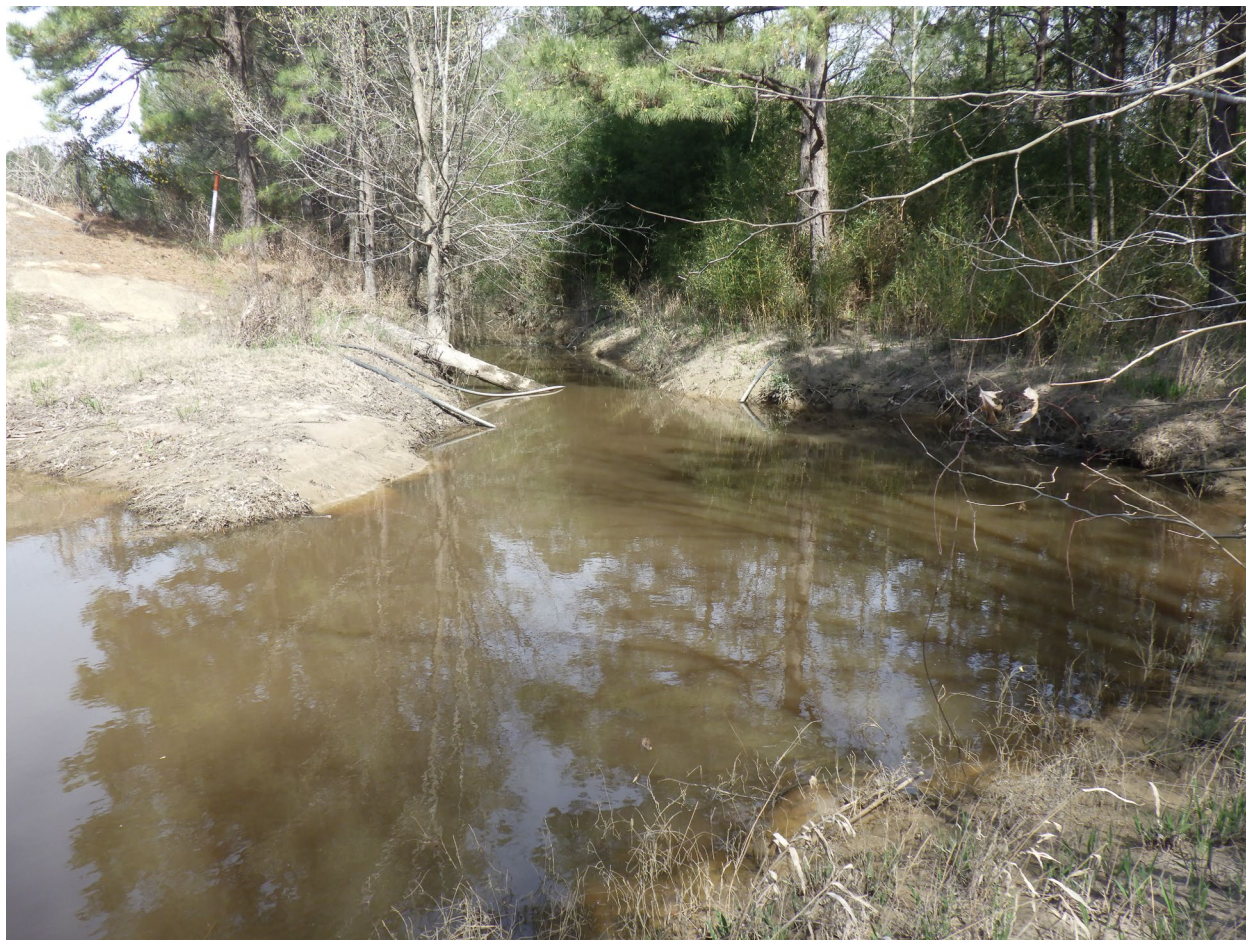
Photo No. 13

**Description:** This photo was taken looking upstream (N) from the TDS reading in Photo No. 12 showing stream characteristics of Wolf Creek. The TDS reading in photo No. 11 was taken where the flowline's cross Wolf Creek.

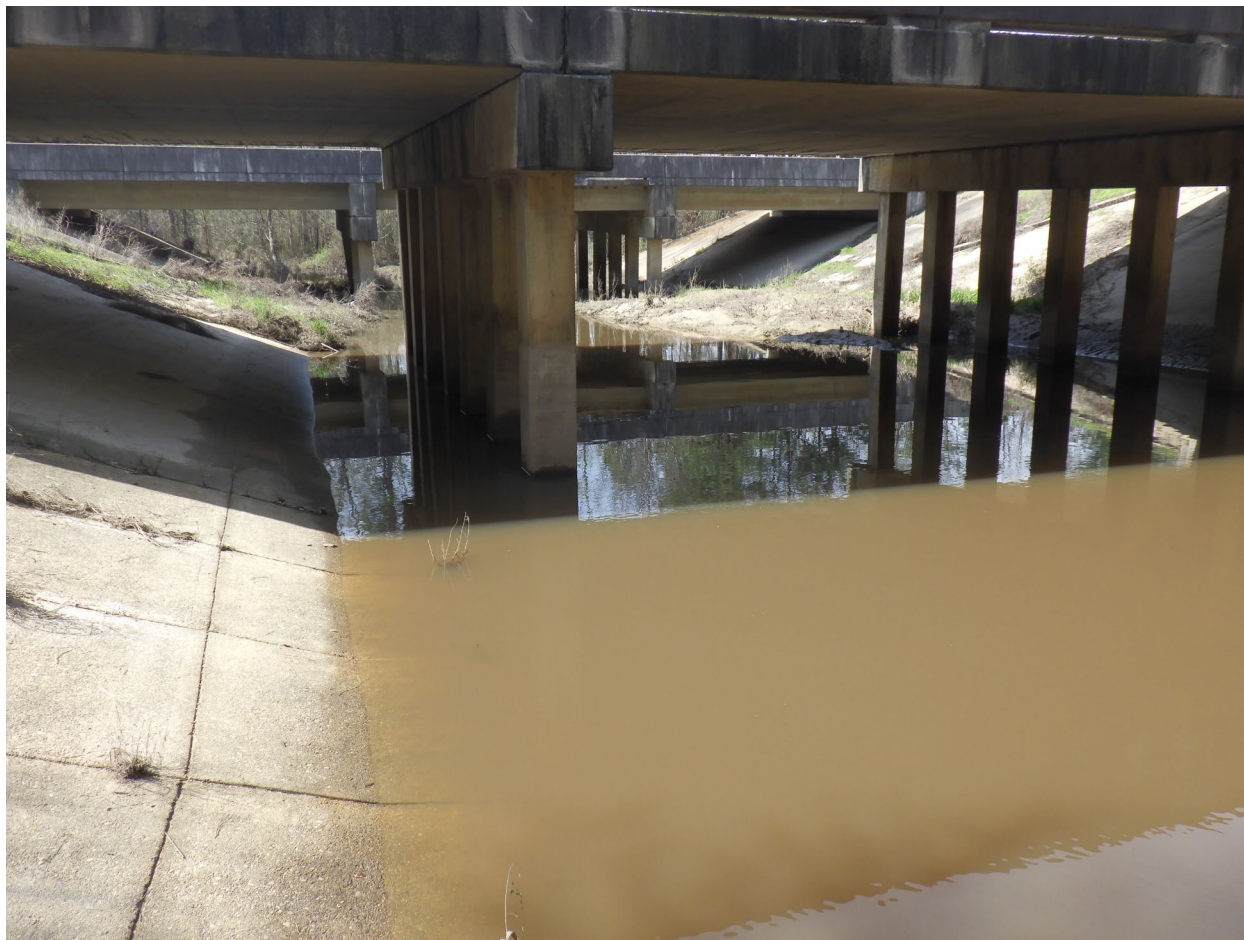
Photo No. 14

**Description:** This photo was taken looking downstream (WSW) towards the Highway 7 bridge where the TDS reading in Photo No. 15 was taken showing the stream characteristics of Wolf Creek.

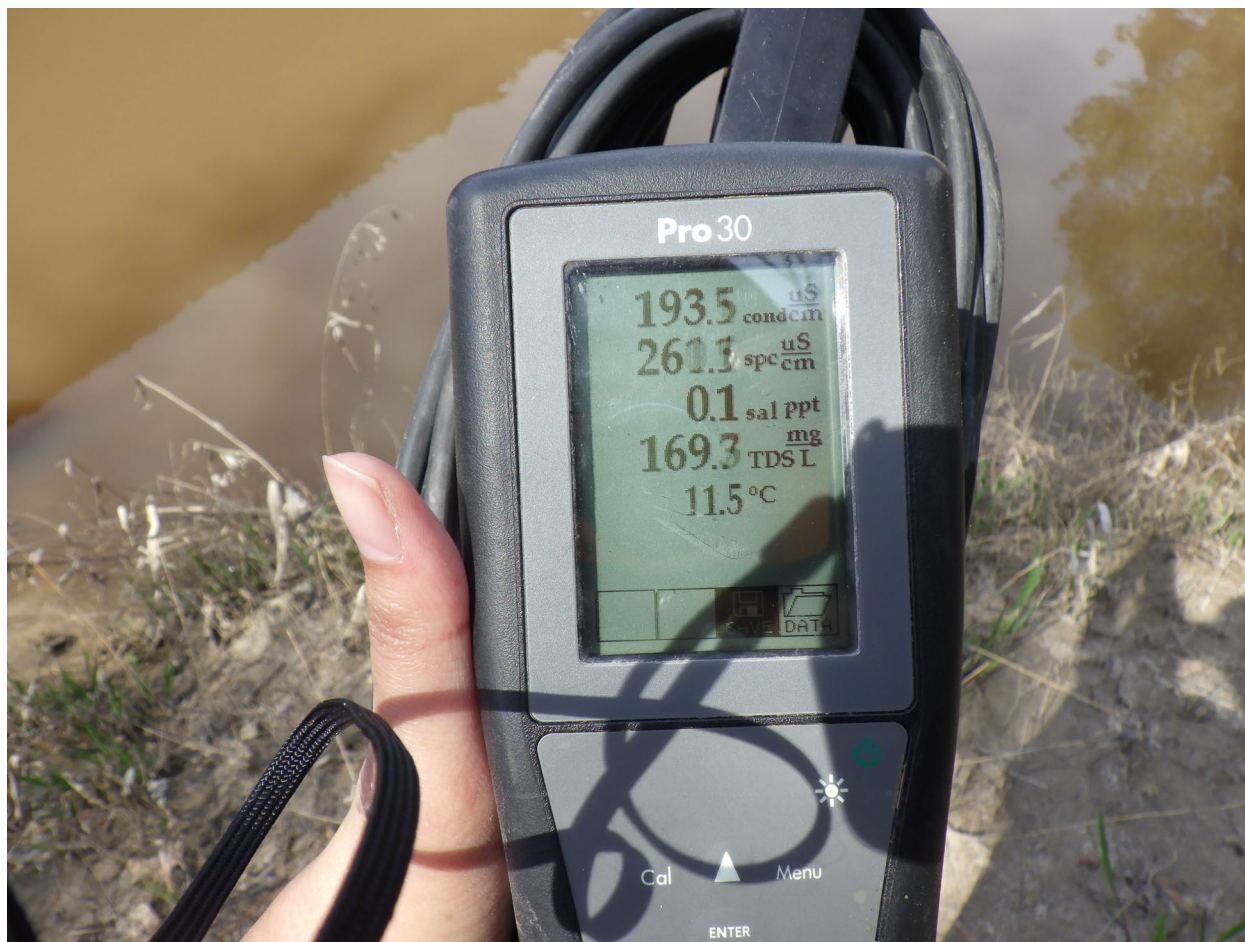
Photo No. 15

Under the east side of the Highway 7 bridge, I observed a background TDS reading of 169.3 mg/L, see photo No. 15.

**Description:** This photo was taken showing a background TDS reading of 169.3 mg/L on the E side of Highway 7 bridge.
