## **RCRA Inspection Report**

Hallstar Greensboro, LLC  
520 Broome Rd.  
South Greensboro, N.C. 27406

EPA ID#: NCD061795696  
NAICS #: 325199 – All other Basic Organic  
Chemical Manufacturing  
325998 – All Other Miscellaneous Chemical  
Product and Preparation Manufacturing

October 19, 2023, at 8:50 AM.

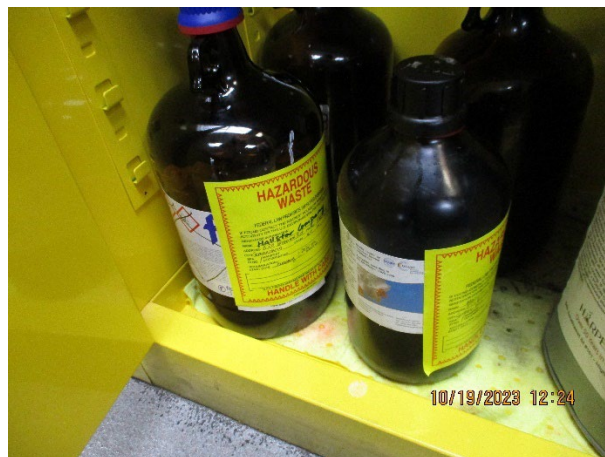
During the inspection, facility representatives placed hazardous waste labels on both containers (Photo 2).

**Photo 2:** Hazardous waste labels placed on SAA containers in laboratory.

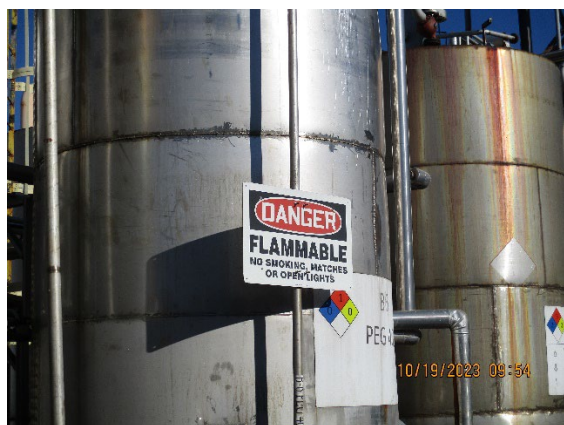
The B-Tank farm is located on the south side of the facility. Most ASTs in the B-Tank farm are for bulk storage of raw material (liquid chemicals) and for the hazardous waste tank. The tanks are situated on concrete secondary containment which had no evidence of holes or visible cracks. The area is identified with a sign that reads "Danger, Flammable, No Smoking, Matches, or Open Lights" (Photo 3). There is a fire hydrant and extinguisher located right next to the tank farm (Photo 4).

**Photo 3:** "No Smoking" sign.

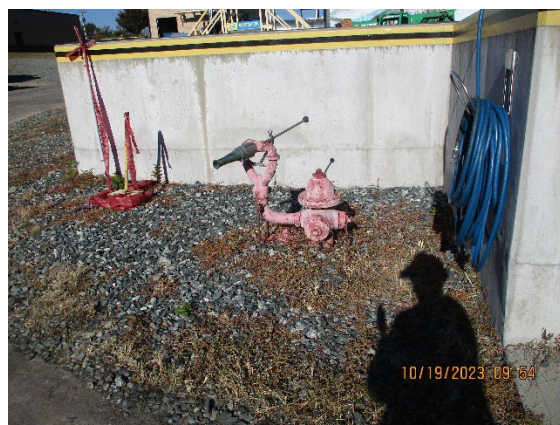
**Photo 4:** Fire hydrant next to B-Tank Farm.

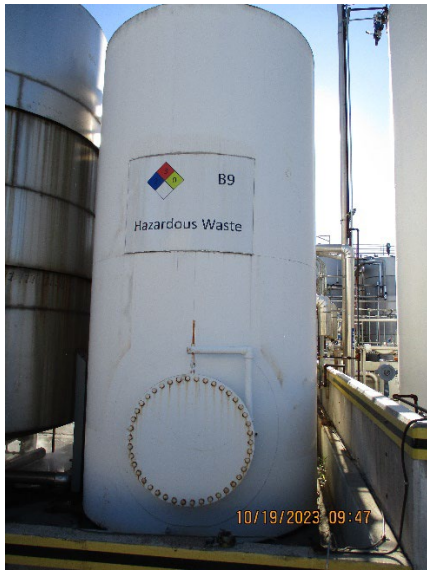
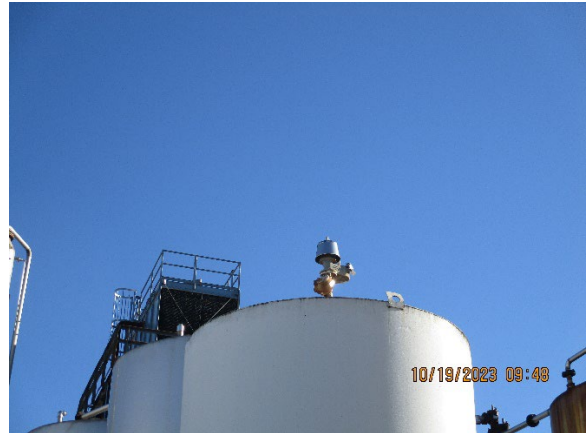
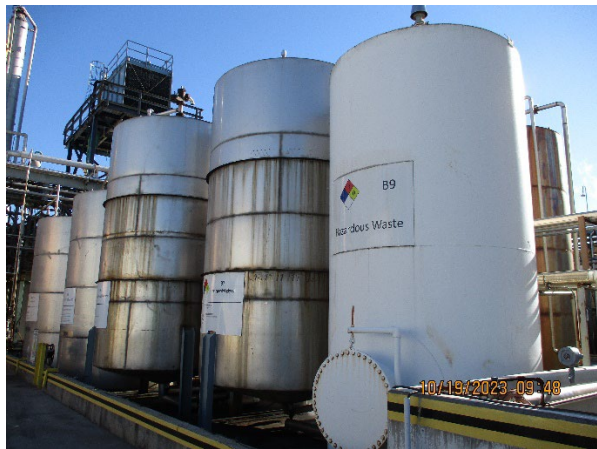
Hazardous waste Tank B-9 is a 9000-gallon AST with a fixed roof and is equipped with a conservation vent and a flame arrestor for air emission control. The tank is also equipped with a pneumatic valve as a closure device for the fill port. The tank level is monitored electronically

The tank is labeled "Hazardous Waste" and marked with an NFPA hazard diamond to indicate the hazard of the contents (Photos 5-8). The hazardous waste tank is not labeled with an accumulation start date; however, the facility empties and ships off at least 4,000-gallons of the waste isobutyl alcohol and xylene from Tank B-9 at a minimum every 90-days. The facility uses their hazardous waste manifests to demonstrate compliance with the 90-day storage limit. The next shipment of hazardous waste from the tank is scheduled for 12/11/2023. The previous two shipments were: 09/11/2023, Manifest 017674059FLE (4,400 gallons) and 06/14/2023, Manifest 018320302FLE (4,600 gallons). Previously, the facility would ship waste from Tank B-9 twice every 90 days; however, within the last year the facility has not been generating as much waste.

**Photo 5:** Hazardous waste Tank B-9.

**Photo 6:** Top of Tank B-9.

**Photo 7:** Hazardous waste Tank B-9.

**Photo 8:** Fill port side of Tank B-9.

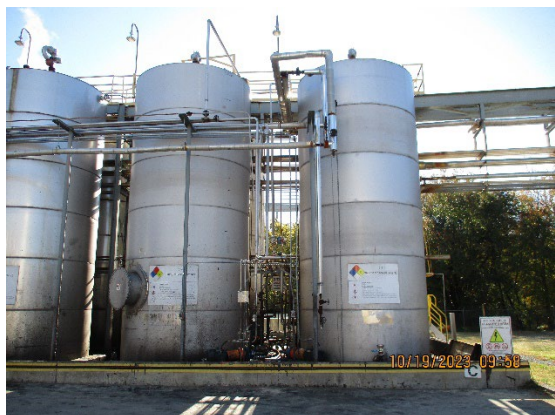
The C-Tank farm is located directly across from the B-Tank farm and stores additional process tanks in secondary containment including two (2) 15,000-gallon process tanks that are used to recover solvent through a distillation column. Tank C-9 is labeled "Dirty Mixed Solvents" which goes through solvent distillation and enters tank C-11 which is labeled as "Recovered Mixed Solvents". Both ASTs have an NFPA diamond next to their respective tank names (Photo 9). Both ASTs are constantly in use and do not store solvent for long as the contents are constantly changed out. The volume of the tanks can be tracked through the facility's electronic DCS system which can display the amount of material in each tank and when material is added or removed.

**Photo 9:** Process Tanks C-9 (Dirty Mixed Solvents) and C11 (Recovered Mixed Solvents).

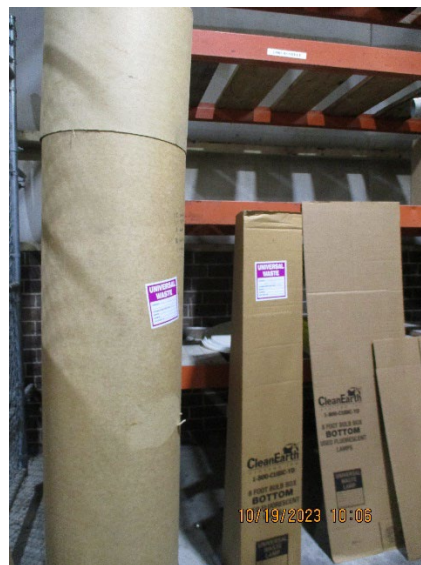
- One (1) cylinder cardboard container of 8-ft used lamps. The container was closed, labeled “Universal Waste” but did not have a start accumulation date.
- One (1) cardboard box of 5-ft used lamps. The container was labeled “Universal Waste” but was open and not dated.

**Photo 10:** Universal waste container to the right is open.

**Pursuant to 15A NCAC 13A .0119(b) [40 C.F.R. § 273.13(d)(1)], a small quantity handler of universal waste must contain any lamp in containers or packages that are structurally sound, adequate to prevent breakage, and compatible with the contents of the lamps. Such containers and packages must remain closed and must lack evidence of leakage, spillage or damage that could cause leakage under reasonably foreseeable conditions.**

On October 20, 2023, Susan Gay sent a photo via email showing the 5-ft box containing universal waste lamps was taped up and properly closed (Photo 11).

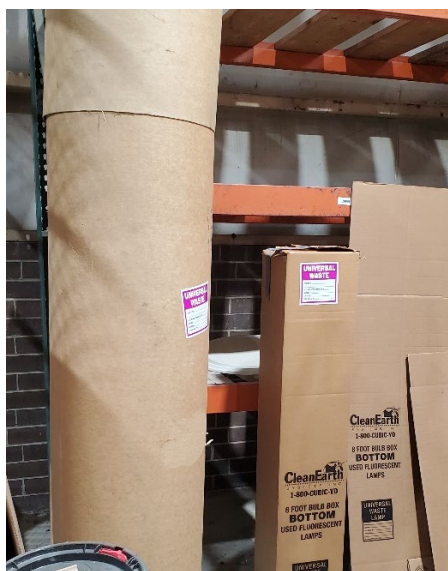
**Photo 11:** Universal waste container closed and taped up on the top.

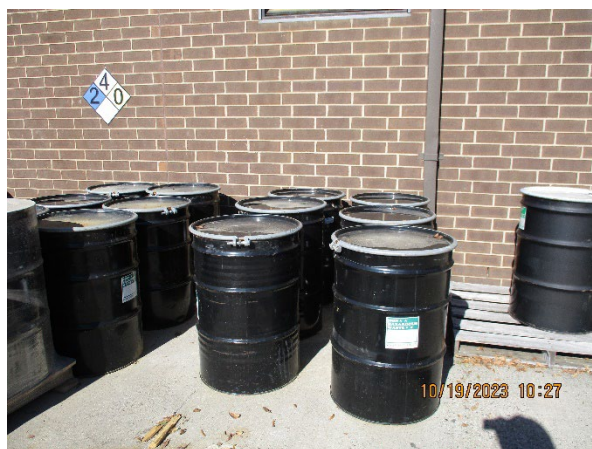
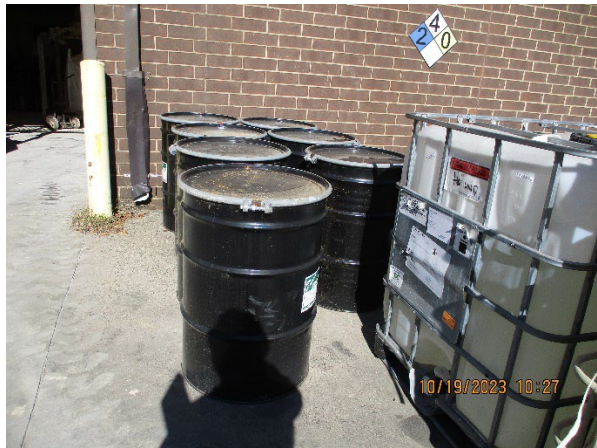
Outside of Building D, the inspectors observed 20x 55-gallon drums labeled “Non-hazardous waste” from well sampling collected from monitoring wells owned by LANXESS Corporation as part of an ongoing soil remediation project. NCDEQ defines this type of waste as investigational derived waste (IDW). The soil remediation activities are being managed by LANXESS Corporation and are not a part of Hallstar’s facility operations. At the time of the inspection the IDW was pending laboratory analysis before being shipped offsite to a designated disposal facility (Photos 12-14). The inspectors expressed some concern due to the containers being labeled as non-hazardous waste without the results of the pending laboratory analysis and requested that Hallstar representatives contact LANXESS Corporation to address the labeling concerns. Towards the end of the inspection Anthony Kellog, environmental consultant for LANXESS Corporation arrived at the facility to re-label the containers as “Hazardous Waste—Pending Analysis” and would be marking the containers with the proposed indication of the hazard of the contents.

The IDW was confirmed to have been generated on the property by LANXESS while conducting independent assessment and cleanup action for the Unitex Chemicals project listed on the NCDEQ Inactive Hazardous Sites Branch List. The results of the analysis determined that one (1) 55-gallon container of soil drill cuttings was hazardous. The IDW that was generated on the property still uses the EPA ID for the property but will ship with comments and contact information for LANXESS. NCDEQ has taken lead on correspondence with LANXESS.

**Photo 12:** Soil samples from LANXESS Corporation monitoring wells.

**Photo 13:** Soil samples from LANXESS Corporation monitoring wells.

**Photo 14:** Soil samples from LANXESS Corporation monitoring wells.
