## RCRA Inspection Report

Naval Submarine Base - Kings Bay  
1063 USS Tennessee Avenue  
Kings Bay, GA 31547

EPA ID#: GA4170090001  
NAICS #: 28110 – National Security

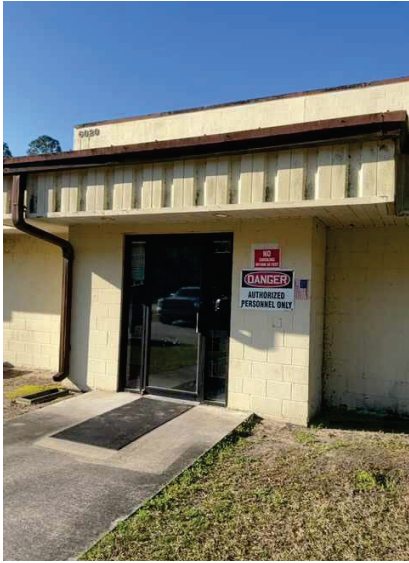
**Photo 1:** Front of (b) (3) (A) — (b) (3) (A) (b) (3) (A) Facility. Photo taken with iPad in Smart Tools. 2/27/24, 8:56 AM.

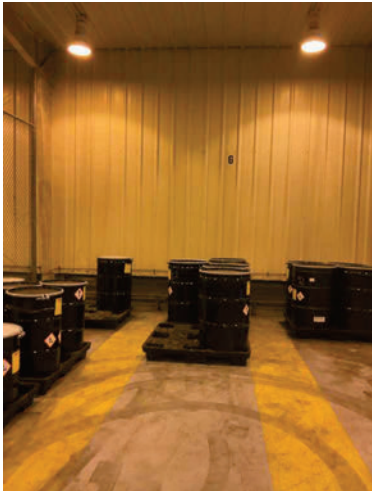
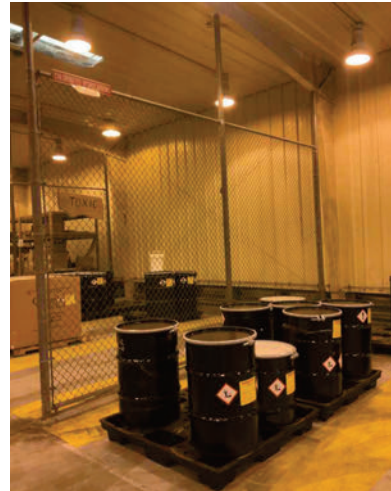
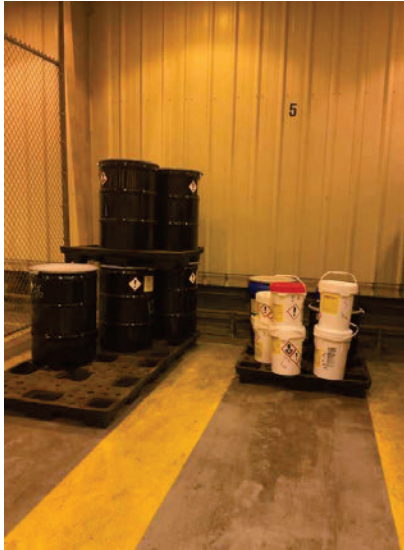
**Photo 2:** (b) (3) (A) — (b) (3) (A) (b) (3) (A) Photo taken with iPad in Smart Tools. 2/27/24, 9:03 AM.

All hazardous waste and nonhazardous waste containers are assigned a waste ID number for identification and inventory purposes. The ID number details the accumulation start date for the waste, where the waste originated from, where the waste is located within the building, and information on waste determinations. Hazardous waste is separated and stored based on compatibility in one of 12 bays within the building (Photos 2-5). Spill and fire control equipment

Adequate aisle space was observed for hazardous waste containers and there were no visible signs of cracks or damage to the concrete containment. Each container of hazardous waste was observed to be closed, labeled with the words “Hazardous Waste”, marked with an indication of the hazard of the contents, and dated with an accumulation start date. The oldest date recorded was 09/22/2023, which is compliant with the one-year accumulation time limit. The inspectors reviewed the current inventory report to check for accuracy of the amount and type of hazardous waste onsite. Based on what was observed onsite and the inventory report, the facility was compliant in storing waste below the storage capacity limit of 59,840 gallons (equivalent to 1,088 55-gallon drums). The inspectors also selected the following waste ID numbers to review waste profiles: Garnet Sludge 24660222, Non-flammable Adhesives Sealants 24333006, and Blast Media 24338010.

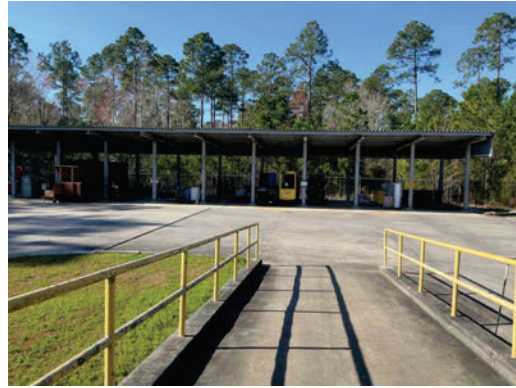
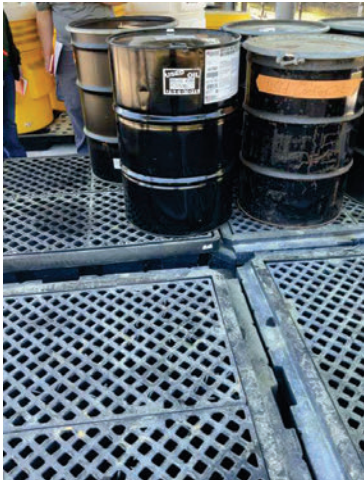
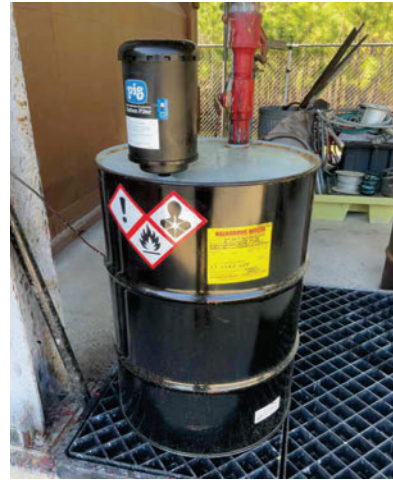
Photo 6: (b) (3) (A) — (b) (3) (A)  
(b) (3) (A). Photo taken with iPad in Smart Tools. 2/27/24, 9:33 AM.

Behind Building 6020 is a concrete pad with a roof which stores used oil, an aerosol can puncture device and a satellite accumulation area (SAA) for spent aerosol cans. The inspectors observed the following wastes (Photos 6-8):

- Three (3) 55-gallon containers of used oil. The containers were closed and labeled “Used Oil”; and
- One (1) 55-gallon SAA container of paint waste. The container was closed, labeled “Hazardous Waste”, and marked with an indication of the hazard of the contents.

Photo 7: (b) (3) (A) — (b) (3) (A)  
(b) (3) (A). Used oil 55-gallon containers. Photo taken with iPad in Smart Tools. 2/27/24, 9:35 AM.

Photo 8: (b) (3) (A) — (b) (3) (A)  
(b) (3) (A). SAA for spent aerosol cans. Photo taken with iPad in Smart Tools. 2/27/24, 9:38 AM.

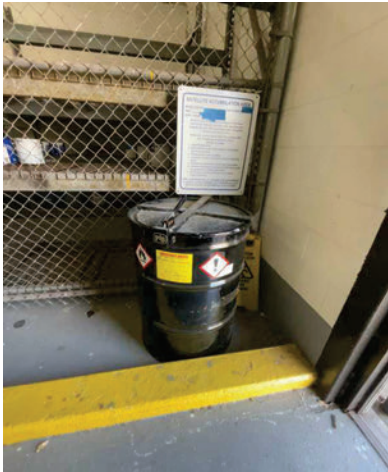
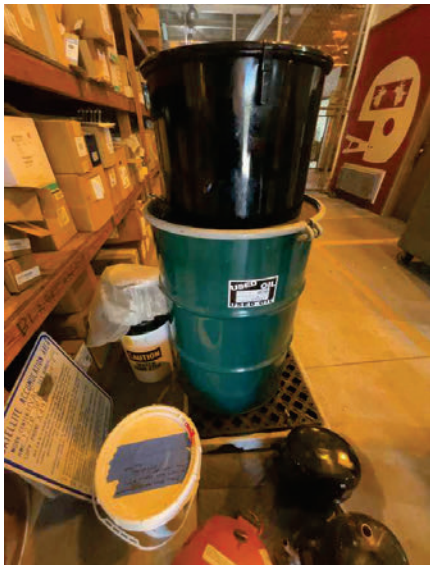
**Photo 9:** (b) (3) (A) — (b) (3) (A)  
(b) (3) (A) . Photo taken with iPad in Smart Tools. 2/27/24, 10:14 AM.

This building is a general maintenance paint shop which also has an HVAC maintenance shop and several SAAs. The inspectors observed the following wastes (Photos 9-11):

- One (1) 55-gallon SAA container of used aerosol cans. The container was closed, labeled “Hazardous Waste”, and marked with an indication of the hazard of contents;
- One (1) 55-gallon SAA container of spent paint. The container was closed, labeled “Hazardous Waste”, and marked with an indication of the hazard of contents;
- One (1) 55-gallon container of used oil. The container was closed and labeled “Used Oil”; and
- One (1) 5-gallon container of spent thermostats. The container was labeled “Universal Waste—Used Mercury Thermostats”, closed, and dated 01/08/2024.

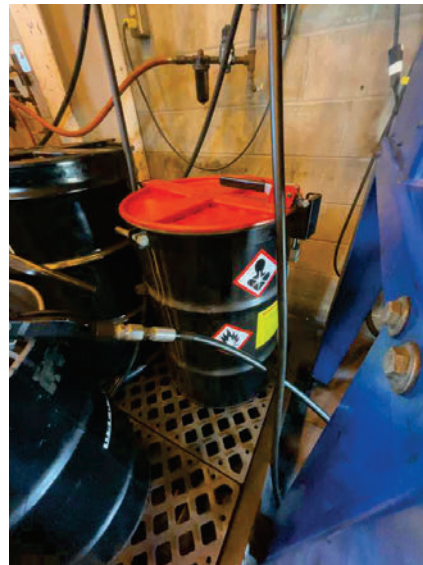
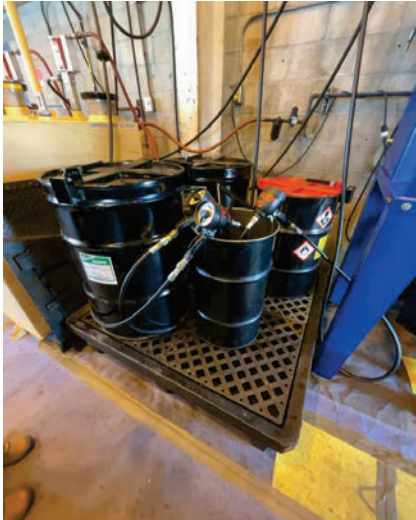
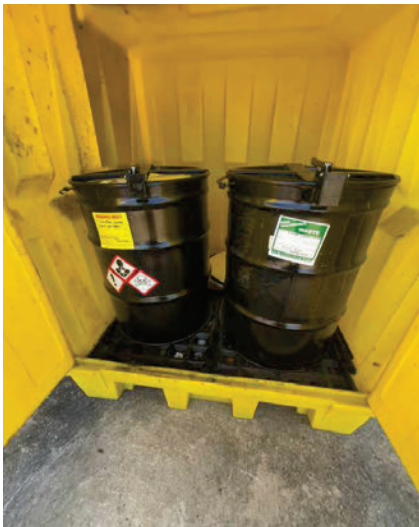
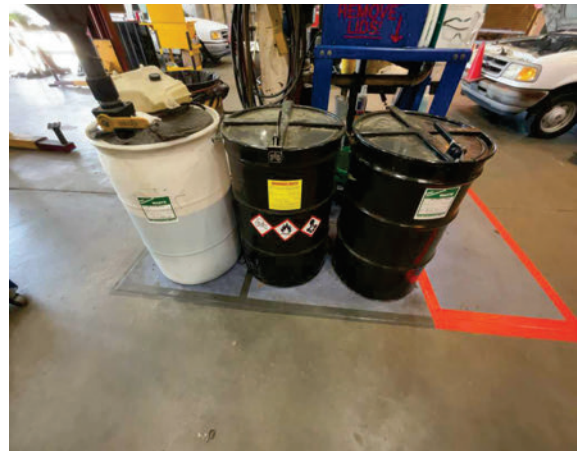
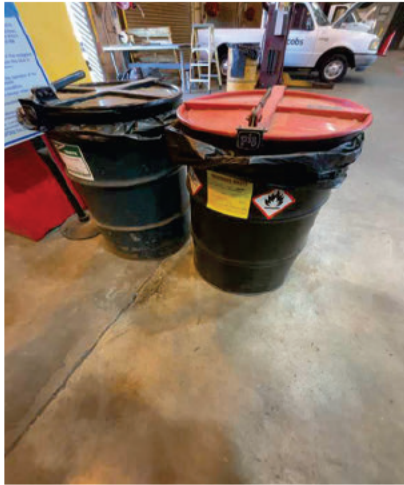
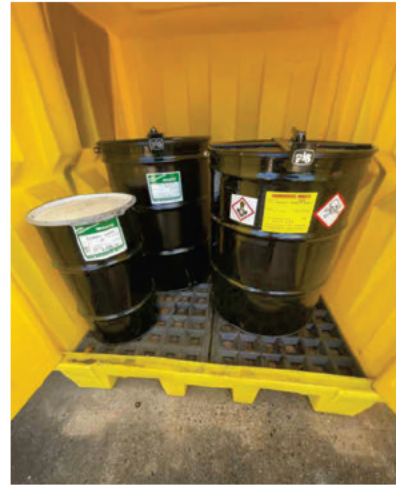
**Photo 12:** Building (b) (3) (A)  
(b) (3) (A)  
(b) (3) (A) . Photo taken with iPad in Smart Tools. 2/27/24, 10:25 AM.

This maintenance shop is used to perform maintenance on vehicles used throughout the facility. The inspectors observed the following wastes (Photos 12-18):

- One (1) 30-gallon container of used gasoline filters. The container was closed and labeled “Used Gasoline Filters”;
- One (1) 55-gallon container of used gasoline filters. The container was closed and labeled “Used Gasoline Filters”;
- One (1) container of used antifreeze and water. The container was closed and labeled “Used Antifreeze”;
- One (1) 10-gallon used oil caddy. The container was closed and labeled “Used Oil”;
- One (1) parts washer which was closed and is serviced quarterly by Safety-Kleen;
- One (1) SAA container of spent aerosol cans. The container was closed, labeled “Hazardous Waste”, and marked with an indication of the hazard of contents; and
- One (1) SAA container of used solvent rags and debris. The container was closed, labeled “Hazardous Waste”, and marked with an indication of the hazard of contents.

- One (1) 55-gallon container of used anti-freeze. The container was closed and labeled “Used Anti-freeze”;
- One (1) 55-gallon container of used grease which was closed and labeled “Used Grease”; and
- One (1) 55-gallon SAA container of used solvent and debris. The container was closed, labeled “Hazardous Waste”, and marked with an indication of the hazard of contents.

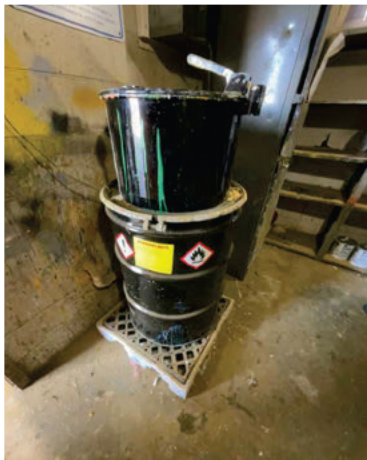
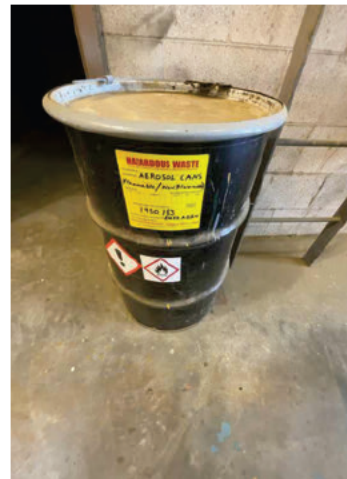
Photo 19: Building (b) (3) (A)  
 (b) (3) (A) Photo taken with iPad in  
 Smart Tools. 2/27/24, 10:39 AM.

This building is another maintenance and paint shop. The inspectors observed the following wastes (Photos 19-20):

- One (1) 55-gallon SAA container of spent paint. The container was closed, labeled “Hazardous Waste”, and marked with an indication of the hazard of contents; and
- One (1) 30-gallon SAA container of spent aerosol cans. The container was closed, labeled “Hazardous Waste”, and marked with an indication of the hazard of contents.

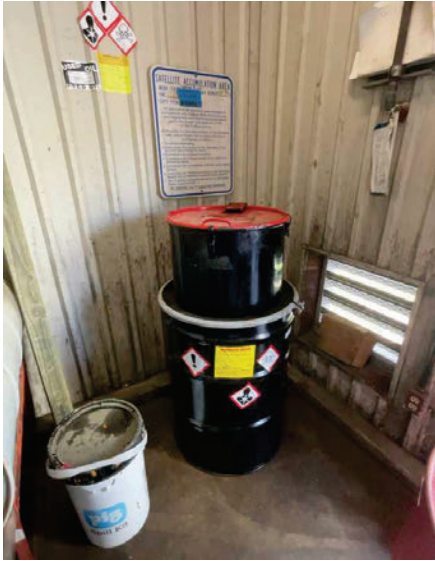
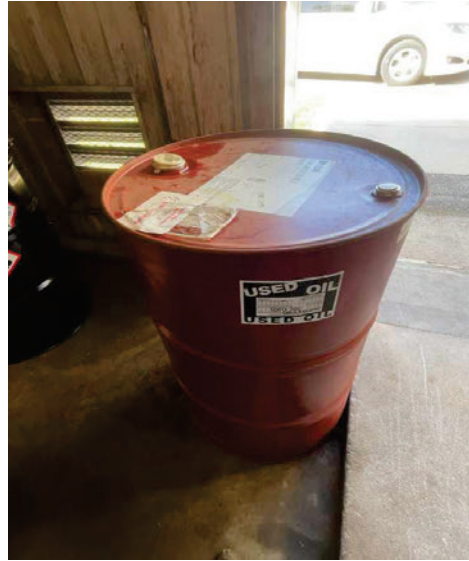
**Photo 21:** Building (b) (3) (A). Photo taken with iPad in Smart Tools. 2/27/24, 10:50 AM.

The thermal plant is used to run hot and cold water throughout the base to different HVAC units. The inspectors observed the following wastes (Photos 21-22):

- One (1) 55-gallon container of used oil. The container was closed and labeled “Used Oil”; and
- One (1) 55-gallon SAA container of solvent rags and debris. The container was closed, labeled “Hazardous Waste”, and marked with an indication of the hazard of contents.

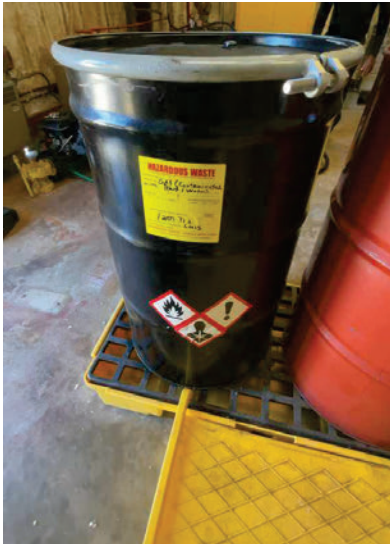
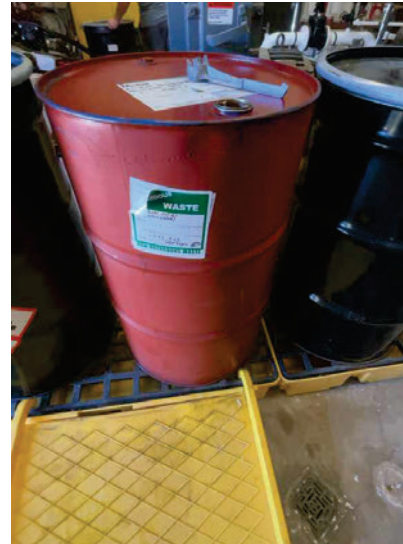
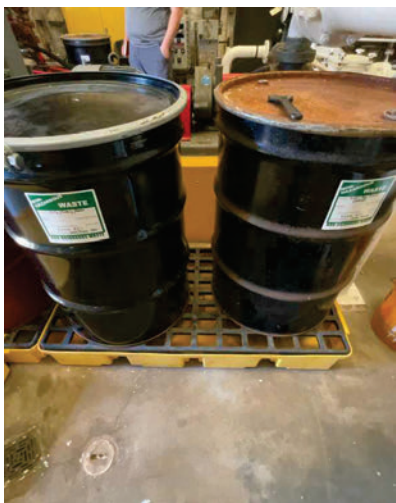
**Photo 23:** Building (b) (3) (A). Photo taken with iPad in Smart Tools. 2/27/24, 10:59 AM.

The fuel farm stores two 210,000-gallon above ground storage tanks, one for diesel and one for gasoline fuel. There is also one 500-gallon above ground storage tank for new lubricant oil. The inspectors observed the following wastes inside the fuel farm in Building 2030 (Photos 23-25):

- One (1) 55-gallon container of used gasoline. The container was closed, labeled “Hazardous Waste”, and marked with an indication of the hazard of contents;
- One (1) 55-gallon container of used diesel fuel oil. The container was closed and labeled “Nonhazardous Waste – Used Diesel Fuel Oil”;
- One (1) 55-gallon container of oily debris. The container was closed and labeled “Nonhazardous Waste – Oily Debris”; and
- One (1) 55-gallon container of used diesel fuel filters. The container was closed and labeled “Nonhazardous Waste Used Diesel Fuel Filters”.

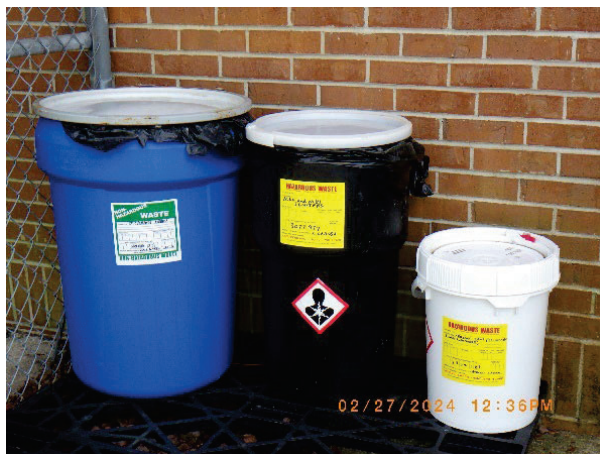
Photo 26: Building (b) (3) (A)

The inspectors were introduced to (b) (6), EOD 1 who explained that EOD staff conduct OB/OD activities at the permitted OB/OD Range. Building 2013 is their office. Cleaning and maintenance activities generate greasy oil debris and used igniters from demolition activities. The inspectors observed the following wastes (Photo 26):

- One (1) 15-gallon SAA container of used M60 and M81 igniters. The container was closed, labeled “Hazardous Waste”, and marked with an indication of the hazard of contents;
- One (1) 5-gallon SAA container of spent aerosol cans. The container was closed, labeled “Hazardous Waste”, and marked with an indication of the hazard of contents; and
- One (1) 30-gallon container of oil/ greasy debris. The container was closed and labeled “Nonhazardous Waste—Oil/ Greasy debris”.

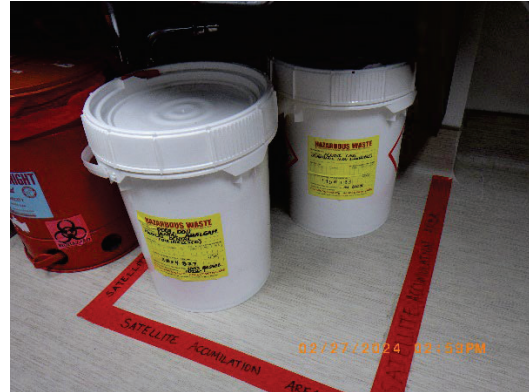
Photo 30: Building (b) (3) (A)  
 (b) (3) (A)  
 (b) (3) (A)  
 (b) (3) (A). Photo taken by (b) (6).

The inspectors observed the following wastes in the Dental Clinic (Photo 30):

- One (1) 5-gallon SAA container of dental amalgam waste. The container was closed, labeled “Hazardous Waste”, and marked with an indication of the hazard of the contents; and
- One (1) 5-gallon SAA container of waste aerosol cans. The container was closed, labeled “Hazardous Waste”, and marked with an indication of the hazard of the contents.

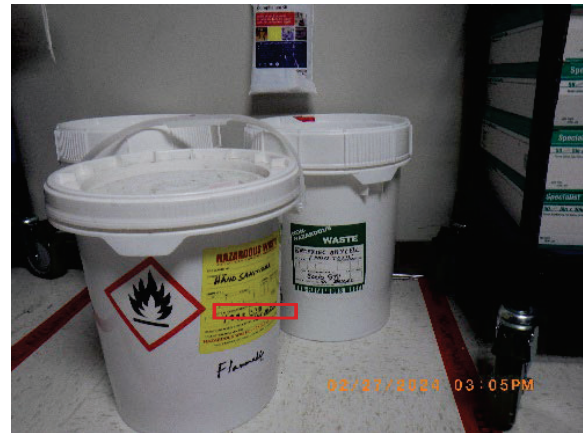
Photo 32: Building (b) (3) (A)  
 (b) (3) (A)  
 (b) (3) (A)  
 (b) (3) (A). Photo  
 taken by (b) (6).

The inspectors observed the following wastes in the medical supply (Photos 32-33):

- One (1) 5-gallon SAA container of waste hand sanitizer. The container was closed, labeled “Hazardous Waste”, and marked with an indication of the hazard of the contents;
- One (1) 5-gallon SAA container of waste aerosol cans. The container was closed, labeled “Hazardous Waste”, and marked with an indication of the hazard of the contents; and
- One (1) 5-gallon container of nonhazardous waste dry cell batteries.

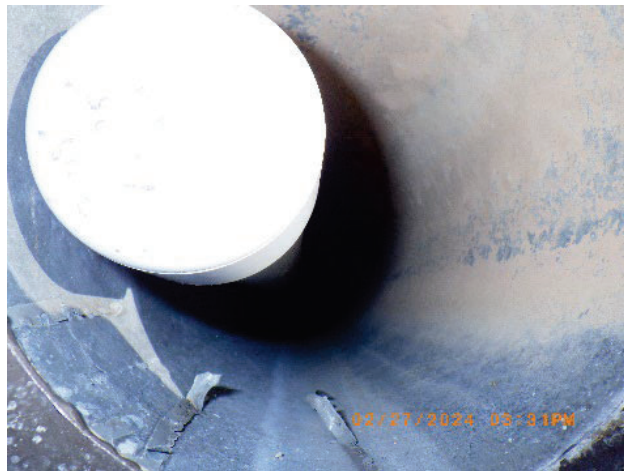
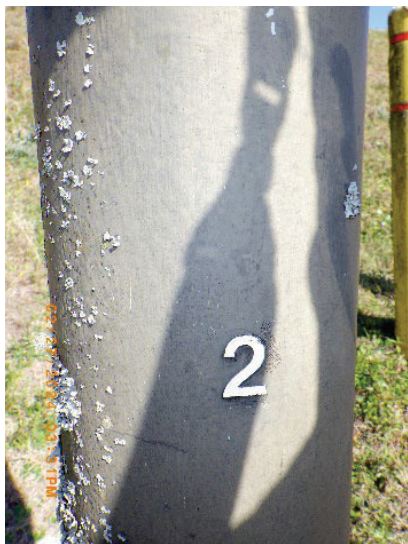
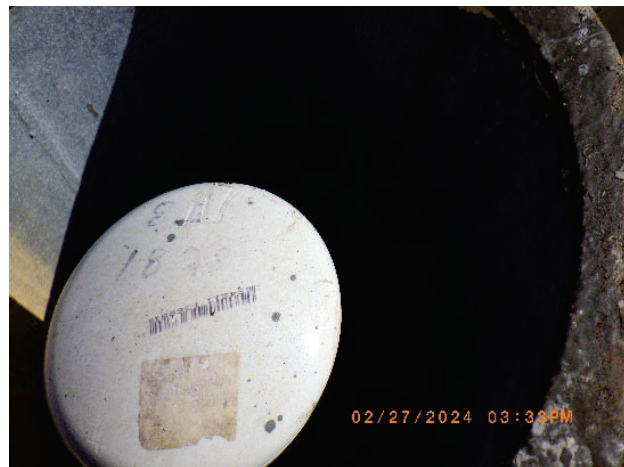
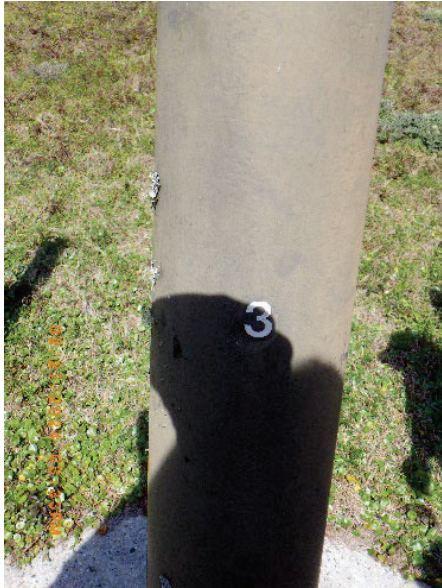
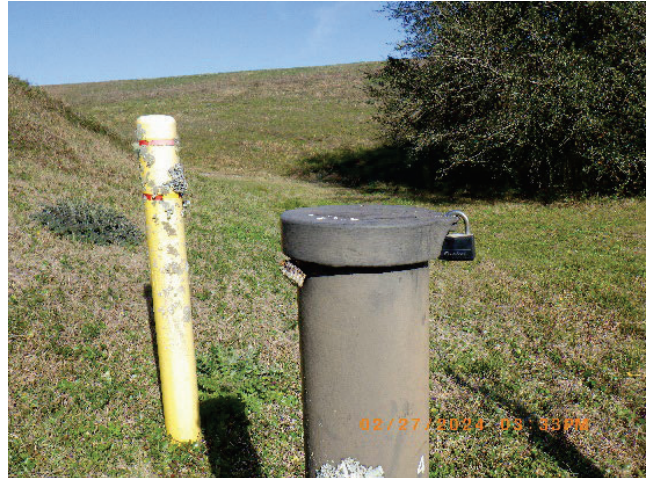
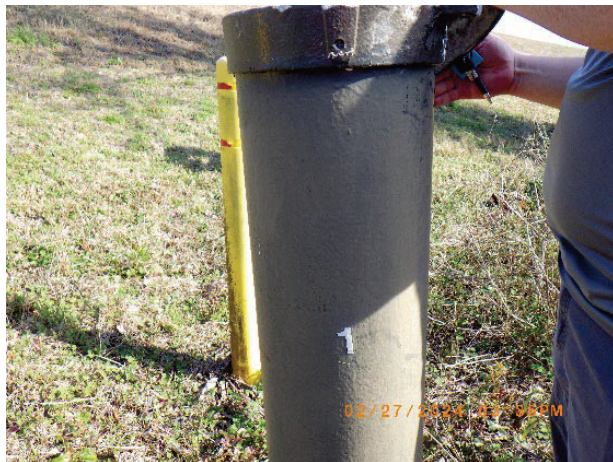
Photo 34: (b) (3) (A)

The inspectors went out to the OB/OD range to inspect the monitoring wells onsite and to see if there were any hazardous waste containers generated from OB/OD activities. EOD staff request containers to transport the treated hazardous waste to the permitted storage facility after OB/OD activities. The waste is picked up within 72 hours of completion of OB/OD activity. All monitoring wells were locked and secure with no issues noted (Photos 34-39). No hazardous waste was observed in the OB/OD Range.

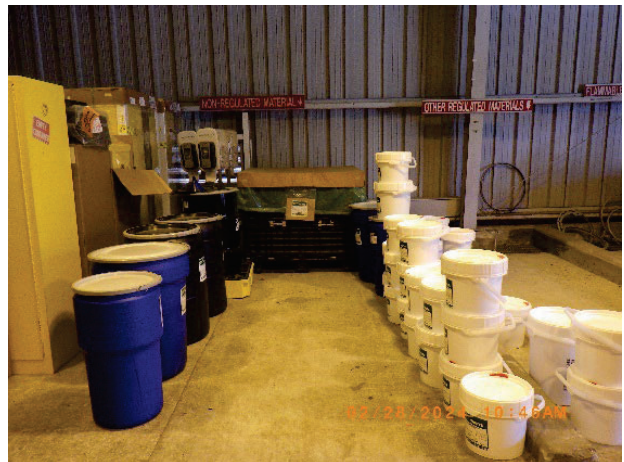
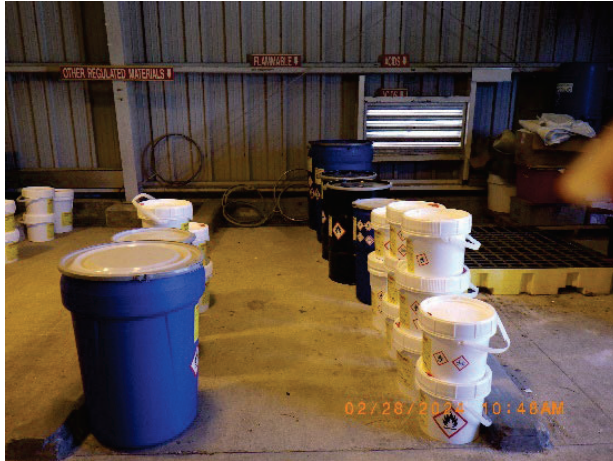
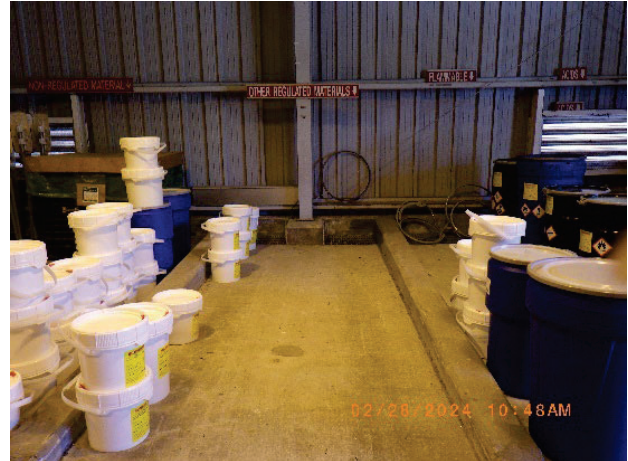
Photo 40: Building (b) (3) (A)  
Photo taken by (b) (6).

This building is a CAA for waste generated at the Trident Refit Facility (TRF) (Photos 40-42). The CAA is equipped with spill control equipment and fire control equipment. Acid wastes are separated from ignitable waste. All containers of hazardous waste were closed, labeled “Hazardous Waste,” marked with an indication of the hazard of contents, and dated with the oldest accumulation start date being 01/05/2024.
