## **RCRA Inspection Report**

Flexco Corporation  
1401 East 6<sup>th</sup> Street  
Tuscumbia, Alabama 35674

EPA ID#: ALR000000984  
NAICS #: 32619 – Other Plastics Product  
Manufacturing

03/19/2024 at 8:30 a.m.

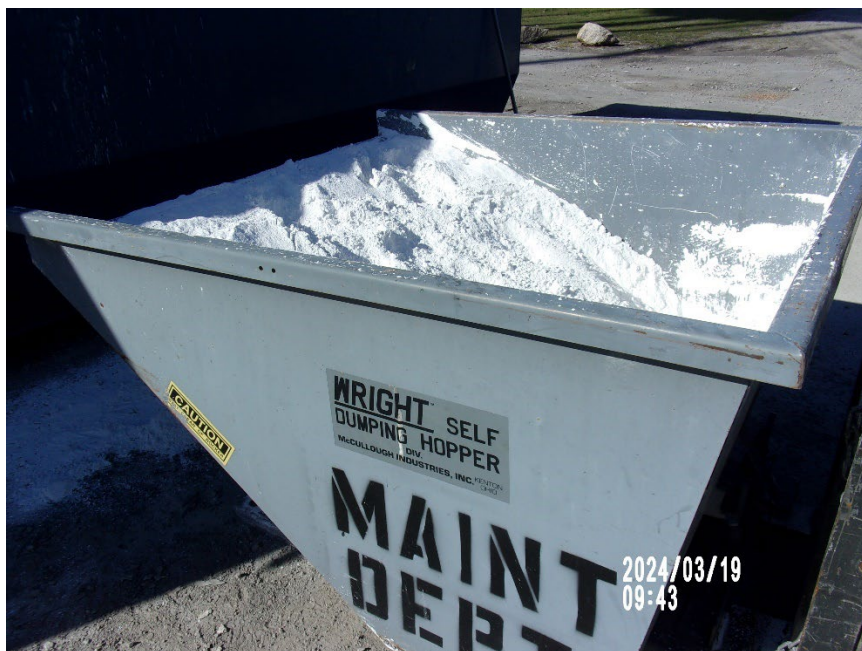
Marcus Hyde escorted the inspectors to the outside of the production building. The facility had encountered a spill of calcium carbonate in an outside loading area the morning of the inspection. Facility staff were in the process of cleaning up this spill. This material has been determined by the facility to be non-hazardous and was being loaded into a general waste roll-off (Photograph 1).

Photograph 1: Spilled calcium carbonate from a 3/19/2023 spill that has been loaded into a hopper.

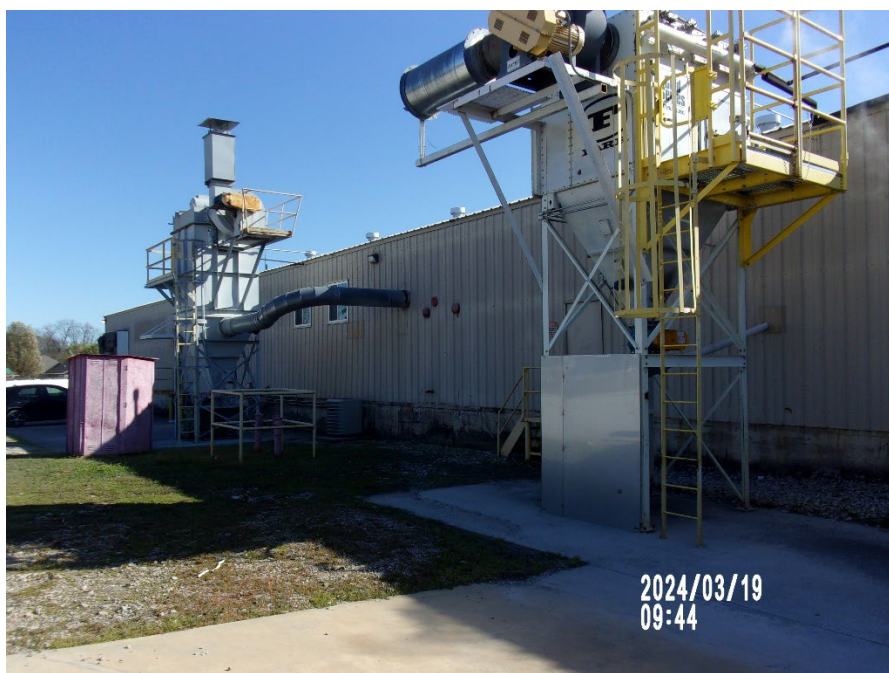
The inspectors then observed the outside area of the baghouse area utilized for the Tufflex building (Photograph 2). This area was well kept; and no spills or releases were observed. Dust from the baghouses is collected and reinserted into the production process (Photographs 3).

Photograph 2: Picture of Facility Baghouses.

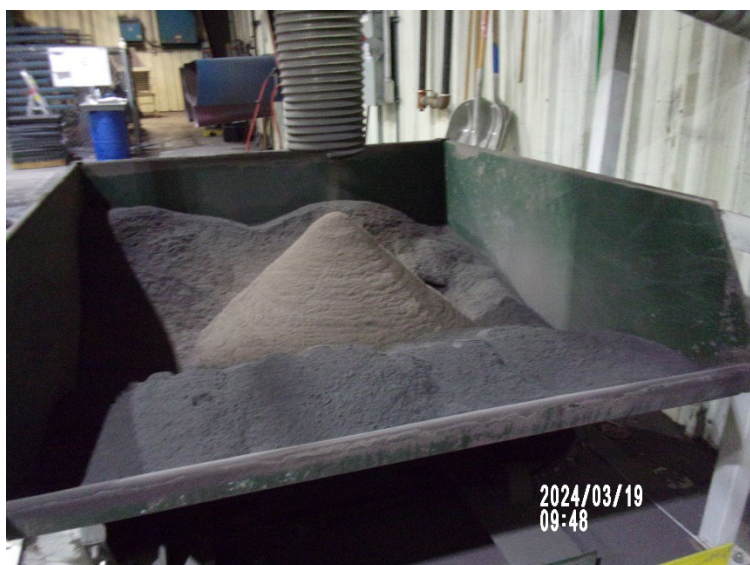
Photograph 3: Materials from the air pollution control baghouses that will be reinserted into the production process.

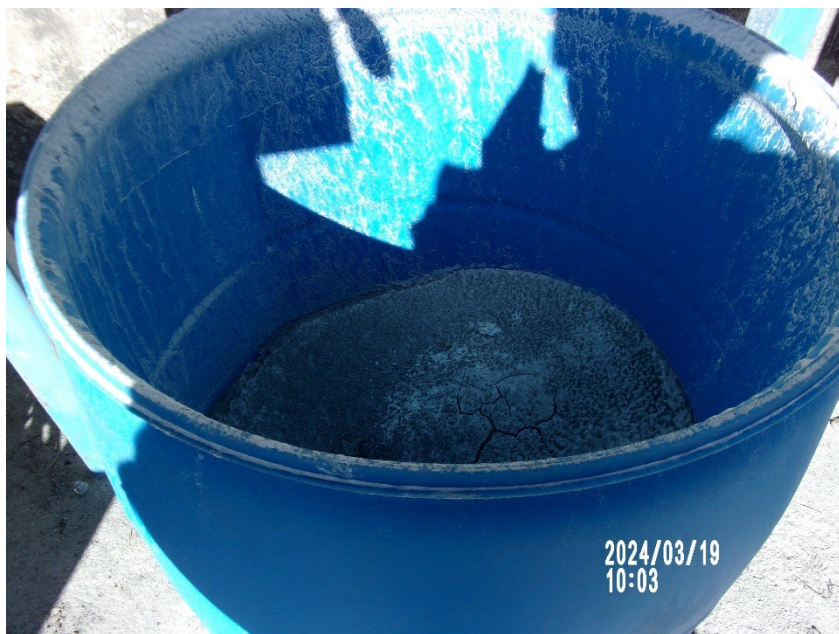
The inspectors were escorted to the quartz tile area. This area was decommissioned in March 2023. There were two opened containers of by-product leftover from this production line (Photographs 4 and 5). Flexco Corporation had determined that the material was non-hazardous. No other waste was observed in this area.

Photograph 4: Material from the inactive Quartz Production Process.

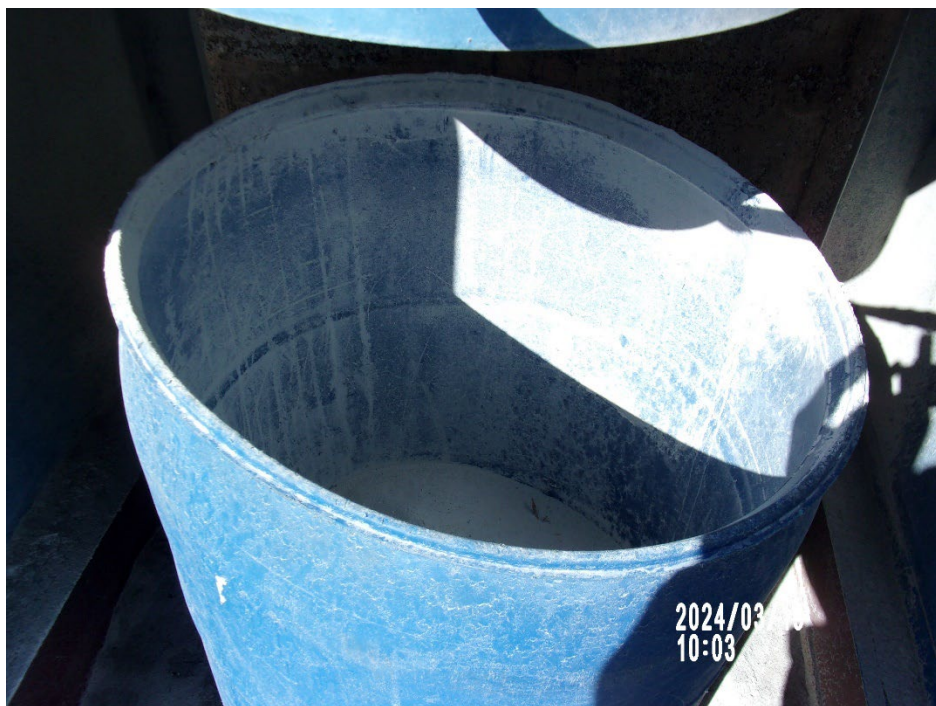
Photograph 5: Material from the inactive Quartz Production Process.

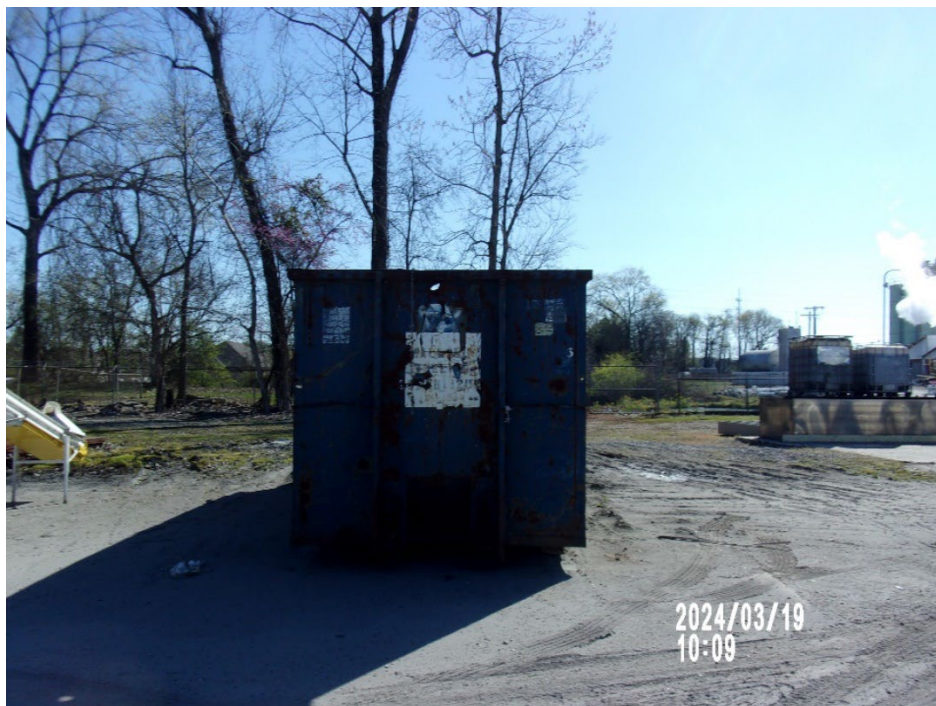
The inspectors were escorted to the Scrap Metal and Used Oil area. This area had one 25 cubic yard roll-off for scrap metal (Photograph 6) and two 250-gallon containers of used oil (Photograph 7). The used oil containers were closed, elevated off the ground, and were within a secondary containment system that appeared adequate to contain the volume of either container in case of complete release. One container was labeled as "Used Oil" but one container was missing the Used Oil label. There was a "Used Oil" sign for the area, but it had been broken off and had fallen into the containment area. This compliance observation was corrected during the inspection and a photograph was sent by the facility to the inspection team (Photograph 15).

Photograph 6: Scrap Metal Roll-Off Container

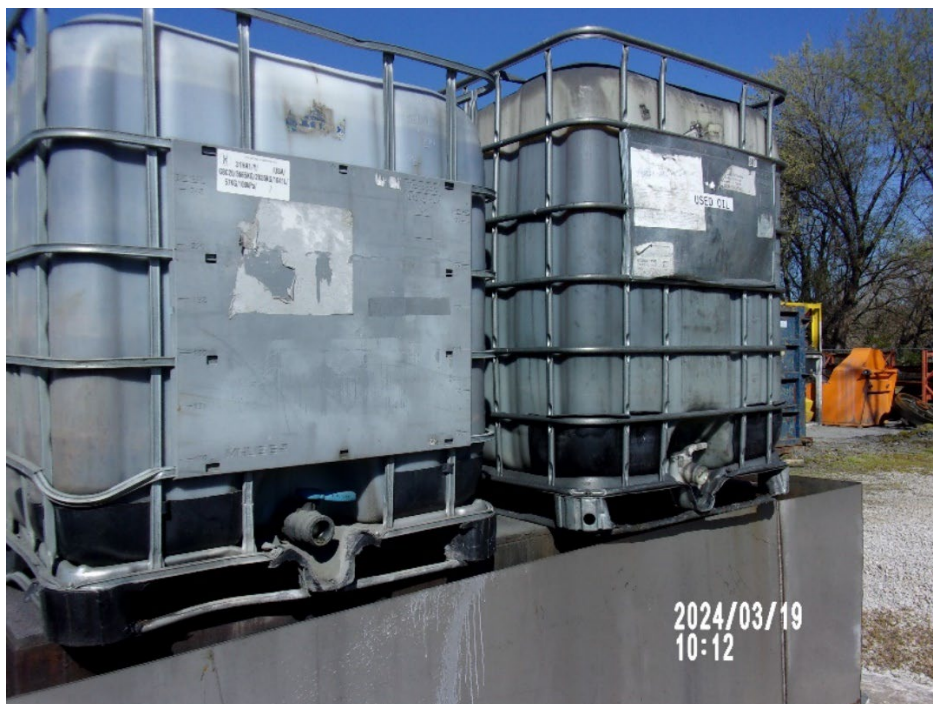
**Pursuant to ADEM Admin. Code r. 335-14-17-.03(4)(c)1. [40 C.F.R. § 279.22(c)(1)] containers and aboveground tanks used to store used oil at generator facilities must be labeled or marked clearly with the words "Used Oil".**

Photograph 7: Picture of Used Oil Containers Above Secondary Containment. One container Is Missing the “Used Oil” Label.

A closing conference was held after the walk-through and records review portion of the inspection. No compliance observations of concern were identified excepting the one used oil label that was corrected during the inspection.

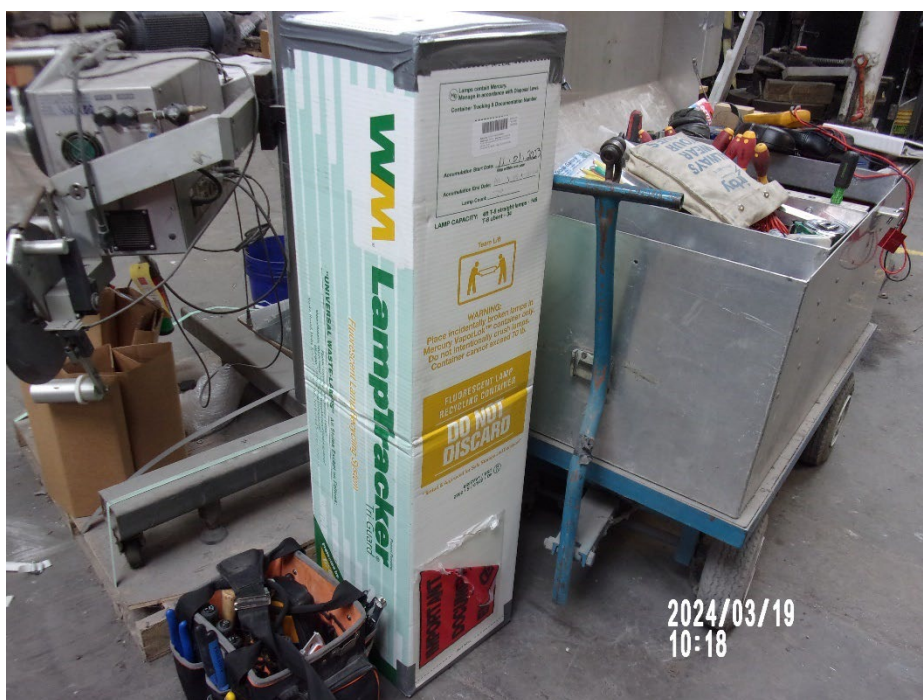
The inspectors were escorted to the maintenance shop. This area stores the facility's universal waste and hazardous waste aerosol puncture station. One cardboard container of universal waste lamps was closed, labeled with the words "Universal Waste-Lamps", and had a start accumulation date of 11-01-2023 (Photograph 8). Another cardboard box of universal waste lamps was dated 2/20/2024, closed, and properly labeled. This area also had several small containers of universal waste batteries in 2-3-gallon size plastic containers that were in an outer cardboard box (Photograph 9). The containers were closed, labeled with the words "Universal Waste-Batteries", and were dated 3/20/2023, 8/8/2023, and 3/11/2024. A hazardous waste aerosol puncture station was in operation. The hazardous waste satellite accumulation container was closed, in good condition and was labeled with the words "Hazardous Waste", and during the inspection a hazard marking was added (Photograph 10).

Photograph 8: Universal Waste Container for Lamps. Box is closed and dated.

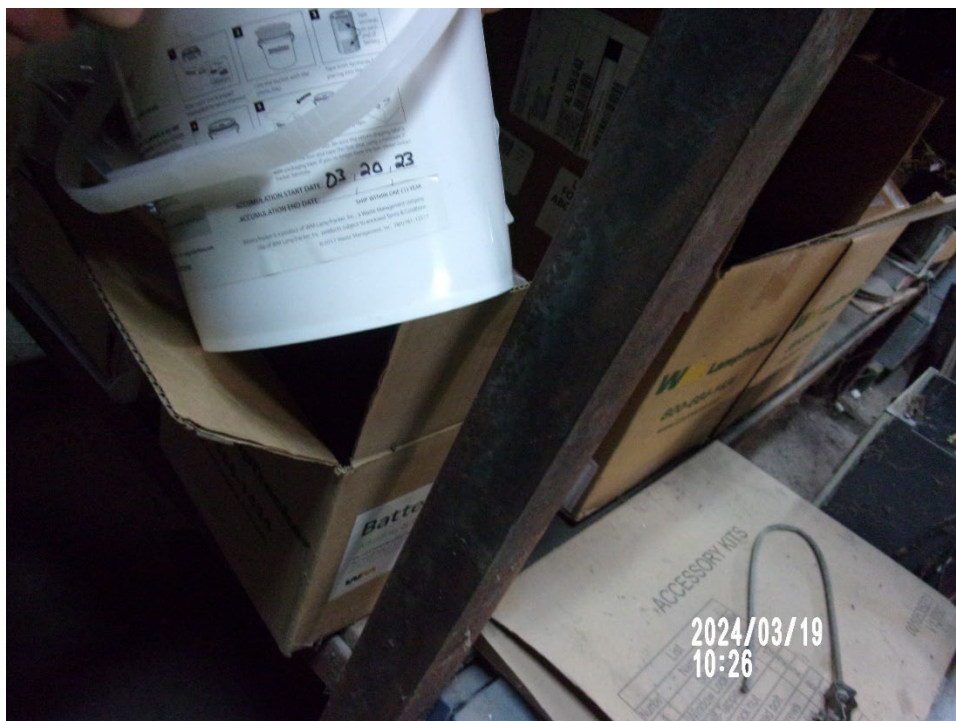
Photograph 9: Universal Waste Batteries Container. Container was labeled, closed, and also enclosed in an outer cardboard box.

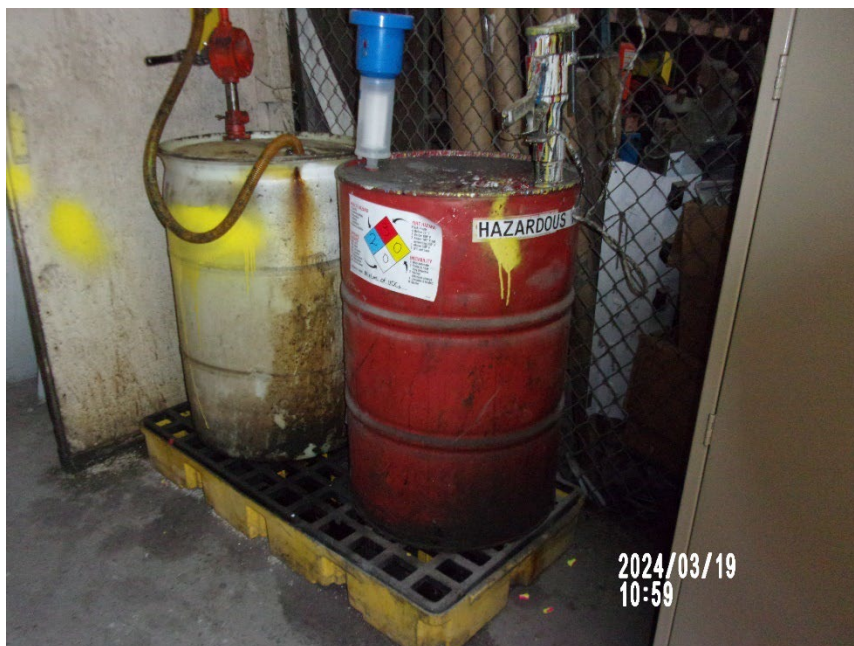
Photograph 10: Hazardous Waste Satellite Accumulation Container. Container is Labeled as Hazardous Waste and has a Hazard Marking.

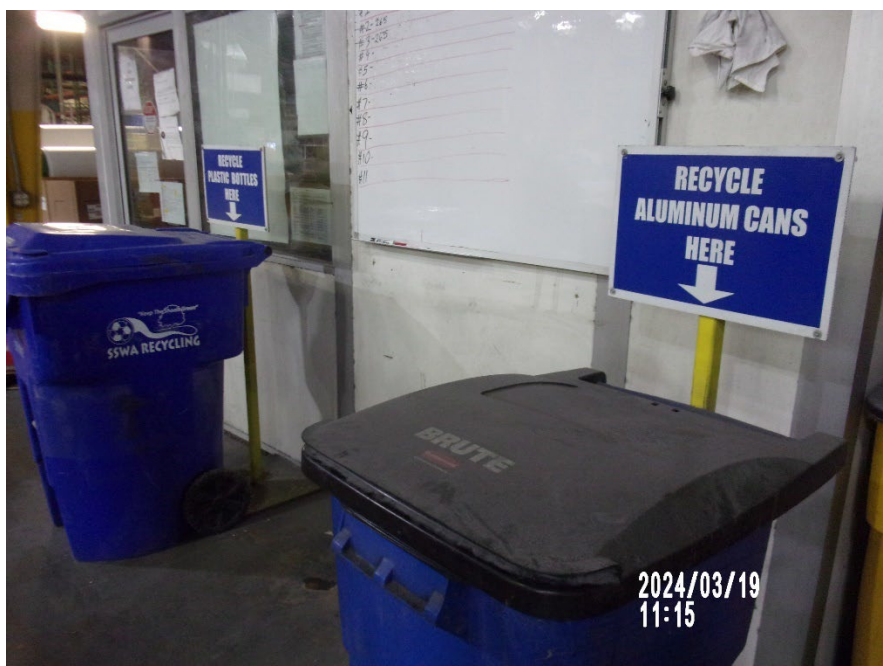
Photograph 11: Example of Facility Recycling.

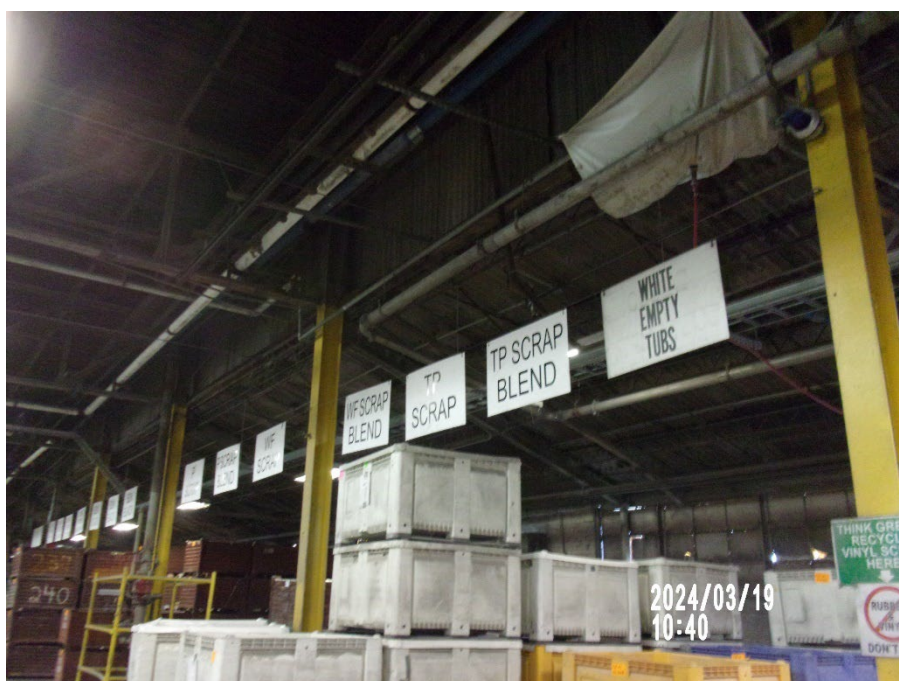
Photograph 12: Facility Recycling Area.

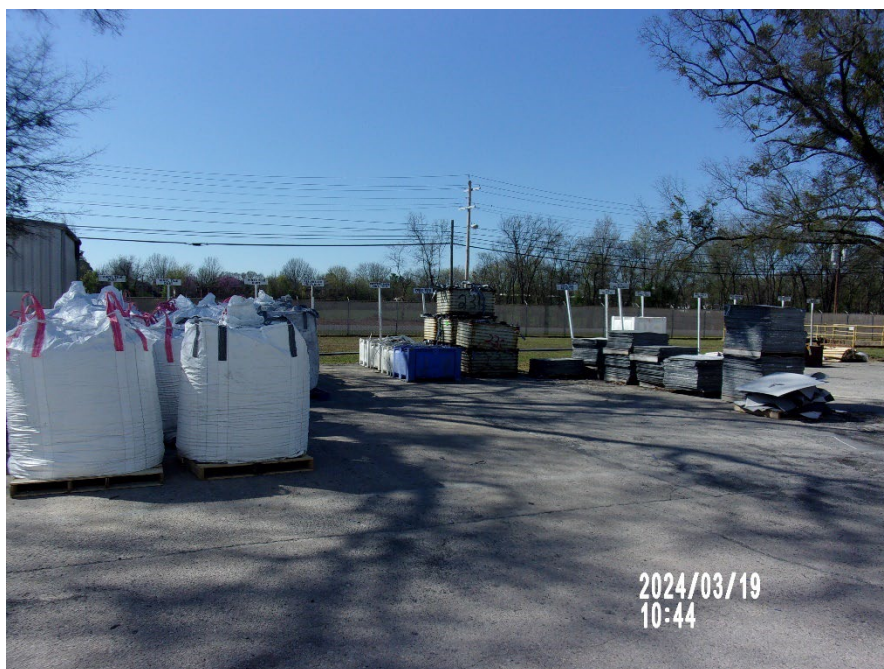
Photograph 13: Facility Recycling Staging Area.

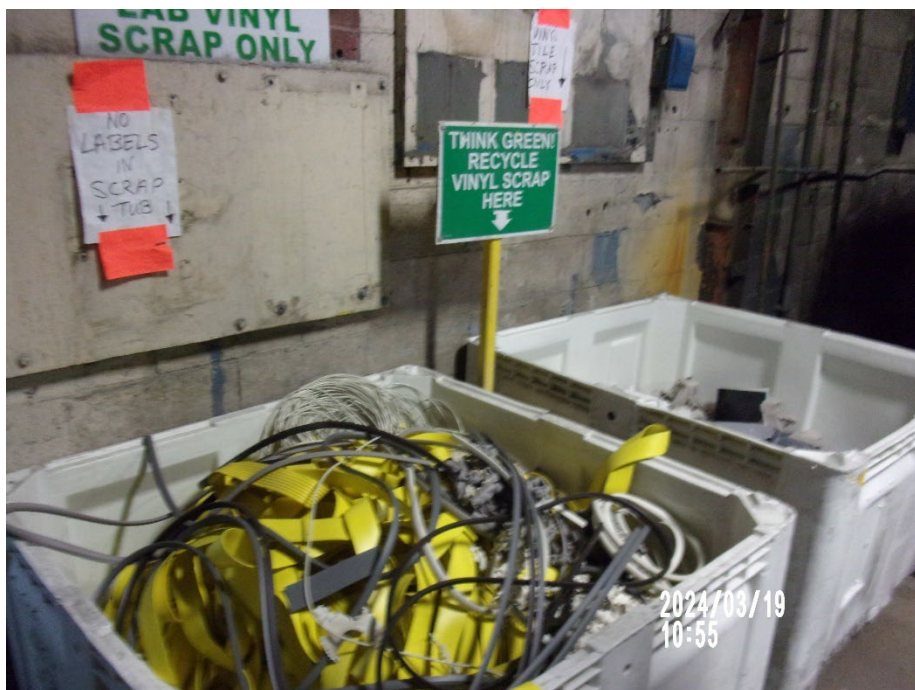
The facility operates a laboratory area with bench scale (scaled down) production processes for testing and development and product testing. This area was not producing hazardous waste but was collecting materials for recycling or solid waste disposal (Photograph 14).

Photograph 14: Photograph of Laboratory Testing Waste.

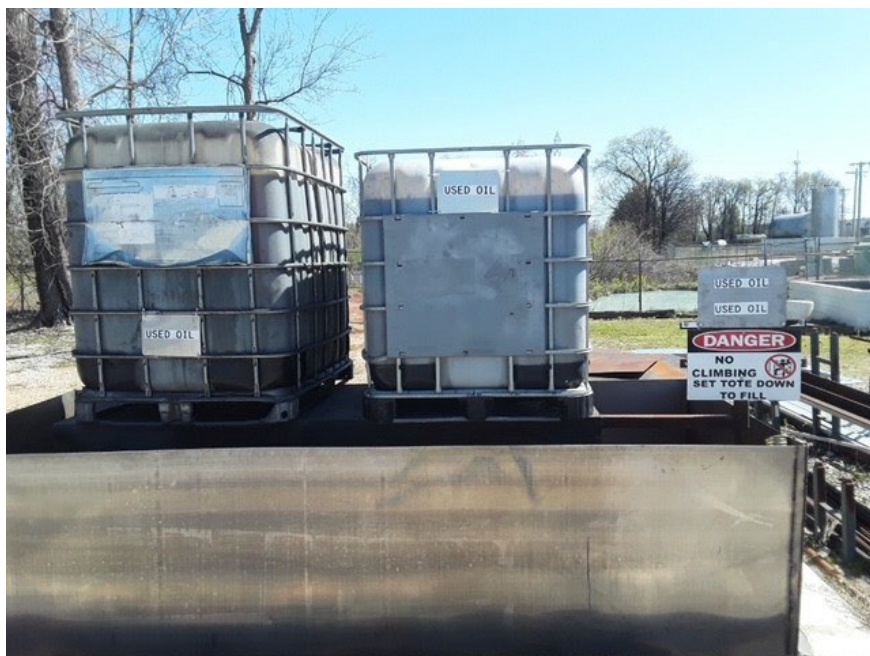
Photograph 15: Picture of Corrected Used Oil Labeling Provided by Flexco Corporation on 3/19/2024 (day of inspection).
