# RCRA Compliance Evaluation Inspection Report

MacDill Air Force Base  
7621 Hillsborough Loop Dr.  
Tampa, Florida 33621  
EPA ID #: FL6570024582

March 29, 2022, 9:30 a.m.

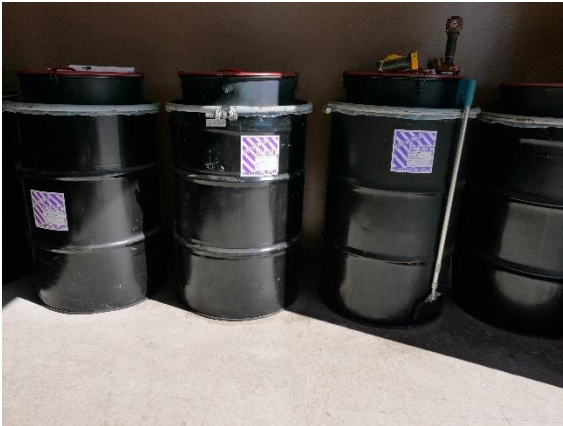
- One closed 55-gallon metal container of spent alkaline batteries with an accumulation start date of September 10, 2020 (Photograph #1);

- One closed 55-gallon metal container of spent Ni-Cad batteries with an accumulation start date of February 25, 2022 (Photograph #1);
- One closed 55-gallon metal container of spent lithium batteries with an accumulation start date of February 7, 2022;
- One closed 55-gallon metal container of spent nickel metal hybrid batteries with an accumulation start date of June 1, 2021 (Photograph #1);
- One closed 55-gallon metal container of spent lead acid batteries with an accumulation start date of February 20, 2022;
- One closed 55-gallon metal container of broken florescent bulbs with an accumulation start date of February 27, 2020; and
- One cardboard tube of spent four-foot fluorescent bulbs with an accumulation start date of March 28, 2022. The container was not closed at the time of the inspection. A lid was placed on the container during the inspection.

Photograph #1 – 55-gallon universal waste containers in Building 885.

**Pursuant to Fla. Admin. Code Ann. r. 62-730.185(1) [40 C.F.R. § 273.15(a) and (c)], a small quantity handler of universal waste may accumulate universal waste no longer than one year and must be able to demonstrate the length of time that the universal waste has accumulated from the date that it became a waste or was received.**

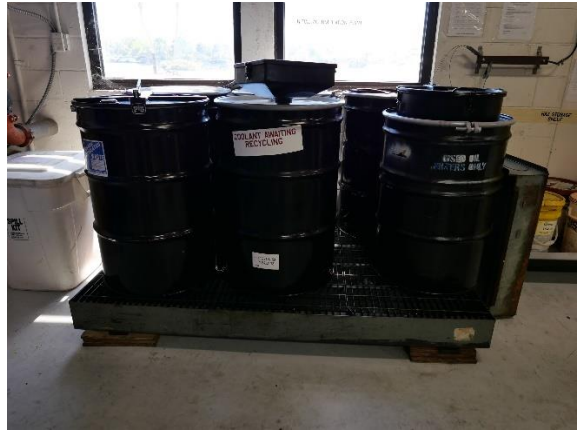
- One closed 55-gallon metal container for the collection of drained used oil filters, marked “Used Oil Filters” (Photograph #2);
- One closed 55-gallon metal container for the collection of used antifreeze/coolant, marked “Coolant awaiting Recycling” (Photograph #2);
- One closed 55-gallon metal container for the collection of waste aerosol cans, marked “Universal Waste”;
- One 55-gallon metal container for non-hazardous waste;
- One closed 5-gallon bucket of used oil;
- A 30-gallon used oil filter press to collect used oil from the crushed filters;
- A cardboard tube of spent four-foot fluorescent bulbs; and

Photograph #2 - 55-gallon container of used oil and coolant in AGE Shop.

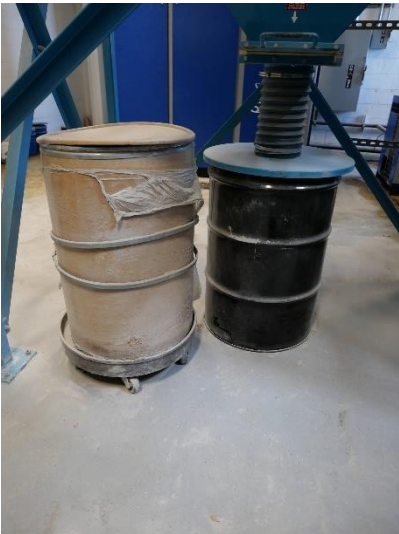
The Corrosion Control Shop contains a large blast booth for large aircraft parts. The blast media waste from this unit is connected to a baghouse hopper located in the Compressor Room. The hopper is connected to an unmarked 55-gallon drum which collects the blast media waste (Photograph #3). Mr. Ritch stated that the container is marked “Hazardous Waste” once it is disconnected from the hopper and the full container is moved to the 90-Day Storage Building. At the time of the inspection, fugitive dust from the collection hopper was present on all surfaces within the room (Photographs #3 and #4). According to the facility personnel, this room is swept/cleaned each Friday and any dust collected is placed into the 55-gallon blast media waste container. On April 8, 2022, Mr. Ritch stated that the large blast booth was shut down following the March 29, 2022, inspection and was investigated to determine the source of the fugitive dust. The investigation determined that the seals on the doors were no longer functional and were replaced. The room was completely cleaned, and the spent blast media/dust/debris was collected, placed in a container, and taken to the 90-Day Storage Building. FDEP’s follow-up inspection on April 8, 2022, inspection indicated that the unit was back in operation and fugitive dust was not observed. The facility indicated that the facility personnel will conduct monthly checks to ensure that all the seals associated with the blasting unit working.

Photograph #3 – Unmarked black 55-gallon container of blast media and dust in the baghouse room.

The inspectors indicated that all baghouse spent blast media IAP container connected to a blasting unit must be closed at all times during accumulation, except when adding, removing, or consolidating waste; marked with the words “Hazardous Waste”; and an indication of the hazards of the contents.

**Pursuant to Fla. Admin. Code Ann. r. 62-730.160(1) [40 C.F.R. § 262.15(a)(5)], which is a condition of the SAA Permit Exemption, a generator must mark or label its containers with**

On June 1, 2022, Mr. Ritch provided photographs of spent blast media containers showing the words “Hazardous Waste” and an indication of the hazards of the contents.

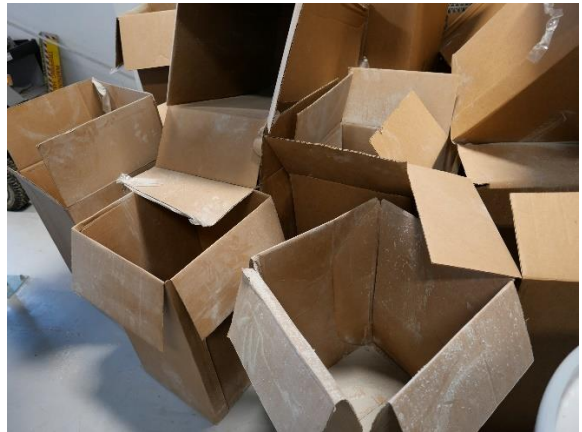
Photograph #4 – Fugitive dust covered empty boxes in the baghouse hopper room.

Pursuant to Fla. Admin. Code Ann. r. 62-730.160(1) [40 C.F.R. § 262.17(a)(6)], which incorporates Fla. Admin. Code Ann. r. 62-730.160(1) [40 C.F.R. § 262.255], and is a condition of the LQG Permit Exemption, a LQG generator must maintain and operate its facility to minimize the possibility of a fire, explosion, or any unplanned sudden or non-sudden release of hazardous waste or hazardous waste constituents to air, soil, or surface water which could threaten human health or the environment.

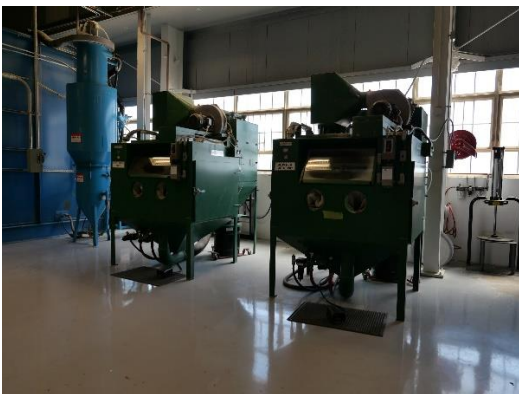
The Corrosion Control shop also contains two small blast booths, one for steel parts and one for aluminum parts (Photograph #5). Each unit is connected to unmarked 30-gallon container which collects the spent blast media (Photograph #6). Mr. Ritch stated that the containers are labeled once they are disconnected from the blaster units and the full containers are moved to the 90-Day Storage Building.

Photograph #5: Two blast booths for steel and aluminum aluminum parts.

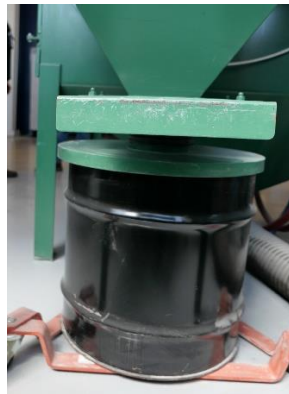
Photograph #6: Unmarked 30-gallon container to collect paint/blasting media chips.

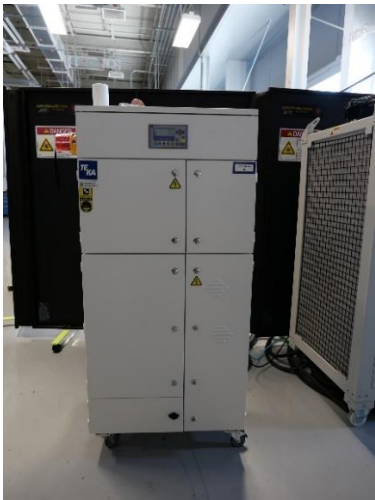
The shop recently installed a 2,000-watt Clean Laser paint removal unit. The waste paint removed by this unit is collected using a built-in vacuum system and the waste paint is collected in a small pan located within the unit (Photograph #7). To date, no waste has been removed from the laser paint removal unit; once removed this waste will be containerized and handled as hazardous waste. The pan was not marked with the word “Hazardous Waste” and an indication of the hazard contents.

Photograph #7 – Lab 2651 SAA containers.

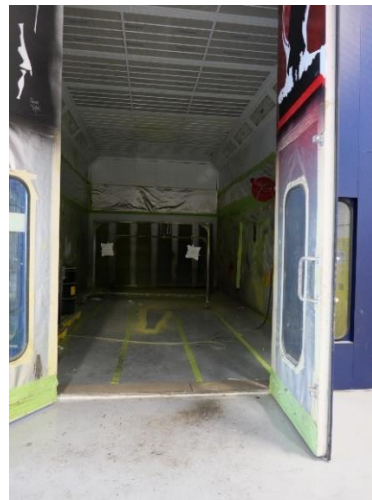
A large paint booth is present in this shop (Photograph #8). According to the facility personnel, the small filters are changed quarterly, the large filters are changed every six months, and the box filters are changed annually. Filter changes are coordinated with PAE to ensure the spent filters are properly containerized, marked and the closed containers are moved to the 90-Day Storage Building. There was one closed 55-gallon container of waste paint/solvents. The container was marked “Hazardous Waste” but did not have an indication of the hazard contents.

Photograph #8 – Building 684-A, outside 90-day storage area.

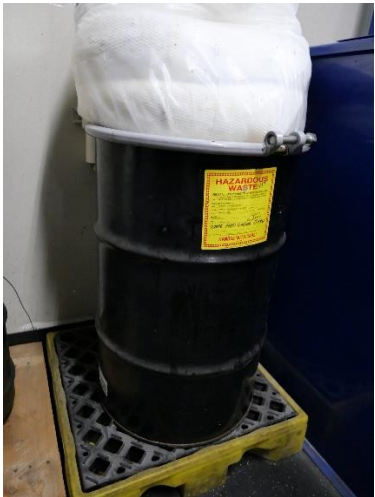
Photograph #9 – 35-gallon container of paint washer filter.

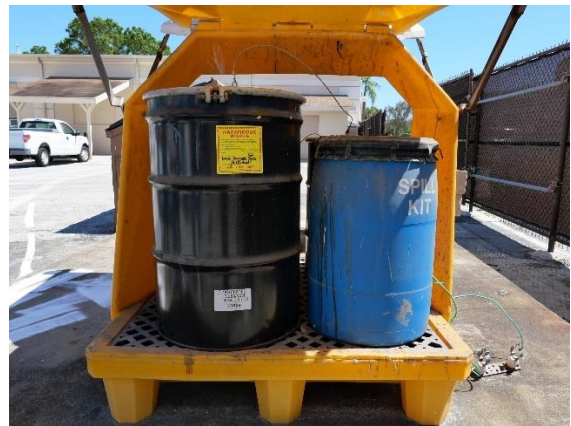
- One closed 55-gallon metal container of non-hazardous waste latex paint;
- One 35-gallon polypropylene container containing a spill kit (Photograph #10);
- One closed 55-gallon metal container of hazardous waste flammable paint/solvents (Photograph #10);
- One closed 35-gallon metal container of universal waste aerosol cans. The container had an accumulation start date of February 2, 2022.

Photograph #10 – 55-gallon metal container of flammable paint and solvent at the CE Paint Shop.

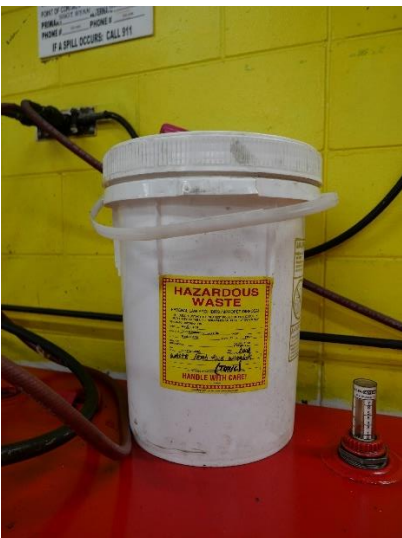
- A closed 5-gallon plastic bucket of waste lead tire weights. The bucket contained a hazardous waste label but was not labeled with an indication of the hazard. The word “Toxic” was added during the inspection (Photograph #11).

Photograph #11 – 5-gallon container of waste lead tire weight in Vehicular Maintenance Shop.

**Pursuant to Fla. Admin. Code Ann. r. 62-730.160(1) [40 C.F.R. § 262.15(a)(5)(ii)], which is a condition of the SAA Permit Exemption, a generator must mark or label its containers with the following: (ii) an indication of the hazards of the contents (examples include, but are not limited to, the applicable hazardous waste characteristic(s) (i.e., ignitable, corrosive, reactive, toxic); hazard communication consistent with the Department of Transportation requirements at 49 C.F.R. part 172 subpart E (labeling) or subpart F (placarding); a hazard statement or pictogram consistent with the Occupational Safety and Health Administration Hazard Communication Standard at 29 C.F.R. 1910.1200; or a chemical hazard label consistent with the National Fire Protection Association code 704).**

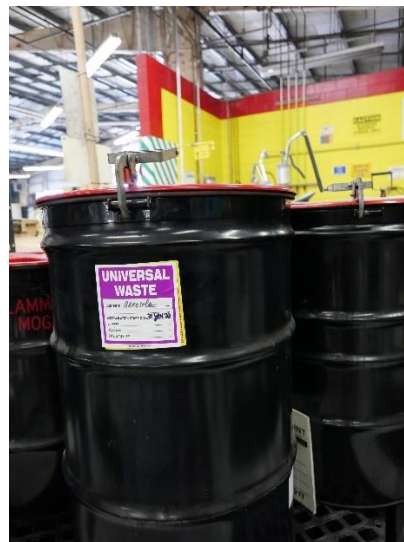
- One closed 55-gallon metal container of universal waste aerosol cans (Photograph #12); and
- One closed 35-gallon container of drained hazardous used fuel filters (EPA waste code D001 and D018). The container was not marked “Hazardous Waste” and an indication of the hazards of the contents. The “Hazardous Waste,” “Flammable,” and “Toxic” labels were added at the time of the inspection (Photograph #13).

Photograph #12 – 55-gallon container of universal waste aerosol cans in JCSE.

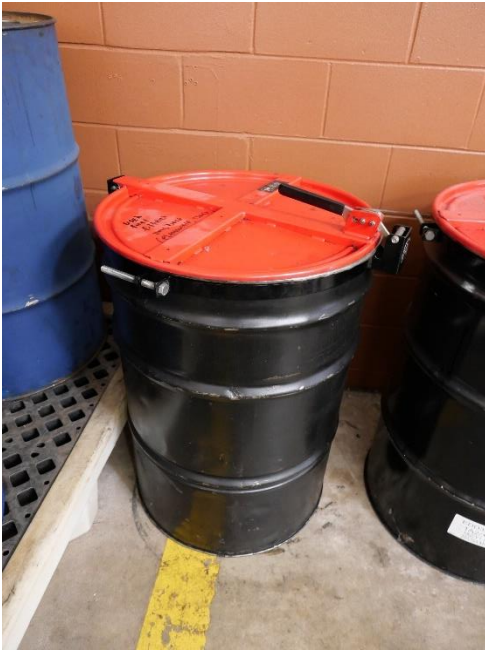
Photograph #13 – Unmarked 35-gallon container of hazardous used filters in JCSE.

**Pursuant to Fla. Admin. Code Ann. r. 62-730.160(1) [40 C.F.R. § 262.15(a)(5)], which is a condition of the SAA Permit Exemption, a generator must mark or label its containers with the following: (i) the words “Hazardous Waste” and (ii) an indication of the hazards of the contents (examples include, but are not limited to, the applicable hazardous waste characteristic(s) (i.e., ignitable, corrosive, reactive, toxic); hazard communication consistent with the Department of Transportation requirements at 49 C.F.R. part 172 subpart E (labeling) or subpart F (placarding); a hazard statement or pictogram consistent with the Occupational Safety and Health Administration Hazard Communication Standard at 29 C.F.R. 1910.1200; or a chemical hazard label consistent with the National Fire Protection Association code 704).**
