## **RCRA Inspection Report**

Hydro Extrusion USA, LLC  
2905 Old Oakwood Road  
Gainesville, GA 30504

EPA ID#: GAD981238199  
NAICS #: 331318 – Other Aluminum Rolling,  
Drawing, and Extruding

May 18, 2023, at 9:00 am

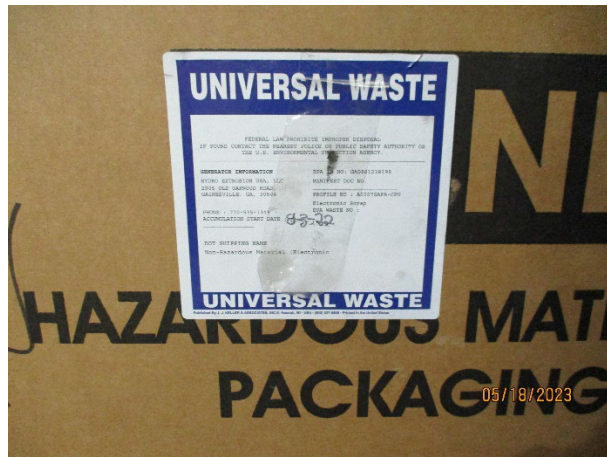
**Photo 1:** One (1) cubic yard cardboard box labeled Electronic Waste, closed, and dated.

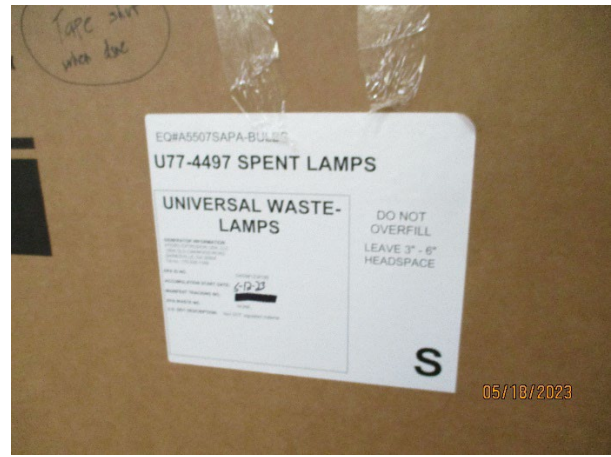
**Photo 2:** One (1) cubic yard cardboard box labeled Universal Waste - Lamps, closed, and dated.

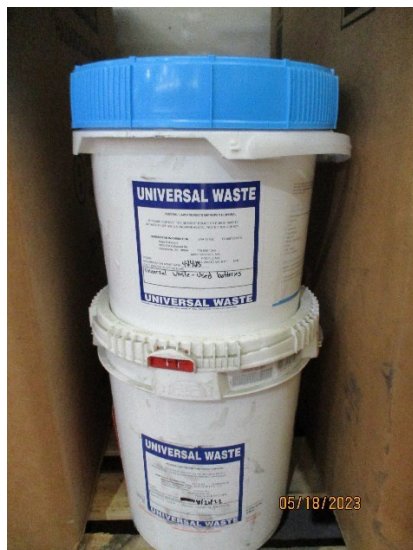
**Photo 3:** One (1) 2-gallon container labeled Universal Waste Batteries and one (1) 2-gallon container labeled Universal Waste Mercury-containing Equipment. Both containers were dated and closed.

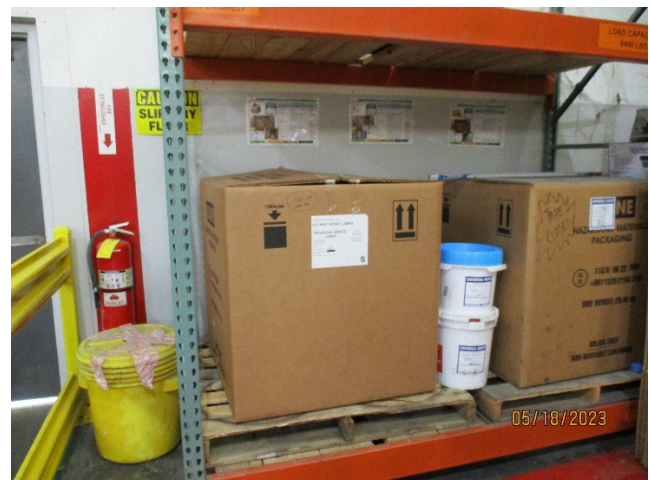
The universal waste storage is kept in the Press 5 Area (part of the extrusion process area). The inspectors observed the following (Photos 1-4):

**Photo 4:** Universal Waste Storage Area 1.

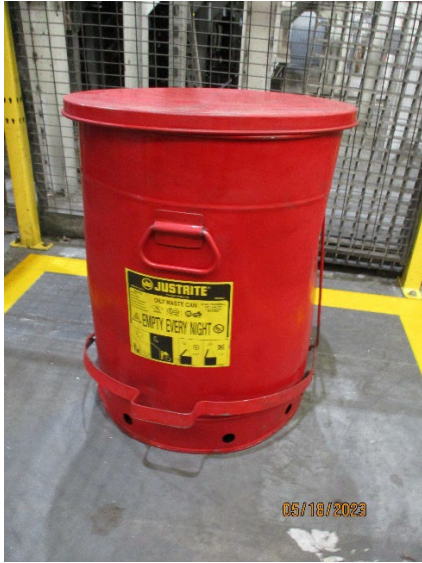
**Photo 5:** 5-gallon red container labeled “Oily Waste Can”.

Several feet away from the universal waste storage area was a closed 5-gallon red container labeled "Oily Waste Can" (Photo 5). These containers are used to hold used oily rags. It was recommended to the facility staff to label these containers with the words "used oil rags" or "used oily rags" so that it is made clear that only rags containing used oil are placed in these containers. On 05/23/2023 Laura McGaha, Southeast Regional Environmental Systems Engineer for Hydro Extrusion sent an email to the inspectors with a photo of the red can with a new "oily rags" label.

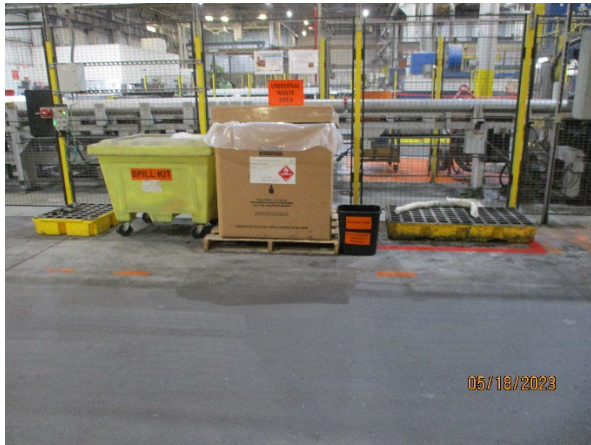
Near to the extrusion preparation area is a second universal waste storage area. Universal waste aerosol cans are stored in this area. The inspectors observed one (1) cubic yard cardboard box labeled Universal Waste – Aerosol Can(s), dated 05/12/23, and partially open (Photo 7). The container had a lid on it, but the lid was not properly fitted and placed on top of the box to securely close it. It did not appear that anyone was adding or removing universal waste from the container. Facility representatives could not access the area at the time of the inspection to properly secure the lid due to it being a hot work area where maintenance was being conducted with overhead machinery several feet away from the universal waste storage area.

**Pursuant to Ga. Comp. R. and Regs. 391-3-11-.18 [40 C.F.R. §40 C.F.R. 273.13(e)], a small quantity handler of universal waste must manage universal waste aerosol cans in a way that prevents releases of any universal waste or component of a universal waste to the environment.**

**Photo 7:** Universal Waste Storage Area 2 for used aerosol cans. Container was labeled “universal waste”, with a start accumulation date, but slightly open.

On 05/23/2023, Laura McGaha sent an email to the inspectors with a photo of the container securely closed (Photo 30).

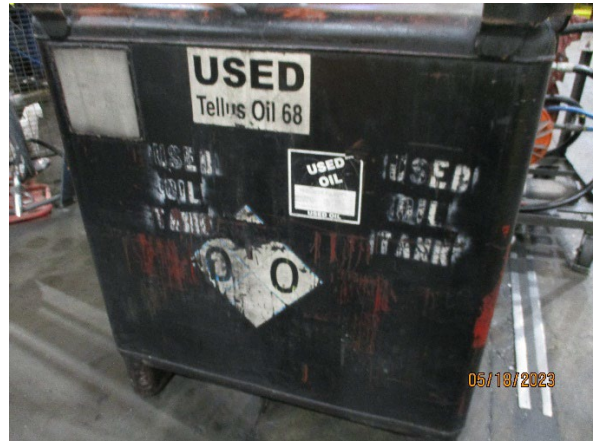
Next to an extrusion press machine was a 350-gallon, double-walled above ground storage tank (AST) for used oil (Photo 8). Used oil is generated from pits under the extrusion press which is then pumped into the AST. The AST was labeled with the words “Used Oil” and appeared in good condition with no signs of leaks or deterioration. There was also another Aramark Towel Manager station. No hazardous waste was observed in this area.

**Photo 8:** 250-gallon double-walled AST labeled “Used Oil”.

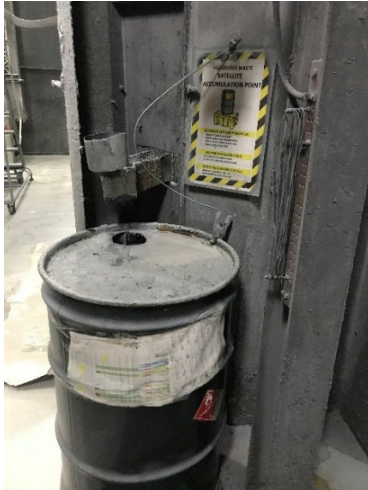
The inspectors were allowed to enter the two paint booths on the other side of the paint room. Here the inspectors observed four (4) 55-gallon drums of hazardous waste still bottom, labeled “Hazardous Waste and marked with an indication of hazard”. One drum for each paint booth was in position to actively collect still bottoms while the two drums were empty. The four drums had the same type of lid with an open hole for collecting paint sludge (Photo 9) taken by GAEPD with an iPhone on airplane mode).

The SAA Permit Exemption requires hazardous waste containers to be closed at all times unless the facility is actively adding or removing hazardous waste from an open container. The two (2) 55-gallon drums in the paint booths that were not in-use did not appear to be collecting paint sludge (Photo 9).

**Pursuant to Ga. Comp. R. and Regs. 391-3-11-.08(1) [40 C.F.R. 262.15(a)(4)] a container holding hazardous waste must be closed at all times during accumulation, except: (i) When adding, removing, or consolidating waste; or (ii) When temporary venting of a container is necessary (A) For the proper operation of equipment, or (B) To prevent dangerous situations, such as build-up of extreme pressure.**

**Photo 9:** 55-gallon drum of paint sludge/ still bottom actively collecting paint sludge. Container is labeled “Hazardous Waste” with an indication of hazard.

Since the facility operates 24/7, an employee should be monitoring the paint sludge entering the hazardous waste drums and replace the lids with holes with a completely sealed closed lid when

paint sludge appears to no longer be depositing into the drum. Although the paint booths are equipped with an air emission control device, hazardous waste containers are required to be properly closed at all times unless adding or removing waste.

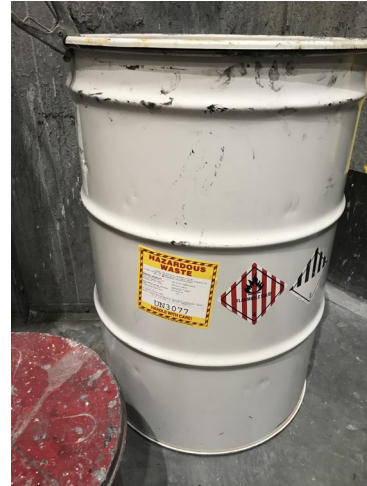
**Photo 10:** One (1) 55-gallon drum of paint debris solids (filters), the drum was closed, labeled “Hazardous Waste” and with an indication of hazard.

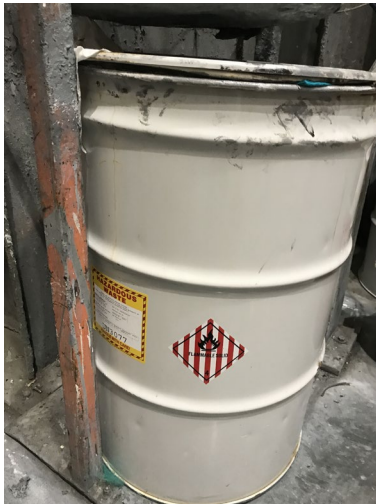
**Pursuant to Ga. Comp. R. and Regs. 391-3-11-.08(1) [40 C.F.R. § 262.15(a)(4)] a container holding hazardous waste must be closed at all times during accumulation, except: (i) When adding, removing, or consolidating waste; or (ii) When temporary venting of a container is necessary (A) For the proper operation of equipment, or (B) To prevent dangerous situations, such as build-up of extreme pressure.**

**Photo 11:** One (1) 55-gallon drum of paint debris solids (filters), drum is slightly open, labeled “Hazardous Waste”, and with an indication of hazard.

Facility representatives immediately retrieved a ring for the drum and properly secured and closed the drum.

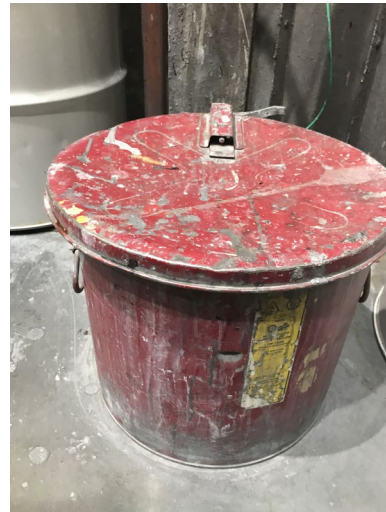
- One (1) 55-gallon drum of paint debris solids (filters), labeled “Hazardous Waste”, the drum was closed, and marked with an indication of hazard (Photo 10)
- One (1) 55-gallon drum of paint debris solids (filters), labeled “Hazardous Waste”, marked with an indication of hazard, and slightly open (Photo 11)
- One (1) 5-gallon container of solvent rags (managed as hazardous waste). The container was closed, with no label, and no indication of hazard (Photo 12).

**Pursuant to Ga. Comp. R. and Regs. 391-3-11-.08(1) [40 C.F.R. §262.15(a)(5)(i)], which is a condition of the SAA permit exemption, a generator must mark or label its container with the following: (i) The words “Hazardous Waste”.**

**Pursuant to Ga. Comp. R. and Regs. 391-3-11-.08(1) [40 C.F.R. §262.15(a)(5)(ii)], which is a condition of the SAA permit exemption, a generator must mark or label its container with the following: (ii) an indication of the hazards of the contents (examples include, but are not limited to, the applicable hazardous waste characteristic(s) (i.e., ignitable, corrosive, reactive, toxic); hazard communication consistent with the Department of Transportation requirements at 49 CFR part 172 subpart E (labeling) or subpart F (placarding); a hazard statement or pictogram consistent with the Occupational Safety and Health Administration Hazard Communication Standard at 29 CFR 1910.1200; or a chemical hazard label consistent with the National Fire Protection Association code 704).**

**Photo 12:** One (1) 5-gallon container of solvent rags, container was closed, no label, no accumulation start date.

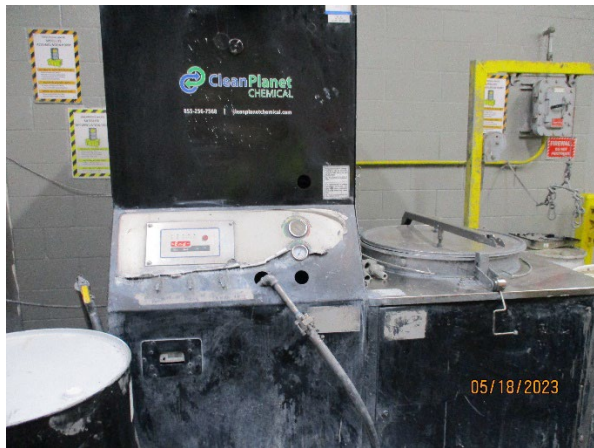
Paint products are mixed here. There is a Clean Planet Chemical Xylene recovery unit that recovers xylene solvent from the flushing of paint lines (Photo 13). Clean Planet services the machine on a monthly basis. The paint mix room is also connected to the thermal oxidizer. The inspectors observed the following waste:

**Photo 13:** Clean Planet Chemical Xylene Recycler.

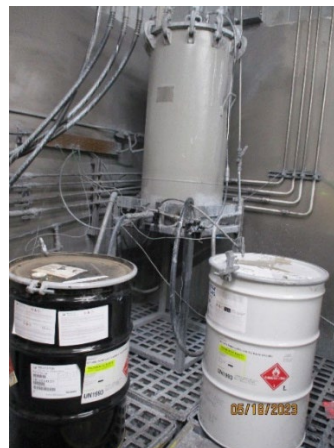
- Two (2) 5-gallon red cans for oily rags that were closed.
- Two (2) 55-gallon drums of paint line flushing (from two different paint lines), properly closed, labeled “Hazardous Waste”, and marked with an indication of hazard (Photo 14)

**Photo 14:** Two (2) 55-gallon drums of paint line flushing (from two different paint lines), properly closed, labeled “Hazardous Waste”, and marked with an indication of hazard.

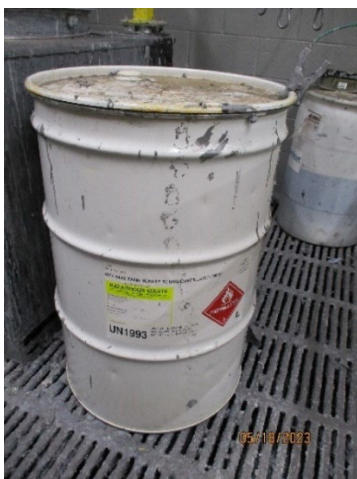
- One (1) 55-gallon drum of waste sludge (still bottom), labeled “Hazardous Waste”, marked with an indication of hazard, and not securely closed with a drum ring (Photo 15).

**Pursuant to Ga. Comp. R. and Regs. 391-3-11-.08(1) [40 C.F.R. § 262.15(a)(4)] a container holding hazardous waste must be closed at all times during accumulation, except: (i) When adding, removing, or consolidating waste; or (ii) When temporary venting of a container is necessary (A) For the proper operation of equipment, or (B) To prevent dangerous situations, such as build-up of extreme pressure.**

**Photo 15:** One (1) 55-gallon drum of waste sludge (still bottom), labeled “Hazardous Waste”, marked with an indication of hazard, and not securely closed with a drum ring.

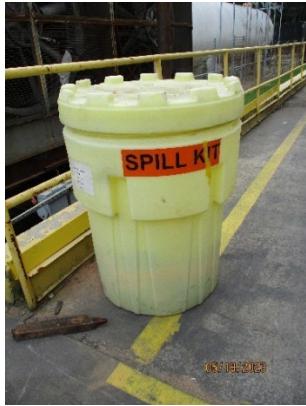
**Photo 17:** Spill kitt in CAA for drum waste.

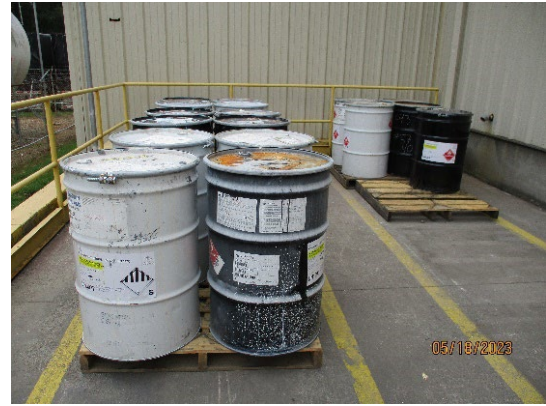
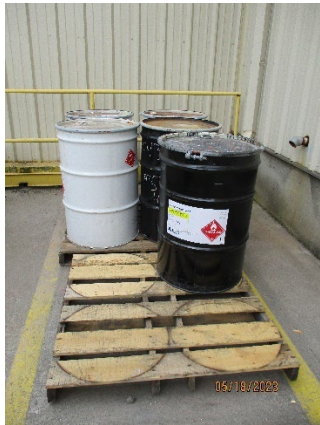
The inspectors observed 17 55-gallon drums of hazardous waste (Photos 18 and 19). Drums had adequate aisle space to inspect each drum and were all properly closed. The drums were all labeled “Hazardous Waste” with EPA waste codes and content information. The drums were all marked with an indication of hazard for flammability. Every drum was marked with an accumulation start date, with the oldest accumulation start date being 05/11/2023.

**Photo 18:** (18) 55-gallon drums of hazardous waste in the CAA for drum waste.

**Photo 19:** Hazardous waste drums in CAA for drum waste.

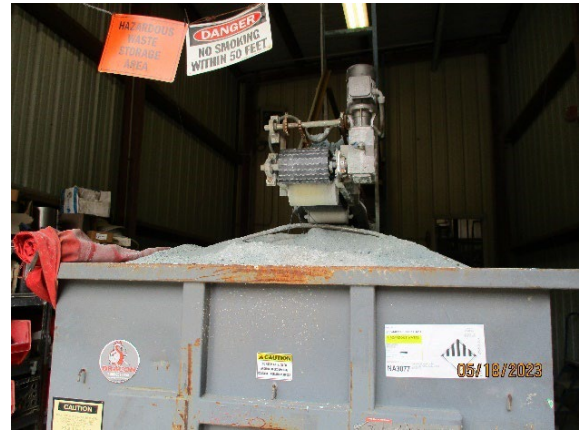
The inspectors observed one (1) roll off container with hazardous waste filter cake actively being added to it (Photo 20). The container was labeled “Hazardous Waste” with a Class 9 label and no start accumulation date. Facility representatives were educated on the container being a CAA container and not a SAA since it is over 55-gallons of hazardous waste. The inspectors also explained that the Class 9 DOT Placard indicates a miscellaneous hazardous material which does not indicate the hazard (flammable, corrosive, reactive, or toxic).

**Pursuant to Ga. Comp. R. and Regs. 391-3-11-.08(1) [40 C.F.R. §262.15(a)(6)(i)], a generator who accumulates either acute hazardous waste listed in § 261.31 or § 261.33(e) of this chapter or non-acute hazardous waste in excess of the amounts listed in 40 C.F.R. 262.15(a) of this section at or near any point of generation must do the following: (i)**

**Photo 20:** Filter cake being added to hazardous waste roll off container in WWTP.

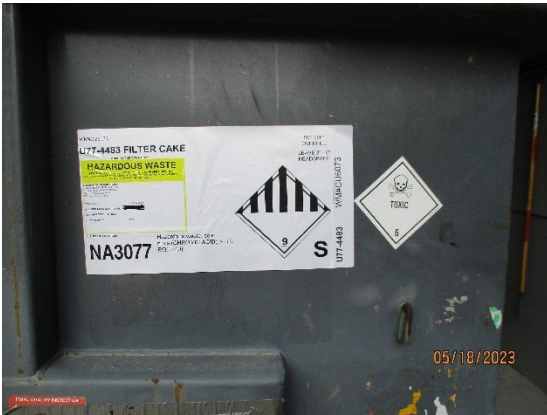
**Pursuant to Ga. Comp. R. and Regs. 391-3-11-.08(1) [40 C.F.R. § 262.17(a)(5)(i)(B)], an indication of the hazards of the contents (examples include, but are not limited to, the applicable hazardous waste characteristic(s) (i.e., ignitable, corrosive, reactive, toxic); hazard communication consistent with the Department of Transportation requirements at 49 C.F.R. part 172 subpart E (labeling) or subpart F (placarding); a hazard statement or pictogram consistent with the Occupational Safety and Health Administration Hazard Communication Standard at 29 C.F.R. 1910.1200; or a chemical hazard label consistent with the National Fire Protection Association code 704);**

**Photo 21:** New toxic placard added to roll off container of filter cake since Class 9 placard does not indicate the hazard content.

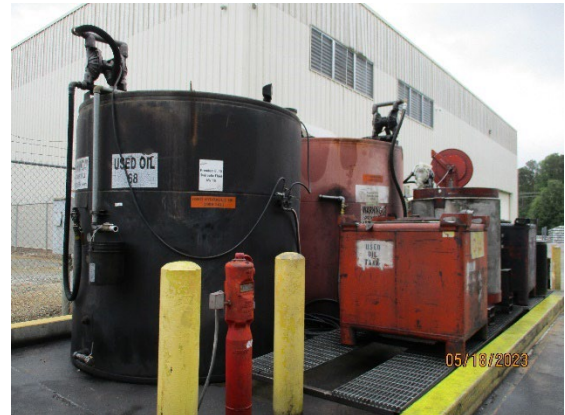
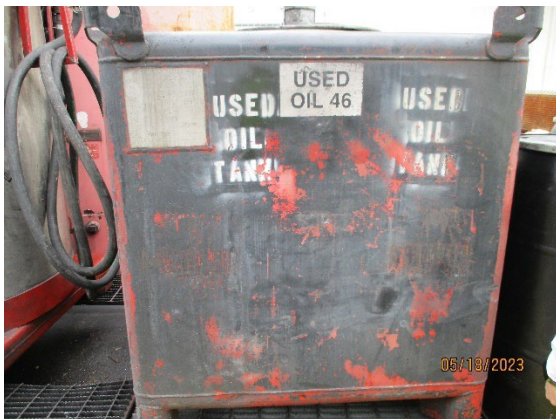
Used oil is stored on the east side of the facility in a concrete containment pad. Universal Environmental Services takes the used oil for recycling. Aramark launders used oily rags. No hazardous waste was observed in this area. The inspectors did observe the following waste (Photos 22-24):

**Photo 22:** Used Oil Storage Area 1

**Photo 23:** 350-gallon AST labeled "Used Oil" in Used Oil Storage Area 1.

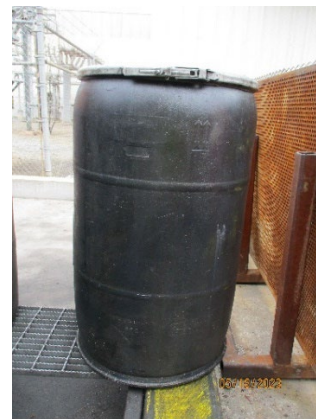
**Photo 24:** Container of oil absorbents in Used Oil Storage Area 2. Inspectors requested a label for the container.

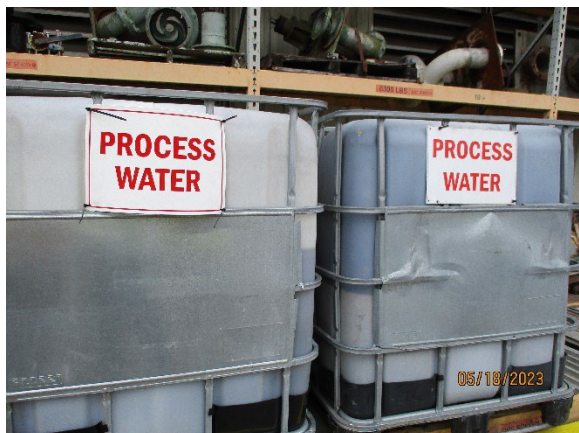
There is a second used oil storage area on the northeast side of the facility where the facility stores oily water in 250-gallon totes. The inspectors observed two (2) 250-gallon totes labeled “process water” (Photo 25). The inspectors recommended that the facility label the containers as “oily water” if oil and water are the only contents in the totes. No hazardous waste was observed in this area. On 05/23/2023, Laura McGaha sent an email to the inspectors with a photo of the containers re-labeled (Photo 26).

**Photo 25:** Used Oil Storage Area 2 for oily water. Inspectors recommended re-labeling the containers to “Oily Water” instead of process water.

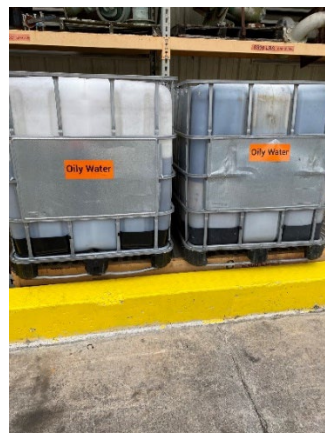
**Photo 26:** Containers of oily water with new labels.

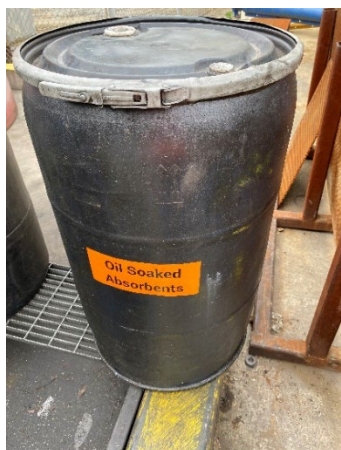
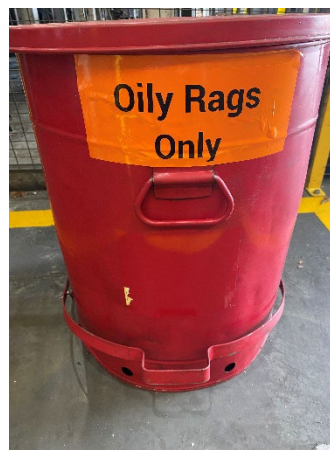
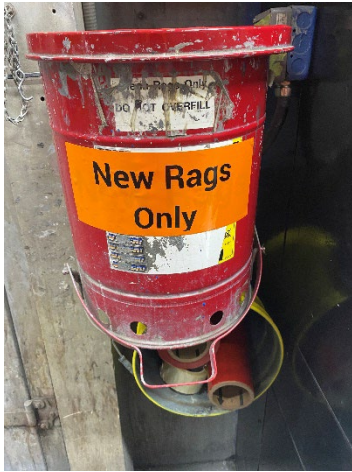
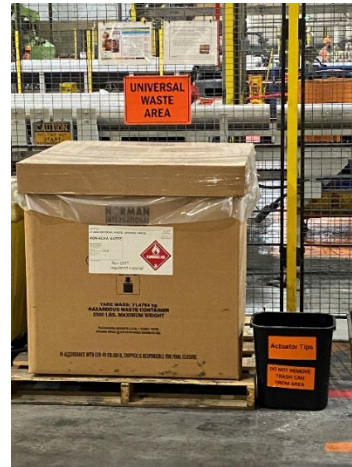
**Photo 27:** Label placed on absorbents with used oil.

**Photo 28:** New label specifying designated containers are for oily rags only.

**Photo 29:** New label for red container in Paint Room (in between paint booths) for new rags only.

**Photo 30:** Universal waste aerosol cans with lid properly secured onto cubic yard box.

The email also contained photos (Photos 27-30) of the drum missing a label for used oil absorbents, the red containers of used oily rags with new labeling to specify the containers are just for used oil rags, a photo for the red container in the Paint Room labeled “New Rags Only”, and a photo of the cubic yard box of universal waste aerosol cans with the lid properly secured on it.
