**Region 6 Compliance Assurance and Enforcement Division  
INSPECTION REPORT**

| Inspection Date(s): | 04/18/2016 | | |
| Regulatory Program(s) | SDWA | | |
| Company Name: | <b>Santa Socorro Trailer Park</b> | | |

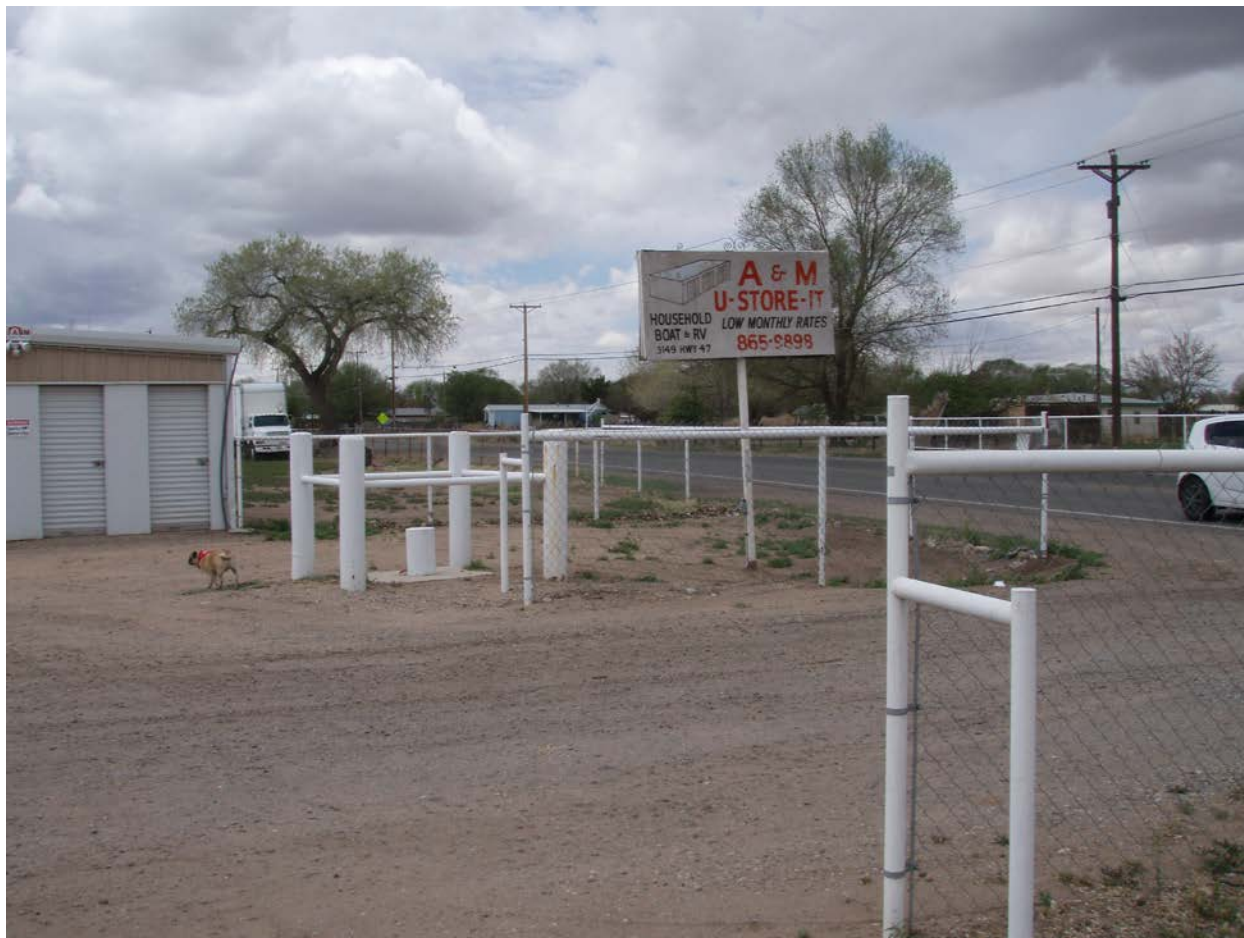
Photo No. 1

NMED's 2014 sanitary survey cited a lack of site security at the well head. Well #1 is 120 feet deep and is protected by metal bars to prevent cars from running it over. Since the sanitary survey, the wellhead has been adequately protected with a heavy, sealed, locked metal covering (Appendix 1, Photo 2). Ms. Montano removes the covering, and well cap is sealed tightly, and well pad is intact with approximately 2.5 feet of concrete on each side. Screening underneath cap is loose and not 24 mesh (Appendix 1, Photo 3).

Description: Well #1 located near Hwy 47, protected from cars with vertical metal bars.

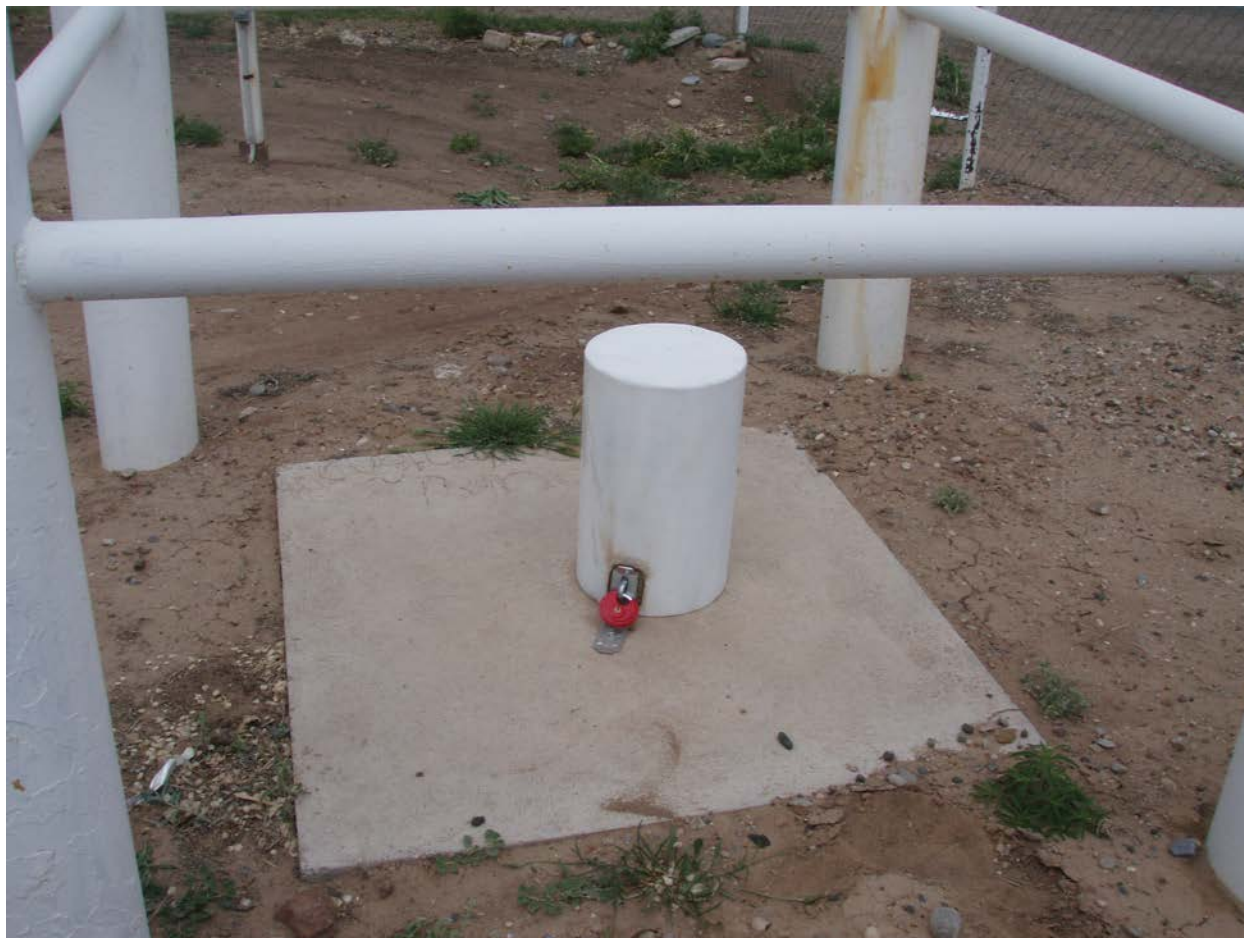
Photo No. 2

Description: Metal case with lock added to Well #1 for wellhead protection.

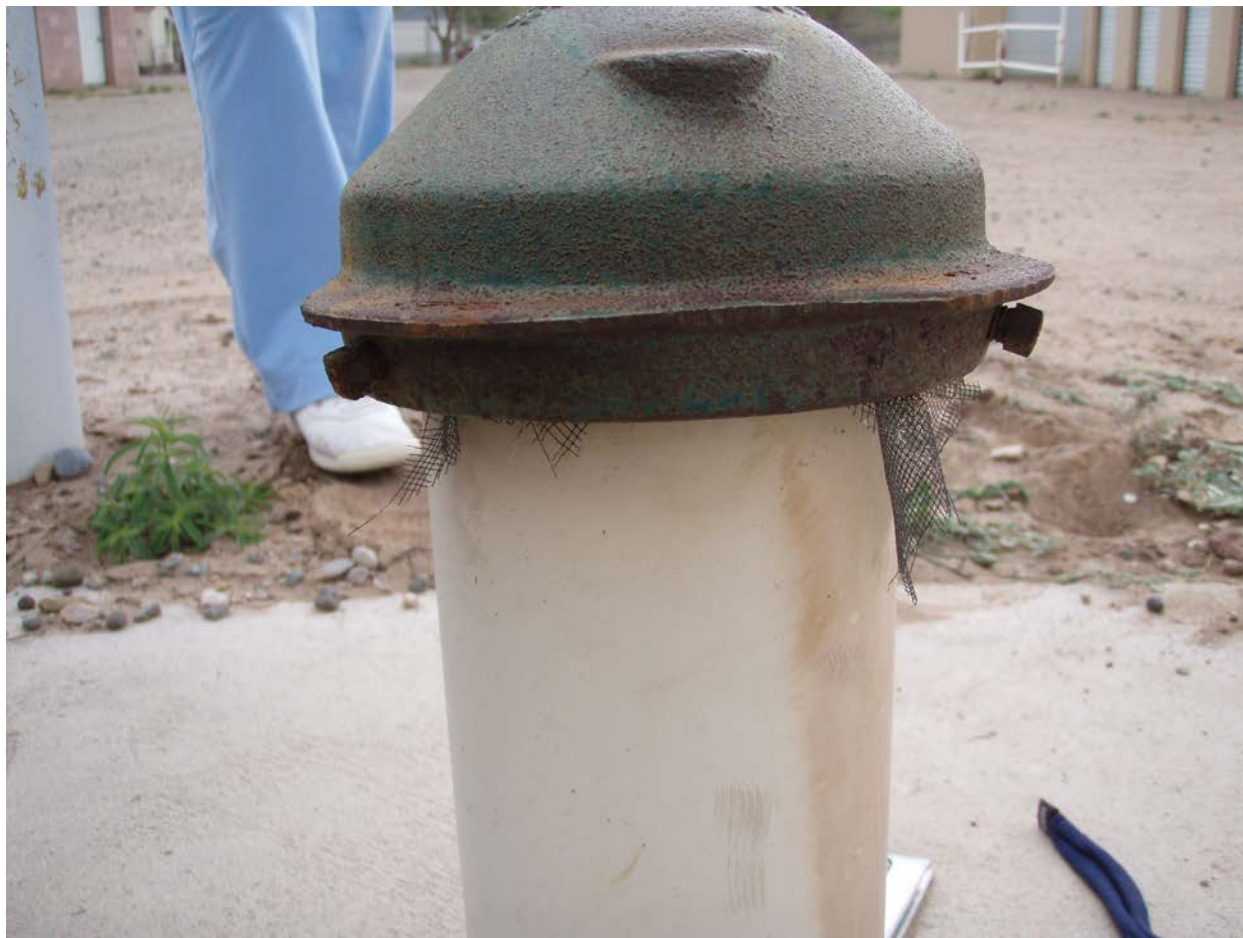
Photo No. 3

Description: Sealed cap on Well #1, but screen is loose and not 24 mesh.

- There was no certified drinking water operator employed at Santa Socorro Trailer Park at the time of inspection.
- Screen on Well 1 should be 24 mesh, sealed tightly around wellhead.

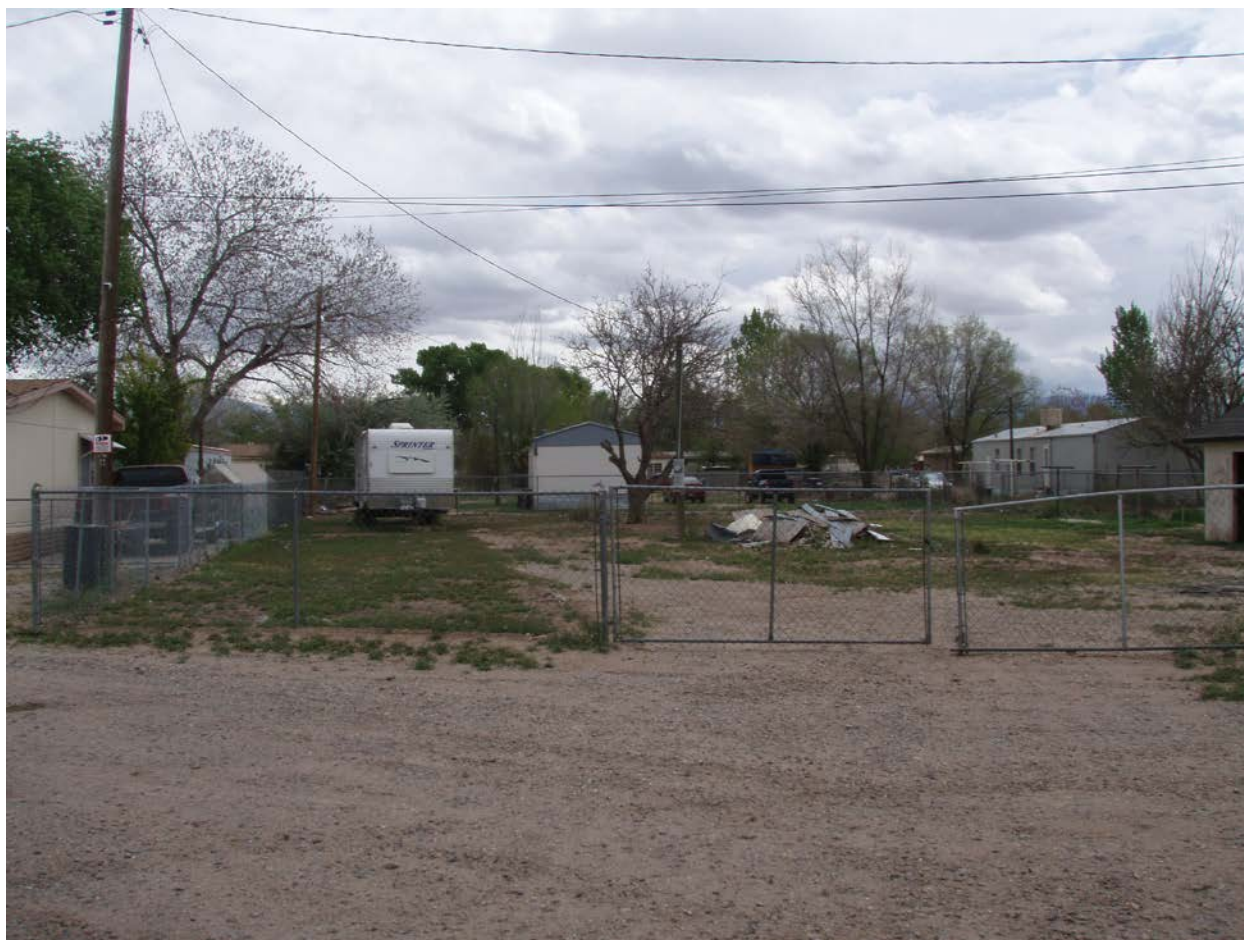
Photo No. 4

Lot C, located about two hundred feet from Well 1, is available for camper parking, but was not being used at the time of inspection (Appendix 1, Photo 4). However, Lot C's service connection is a hose that was lying on the ground surrounded by debris (Appendix 1, Photo 5). The tap opened easily, but would not close completely. There were two Well-X-Trol hydropneumatic pressure tanks on Lot C, stored inside of a shed with insulation. The line connecting storage tanks to the rest of system was leaking (Appendix 1, Photo 6).

Description: Lot C overview with debris.

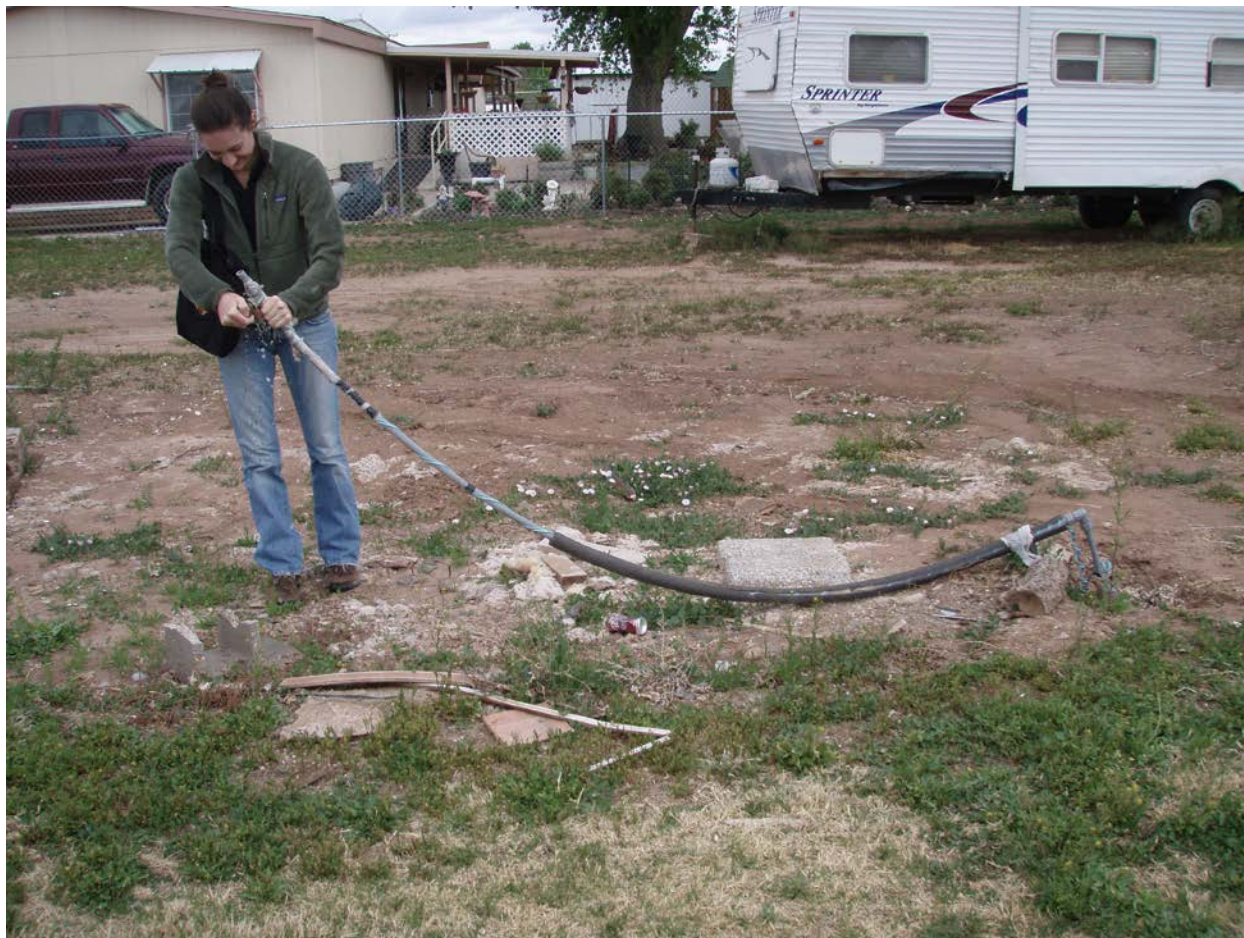
Photo No. 5

Description: Lot C with exposed, active service connection subject to cross contamination.

- The service connection on Lot C was a cross connection and a potential source of contamination into distribution. Due to its proximity to Well 1 and tendency to leak, it is imperative to either disconnect the line, or retrofit it with a hose that is not subject to contamination from dirt and surrounding debris.

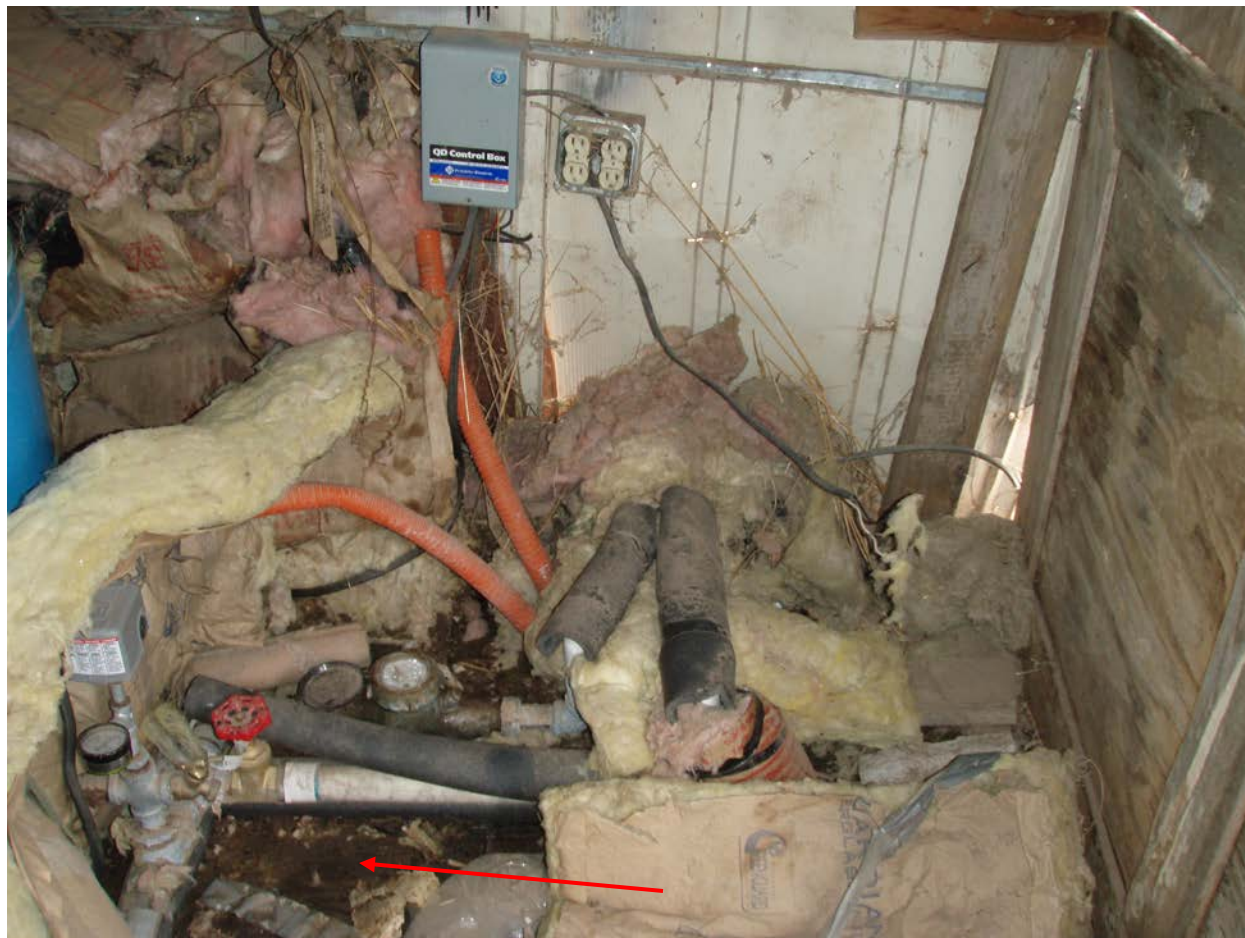
Photo No. 6

Description: Hydropneumatic pressure tanks are stored inside shed on Lot C; water line flowing into/out of tanks is leaking.

- Water lines on inlet/outlet of storage tanks on Lot C were leaking.
- The inactive well on Lot P presents a direct pathway of contamination into the aquifer and must be protected with a tight seal around cap and wellhead. The inactive well should have an intact, concrete pad, and electrical conduit should be disconnected and sealed. Alternatively, the inactive well on Lot P should be abandoned according to NMED standards.

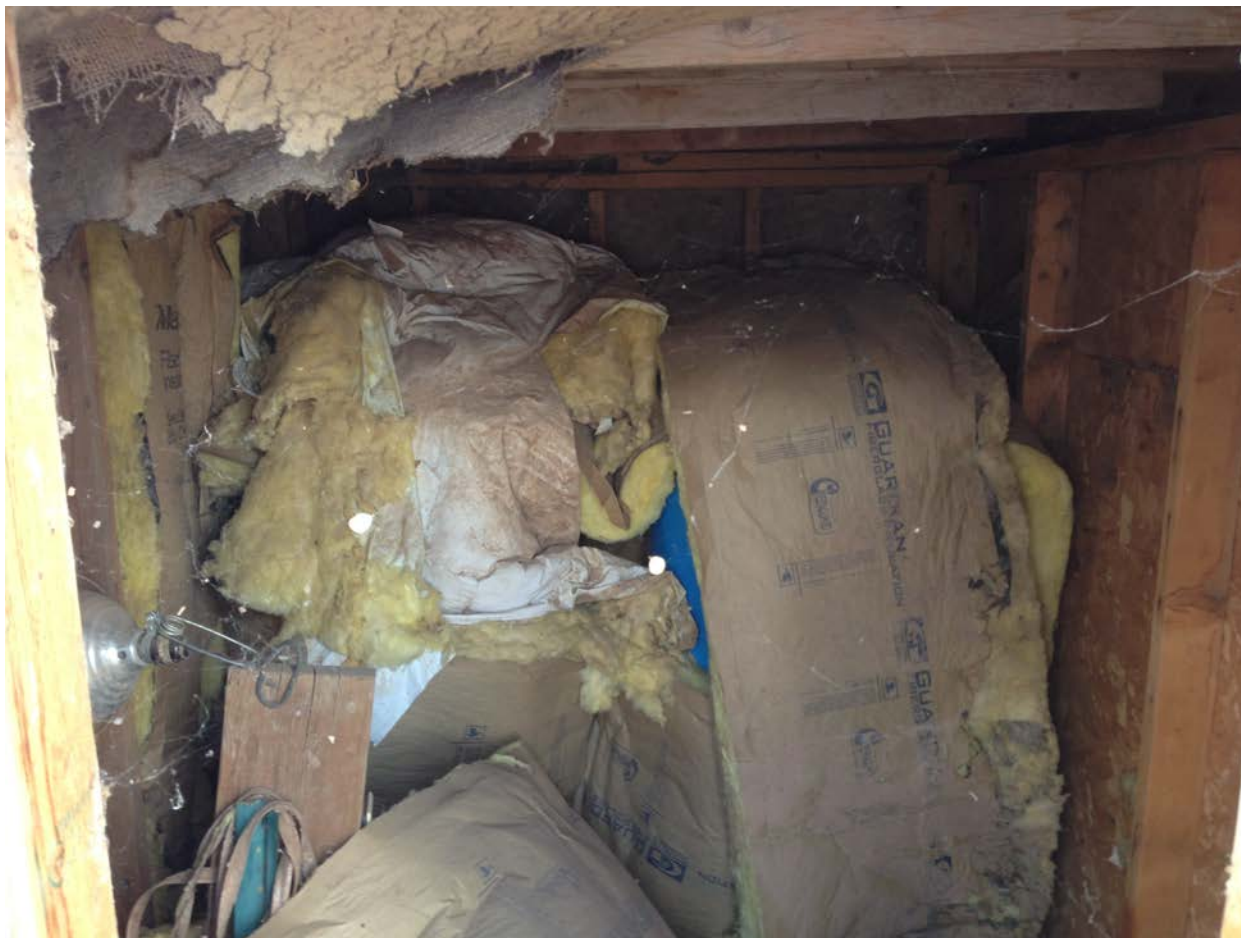
Photo No. 7

We inspected two additional storage tanks, located inside a shed on Lot Q that also contains an inactive well (Appendix 1, Photos 7 & 8). Ms. Montano claimed that the abandoned well was in a different location nearby, but did not remember exactly where. She stated that her husband sealed it with a cap below ground over 10 years ago, though it could be rehabilitated if necessary. The well we observed inside the shed was unprotected – there was no well pad, and the ground surrounding well was uneven, cracked and full of debris (Appendix 1, Photo 8). The cap on well was loose, not sealed, and electrical connection entering wellhead appears intact and is unsealed.

Description: Hydropneumatic pressure tanks are stored inside shed on Lot P, covered with insulation.

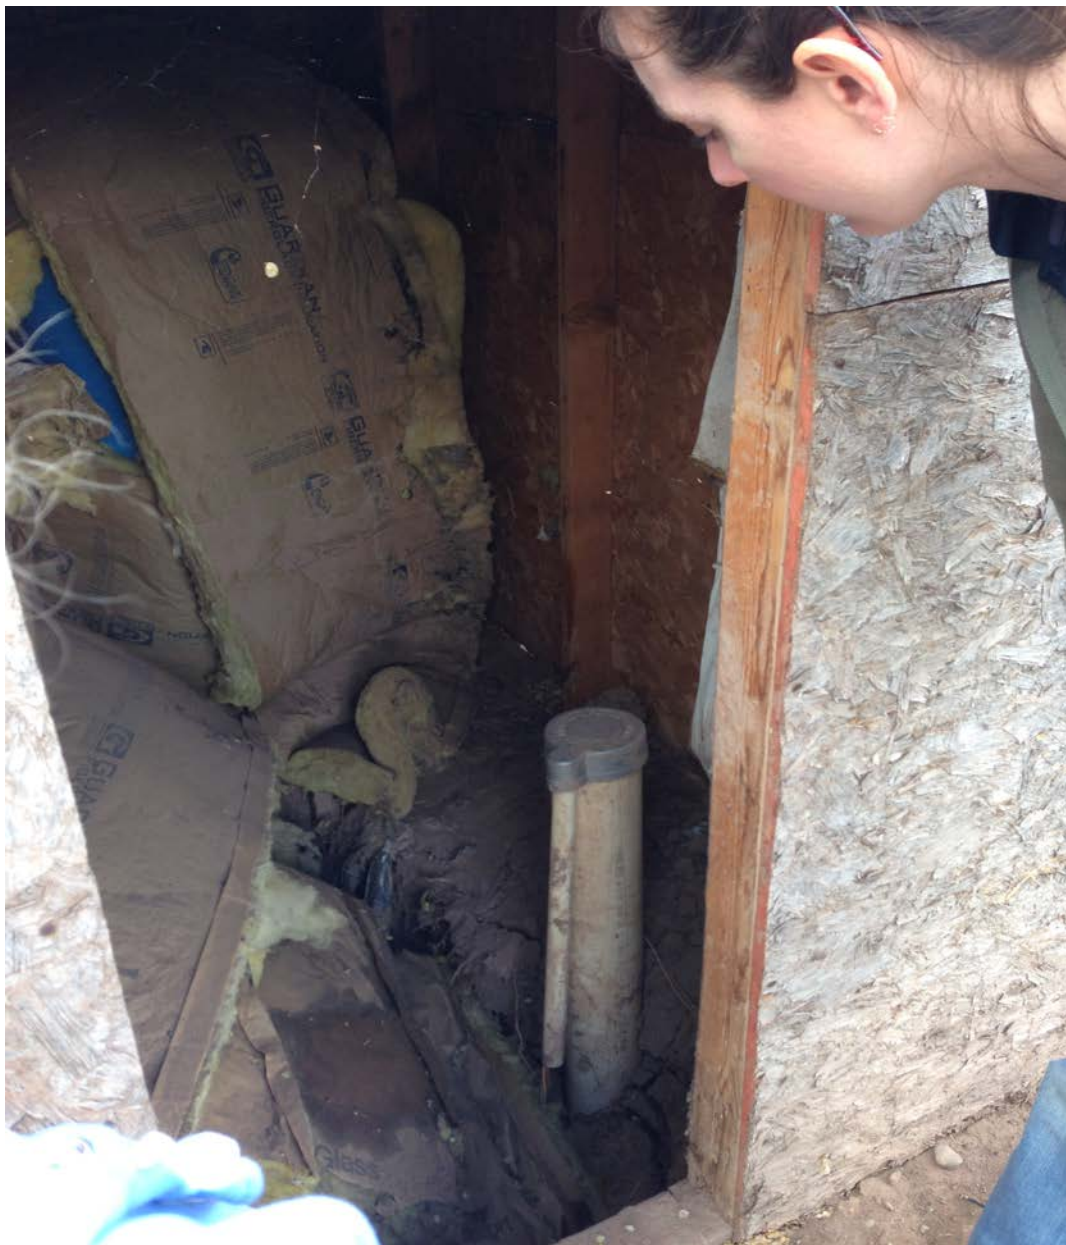
Photo No. 8

Description: Inactive well inside shed on Lot P is not properly sealed or protected.

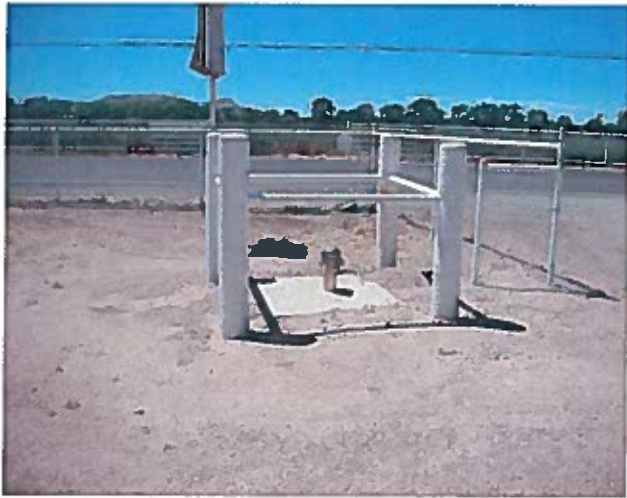
**WELL #1**

**1. Deficiency: (001J) Lack of site security at the well**

**Concern/Description:** Direct Contamination, Delivery – Unauthorized access can result in the water system being contaminated and key components being compromised which could result in a water outage.

**Corrective Action:** Secure the well head to prevent unauthorized access. This could be accomplished by installation of a high security fence or a locking vault around the well head. Submit photo documentation of corrective action.
