## **RCRA Inspection Report**

Tradebe Treatment and Recycling of Tennessee, LLC  
1004 Idlewilde Boulevard  
Columbia, South Carolina 29201  
Richland County  
EPA ID No. SCR000778779

June 16, 2022

Appendix 1–Tradebe Treatment and Recycling of Tennessee, LLC  
RCRA CEI Photographs  
William Kappler, US EPA

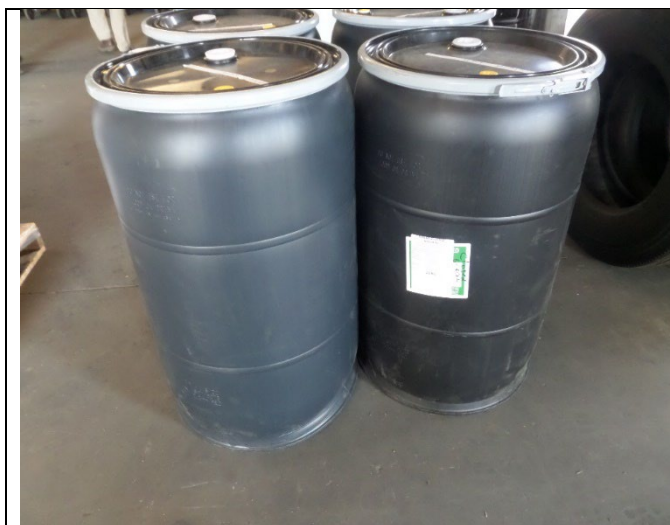
The inspectors observed four 55-gallon containers accumulating non-hazardous waste formalin and tissue samples. The containers were closed and labeled with the words "non-hazardous waste" (Photograph 1). The inspectors also observed two 35-gallon containers accumulating dimethyl ammonium chloride. The containers were accumulating on the loading dock, until shipment, because of the possible incompatibility with hazardous waste accumulating in the trailers (Photograph 2).

Warehouse. The inspector observed four 55-gallon containers accumulating non-hazardous waste formalin and tissue samples. The containers were closed and labeled with the words “non-hazardous waste”. Photograph 1 taken at 11:38 a.m.

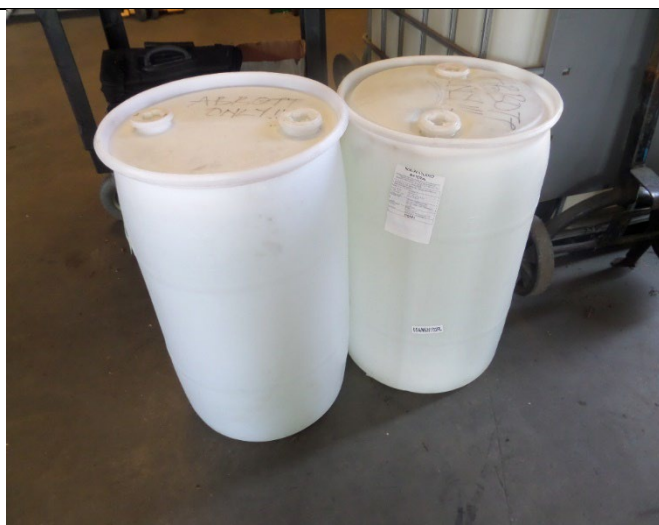
Warehouse. The inspector observed two 35-gallon containers accumulating non-hazardous waste dimethyl amonium chloride. The containers were accumulating on the loading dock, until shipment because of the possible incompatibility with other waste. Photograph 2 taken at 11:38 a.m.

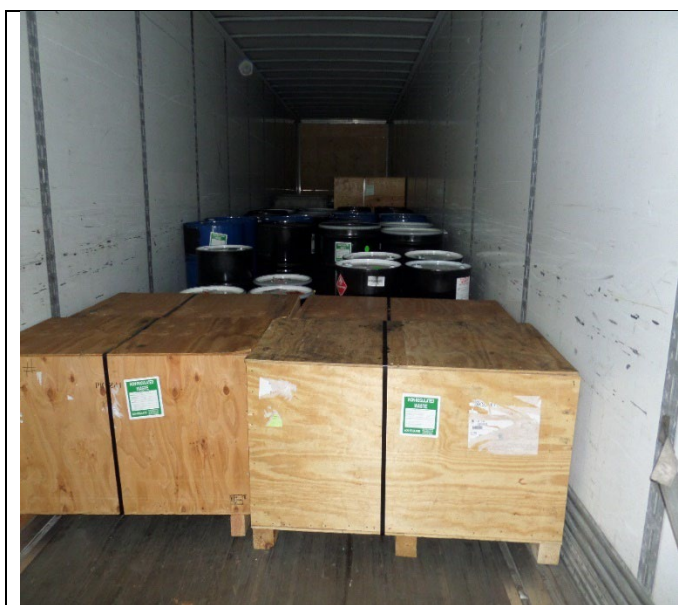
The inspectors observed approximately 35 to 40 containers ranging from 35-gallons to 55-gallons and approximately six one-cubic yard wooden boxes accumulating hazardous waste and non-hazardous waste. The containers were accumulating based on the facility's receipt from the transporter and the first container(s) into the trailer. The inspectors, based on the containers that were observed, were closed, appeared in good condition, labeled with the words hazardous waste, labeled with hazard indicators, and marked with an accumulation start date. The facility should provide as much available aisle space, as possible, to inspect and respond to a release or spill from a container (Photographs 3 and 4).

Warehouse. A.R. Paquette Trailer #292914. The inspector observed approximately 35 to 40 containers ranging from 35-gallons to 55-gallons and approximately six one-cubic yard wooden boxes accumulating hazardous waste and non-hazardous waste. Photograph 3 taken at 11:47 a.m.

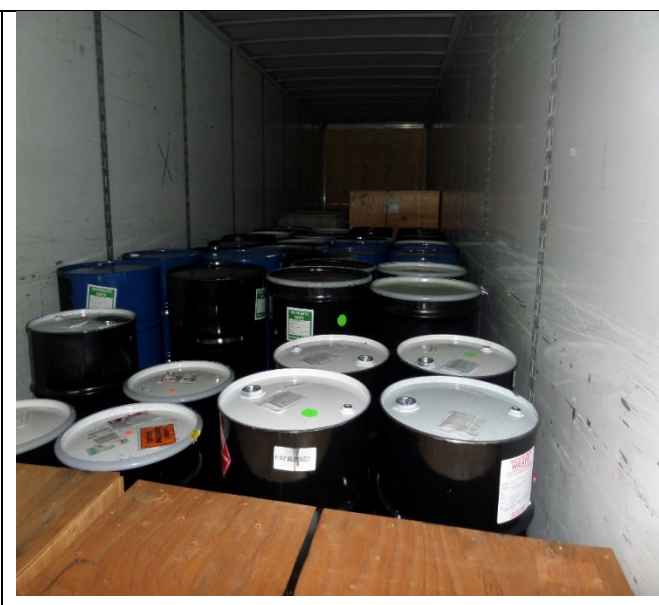
Warehouse. A.R. Paquette Trailer #292914. The inspector observed approximately 35 to 40 containers ranging from 35-gallons to 55-gallons and approximately six one-cubic yard wooden boxes accumulating hazardous waste and non-hazardous waste. Photograph 4 taken at 11:47 a.m.

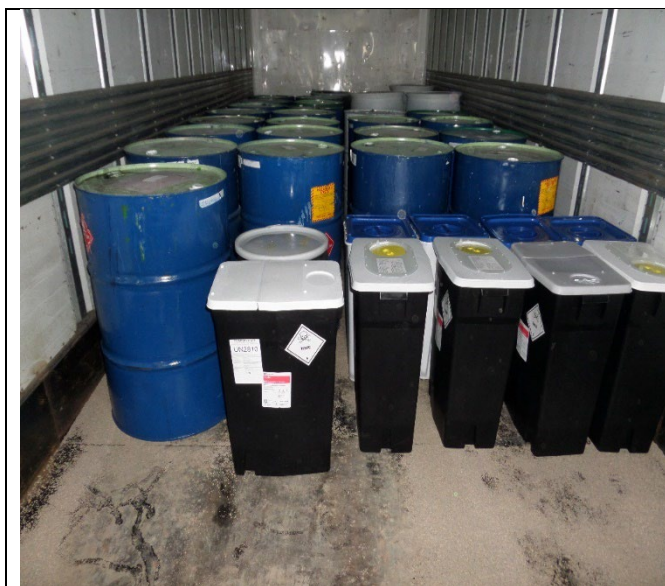
The inspectors observed approximately 47 containers ranging from 35-gallons to 55-gallons accumulating hazardous waste and non-hazardous waste. The containers were accumulating based on the facility's receipt from the transporter and the first container(s) into the trailer. The inspectors, based on the containers that were observed, were closed, appeared in good condition, labeled with the words hazardous waste, labeled with hazard indicators, and marked with an accumulation start date. The facility should provide as much available aisle space, as possible, to inspect and respond to a release or spill from a container (Photograph 5). The inspectors observed three containers accumulating waste near the back of the trailer. The facility separated the containers, because of the possible incompatibility with the other containers of hazardous waste on the trailer. The inspectors also observed next to the containers, a spill of a possible corrosive liquid on the floor of the trailer. The facility was in the process of responding to the spill by neutralizing it and conducting a waste determination (Photograph 6).

Warehouse. Maumee Express, Inc. (MXI) Trailer #5224. The inspector observed approximately 47 containers ranging from 35-gallons to 55-gallons accumulating hazardous waste and non-hazardous waste. Photograph 5 taken at 11:49 a.m.

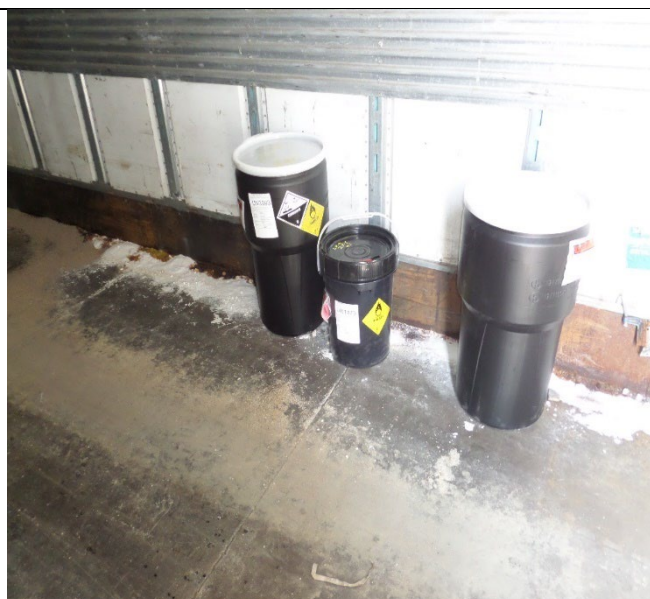
Warehouse. Maumee Express, Inc. (MXI) Trailer #5224. The inspector observed three containers accumulating hazardous waste near the back of the trailer. The inspector also observed a spill of a possible corrosive liquid on the floor of the trailer. The facility was in the process of responding to the spill by neutralizing it and conducting a waste determination. Photograph 6 taken at 11:49 a.m.

Tradebe should manage the generation of waste from its response to a spill or release or from the clean-up of a spill or release at their facility as the generator of that waste. An accurate waste determination must be conducted.

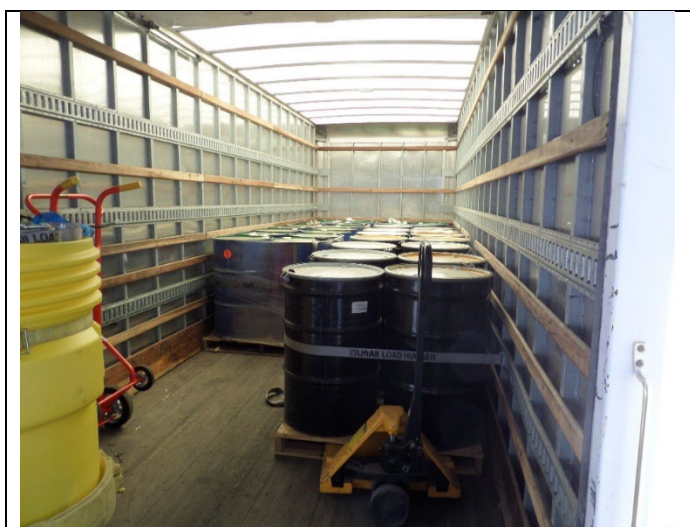
The inspectors observed approximately 36 55-gallon containers accumulating hazardous waste

and non-hazardous waste in the box truck. The inspectors observed the containers were closed, in good condition, labeled with the words hazardous waste, labeled with hazard indicators, and marked with an accumulation start date (Photograph 7).

Warehouse. Tradebe Box Truck #674233. The inspector observed approximately 36 55-gallon containers accumulating hazardous waste and non-hazardous waste in the box truck. Photograph 7 taken at 11:57 a.m.
