## NPDES Inspection Report – Wastewater Treatment Facility

**FULL COMPLIANCE EVALUATION REPORT**

Williston Basin Interstate Pipeline Company

Hardin Compressor Station

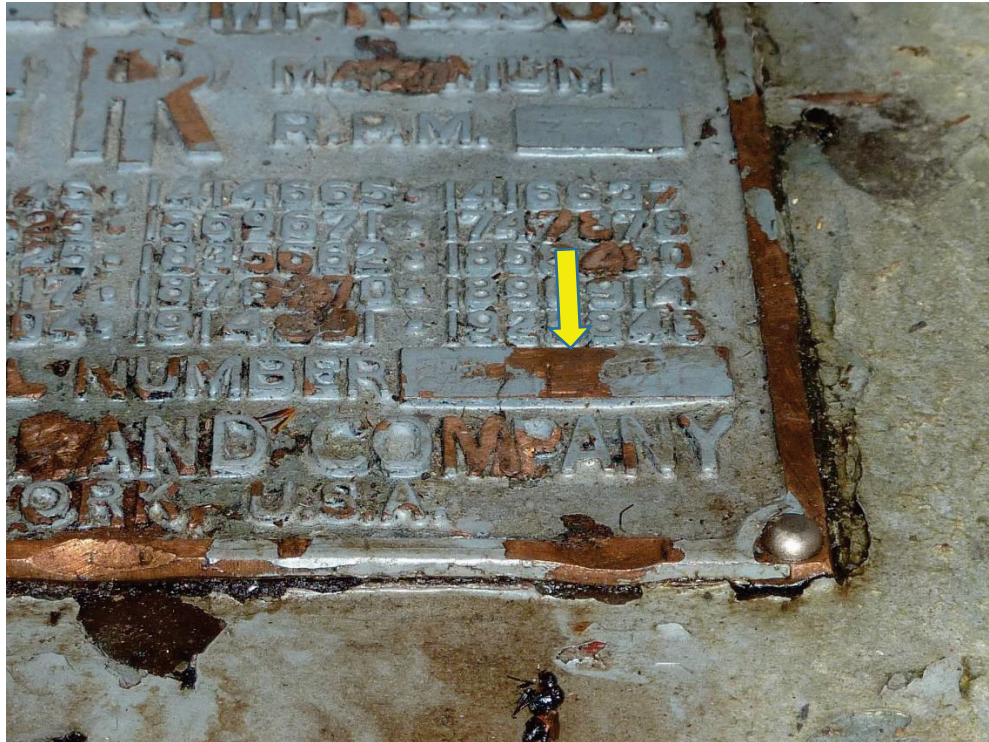
Faceplate of Ingersoll-Rand 62K VG, 660 bhp Reciprocating Compressor Engine – Unit 1  
with Serial Number: 62NL846 (emphasis added)

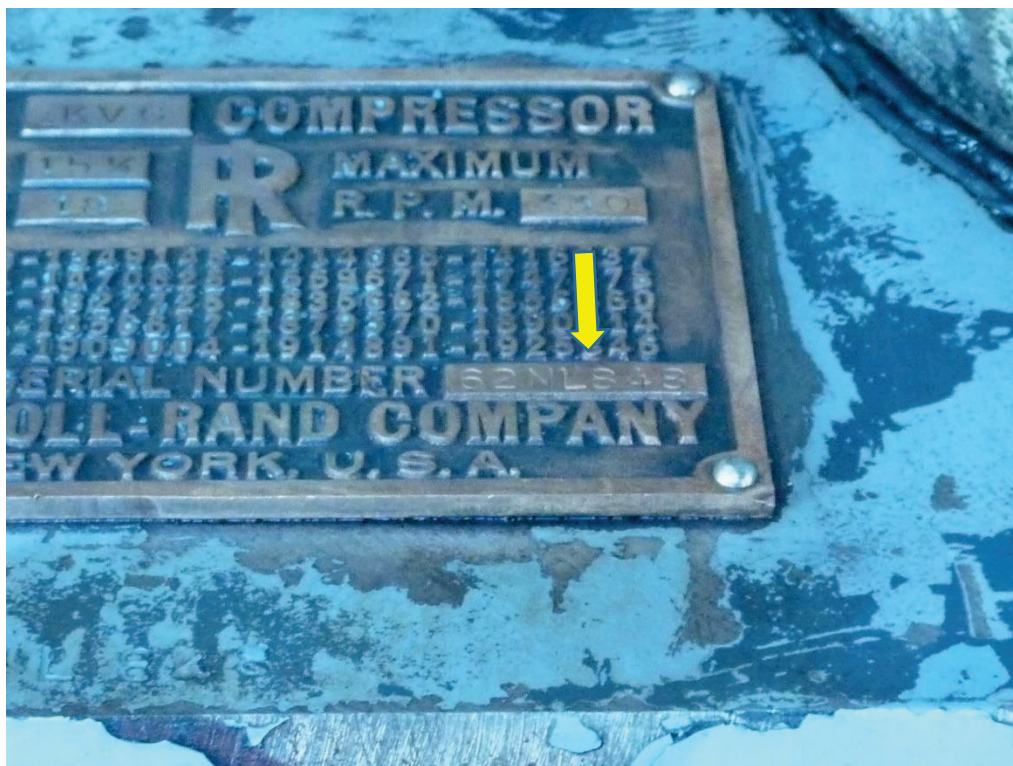
Faceplate of Ingersoll-Rand 62K VG, 660 bhp Reciprocating Compressor Engine – Unit 3 with Serial Number: 62NL848 (emphasis added)

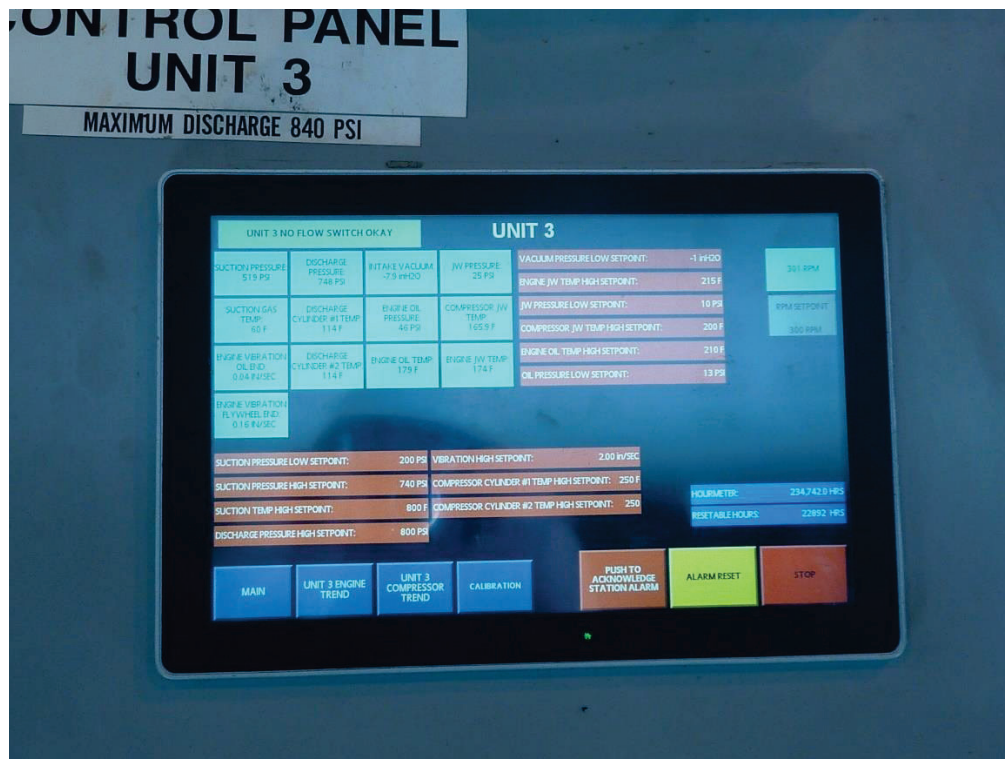
Unit 3 – Operational Information during the Inspection

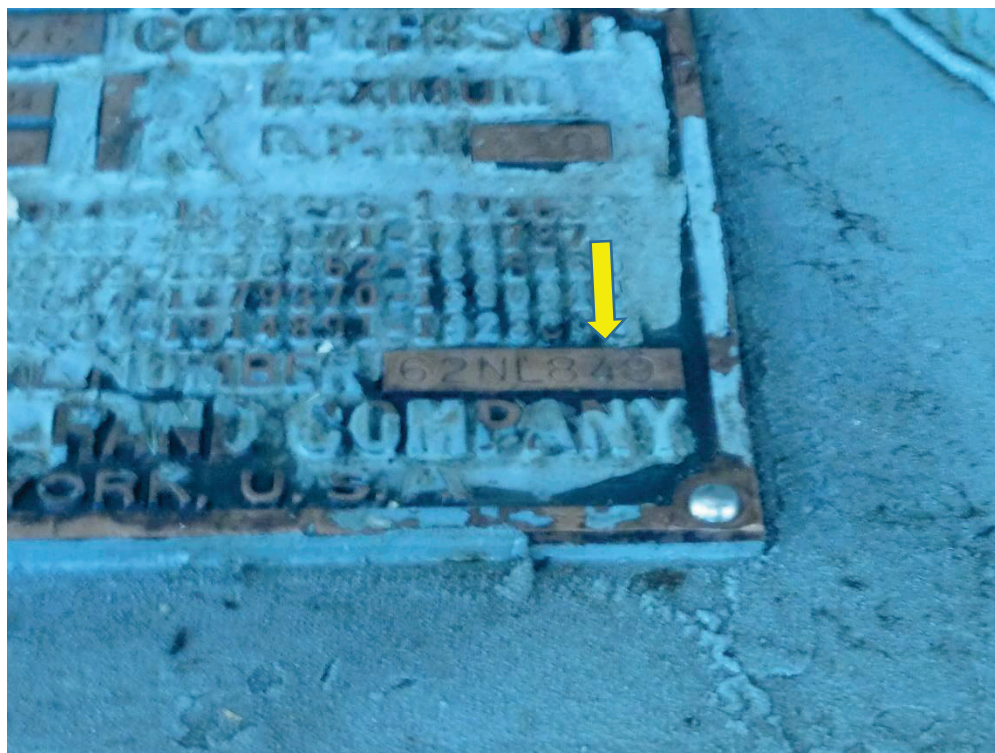
Faceplate of Ingersoll-Rand 62K VG, 660 bhp Reciprocating Compressor Engine – Unit 4 with Serial Number: 62NL849 (emphasis added)

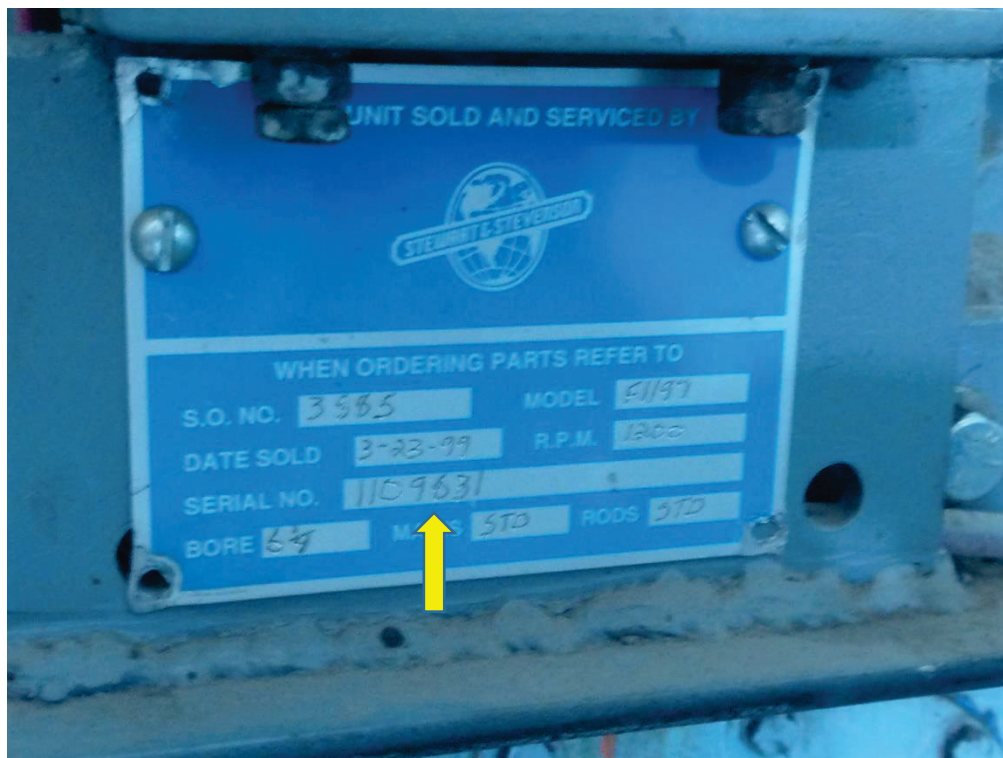
Faceplate of Waukesha F1197G, 100 kW Generator Set with Serial Number: 1109831 (emphasis added)
