## Clean Water Act Section 404: Site Visit/Case Development

| Site Name | Service Unlimiteds, LLC (hereinafter as "Service Unlimiteds") | | | | |

CWA 404 Inspection

**Service Limiteds, LLC**

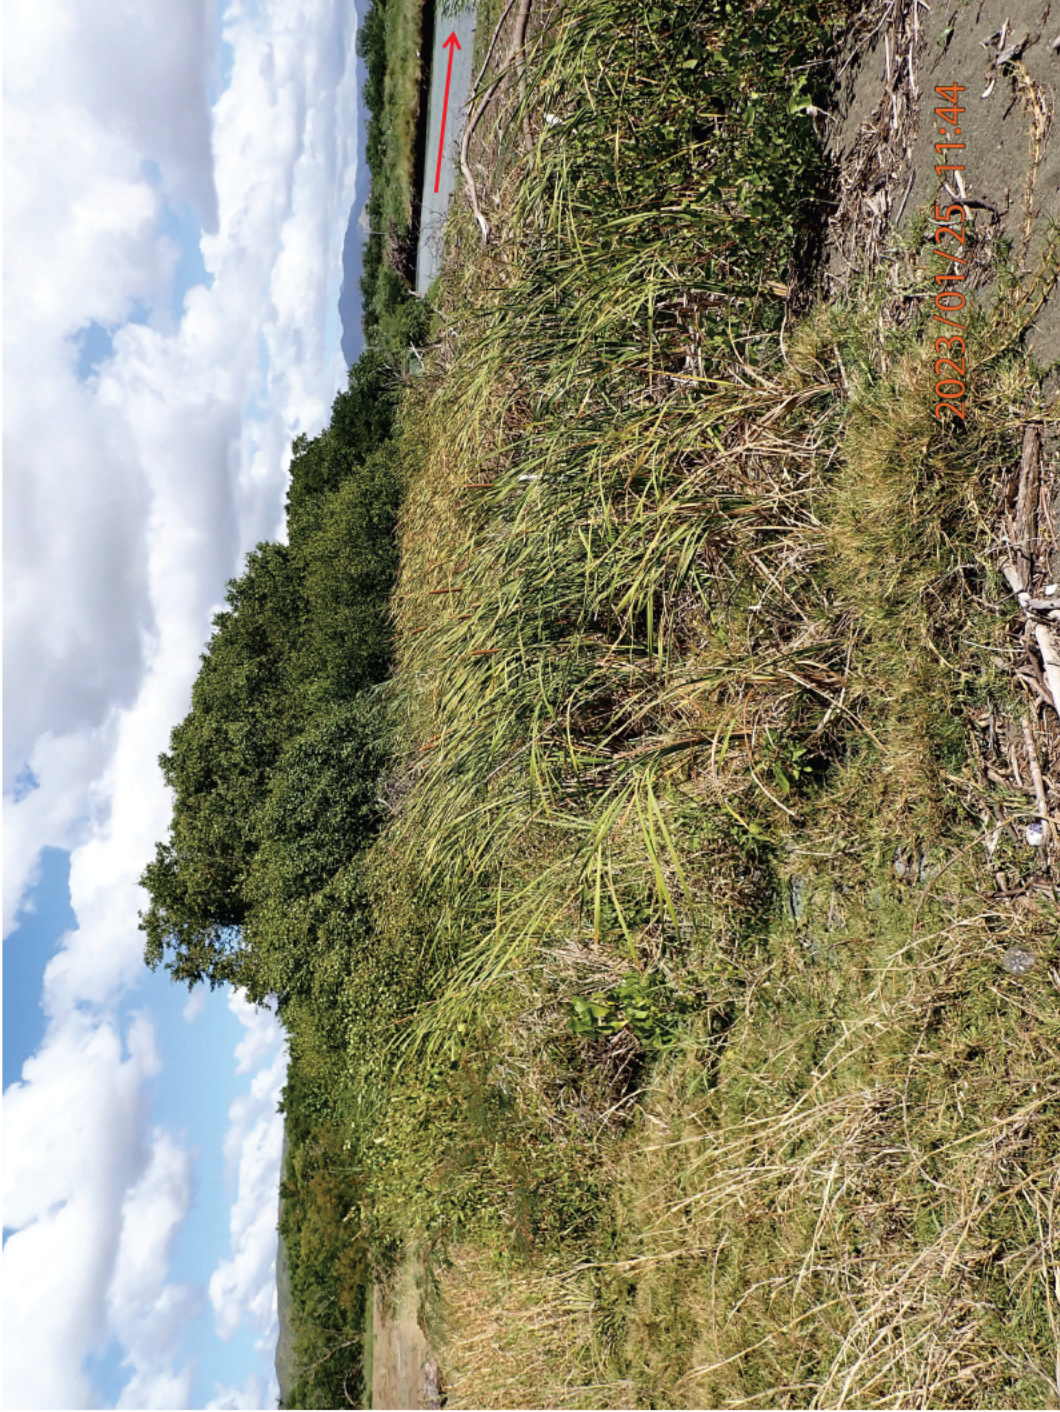
**Photo ID:** P1250424

**Description:** View of the remaining vegetation on the southeastern portion of the Property. Rio Nigua can be seen on the right.

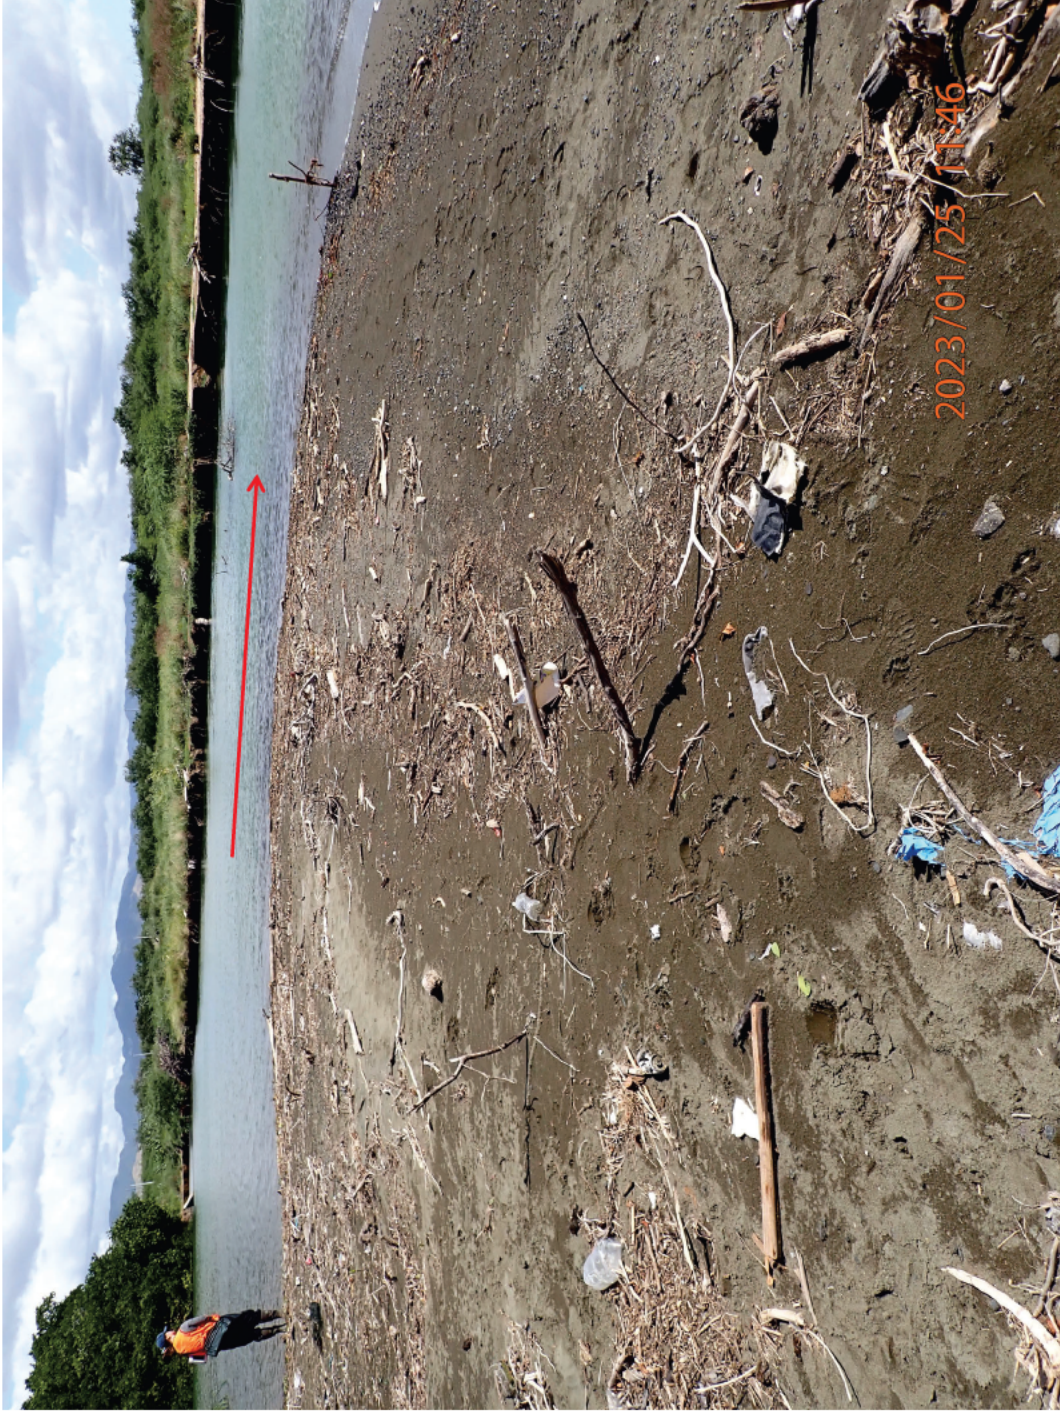
**Photo ID:** P1250426

**Description:** View of Rio Nigua at the southeastern most point of the Site. Widespread vegetative clearing and evidence of earthmoving work can be seen throughout the Site.

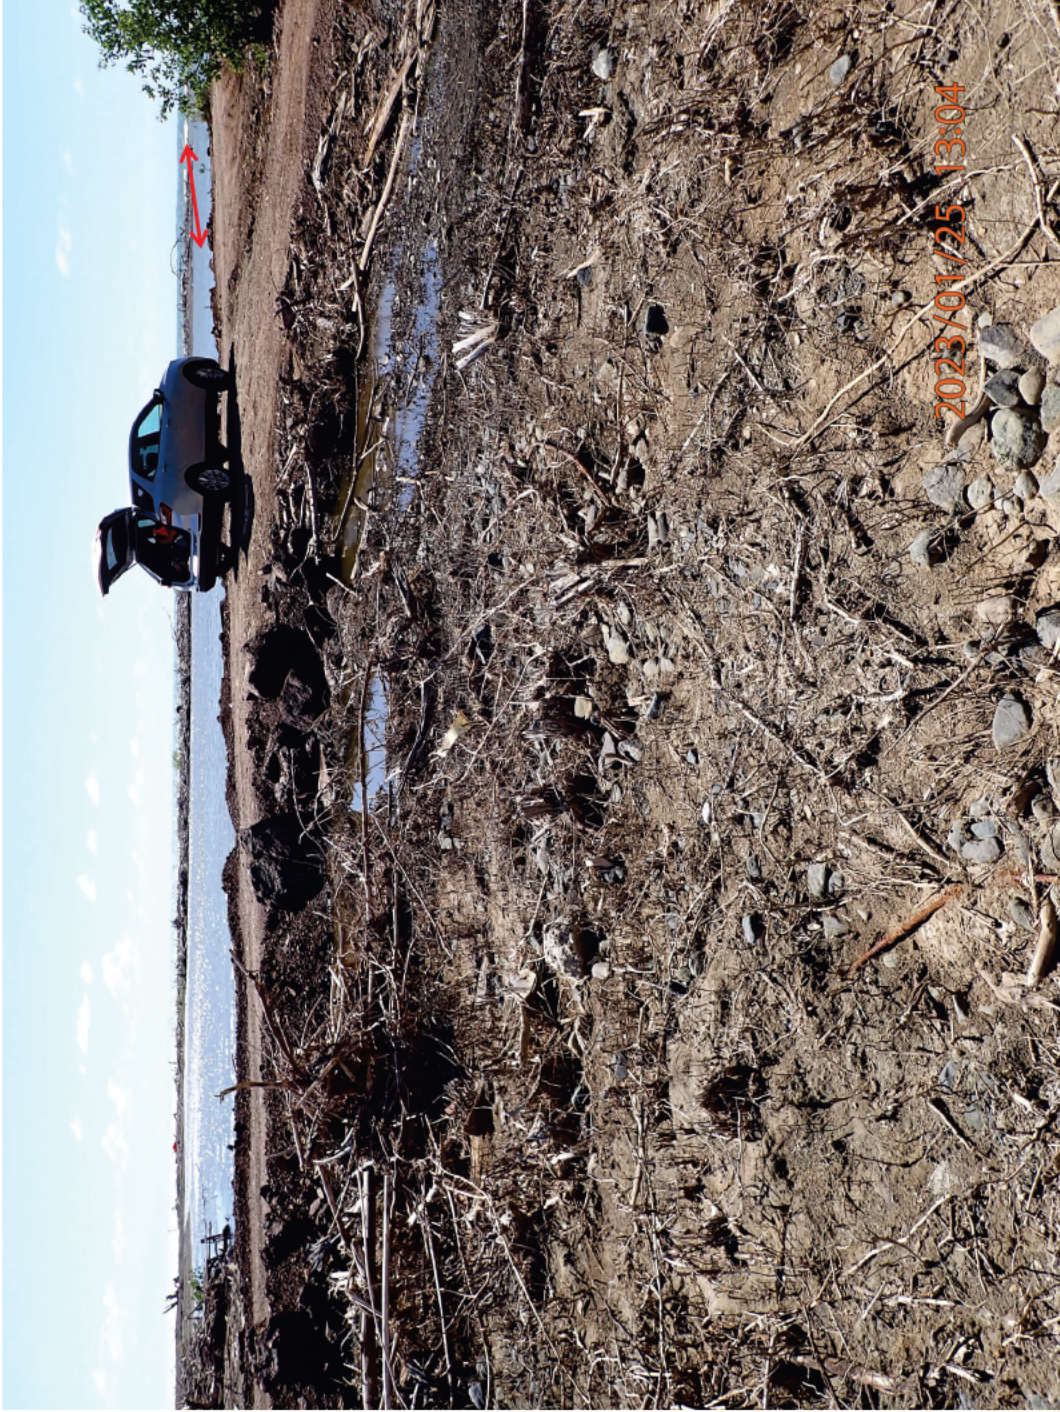
**Photo ID:** P1250504

**Description:** Widespread vegetative clearing and evidence of earthmoving work can be seen throughout the Site.

Approximately 1.5 feet of fill material was placed throughout the Site for the purposed of creating a road for vehicular access.

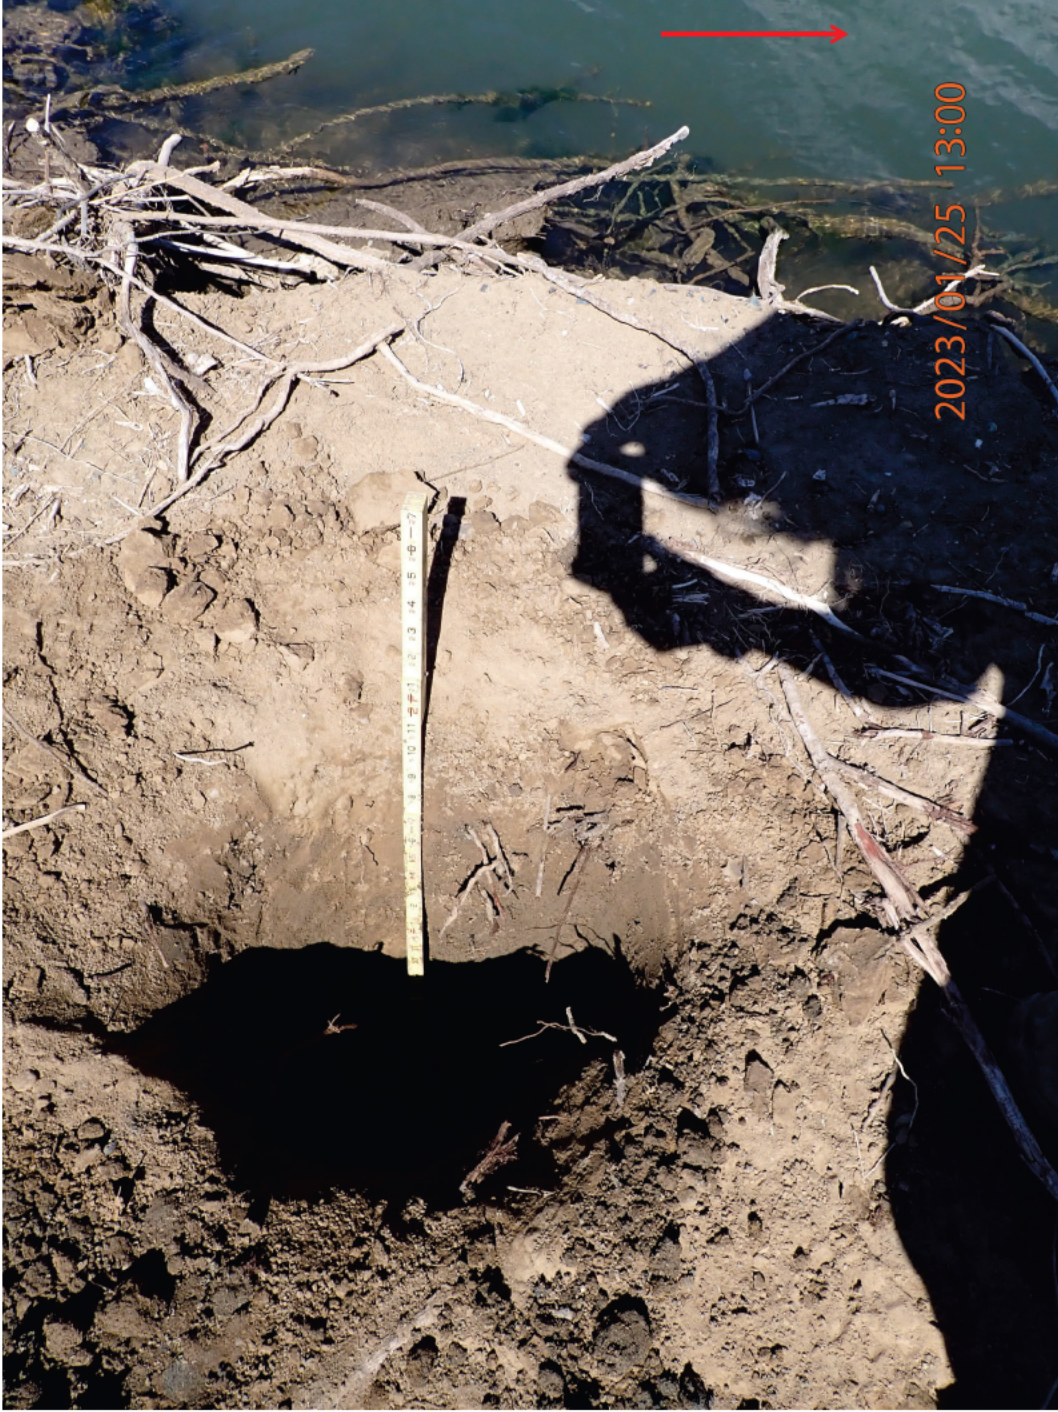
**Photo ID:** P1250494

**Description:** About 3 feet away from the bank of Rio Nigua, approximately 2 of fill material was found on top of saturated soils and mangrove roots.

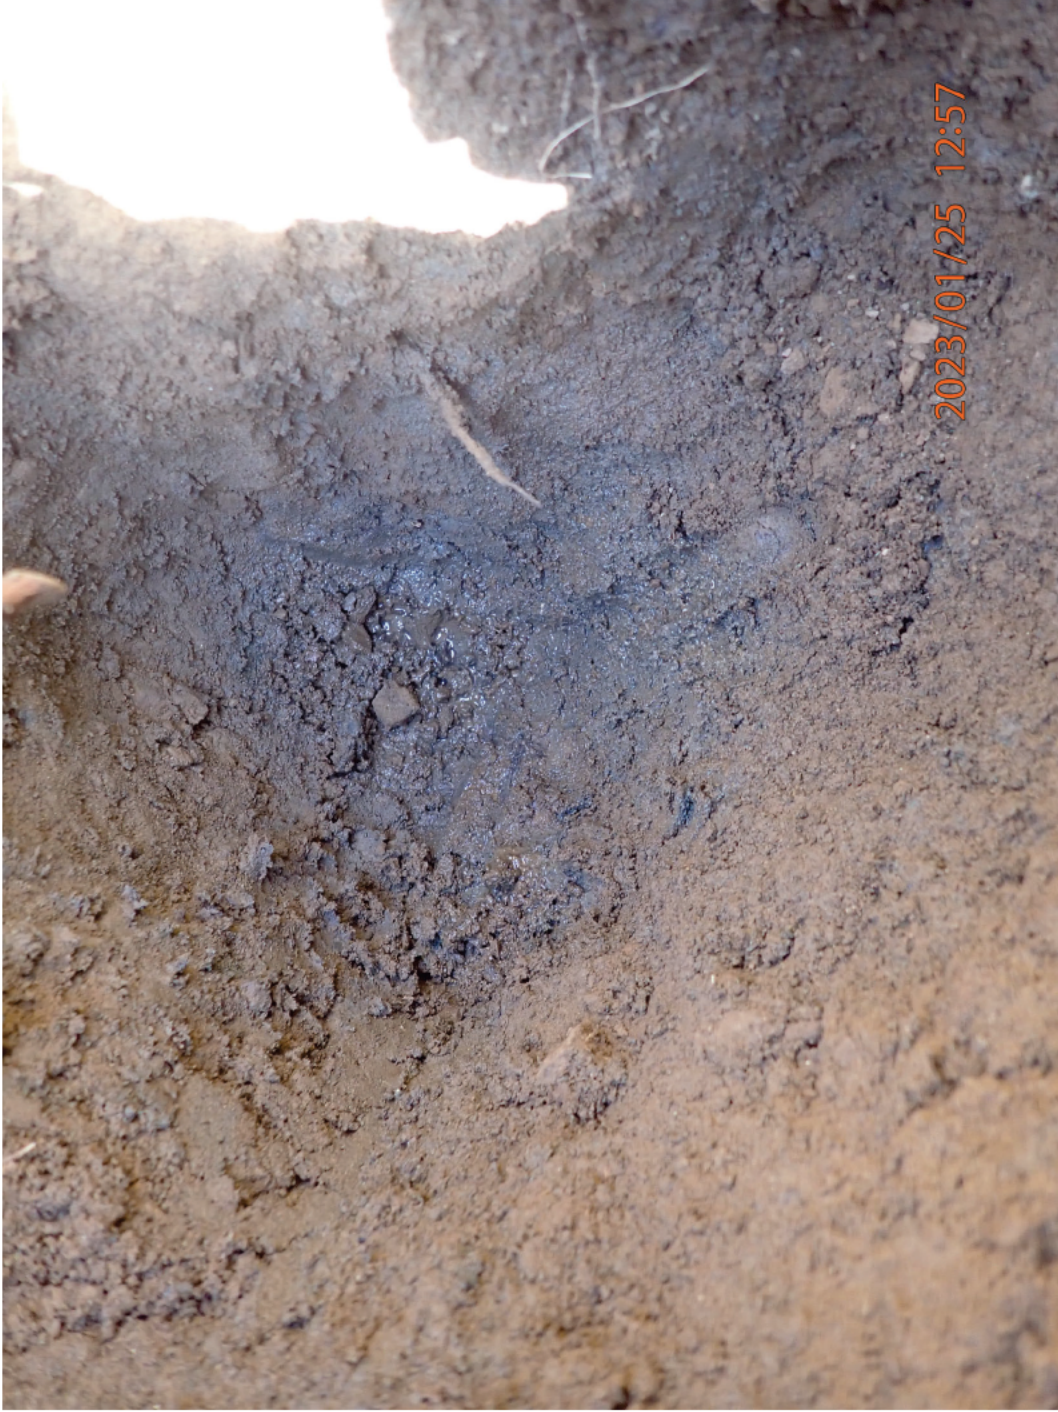
**Photo ID:** P1250481

**Description:** Saturated soils found below 2 feet of soil.

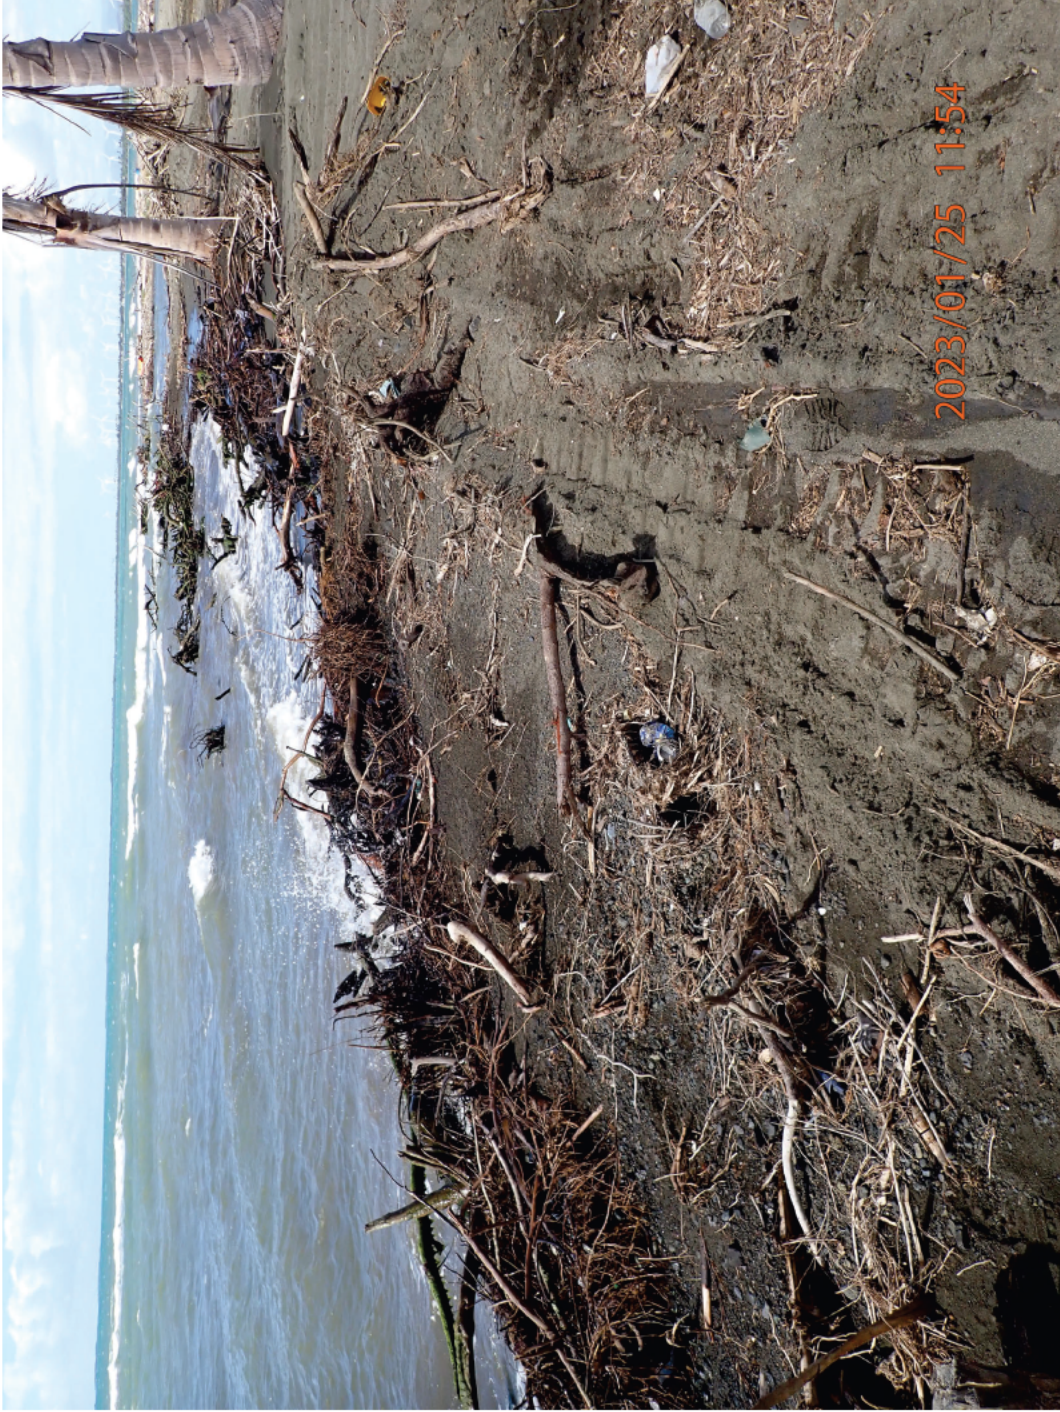
**Photo ID:** P1250429

**Description:** View of the southern coast of the Site.  
Widespread vegetative clearing and evidence of  
earthmoving work can be seen throughout the Site.

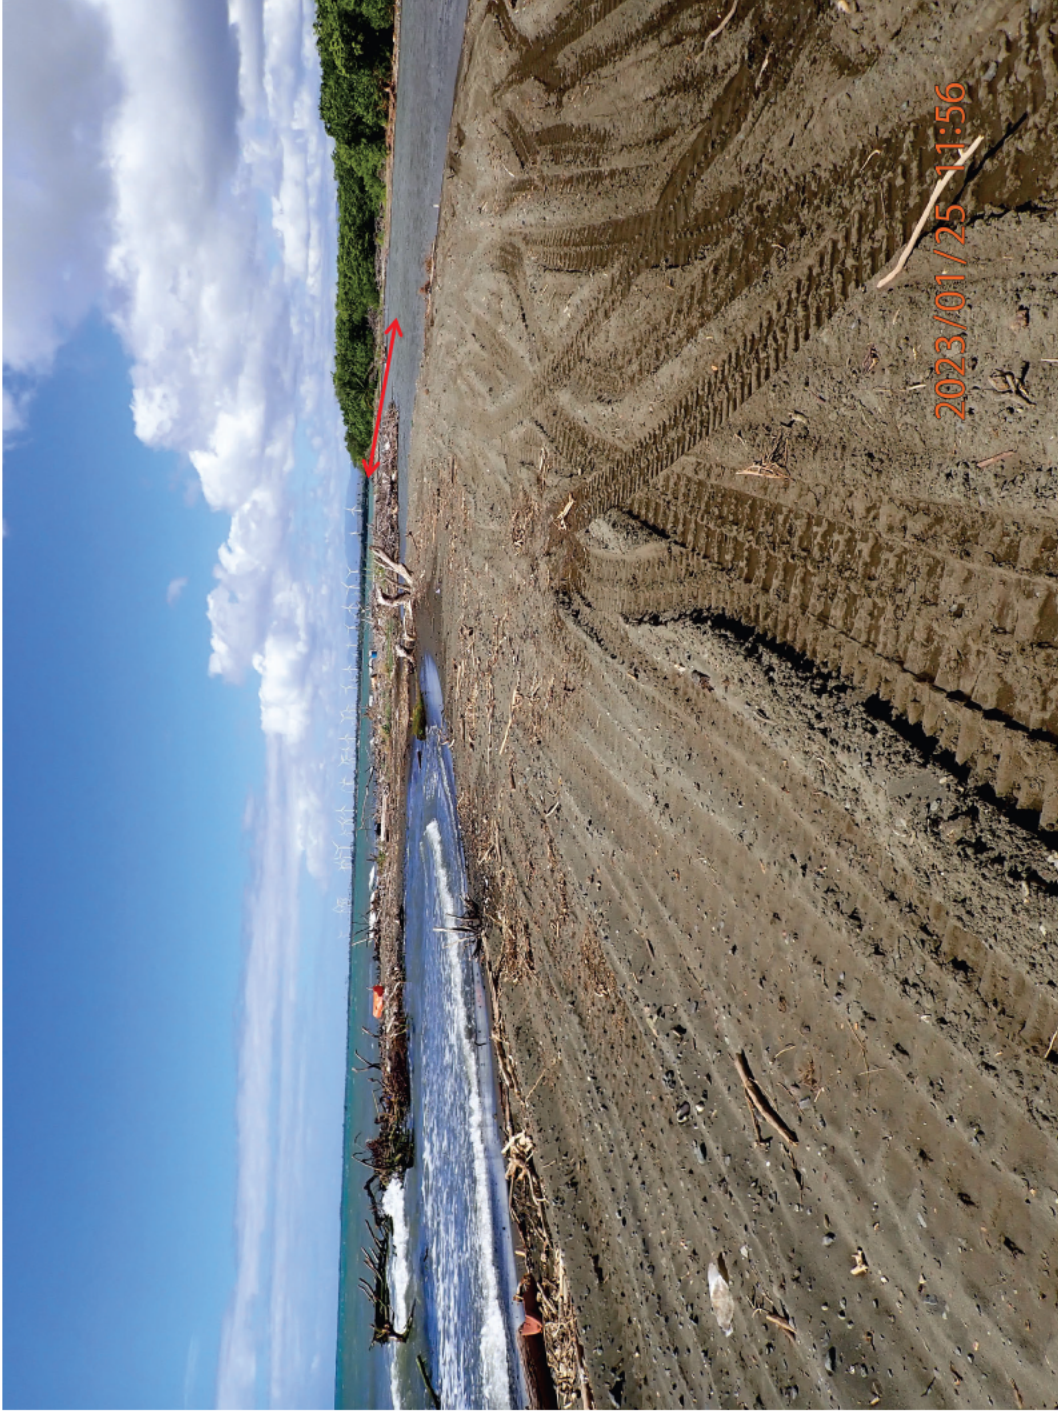
**Photo ID:** P1250439

**Description:** View of the southern coast of the Site.  
Widespread vegetative clearing and evidence of  
earthmoving work can be seen throughout the Site.

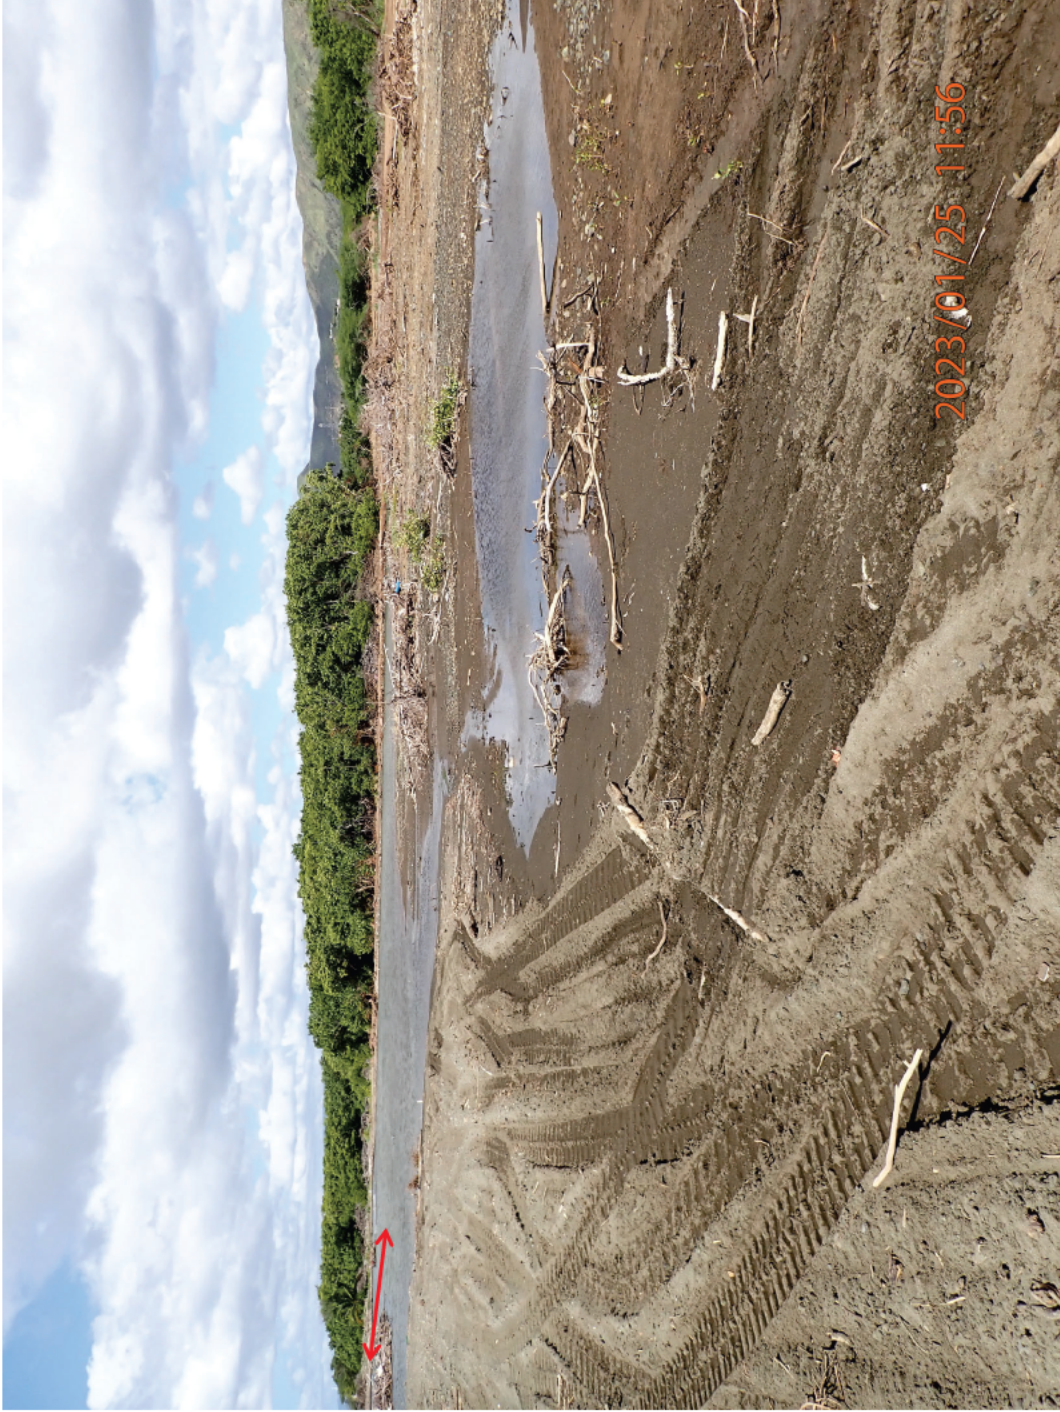
**Photo ID:** P1250440

**Description:** View of the southern coast of the Site.  
Widespread vegetative clearing and evidence of  
earthmoving work can be seen throughout the Site.

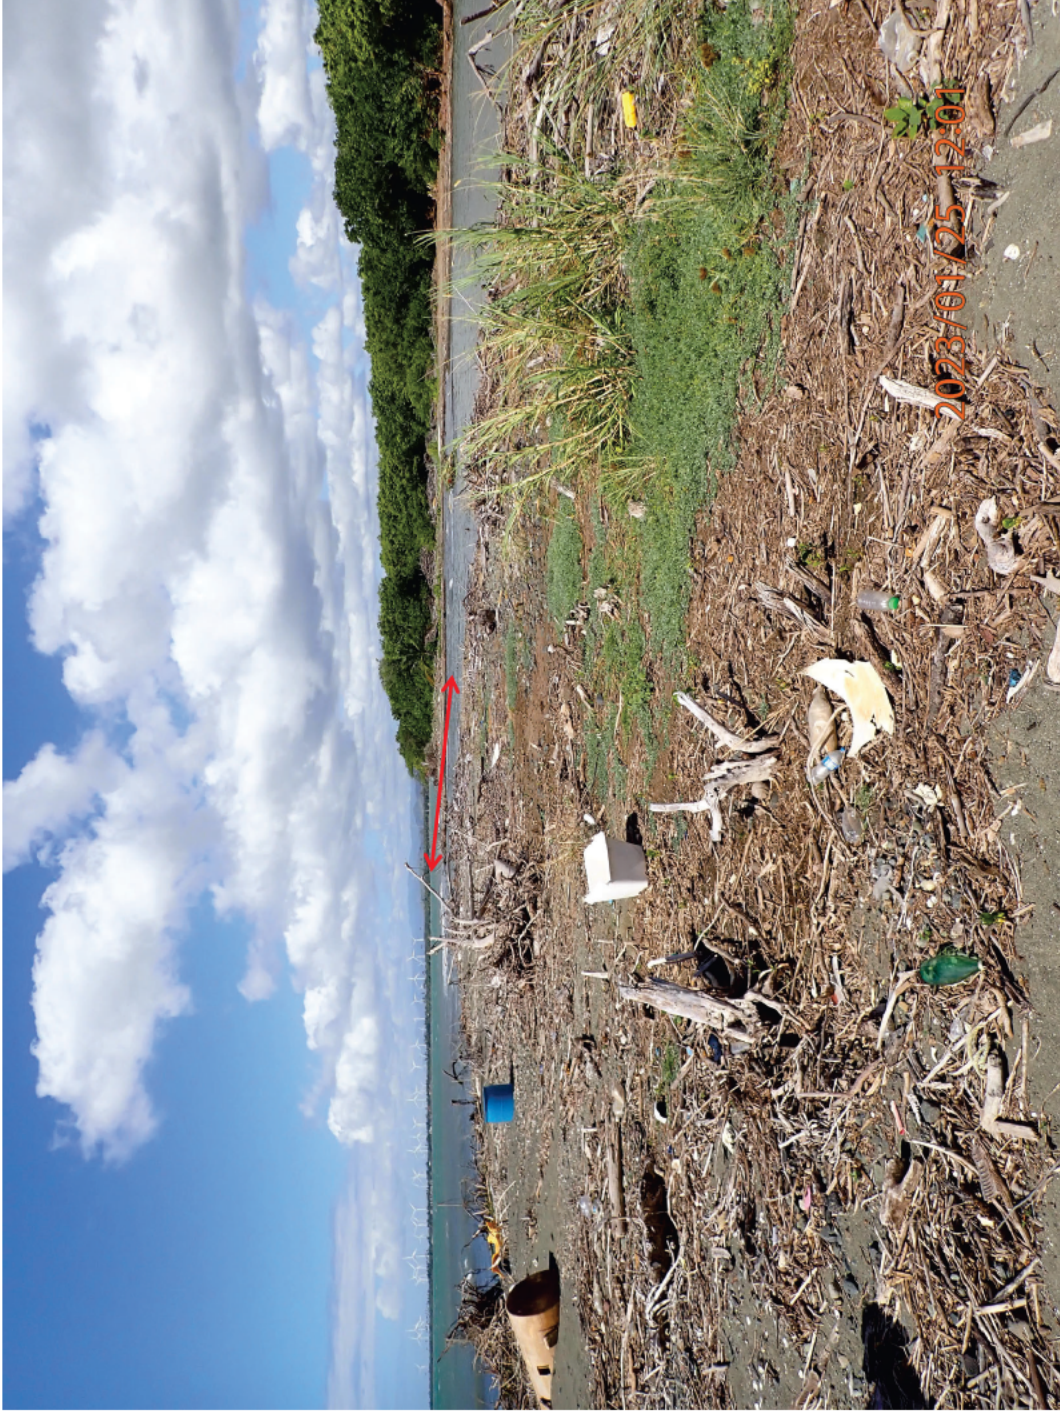
**Photo ID:** P1250448

**Description:** View of the southern coast of the Site.  
Widespread vegetative clearing and evidence of  
earthmoving work can be seen throughout the Site.

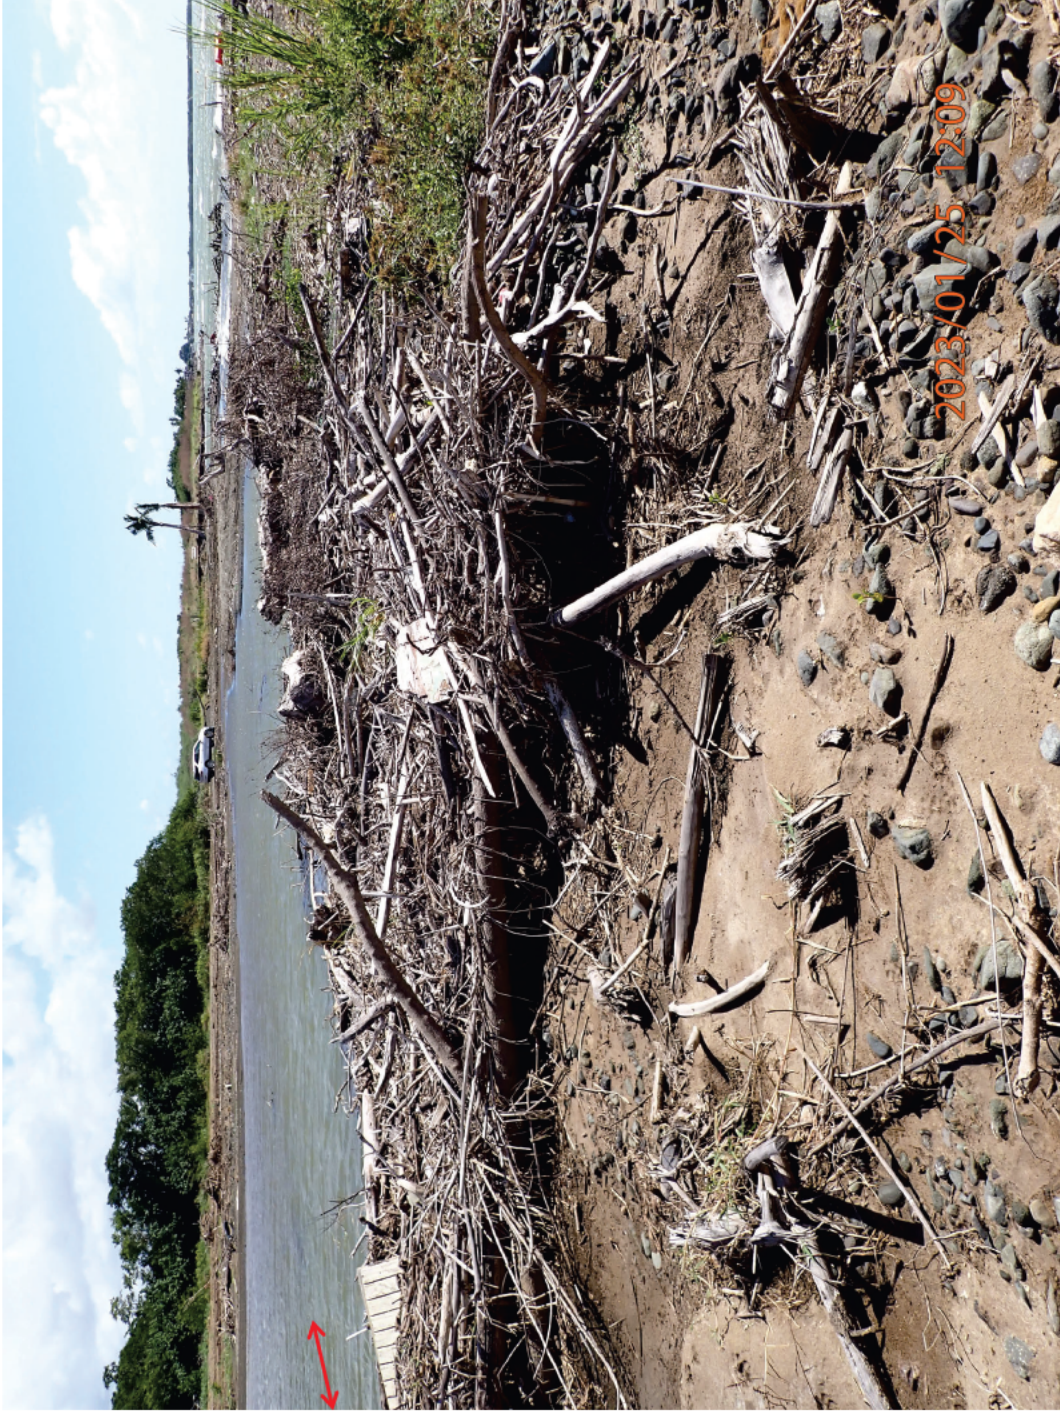
**Photo ID:** P1250454

**Description:** View of the southern coast of the Site.  
Widespread vegetative clearing and evidence of  
earthmoving work can be seen throughout the Site.

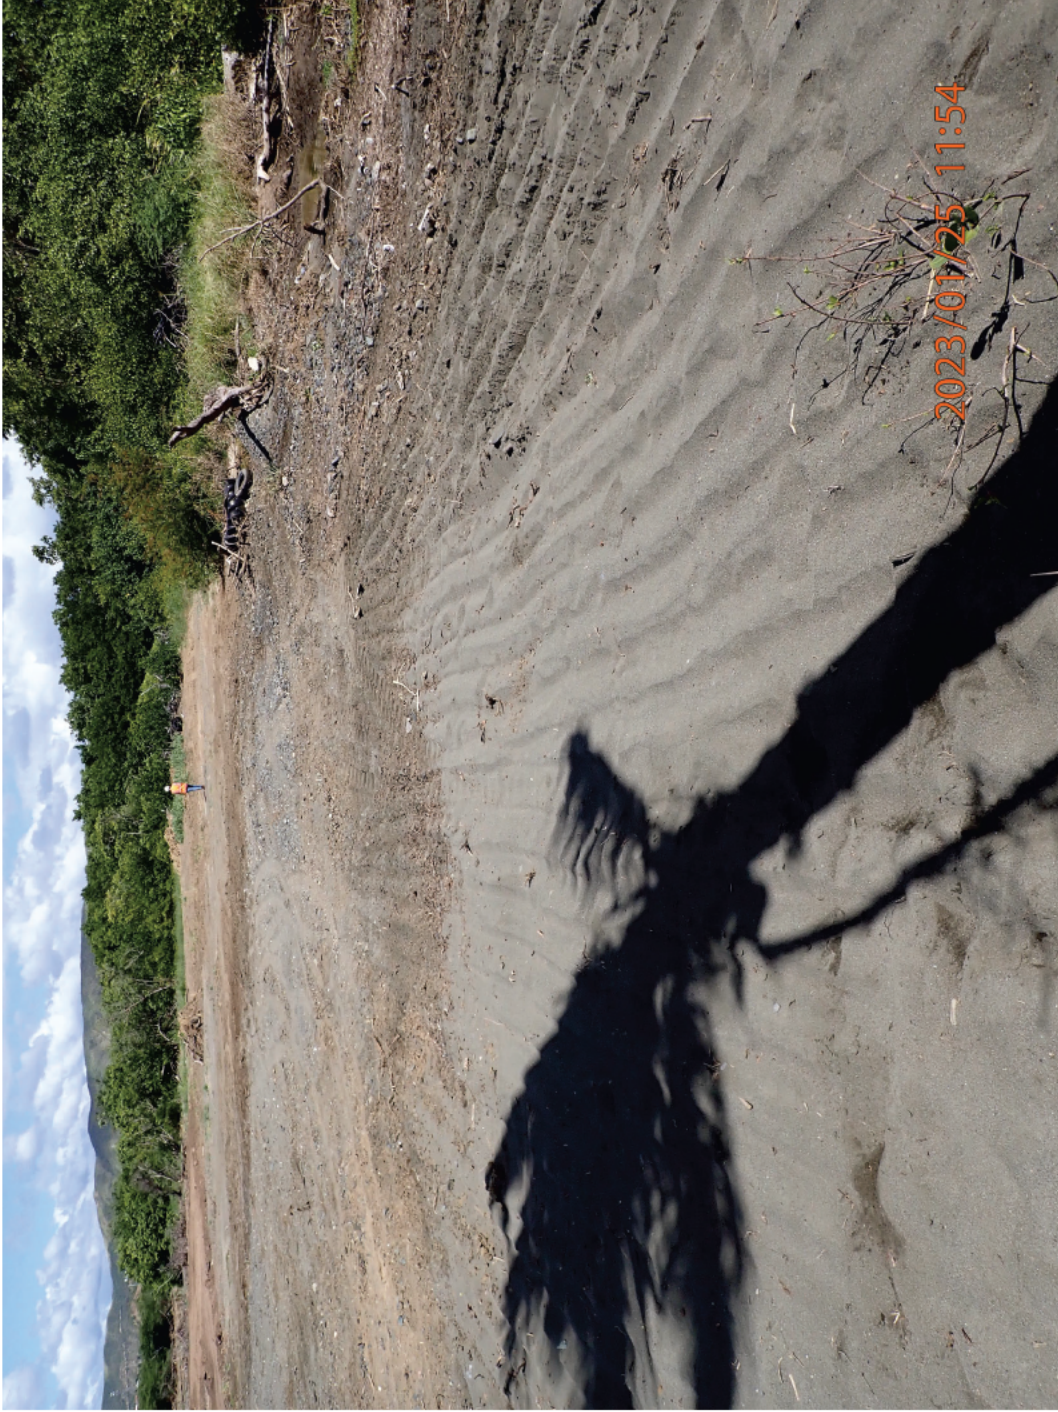
**Photo ID:** P1250431

**Description:** Widespread vegetative clearing and evidence of earthmoving work can be seen throughout the Site.

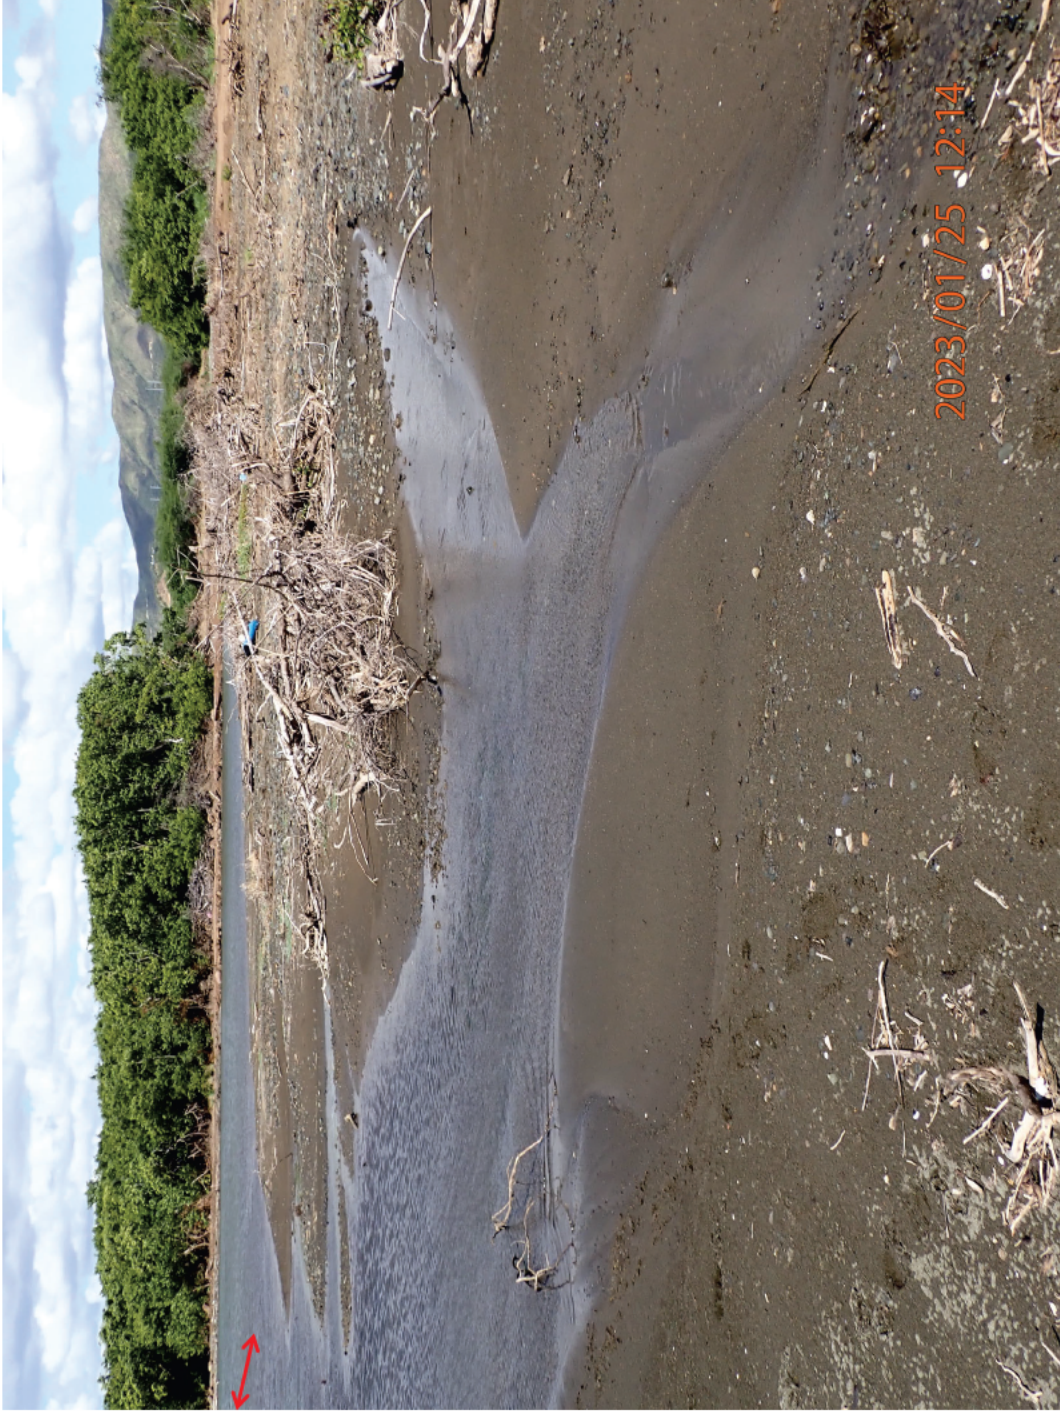
**Photo ID:** P1250465

**Description:** View of the southern coast of the Site.  
Widespread vegetative clearing and evidence of  
earthmoving work can be seen throughout the Site.

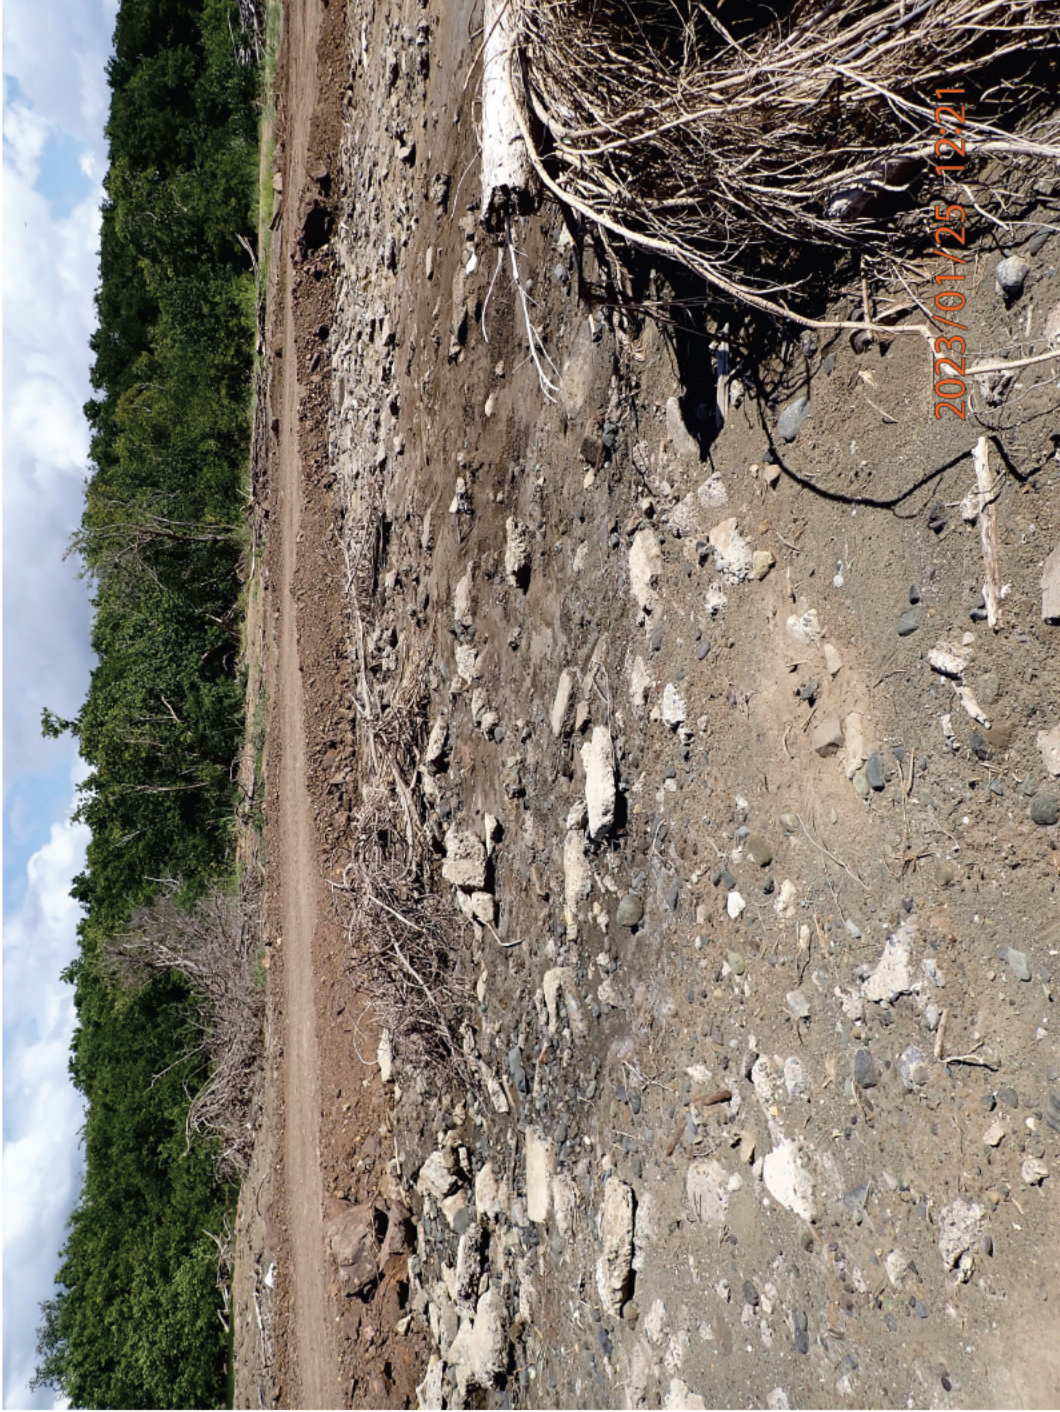
**Photo ID:** P1250476

**Description:** Widespread vegetative clearing and evidence of earthmoving work can be seen throughout the Site.

Approximately 1.5 feet of fill material was placed throughout the Site for the purposed of creating a road for vehicular access.

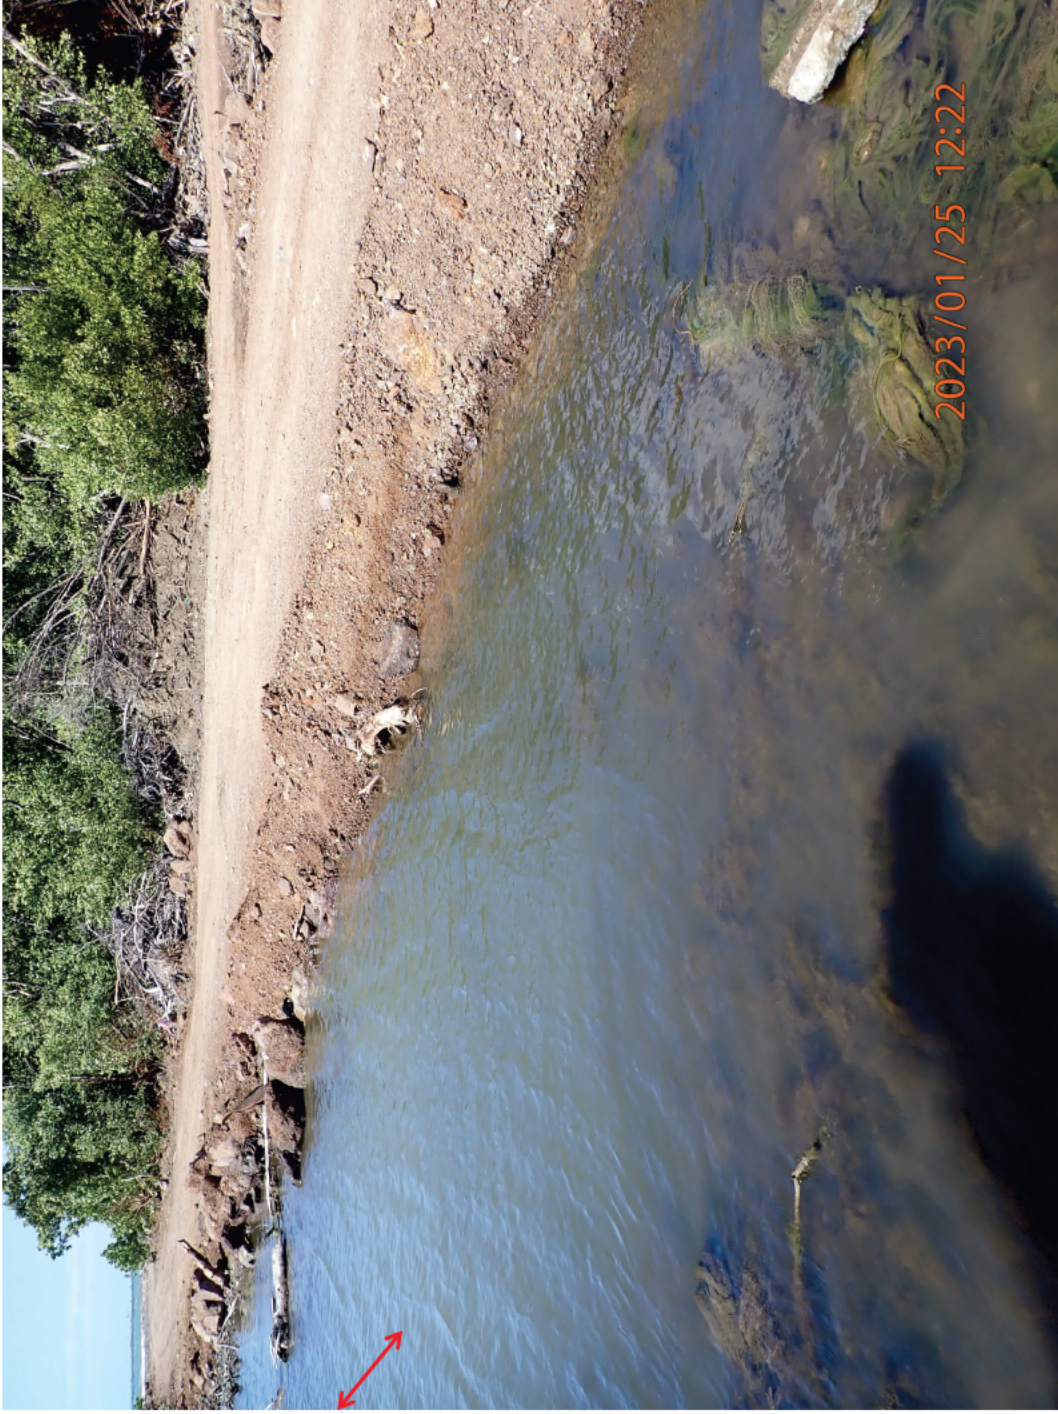
**Photo ID:** P1250479

**Description:** Approximately 1.5 feet of fill material was placed throughout the Site for the purposed of creating a road for vehicular access.

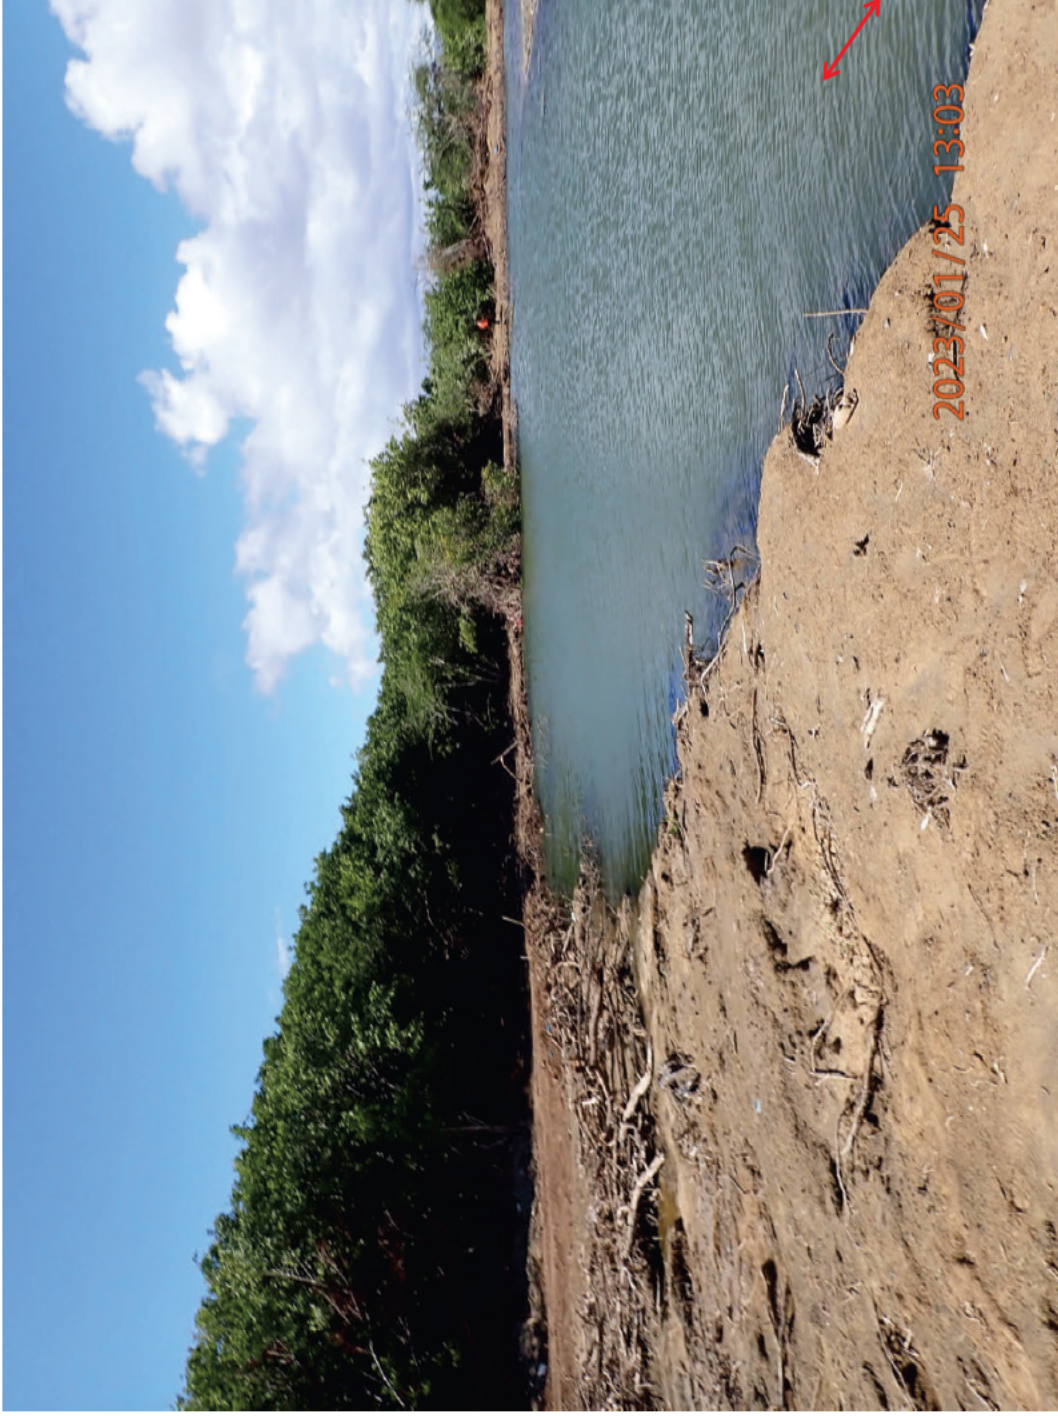
**Photo ID:** P1250497

**Description:** Widespread vegetative clearing and evidence of earthmoving work can be seen throughout the Site.
