## Clean Water Act Section 404: Site Visit/Case Development

| Site Name | Service Unlimiteds, LLC (hereinafter as "Service Unlimiteds") | | | | |

CWA 404 Inspection

**Service Limiteds, LLC**

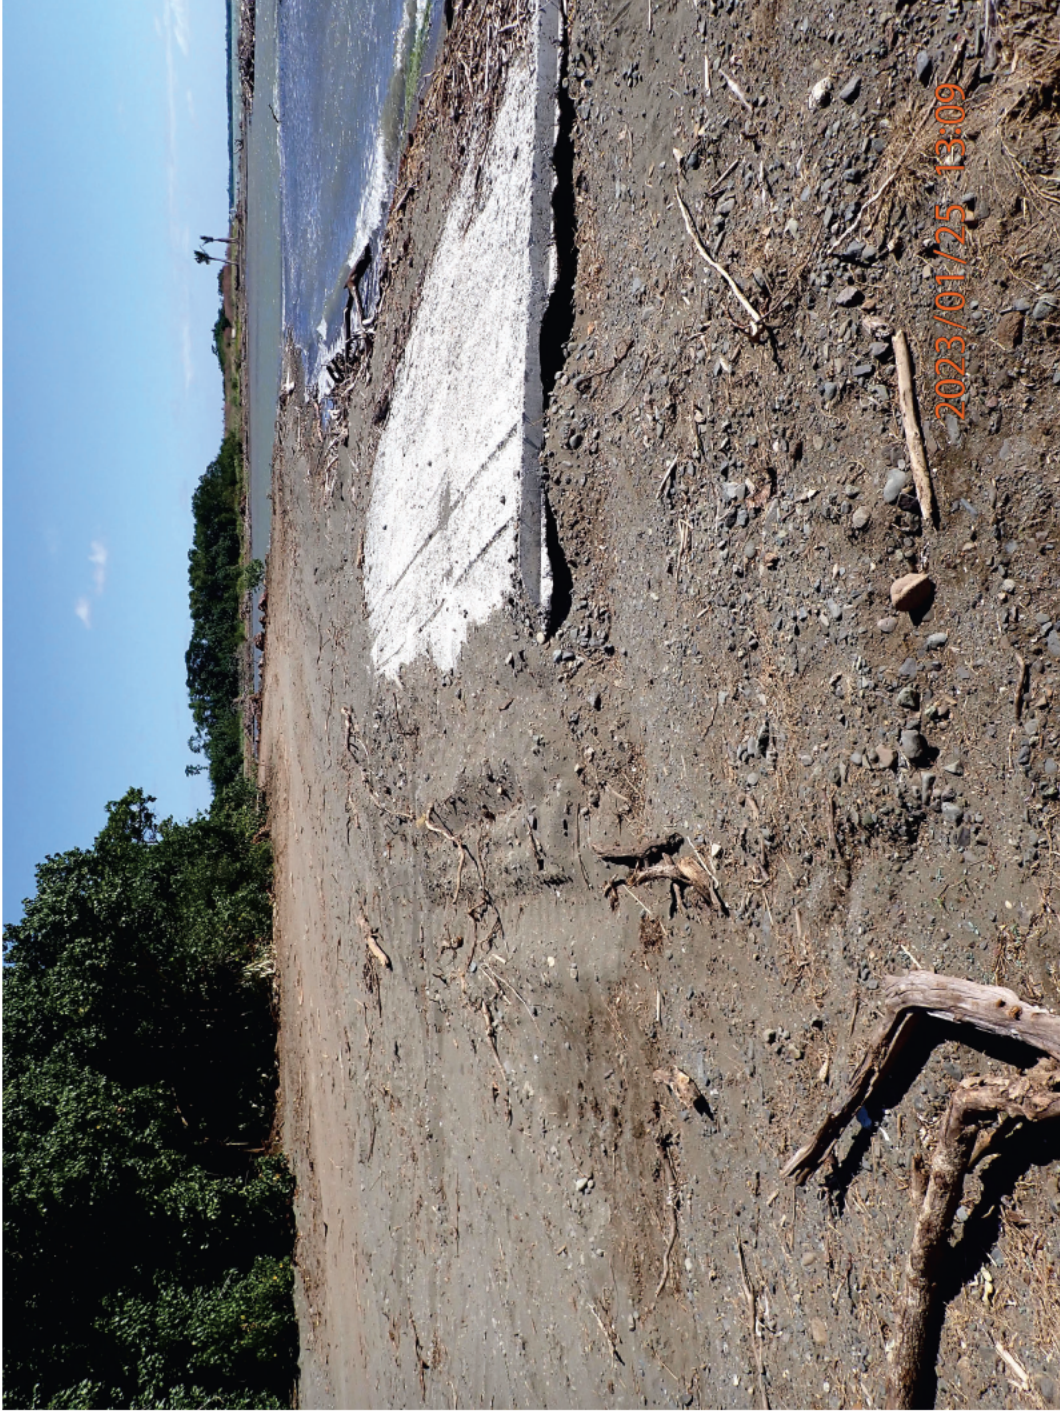
**Photo ID:** P1250515

**Description:** Concrete pad found on the southern coast of the Site.

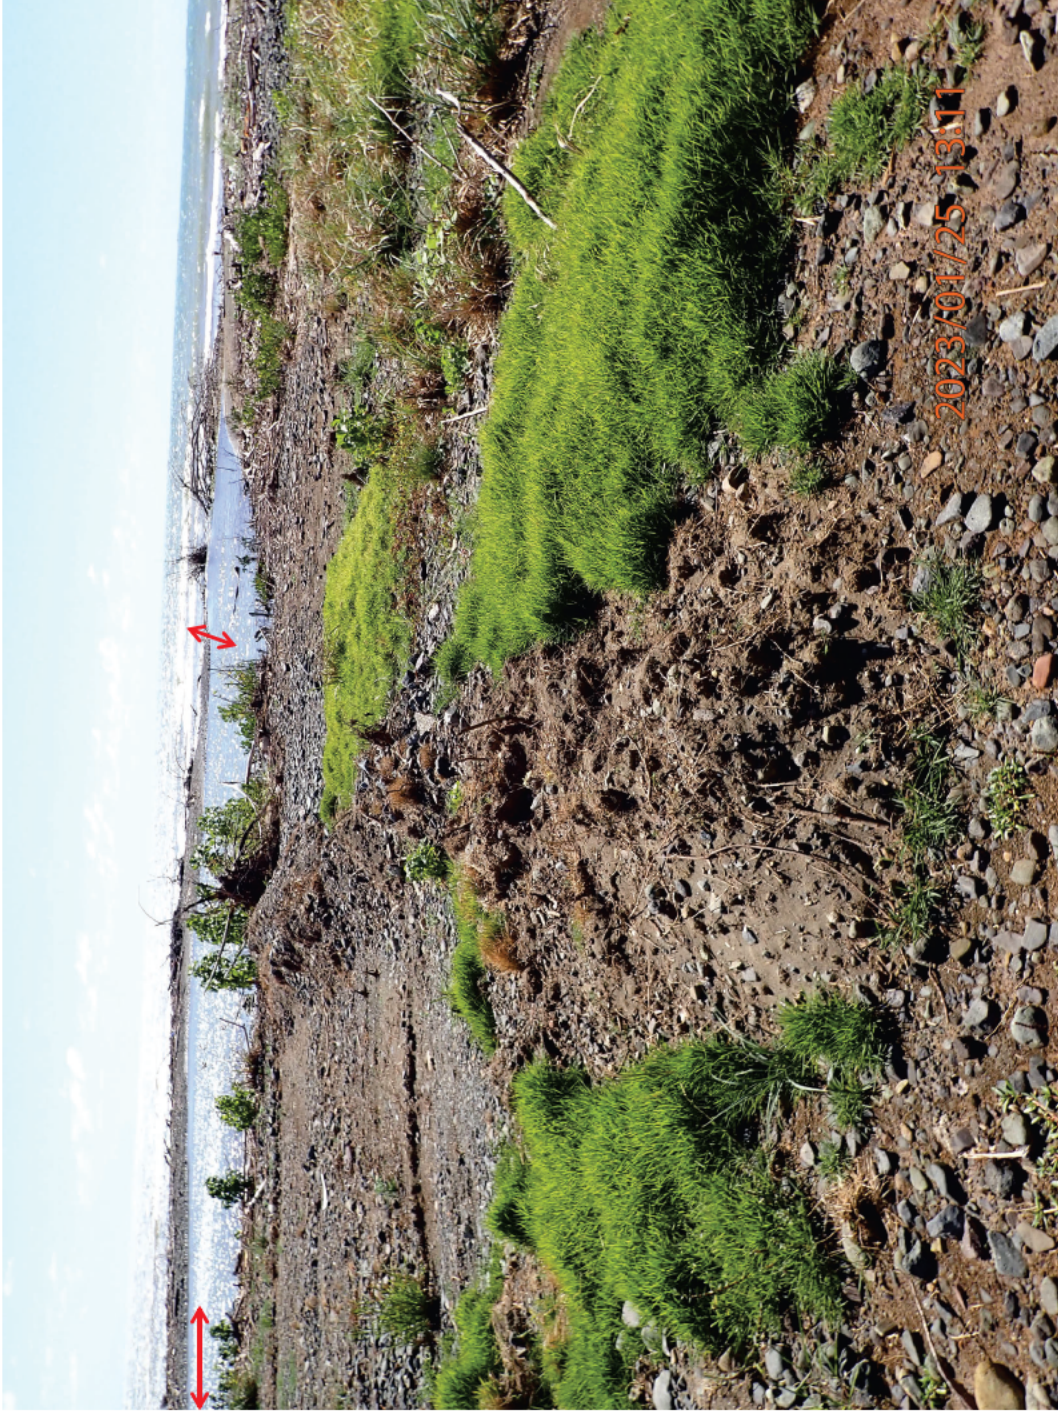
**Photo ID:** P1250529

**Description:** View of the southwestern coast of the Site.

\*Red arrows marks the direction of the flow.

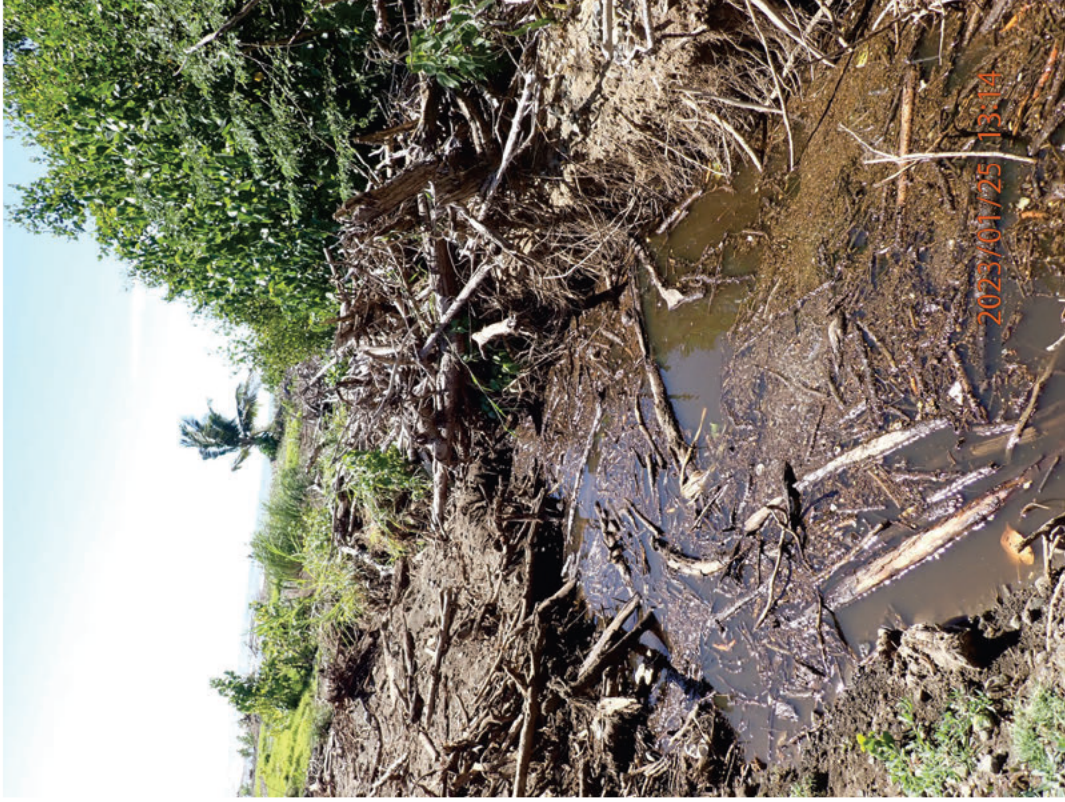
**Photo ID:** P1250532

**Description:** Vegetative clearing and ponding water  
fond on the southwestern portion of the Site.

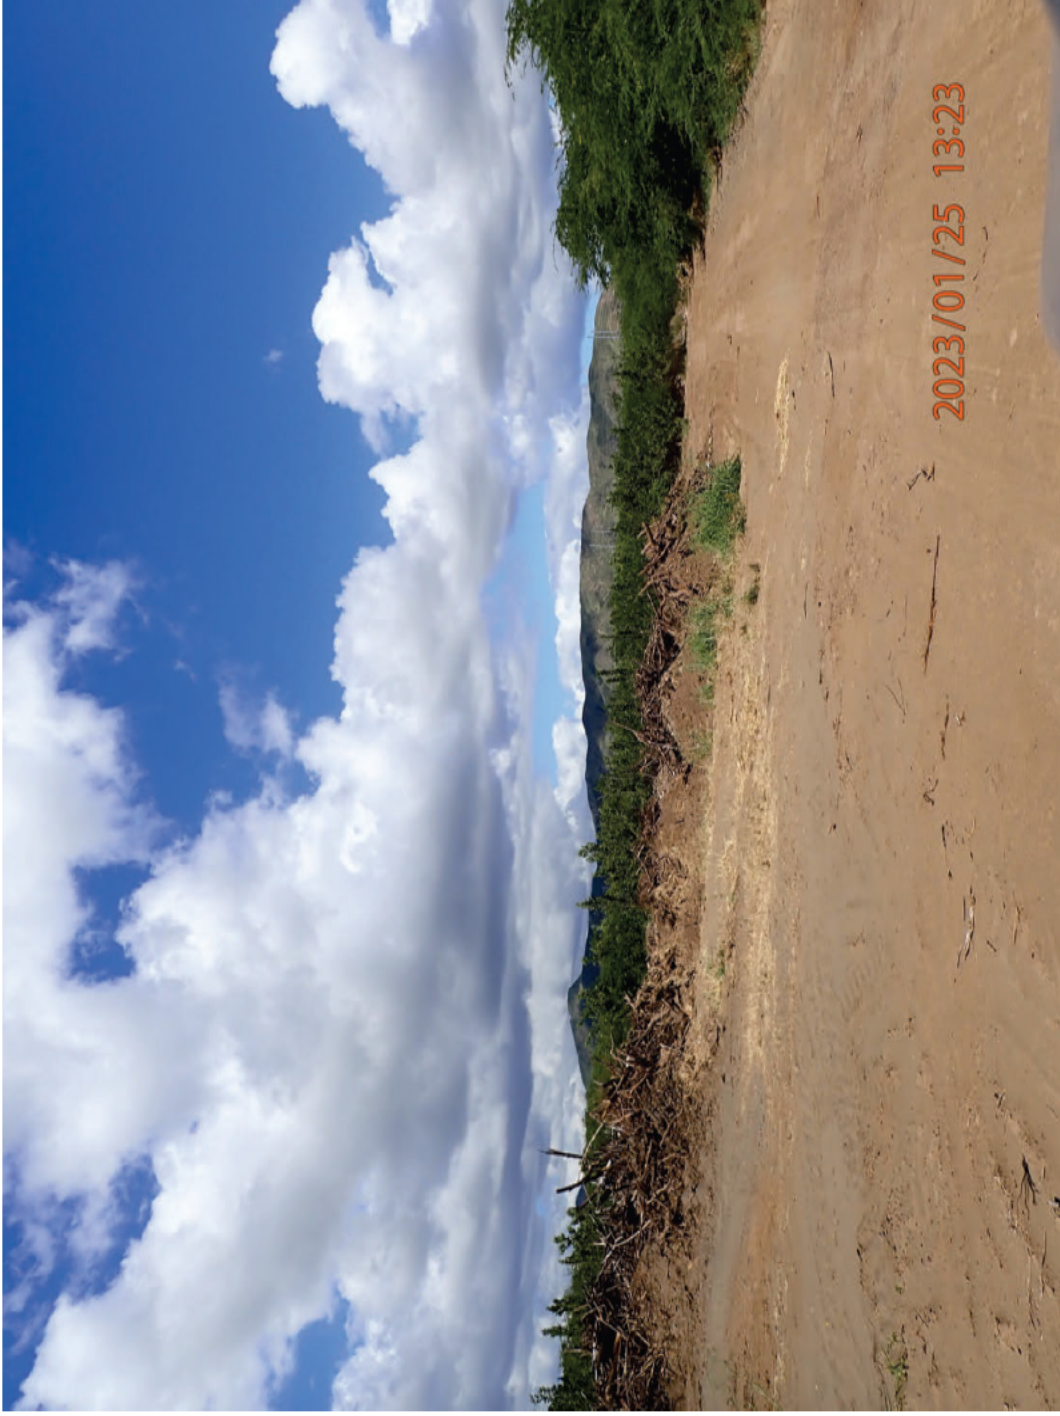
**Photo ID:** P1250538

**Description:** Panorama of the center of the Site where vegetation had been cleared and where the vegetative debris from the Site is stored.

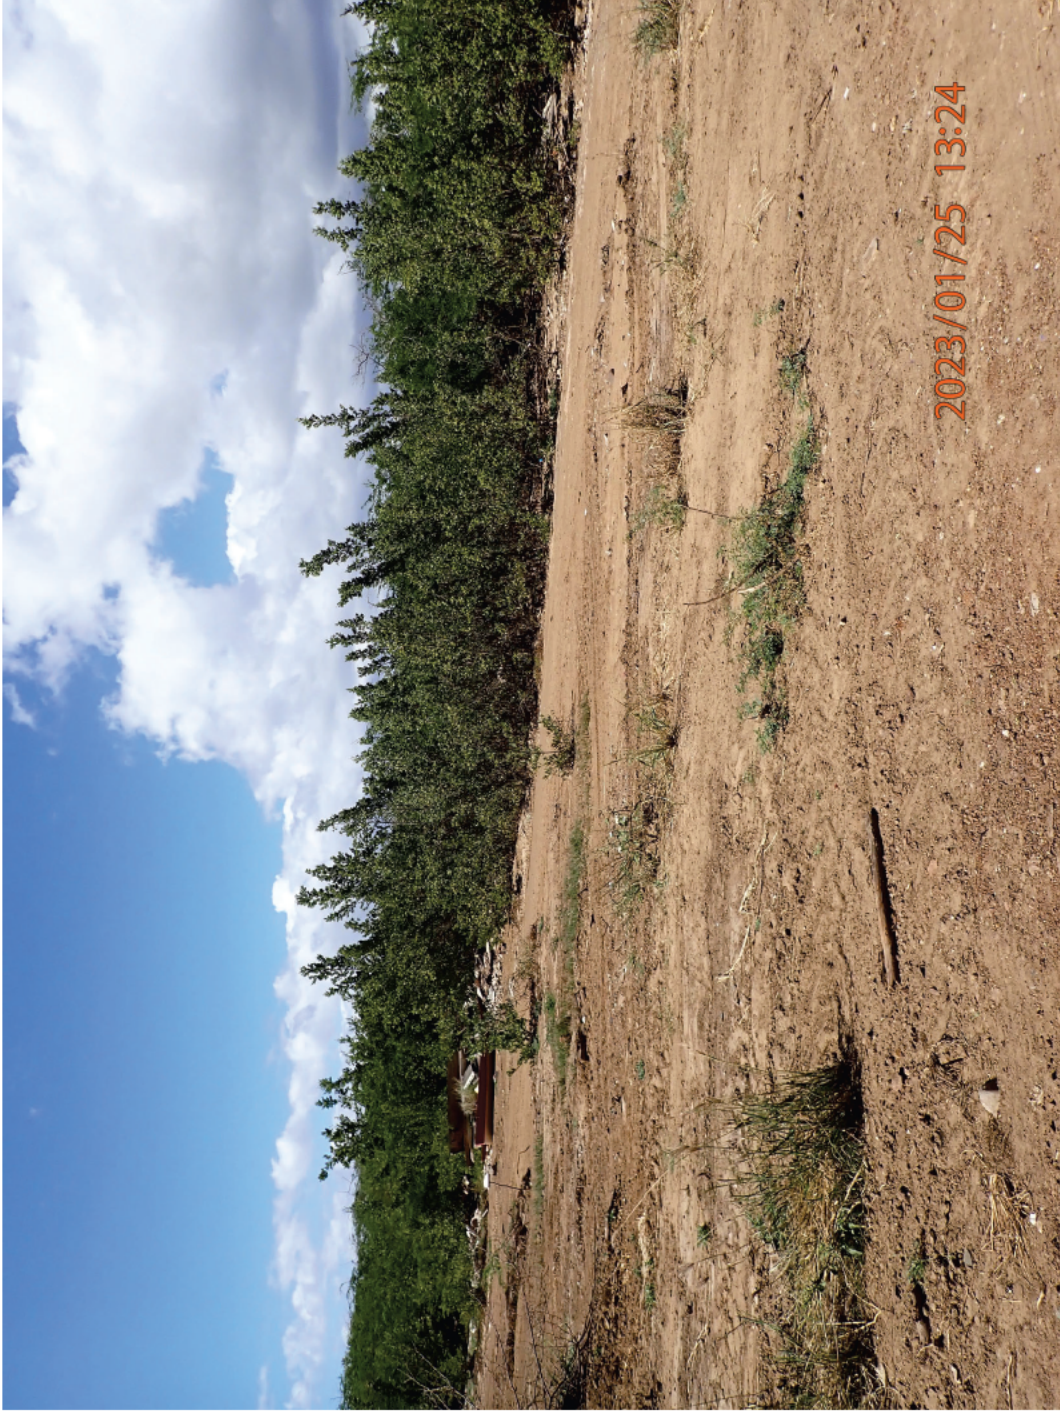
**Photo ID:** P1250541

**Description:** Panorama of the center of the Site where vegetation had been cleared and where the vegetative debris from the Site is stored.

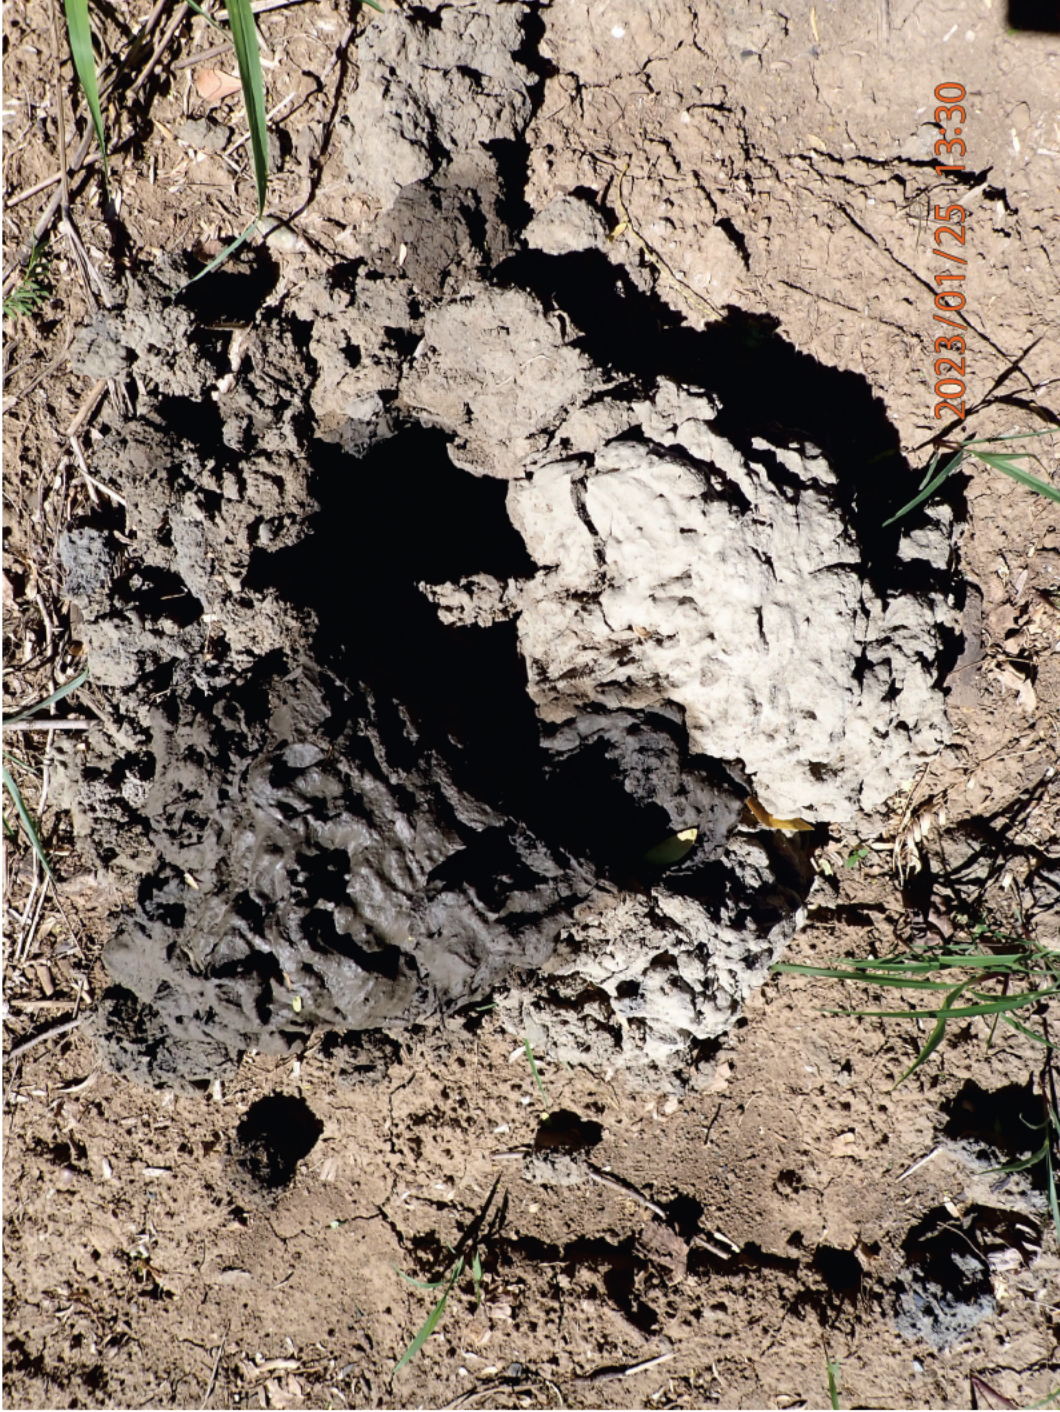
**Photo ID:** P1250543

**Description:** Fresh crab burrows found throughout the Site.
