## Region 6 - Enforcement & Compliance Assurance Division

### INSPECTION REPORT

| Company Name: | Westlake RE Dev Partners, Inc. | |
| Facility Name: | Villagio | |

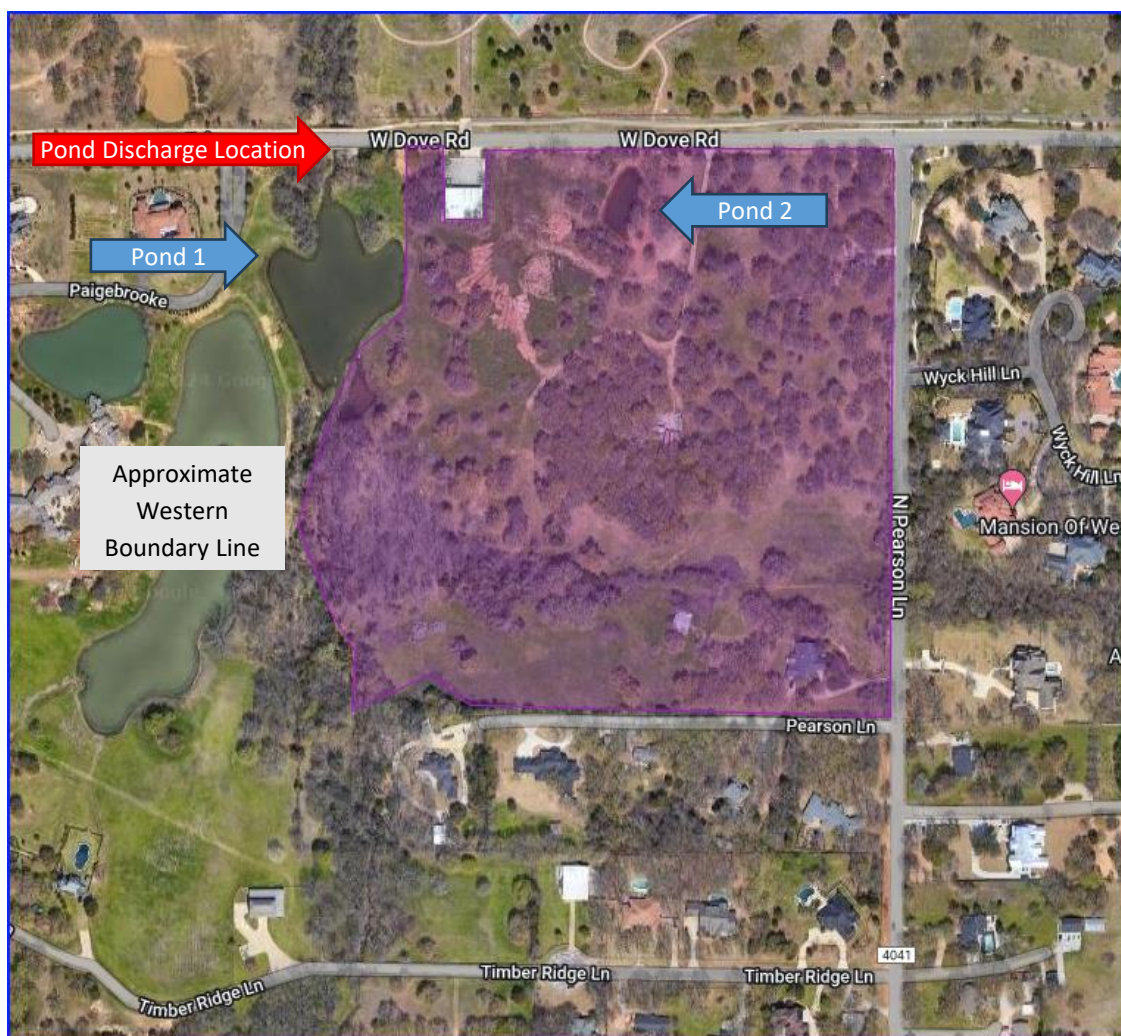
**Aerial Image 1:** The Villagio residential construction site. The site is located within the boundary of W Dove Road, N Pearson Lane, Pearson Ln, and the approximate western purple boundary line depicted above. The aerial photo including the approximate purple boundary lines was provided by the permittee. All additional labels were added by US EPA.

- Upon request, a digital copy of an up-to-date site map and inspection reports were emailed by Mr. Sclafani on November 1, 2024.  
Mr. Sclafani identified the two ponds that water from the site discharge to and confirmed where Pond 1 (as depicted in Aerial Image 1 above) discharges to Turner Lake during a Microsoft Teams call on November 5, 2024.

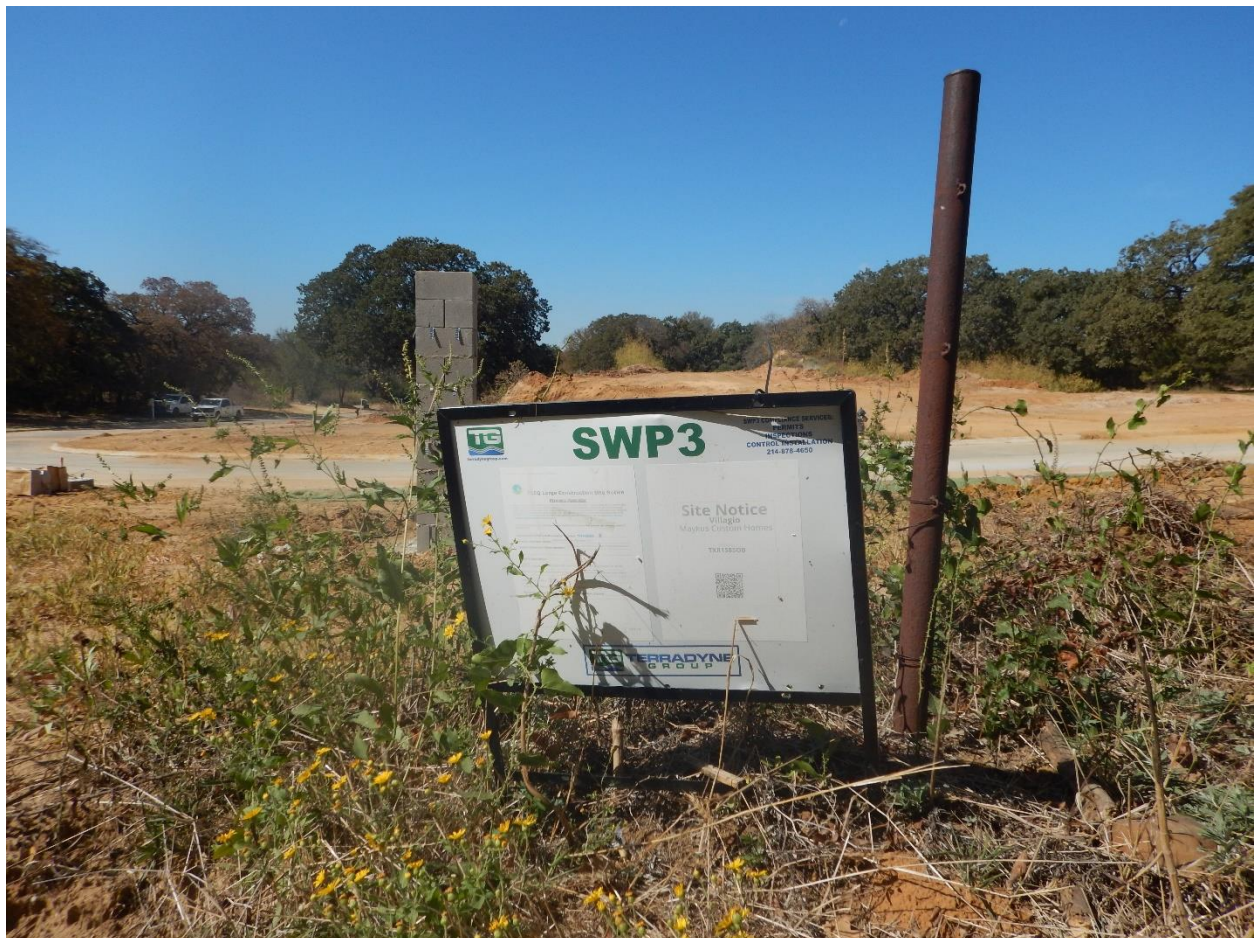
Photo no. 1

- The Large Construction Site Notice (CSN) was posted along N Pearson Ln (south of the construction entrance/intersection of N Pearson Ln and Villagio Blvd near the drop inlet in the ditch) (**Appendix 1, Photos 1-2**). The CSN was issued by the Texas Commission on Environmental Quality (TCEQ) (TCEQ permit number was listed as TXR1585OB. Actual permit number is TXR1585OP according to TCEQ records) with an effective date of October 9, 2023, for coverage under the Construction General Permit (CGP).
- The CSN along N Pearson Ln had a QR code that linked to the operator's Storm Water Pollution Prevention Plan (SWPPP) documentation and inspection reports (**Appendix 1, Photo 1**).

Description: The large CSN posted along N Pearson Ln. The CSN included a QR code which links directly to the site's SWPPP and inspection reports.

- The permit number listed on the CSN and SWPPP is not associated with Villagio. It's recommended that all documentation be reviewed to ensure accuracy of the information listed.
- I observed exposed sediment and uncontained stockpiles throughout the site (**Appendix 1, Photos 3-8**).
- I observed sediment on the street along Serendipity Ct and Villagio Blvd (**Appendix 1, Photos 6-8**).
- I observed inlet protection that needed maintenance due to being heavily silted with sediment throughout the site (**Appendix 1, Photos 3-4**).
- I observed approximately seven (7) paint containers of various sizes stored directly on top of an inlet on Serendipity Ct (**Appendix 1, Photos 4 and 9**).

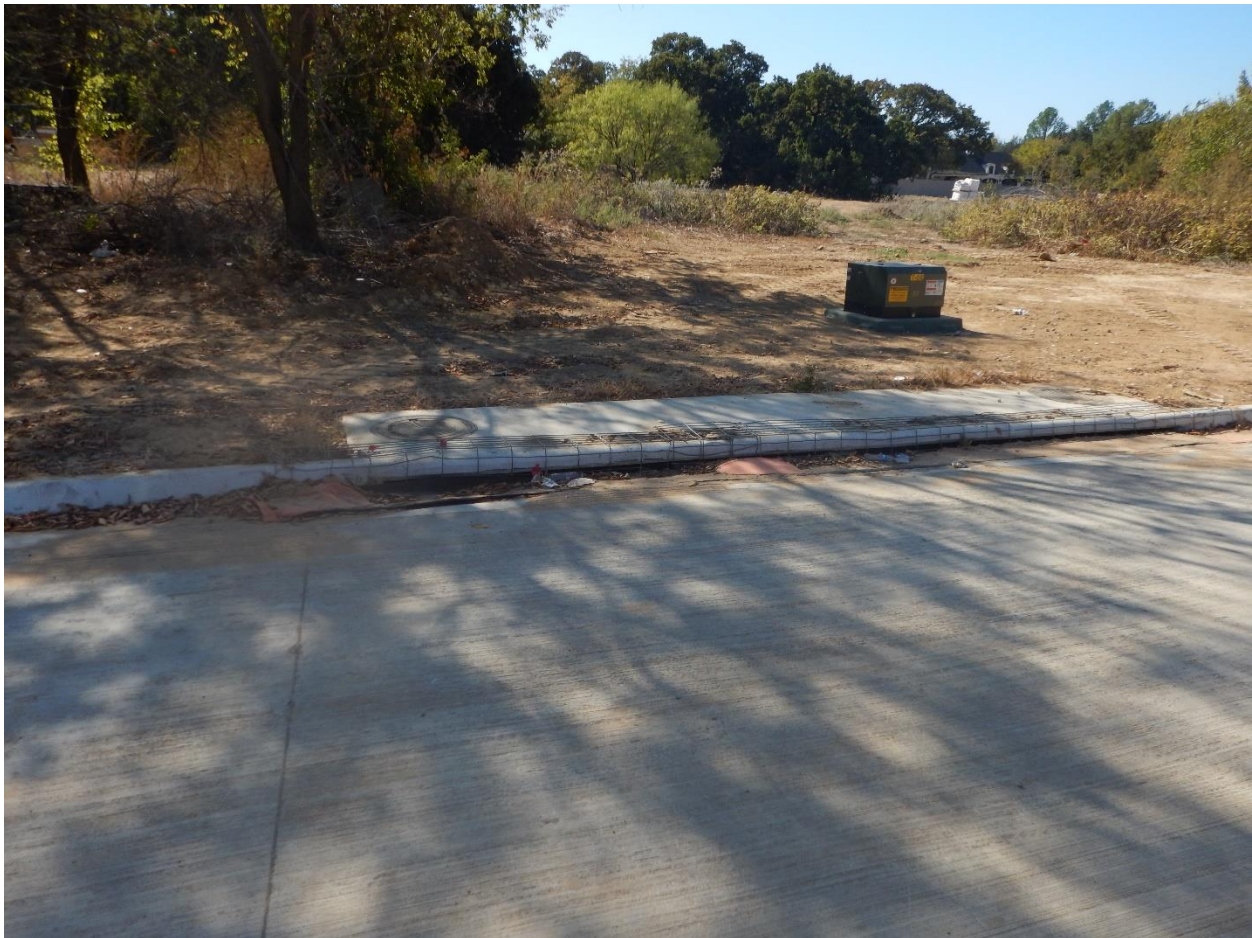
Photo no. 3

- Inlets throughout the site had BMPs installed (**Appendix 1, Photos 3-4**).
- Approximately 50% of the unpaved construction areas on Serendipity Ct consisted of exposed sediment with no Best Management Practices (BMPs) installed (**Appendix 1, Photos 3-7**). The remaining areas had erosion control blankets installed.

Description: Heavily silted inlet protection installed on Serendipity Ct. Exposed sediment was observed along multiple lots.

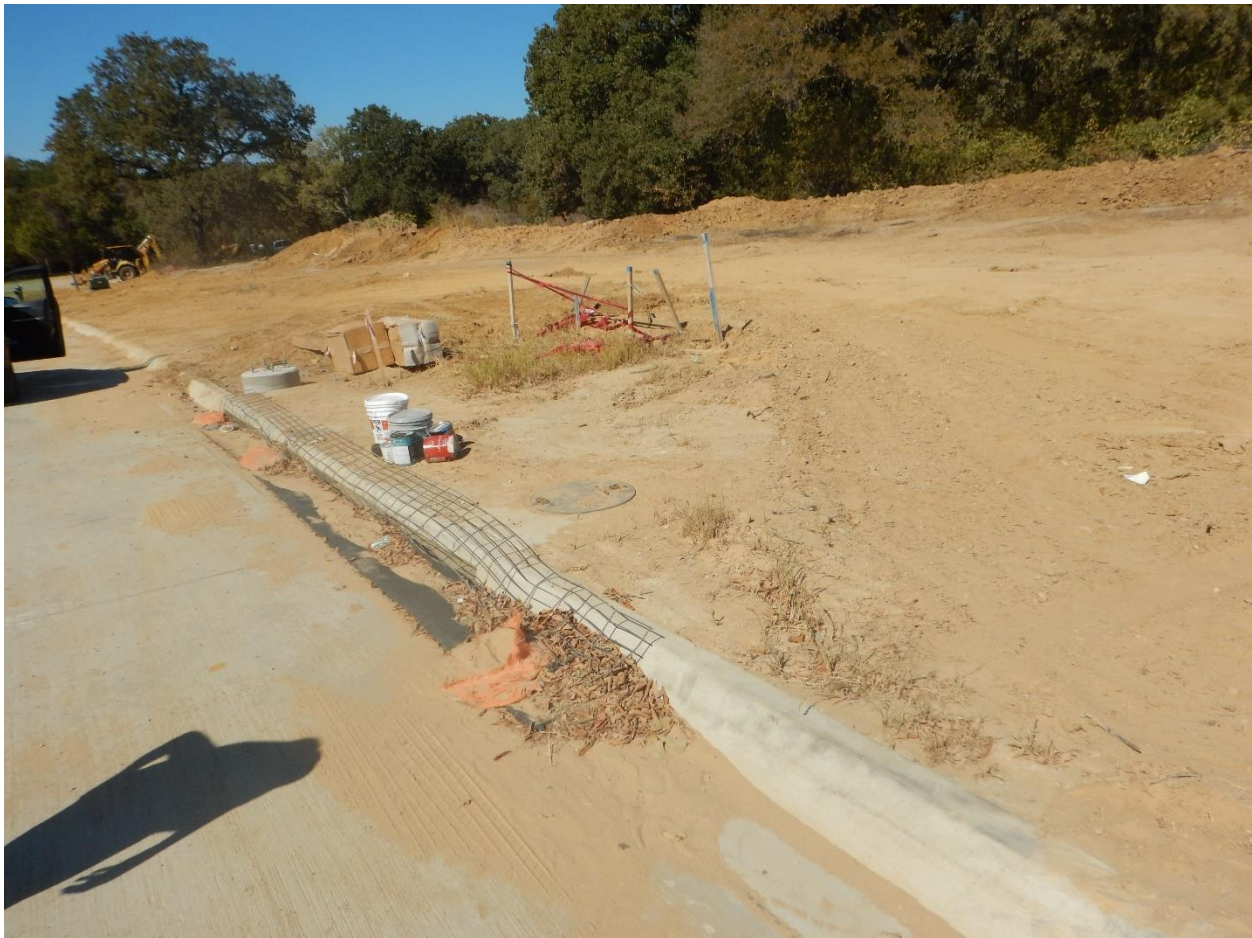
Photo no. 4

Description: Heavily silted inlet protection installed on Serendipity Ct. Multiple paint containers of various sizes were observed stored on top of the inlet. Exposed sediment was observed along multiple lots and sediment was observed on the street.

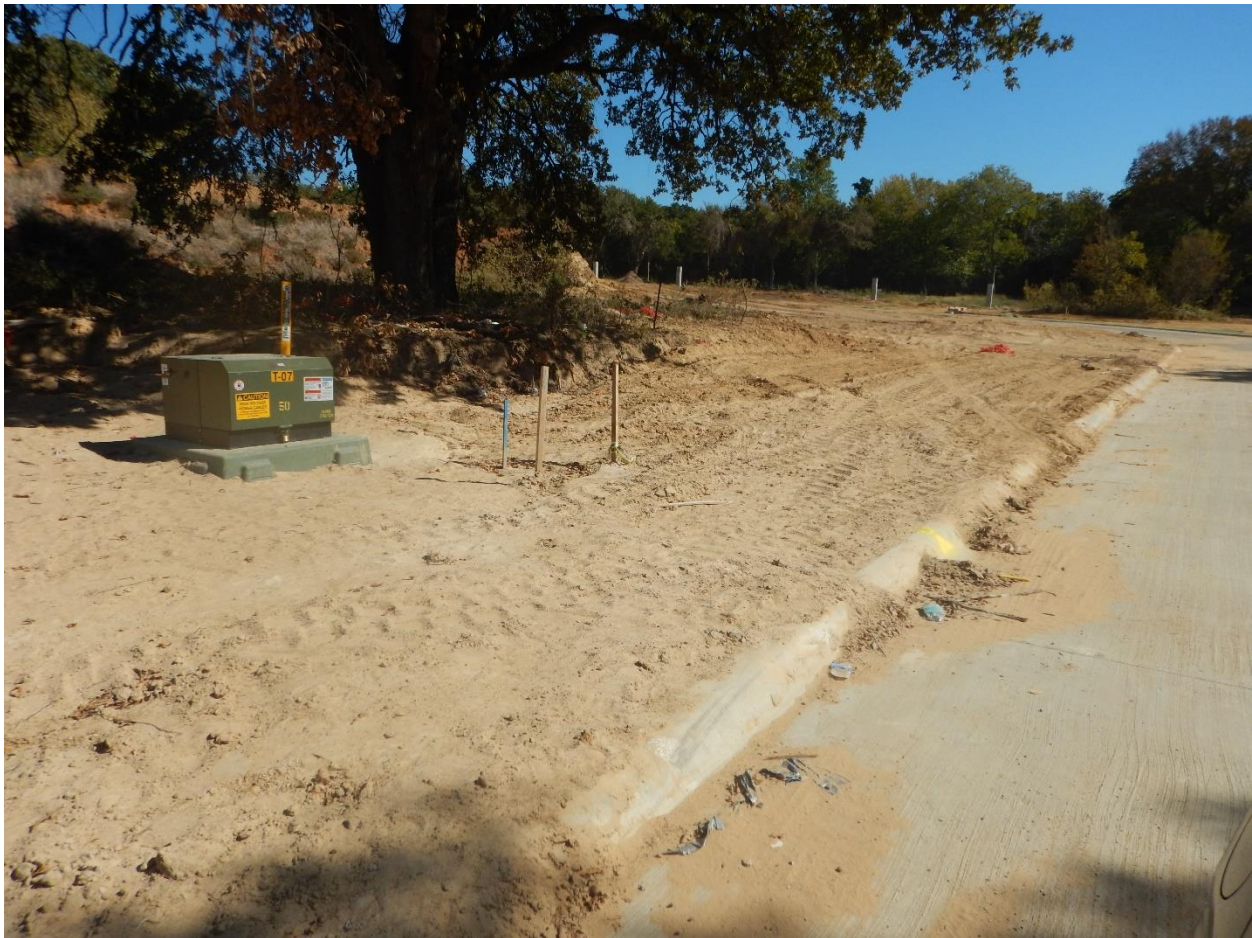
Photo no. 5

**Description:** Exposed sediment along multiple lots on Serendipity Ct.

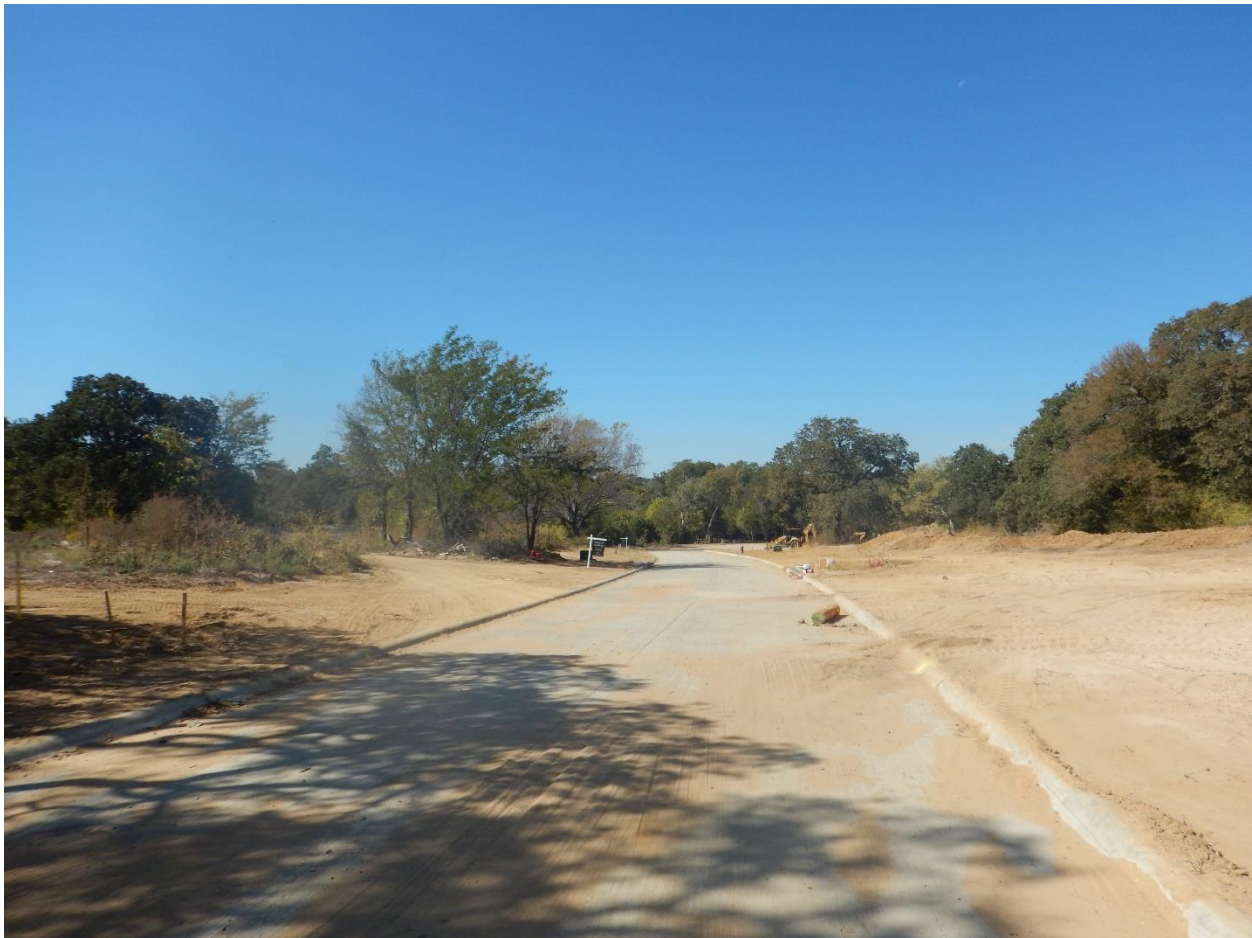
Photo no. 6

Description: Exposed sediment along multiple lots on Serendipity Ct. Due to the absence of effective BMPs, sediment was observed on the street.

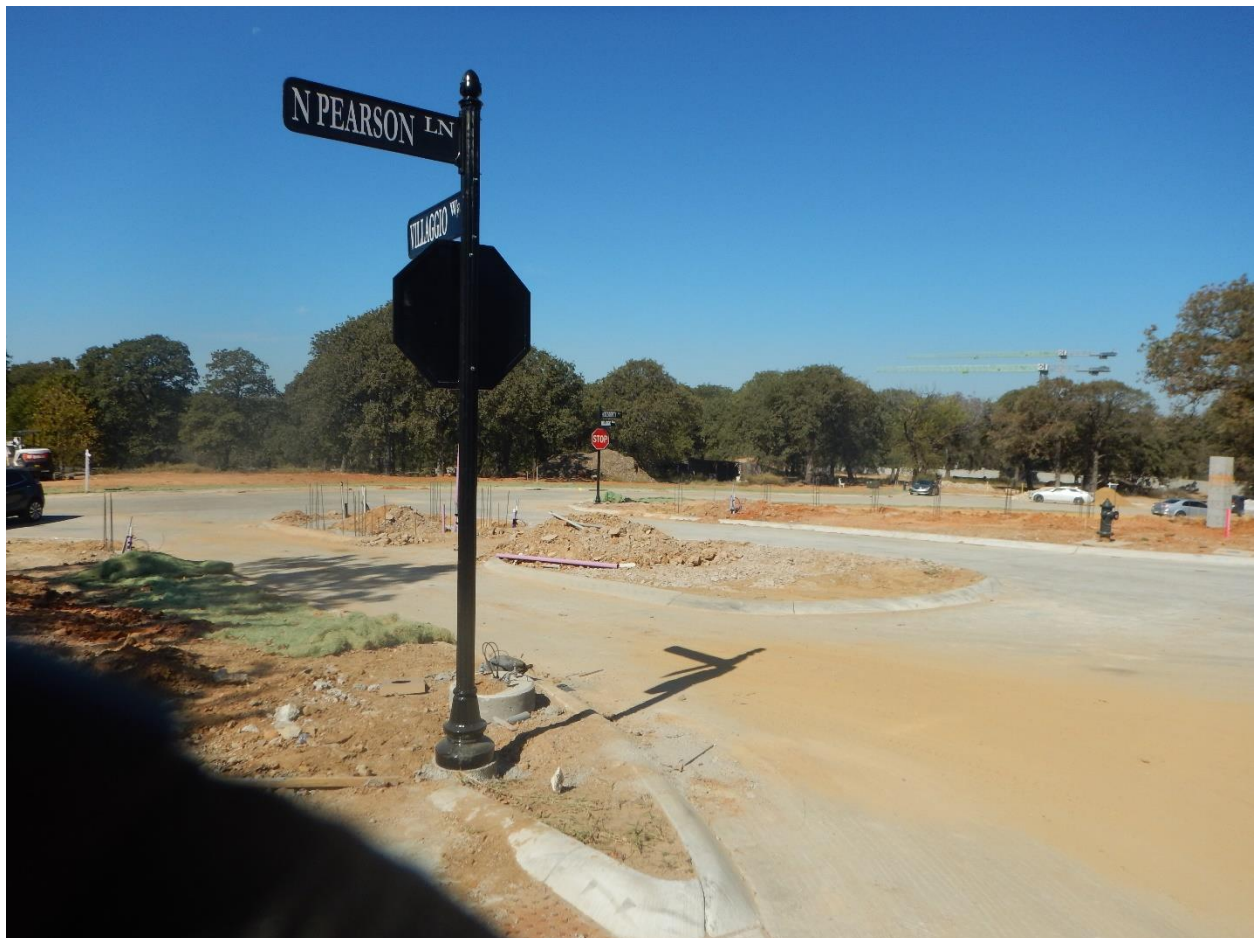
Photo no. 7

Description: The construction entrance located at the intersection of N Pearson Ln and Villagio Blvd. One (1) area of approximately 3-5 feet of erosion control blanket was observed along the entrance/Villagio Blvd. Erosion control blanket was also observed along multiple lots on Serendipity Ct perpendicular to the construction entrance. The remaining areas had no BMPs, and sediment was observed on the street.

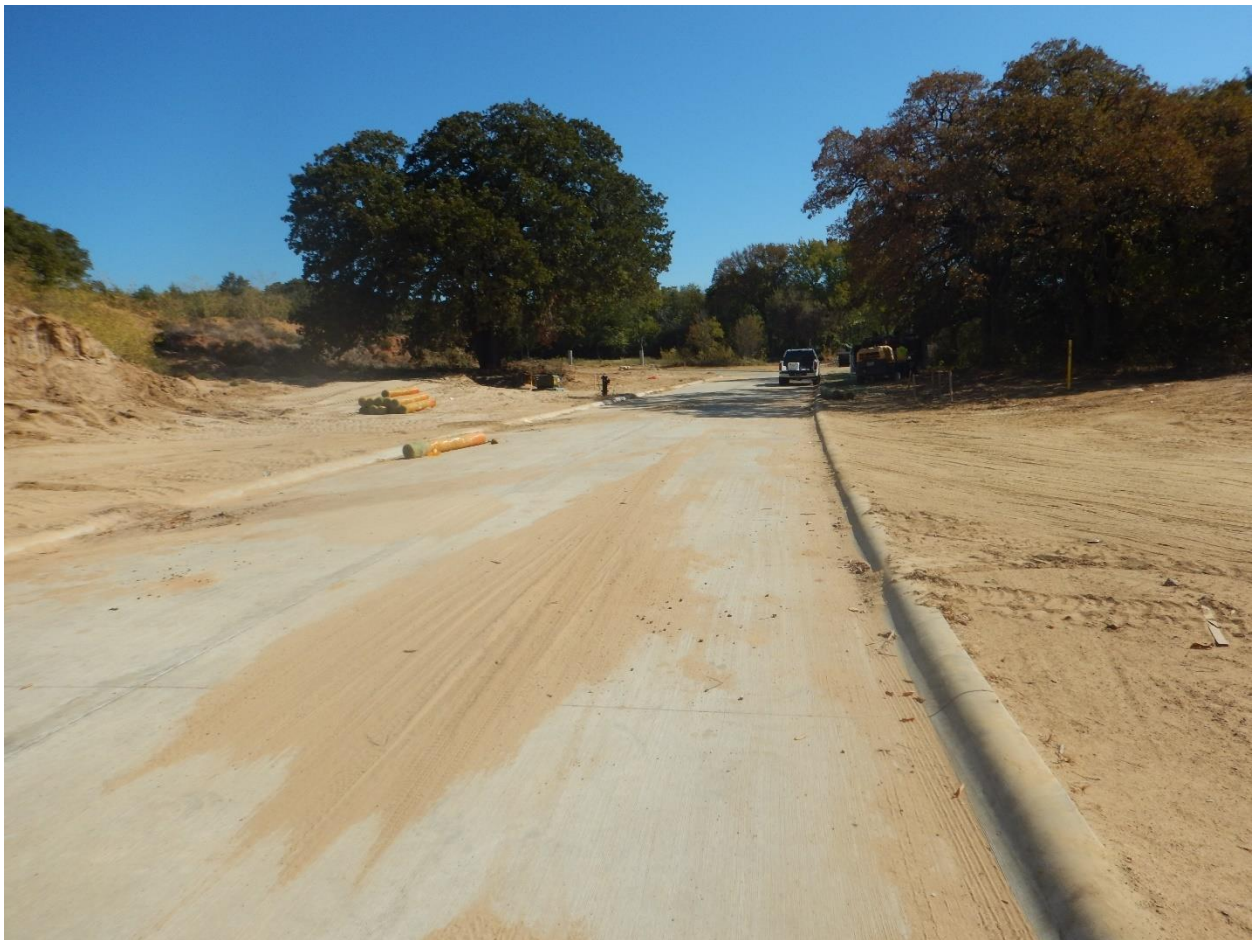
Photo no. 8

- Rolls of erosion control blankets were observed laying on the lots and street on Serendipity Ct waiting to be installed (**Appendix 1, Photo 8**).
- During the inspection Mr. Bonola informed the inspectors that stormwater discharges to two (2) ponds and water from one (1) of the two (2) ponds leaves the site and enters the Town of Westlake storm sewer system (**See Aerial Image 1**). Sammy Sclafani (SWPPP Compliance Manager of Terradyne Group) later identified the two (2) ponds associated with this project as depicted in Aerial Image 1 and described in Section IV of this report.

Description: Exposed sediment and uncontained stockpile(s) along the lots on Serendipity Ct. Rolled erosion control blankets were located on the lots and street, presumably waiting to be installed. Sediment was observed on the street.

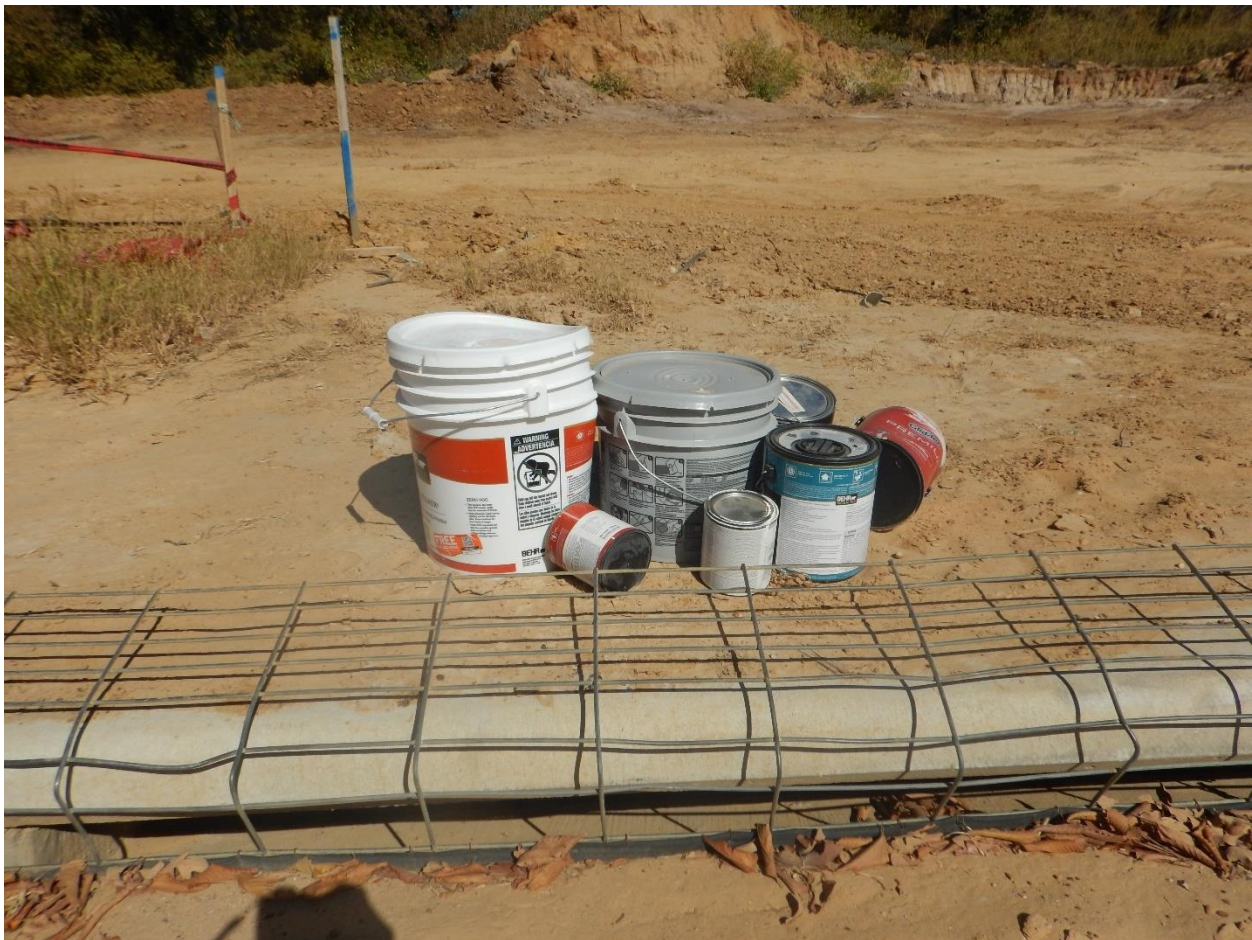
Photo no. 9

Description: Approximately seven (7) containers of paint stored directly on top of an inlet on Serendipity Ct. Two (2) paint containers were knocked over on their side.
