INSPECTION REPORT

| Type of Inspection | Compliance Evaluation Inspection (CEI) | |
| Facility or Site Name | United Mobility Systems DBA American Vacuum | |
| Type of Operation | American Vacuum (AV) is a used oil transporter and transfer facility that picks up used oil waste from barges, boats, and other facilities. | |

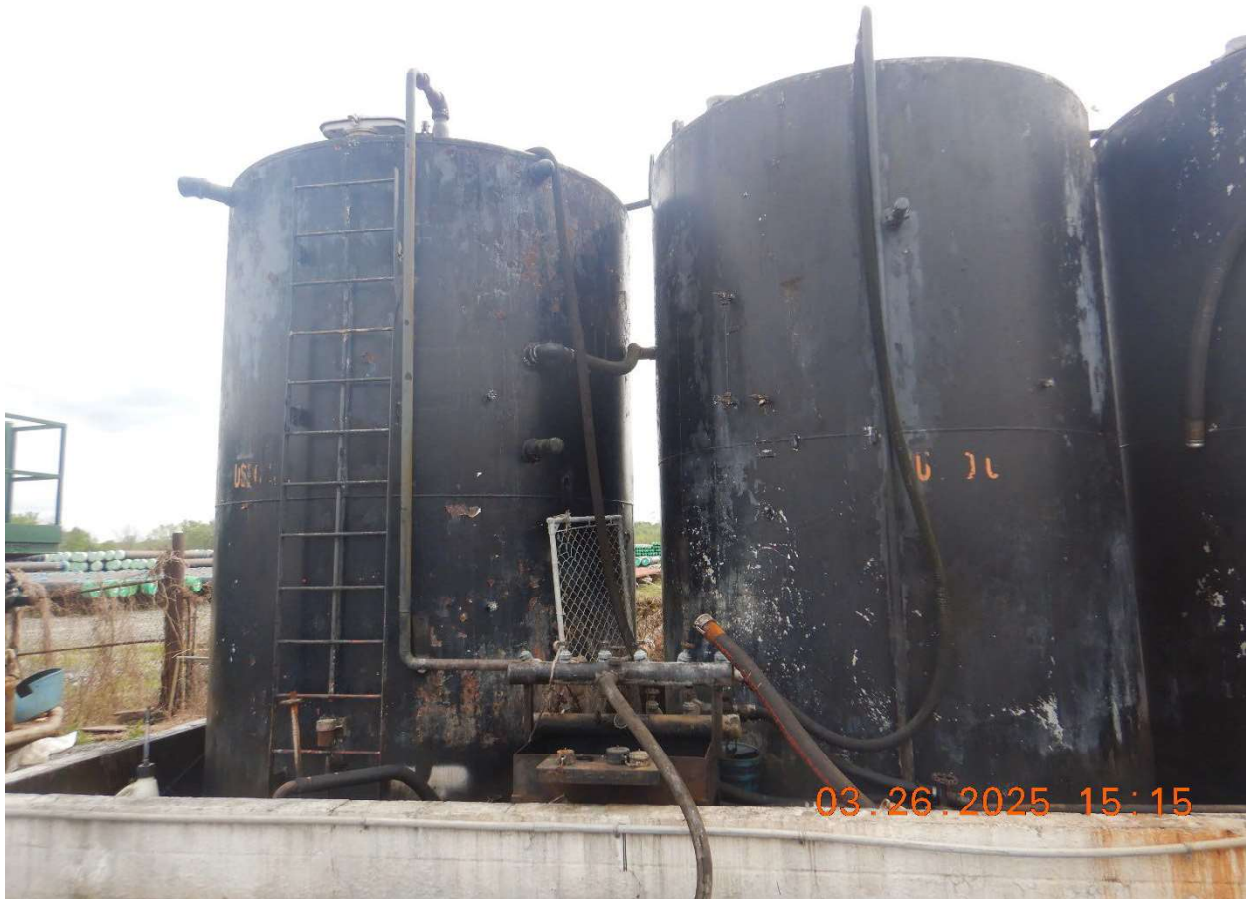
**Photo No. 1**

Description: View of used oil storage Tank #1 (left, holding 7,000 gallons) and used oil storage Tank #2 (right, holding 4,000 gallons) in the tank farm; neither tank is labeled.

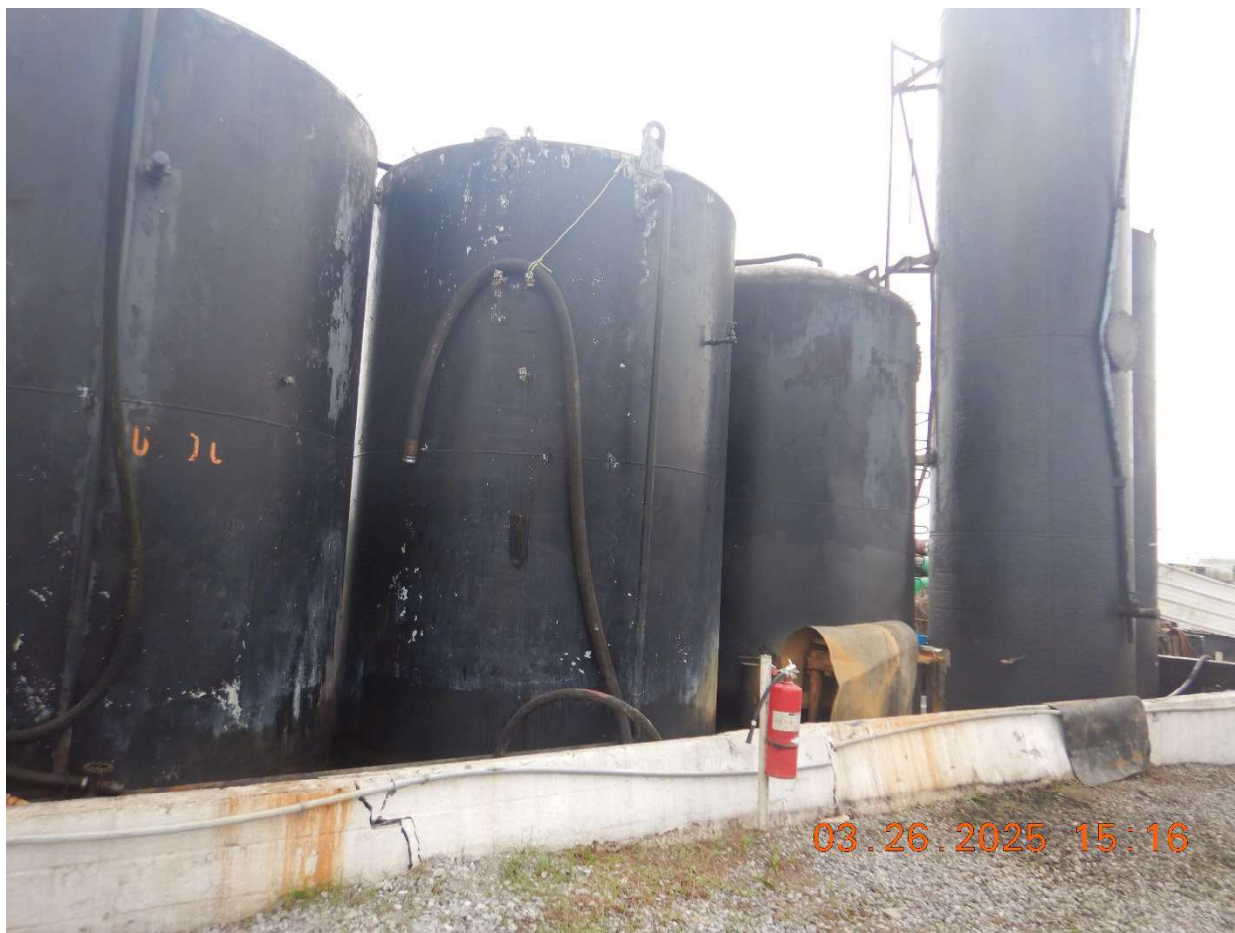
**Photo No. 2**

Description: View of used oil storage Tank #3 (middle left, holding 3,000 gallons) and used oil storage Tank #4 (middle right, empty) in the tank farm; neither tank is labeled.

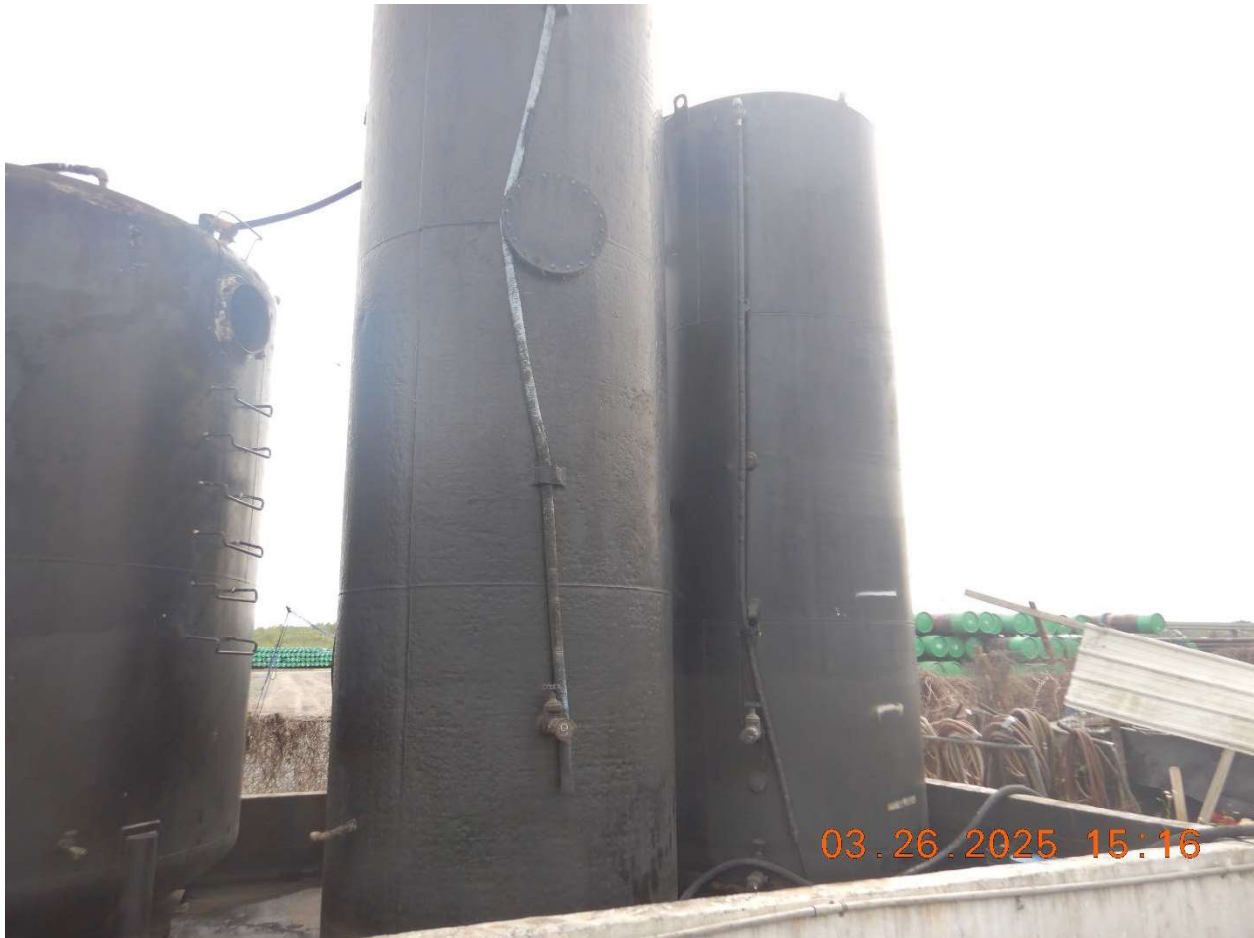
Photo No. 3

Description: View of used oil storage Tank #5 (left, empty) and used oil storage Tank #6 (right, holding 3,000 gallons) in the tank farm; neither is labeled.

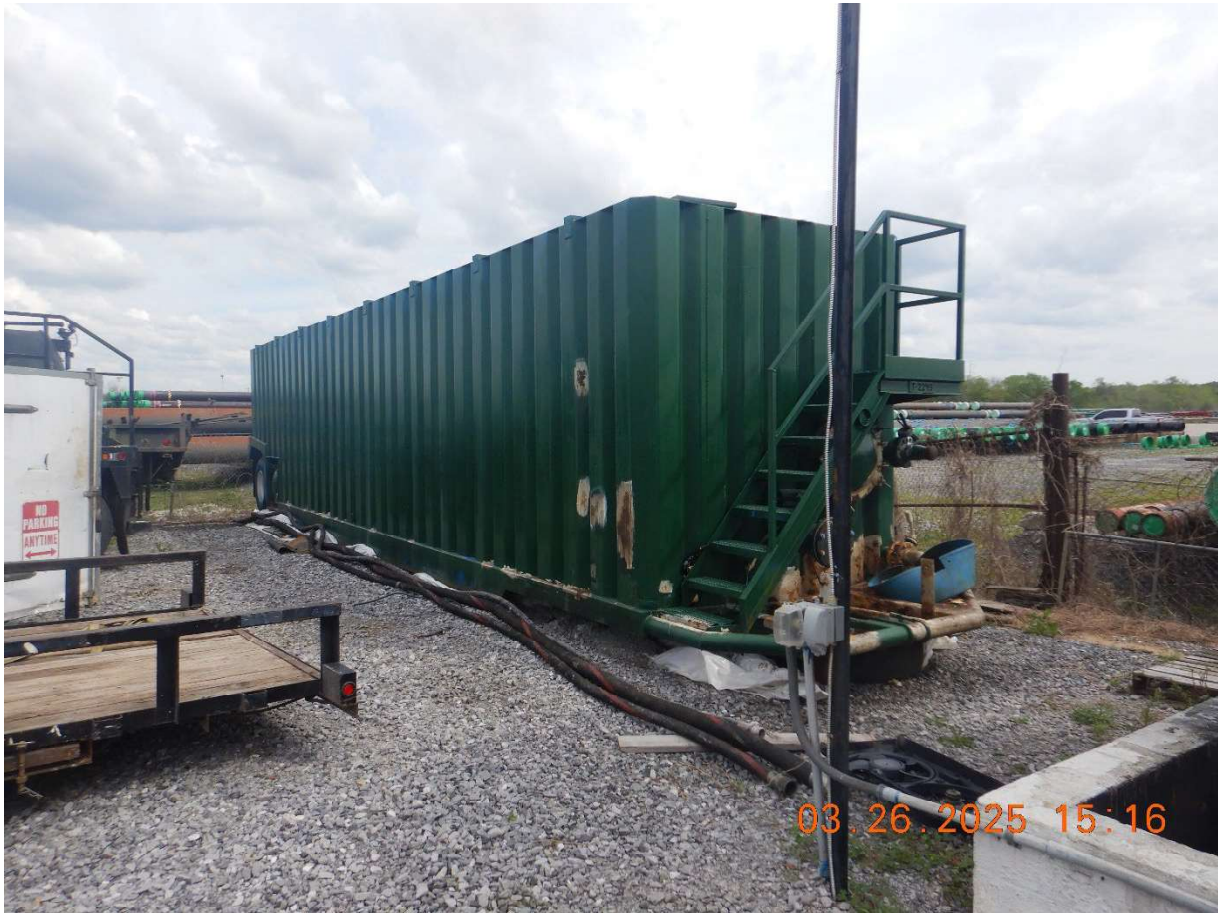
**Photo No. 4**

Description: View used oil frac tank storing 6,000 gallons of used oil; the tank is unlabeled and not in a secondary containment system.

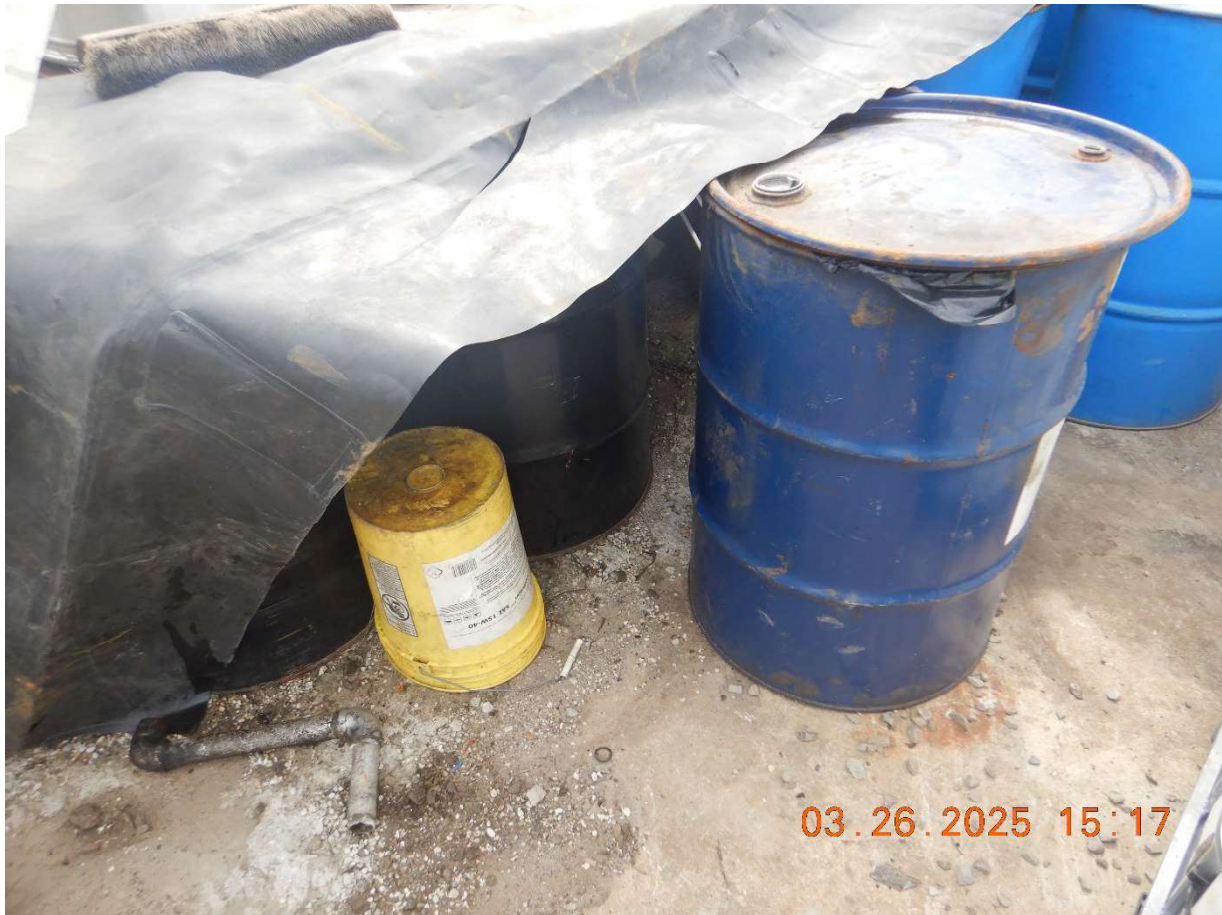
Photo No. 5

Description: View of three of the fifteen 55-gallon drums storing used oil-contaminated solids that were unlabeled and not in a secondary containment system, observed to the right of the tank farm.

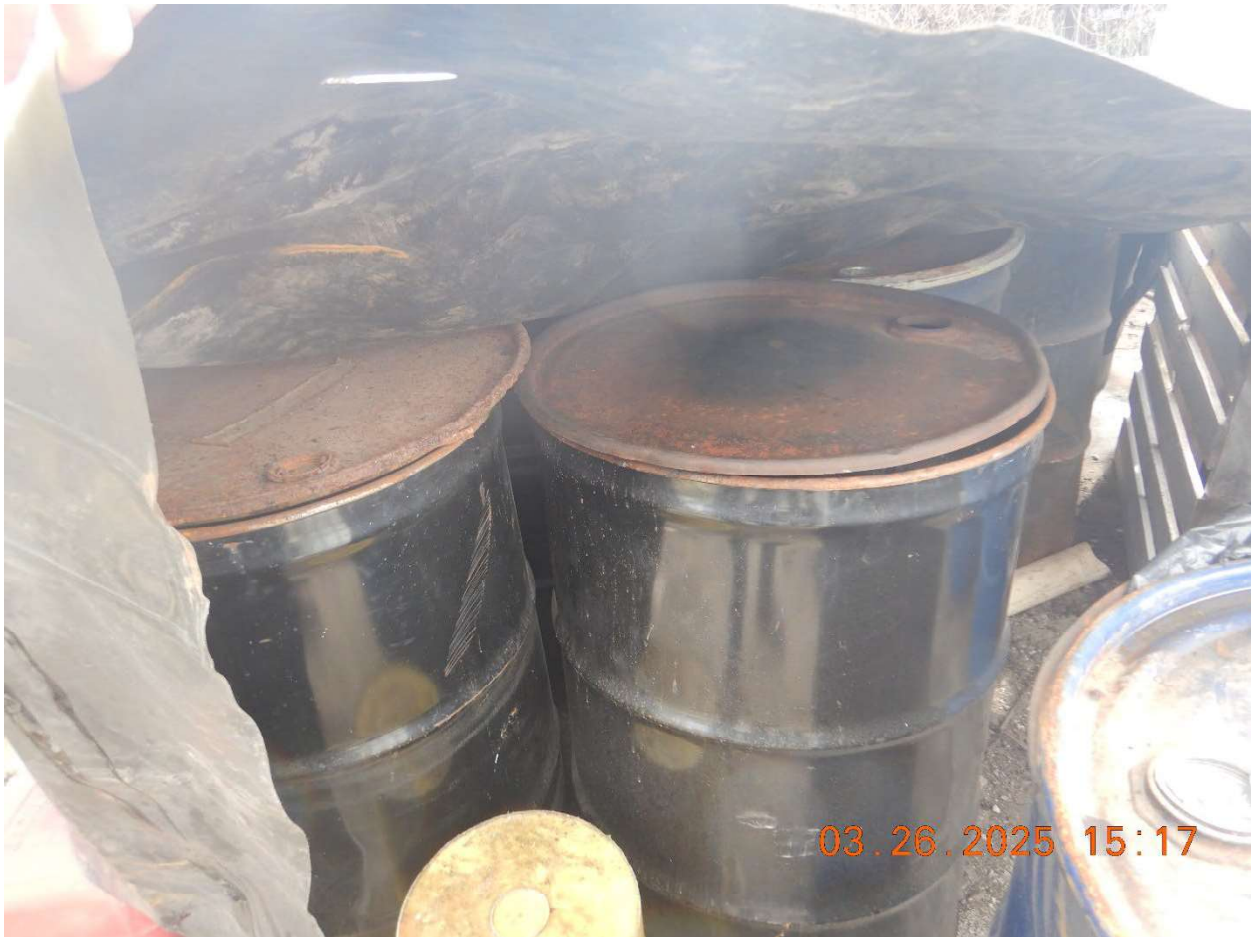
Photo No. 6

Description: View of three more of the fifteen 55-gallon drums storing used oil-contaminated solids that were unlabeled and not in a secondary containment system, observed to the right of the tank farm.

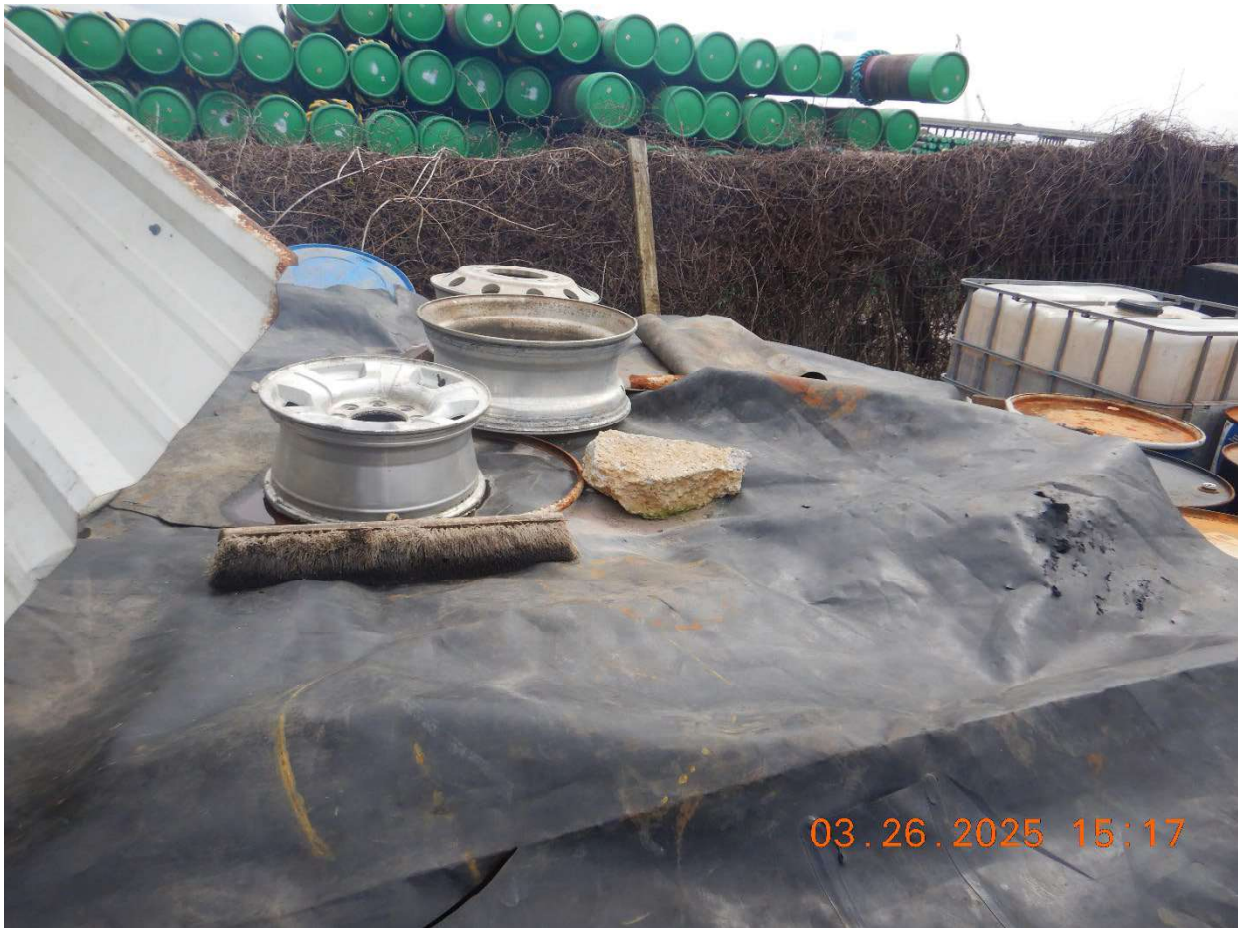
**Photo No. 7**

Description: View of tarp covering the other nine of the fifteen 55-gallon drums storing used oil-contaminated solids that were unlabeled and not in a secondary containment system, observed to the right of the tank farm.

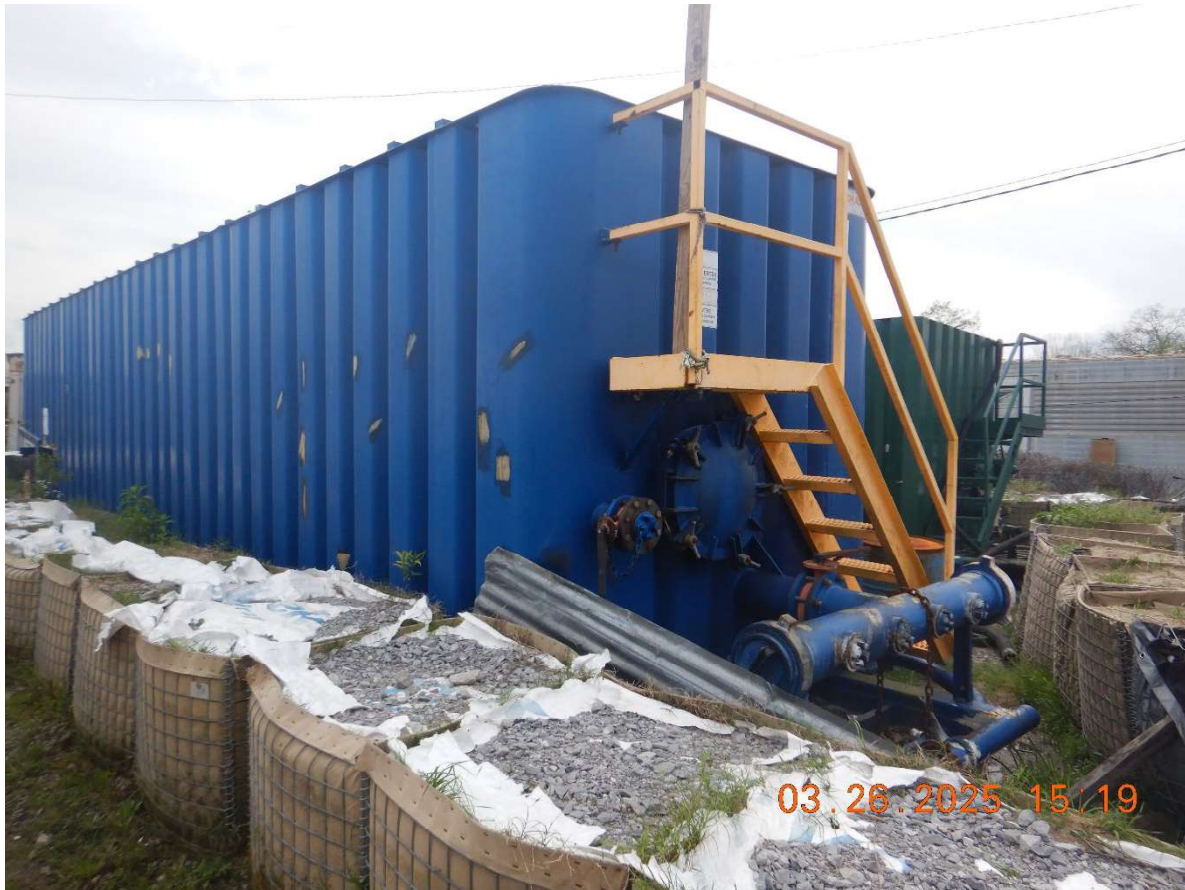
**Photo No. 8**

Description: View of a 20,000-gallon frac tank storing diesel fuel located in the front of the property.

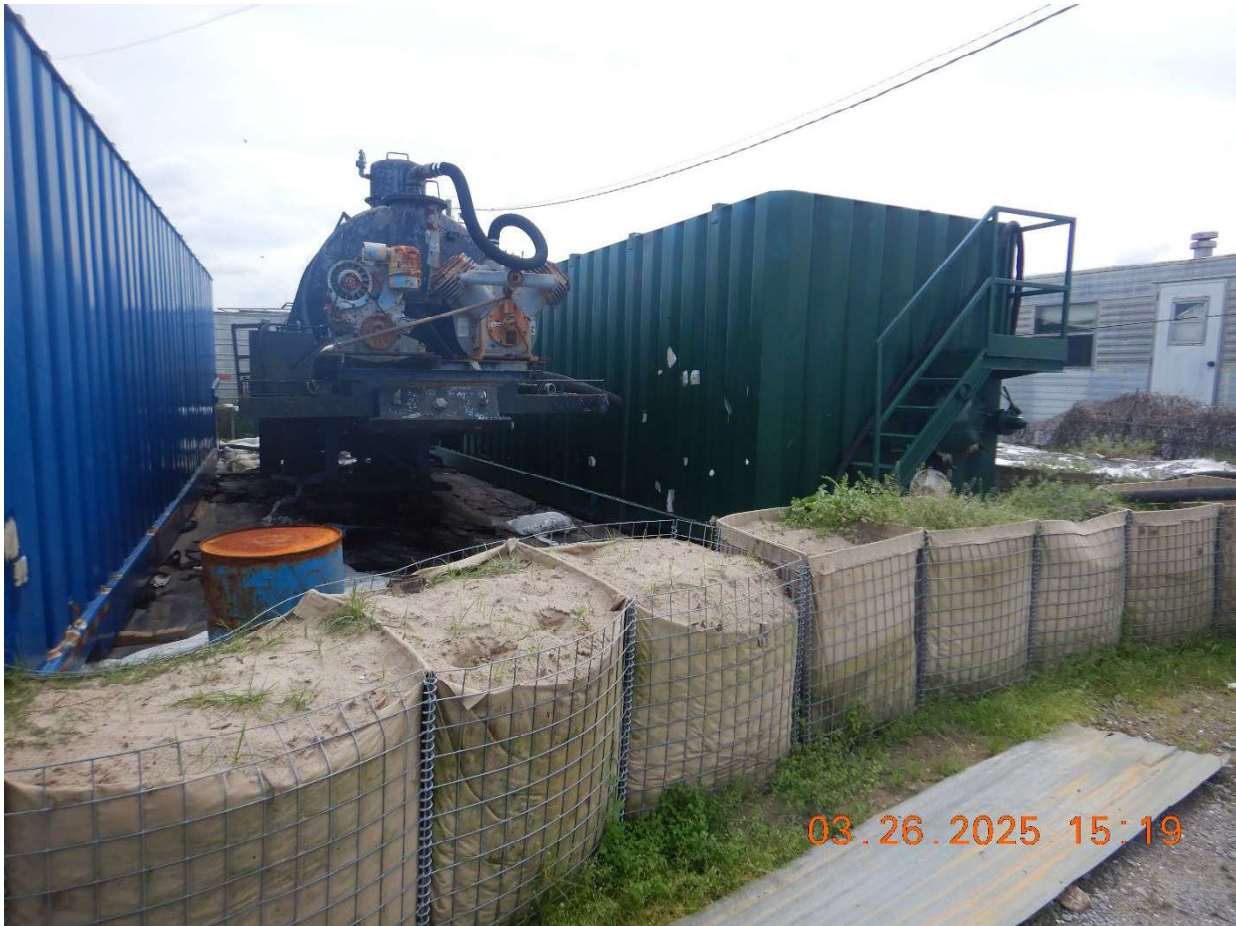
Photo No. 9

Description: View of the second 20,000-gallon frac tank storing diesel fuel located in front of the property.

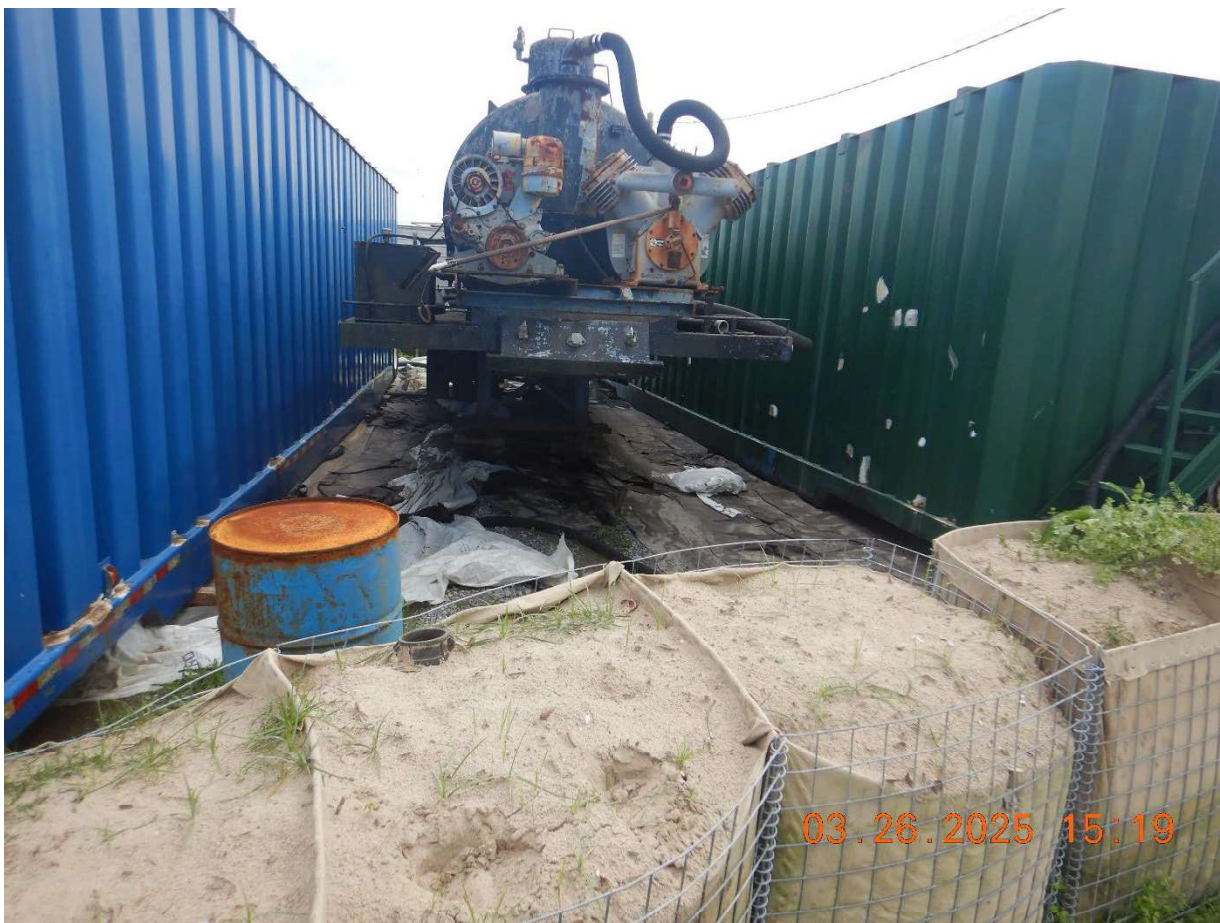
Photo No. 10

Description: View of both 20,000-gallon frac tanks storing diesel fuel located in the front of the property.

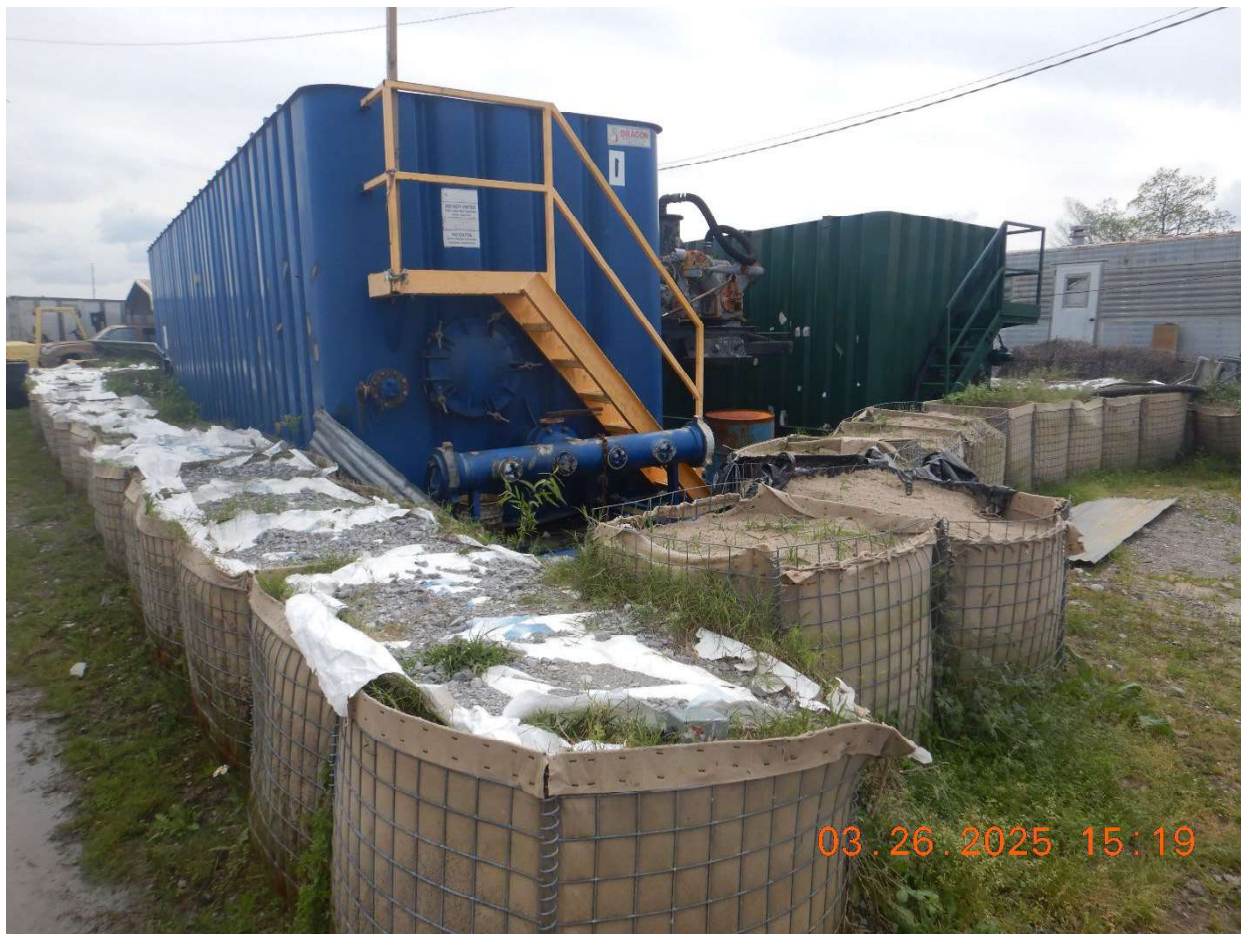
**Photo No. 11**

Description: View of both 20,000-gallon frac tanks storing diesel fuel located in the front of the property.

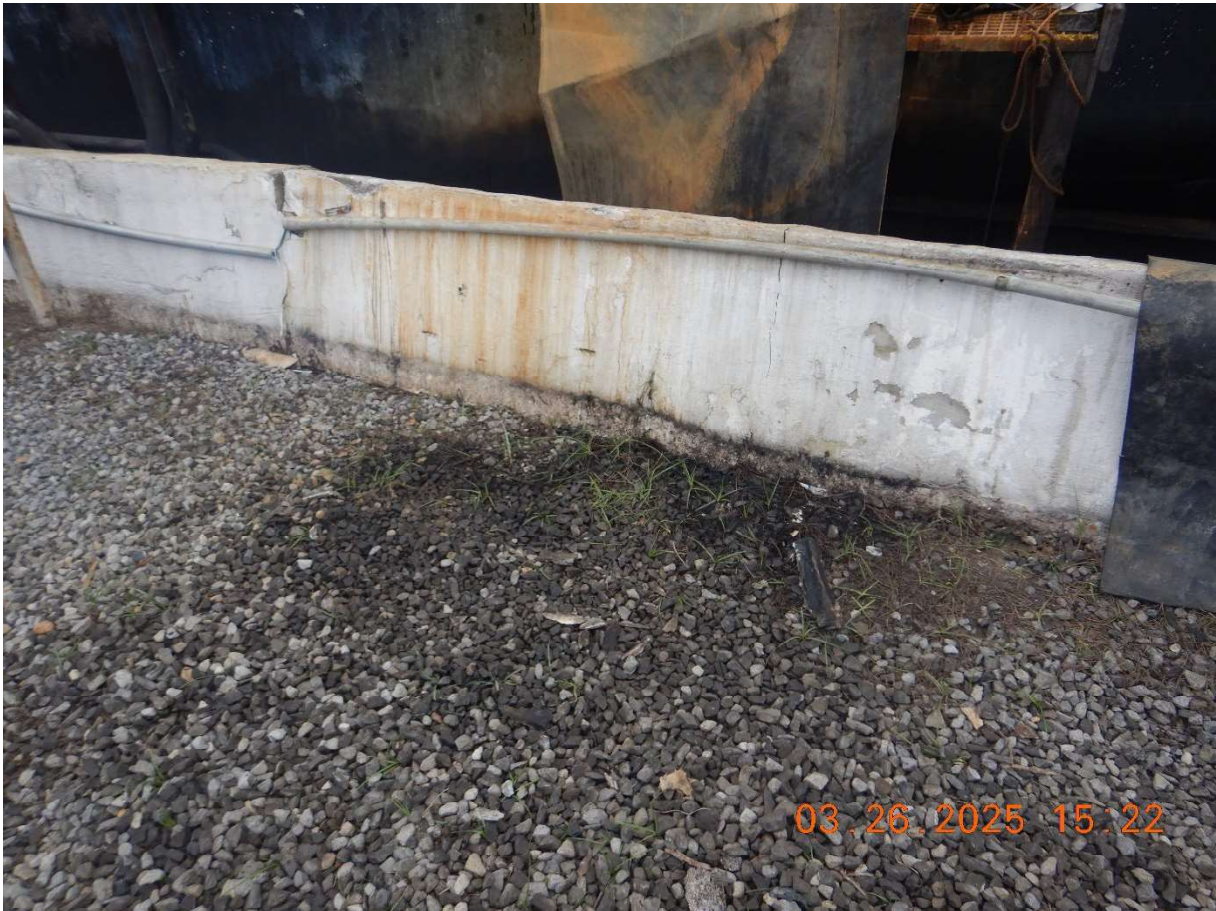
**Photo No. 12**

Description: View of damage sustained to the tank farm secondary containment wall.

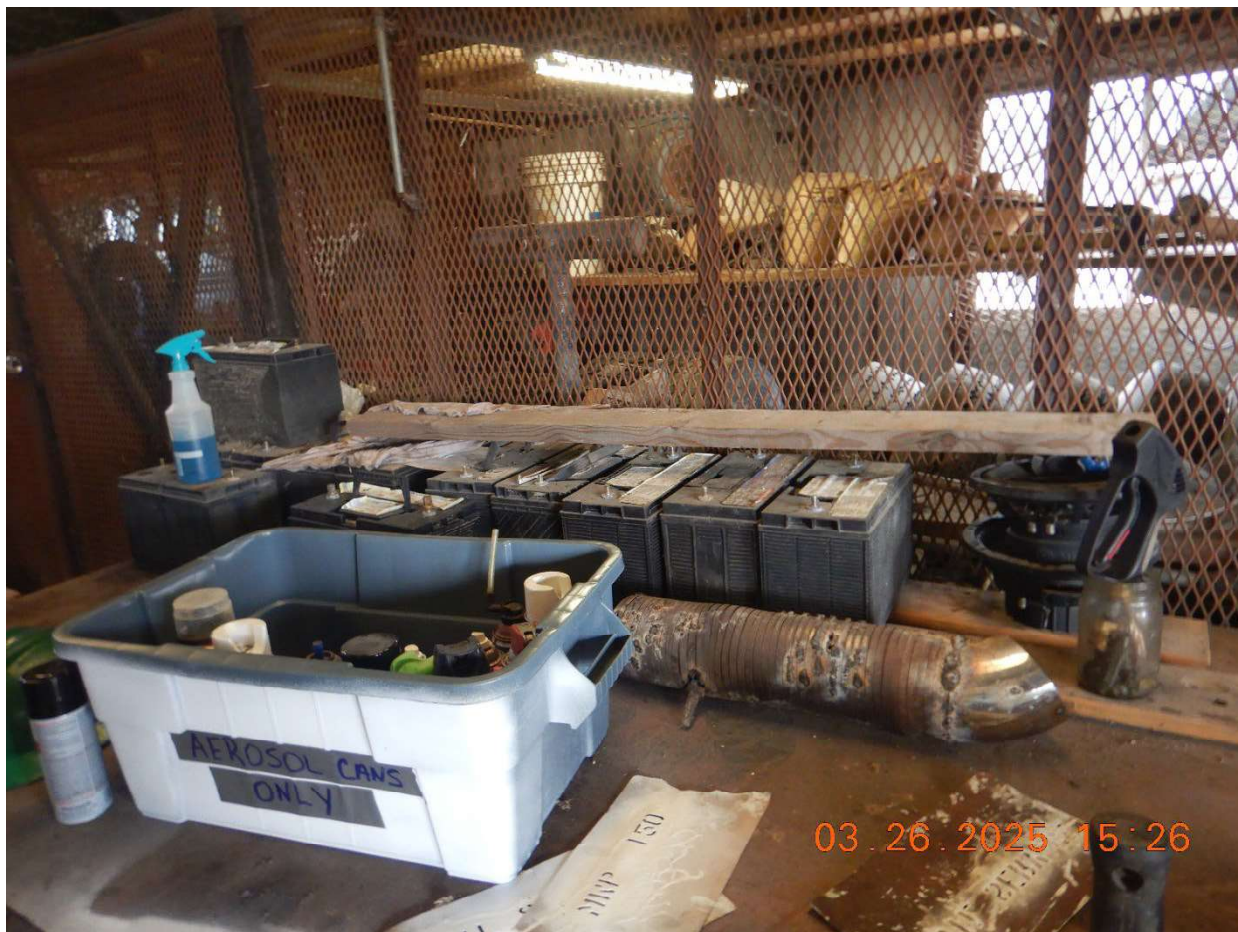
Photo No. 13

Description: View of 11 universal waste batteries located in the maintenance area that were not labeled.

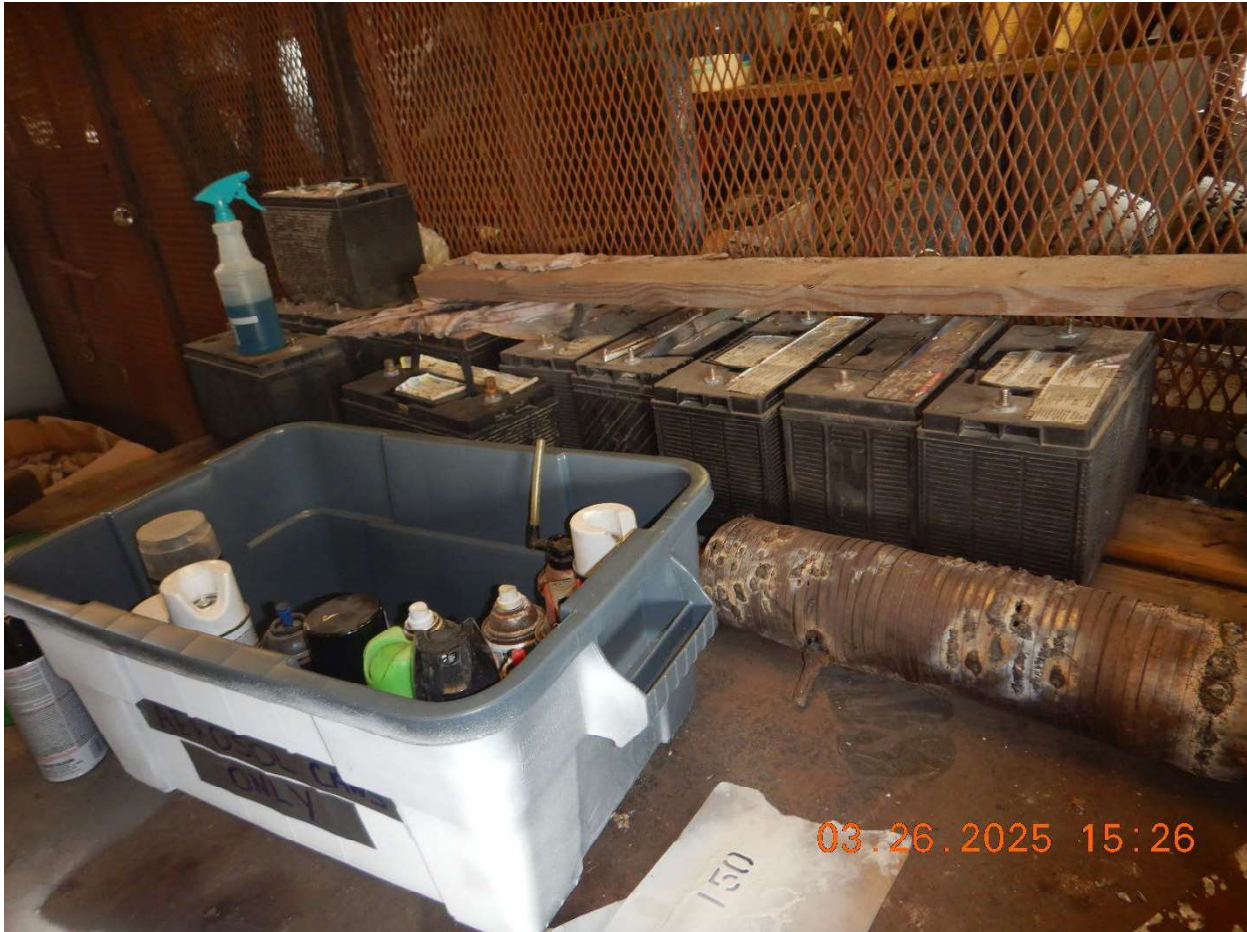
Photo No. 14

Description: View of 11 universal waste batteries located in the maintenance area that were not labeled.
