## **RCRA Inspection Report**

Excel TSD of Tennessee, LLC  
552 Rivergate Road  
Memphis, Tennessee 38109

September 4, 2024; 8:03 a.m. – 6:15 p.m.

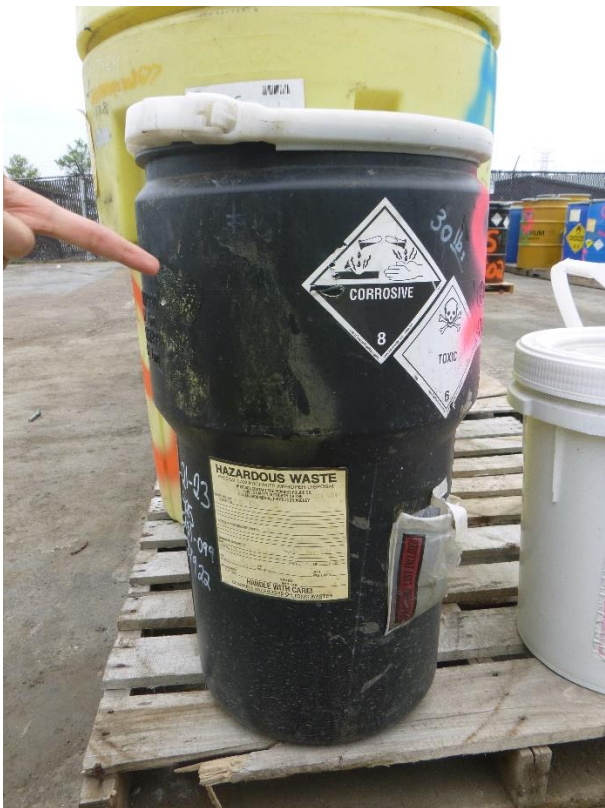
Photograph 45: Permitted Area 2.

The inspection team observed 114 containers in four rows in OHWCMA Area 2 (Photographs 15-45) and noted that 53 of these containers were not labeled with an indication of the hazard of their contents. Although some were labeled with a DOT Class 9 miscellaneous hazard label (Photographs 16-39), the EPA has determined that the DOT Class 9 label is not appropriate to meet the RCRA indication of hazard labeling standard because it does not indicate any specific hazard associated with the waste. The inspection team noted one container that was labeled with a storage accumulation start date of 8/31/2023, which indicates that the container had been in storage for over one year (Photograph 23-25). The inspection team observed one open container that was labeled as Corrosive and Toxic hazardous waste, dated 12/21/2023, and was marked with Excel TSD internal codes 425, 2231-099, and 77922 (Photograph 45-46). Facility personnel closed the open container and began marking each container with an indication of the hazard of its contents, as necessary, during the inspection.

**Pursuant to Permit Condition II.O.3, Land Disposal Restrictions: the storage of hazardous waste restricted from land disposal under Rule 1200-1-11-.10 is prohibited unless the requirements of Rule 1200-1-11-.10(4) are met (however, Rule 1200-1-11-.10(4) was repealed and renumbered 0400-12-01-.10). Pursuant to Tenn. Comp. R. & Regs. 0400-12-01-.10(4)(a)1.(ii)(I)III. [40 C.F.R. § 268.50(a)(2)(i)(C)], each container of hazardous wastes restricted from land disposal must be clearly marked to identify its contents and with an indication of the hazards of the contents.**

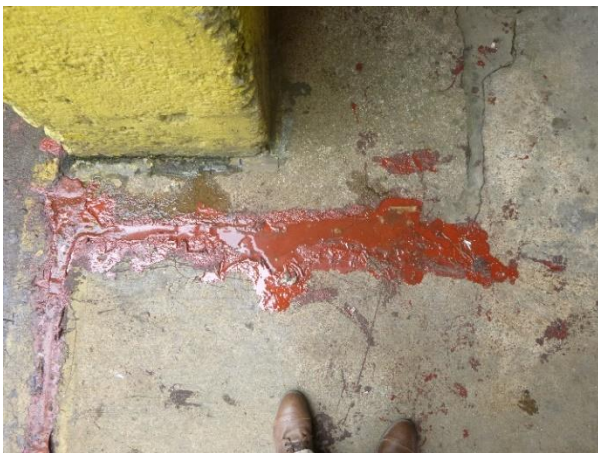
Photograph 55: Permitted Area 4.

The permitted hazardous waste container storage Area 4 consists of a concrete base with curbed sides and a metal roof (Photograph 53-55). The inspection team observed six rows of waste with adequate aisle space. Generally, the inspection team noted all containers (both hazardous and non-hazardous waste) in each row in Area 4. Area 4 is utilized to receive and manage containers of waste pending waste characterization and verification of waste determination and to store containers of liquid hazardous waste and dangerous-when-wet reactive hazardous waste. The inspection team observed cracks and worn coating of the secondary containment in this area. Although the inspection team observed evidence that Excel TSD had conducted repairs on some cracks in the secondary containment system, they did not observe evidence of repairs to the worn coating in this area (Photograph 56).

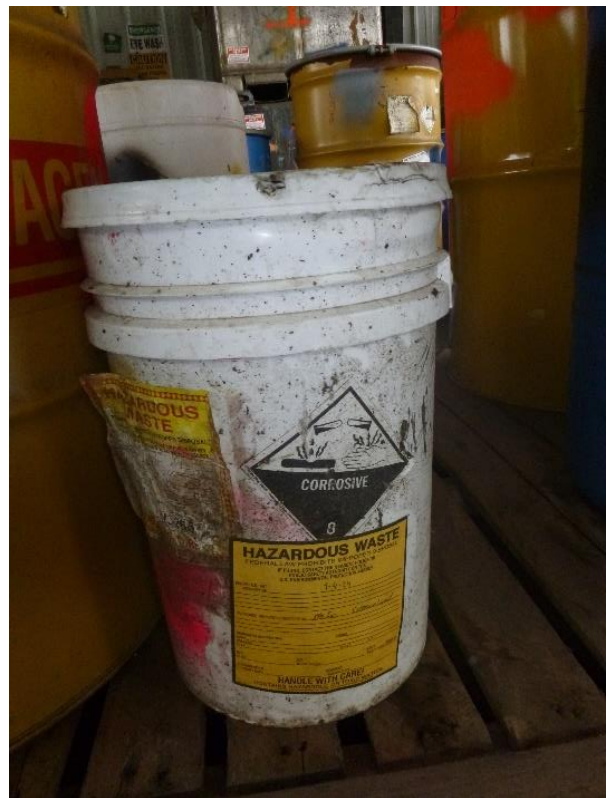
Photograph 62: Container stored over a year  
Area 4.

The inspection team noted 367 containers ranging from 1-gallon to 275-gallon totes in Area 4 on the day of the inspection. The inspection team observed four containers that were labeled with accumulation start dates of greater than one year in storage in Area 4:

**Pursuant to Permit Condition II.O.3, Land Disposal Restrictions: the storage of hazardous waste restricted from land disposal under Rule 1200-1-11-.10 is prohibited unless the requirements of Rule 1200-1-11-.10(4) are met (however, Rule 1200-1-11-.10(4) was repealed and renumbered 0400-12-01-.10). Pursuant to Tenn. Comp. R. & Regs. 0400-12-01-.10(4)(a)3. [40 C.F.R. § 268.50(c)], an owner/operator of a treatment, storage or disposal facility may**

store hazardous wastes restricted from land disposal beyond one year if they prove that such storage was solely for the purpose of accumulation of such quantities of hazardous waste as are necessary to facilitate proper recovery, treatment, or disposal.

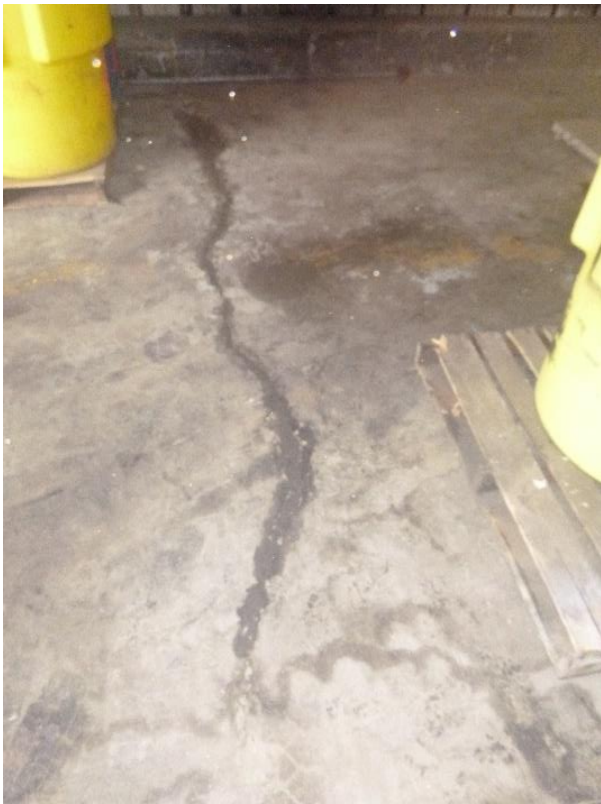
Photograph 112: Permitted Area 5.

The permitted hazardous waste container storage Area 5 (Building A) consists of a concrete base with curbed sides and a metal building (Photographs 107-126). The inspection team observed cracks and worn coating of the secondary containment in this area; some repairs had been conducted but the worn coating had not been addressed by the repairs (Photographs 112-117). The inspection team noted that the floor sumps covered with metal grates were full of debris. Facility representatives stated that waste is removed from the sumps twice a month. This is an area of concern. The inspection team inspected 121 containers in Area 5. The inspection team noted twelve containers that were not marked with an indication of the hazards of their contents (Photograph 118-121). The inspection team noted at least four open boxes of laboratory samples on a table in Area 5 that were not labeled with accumulation start dates and were not at the point of generation (Photograph 122). The inspection team noted that the aisle space between Rows 1 and 2 and between Rows 2 and 3 appeared too narrow to pass easily (Photographs 123-126). The inspection team measured the spaces between these two rows at their narrowest and recorded the distances to be 29.4 inches and 27.5 inches (less than 2.5 feet).

**Pursuant to Permit Condition III.F.2(a), Containment, Detection, and Management of Leaks or Spills: a containment system shall be designed, operated, and maintained as follows: (a) a base shall underlie the containers which is free of cracks or gaps and is sufficiently impervious to contain leaks, spills, and accumulated precipitation until the collected material is detected and removed.**
