## Clean Water Act Section 404: Site Visit/Case Development

| Site Name | Turkey Creek Sand and Gravel | | | | |

Turkey Creek Sand and Gravel  
Photographic Log  
Fayette County, Alabama  
November 1, 2023

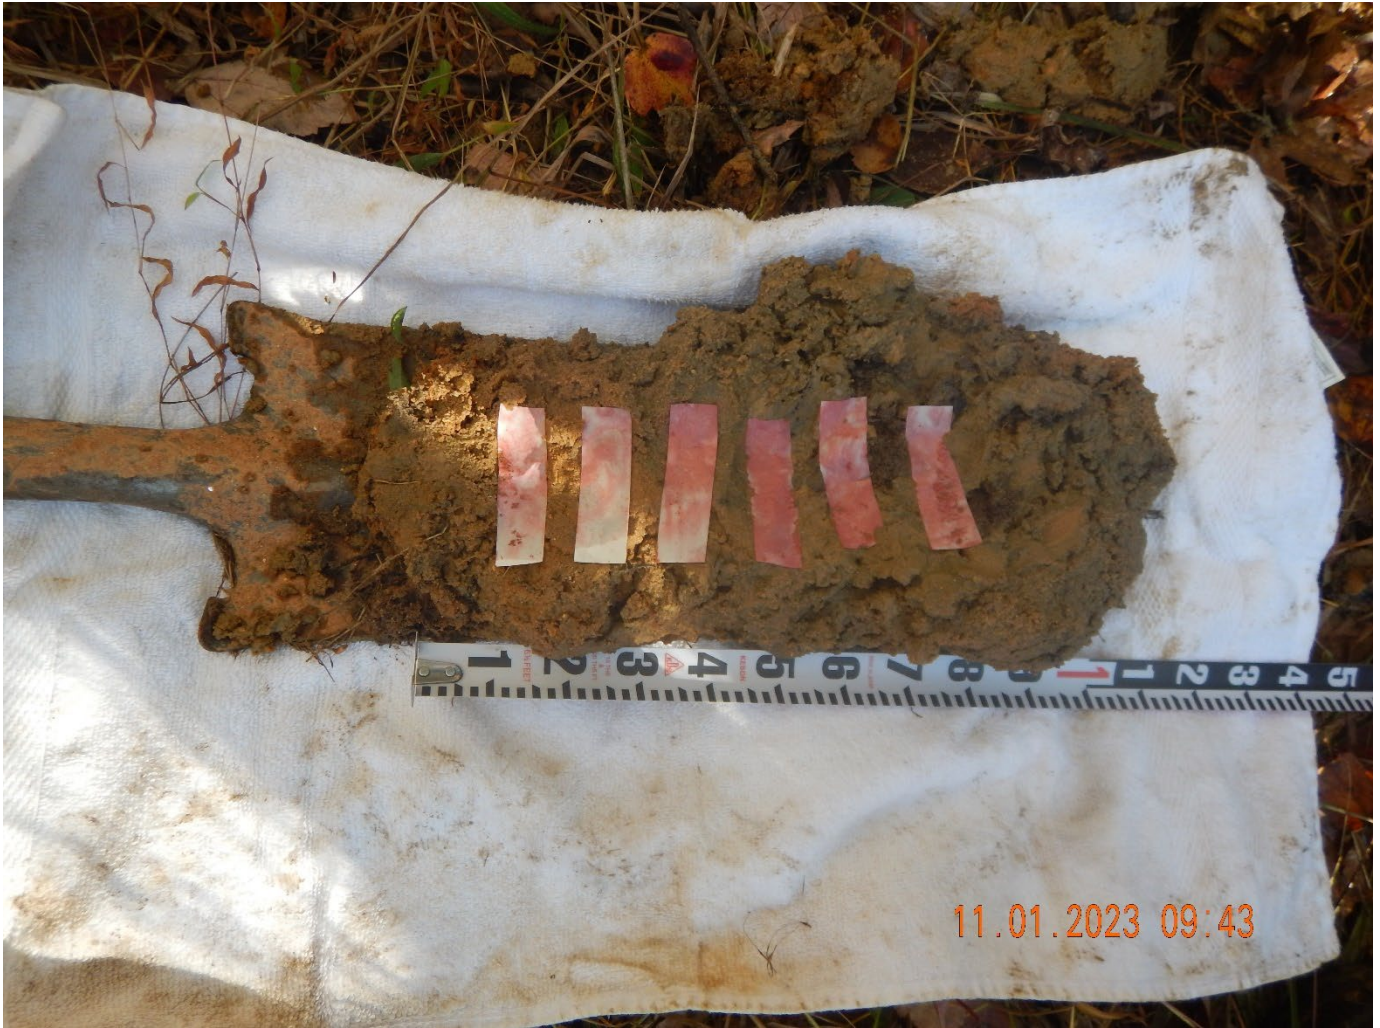
# PHOTO 1

| Description | Soil profile at Data Point A1. |

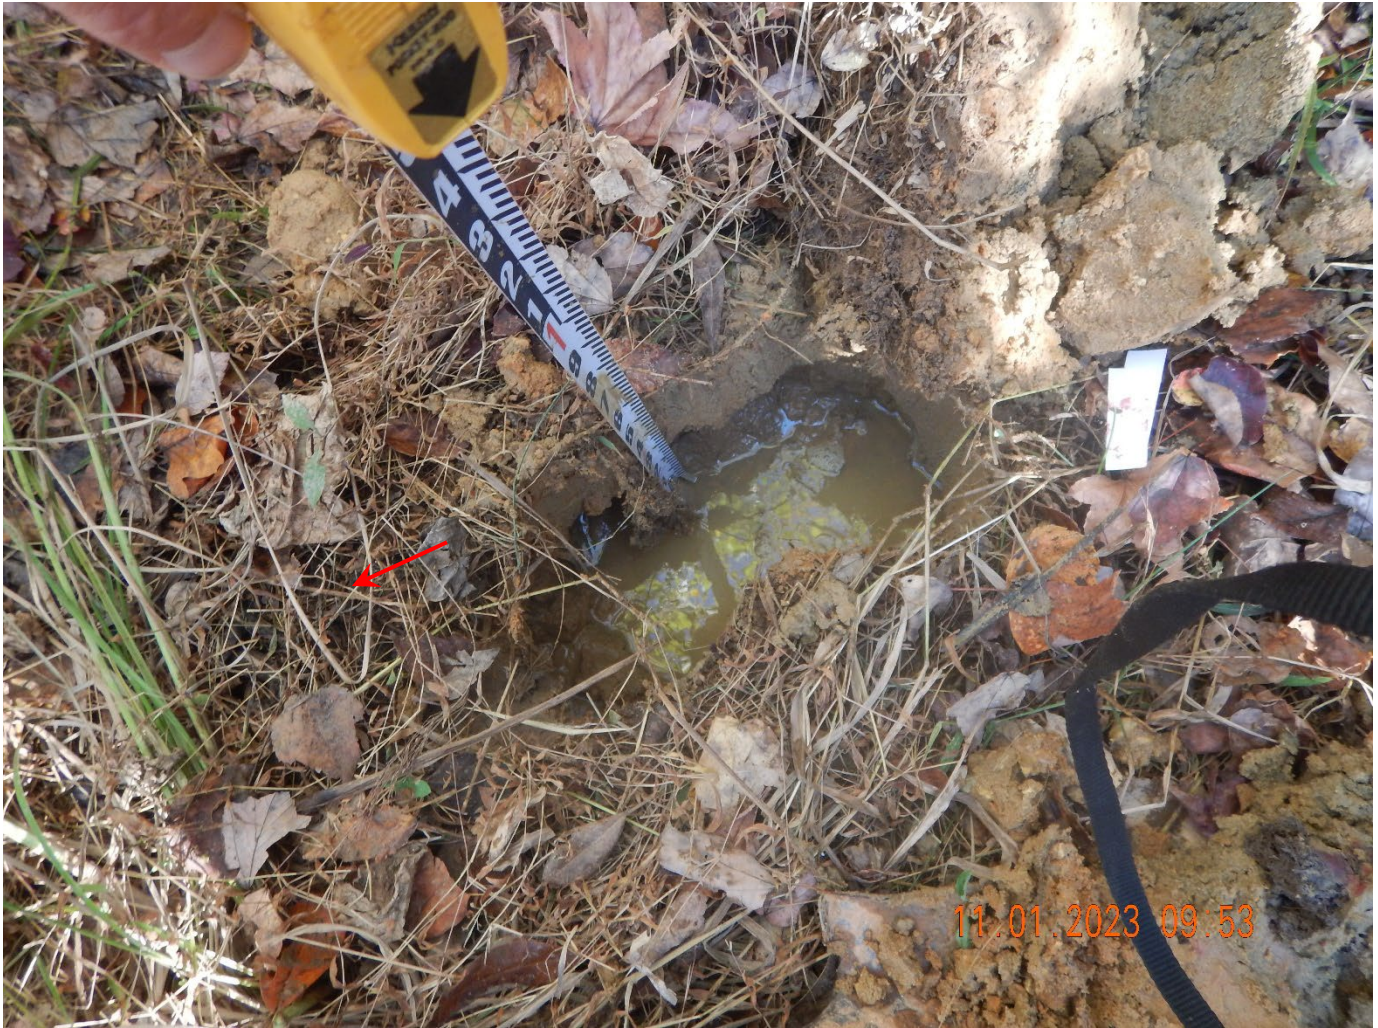
# PHOTO 2

| Description | Soil pit at Data Point A1, water 6 inches from soil surface and saturation to the soil surface. |

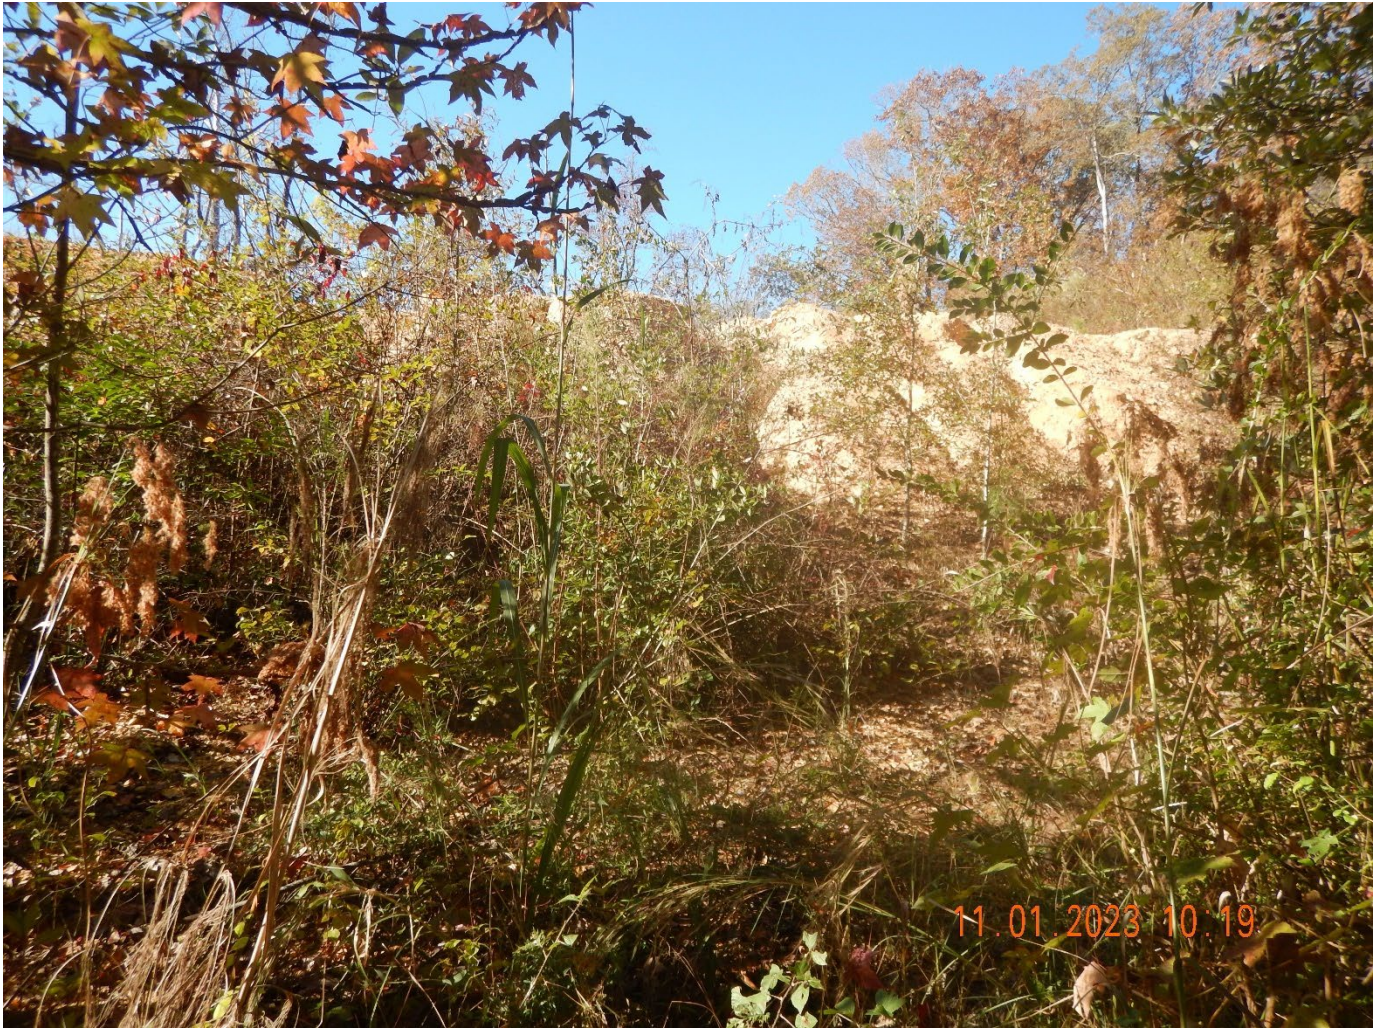
PHOTO 3

| Description | Striking west over Data Point A1. |

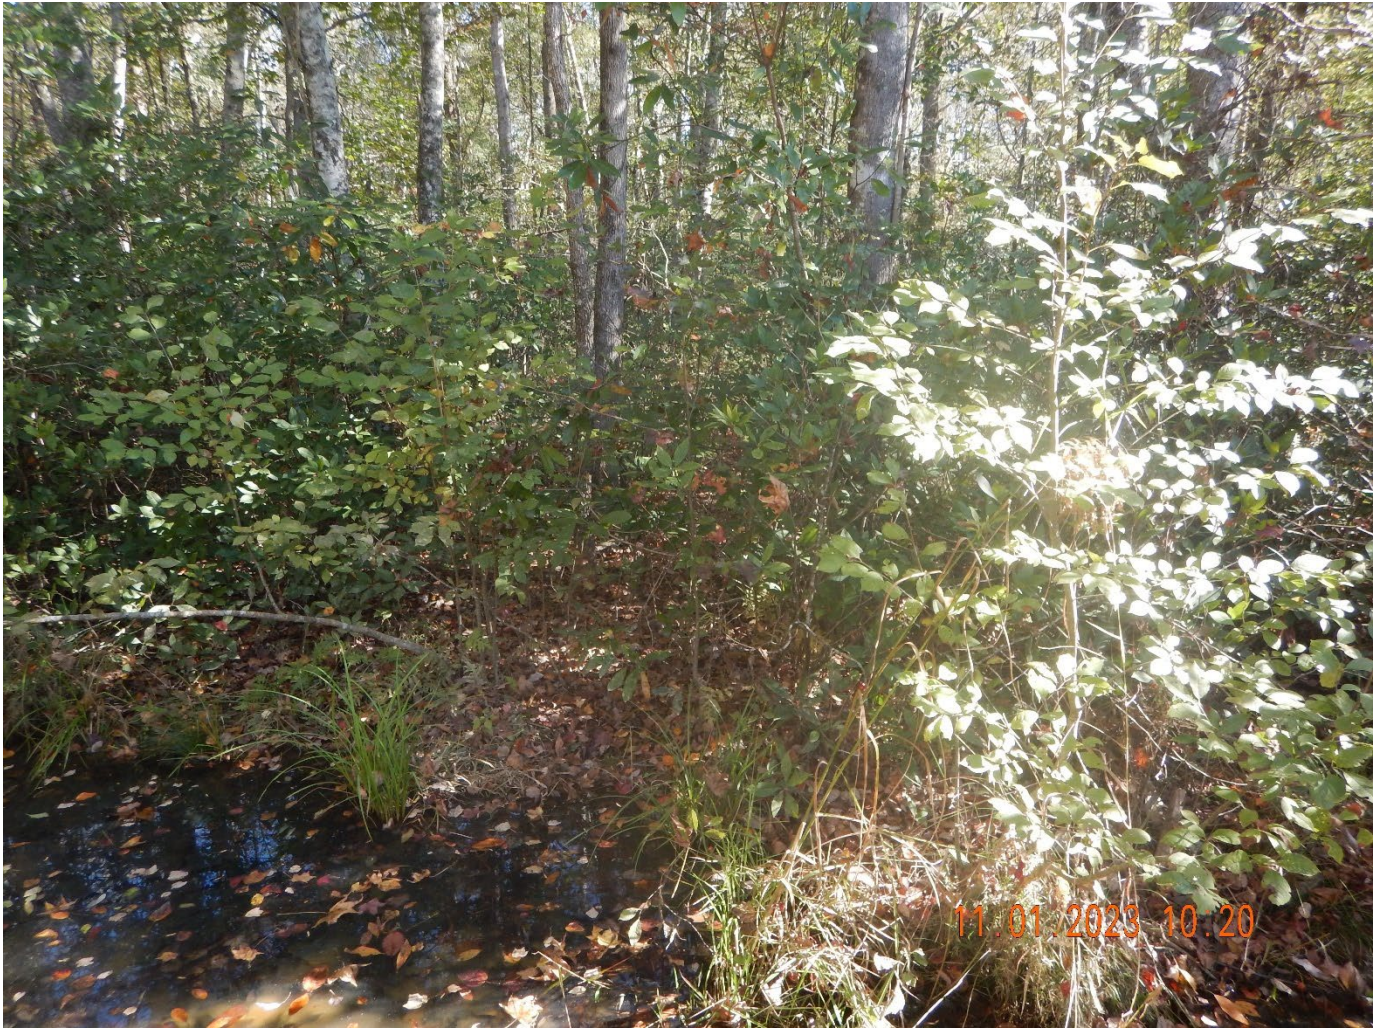
PHOTO 4

| Description | Striking east over data point A1. |

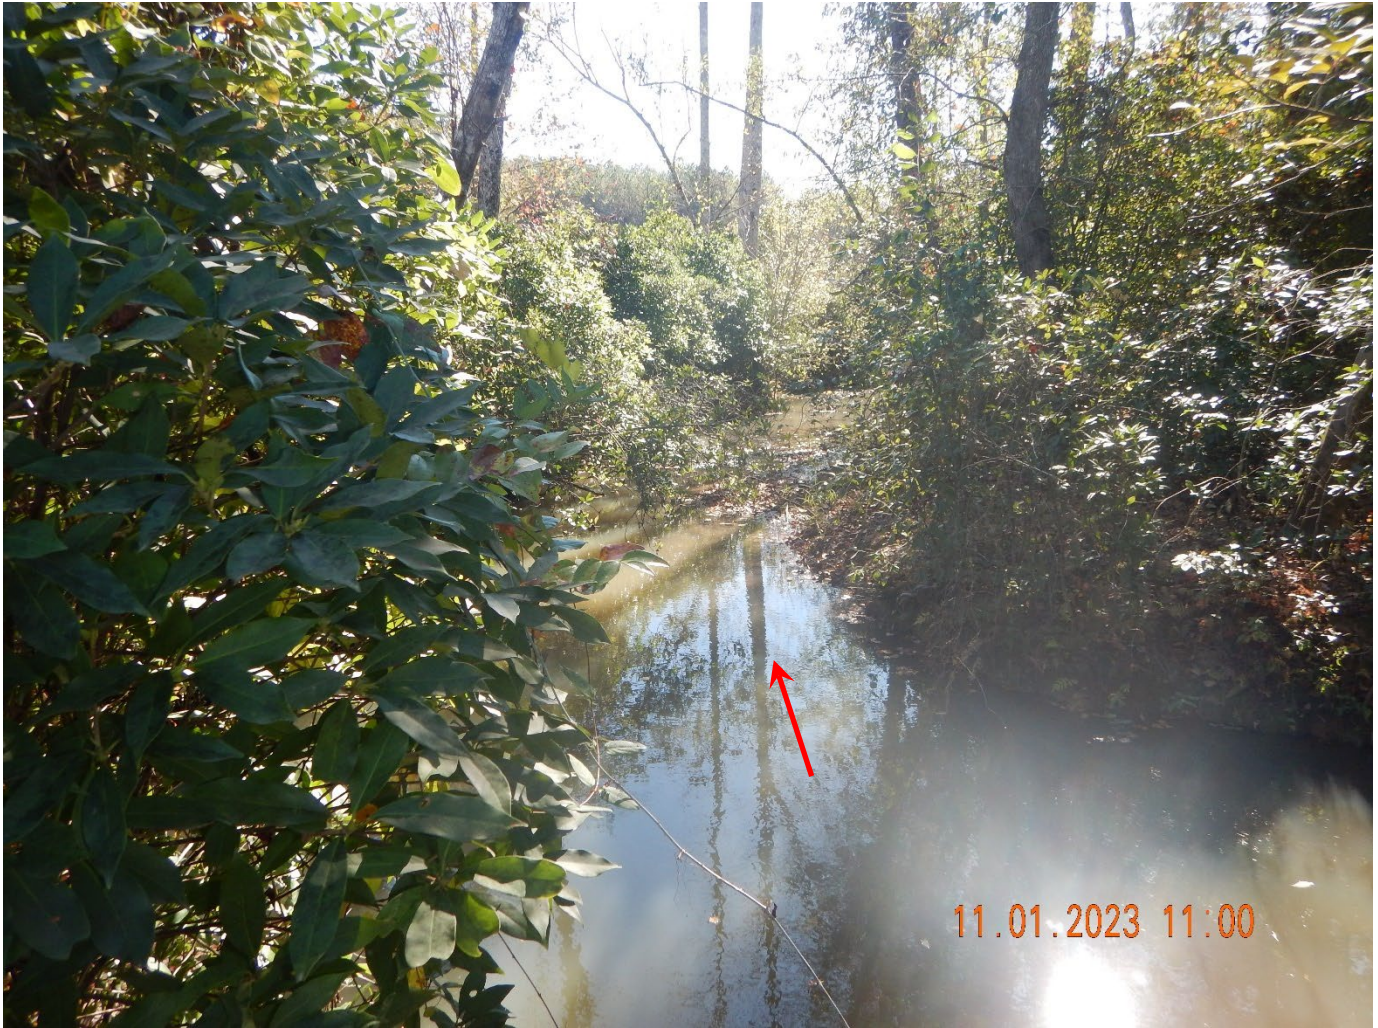
# PHOTO 5

| Description | Striking downstream of Turkey Creek, just upstream of the UT's confluence with Turkey Creek. Site conditions did not allow access to the confluence. Red arrow indicates direction of flow. |

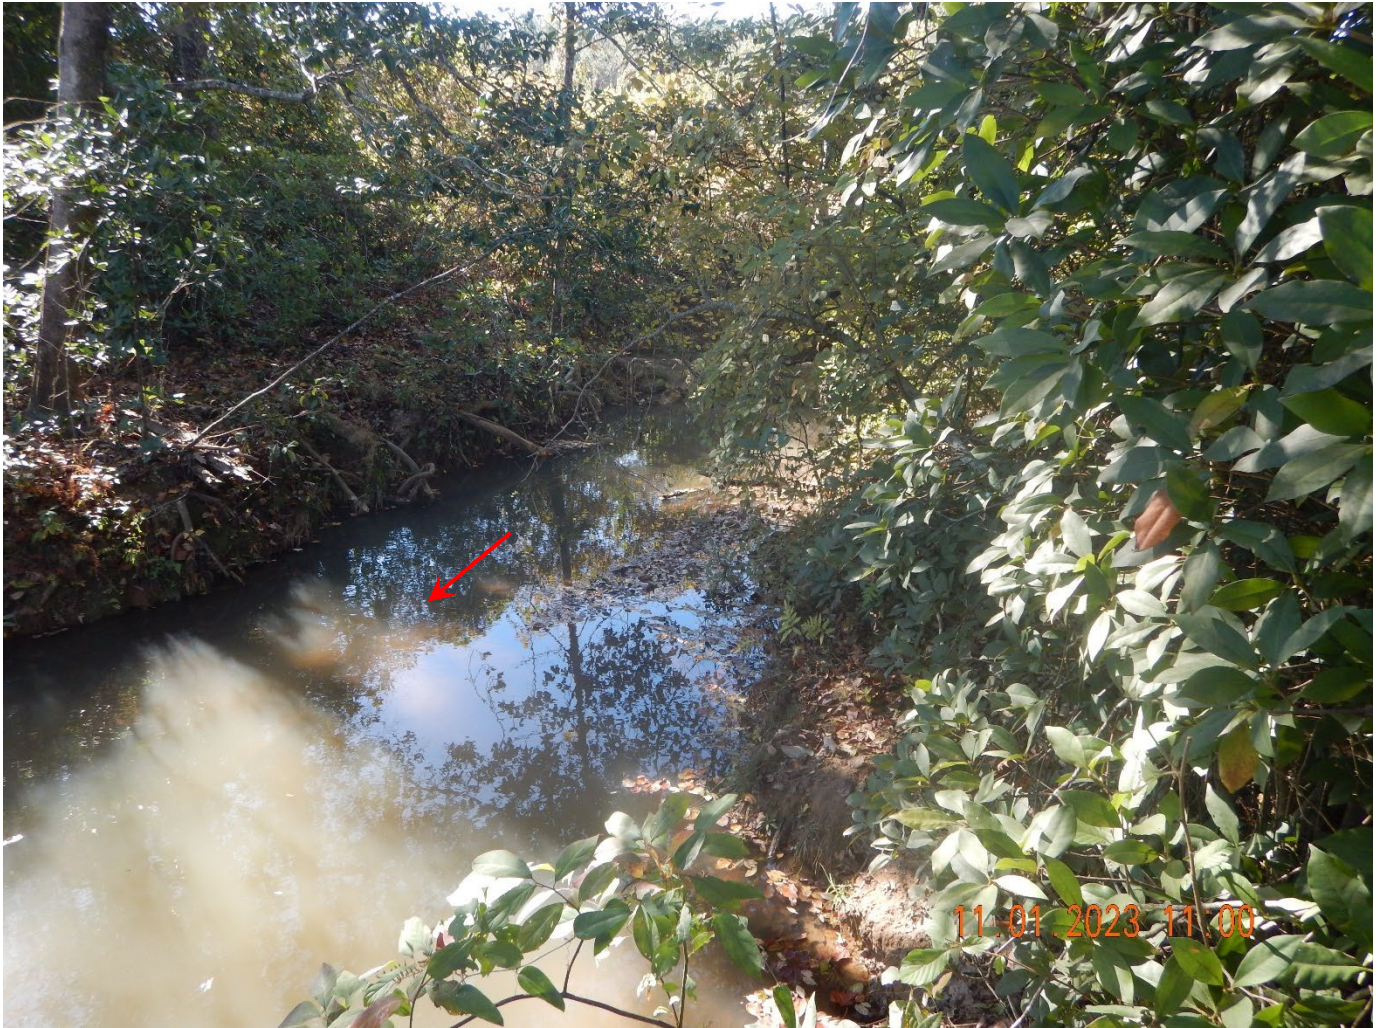
# PHOTO 6

| Description | Striking upstream of Turkey Creek, just upstream of the unnamed tributary's (UT) confluence with Turkey Creek. Site conditions did not allow access to the confluence. Red arrow indicates direction of flow. |

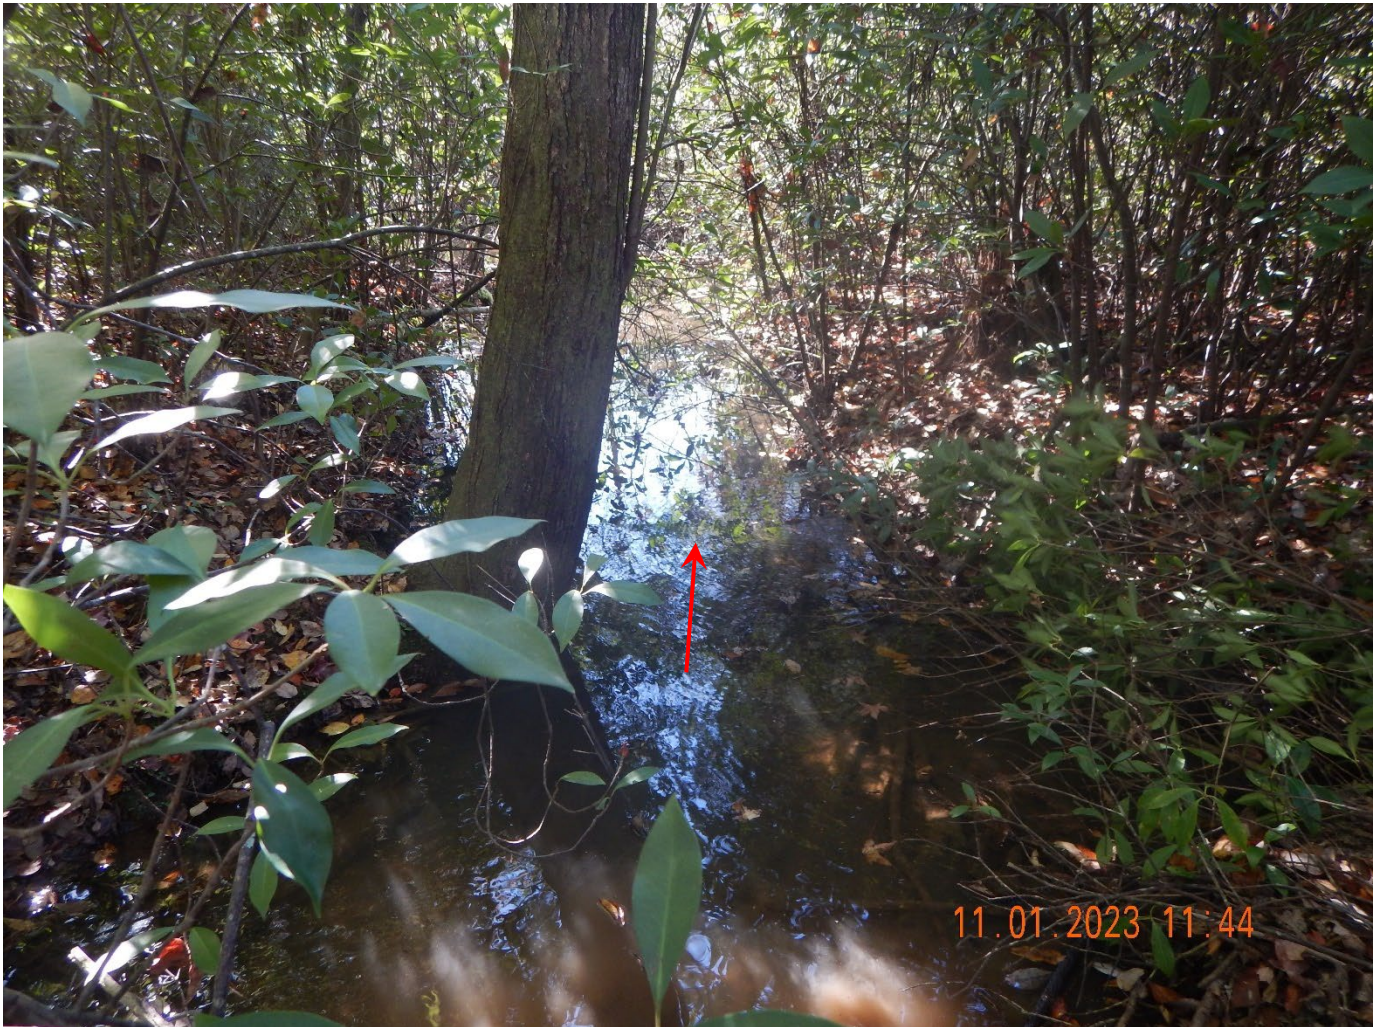
PHOTO 7

| Description | Striking downstream of UT to Turkey Creek. Red arrow indicates direction of flow. |

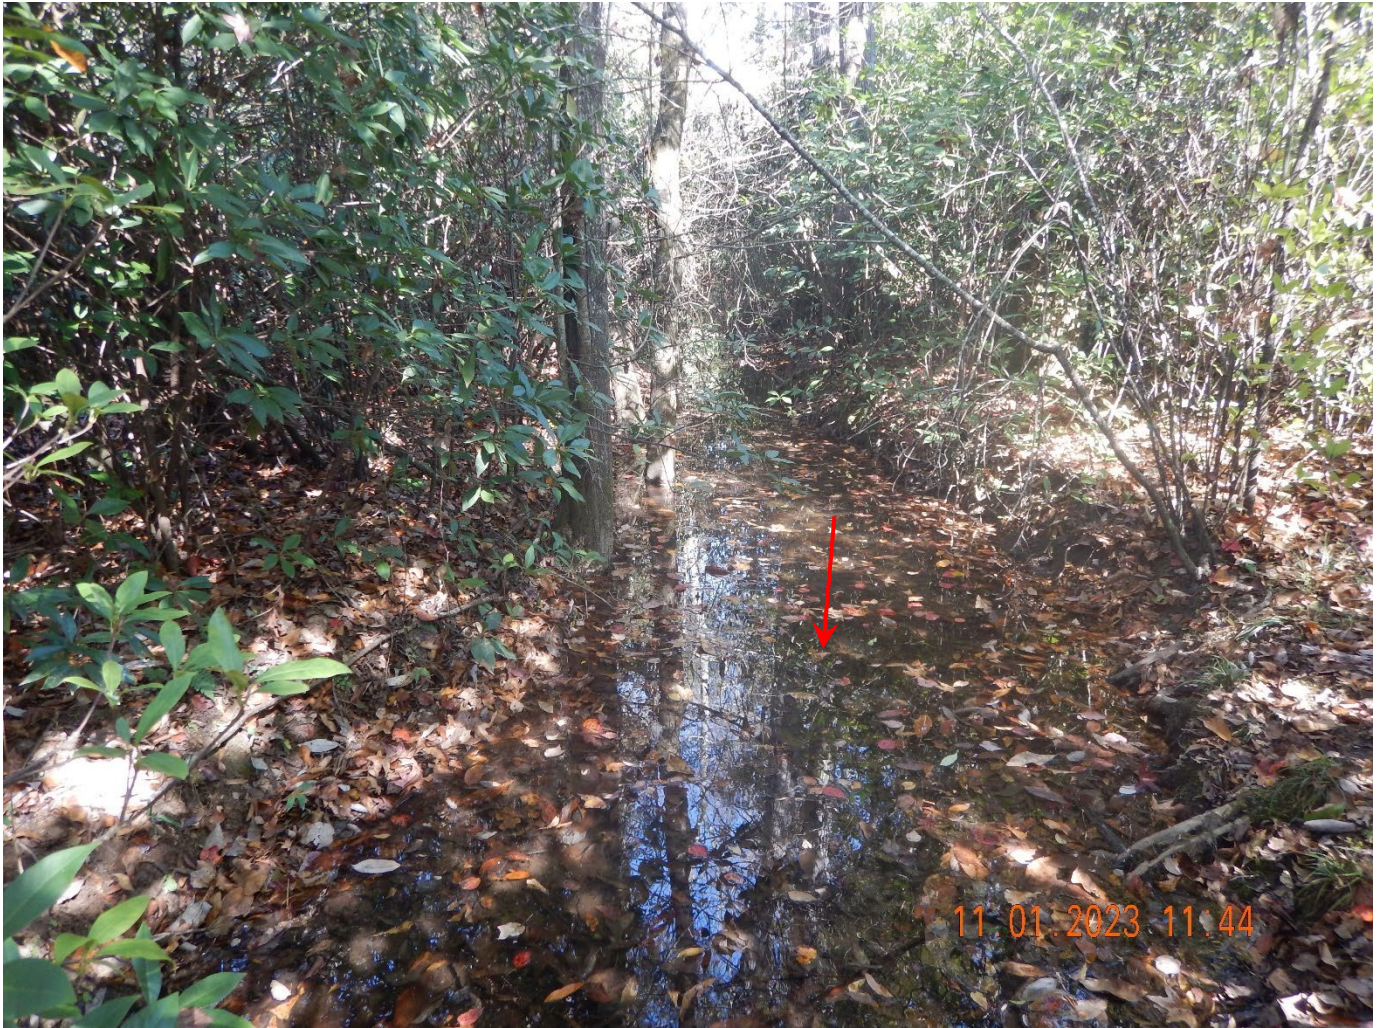
# PHOTO 8

| Description | Striking upstream of UT to Turkey Creek. Red arrow indicates direction of flow. |

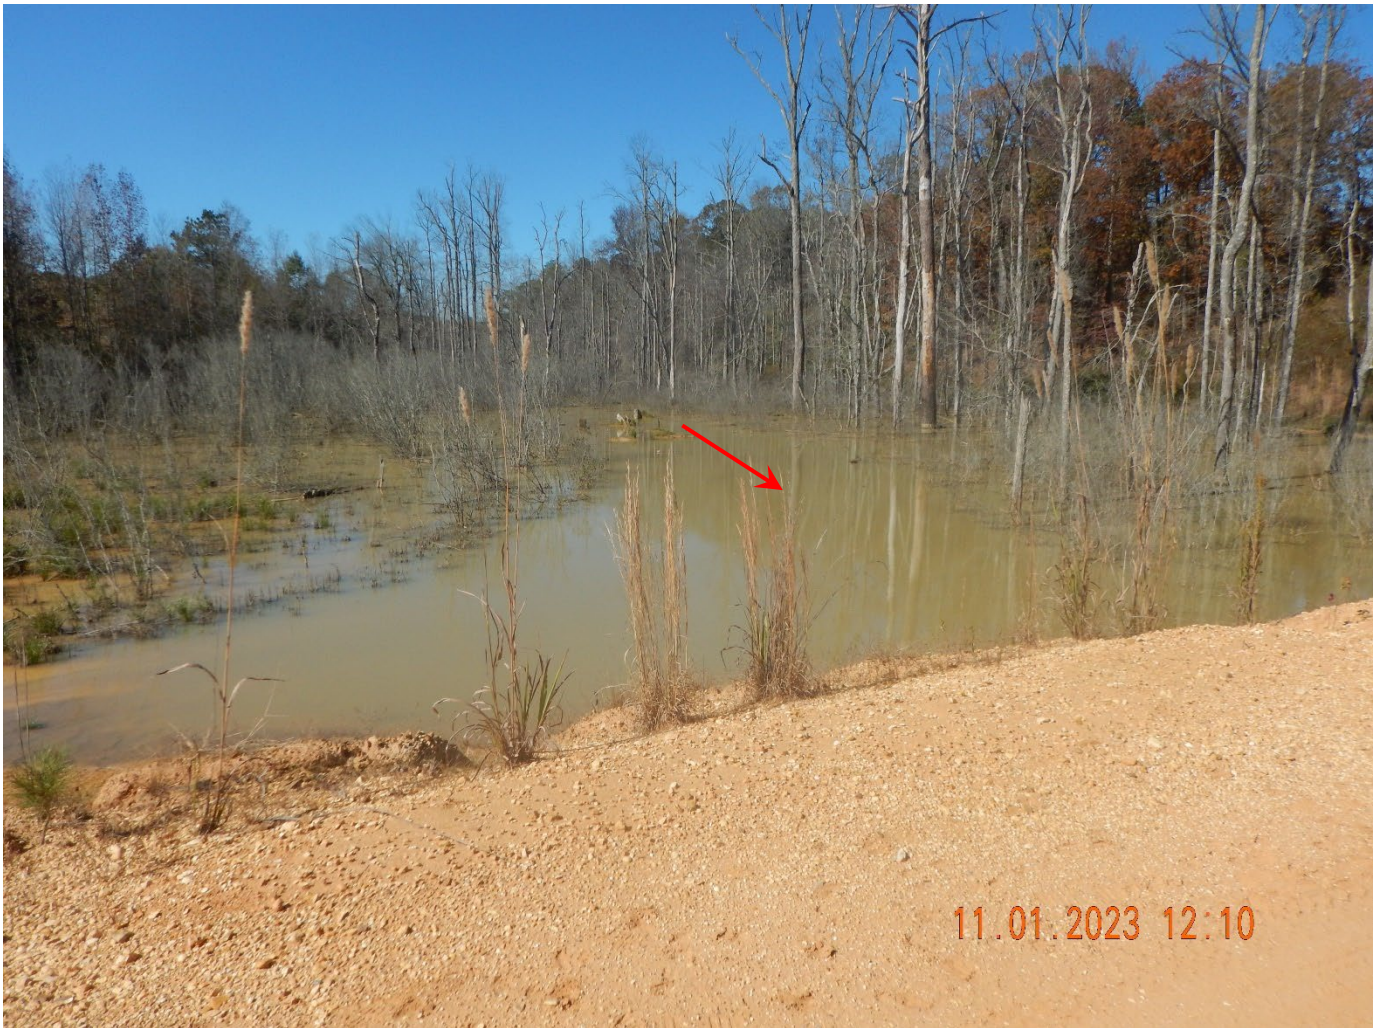
PHOTO 9

| Description | Striking upstream of UT to Turkey Creek from earthen fill material. Red arrow indicates direction of flow. |

| Unauthorized discharges of dredged and/or fill material into wetlands (Sections 301 and 404 of the CWA, 33 U.S.C. §§ 1311 and 1344). | | | |

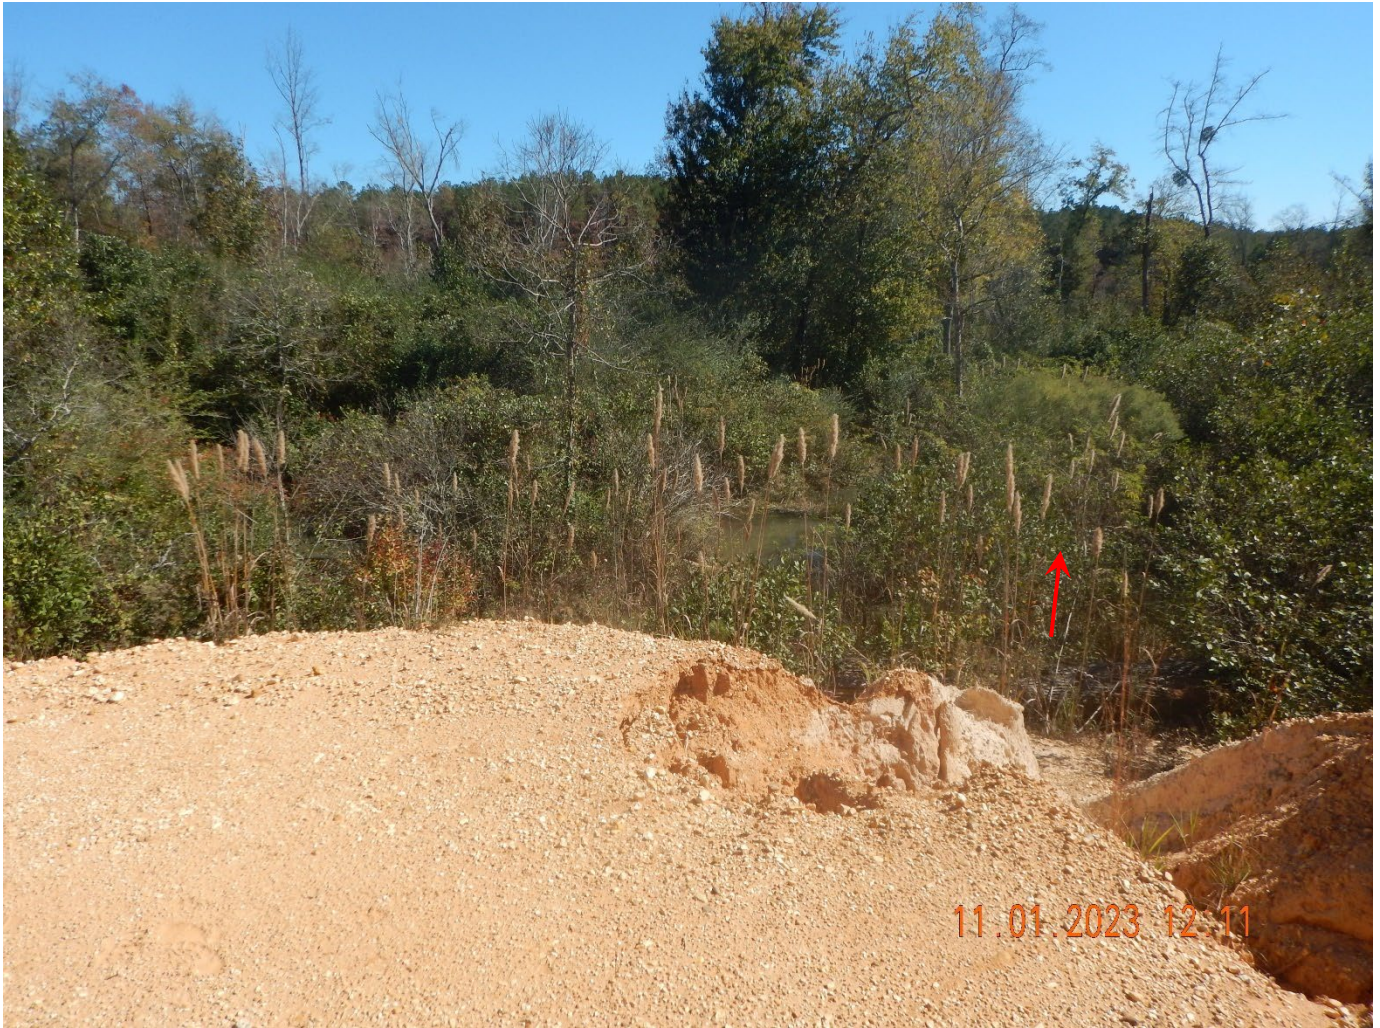
PHOTO 10

| Description | Striking downstream of UT to Turkey Creek from earthen fill material. Red arrow indicates direction of flow. |

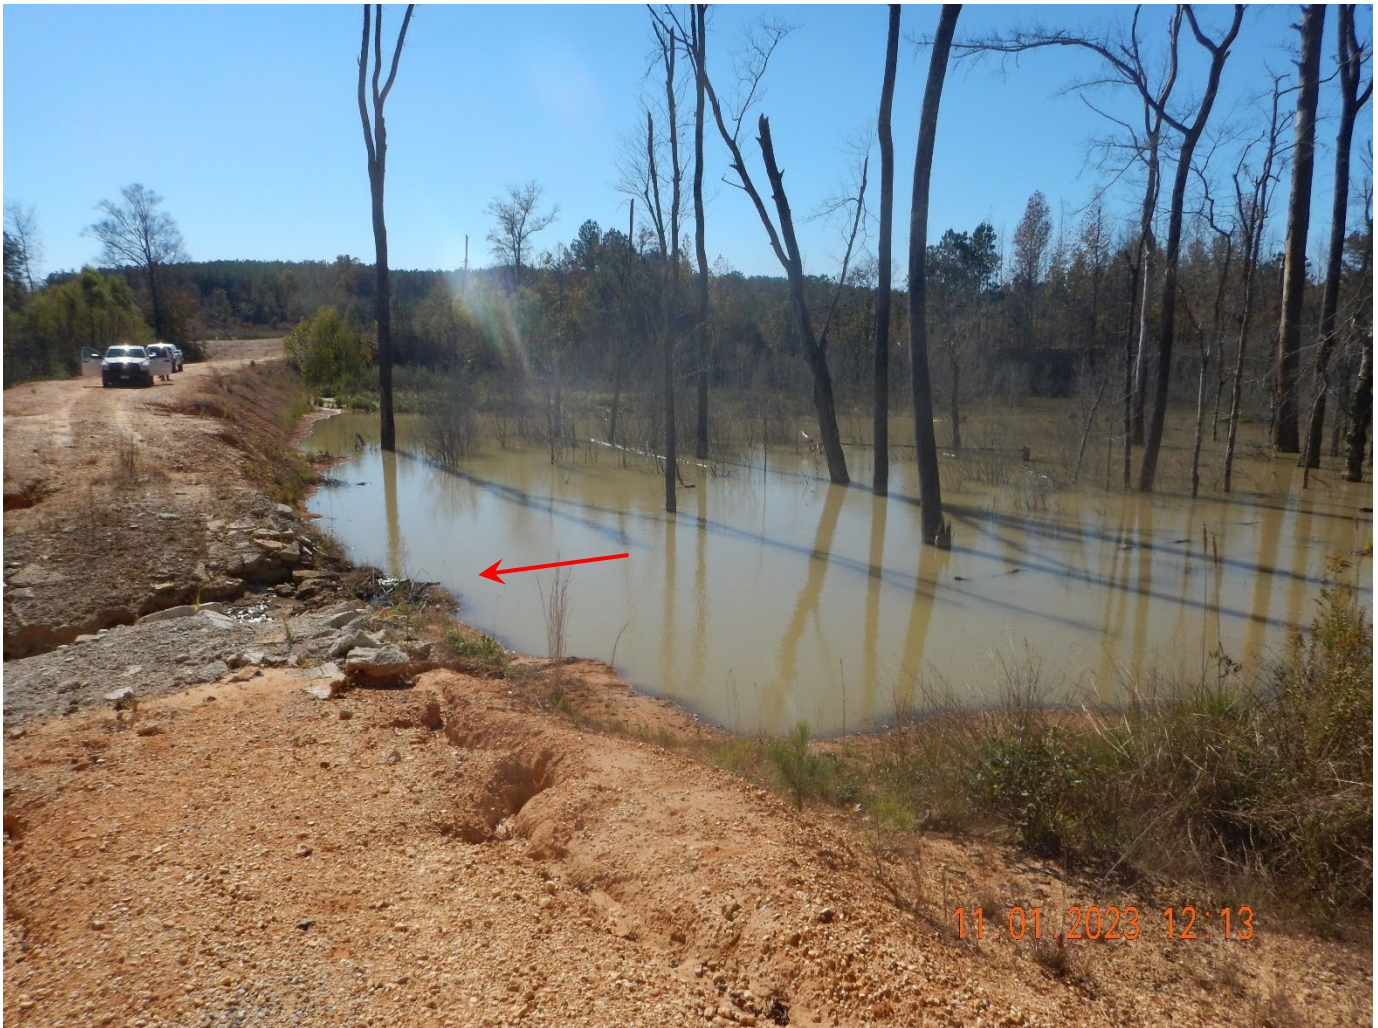
PHOTO 11

| Description | Striking over earthen fill material at UT. Red arrow indicates direction of flow. |

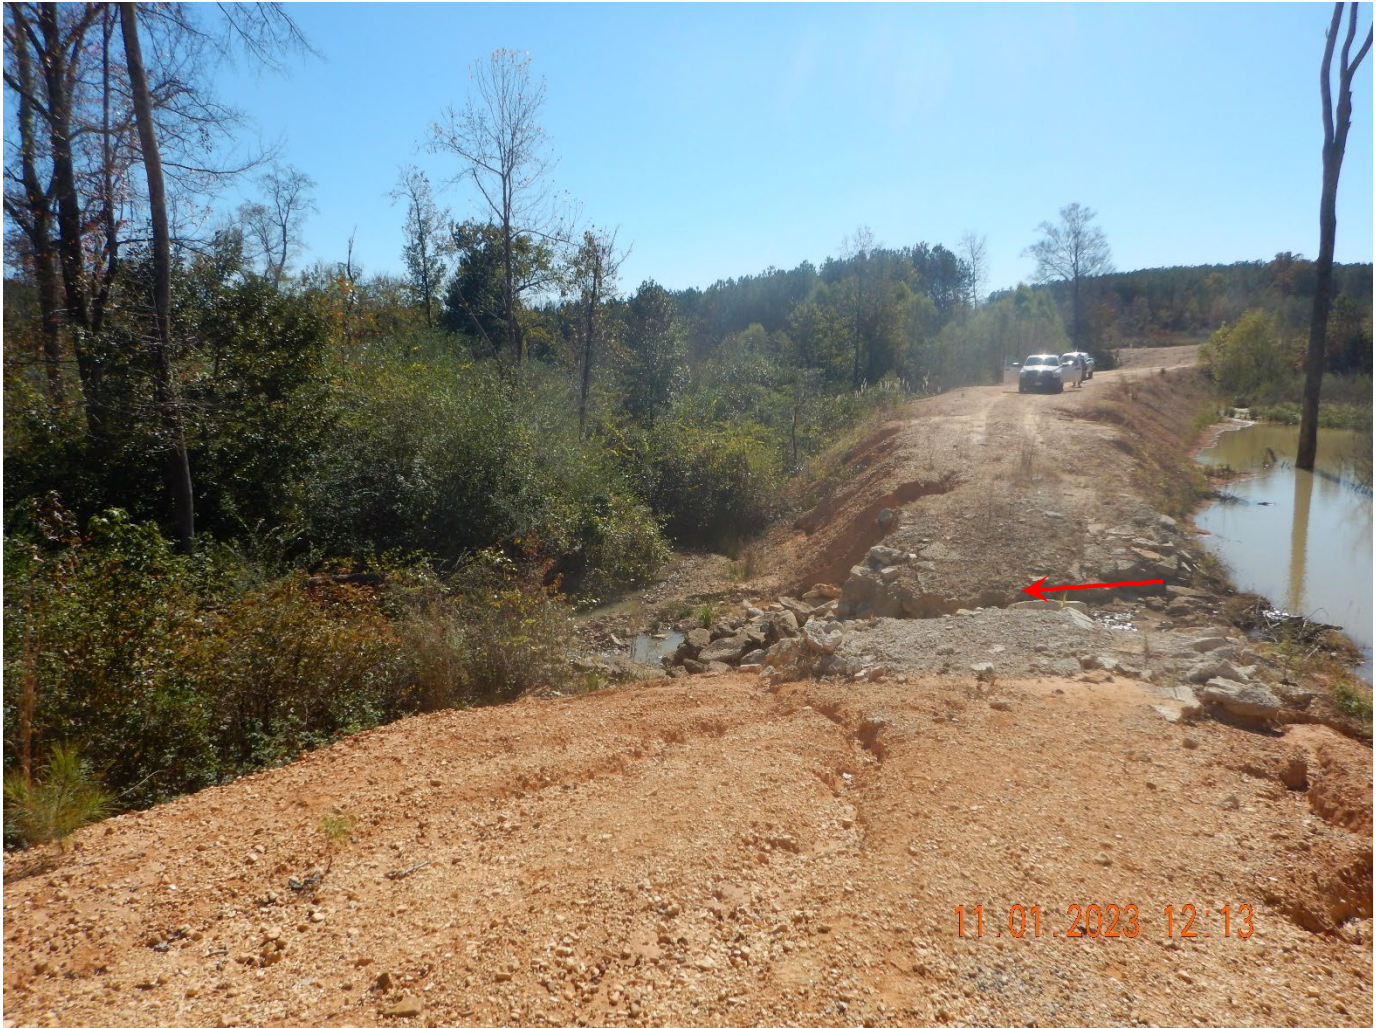
PHOTO 12

| Description | Striking over earthen fill material at UT. Red arrow indicates direction of flow. |

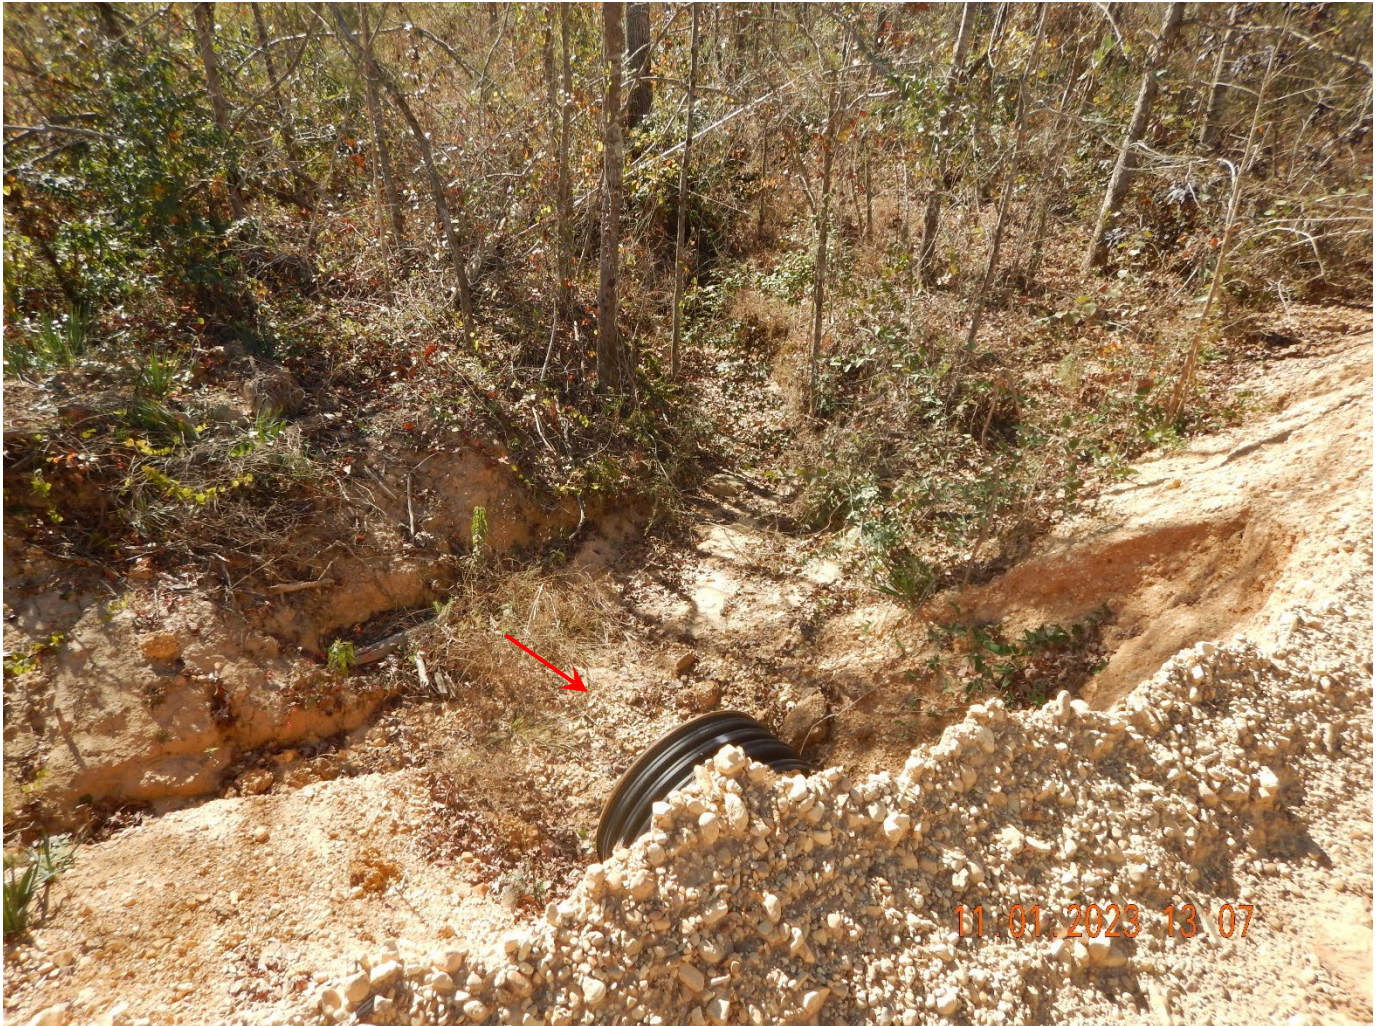
PHOTO 13

| Description | Striking upstream of UT2. Red arrow indicates direction of flow. |

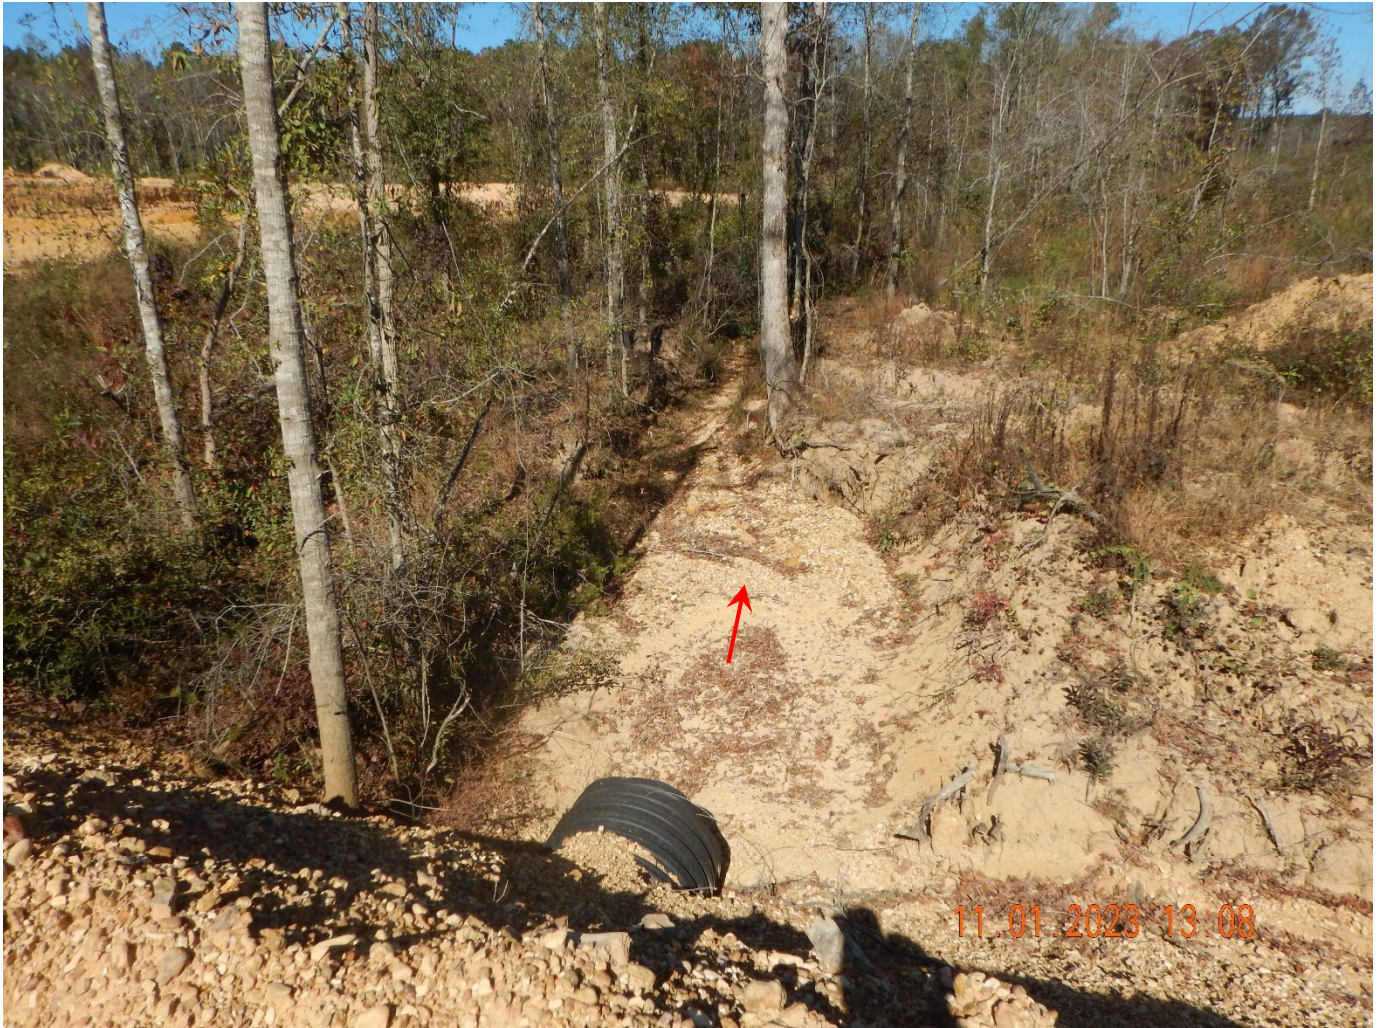
PHOTO 14

| Description | Striking downstream of UT2. Red arrow indicates direction of flow. |

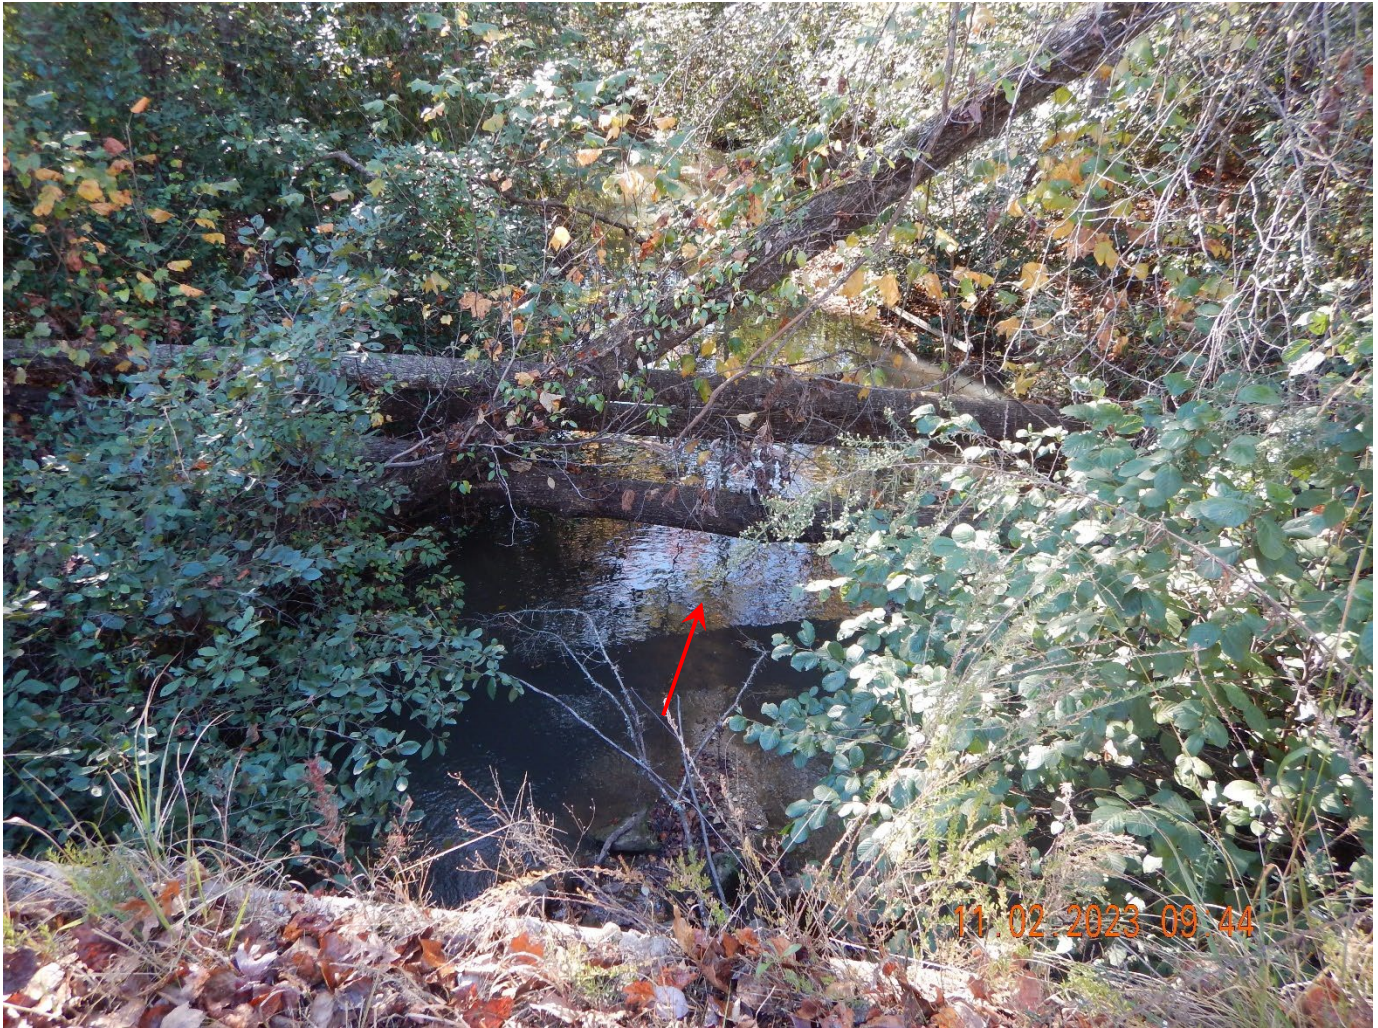
PHOTO 15

| Description | Striking downstream of Turkey Creek at County Road 24 crossing. Red arrow indicates direction of flow. |

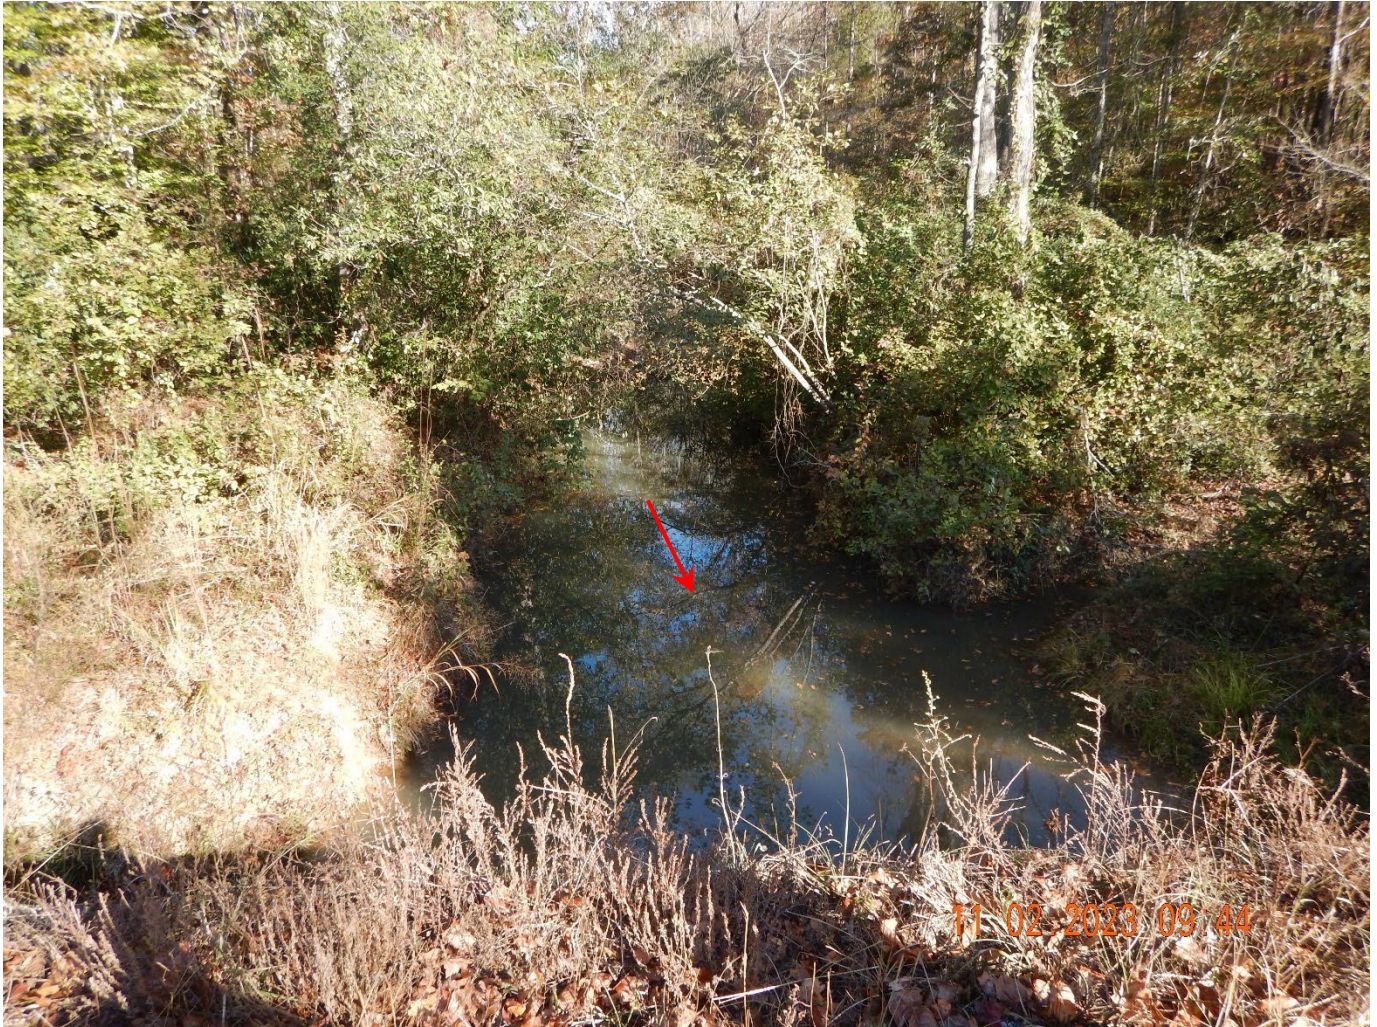
PHOTO 16

| Description | Striking upstream of Turkey Creek at County Road 24 crossing. Red arrow indicates direction of flow. |
