## Clean Water Act Section 404: Site Visit/Case Development

| Site Name | Turkey Creek Sand and Gravel | | | | |

Turkey Creek Sand and Gravel  
Photographic Log  
Fayette County, Alabama  
November 1, 2023

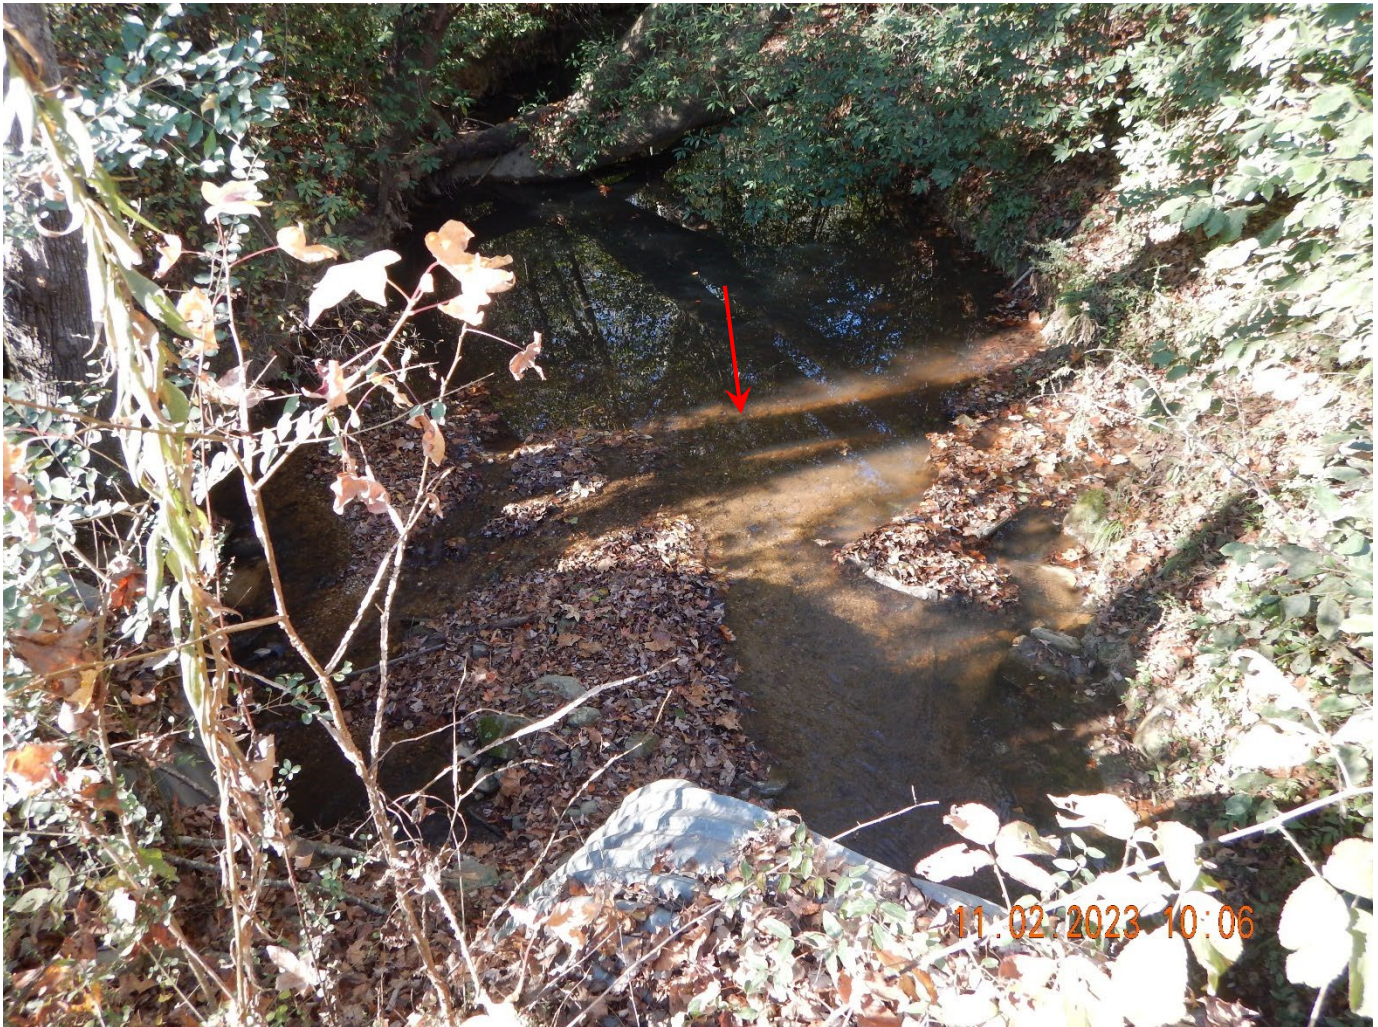
PHOTO 17

| Description | Striking upstream of Turkey Creek at Sand Springs Road crossing. Red arrow indicates direction of flow. |

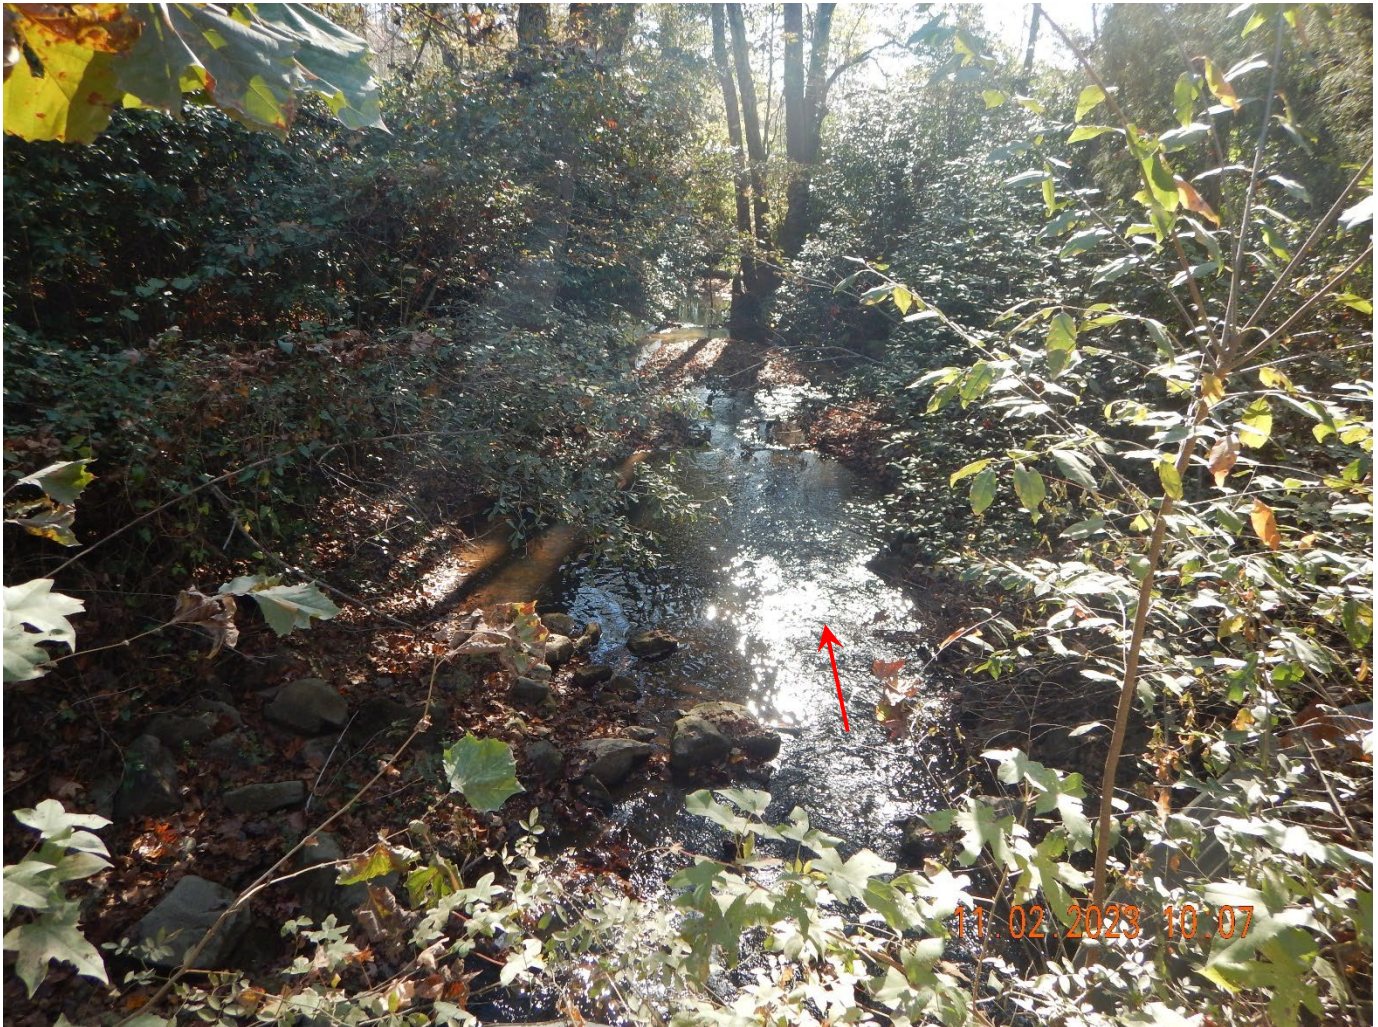
PHOTO 18

| Description | Striking downstream of Turkey Creek at Sand Springs Road crossing. Red arrow indicates direction of flow. |

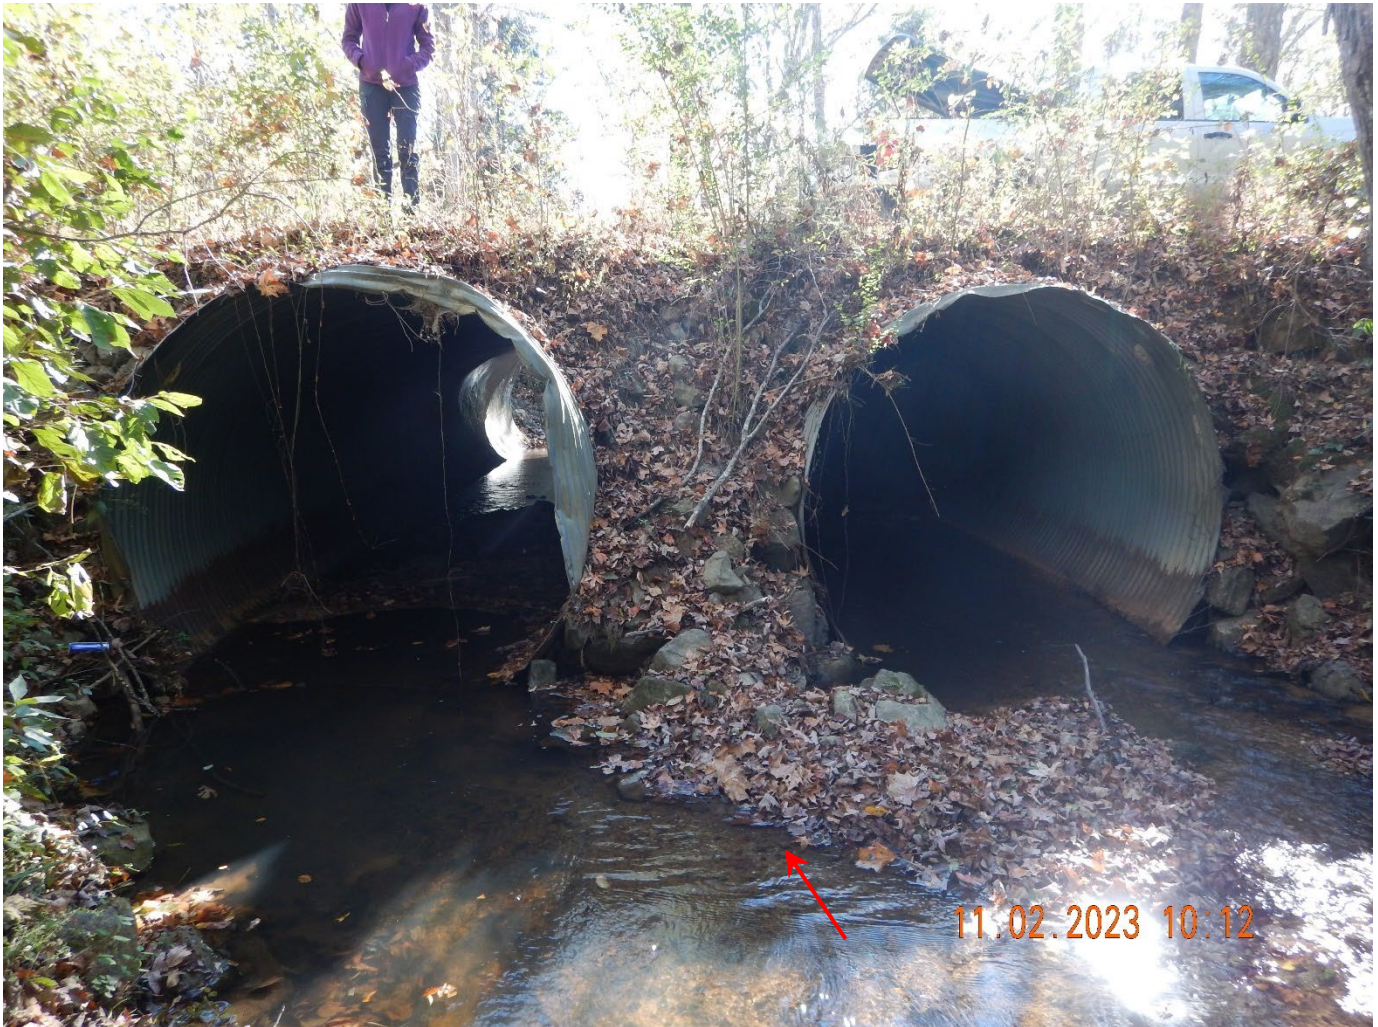
PHOTO 19

| Description | Striking downstream of Turkey Creek at Sand Springs Road crossing. Red arrow indicates direction of flow. |

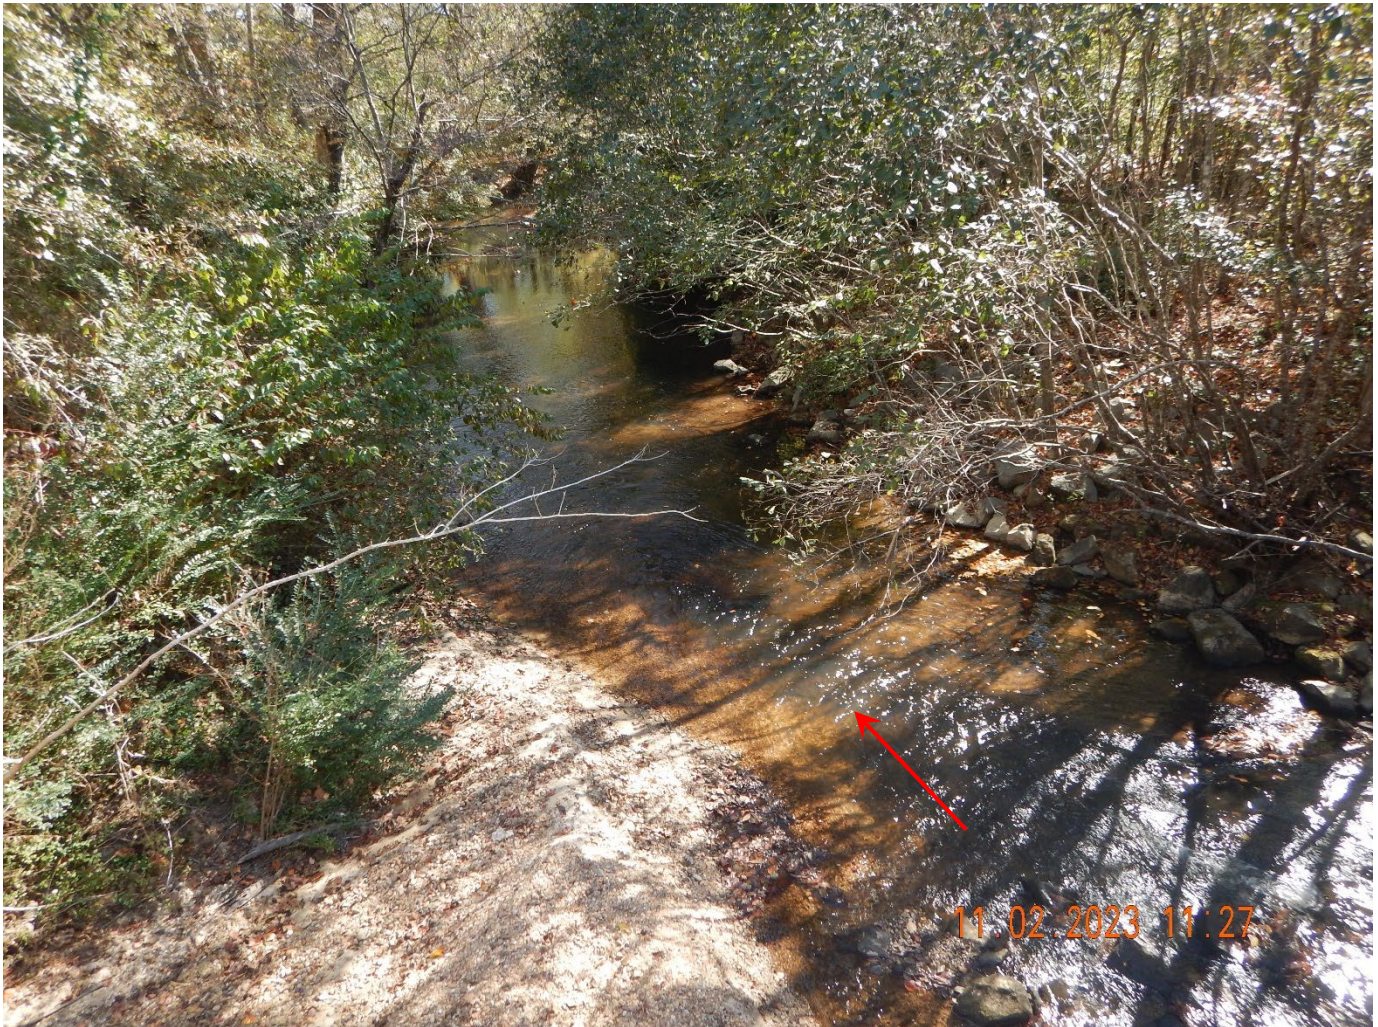
PHOTO 20

| Description | Striking downstream of Turkey Creek at County Road 115 crossing. Red arrow indicates direction of flow. |

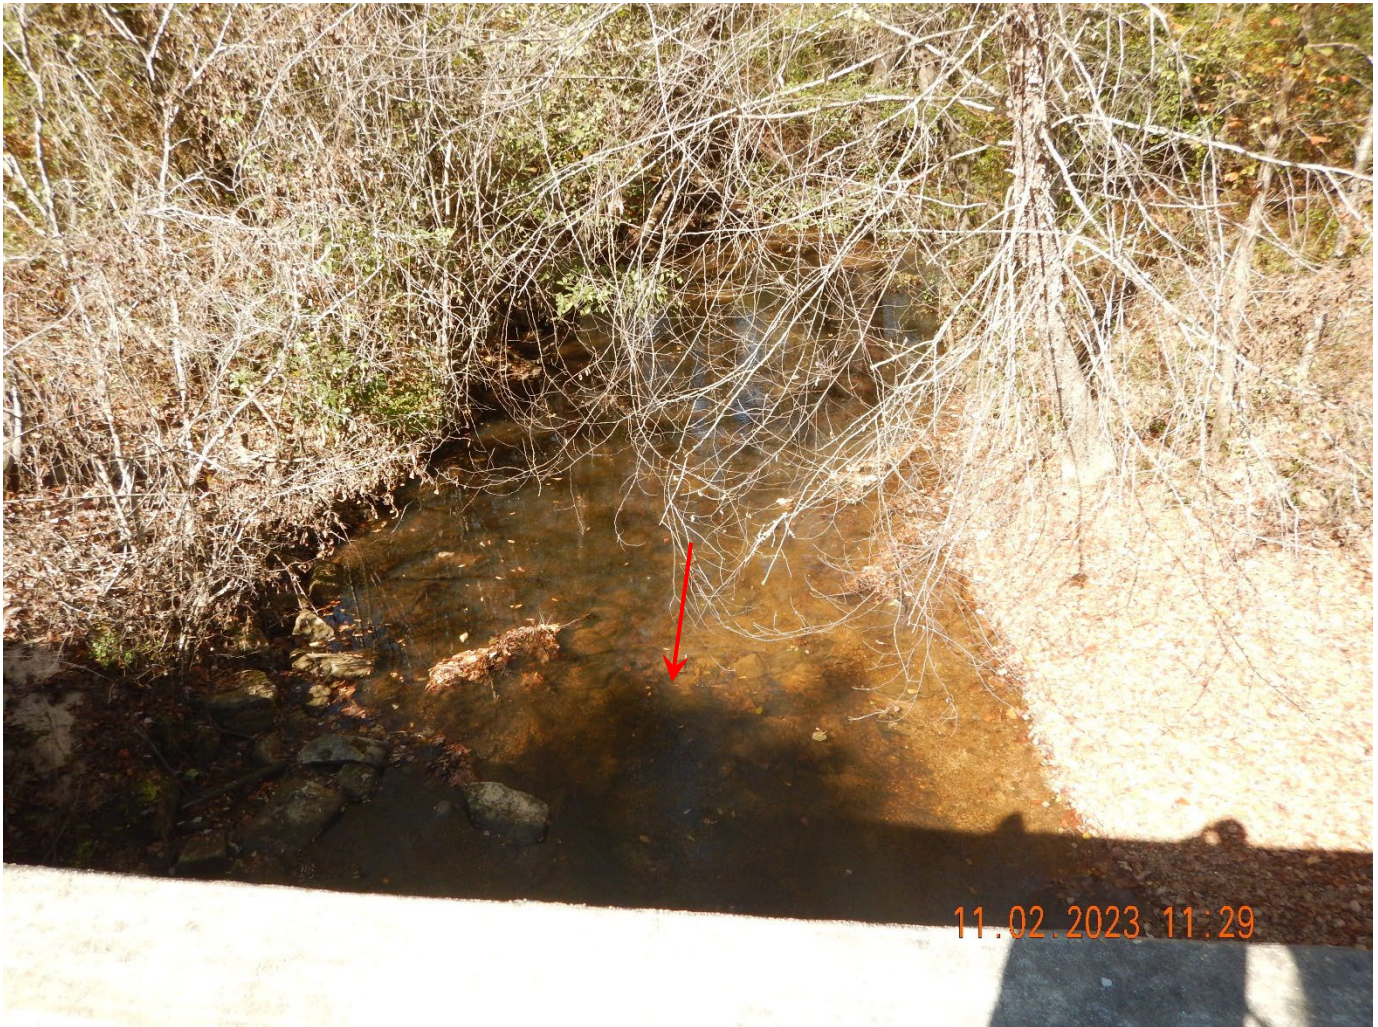
PHOTO 21

| Description | Striking upstream of Turkey Creek at County Road 115 crossing. Red arrow indicates direction of flow. |

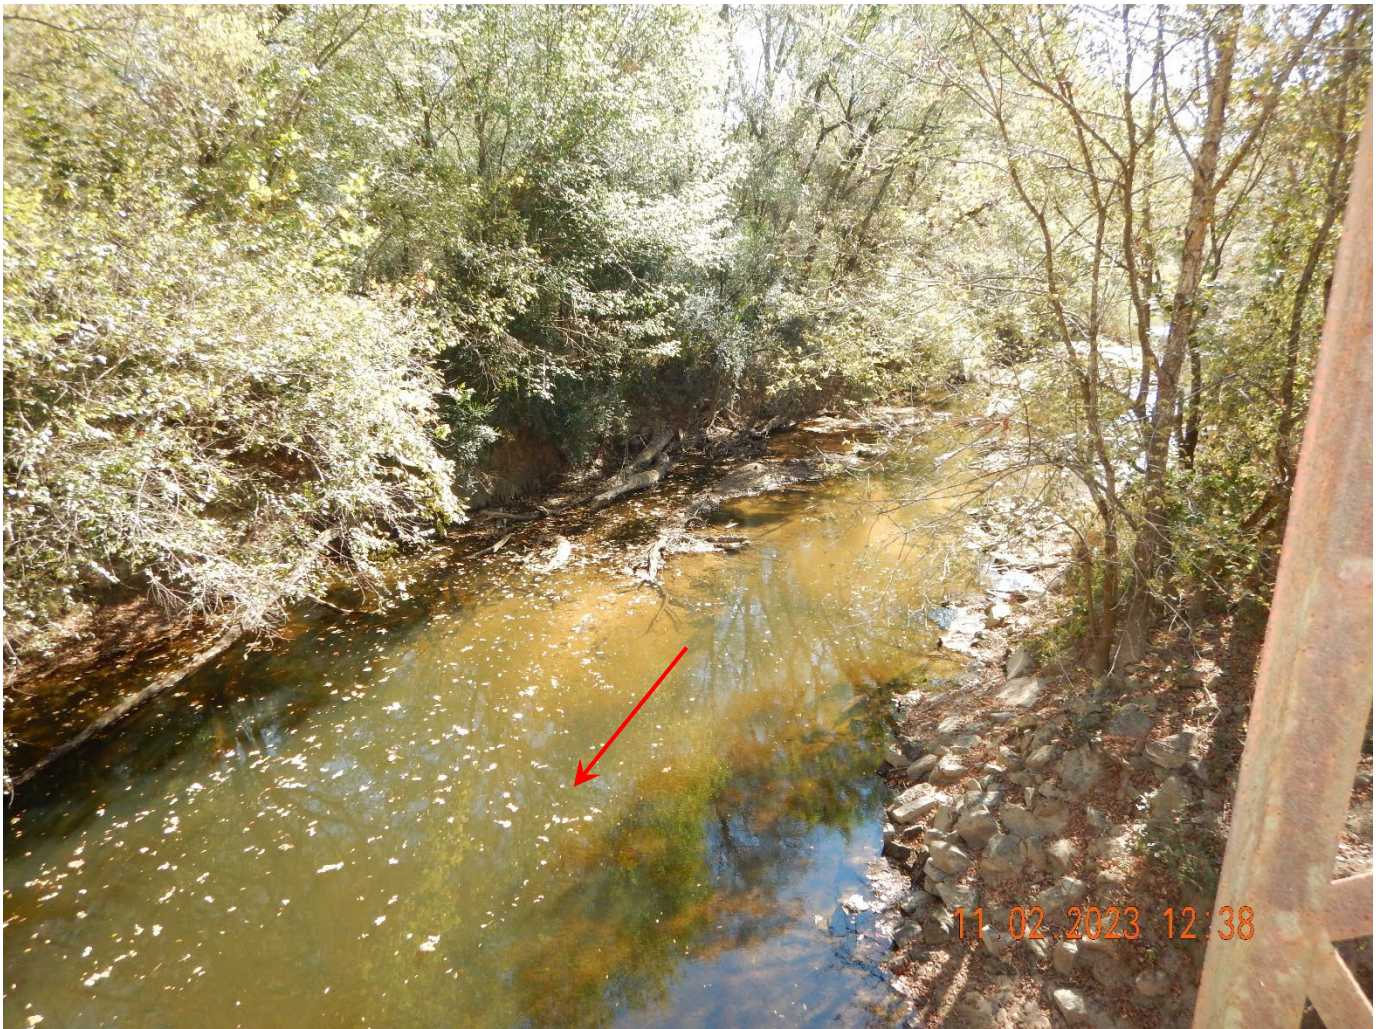
PHOTO 22

| Description | Striking upstream of the Sipsey River at County Road 95 crossing. Red arrow indicates direction of flow. |

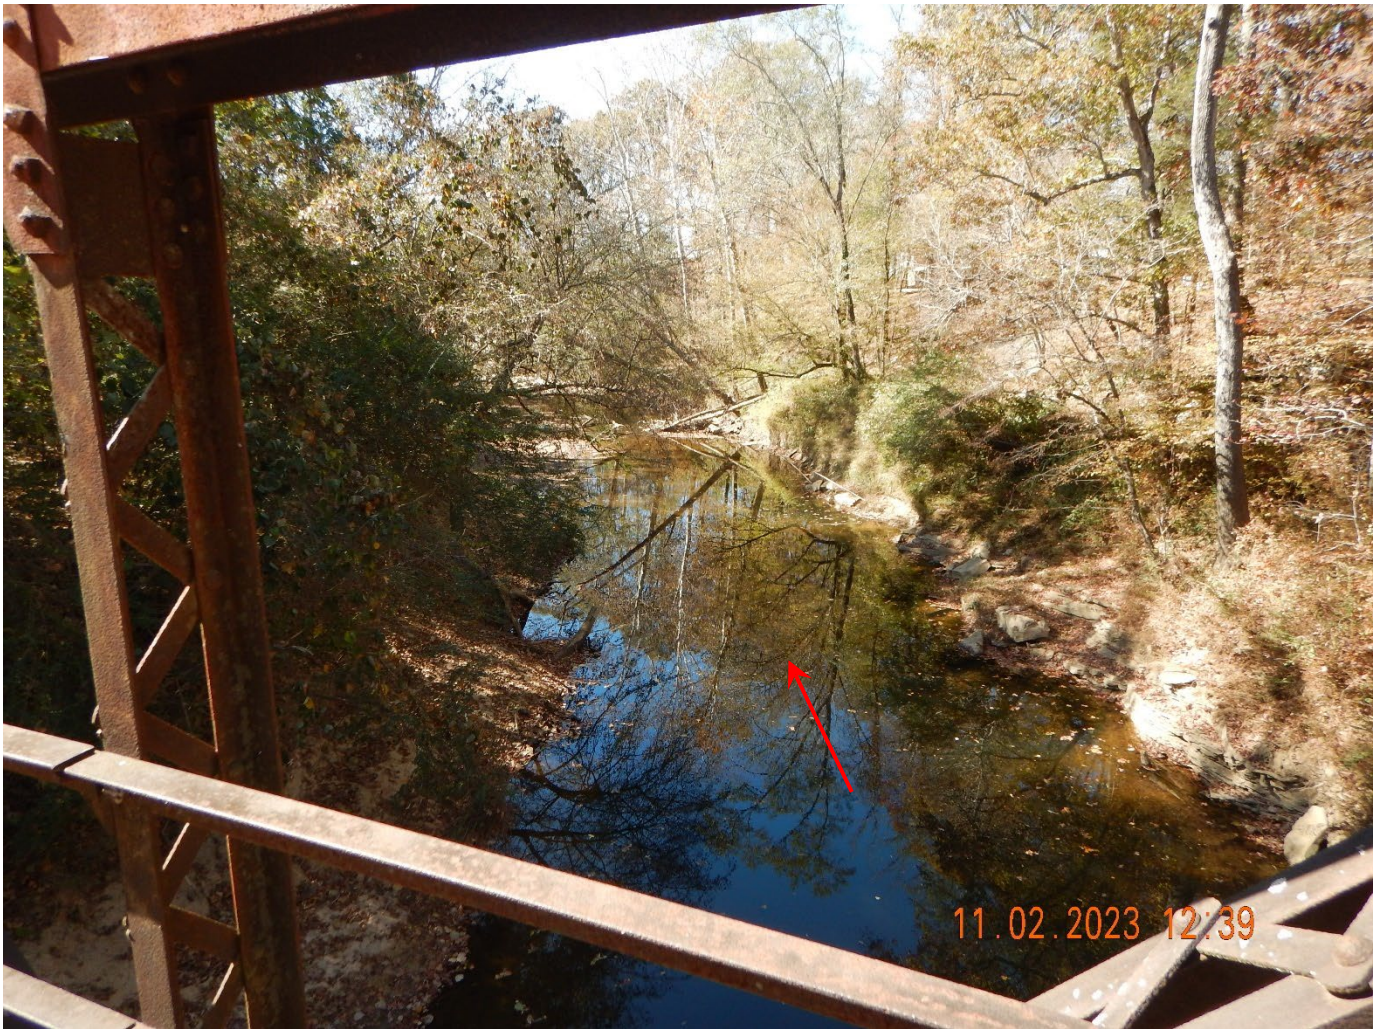
PHOTO 23

| Description | Striking downstream of the Sipsey River at County Road 95 crossing. Red arrow indicates direction of flow. |
