## **RCRA Inspection Report**

University of Kentucky –  
Environmental Management  
355 Cooper Dr  
Lexington, KY 40546

August 23, 2023 9:18am

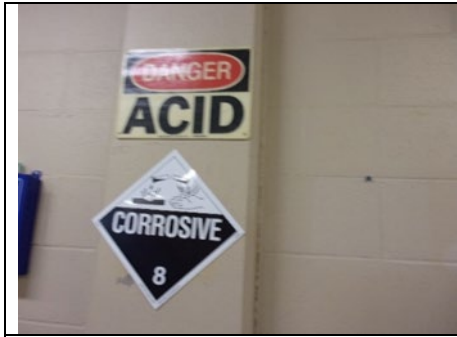
EQMC manages a permitted storage area in the Acid Storage for managing hazardous waste acids that are generated by university operations (Figure 1). The inspectors observed two (2) 35-gallon containers and one 55-gallon container in this area. The containers were located adjacent to smaller containers of waste shelved on metal racks (Figures 2 through 4). The containers were equipped with drum cover lids, which were closed. One of the 35-gallon containers was labeled D001, D002 hazardous waste, included an accumulation start date, and identified with an indication of the hazards of the contents (Figure 3).

Figure 1: 10:21 AM Acid Storage  
Signage of Acid Storage area.

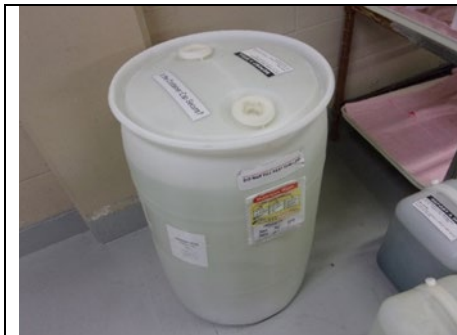
Figure 3: 10:22 AM Acid Storage  
(Photo 2 of 2) One of two 35-gallon containers  
observed with hazardous waste label,  
accumulation start date, and indication of the  
hazards of the contents.

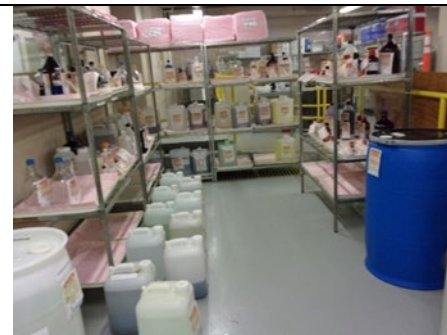
Figure 4: 10:24 AM Acid Storage  
Overall perspective of Acid Storage area with one  
55-gallon container observed.

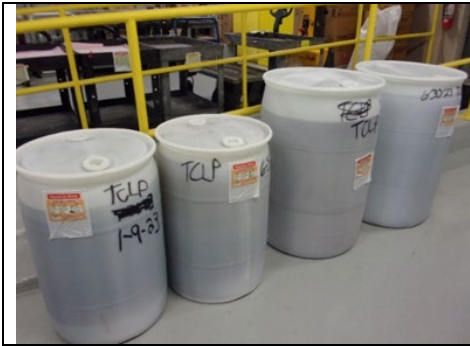
EQMC manages a permitted storage area in the Metals Storage for managing hazardous waste metals that are generated by university operations. The inspectors observed two (2) 35-gallon containers and six (6) 55-gallon containers, and four (4) 5-gallon containers in this area. The containers were located adjacent to smaller containers of waste shelved on metal racks (Figures 5-10). The containers were equipped with drum cover lids, which were closed. The containers were labeled hazardous waste, included an accumulation start date, and identified with an indication of the hazards of the contents.

Figure 5: 10:26 AM Metals Storage  
Two of six 55-gallon containers and two 35-gallon containers with hazardous waste label, accumulation start date, and indication of the hazards of the contents.

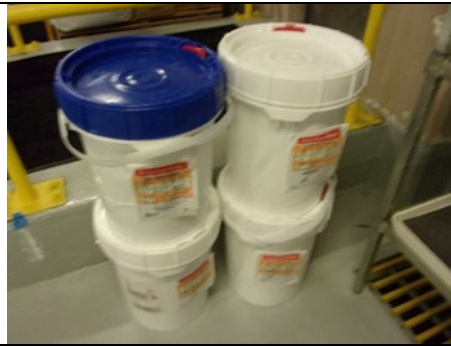
Figure 6: 10:26 AM Metals Storage  
Four (4) 5-gallon containers with hazardous waste label, accumulation start date, and indication of the hazards of the contents.

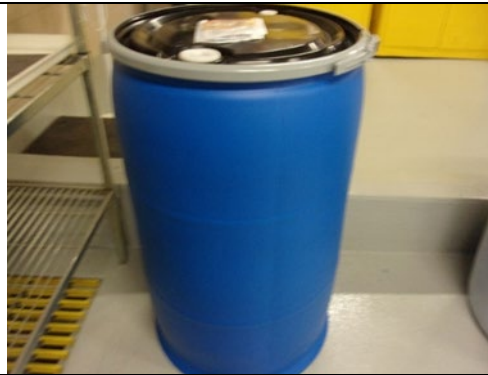
Figure 8: 10:27 AM Metals Storage  
(Photo 2 of 2) Three of six 55-gallon containers with hazardous waste label, accumulation start date, and indication of the hazards of the contents.

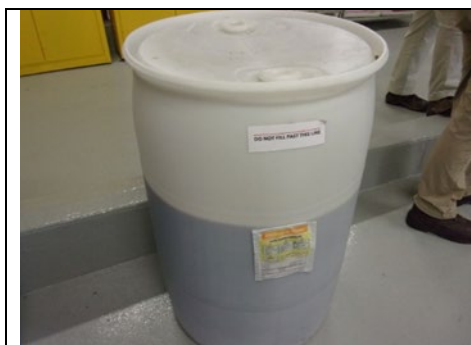
Figure 9: 10:27 AM Metals Storage  
Four of six 55-gallon containers with hazardous waste label, accumulation start date, and indication of the hazards of the contents.

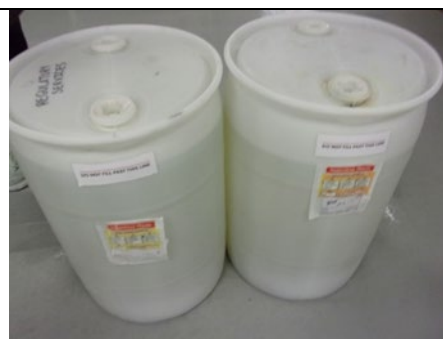
Figure 10: 10:27 AM Metals Storage  
Two of six 55-gallon containers with hazardous waste label, accumulation start date, and indication of the hazards of the contents.

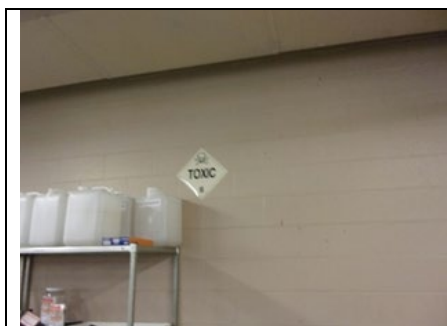
EQMC manages a permitted storage area in the Oxidizer Storage for managing hazardous waste oxidizers that are generated by university operations (Figure 11). The inspectors observed one 1-liter container in this area. The container was located with smaller containers of waste

Figure 11: 10:29 AM Oxidizer Storage  
Signage of Oxidizer Storage area.

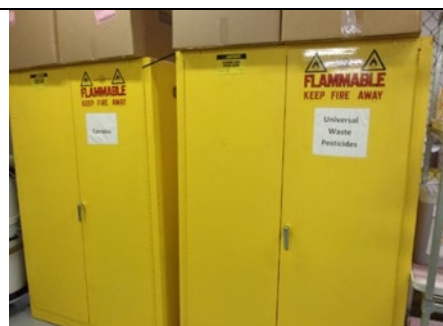
shelved on metal racks adjacent to two (2) flammable cabinets (Figure 12). The container was equipped with a sealable lid, which was closed. The container was labeled hazardous waste hydrogen peroxide solution, included an accumulation start date, and identified with an indication of the hazards of the contents (Figure 13).

Figure 12: 10:29 AM Oxidizer Storage  
Two flammable cabinets observed.

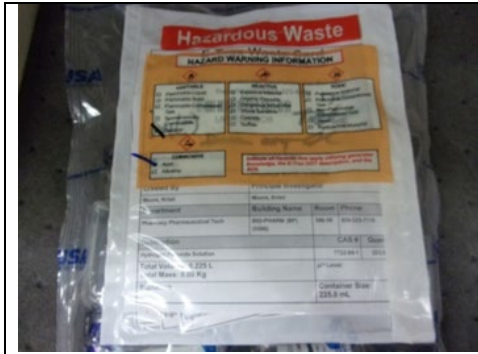
Figure 13: 10:32 AM Oxidizer Storage  
One 1-liter container with hazardous waste label, accumulation start date, and no proper indication of the hazards of the contents.

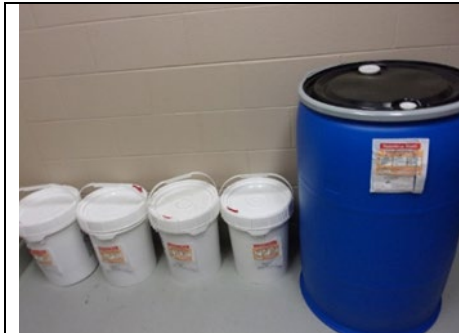
EQMC manages a permitted storage area in the Flammables Storage for managing hazardous waste flammables that is generated by university operations. The inspectors observed twenty-three (23) 55-gallon containers and four (4) 5-gallon containers in this area. The containers were located in different sections of the room (Figures 15-18). The containers were equipped with drum cover lids, which were closed. The four (4) 5-gallon containers were labeled hazardous waste, included an accumulation start date, and identified with an indication of the hazards of the contents. The twenty-three containers were labeled hazardous waste, included an accumulation start date, and identified with an indication of the hazards of the contents. Inspectors observed two 55-gallon containers of used oil (Figure 20).

Figure 15: 10:34 AM Flammables Storage  
Four (4) 5-gallon containers and one of twenty-three 55-gallon containers with hazardous waste label, accumulation start date, and an indication of the hazards of the contents.

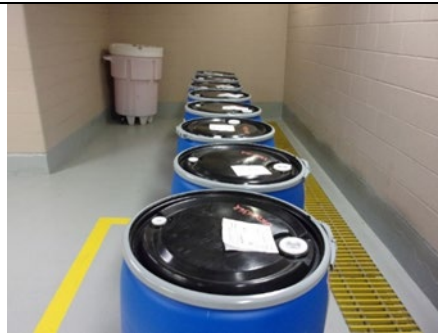
Figure 16: 10:39 AM Flammables Storage  
Eight of twenty-three 55-gal containers with hazardous waste label, accumulation start date, and an indication of the hazards of the contents.

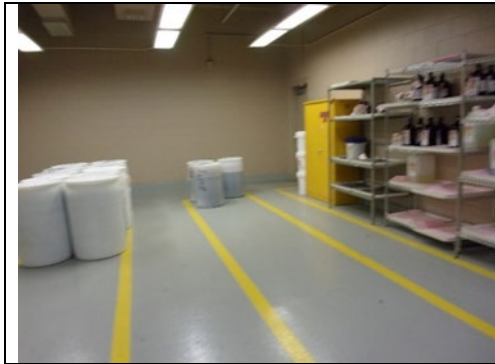
Figure 17: 10:42 AM Flammables Storage  
Nine of twenty-three 55-gal containers with hazardous waste label, accumulation start date, and no proper indication of the hazards of the contents.

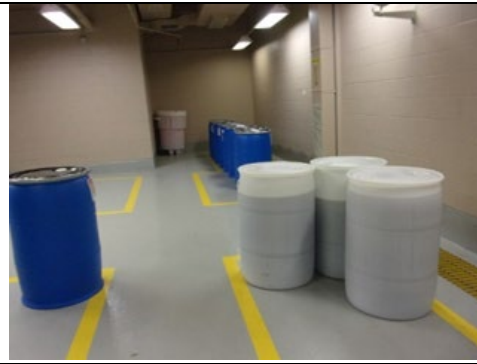
Figure 18: 10:42 AM Flammables Storage  
Four of twenty-three 55-gal containers with hazardous waste label, accumulation start date, and no proper indication of the hazards of the contents.

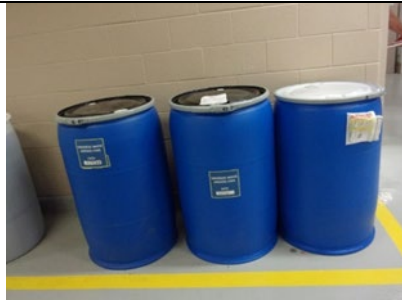
EQMC also manages universal waste aerosol cans in the Flammables Storage area. The inspectors observed two 55-gallon containers of universal waste aerosol cans in this area during the inspection. Two 55-gallon containers of aerosol cans, which were closed and marked with an accumulation start date, were labeled universal waste aerosol cans (Figure 19). The oldest date observed on any container of aerosol cans was April 13, 2023.

Figure 19: 10:42 AM Flammables Storage  
Two (2) 55-gal containers of universal waste aerosol cans and one of twenty-three 55-gallon containers with hazardous waste label, accumulation start date, and no proper indication of the hazards of the contents.

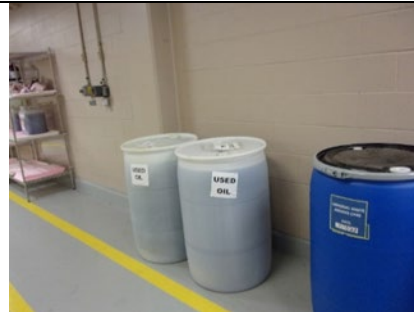
Figure 20: 10:42 AM Flammables Storage  
Two (2) 55-gallon containers of used oil observed.

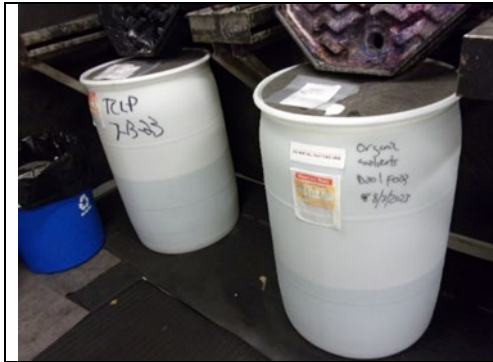
EQMC manages a permitted storage area in the Bulking room for bulking hazardous waste generated by university operations. The inspectors observed three (3) 55-gallon containers in this area. The containers were located in process areas for bulking and were over absorbent material (Figures 21 and 22). The containers were equipped with drum cover lids, which were closed. The first container was labeled D001, F003 hazardous waste organic solvents, and identified with an indication of the hazards of the contents. The second container was labeled hazardous waste, included an accumulation start date, and identified with an indication of the hazards of the contents. The third container was labeled used oil.

Figure 21: 10:46 AM Bulking  
Two of three 55-gal containers observed.  
Containers included a hazardous waste label, accumulation start date, and an indication of the hazards of the contents.

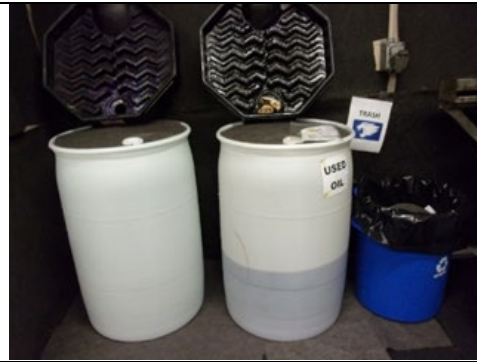
Figure 22: 10:46 AM Bulking  
Three of three 55-gal containers observed.  
Container labeled as Used Oil.

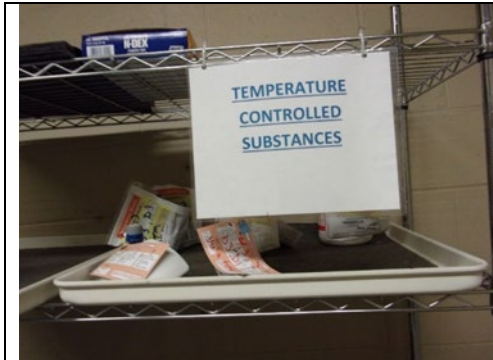
and one 500-milliliter container in this area. The containers were located with other containers of waste shelved on metal racks (Figure 23). The containers were equipped with sealable lids, which were closed. The first container was labeled D001, D003 hazardous waste, included an accumulation start date, and identified with an indication of the hazards of the contents (Figure 24). The second container was labeled D002, D003 hazardous waste, included an accumulation start date, and identified with an indication of the hazards of the contents (Figure 25).

Figure 23: 10:50 AM Reactives Storage  
Signage of Reactives Storage area.

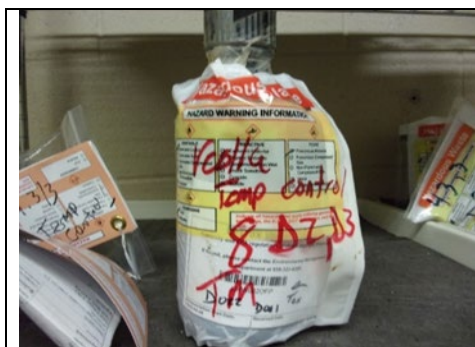
Figure 25: 10:50 AM Reactives Storage  
One 500-milliliter container with hazardous waste label, accumulation start date, and an indication of the hazards of the contents.

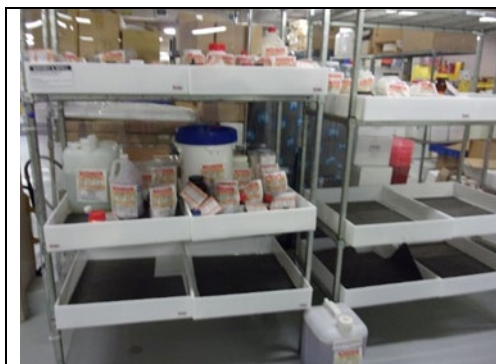
EQMC manages a permitted storage area in the Toxic Room for managing toxic waste that is generated by university operations (Figure 26). The inspectors observed containers that were located on metal racks (Figure 27). The containers were equipped with cap lids, which were closed. The containers were labeled hazardous waste, included an accumulation start dates, and identified with an indication of the hazards of the contents.

Figure 27: 10:52 AM Toxic Room  
Overall perspective of Toxic Room observed.

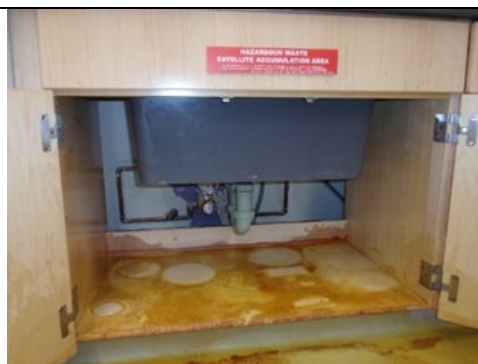
The inspectors observed remnants of a spill in the CP 348 SAA (Figure 28). Inspectors asked facility personnel when the spill occurred and if they needed to notify emergency response contacts. Facility personnel stated that the spill occurred approximately a month before the date of this inspection and that there was no need for emergency response to be contacted since the facility was able to handle and clean up the spill themselves. There were no containers observed in this SAA.

Figure 28: 11:12 AM CP 348  
Satellite accumulation area with remnants of cleaned up spill observed.

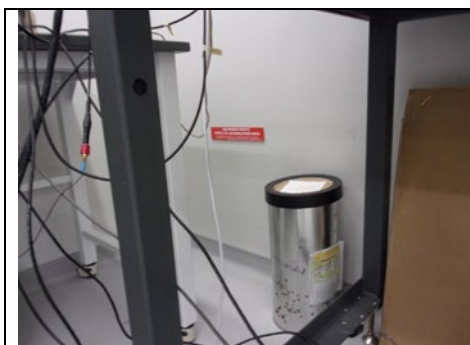
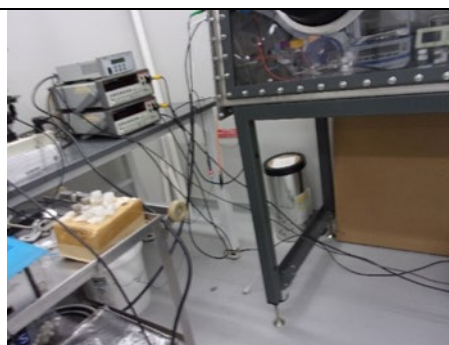
Inspectors observed another SAA in this area (Figures 29 and 30). No containers were observed in this SAA as well. However, access to the SAA was difficult. Therefore, inspectors recommended facility personnel to provide more space for access to the SAA.

Figure 29: 11:14 AM CP 348  
(Photo 1 of 2) SAA with limited access observed.

Figure 30: 11:14 AM CP 348  
(Photo 2 of 2) SAA with limited access observed.

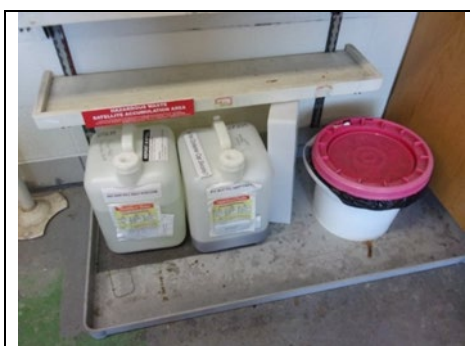
The inspectors observed two (2) 5-gallon containers and one 3-gallon container in this SAA. The containers were located between the CP239 exit door and laboratory equipment (Figure 31). The two (2) 5-gallon containers were equipped with cap lids, which were closed. The containers were labeled hazardous waste and identified with an indication of the hazards of the contents. The one 3-gallon container was equipped with a cover lid, which was not secure. The container was not labeled hazardous waste but included an indication of the hazards of the contents (Figure 33). One 500-milliliter container of Cupric Nitrate was discovered upon observing the inside of the 3-gallon container (Figure 32). Inspectors asked facility personnel if the Cupric

Figure 31: 11:27 AM CP 239  
Two (2) 5-gallon containers and one 3-gallon  
container in SAA observed.

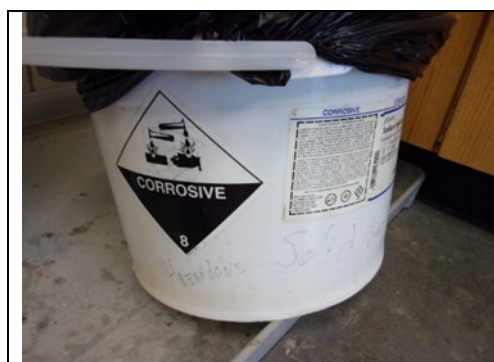
Nitrate was supposed to be in a corrosive container. Facility personnel stated that Cupric Nitrate was a potential oxidizer.

**Pursuant to 401 KAR 39:080, Section 1(1) [40 C.F.R. § 262.15(a)(2)], which is a condition of the SAA Permit Exemption, a generator is required to use a container made of or lined with materials that will not react with, and are otherwise compatible with, the hazardous waste to be accumulated, so that the ability of the container to contain the waste is not impaired.**

Figure 32: 11:32 AM CP 239  
(Photo 1 of 2) 3-gallon SAA container observed  
with Cupric Nitrate.

Figure 33: 11:33 AM CP 239, 243, and 245 (Photo 2 of 2) 3-gallon SAA container observed with a corrosive indication of the hazards of the contents.

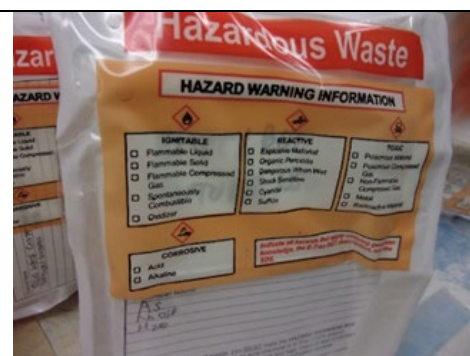
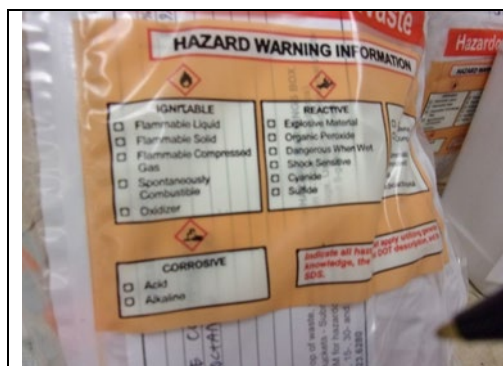
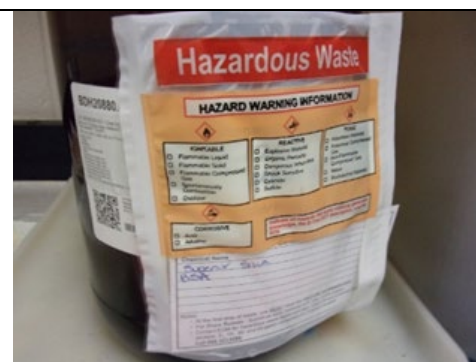
The inspectors observed two (2) bag containers and one 2.5-liter container in this area's SAA. The containers were located in a separate room within the lab. The two (2) bag containers were equipped with a sealable lid, which were closed. The containers were labeled hazardous waste and not identified with an indication of the hazards of the contents (Figures 34 and 35). The one 2.5-liter container was equipped with a cap lid, which was closed. The container was labeled hazardous waste and not identified with an indication of the hazards of the contents (Figure 36).

**Pursuant to 401 KAR 39:080, Section 1(1) [40 C.F.R. § 262.15(a)(5)], which is a condition of the SAA Permit Exemption, a generator is required to mark or label its containers (i) with the words "Hazardous Waste" and (ii) with an indication of the hazards of the contents.**

Figure 34: 12:06 PM Chemical Engineering Building: Room 770  
One of two bag containers observed in SAA. No indication of the hazards of the contents.

Figure 35: 12:06 PM Chemical Engineering Building: Room 770  
Two of two bag containers observed in SAA. No indication of the hazards of the contents.

Figure 36: 12:07 PM Chemical Engineering Building: Room 770  
One 2.5-liter container observed in SAA. No indication of the hazards of the contents.

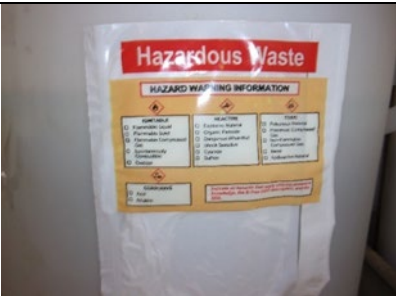
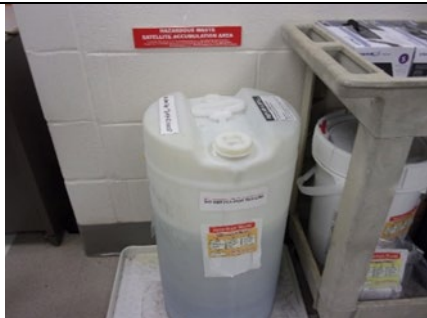
Inspectors observed one 15-gallon container in this area (Figure 38). The container was located in the SAA, and it was equipped with a bung lid, which was closed. The container was labeled hazardous waste and identified with no indication of the hazards of the contents (Figure 37).

**Pursuant to 401 KAR 39:080, Section 1(1) [40 C.F.R. § 262.15(a)(5)], which is a condition of the SAA Permit Exemption, a generator is required to mark or label its containers (i) with the words “Hazardous Waste” and (ii) with an indication of the hazards of the contents.**

| <p>Figure 37: 12:14 PM Chemical Engineering Building: Room 763<br/>(Photo 1 of 2) One 15-gallon container observed in SAA. No indication of the hazards of the contents.</p> | <p>Figure 38: 12:14 PM Chemical Engineering Building: Room 763<br/>(Photo 2 of 2) One 15-gallon container observed in SAA. No indication of the hazards of the contents.</p> |
