**Air Branch Inspection Report**  
**Unannounced Full Compliance Evaluation**  
**Camaco Columbus Manufacturing Company**  
1851 East 32<sup>nd</sup> Avenue  
Columbus, Nebraska 68601  
FRS# 110001512186

**Inspection Date(s):**  
October 30, 2024

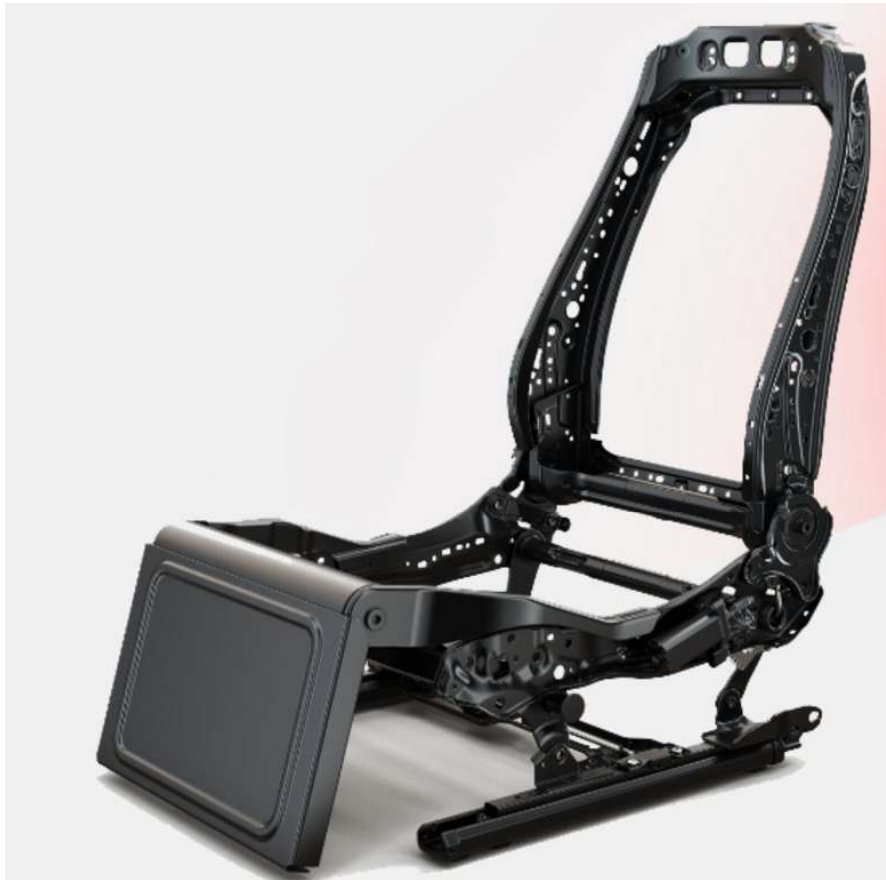
Figure 1. Camaco website finished seat frame image.

Camaco manufactures backseat frames for vehicles through heaters, welding, drying ovens, presses, and painting operations. The facility has a Standard Industrial Classification (SIC) code 3714, categorized as Motor Vehicle Parts and Accessories, and a North American Industry Classification System (NAICS) code 33690, categorized as Other Motor Vehicle Parts Manufacturing. To begin the process, the raw steel arrives at the facility in coils. The steel goes through the tube milling process that forms the tubes. The tubes are cut to specific sizes depending on which line the operation is located. Facility personnel inspects the tubes before each tube continues through the welding process. Different components of the backseat frame are created through the stamping process. Giant presses are used to create the unique stamps. The components of the seat frame get washed and dried. Two different processes exist for painting the seat frame components. First is a powder coating and then heat coating. Once components are powder coated, they will go to the burn-off oven (emission unit-8). The paint that accumulates is burned off in an oven/incinerator for which a construction permit was issued January 31, 2024. Components are loaded into the oven and heated to approximately 800°F. An afterburner raises the temperature of exhaust gas to greater than 1,500°F to completely burn any remaining particulate and volatile compounds. At different points in time, there are different types of welding techniques used to laser the seat frame components together. In essence, Camaco uses a welding process that utilizes an electric arc to generate high temperatures, melting metal filler wire and the base material to create a weld. Camaco uses laser, Metal Inert Gas, Tungsten Inert Gas, and resistance welding to assemble the seat frame components together. Figure 1 depicts one version of a finished seat frame.
