**Region 6 - Enforcement & Compliance Assurance Division**  
**INSPECTION REPORT**

| Inspection Date(s): | 4/4/24 | |
| Company Name: | LaRay Oil, LLC | |
| Facility Name: | Thompson #1 SWD | |

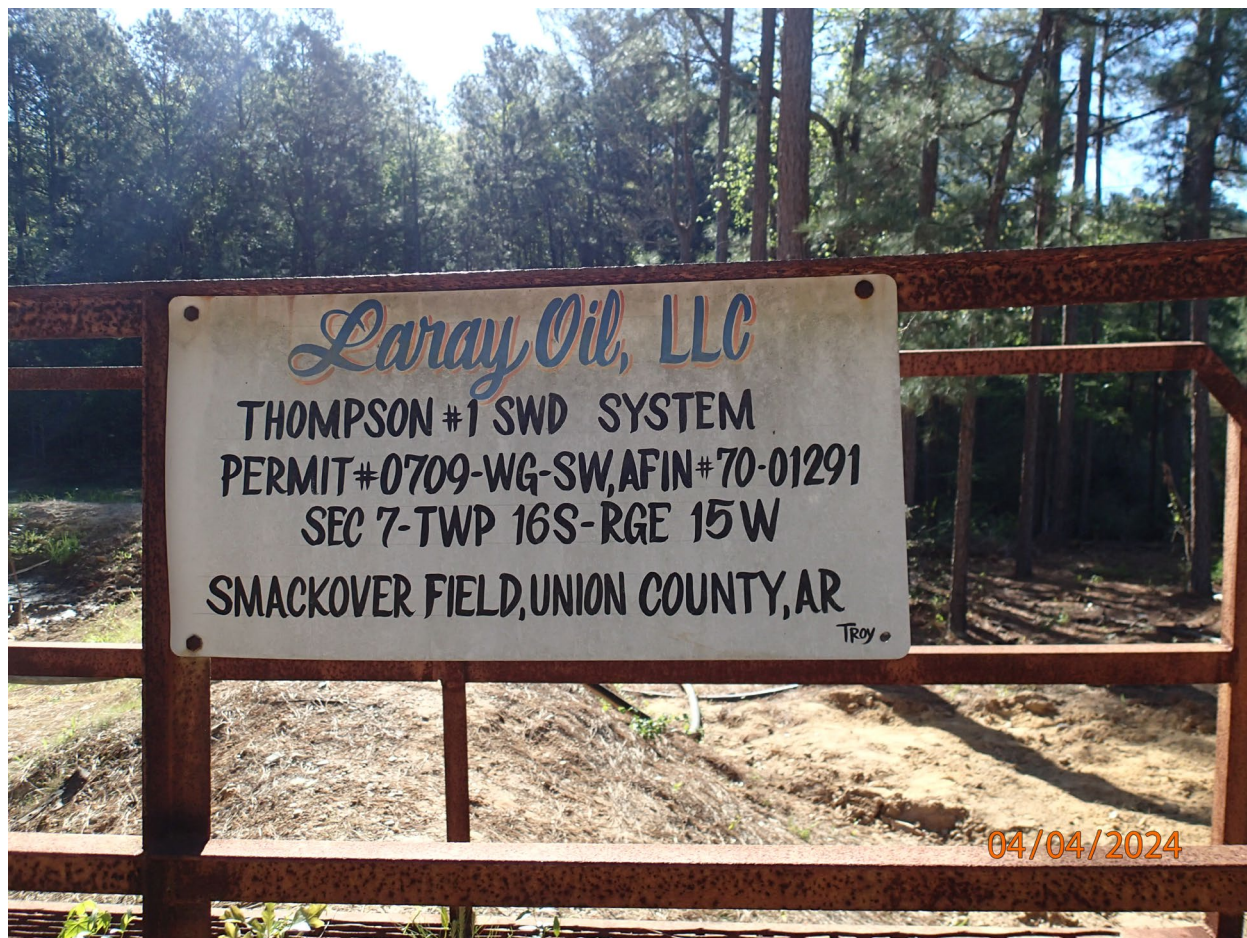
I observed a storage tank and a saltwater disposal (SWD) well belonging to LaRay Oil, LLC; see Appendix 1 (Photographs Log), Photo No. 1 and No. 2. For additional GPS location and photo metadata, see Appendix 1.

Description: Looking W-SW, this photo showed the signage at the facility.

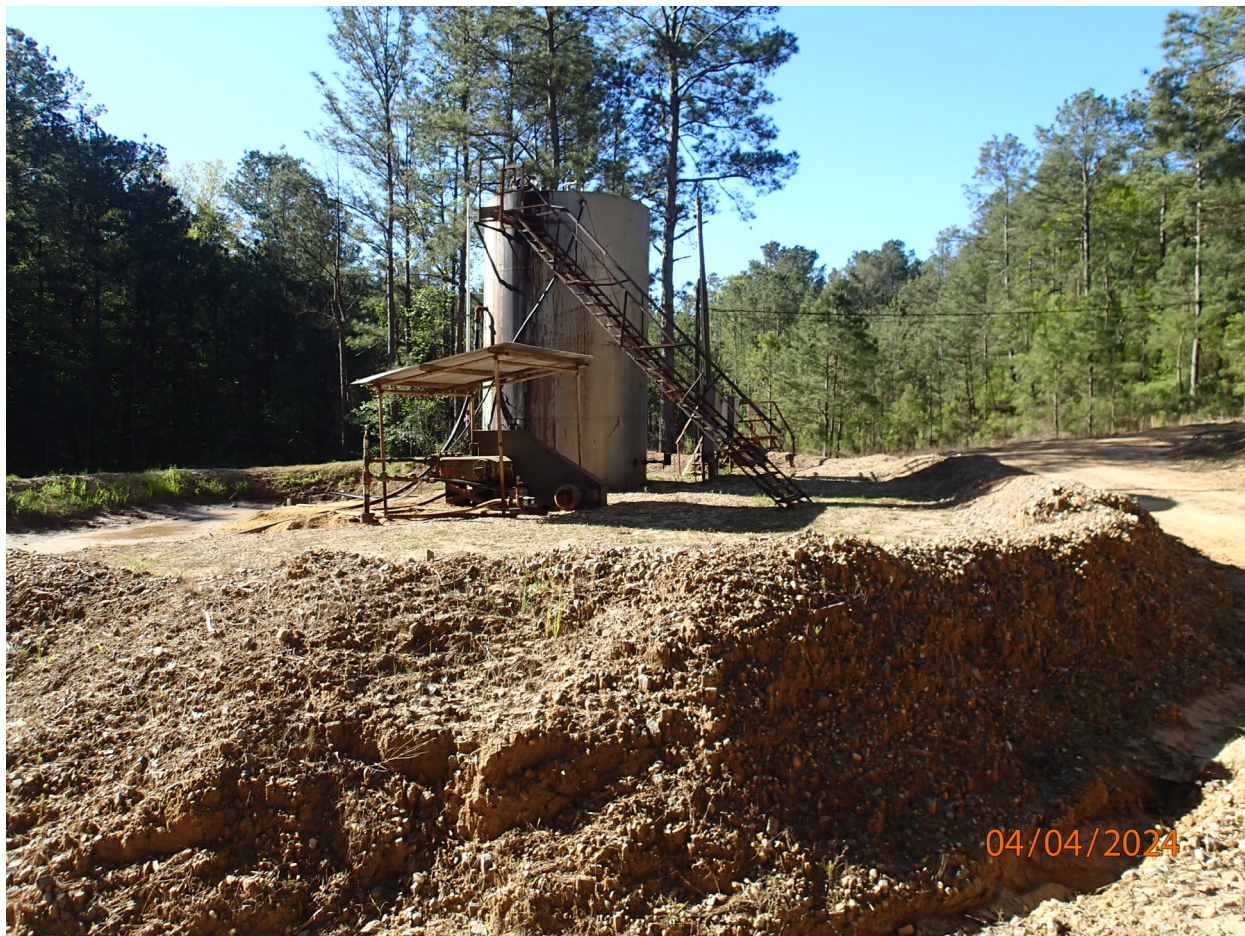
Photo No. 2

**Description:** Looking S-SW, this photo showed an overview of the facility.

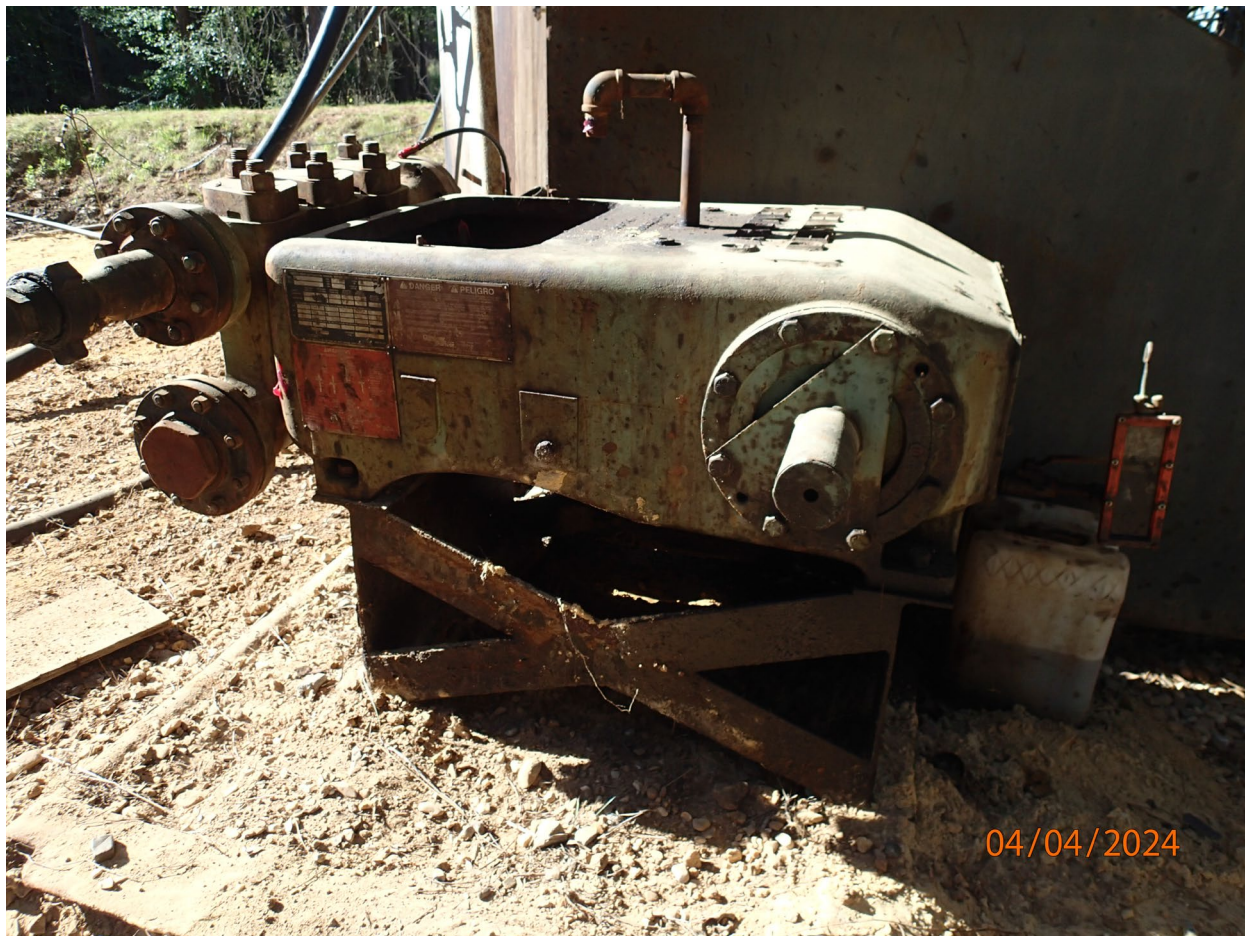
Photo No. 3

I observed the pump for the SWD well; the pump had an active leak; see Photo No. 3.

A closing conference was held with Mr. Jimmy R. Newton, LaRay Oil, LLC; to discuss the findings of the inspection. Areas of concern at the time of the inspection include the active leak at the pump for the SWD well and the elevated TDS readings in the pool adjacent to the facility drainpipe area.

Description: Looking N, this photo showed the pump for the saltwater disposal (SWD) well.

Mr. Newton indicated, during the inspection, that he had parts ordered to fix the SWD well pump at the facility. Additionally, Mr. Newton indicated that he would have the pool next to the facility pumped to the SWD system.

Mr. Newton was advised to document all his repairs; to include invoices, work hours, photographs, etc.

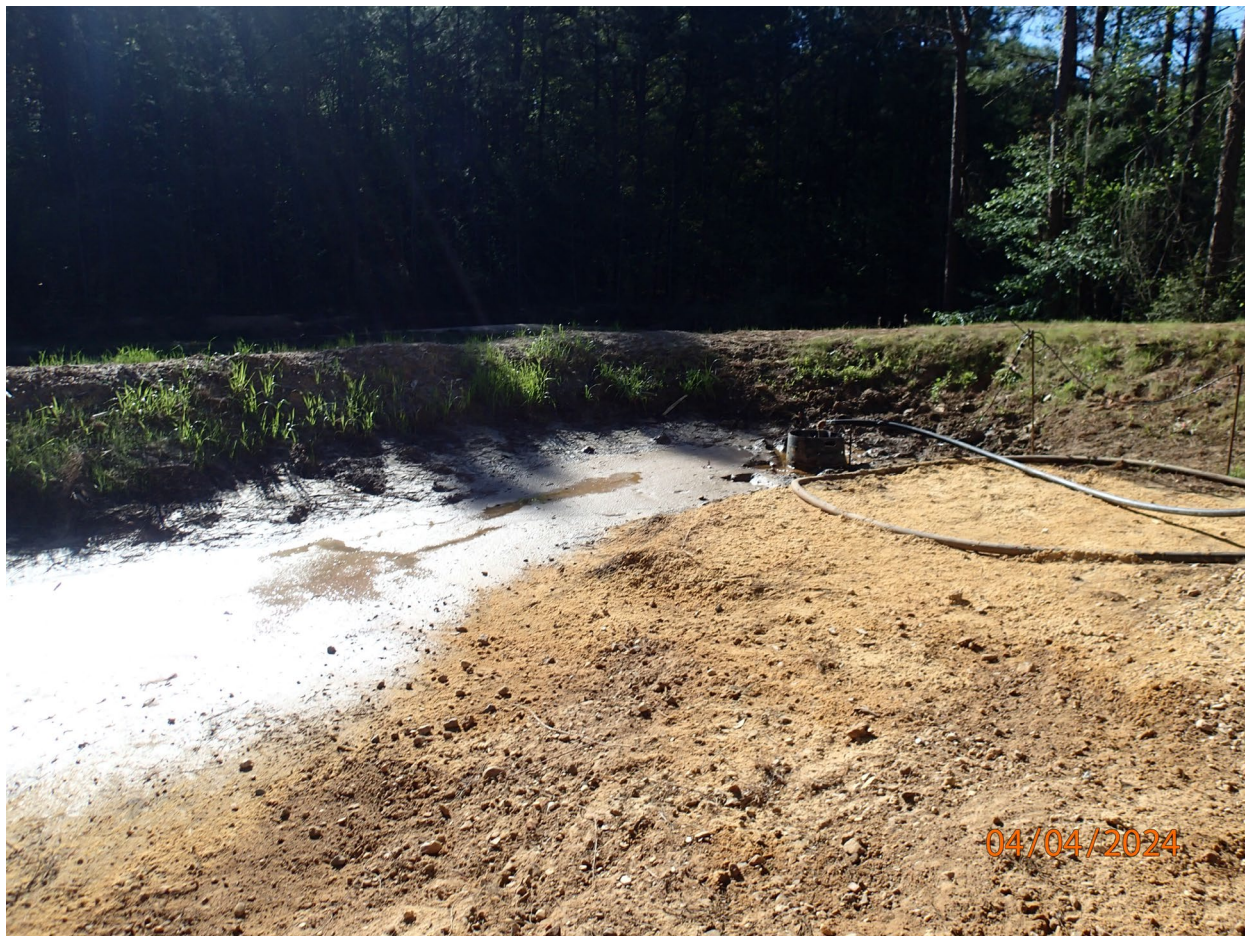
I observed the drainage area and a sump pump that had been installed prior to the inspection, see Photo No. 4 through No. 6.

**Description:** Looking N, this photo showed the drainage area and sump inside the secondary containment.

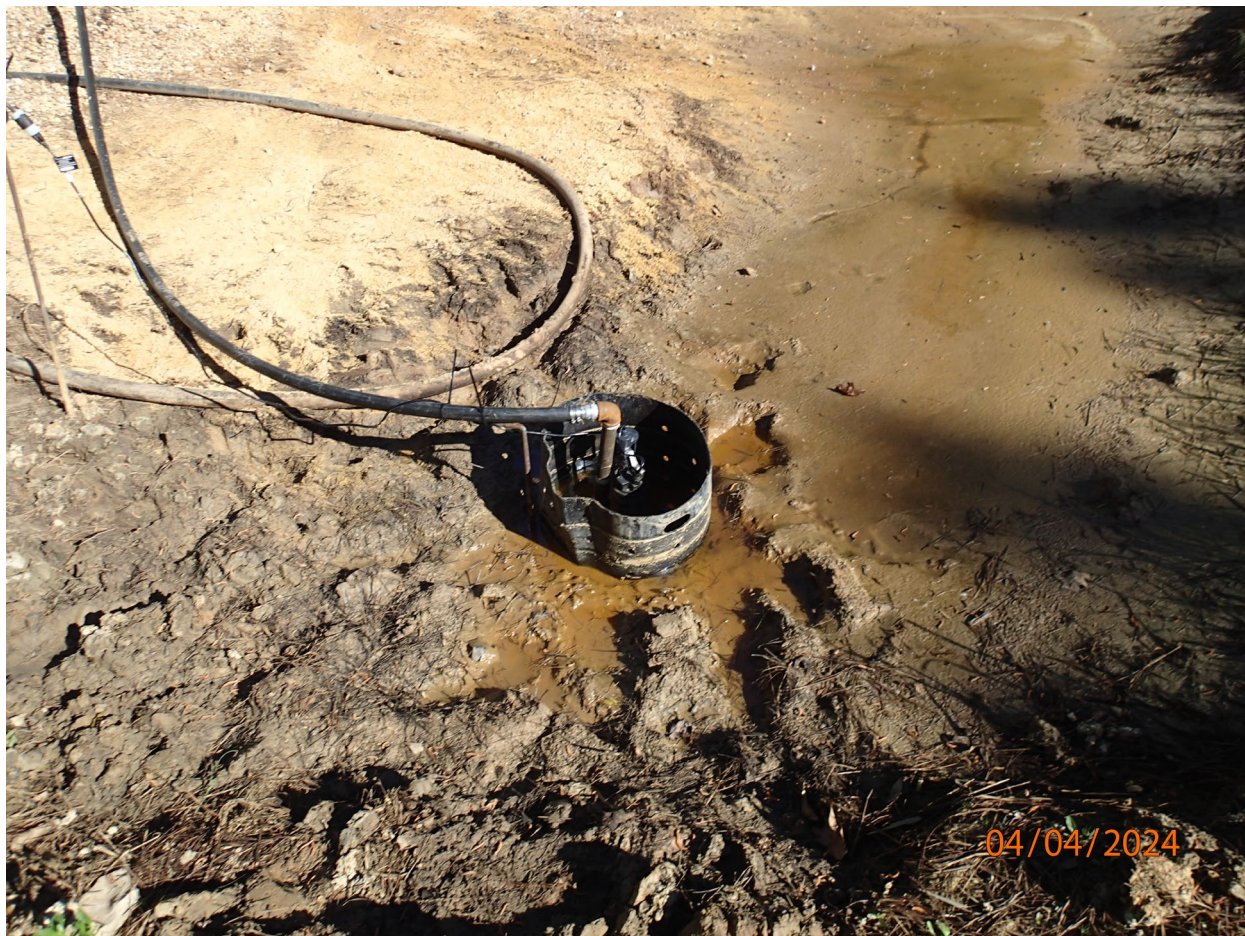
Photo No. 5

**Description:** Looking N-NE, this photo showed the sump installed at the drainpipe to route water back into the disposal system.

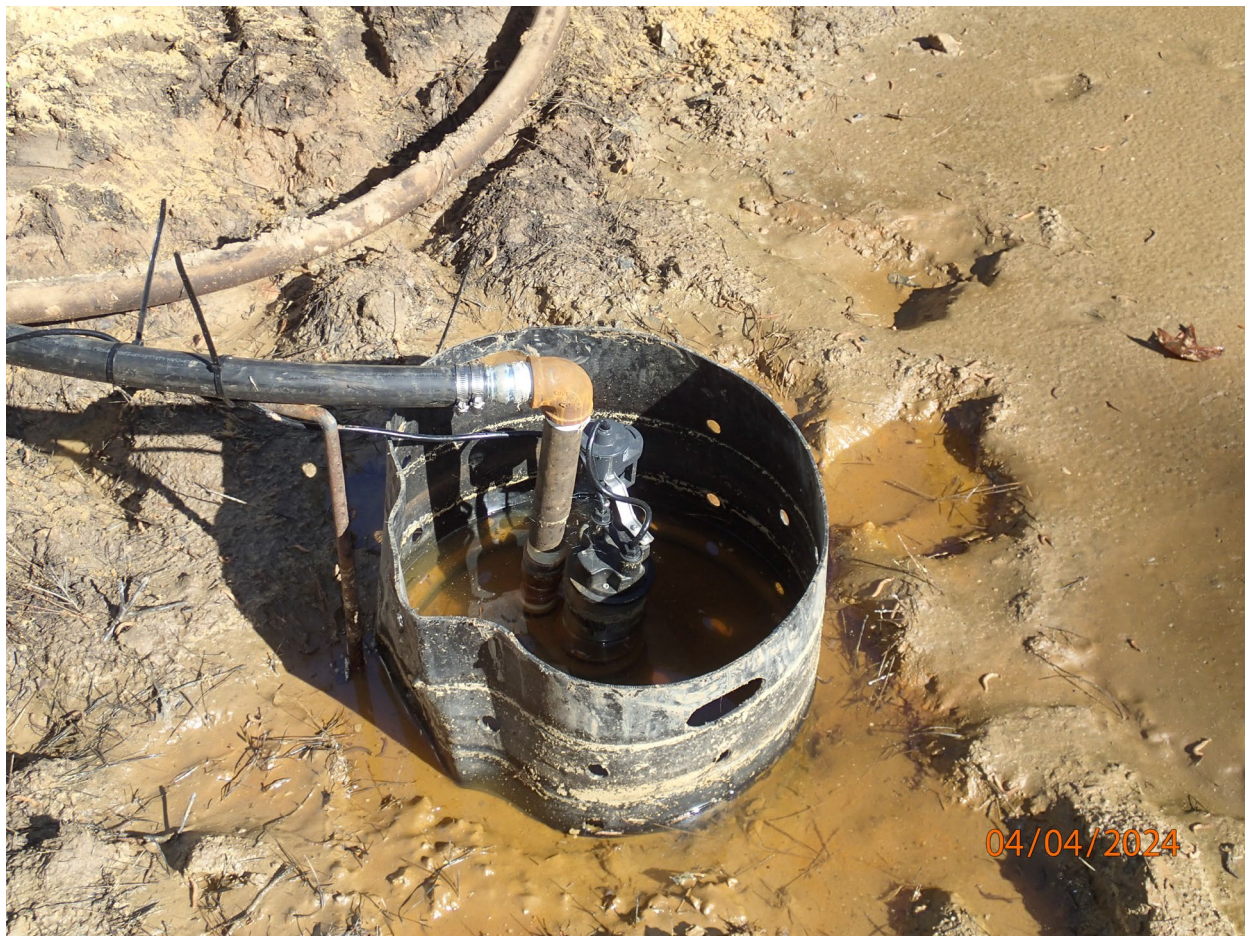
Photo No. 6

**Description:** Looking NE, this photo showed a closeup of the sump installed at the drainpipe from Photo No. 5.

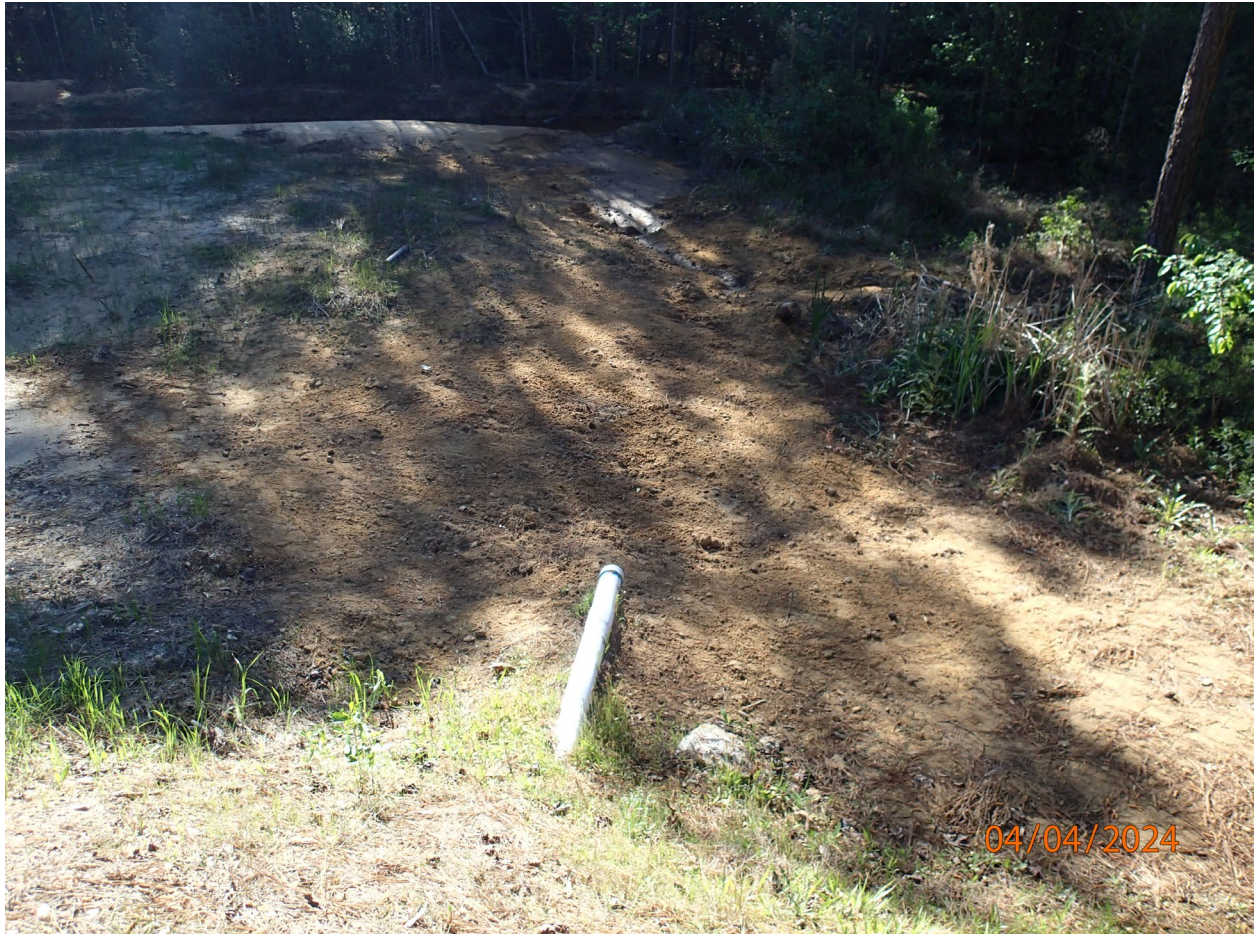
I observed the drainpipe for secondary containment with the shutoff valve removed and the cap bonded to the pipe, see Photo No. 7 and No. 8.

**Description:** Looking SW, this photo showed the drainpipe for the secondary containment with the valve removed and permanently capped.

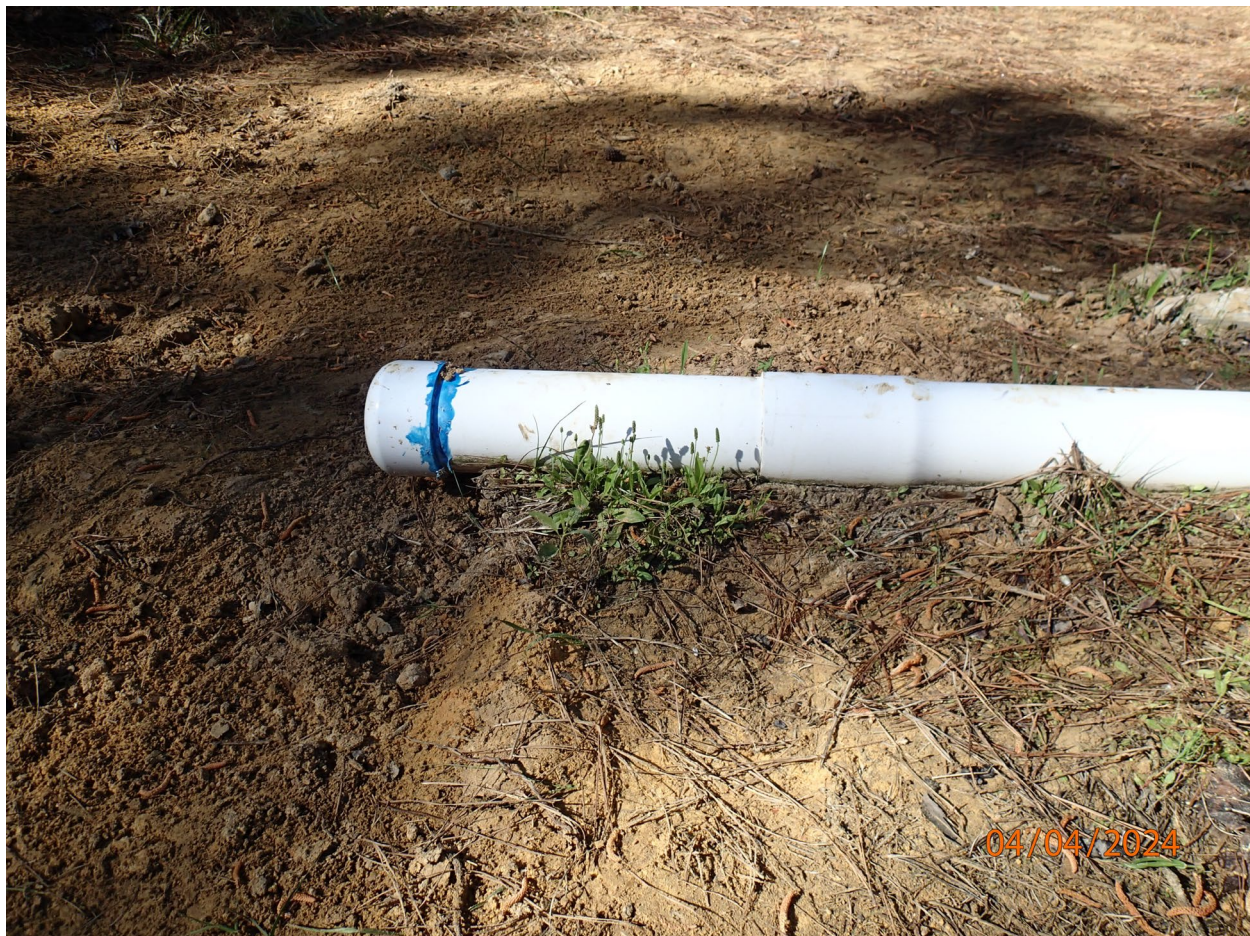
Photo No. 8

**Description:** Looking S-SE, this photo showed a closeup of the drainpipe from Photo No. 7.

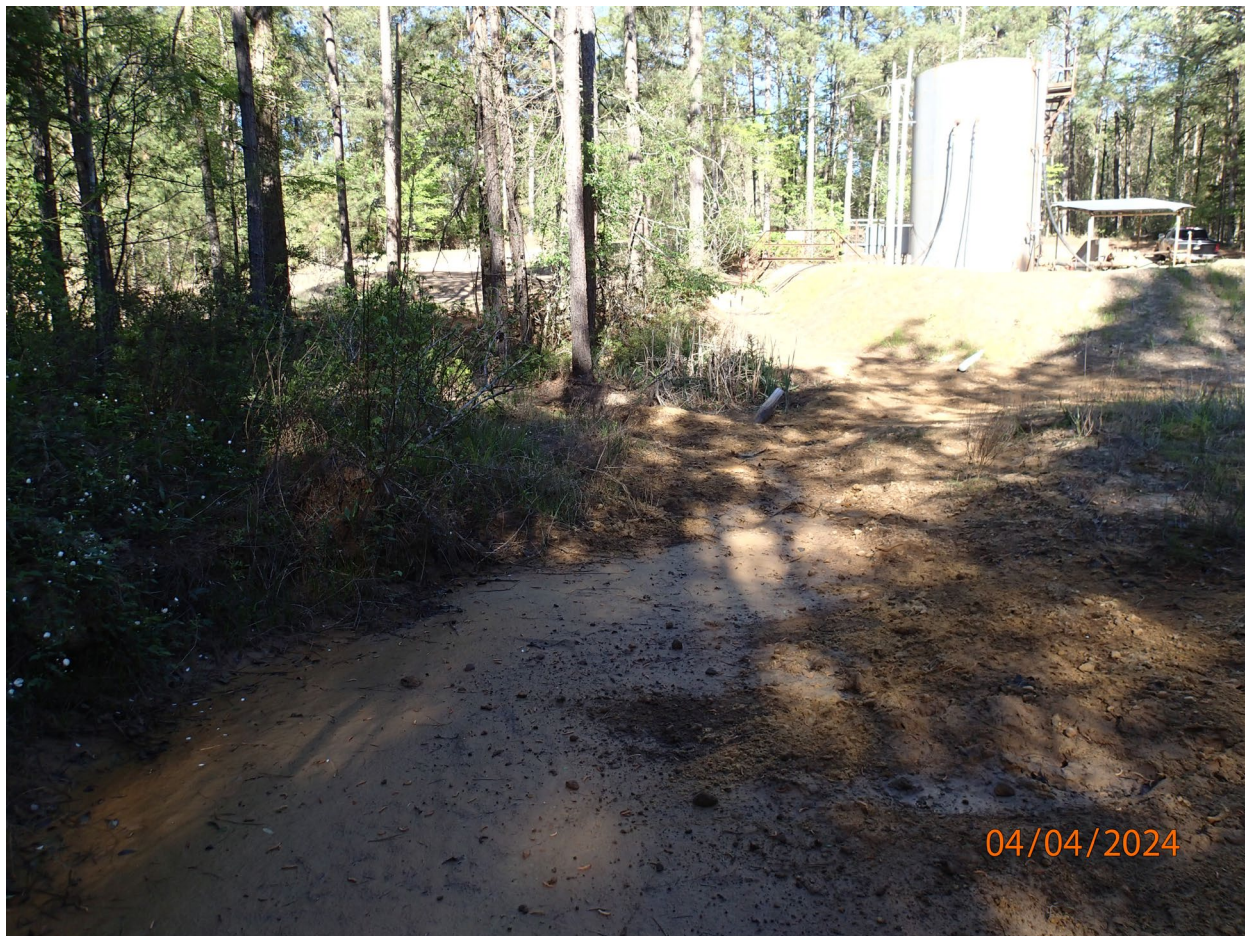
I observed the drainage area associated with the facility; the channel from the drainpipe had been filled with soil prior to the inspection; see Photo No. 9 through No. 12.

**Description:** Looking E-SE, this photo showed the channel from the drainpipe that had been replaced with soil fill.

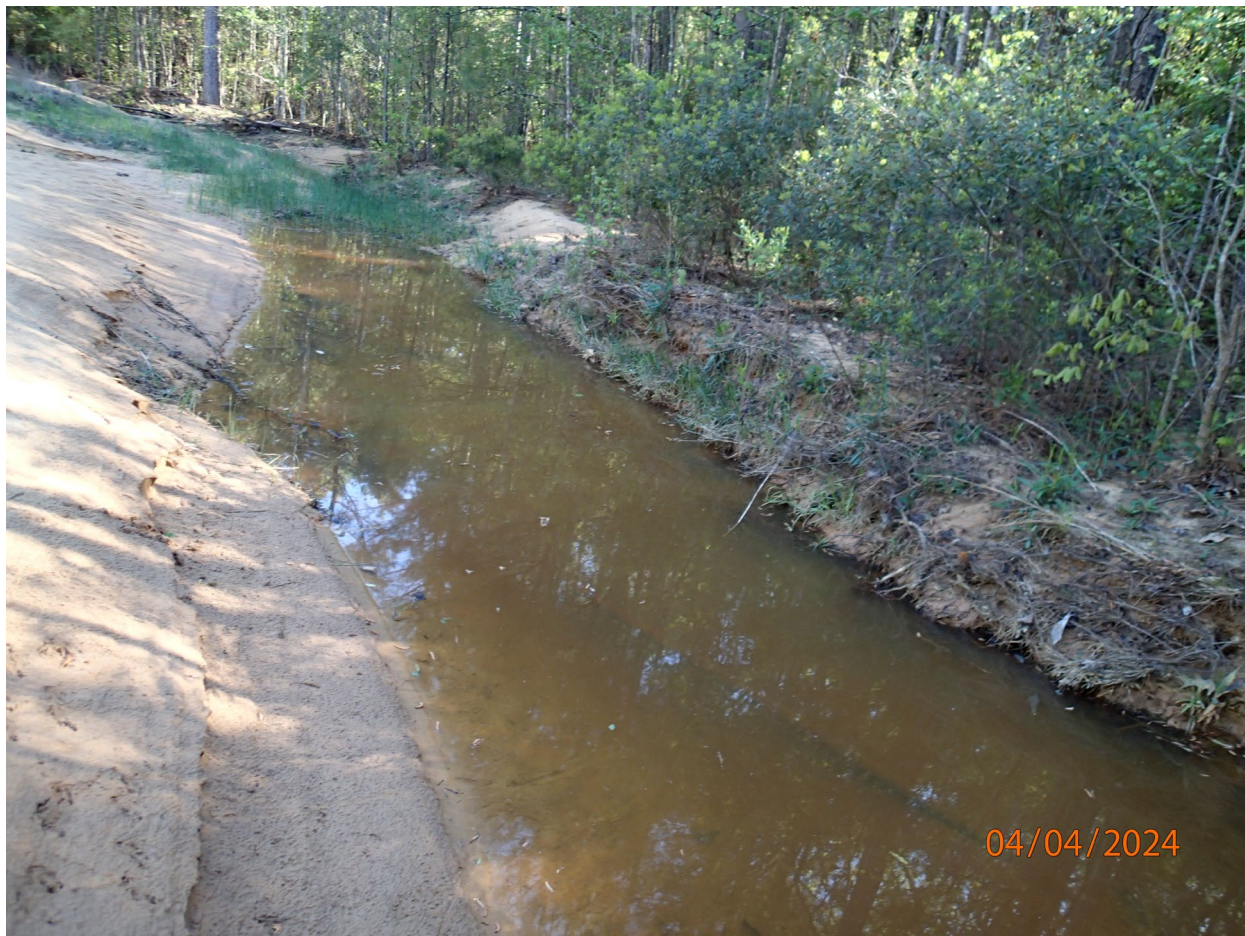
A TDS reading of about 6,000 mg/l was taken in a deep pool adjacent to the facility, see Photo No. 10 of the area sampled.

The following stratified TDS readings were taken in the deep pool adjacent to the facility: surface at about 400 mg/l, mid-level at about 1,500 mg/l, and bottom at about 5,500 mg/l, see Photo No. 10 through No. 12 of the areas sampled.

**Description:** Looking N-NE, this photo showed a pool in the receiving stream that is downstream of the capped drainpipe.

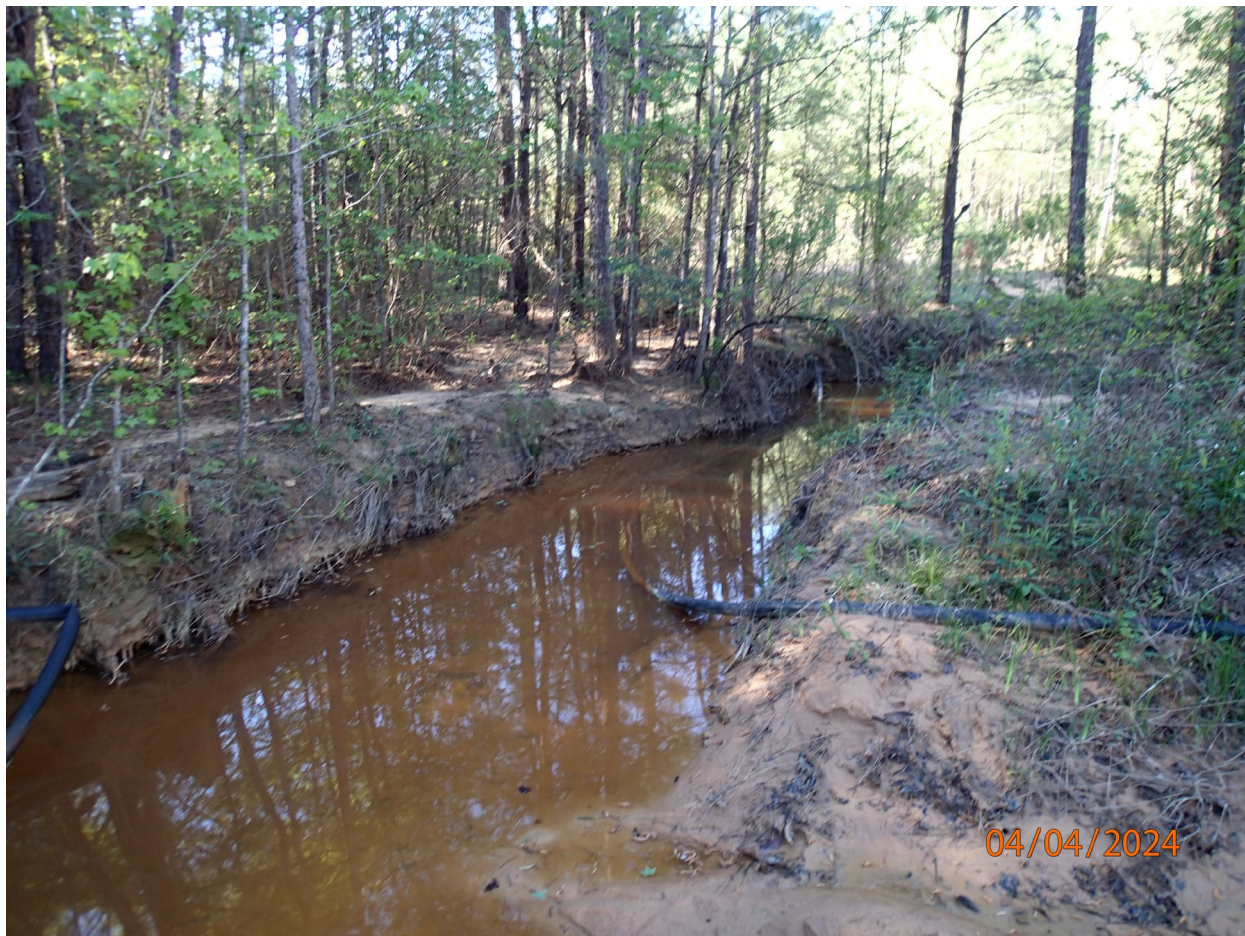
A Total Dissolved Solids (TDS) reading of about 300 mg/l was taken upstream of the facility confluence, see Photo No. 11 of the area sampled.

**Description:** Looking SW, this photo showed the receiving stream upstream of the area in Photo No. 10.

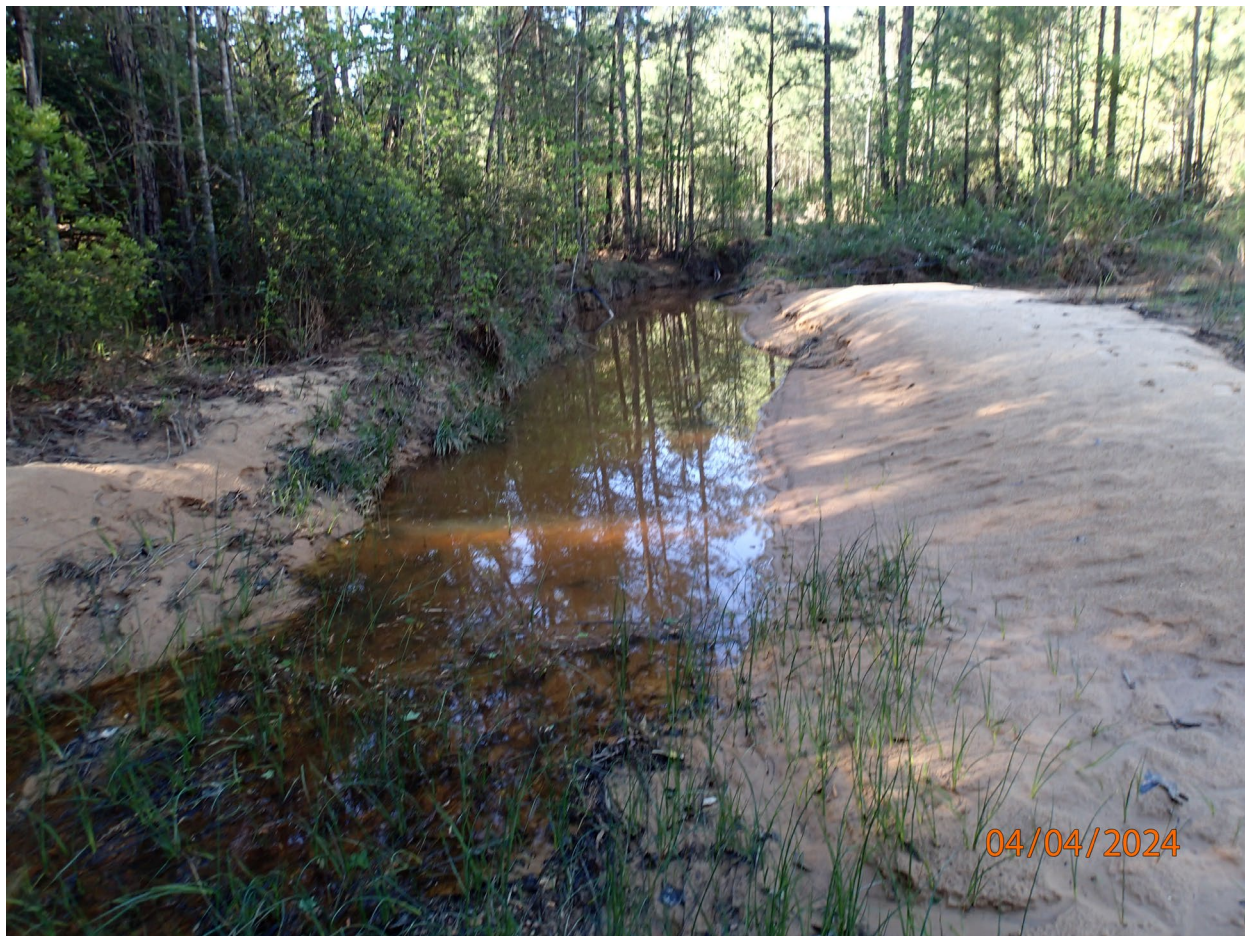
A TDS reading of about 475 mg/l was taken downstream of the deep pool adjacent to the facility, see Photo No. 12 of the area sampled.

**Description:** Looking S-SW, this photo showed the receiving stream downstream of the area in Photo No. 10.
