**Well Inspection**  
**Osage DNR / Environmental Protection Agency**  
**1201 Elm Street, Suite 500**  
**Dallas, Texas 75270**

| | | <b>Lease Name</b> | SECPSU (Kla-Da-Ing 1) | | |
| | | <b>Well ID</b> | 1-1 | | |
| <b>Inspection Reason</b> | MIT | <b>Responsible Company at Time of Inspection</b> | Grace Energy Management | | |

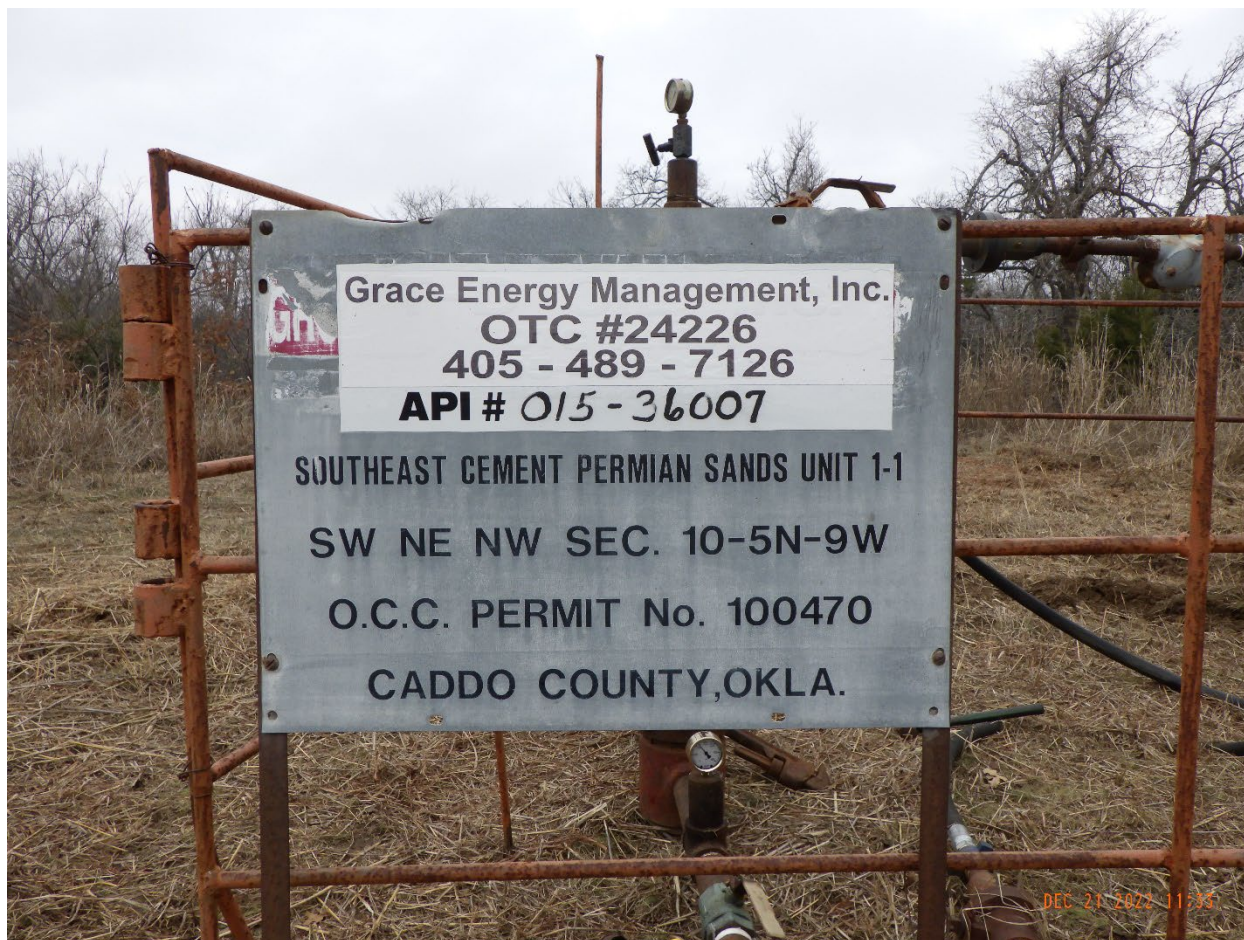
Photo No. 1

Description: OK0088000 well sign.

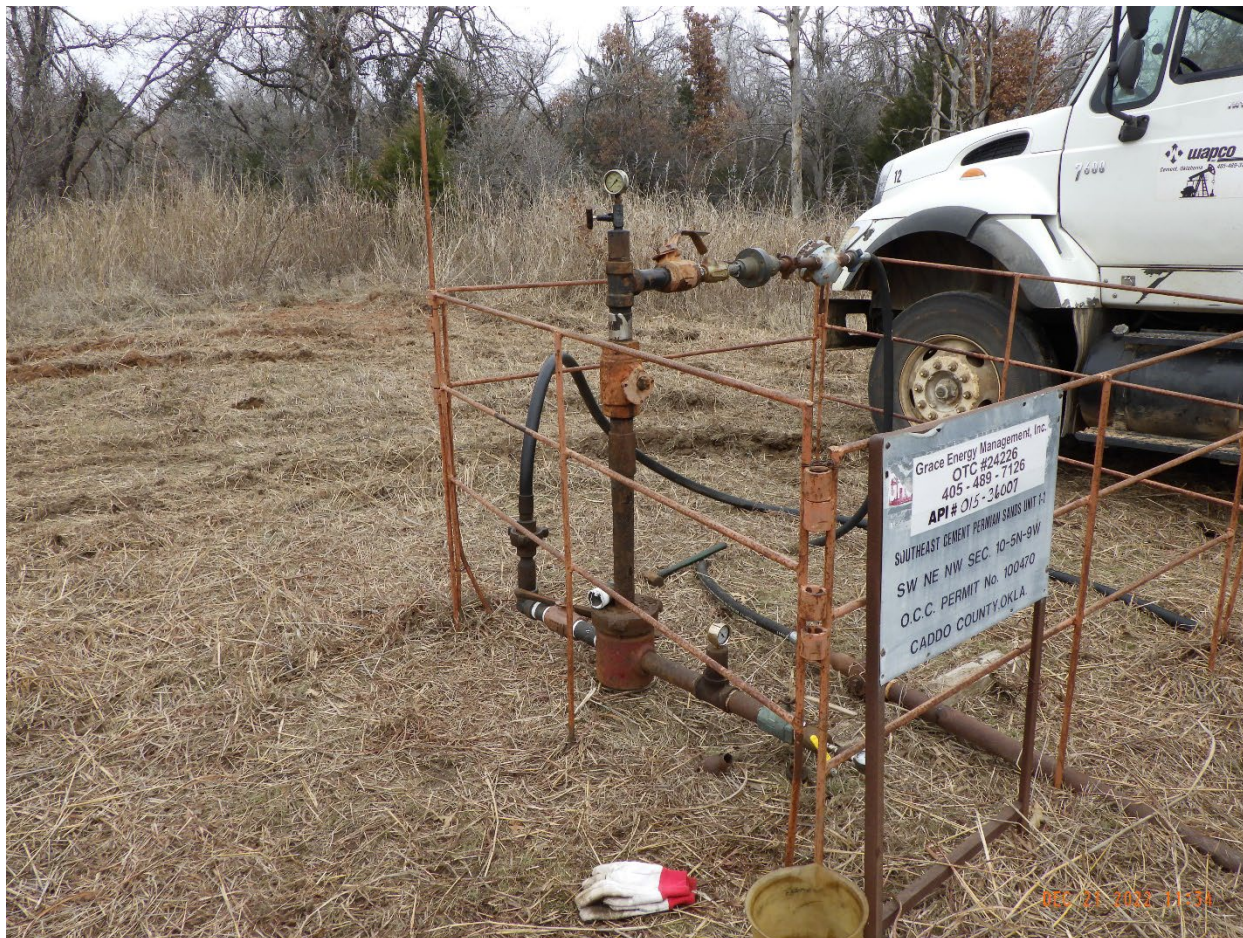
Photo No. 2

| <b>Inspection Comments</b> | <p>Inspector witnessed Standard Annulus Pressure Test (SAPT) on well OK0088000. Pressure, hold OK. I observed no areas of concern at the time of the inspection. EPA enforcement staff will review inspection data to determine compliance with EPA UIC regulations.</p> <p>Initial: 220psi<br/> Mid: 220psi<br/> Final: 220psi<br/> Pressure Hold OK</p> <p>Total flowback: 7,500ml</p> | | | | |

**Description:** Well, OK0088000 with EPA gauge and bleeder assembly attached, well pressured and being observed during MIT.
