## Clean Water Act Section 404: Site Visit/Case Development

| Site Name | Har Shalom Cemetery | | | | |

CWA 404 Inspection  
Har Shalom Cemetery  
44 Hillside Avenue  
Airmont, Rockland County, NY

March 18, 2022

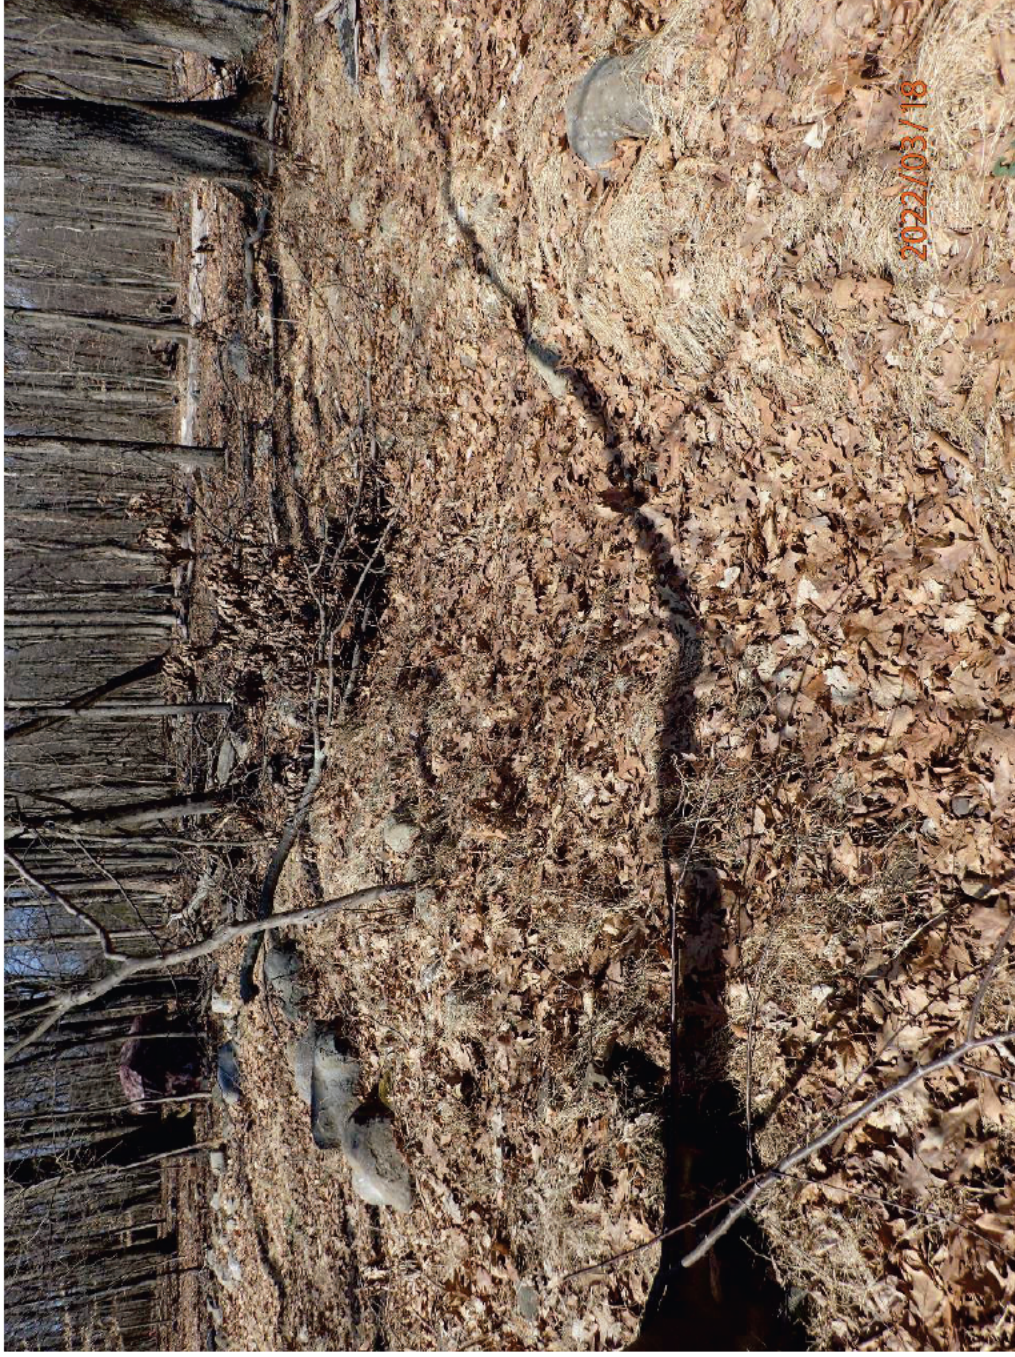
**Date:** 03/18/2022  
**Time:** 2:07 PM  
**Photographer:** SSA  
**Photo ID:** 1 – P3180001

Stream channel at Site; not  
flowing at time of inspection.

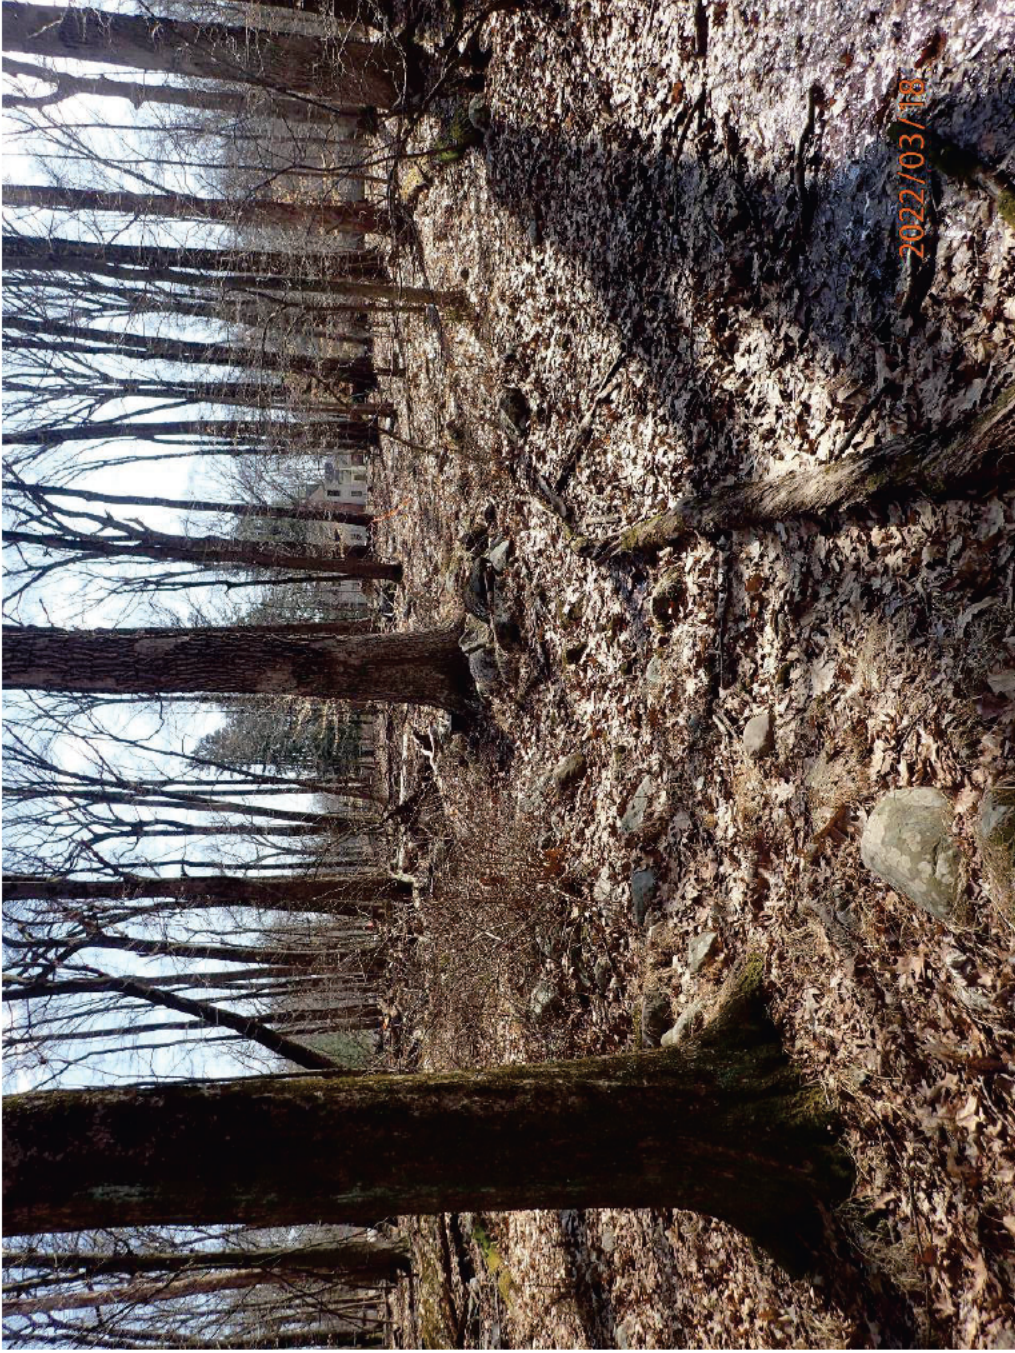
**Date:** 03/18/2022  
**Time:** 2:22 PM  
**Photographer:** SSA  
**Photo ID:** 2 – P3180002

**Description:**  
(1/3) Panorama

Stream exiting Wetland B

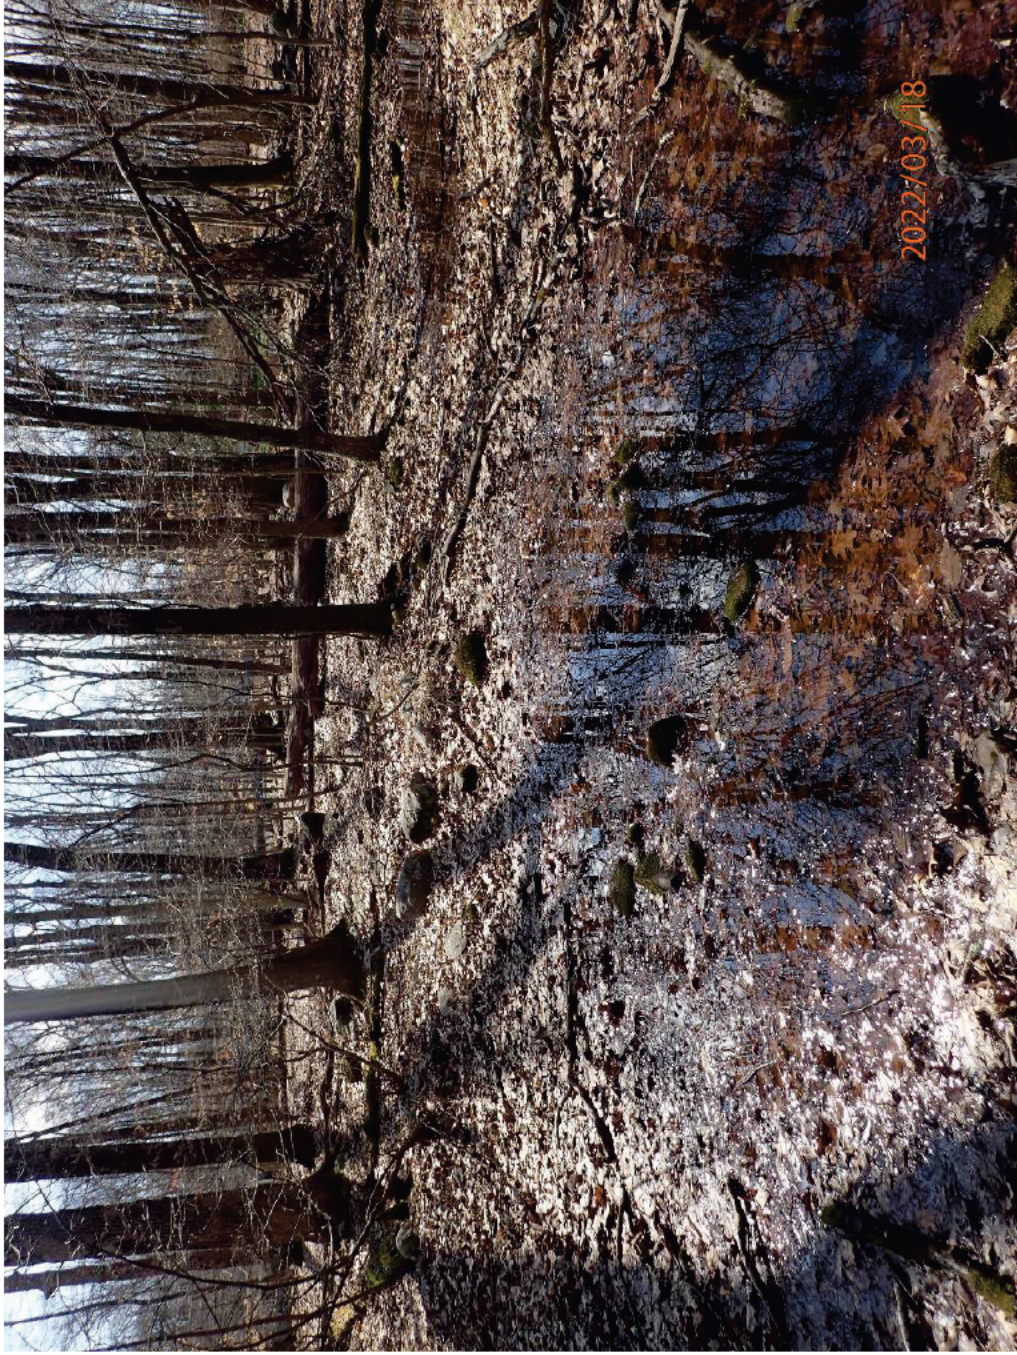
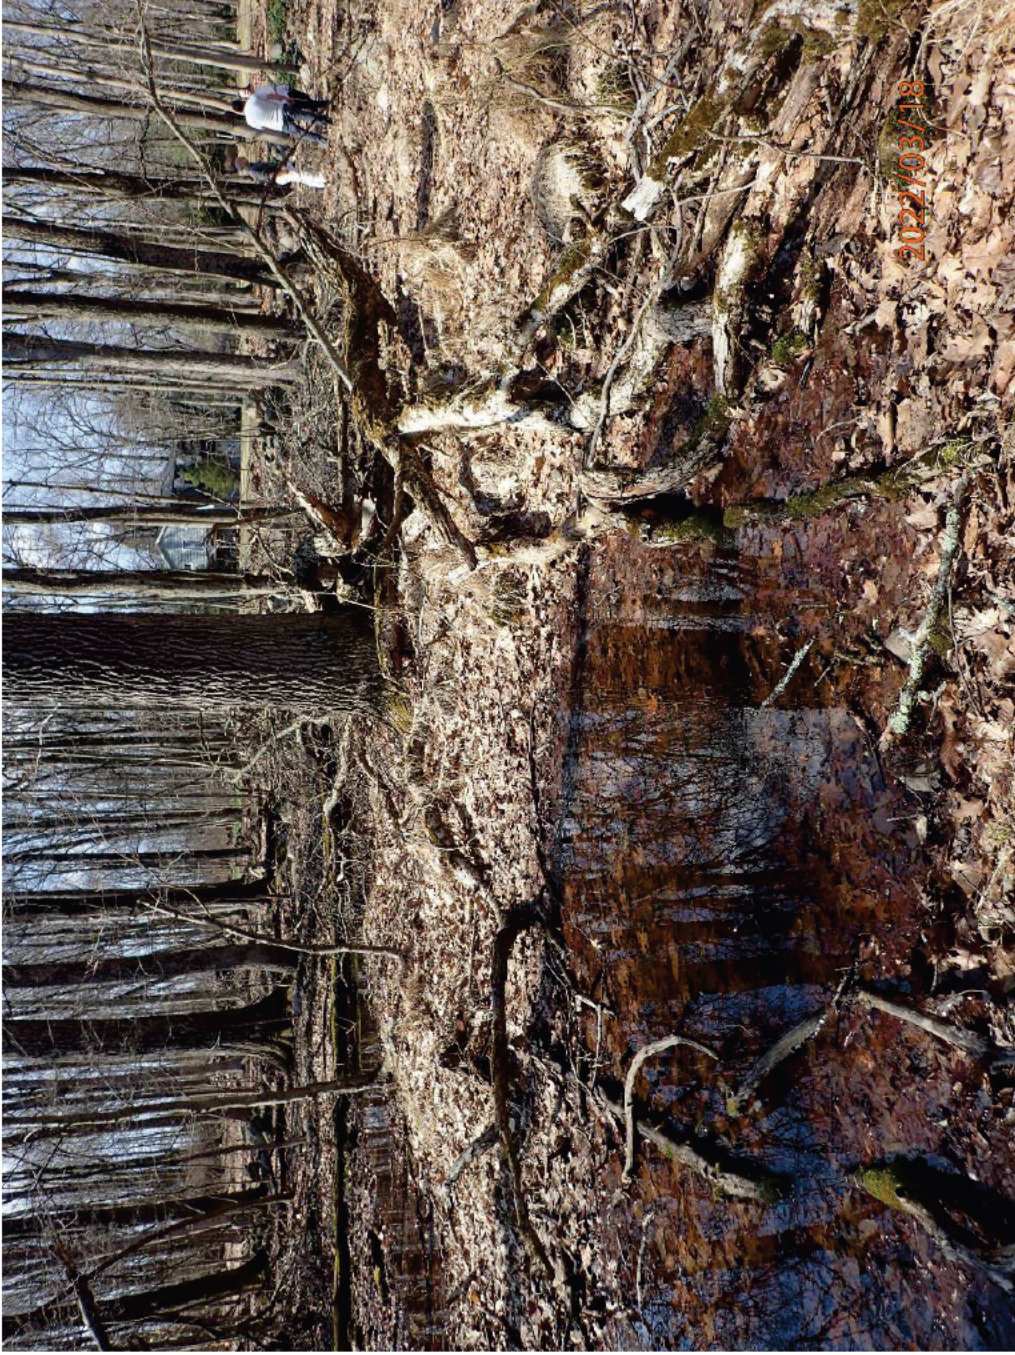
**Date:** 03/18/2022  
**Time:** 2:23 PM  
**Photographer:** SSA  
**Photo ID:** 3 – P3180003

**Description:**  
(2/3) Panorama

Wetland B

**Description:**  
(3/3) Panorama

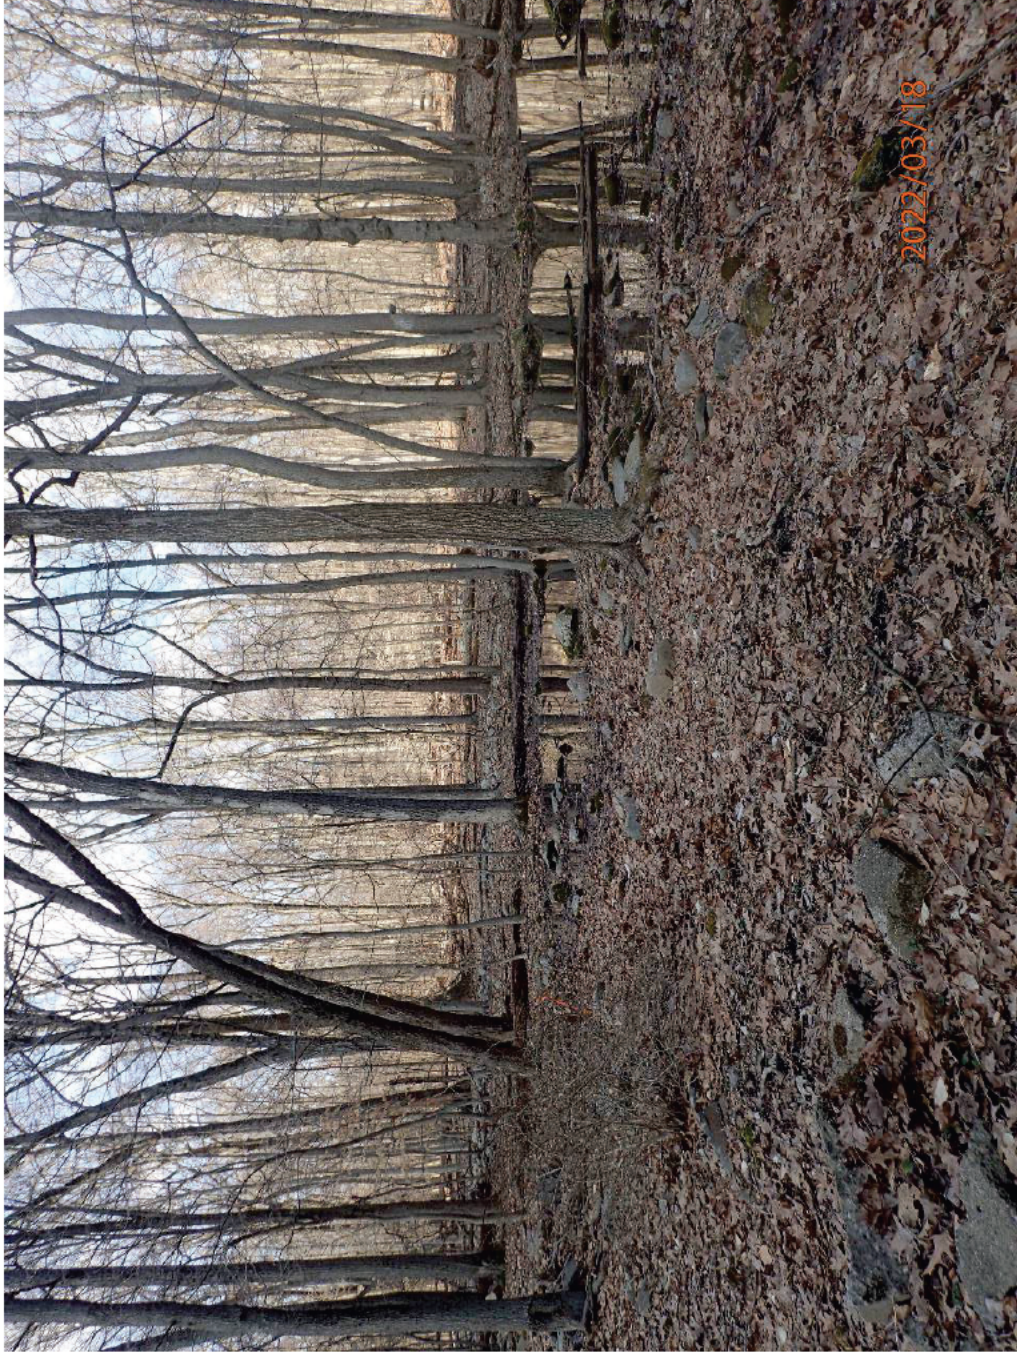
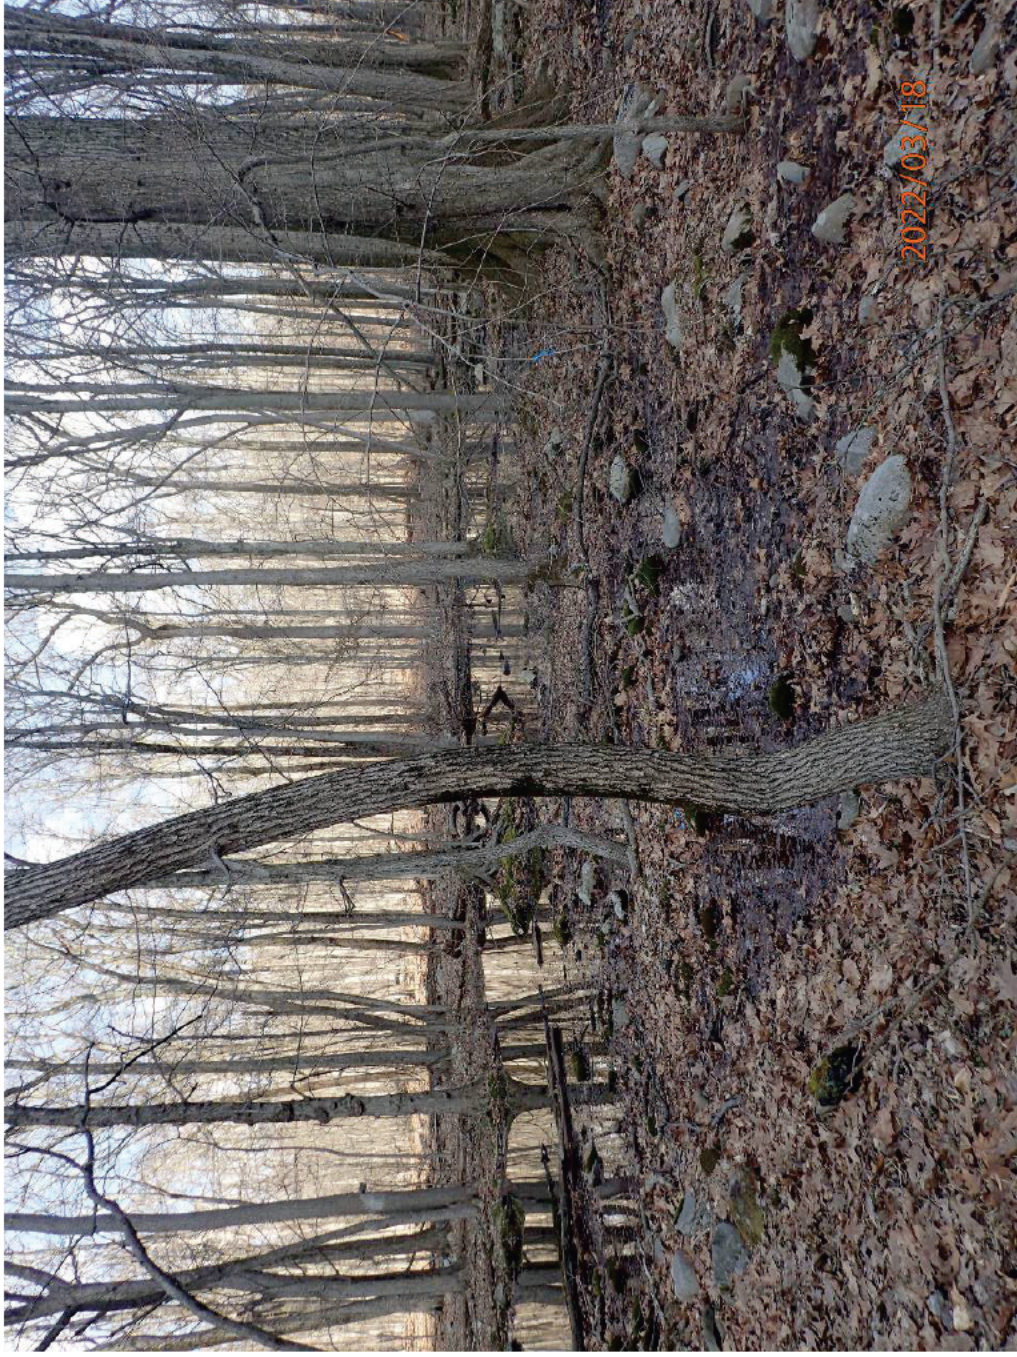
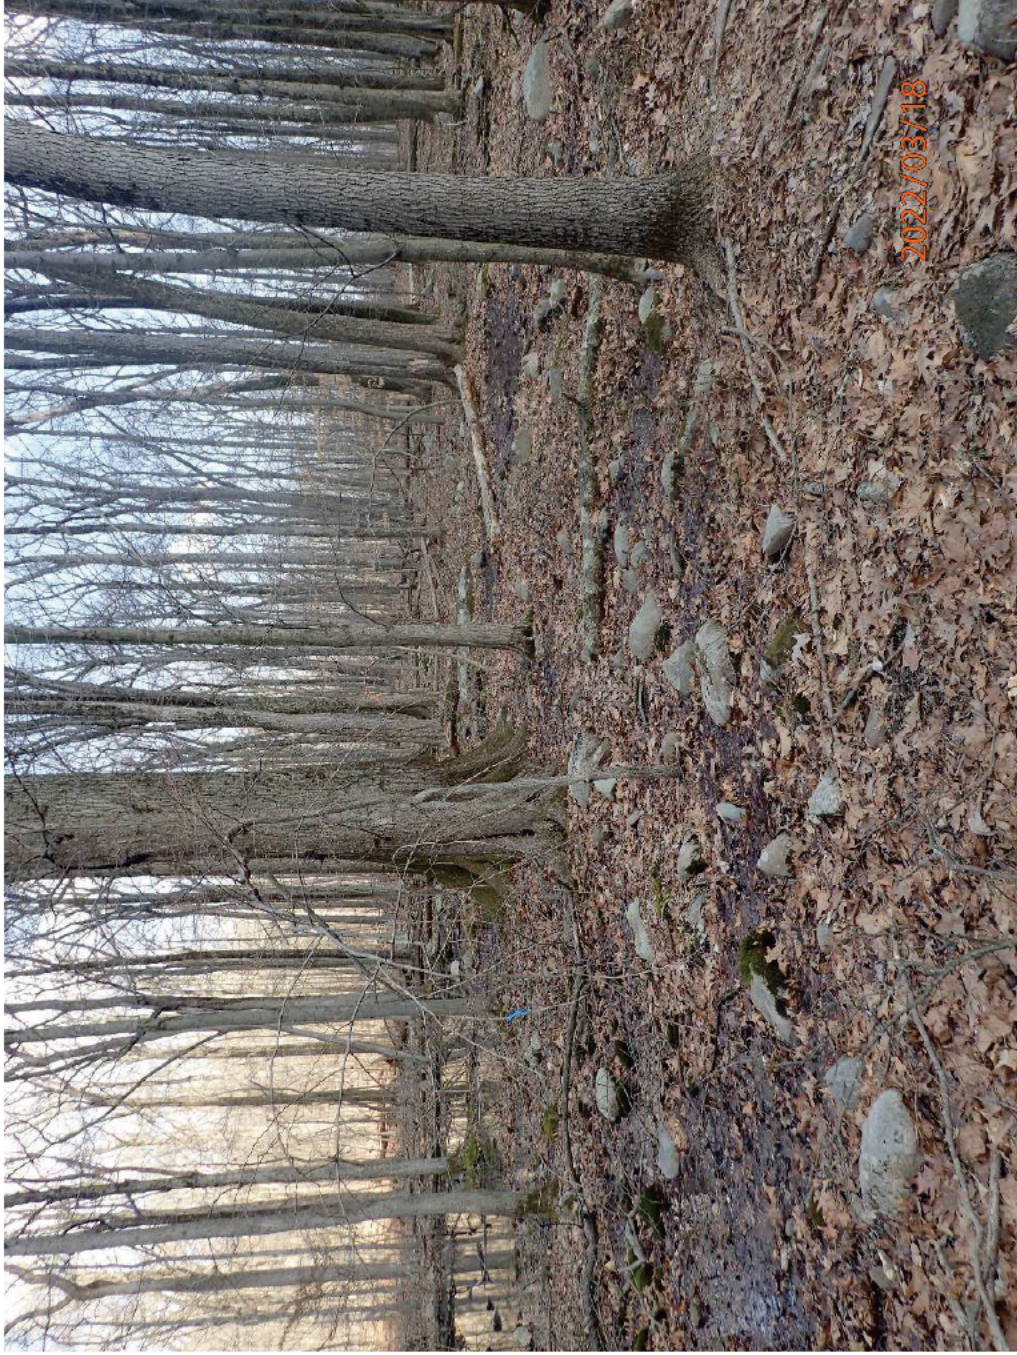
**Date:** 03/18/2022  
**Time:** 2:42 PM  
**Photographer:** SSA  
**Photo ID:** 5 – P3180005

**Description:**  
(1/3) Panorama

Wetland A

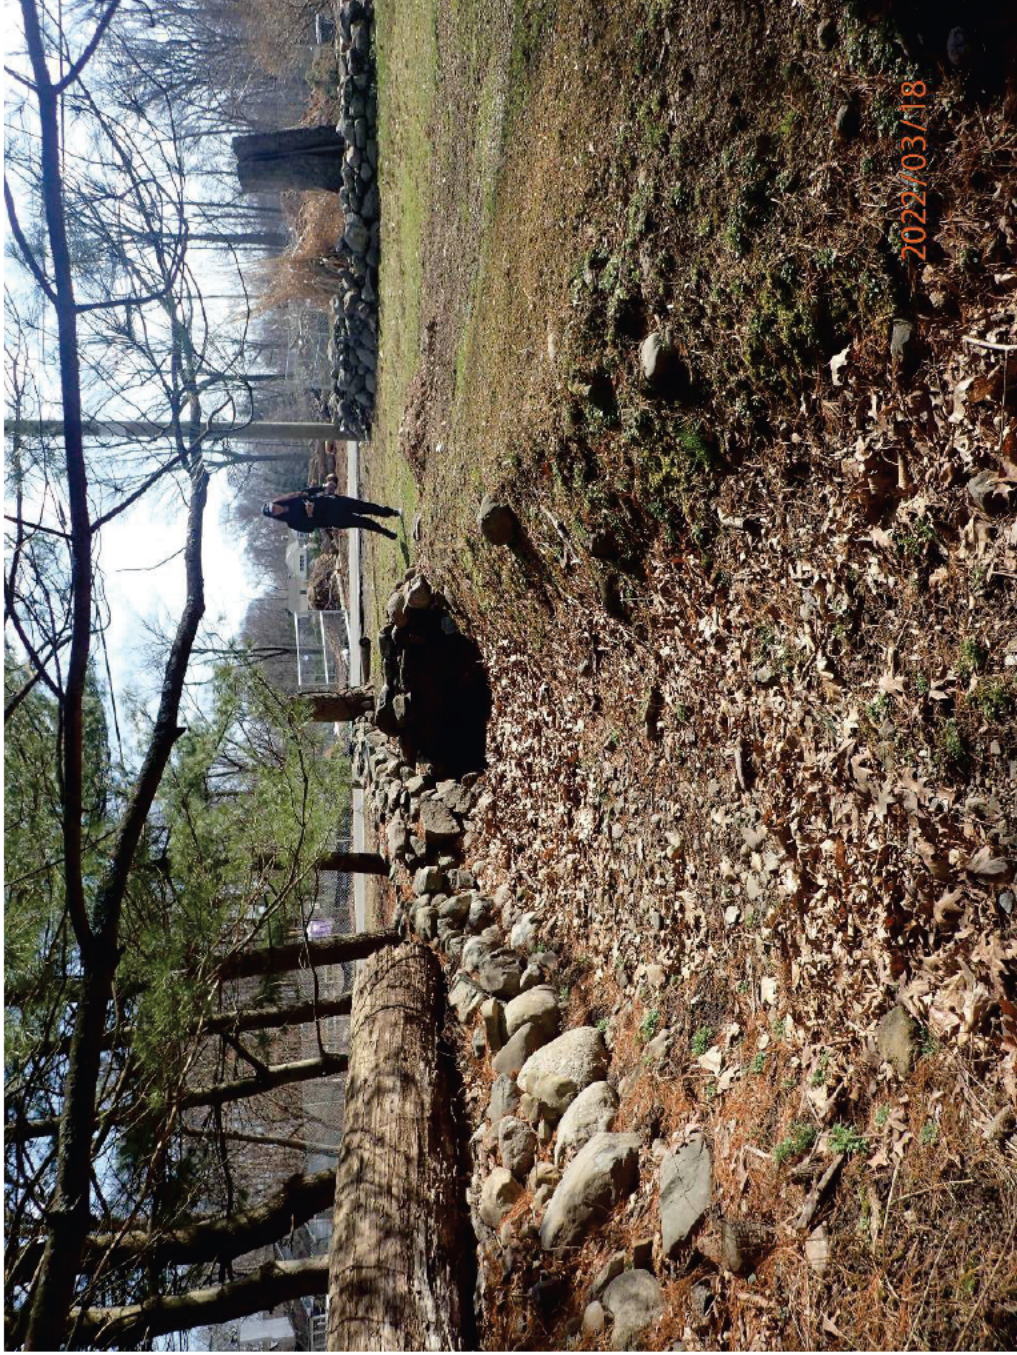
**Date:** 03/18/2022  
**Time:** 3:14 PM  
**Photographer:** SSA  
**Photo ID:** 8 – P3180008

Stream channel between properties

Channel was dry at time of inspection

Channel culverted under Hillside Avenue

Photo taken facing downstream

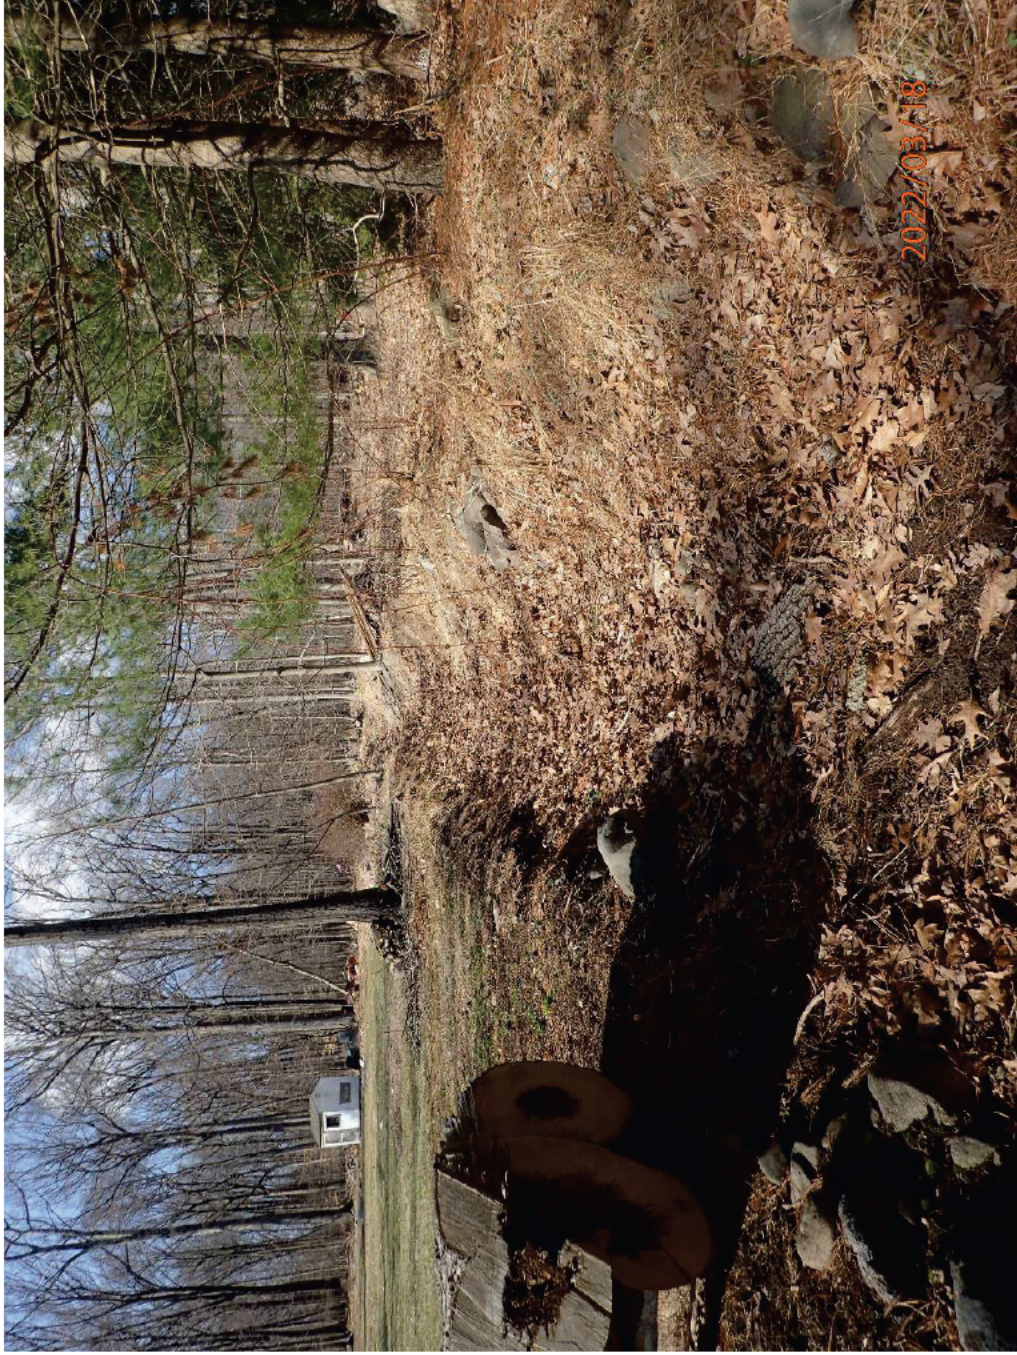
**Date:** 03/18/2022  
**Time:** 3:14 PM  
**Photographer:** SSA  
**Photo ID:** 9 – P3180009

Stream channel between properties

Channel was dry at time of inspection

Channel culverted under Hillside Avenue

Photo taken facing upstream

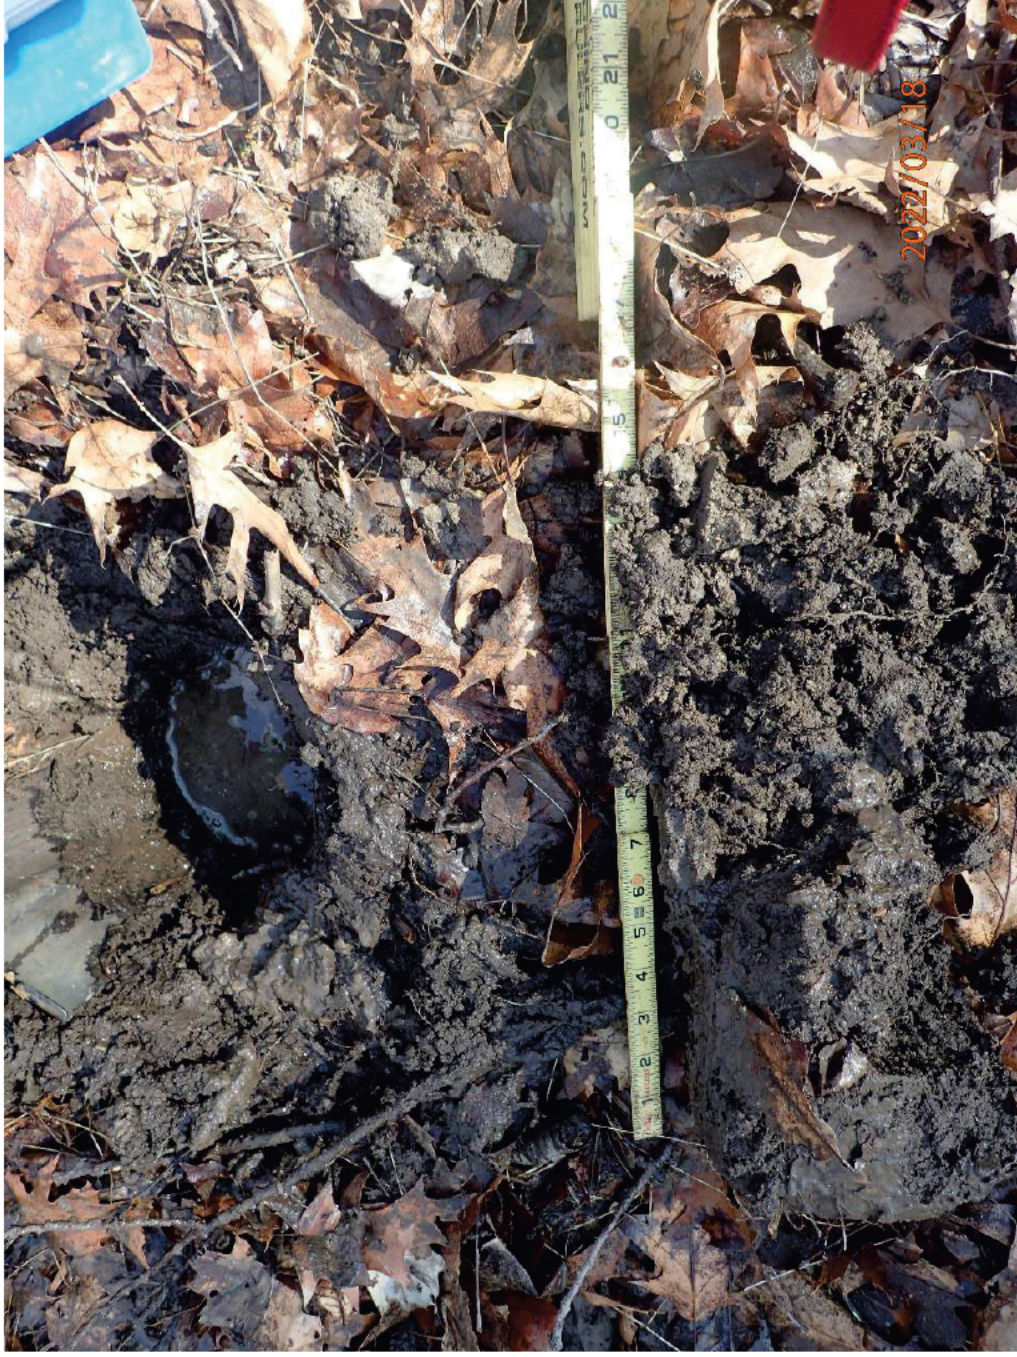
**Date:** 03/18/2022  
**Time:** 3:49 PM  
**Photographer:** SSA  
**Photo ID:** 10 – P3180010

Soil Profile – soil was not hydric

Water table 8" below surface

GPS Point taken

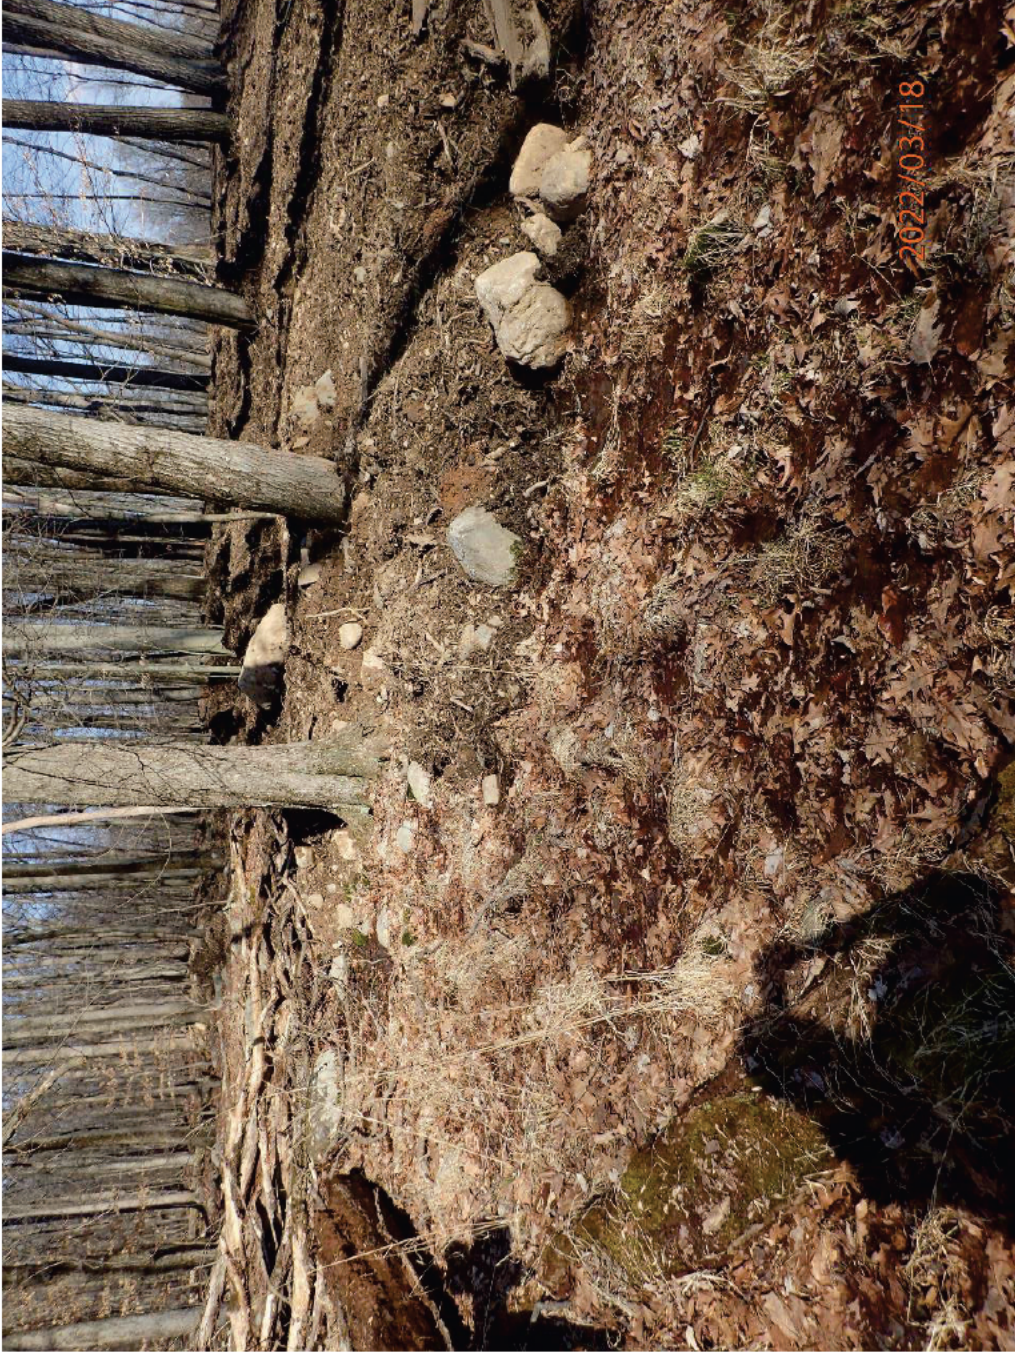
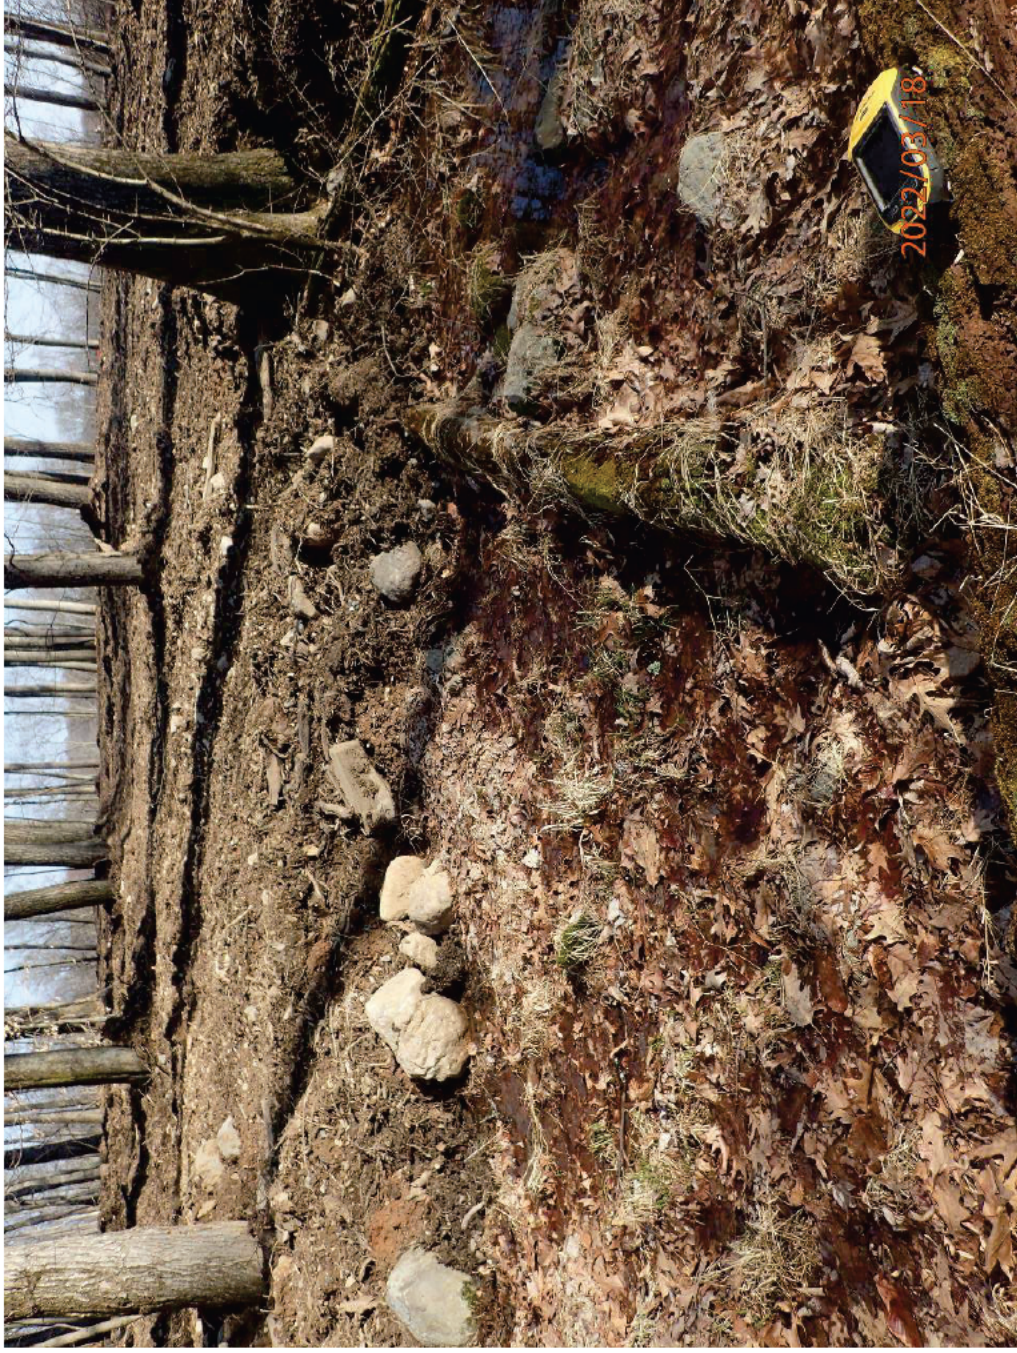
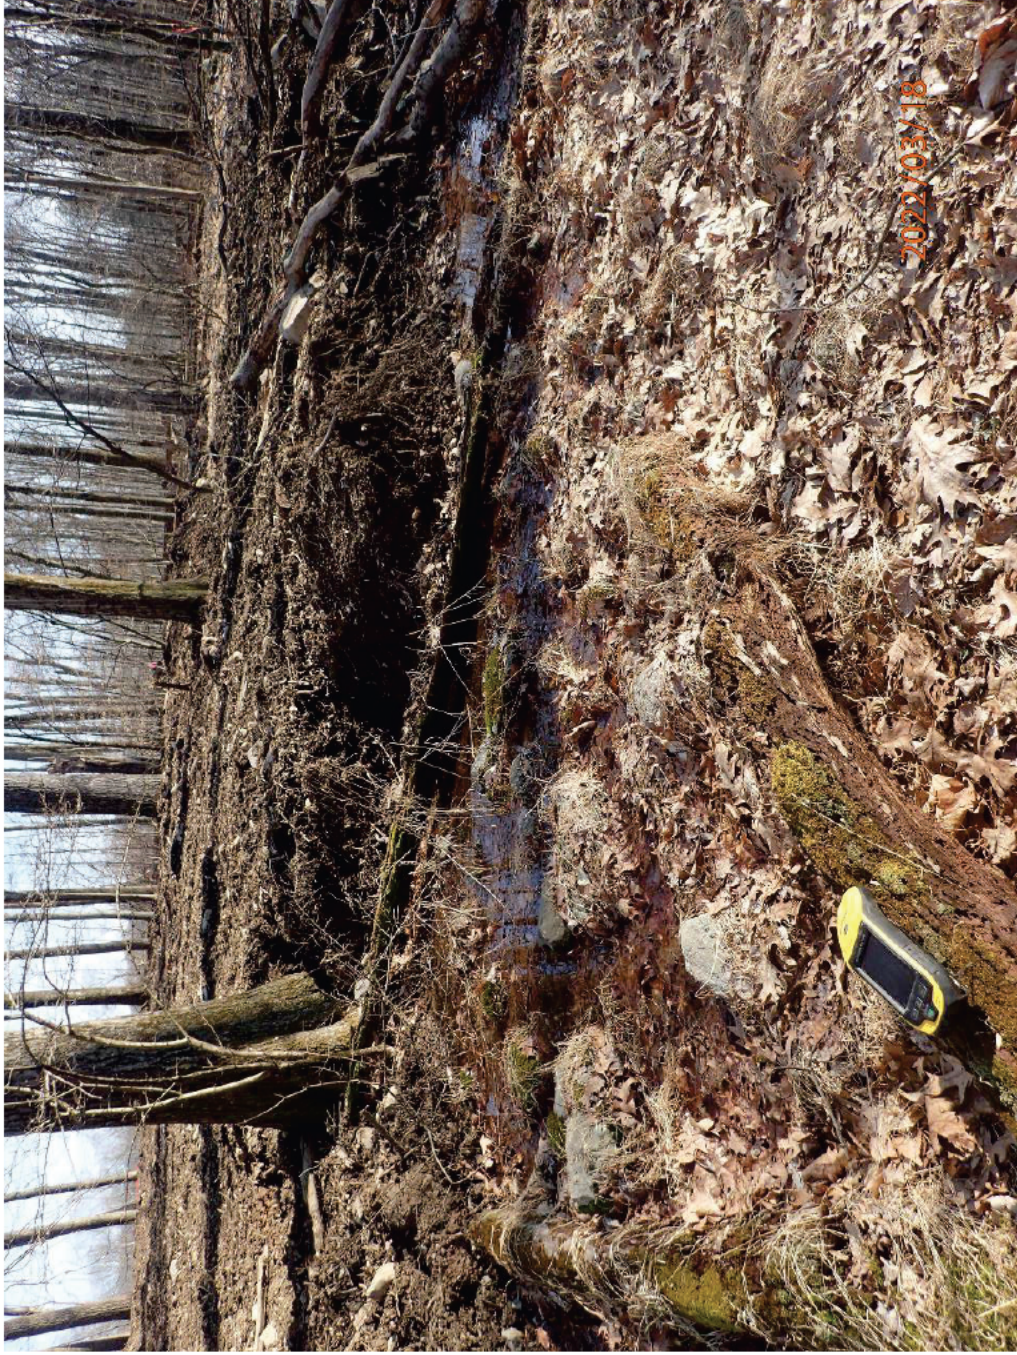
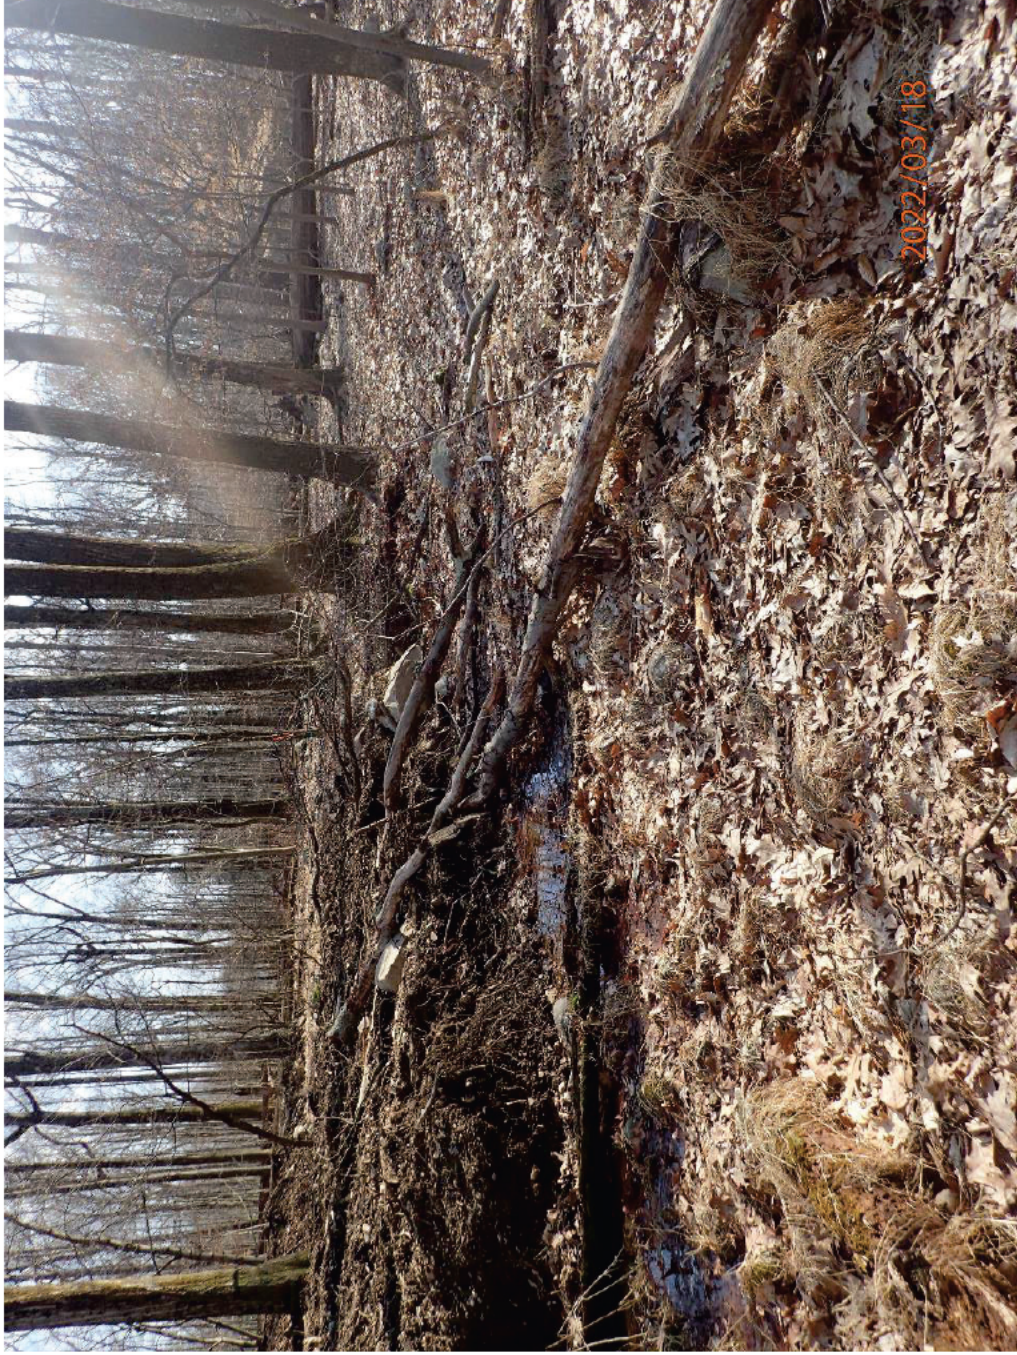
**Date:** 03/18/2022  
**Time:** 4:12 PM  
**Photographer:** SSA  
**Photo ID:** 11 – P3180011

| <b>Potential Issues of Concern Including Regulatory Citations</b><br>A potential wetland area and stream that may have been missed during the initial delineation were potentially filled with several feet of wood chips, soil, and rock. EPA informed the landowner and consultant that they should work with the Corps to resolve potential issues with the submitted wetland delineation and filling at the property. | | | |

**Description:**  
(1/4) Panorama

Potential Wetland Area adjacent  
to fill material. Standing water

GPS Point taken

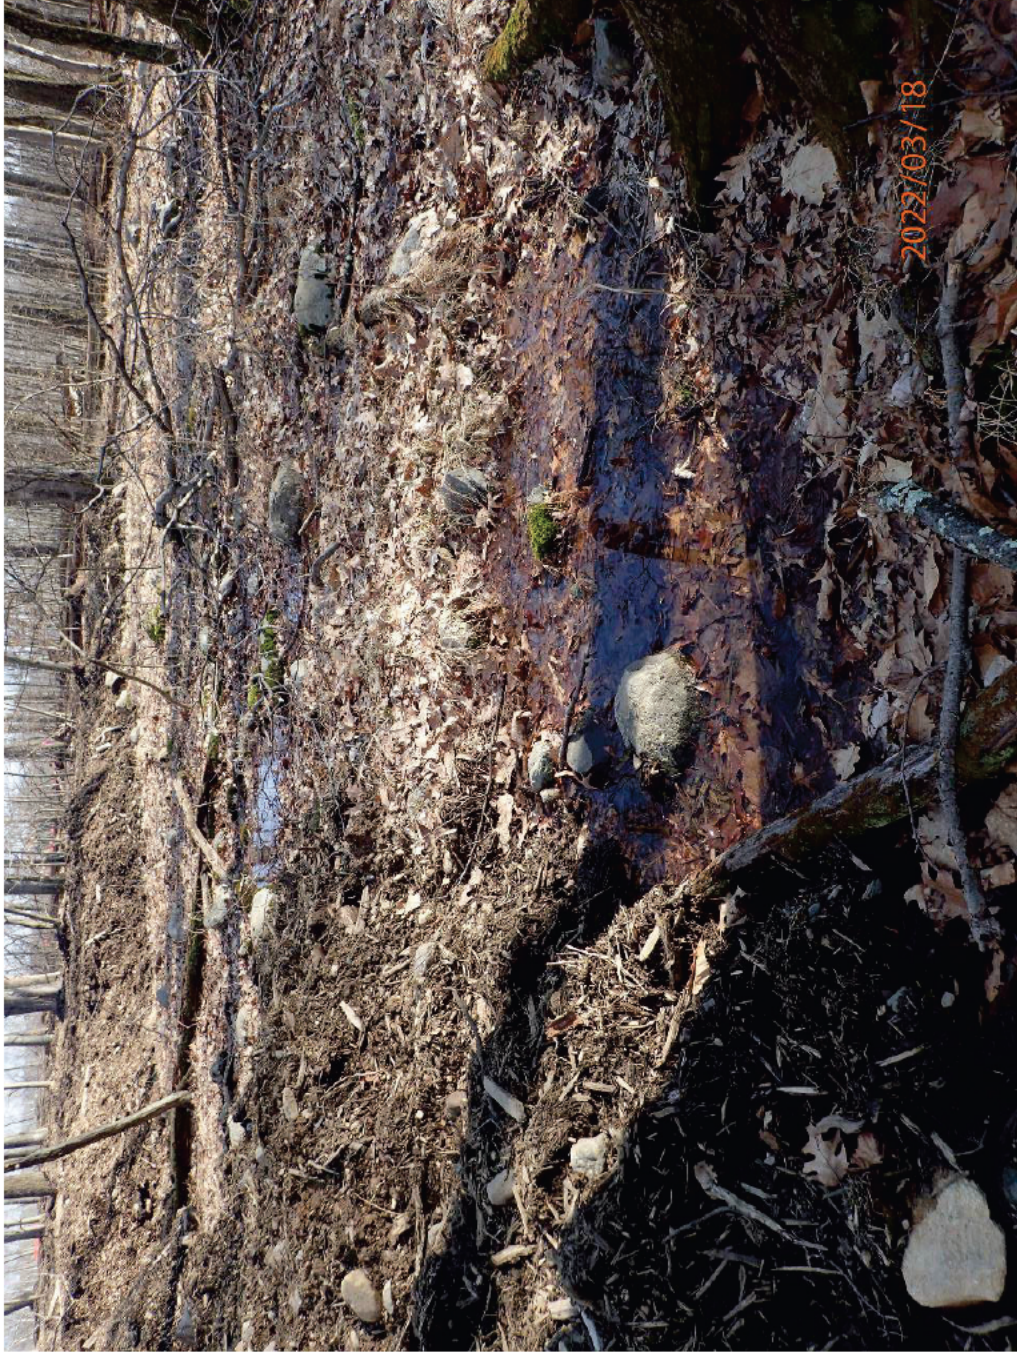
**Date:** 03/18/2022  
**Time:** 4:15 PM  
**Photographer:** SSA  
**Photo ID:** 15 – P3180015

Standing water adjacent to fill material
