## RCRA Inspection Report

Daikin America Inc.  
905 State Docks Road  
Decatur, Alabama 35601  
Morgan County

November 12, 2024, at 10:30 a.m. CST

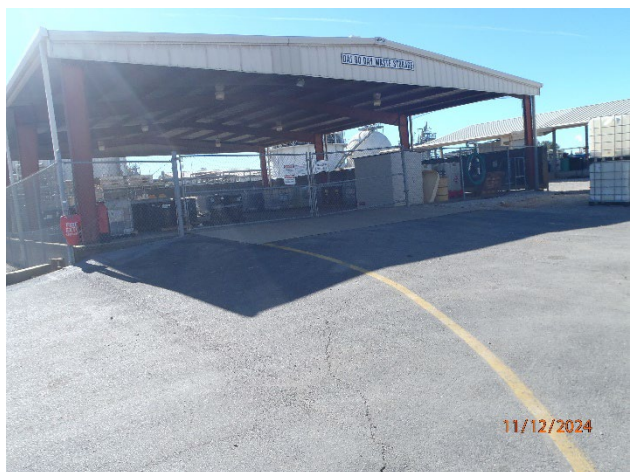
The tour began at the DAI less than 90-day central accumulation area (CAA) (Pictures 1-6). DAI manages a hazardous waste CAA in the Building B1 Gas Plant Control Area. The CAA was identified with a sign which read "danger, hazardous waste storage." DAI manages ignitable, corrosive, and toxic wastes in this CAA, and the inspectors did not observe "No Smoking" signs on the front gate or posted on the enclosure fencing. However, the front gate did have a "Storage Area Flammable Material" sign posted.

Picture 1 – DAI Hazardous Waste Storage Area

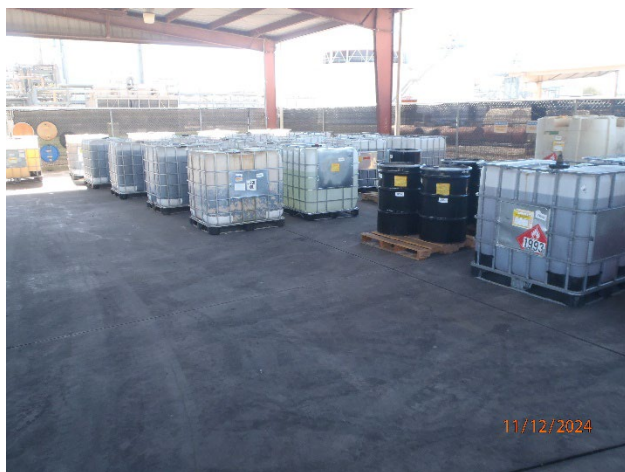
There were 21 250-gallon totes of hazardous waste containing either waste formic acid or waste methanol. The inspectors also observed four 55-gallon containers of fluoroalkylacrylate polymer, Unidyne B-12 solids, and Methane/terpene wastes. All containers were observed, closed, labeled "Hazardous Waste," labeled with a hazard identification, and dated. No issues were observed in this area and the oldest hazardous waste container was dated October 17, 2024.

Picture 4 – Hazardous Waste Storage Area - HW

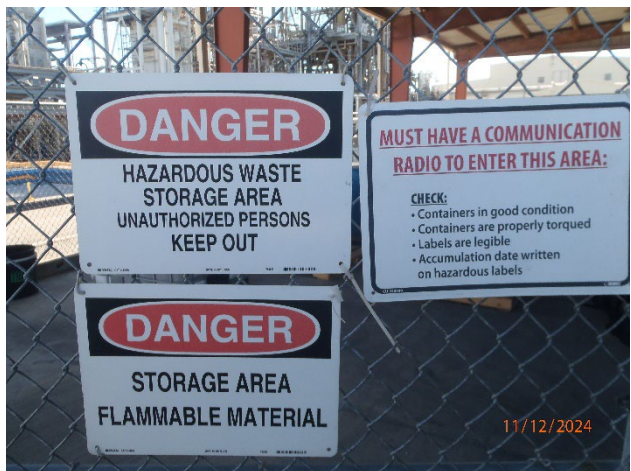
Picture 2 – Hazardous Waste Storage Area

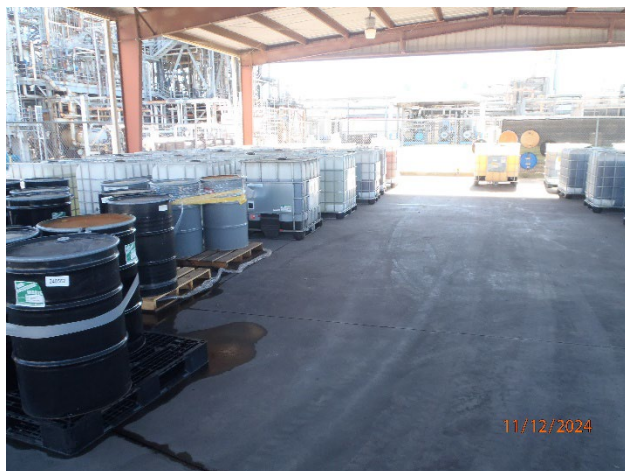
The inspectors observed the CAA was divided into two areas containing non-hazardous and hazardous wastes. There were 17 55-gallon non-hazardous waste containers, one blue 55-gallon container of AFF solution, 13 used oil and/or used oil debris containers in 55-gallon containers, four used oil totes, and one aerosol can puncture system on a 55-gallon container. All containers in this area were observed closed, labeled, and stored on wooden pallets.

Picture 5 – Hazardous Waste Storage Area – non-HW

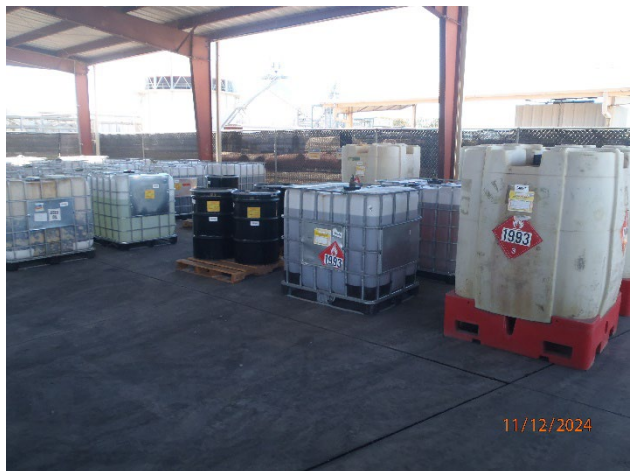
Picture 3 – Hazardous Waste Storage Area – HW

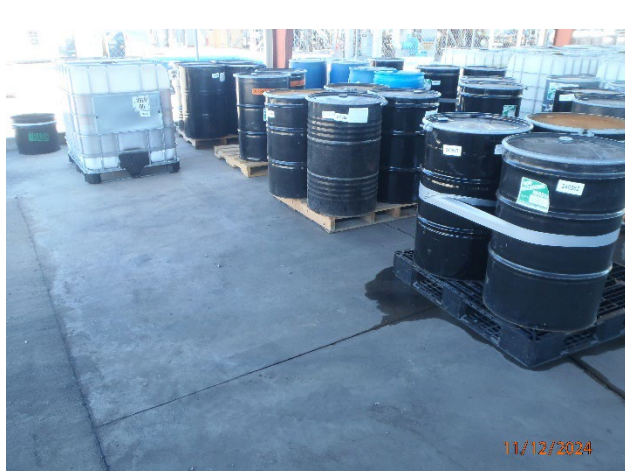
Picture 6 – Hazardous Waste Storage Area – non-HW

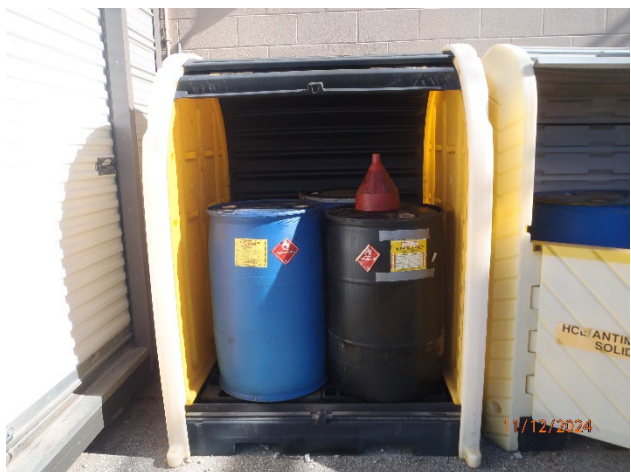
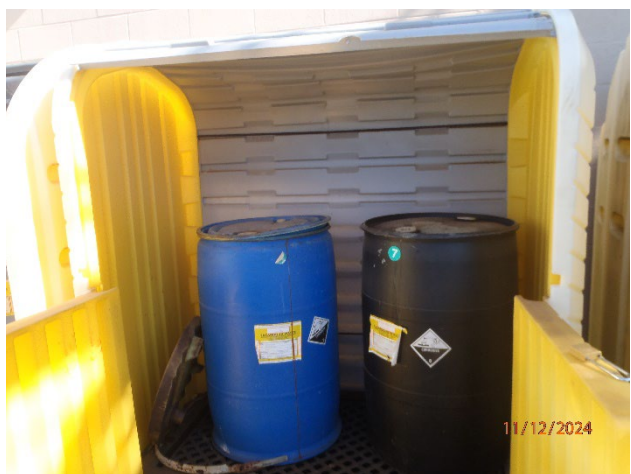
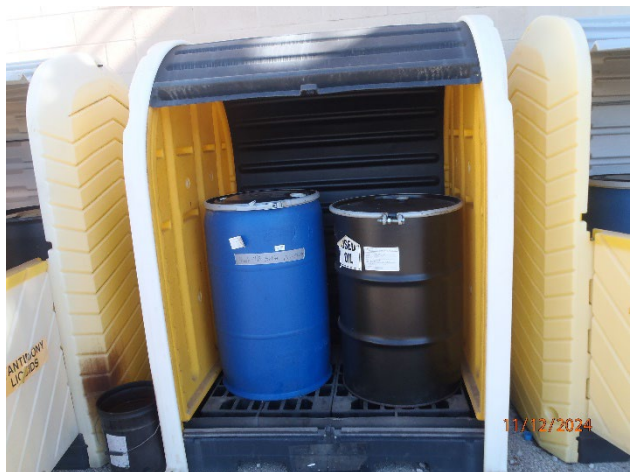
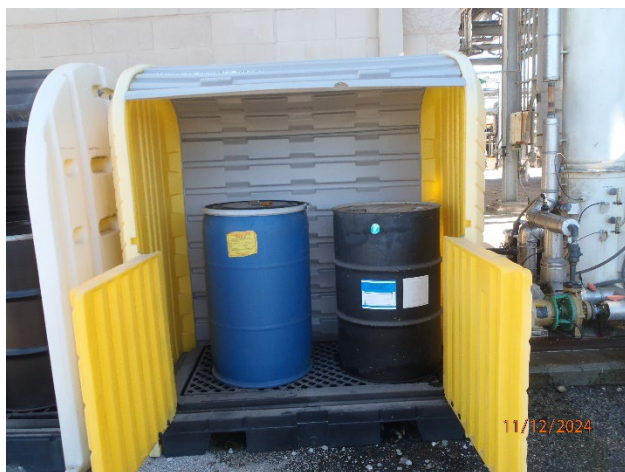
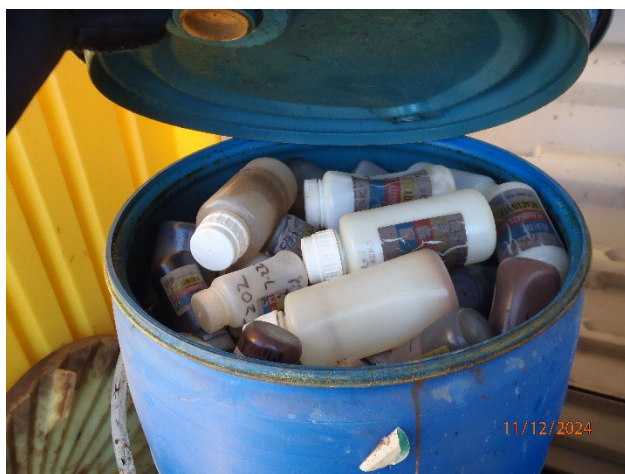
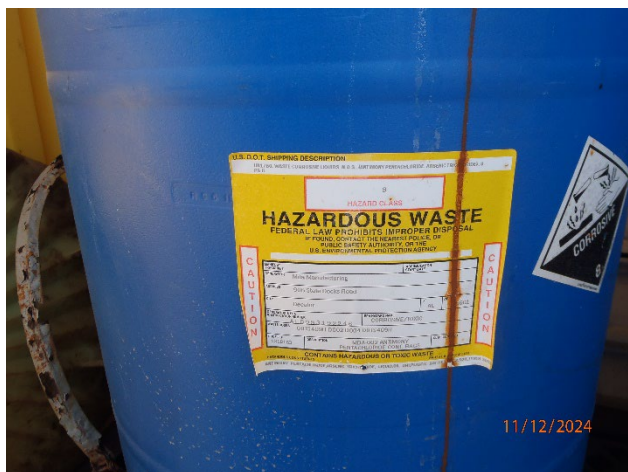
The B1 TFE Plant satellite accumulation areas were located near the CAA. The inspectors observed four yellow clamshells with secondary containment that were locked (Pictures 7-13). The containers inside the clamshells were marked with waste profile numbers, labeled with the waste code, were labeled "Hazardous Waste," and identified with a hazard identification. Unless otherwise noted, the containers were closed.

Picture 7 – BI TFE Plant SAAs

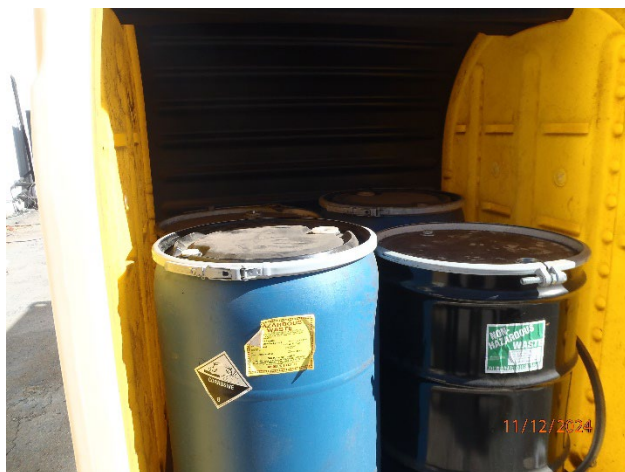
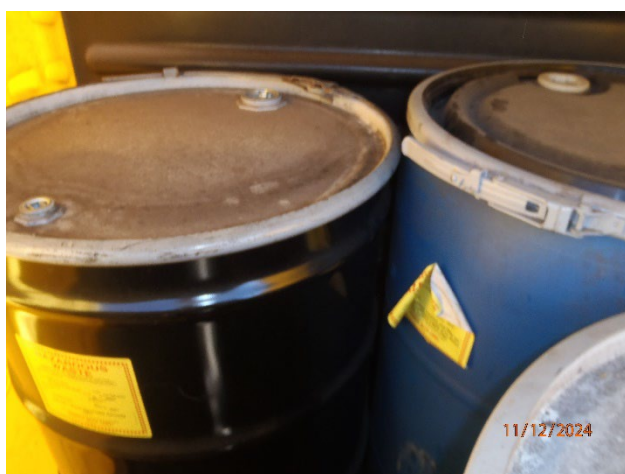
The Maintenance Shop Area had a yellow SAA clamshell outside of the shop. The clamshell held three 55-gallon hazardous waste containers and one non-hazardous waste container (Pictures 16-17). The hazardous waste containers inside the clamshell were marked with waste profile

number, labeled with the waste code and the words "Hazardous Waste," and identified with a hazard identification. Unless otherwise noted, the containers were closed.

Picture 16 – Maintenance Shop Outside SAA

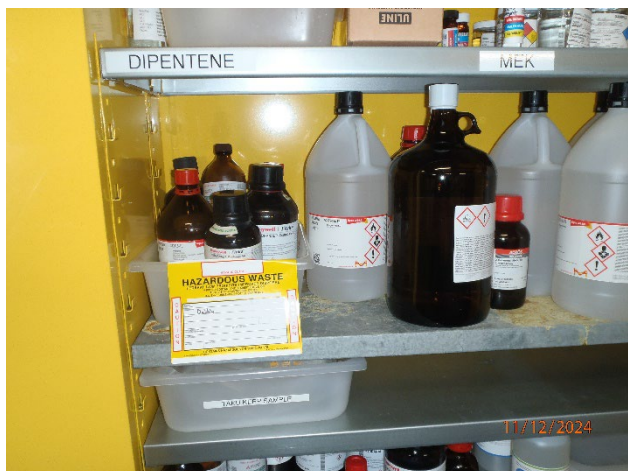
The J1/J2 lab services both DAI and MDA. The inspectors observed a catalyst sample container in a fume hood incorrectly labeled as “Wasted.” Arash Ghoja stated that the container was a sample and not waste. Arash Ghoja had the bottle immediately corrected by removing the word “Wasted.” A yellow flammable storage cabinet was located inside the lab. At the time of the inspection the inspectors observed a medium sized plastic tub with six bottles ranging from 0.5 liters to 1 liter was marked “DISPOSE” (Pictures 14-15). The bottles were not marked with waste profile numbers, labeled with the waste codes, were not labeled with the words “Hazardous Waste,” and were not identified with hazard identifications. However, the containers were closed. In the past, the facility had not identified the tub with bottles as a SAA. Arash Ghoja at the request of the inspectors placed a hazardous waste label on the tub.

Picture 15 – J1 Lab Flammable Cabinet SAA - label

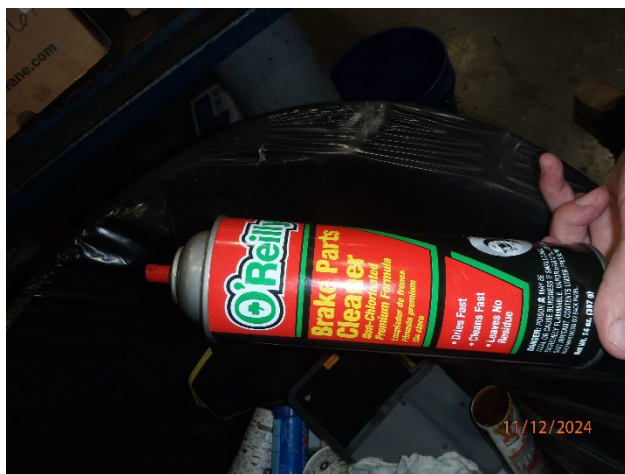
Inside the Maintenance Shop, the inspectors observed a spent aerosol can of O'Reilly Brake Parts Cleaner in the trash can (Picture 18). John Jackson immediately retrieved the spent aerosol can for proper disposal. The inspectors also observed a 7.5-gallon white container of unknown green liquid in a corner (Picture 19). The container was not closed and not labeled. Arash Ghoja immediately had maintenance personnel retrieve the container. Arash Ghoja stated that personnel believed it to be Simple Green parts washer liquid brought in by a former employee.

Inside the Maintenance Shop, a spent aerosol can of O’Reilly Brake Parts Cleaner was found in the trash can.

Picture 18 –Maintenance Shop Inside trashcan – spent aerosol can

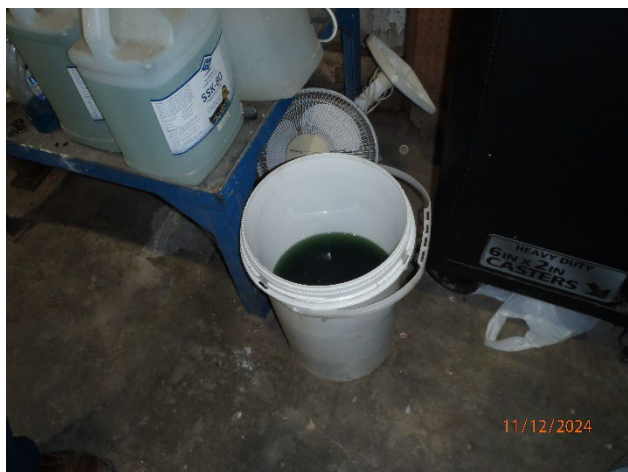
The inspectors also observed a 7.5-gallon white container of unknown green liquid in a corner. The container was not closed and not labeled.

Picture 19 –Maintenance Shop Inside – 5-gal container of identified as Simple Green

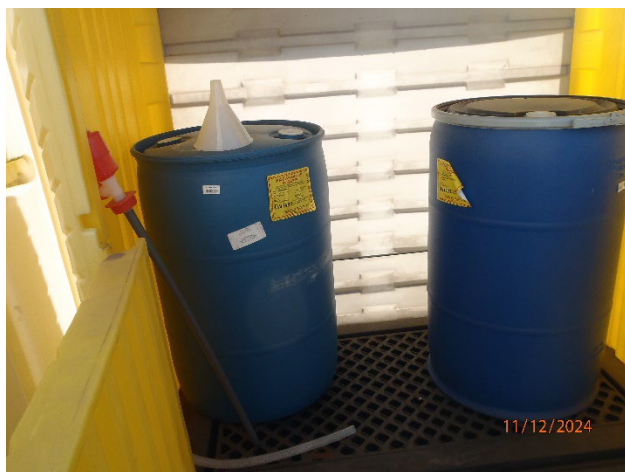
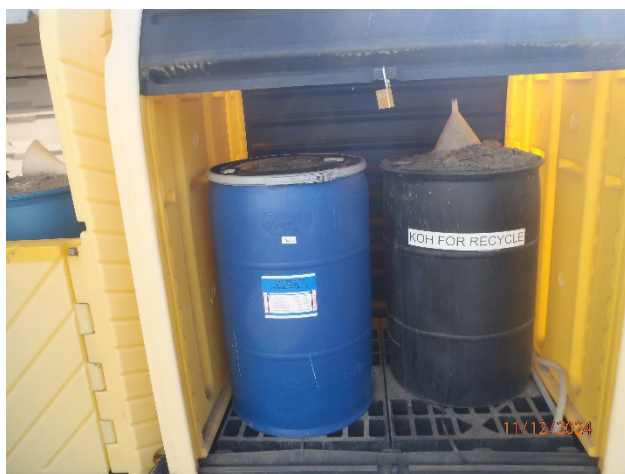
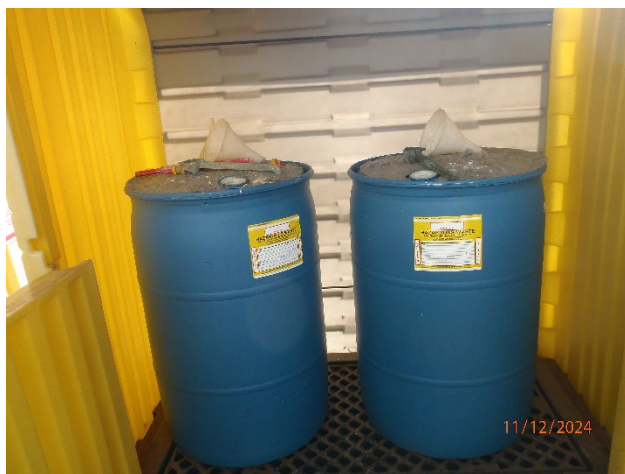
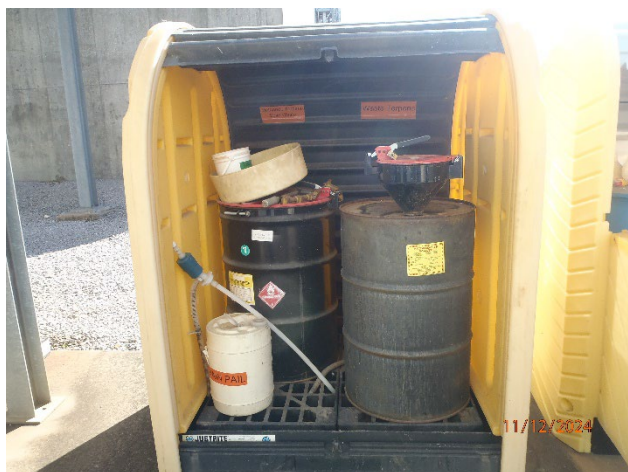
OPTOOL Unidyne area had four yellow clamshells SAAs (Pictures 22-25). The containers inside the clamshells were marked with waste profile number, labeled with the waste code and the words "Hazardous Waste," and identified with a hazard identification. Unless otherwise noted, the containers were closed.

Picture 22 – OPTOOL SAA#1

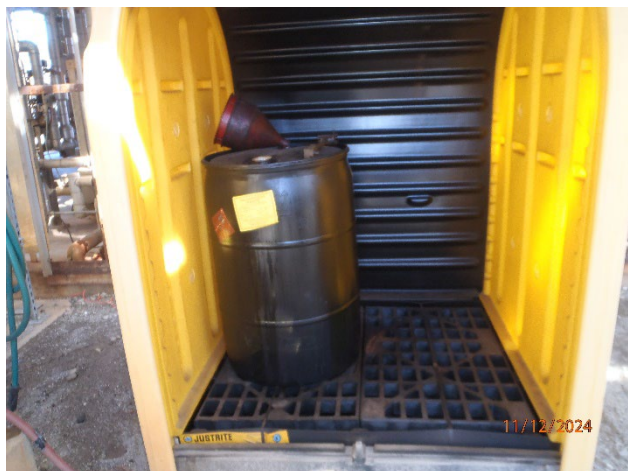
The inspectors toured the N1 TFE plant and observed a yellow clamshell with a 55-gallon container of DAI-005 (methanol/terpene liquid) (Picture 20). The container inside the clamshell was marked with waste profile number, labeled with the waste code, was labeled with the words "Hazardous Waste," identified with a hazard identification, and closed. At the time of the inspection, the inspectors observed overspill inside the secondary containment that needed to be cleaned out (Picture 21).

Picture 20 – TFE N1 Plant SAA

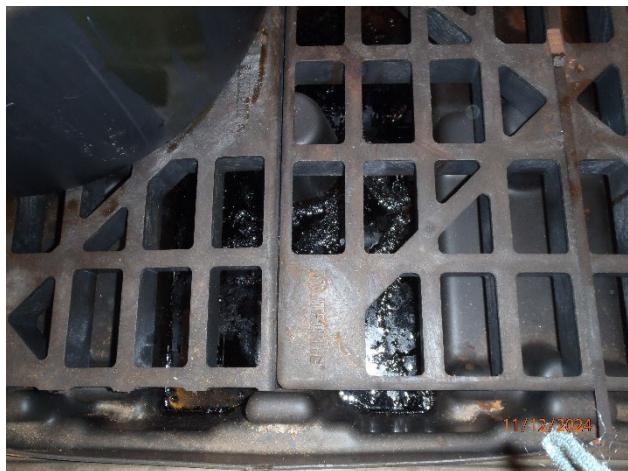
Picture 21 – TFE N1 Plant SAA secondary containment needs cleanout

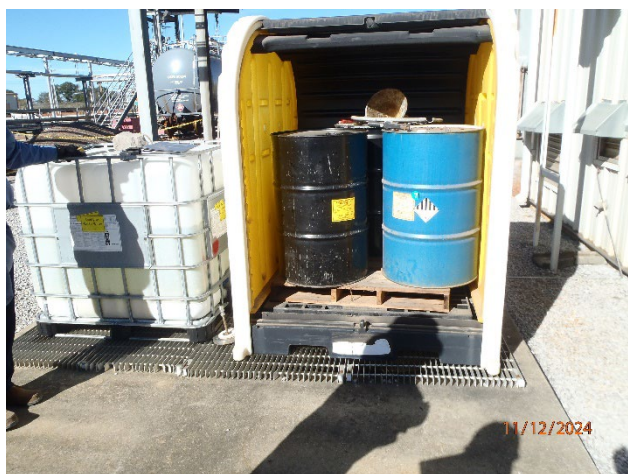
The inspectors observed a yellow clamshell with a black 55-gallon container of DAI-238, a blue 55-gallon container of DAI-095 and an empty container (Picture 26). The containers inside the clamshell were marked with waste profile numbers, labeled with the waste codes, had the hazardous waste names listed, identified with hazard identifications, and closed. Beside the clamshell was a 275-gallon tote of Unidyne wastewater. Arash Ghoja stated that the wastewater was non-hazardous.

Picture 26 – SMT Unidyne SAA

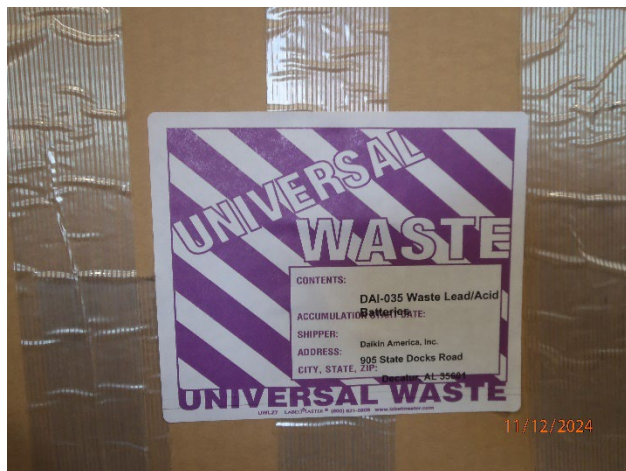
The E15 Building was a new addition to the facility. It currently houses the universal waste, used oil container, and lubricant oils. The inspectors observed the following universal waste stored on shelves (Pictures 27-29):

Picture 28 – E15 Building UW Storage Area  
– not dated

John Jackson immediately called the front office and obtained the missing date of August 30, 2024, for the universal waste batteries.

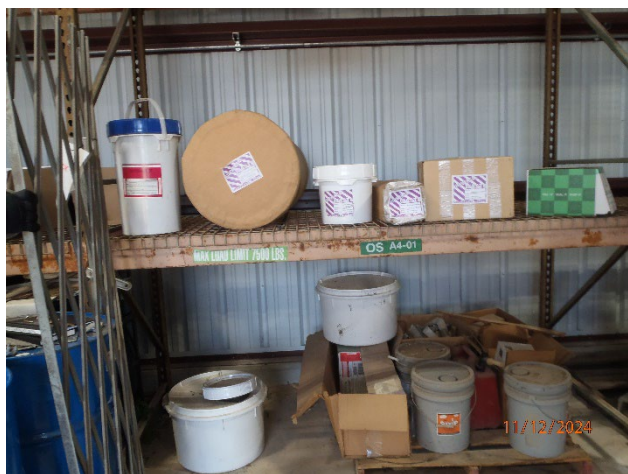
Picture 27 – E15 Building UW Storage Area

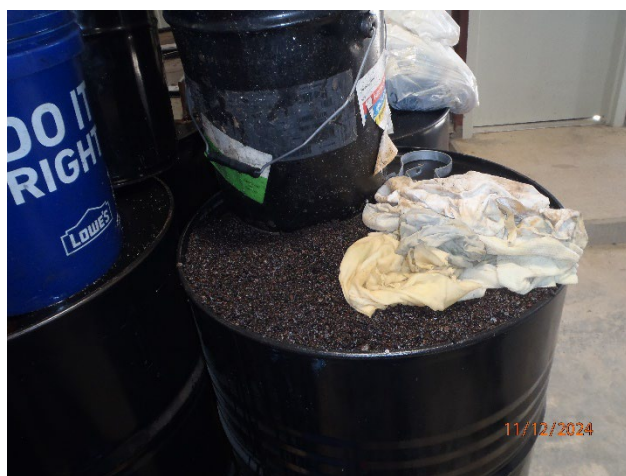
Next to the building entrance were 5-gallon and 55-gallon used oil containers (Pictures 30-39). At the time of the inspection, the inspectors observed the following:

Picture 30 – E15 Building Used Oil  
containers and release

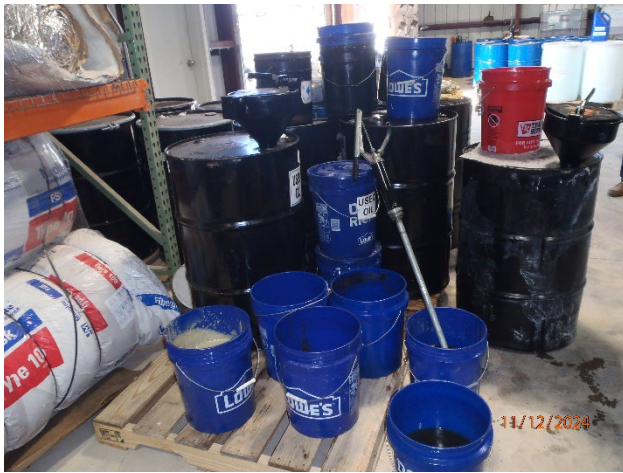
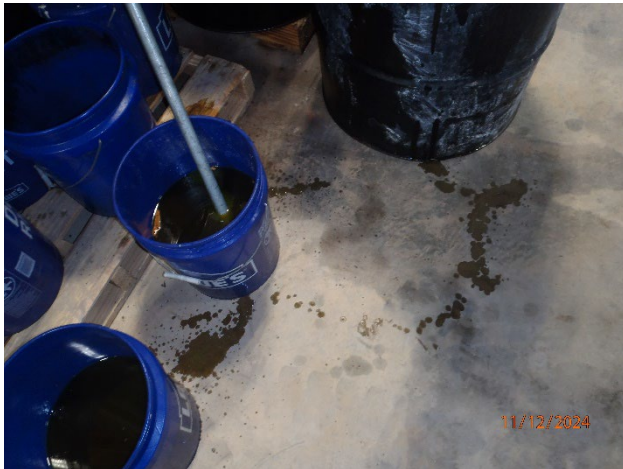
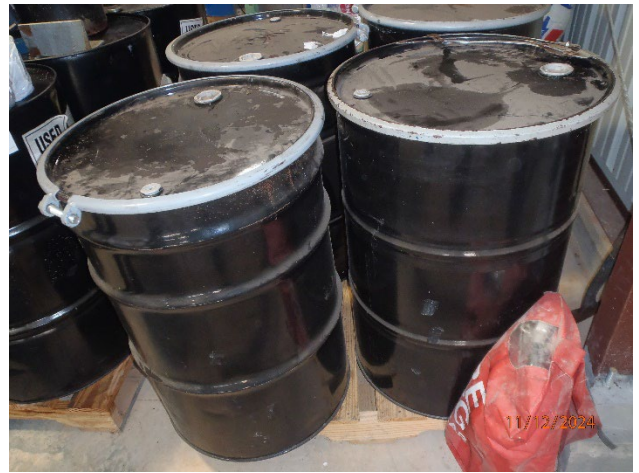
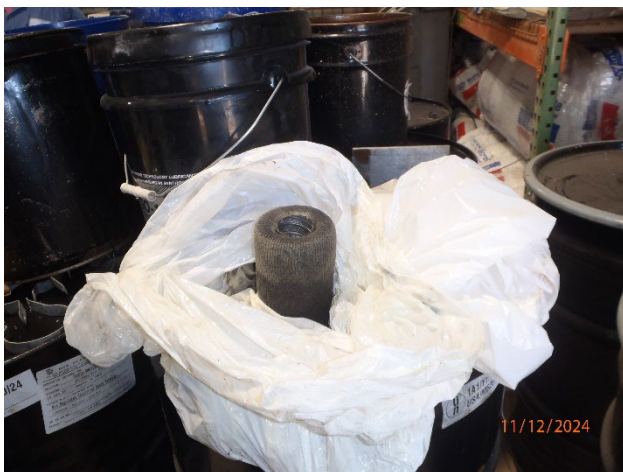
Picture 31 – E15 Building Used Oil containers

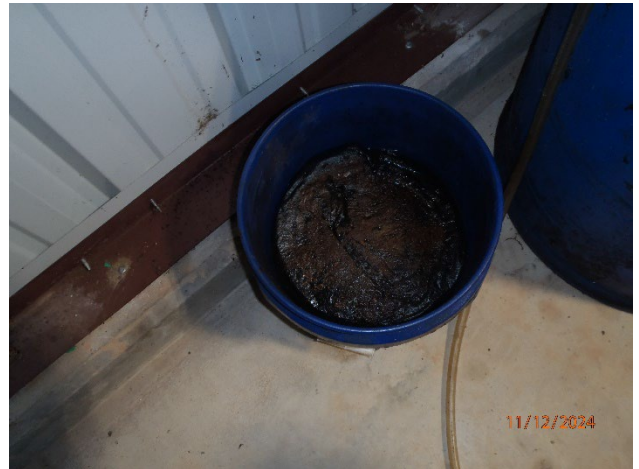
Picture 35 – E15 Building Used Oil and debris in container

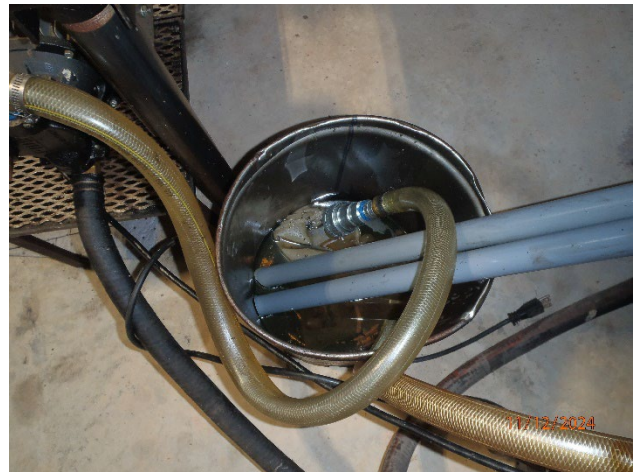
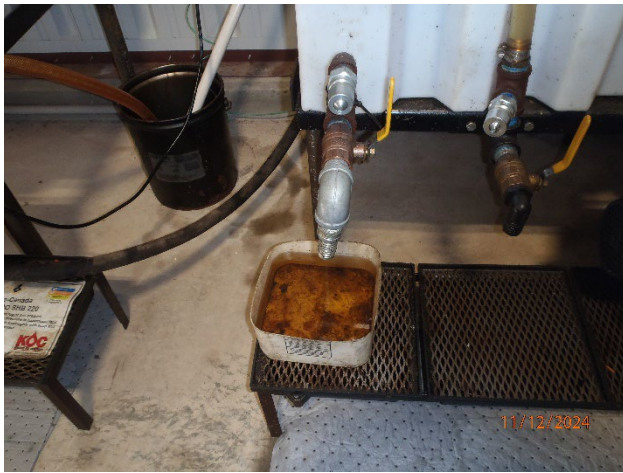
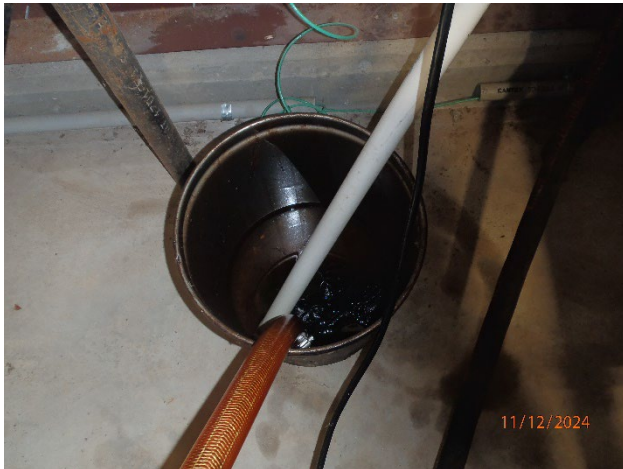
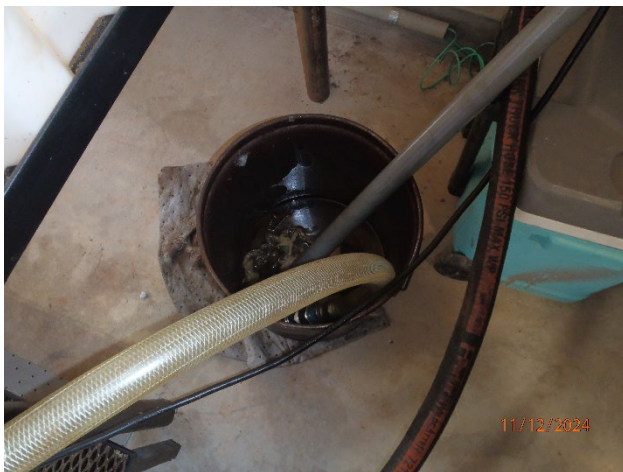
Picture 36 – E15 Building unlabeled and open Used Oil container

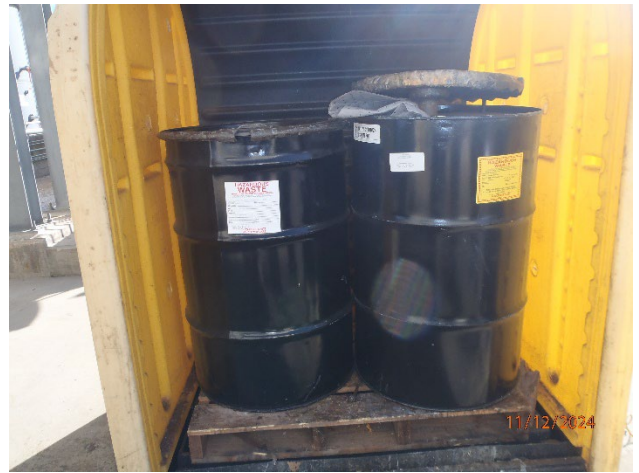
The inspectors observed a yellow clamshell with a 55-gallon container of DAI-240 (MEK) and a 55-gallon container of DAI-238 (Unidyne) (Picture 40). The containers inside the clamshell were marked with waste profile numbers, labeled with the waste codes, had the hazardous waste names listed, identified with hazard identifications, and closed.

Picture 40 – B-12 Packaging SMT SAA

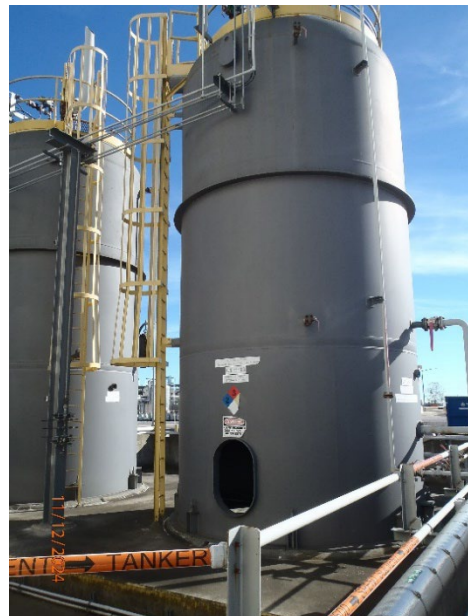
The inspectors observed a hazardous waste tank labeled as U1-V613, Spent Solvent Storage Tank, Waste MEK, with the waste codes D001, D035 and F005 and last emptied on October 10, 2024 (Picture 41). The tank valves and flanges had metal leak detection and repair (LDAR)

Picture 41 – U1-V613 Hazardous Waste Tanks

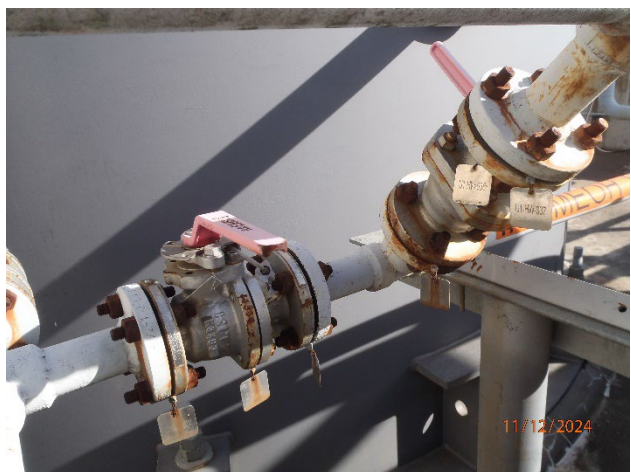
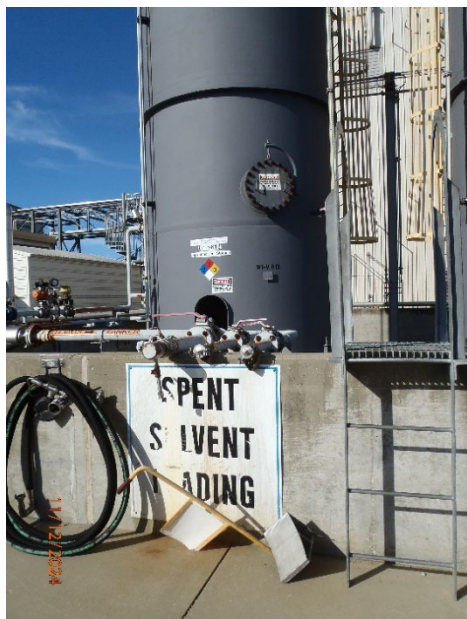
identification tags, and the secondary containment was clean and free of cracks and gaps (Pictures 42-43). Arash Ghoja stated that the tank held a limited amount of waste but was currently active.

Picture 42 – U1-V613 Hazardous Waste Tank BB tags

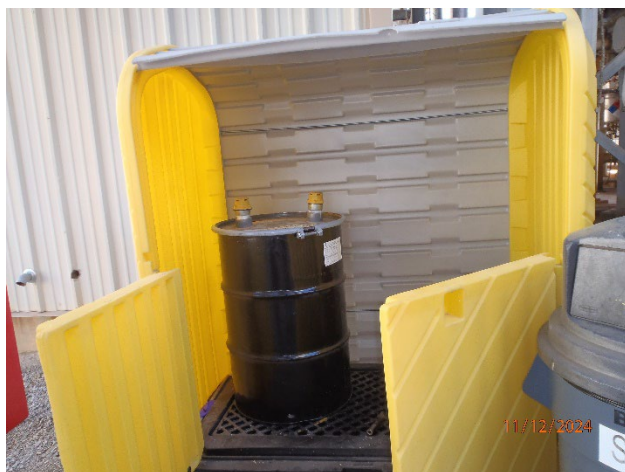
The N1 area had three yellow clamshell SAAs. The N1 SAA held a black 55-gallon non-hazardous waste container (Picture 44). The N1A Polymer Waste SAA held a 55-gallon container of DAI-007 (Picture 45), and the N1 Polymer Waste SAA held a used oil tote (DAI-004) that was closed and labeled (Picture 46). The N1A container was marked with waste profile number, labeled with the waste code, had the hazardous waste name listed, identified with hazard identification, and closed.

Picture 44 – N1 SAA – non-hazardous waste

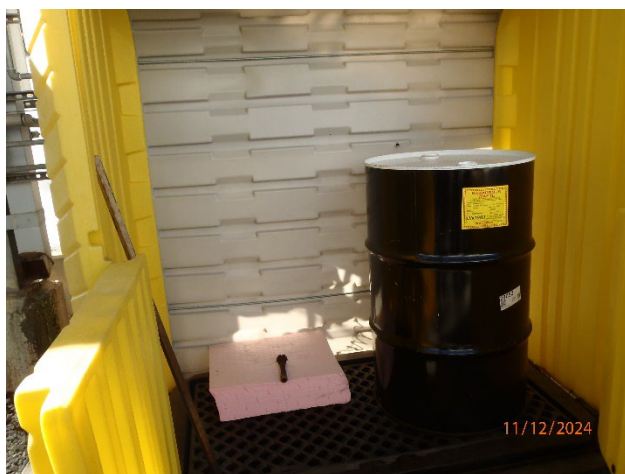
Picture 45 – N1A SAA – polymer waste

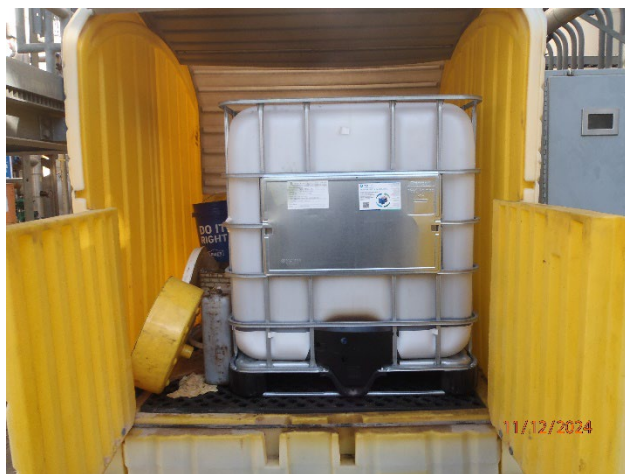
Picture 46 – N1 Polymer Waste SAA
