## **RCRA Inspection Report**

University of Kentucky  
Environmental Quality Management  
355 Cooper Drive  
Lexington, Kentucky 40546  
Fayette County

February 12, 2025 at 9:00 EST

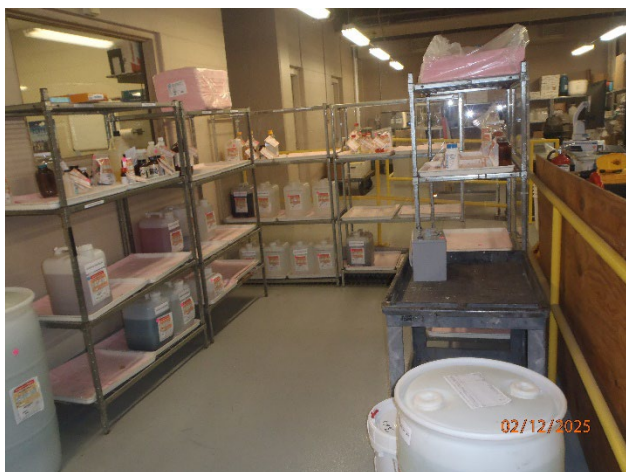
Picture 1 – EQMC TSD Acid Area

- Acid Area where elementary neutralization occurs
- Receiving Area with spill supplies
- Toxic/Metals for water high in organic material (i.e., phosphate buffer feeds algae)
- Bases
- Upcycling which is UK's recycling program to collect and give away reusable products as a part of their waste minimization program.
- Oxidizers in an enclosed room
- Cylinder Room with four small hazardous waste cylinders
- Flammables which include universal waste aerosol and used oil
- Bulking Room for high water, used oil and toxicity characteristic leaching procedure (TCLP) chemicals under a fume hood. A shelf of spill material was against the wall, and an eyewash and shower were in the room. The bulk containers once full are moved to the hazardous characteristic area. Blue bottle recycling bins are in the room for collecting the emptied glass, plastic and metal containers.

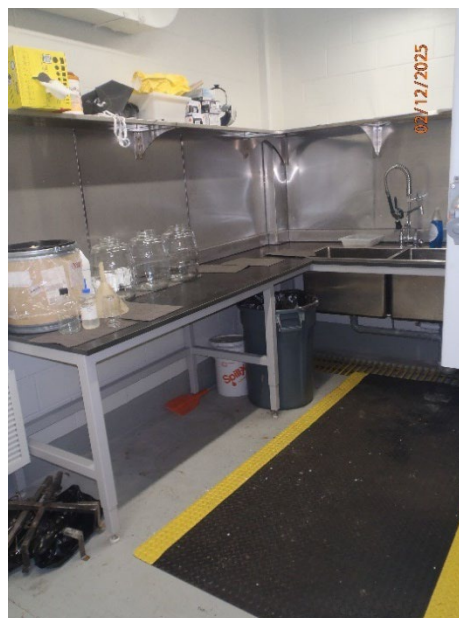
Picture 19 – EQMC TSD E-Trax ticket w/2024 date

- Toxics Area. The inspectors observed a container with a E-TRAX ticket dated January 23, 2024. Mrs. Loyselle and Mr. Chuck Lowe explained that the generator placed the date they started generating the waste on the ticket instead of the date the waste was requested to be picked up which was February 7, 2025. Mrs. Loyselle and Mr. Lowe immediately provided a correct ticket beside the original ticket.
- Supplies (i.e., containers)
- Lab for drinking and sewer water testing
- Reactive waste in a temperature-controlled room

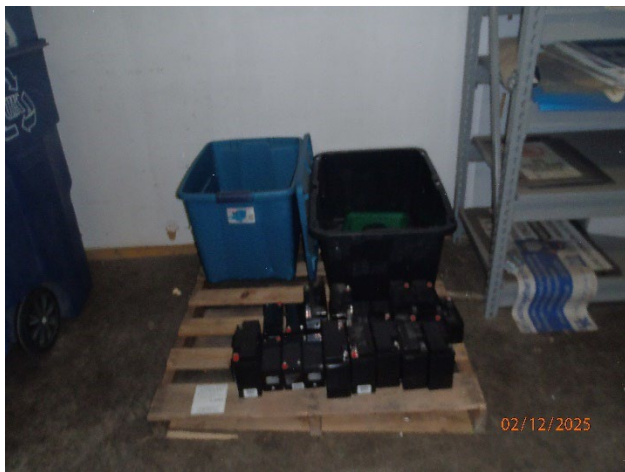
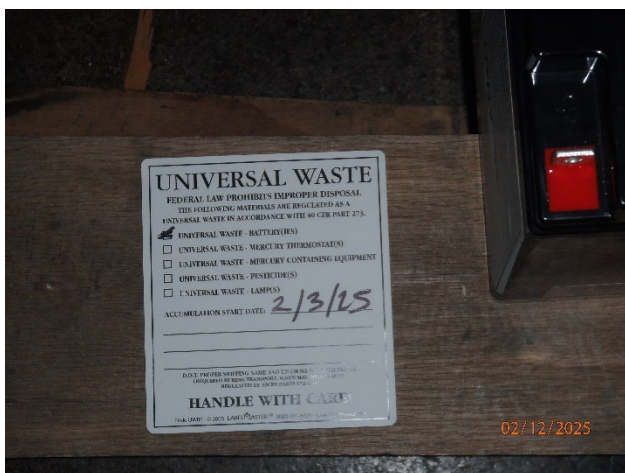
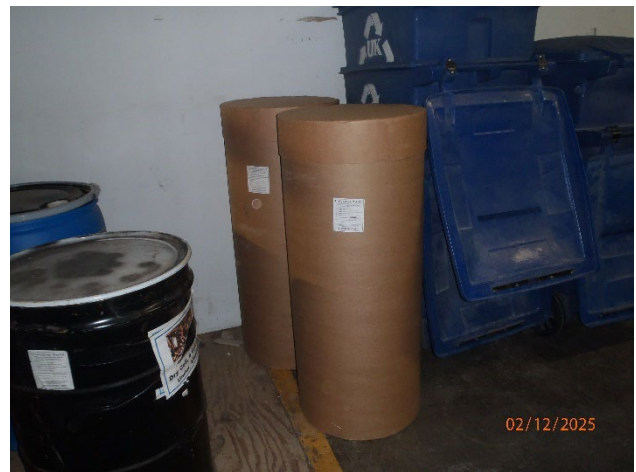
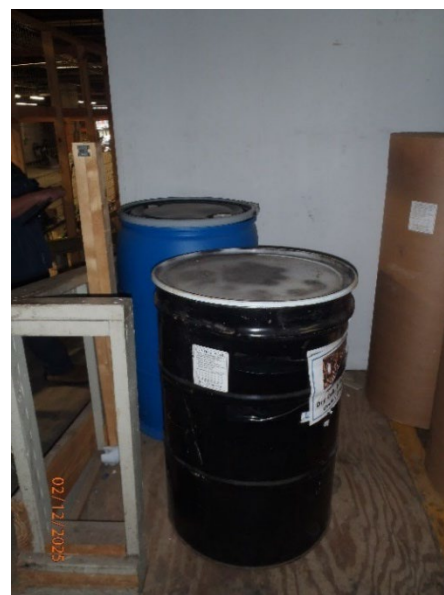
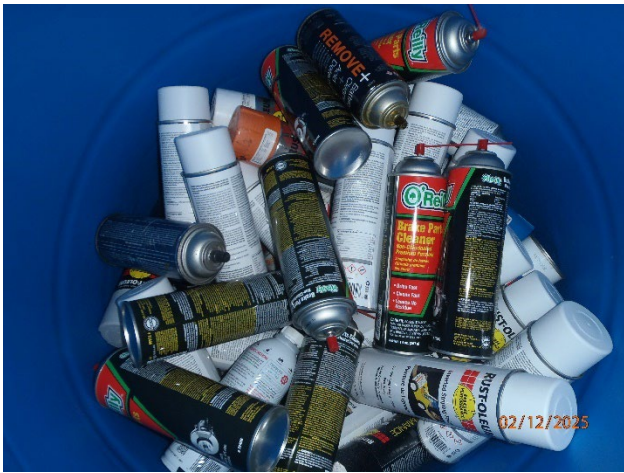
Picture 29 – Service Management UW Storage Area

The inspectors observed the following in the UK Recycling Area located by the stairs (Pictures 29-35):

- A pallet of spent lead acid batteries labeled as universal waste batteries and dated February 3, 2025
- Two 4-foot fiberboard containers of universal waste lamps, closed, labeled and dated January 10, 2025
- One blue 55-gallon container of universal waste aerosol cans (the lid ring not closed), labeled and dated June 1, 2024
- One black 55-gallon container of universal waste ballasts mislabeled as universal waste batteries, not closed, missing the metal ring, and dated March 20, 2024

- *The inspection at the UK Recycling area identified missing proper labeling and open containers. These issues were immediately corrected by EQM personnel on the same day (2/12/2025). The batteries were also collected the same day by the vendor recycling company day for proper processing.*
- *EQM follow-up on February 27, 2025, found the area in compliance with the regulations. The 55-gallon drum of aerosol cans was pick up for disposal have been placed in the area saying, "Universal waste". **Attachment 2** shows the before and after pictures.*

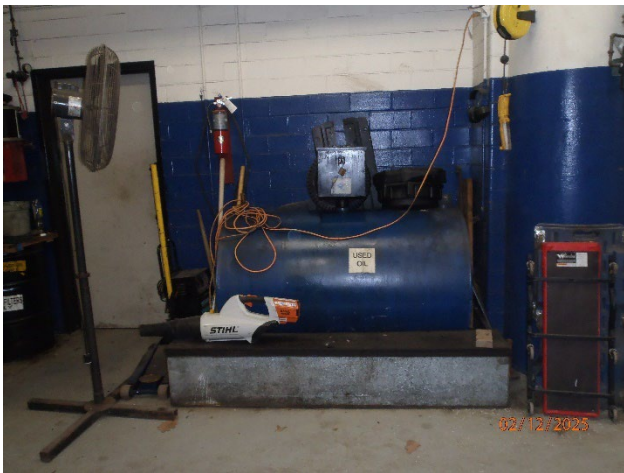
Picture 36 – Garage Used Oil Tank

In the Garage, the inspectors observed a 275-gallon used oil tank in a secondary containment (Picture 36). The tank was labeled as "Used Oil", and the secondary containment appeared clean.

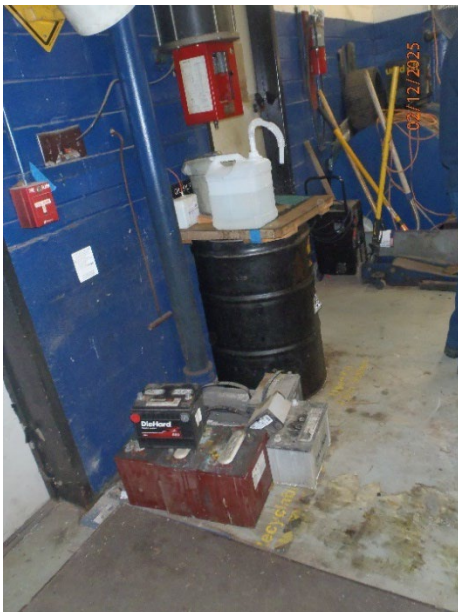
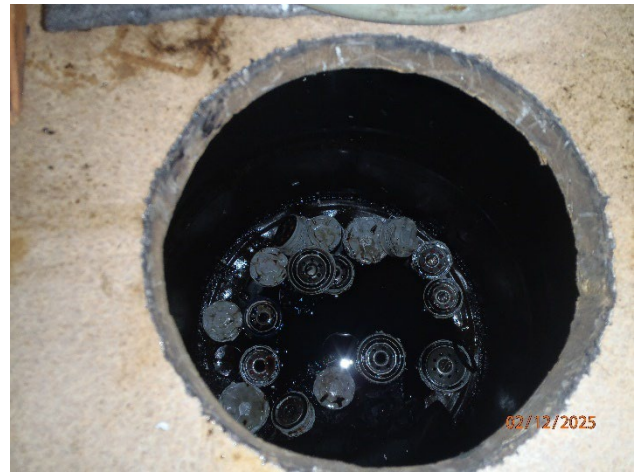
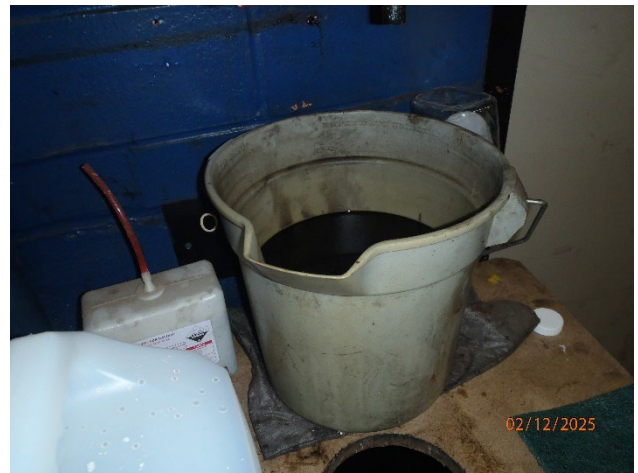
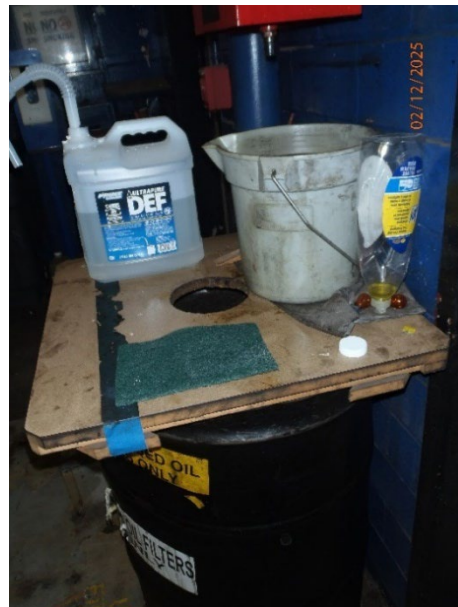
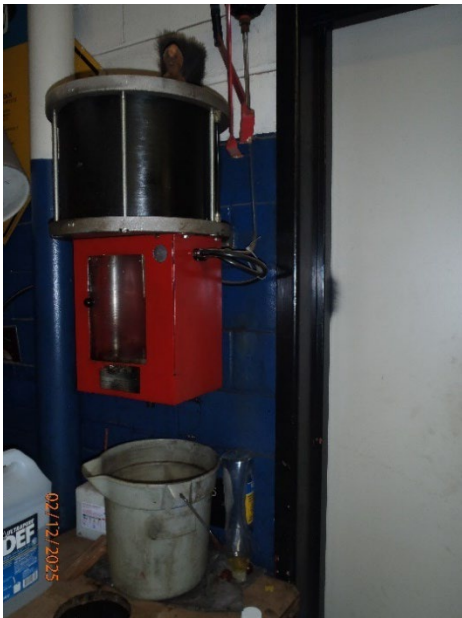
Near the used oil tank is the used oil filter crusher with a gray catch bucket underneath to collect the released used oil (Pictures 37-41). The catch bucket sits on top of wood board with a hole cut in the center. The used oil and the used filters are dropped via the hole into the black 55-gallon container. The used oil container was observed to be labeled as "Used Oil"; however, the catch bucket was not labeled. Next to the used oil container, there were nine spent lead acid batteries that were not labeled or dated as universal waste batteries or labeled as "To Be Returned to Vendor."

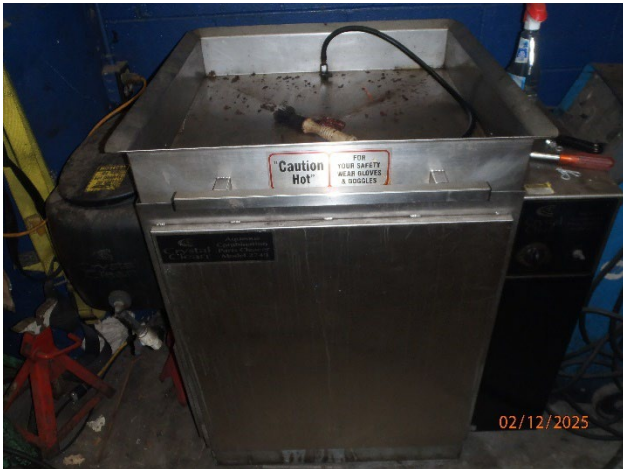
Picture 42 – Garage Crystal Clean parts washer

The inspectors also observed a Crystal Clean parts washer using solvent based cleaner and a media blaster using glass beads (Picture 42). The maintenance staff explained the parts washer was maintained and resupplied every three months by Heritage Crystal Clean. The media blaster was used mostly for brake work. No issues were observed for the equipment.

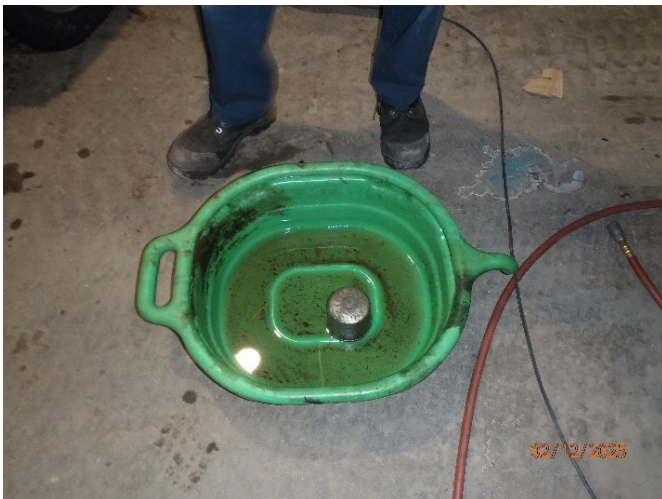
Picture 43 – Garage green used oil catch pan with used diesel

inspectors observed a green catch pan labeled as “Used Oil” but actually contained spent diesel fuel and a diesel fuel filter draining inside (Picture 43). The garage staff was willing to show the inspectors how the filter crusher operated by crushing a spent diesel filter. The inspectors declined the demonstration. The inspectors also observed a black catch pan that collects used oil was not labeled as “Used Oil”.

***Area of Concern: Pursuant to 40 C.F.R. 279.10(d)(2) mixtures of used oil and diesel fuel mixed on-site by the generator of the used oil for use in the generator's own vehicles are not subject to this part once the used oil and diesel fuel have been mixed. Prior to mixing, the used oil is subject to the requirements of subpart C of this part. However, if the mixture of used oil and diesel fuel are not used on site by the generator then the mixture is subject to 40 C.F.R. 279.10(b)(2) which states that mixtures of used oil and hazardous waste that solely exhibit one or more of the hazardous waste characteristics may be subject to regulation.***

The inspectors observed that the crushed used oil filters should be collected in a separate container and not added to the 55-gallon used oil container. In addition, no fuel filters or non-used oil spent liquids should be added to the used oil. At the time of the inspection, the

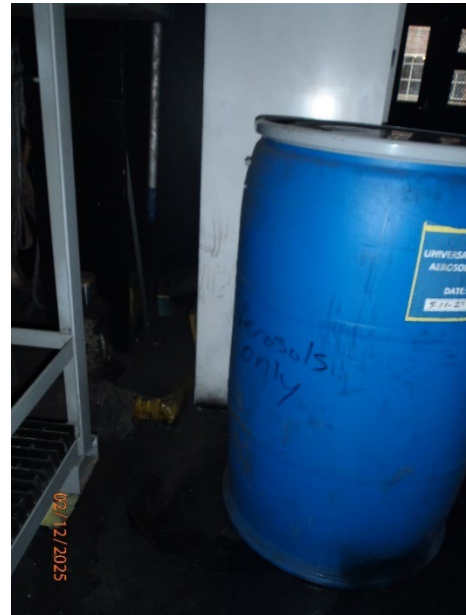
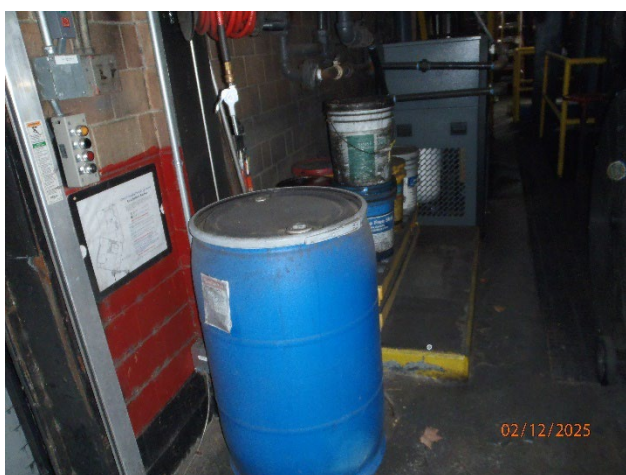
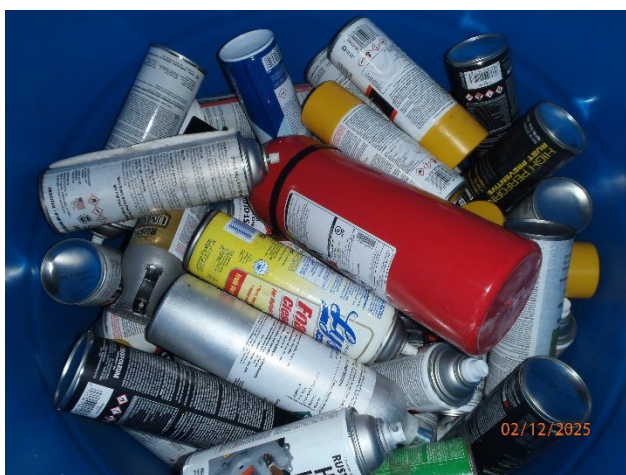
The inspectors met with Mr. Graham Gray and Mr. Paul Zeer and were escorted around the plant. The inspectors observed the following during the walk through (Pictures 44-48):

- *These deficiencies were corrected immediately on 2/12. The drums and buckets were picked up for disposal, and new, properly labeled new drums were provided the same day (2/12).*

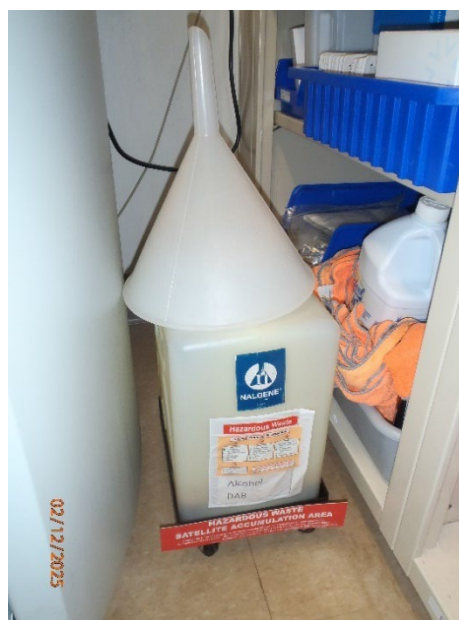
Picture 54 – Hospital Histology Immunochemistry SAA

hazard identification. A second SAA held a 5-gallon carboy labeled hazardous waste DAB Alcohol that was equipped with a screw on lid and identified with a Flammable hazard identification (Picture 54).

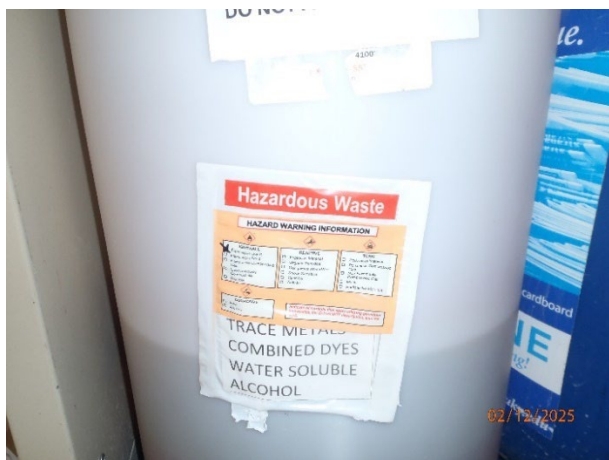
The Histology Immunochemistry lab manages a SAA with 15-gallon container of hazardous waste stain in Room HL409. The container was located under a cabinet, and it was equipped with a bunghole lid, which was closed (Pictures 52-53). The container was labeled hazardous waste Trace Metals Combined Dyes Water Soluble Alcohol and identified with a Flammable

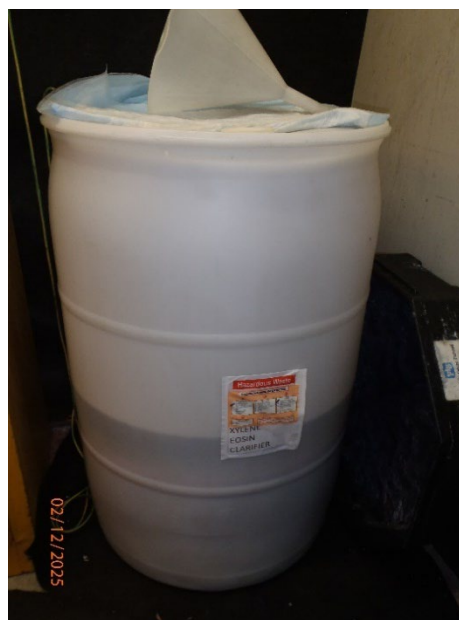
In Room HL409B a SAA with a 55-gallon container of hazardous waste clarifier located in a corner, and it was equipped with a bung hole, which was closed (Pictures 55-56). The container was labeled hazardous waste Xylene Eosin Clarifier” and identified with a Flammable and Toxic hazard identification.

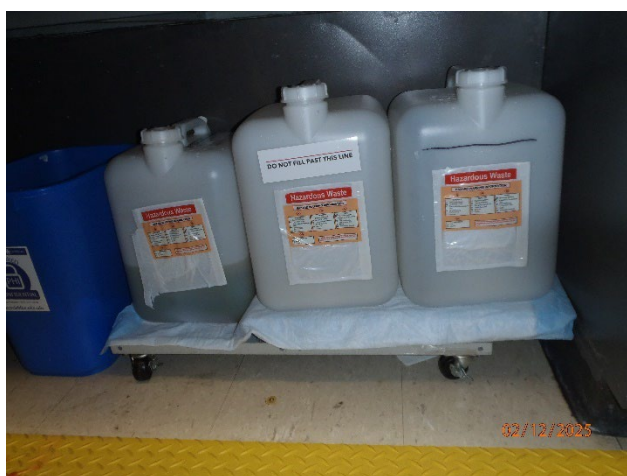
Picture 57 – Hospital Pathology/Cytology SAA

The Pathology Cytology lab manages a SAA with three 5-gallon carboys of hazardous waste poisonous material in Room HL412. The containers were located under a cabinet, and were equipped with a bung hole lids, which were closed (Picture 57). The containers were labeled hazardous waste Poisonous Material and identified with a Toxic hazard identification. A second SAA held a 15-gallon carboy labeled hazardous waste stain that was equipped with a screw on lid and identified with a Flammable and Toxic hazard identification (Picture 58).

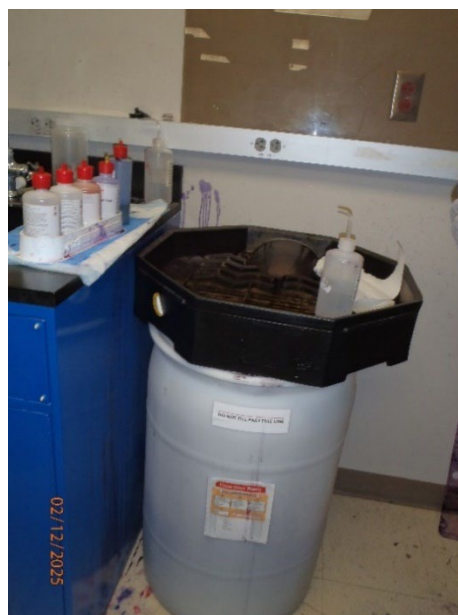
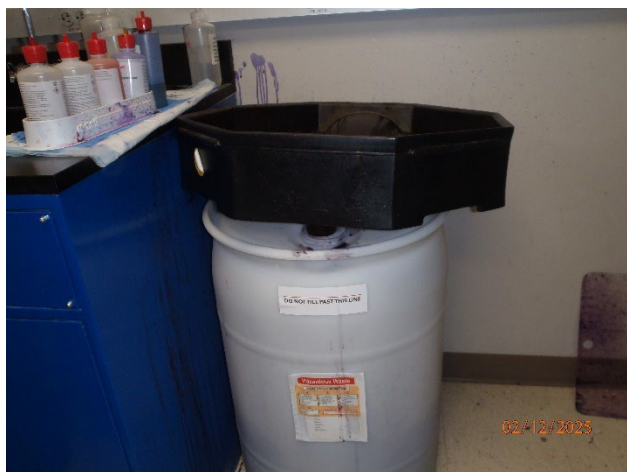
The Microbiology lab manages a SAA with a white 30-gallon container of hazardous waste stain for slides in HA635. The container was located in a corner beside the sink, and was equipped with a bung hole lid, which was not closed (Pictures 61-62). At the time of the inspection, the lab manager removed the black funnel and closed the container. The container was labeled hazardous waste stain and identified with a Toxic hazard identification. The inspectors observed that the hazardous waste stain had been splattered on the floor and the wall behind the container. The inspectors recommended that the container should have a secondary containment pallet.

Pursuant to 401 KAR 39:080, Section 1(1) [40 C.F.R. § 262.15(a)(4)], which is a condition of the SAA Permit Exemption, a generator is required to keep containers of hazardous waste closed at all times during accumulation, except when adding, removing, or consolidating waste; or when temporary venting of a container is necessary for the proper operation of equipment, or to prevent dangerous situations, such as build-up of extreme pressure.

Pursuant to 401 KAR 39:080, Section 1(1) [40 C.F.R. § 262.17(a)(6)], which incorporates 401 KAR 39:080, Section 1(1) [40 C.F.R. § 262.251], and is a condition of the LQG Permit Exemption, a generator is required to maintain and operate its facility to minimize the possibility of a fire, explosion, or any unplanned sudden or non-sudden release of hazardous waste or hazardous waste constituents to air, soil, or surface water which could threaten human health or the environment.

- All identified deficiencies have been corrected. The two satellite accumulation areas now have secondary containment, new funnels to prevent contamination and keep containers closed, and absorbent pads for spill protection and waste tracking control. Sixth-floor personnel have been informed of these changes and the need to follow the updated practices. Attachment 4 shows the before and after pictures.*

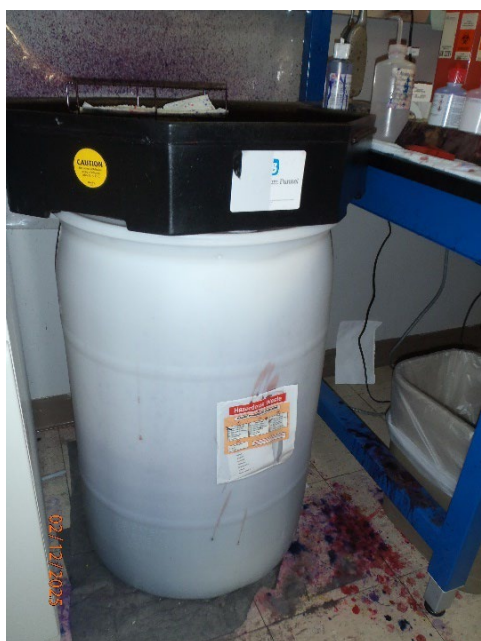
Picture 63 – Hospital Microbiology SAA w/stains on floor and open funnel

A second SAA had a white 30-gallon container of hazardous waste stain for slides (Picture 63). The container was located between a sink and a workbench, and was equipped with a bung hole lid, which was not closed because the black funnel was inside the bung hole. The container was labeled hazardous waste stain and identified with a Toxic hazard identification. The inspectors observed that the hazardous waste stain had been splattered on the floor and the wall behind the container. The inspectors recommended that the container should have a secondary containment pallet to replace the absorbent mat on the floor.

The inspectors asked if the container was being used at the time, and the lab manager explained that chemists routinely dump the stains into the container throughout the shift. The inspectors recommended that EQM research a different funnel that allows the chemists to close the lid after each use.

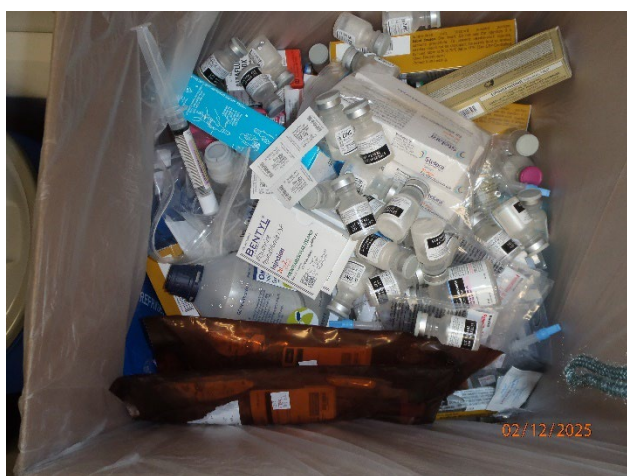
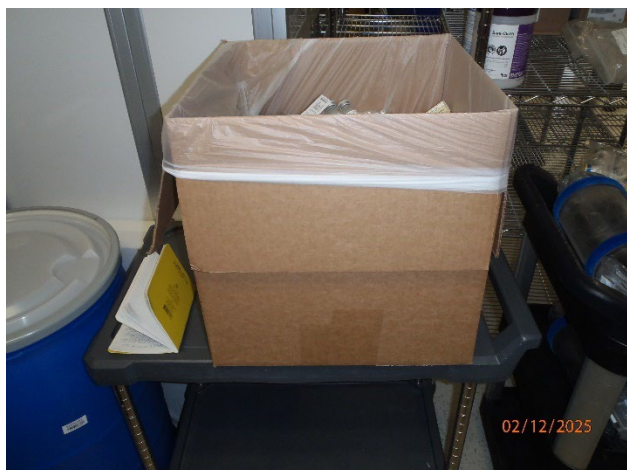
The inspectors observed the Pyxis C Safe where controlled substances are stored. Mrs. Mastalerz stated that Mr. David Marr handles the reverse distribution of expired and unused pharmaceuticals to Inmar Intelligence in Grand Prairie, TX and the reverse distribution of controlled substances to the Drug Enforcement Agency (DEA). Mr. Marr provide the records of the recent reverse distribution pick-ups for both expired and unused pharmaceuticals and controlled substances on January 10, 2025. In addition, Inmar provided a pickup of non-regulated pharmaceutical waste on February 12, 2025 (Pictures 66-67).

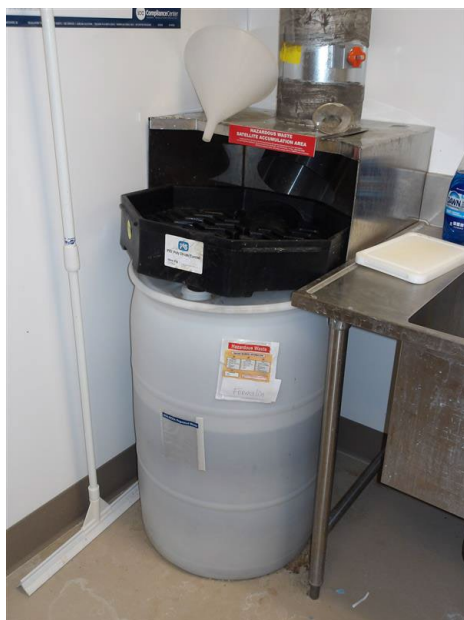
The inspectors observed inside the morgue. The Morgue manages a SAA with a 55-gallon container of hazardous waste formalin (Pictures 68-69). The container was located inside the morgue, and it was equipped with a black funnel for the bung hole, which was closed. The container was labeled hazardous waste Formalin and identified with a hazard identification but not marked for the specific hazard indicator.
