## **RCRA Inspection Report**

H & S Swansons Tool Company  
9000 68<sup>th</sup> Street  
Pinellas Park, Florida 33782-4499  
Pinellas County

EPA ID No.: FLD982160723

March 31, 2021, at 9:22 a.m.

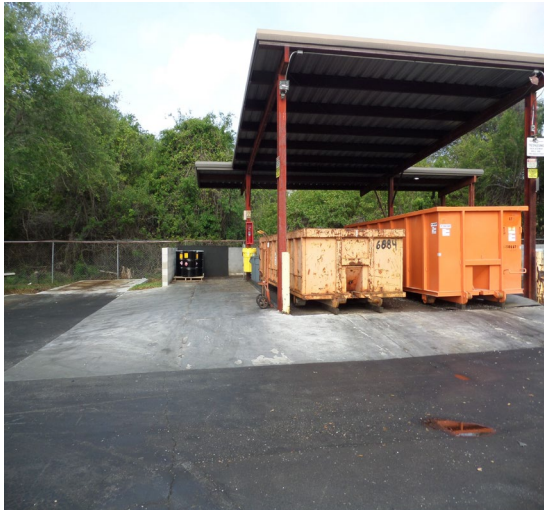
The 90-Day or Less Accumulation Area (90-Day) is in the rear of the building and is constructed with a concrete pad, that slopes toward the surrounding pavement. The concrete pad is surrounded on one side and in the rear of the pad by a four to five-foot high cinder block containment wall. A metal roof is constructed over a portion of the pad. The inspector observed Danger and Caution signs posted in this area. The property behind the facility's fence line is owned by H & S (Photograph 1).

Six 55-gallon containers were observed accumulating hazardous waste in the 90-Day. The containers were on wooden pallets, closed, in good condition, labeled with the words hazardous waste, labeled with corrosive and flammable hazard indicators and marked with the date March 30, 2021. Seven containers accumulating used oil were also observed in this area. The containers were closed and labeled with the words used oil. The used oil tank observed during FDEP's October 2, 2018 inspection was no longer on-site. The concrete pad appeared in good condition.

H & S Swansons Tool Company (H & S). 90-Day or Less Accumulation Area. Observed six 55-gallon containers accumulating hazardous waste. Photograph 1 taken at 9:47 a.m.

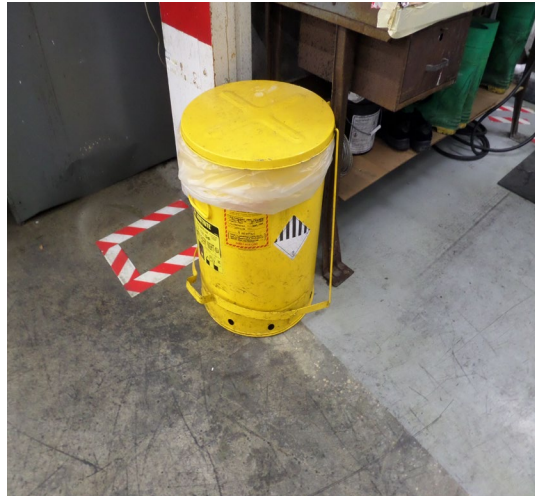
A 30-gallon step can (step can) was observed outside the entrance to the Chem Film/Chromate Room. The step can was accumulating contaminated paper towels and gloves. The step can was closed, marked with the waste codes D007, F019 and labeled as hazardous waste. The step can

was labeled with a Class 9 DOT label, which is not an indication of the ignitable, corrosive, reactive, or toxic hazard accumulating in it (Photograph 2). The hazardous waste in the step can is transferred to a 55-gallon container in the Paint Department. On March 31, 2021, Mr. Tagler emailed the EPA and FDEP a photograph documenting that corrosive and flammable solid labels were placed on the step can.

H & S. Chem Film/Chromate Room. Observed the 30-gallon step can had a Class 9 DOT label. Photograph 2 taken at 10:20 a.m.

**Pursuant to F.A.C. Chapter 62-730.160(1), [40 C.F.R. § 262.15(a)(5)(ii)], which is a condition of the SAA Permit Exemption, a generator is required to mark or label its containers with an indication of the hazards of the contents.**

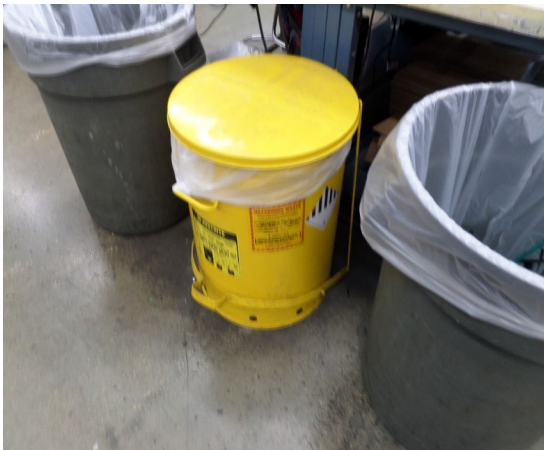
The casting is painted in this area with or without processing in the Chem Film/Chromate Room. Two 30-gallon step cans (step cans) were observed in this area. The step cans were accumulating contaminated paper towels and gloves. The step cans were closed, marked with the waste codes D007, F019 and labeled as hazardous waste. The step cans were labeled with a Class 9 DOT label, which is not an indication of the ignitable, corrosive, reactive, or toxic hazard accumulating in it (Photographs 3 and 4). The hazardous waste in the step cans is accumulated for approximately one month prior to transferring the content to a 55-gallon container in the Paint Department. The 55-gallon container was initially designated as a satellite accumulation area (SAA) but changed to a 90-Day or Less Accumulation Area during the inspection. On March 31, 2021, Mr. Tagler emailed the EPA and FDEP a photograph documenting that corrosive and flammable solid labels were placed on the 30-gallon step cans.

H & S. Paint Department. Observed the 30-gallon step can had a Class 9 DOT label. Photograph 3 taken at 10:20 a.m.

**Pursuant to F.A.C. Chapter 62-730.160(1), [40 C.F.R. § 262.15(a)(5)(ii)], which is a condition of the SAA Permit Exemption, a generator is required to mark or label its containers with an indication of the hazards of the contents.**

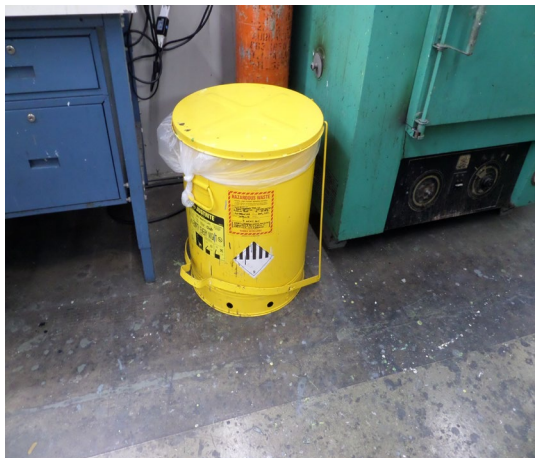
H & S. Paint Department. Observed the 30-gallon step can had a Class 9 DOT label. Photograph 4 taken at 10:22 a.m.

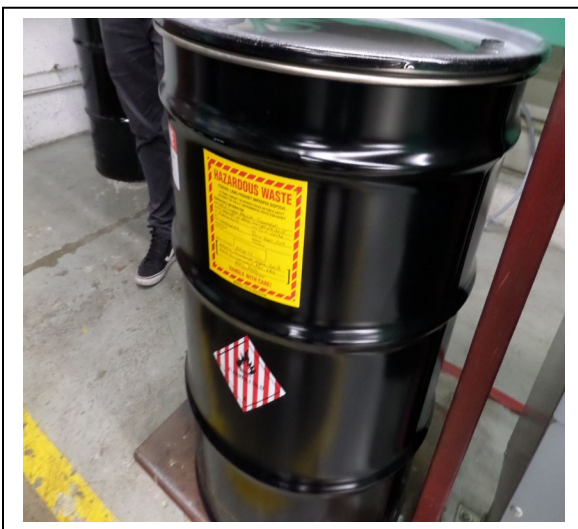
The hazardous waste is transferred from the three 30-gallon step cans to the 55-gallon container for consolidation. The 55-gallon container in the Paint Department was observed connected to a compactor. The 55-gallon container was closed, marked with the waste codes D007, F019, labeled as hazardous waste and labeled with an indication of the hazards of the contents. The

container was not marked with a date (Photograph 5). Inspectors explained the point of generation for the hazardous waste transferred to this 55-gallon container was at the three 30-gallon step cans and an accumulation start date is required to be clearly marked on the 55-gallon container. The container must be inspected weekly. H & S marked the container with a date at the time of this inspection and will begin conducting weekly inspections.

H & S. Paint Department. Observed the 55-gallon container accumulating hazardous waste as a SAA container and not marked with a date. Hazardous waste generated at other points of generation. Photograph 5 taken at 10:29 a.m.

**Pursuant to Florida Administrative Code Annotated (F.A.C.) Chapter 62-730.160(1), [40 C.F.R. § 262.15(a)], a generator may accumulate as much as 55 gallons of non-acute hazardous waste in containers at or near any point of generation where wastes initially accumulate, which is under the control of the operator of the process generating the waste, without a permit or without having interim status, as required by Chapter 403 of the Florida Statutes, Fla. Stat. § 403.702 et seq., [Section 3005 of RCRA, 42 U.S.C. § 6925], and without complying with F.A.C. Chapter 62-730.160(1), [40 C.F.R. § 262.16(b) or § 262.17(a)], except as required in F.A.C. Chapter 62-730.160(1), [40 C.F.R. § 262.15(a)(7) and (8)], provided that the generator complies with the satellite accumulation area conditions listed in F.A.C. Chapter 62-730.160(1), [40 C.F.R. § 262.15(a)].**

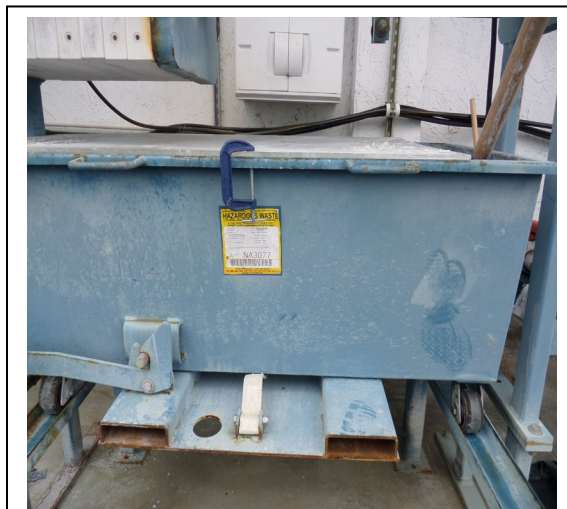
Hazardous waste solids generated from the treatment process are filtered in a plate and frame press. The dried hazardous waste solids are discharged from the plate and frame press to a 64-gallon metal hopper on wheels that can be removed from its stand using a forklift. Jordan Swift explained the hazardous waste is transferred from the hopper to a one-cubic yard container, sometimes several times per day during its daily operation. The hopper was observed labeled with the words hazardous waste, marked with the waste codes D007, F019, but it was open with a shovel inserted in the hopper and it was not labeled or marked with an indication of the hazard (Photograph 6). Hazardous waste was not being added or removed from the hopper at the time of this CEI. H & S closed the hopper (Photograph 9). The one-cubic yard container was observed closed, labeled with the words hazardous waste, and marked with the waste codes D007, F019, but it was not marked with an accumulation start date and not labeled or marked with an indication of the hazard (Photograph 7). H & S marked the container with the date March 30, 2021 (Photograph 8). H & S marked the hazardous waste labels on the hopper and one-cubic yard container with the word "Toxic" as an indication of the hazard at the time of the inspection. On April 5, 2021, Mr. Tagler emailed the EPA and FDEP photographs documenting a toxic label was placed on the one-cubic yard container. The EPA and FDEP recommended to H & S to maintain a log of the waste entering and being removed from the hopper to ensure the 55-gallon capacity is not exceeded.

H & S. Wastewater Pretreatment System. Observed hopper was open and not marked or labeled with an indication of the hazard. Photograph 6 taken at 12:22 p.m.

**Pursuant to F.A.C. Chapter 62-730.160(1), [40 C.F.R. § 262.15(a)(4)], which is a condition of the SAA Permit Exemption, a generator is required to keep containers of hazardous waste closed at all times during accumulation, except when adding, removing, or**

consolidating waste; or when temporary venting of a container is necessary for the proper operation of equipment, or to prevent dangerous situations, such as build-up of extreme pressure.

Pursuant to F.A.C. Chapter 62-730.160(1), [40 C.F.R. § 262.15(a)(5)(ii)], which is a condition of the SAA Permit Exemption, a generator is required to mark or label its containers with an indication of the hazards of the contents.

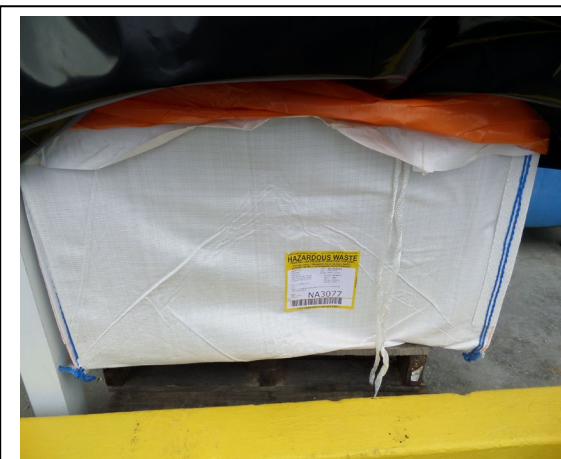
H & S. Wastewater Pretreatment System. Observed a one-cubic yard container accumulating F019 solids. Not marked with a date and no indication of the hazard. Photograph 7 taken at 12:23 p.m.

Pursuant to Florida Administrative Code (F.A.C.) Chapter 62-730.160(1) [40 C.F.R. § 262.17], a LQG may accumulate hazardous waste on-site for 90 days or less without a permit or without having interim status, as required by Chapter 403 of the Florida Statutes, Fla. Stat. § 403.702 et seq., [Section 3005 of RCRA, 42 U.S.C. § 6925], provided that the generator complies with the conditions listed in F.A.C. Chapter 62-730.160(1) [40 C.F.R. § 262.17] (hereinafter referred to as the “LQG Permit Exemption”).

Pursuant to F.A.C. Chapter 62-730.160(1), [40 C.F.R. § 262.17(a)(5)(i)(A)], which is a condition of the LQG Permit Exemption, a generator must mark or label the date upon which each period of accumulation begins clearly visible for inspection on each container.

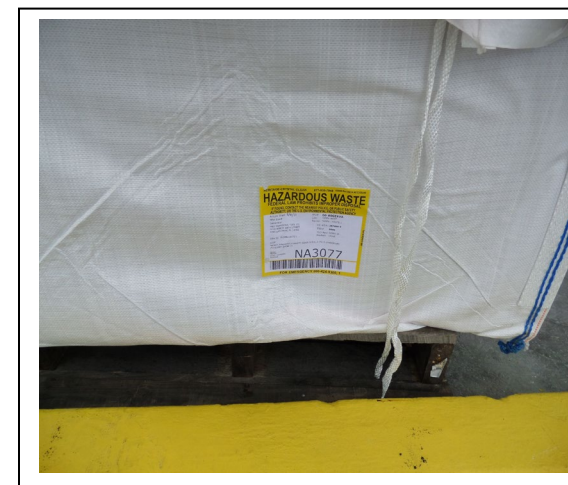
H & S. Wastewater Pretreatment System. Observed a one-cubic yard container accumulating F019 solids. H & S marked the container with the date 3/30/21 and marked it with an indication of the hazard. Photograph 8 taken at 12:23 p.m.

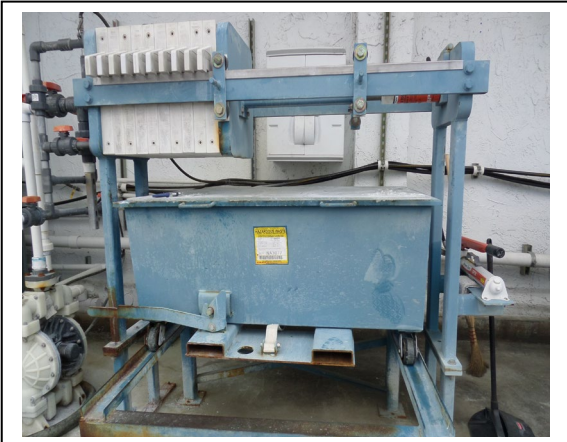
H & S. Wastewater Pretreatment System.  
H & S closed the hopper and marked it with  
an indication of the hazard. Photograph 9  
taken at 12:23 p.m.
