**Region 6 - Enforcement & Compliance Assurance Division**  
**INSPECTION REPORT**

| Regulatory Program(s) | Water (CWA) Brine Program (Oil & Gas inspection) | |
| Company Name: | <b>R McNeely Oil Company</b> | |
| Facility Name: | <b>Childs C; Wells 1, 2 Tank Battery</b> | |

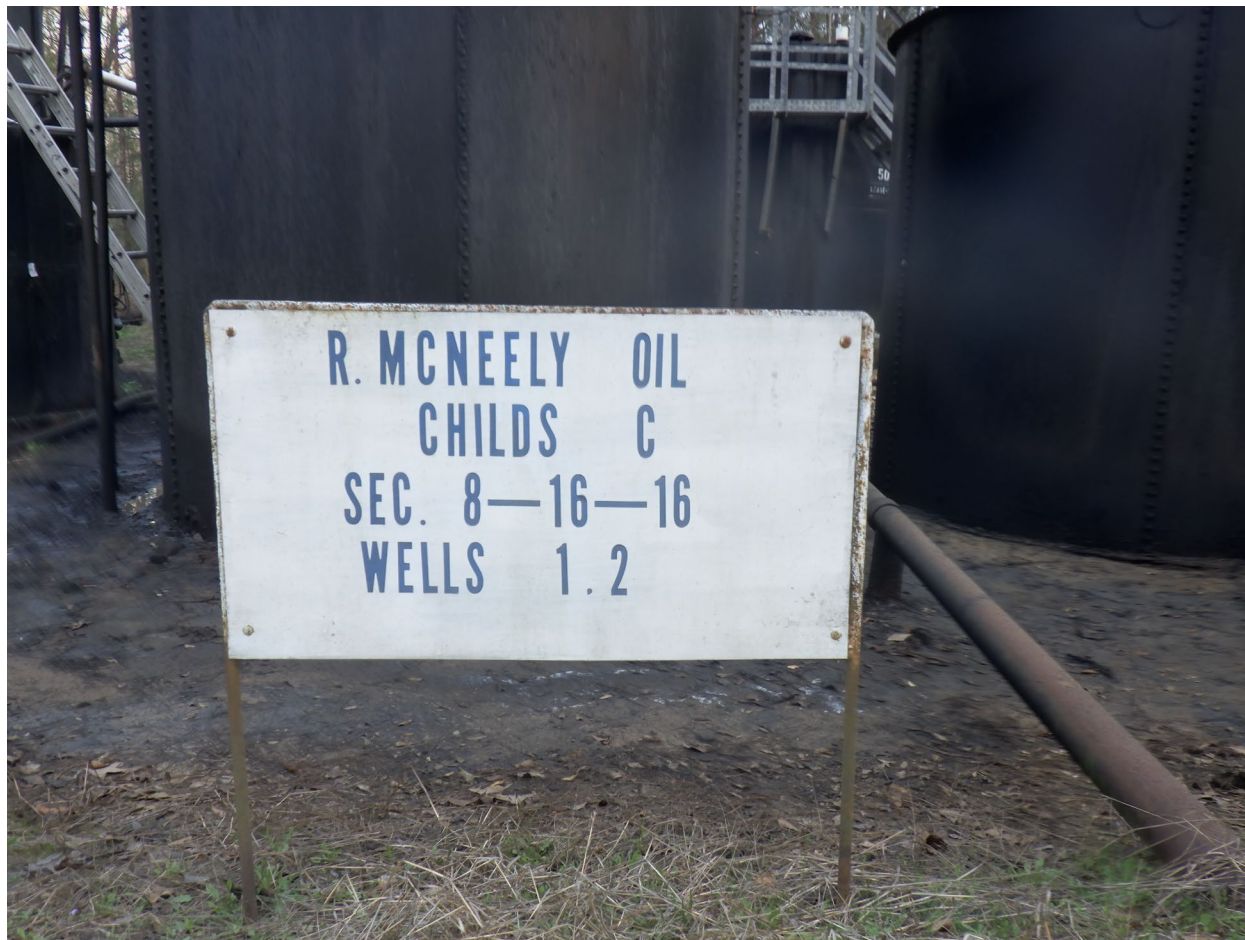
Photo No. 1

**Description:** This photo was taken looking E-SE at the facility showing the facility sign.

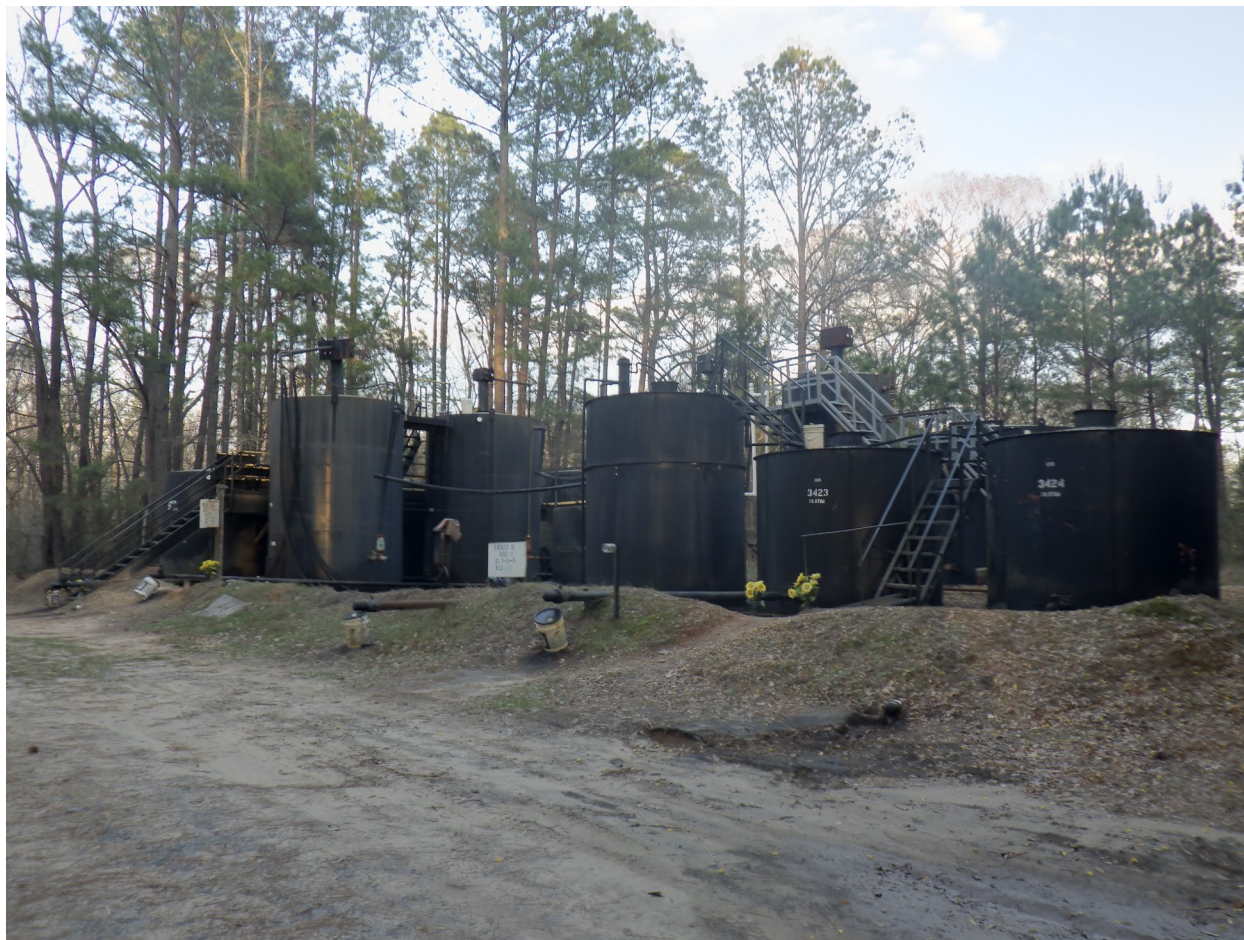
Photo No. 2

I observed the facility sign, secondary containment, oil-water separators, pipes and valves, and storage tanks located at the facility; see Appendix 1 (Photographs Log), Photo No. 1 and No. 2. For additional GPS location and photo metadata, see Appendix 1.

**Description:** This photo was taken looking E at the facility showing the facility overview.

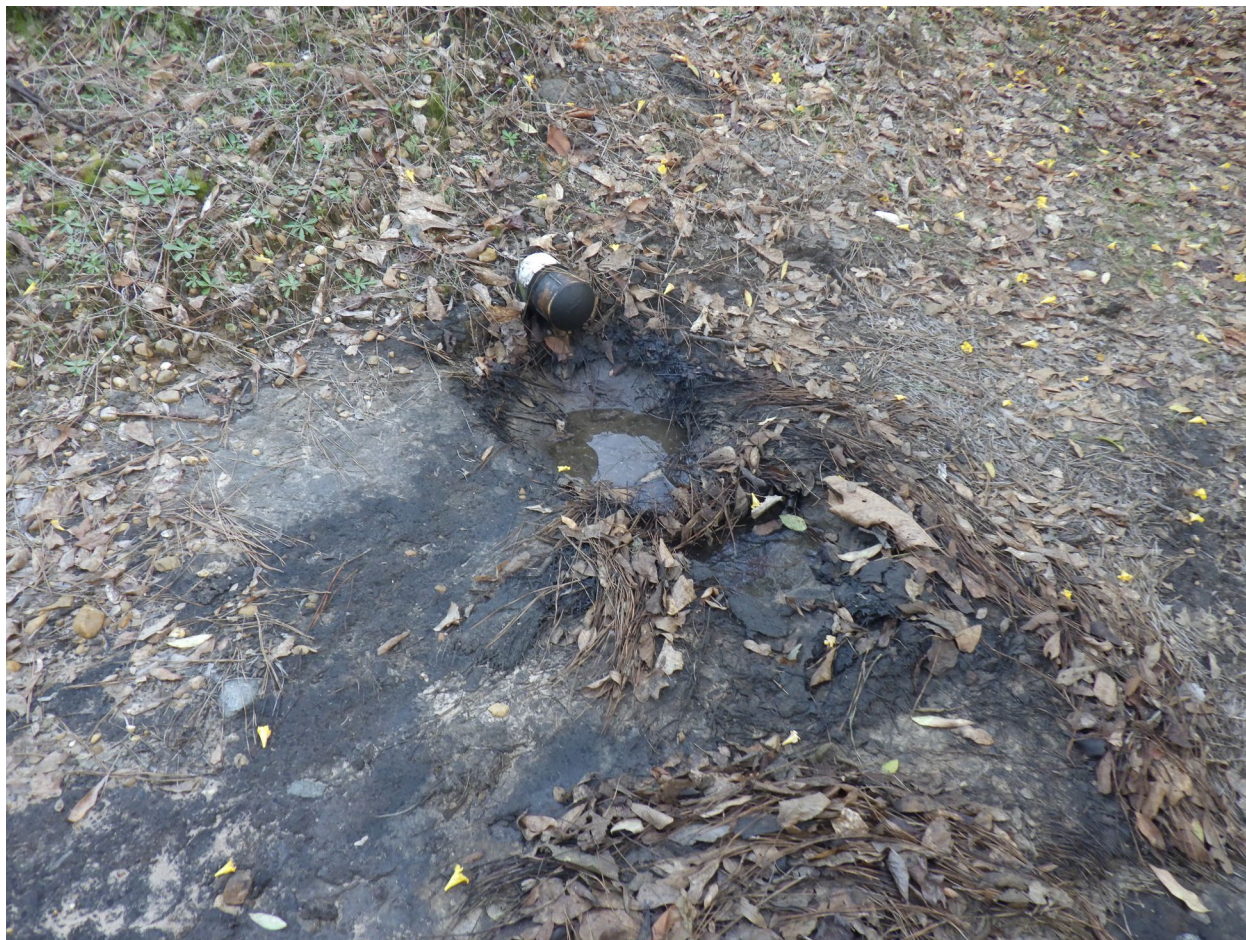
Photo No. 3

I observed a drainpipe for secondary containment with loose oil around the area, see Photo No. 3.

**Description:** This photo was taken looking S-SE showing the drainpipe for secondary containment with loose oil outside containment.

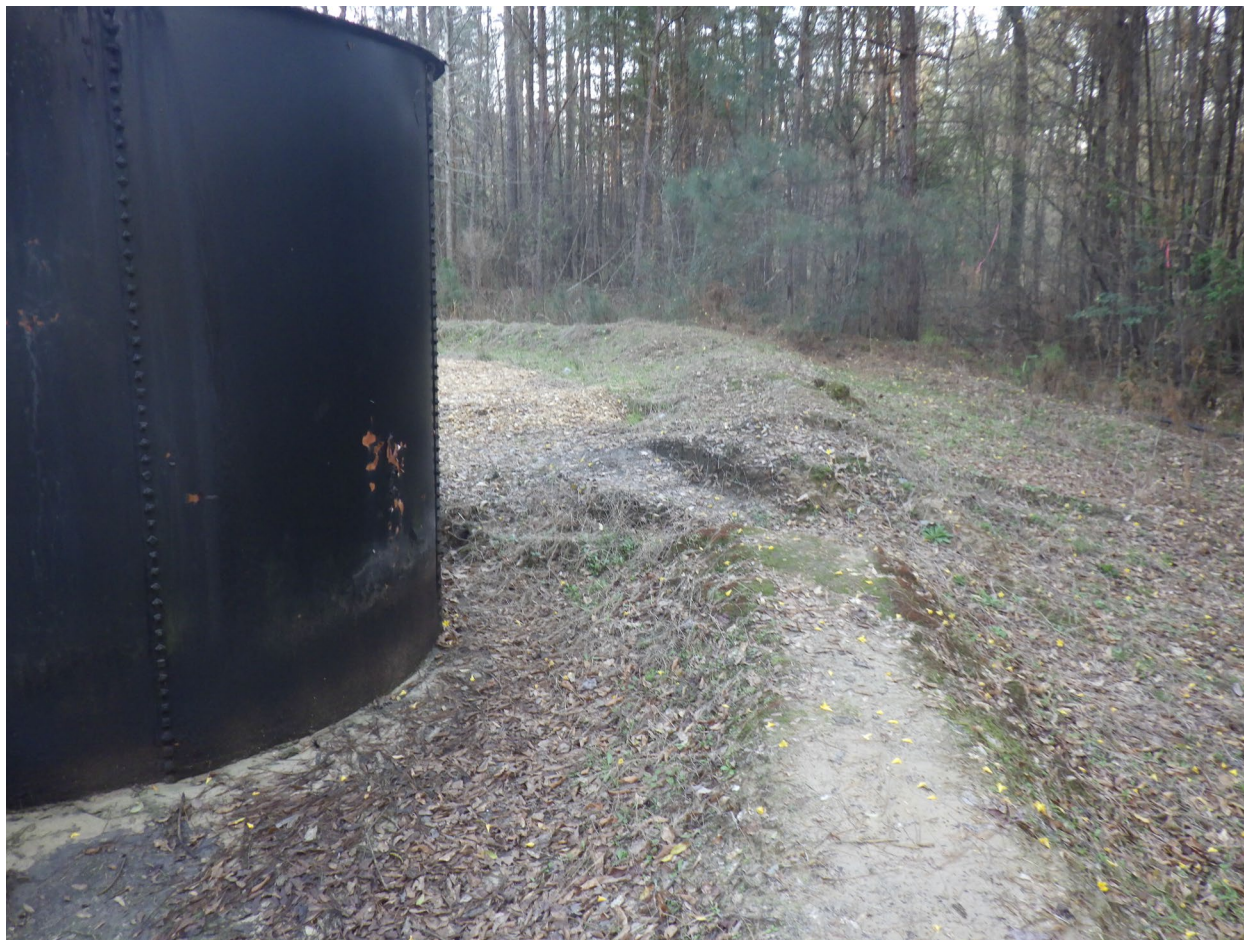
Looking SE at the top of secondary containment, I observed a low area in the secondary containment, see Photo No. 4 and No. 5.

**Description:** This photo was taken looking SE showing a low area in secondary containment.

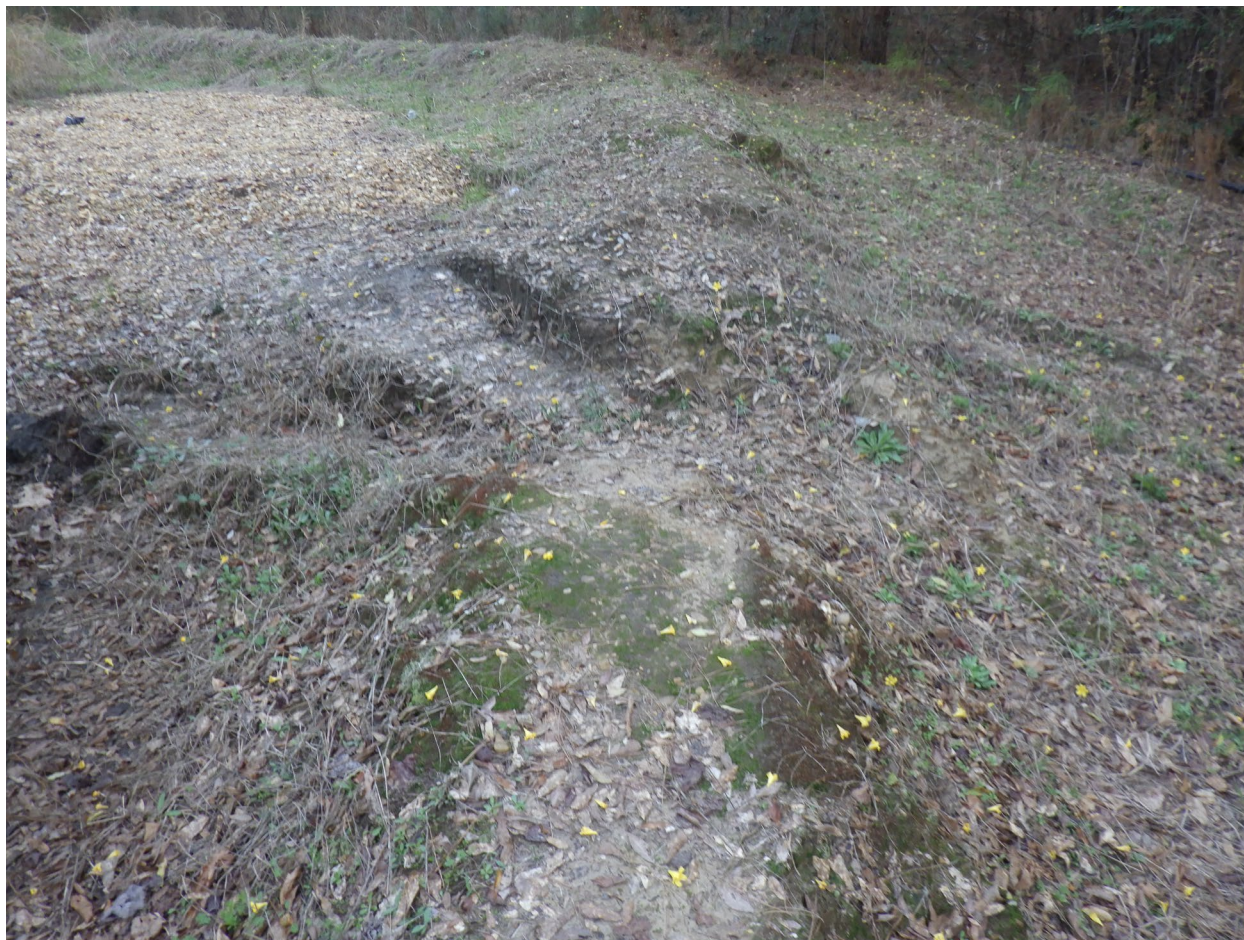
Photo No. 5

**Description:** This photo was taken looking SE showing a closeup of the low area in secondary containment.

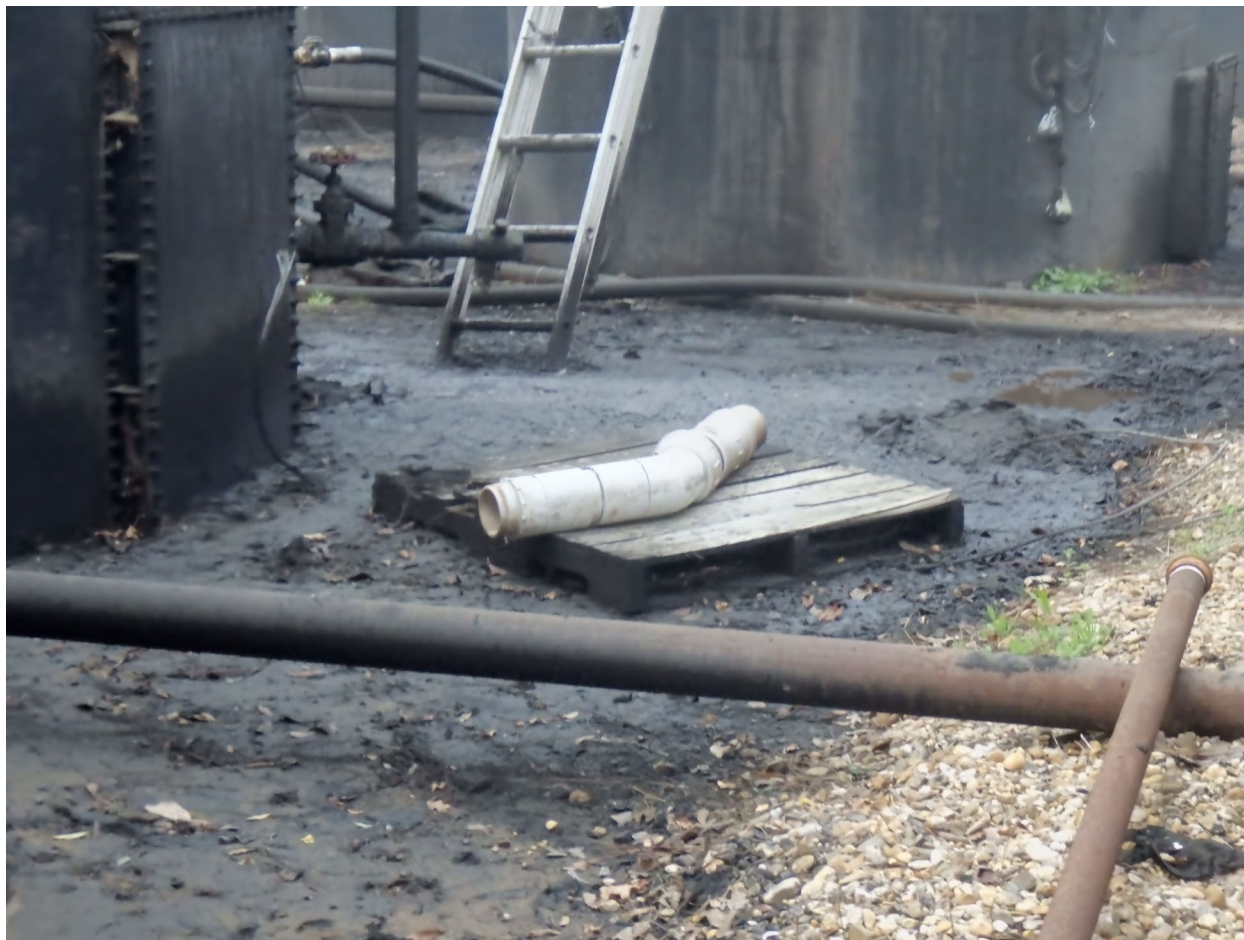
Photo No. 6

Looking N-NE inside the secondary containment, I observed loose oil on the ground around a tank; see Photo No. 6.

**Description:** This photo was taken looking N-NE showing loose oil inside the secondary containment.

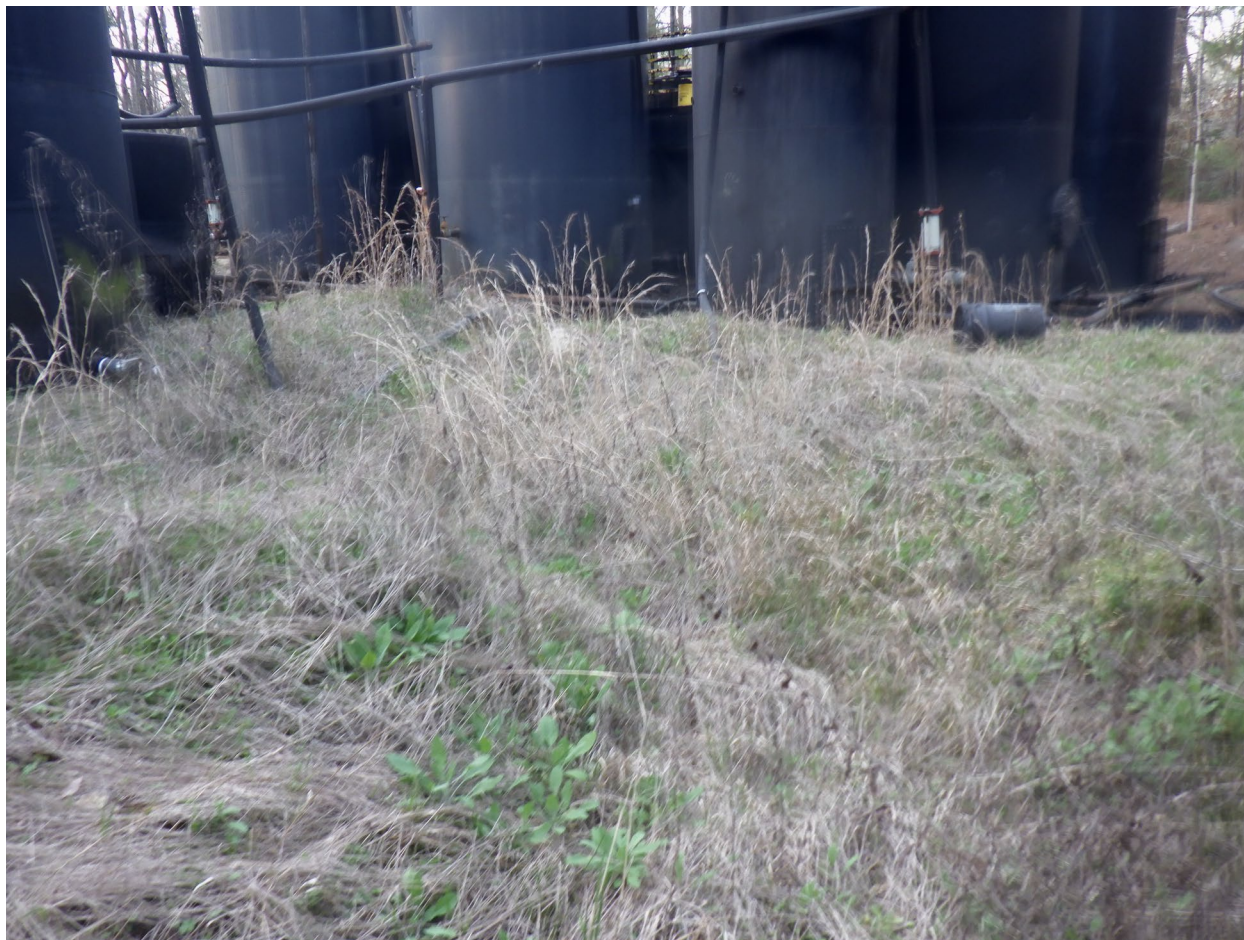
Photo No. 7

I observed excessive vegetation on the outside of the secondary containment, see Photo No. 7.

**Description:** This photo was taken looking N showing excessive vegetation growing on the secondary containment.

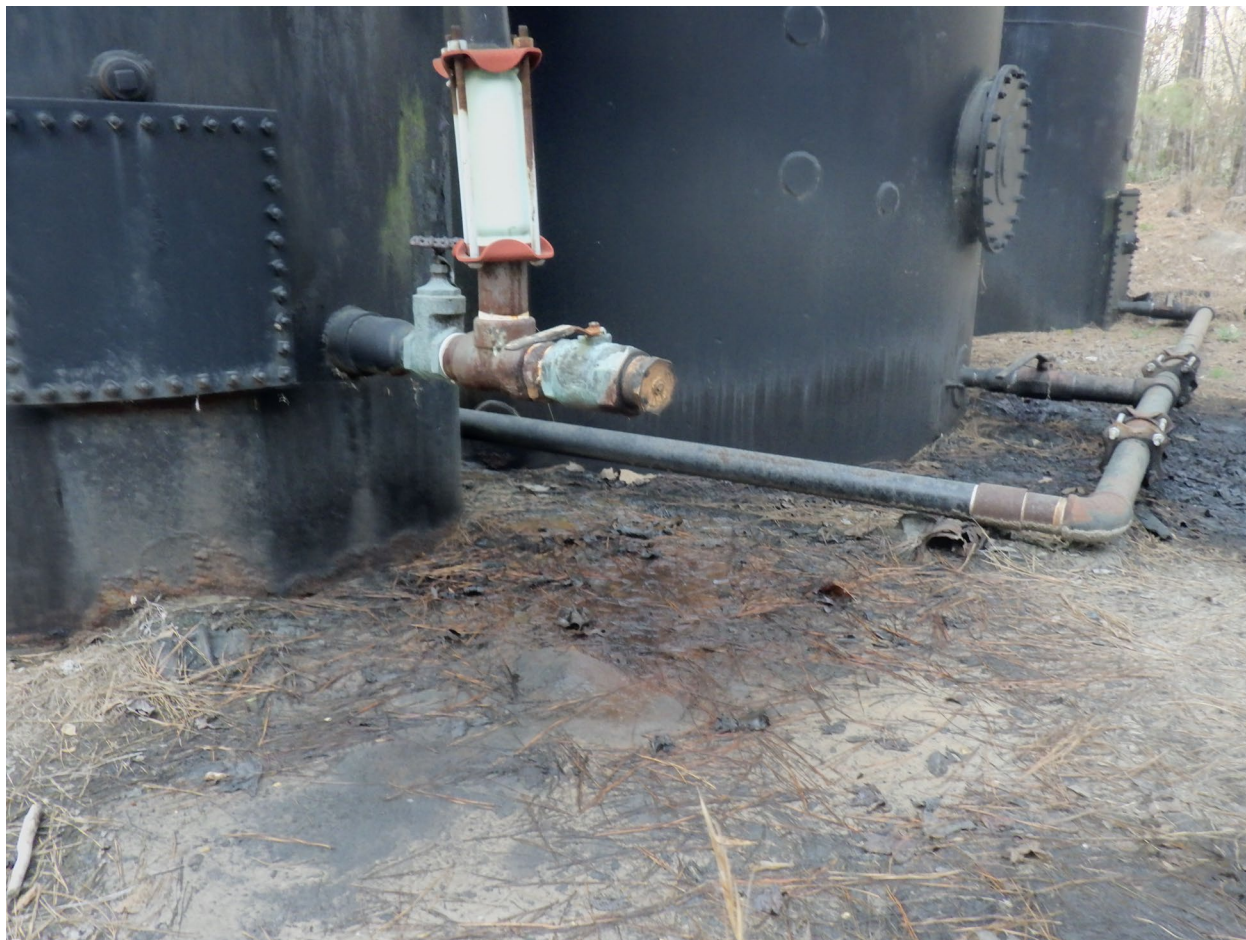
For one of the tanks, I observed an active leak from a valve; see Photo No. 8 and No. 9.

**Description:** This photo was taken looking N showing a tank with a valve with an active leak.

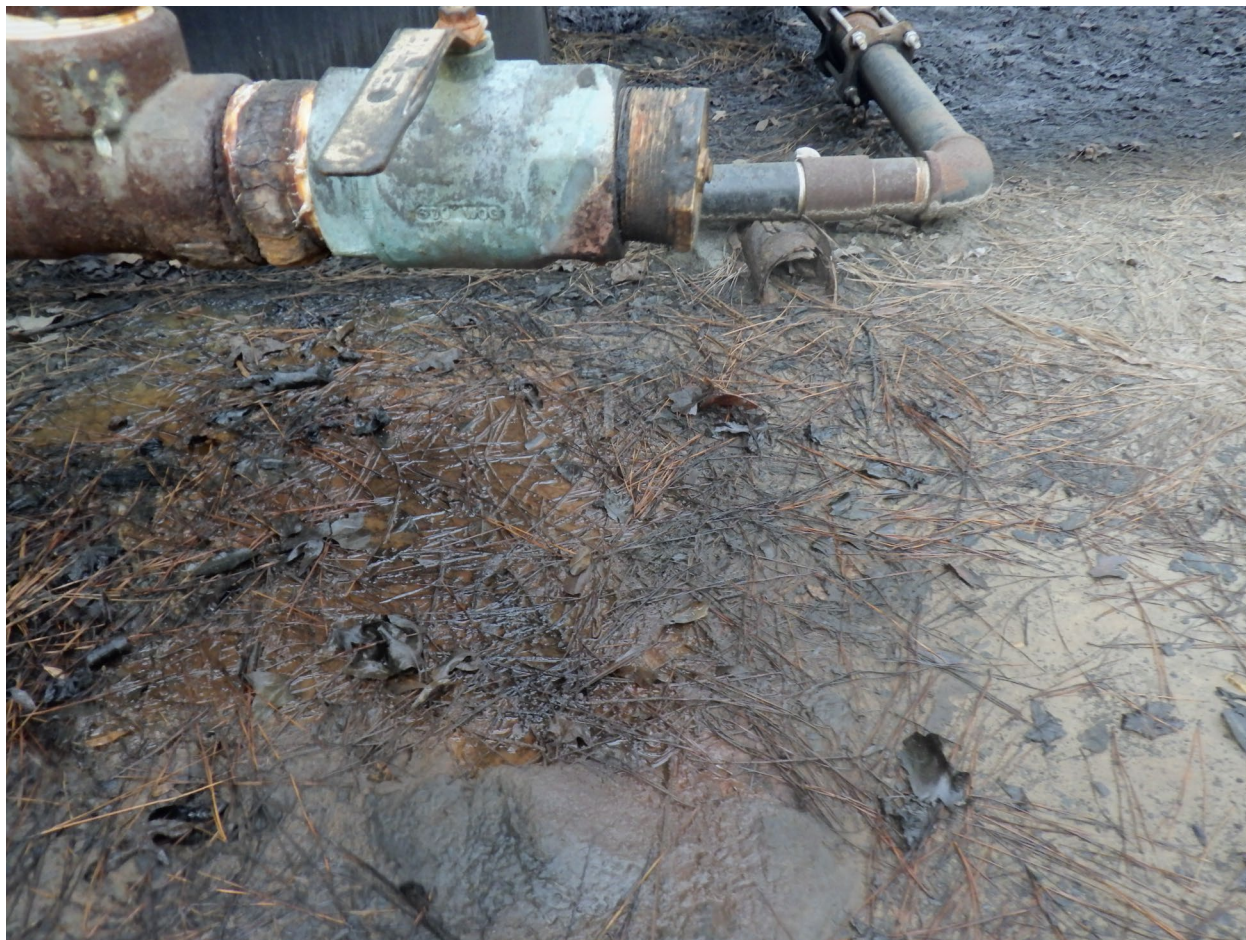
Photo No. 9

**Description:** This photo was taken looking NE showing a closeup of the active leak from a valve and the area surrounding the leak in Photo No. 8.

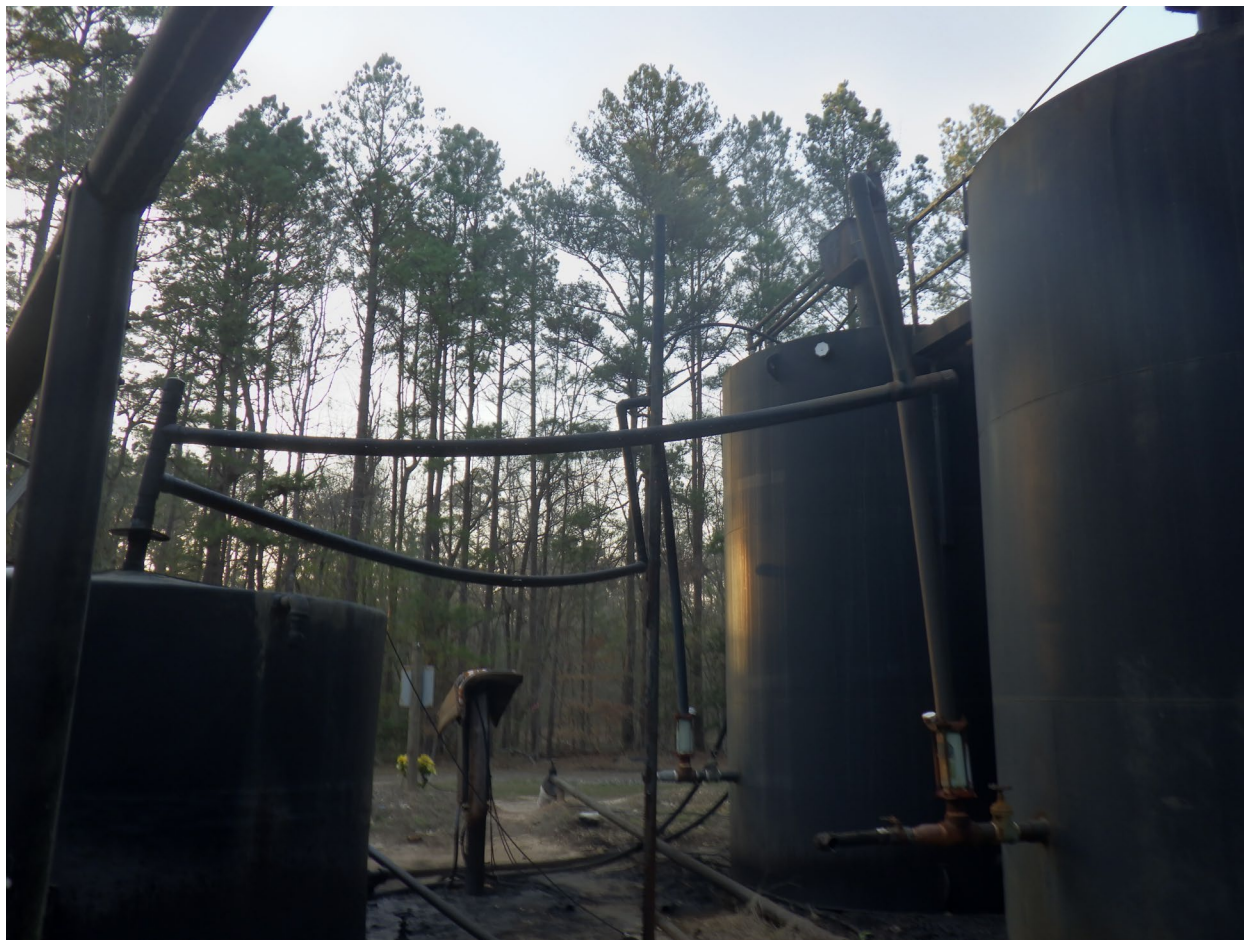
I observed pipes without support leading to and from the tanks inside secondary containment, see Photo No. 10 through Photo No. 12.

**Description:** This photo was taken looking W-NW showing tanks with pipes without support sagging and pulling on the tanks.

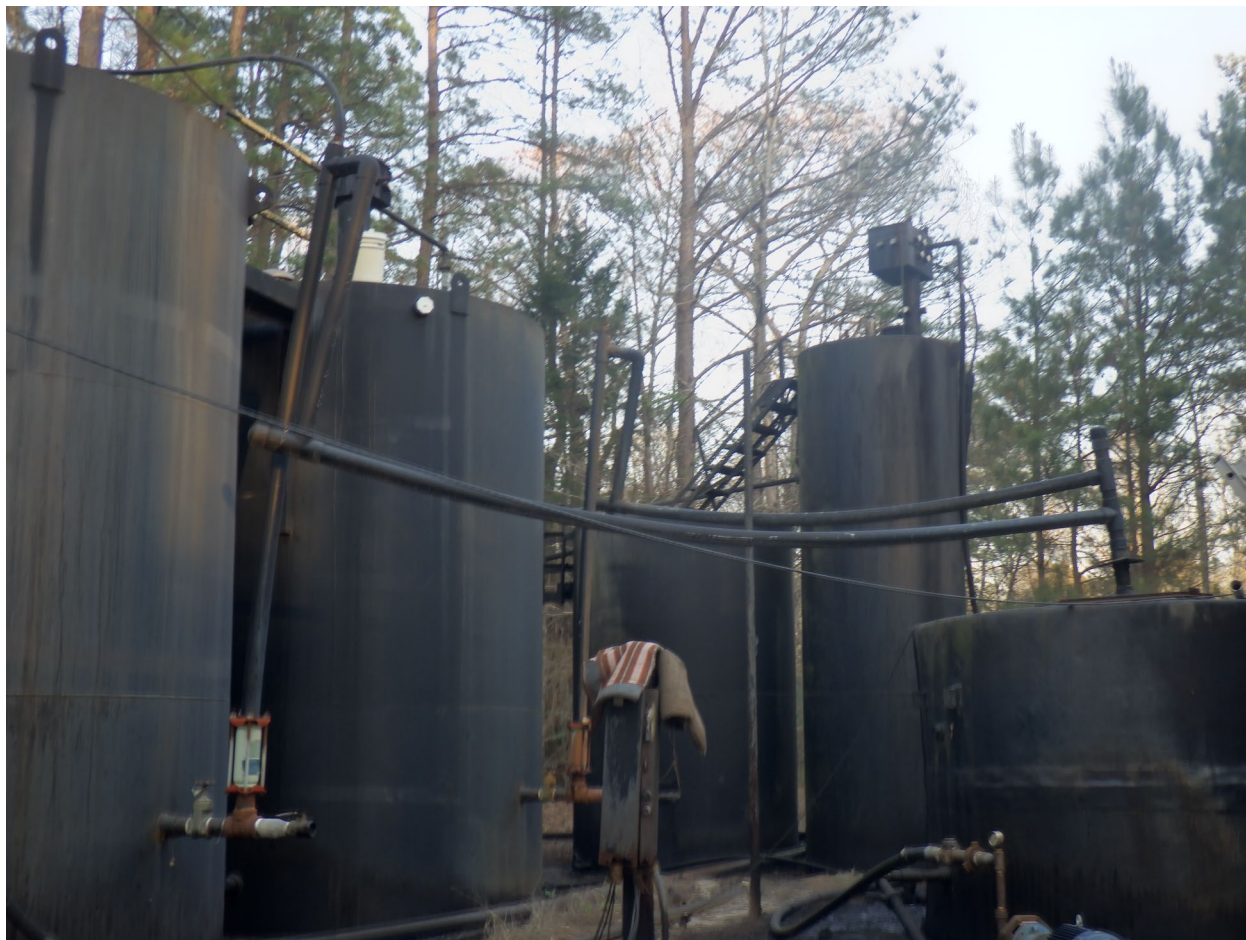
Photo No. 11

**Description:** This photo was taken looking E-SE showing another angle of the tanks with pipes without support sagging and pulling from the tanks in Photo No. 10.

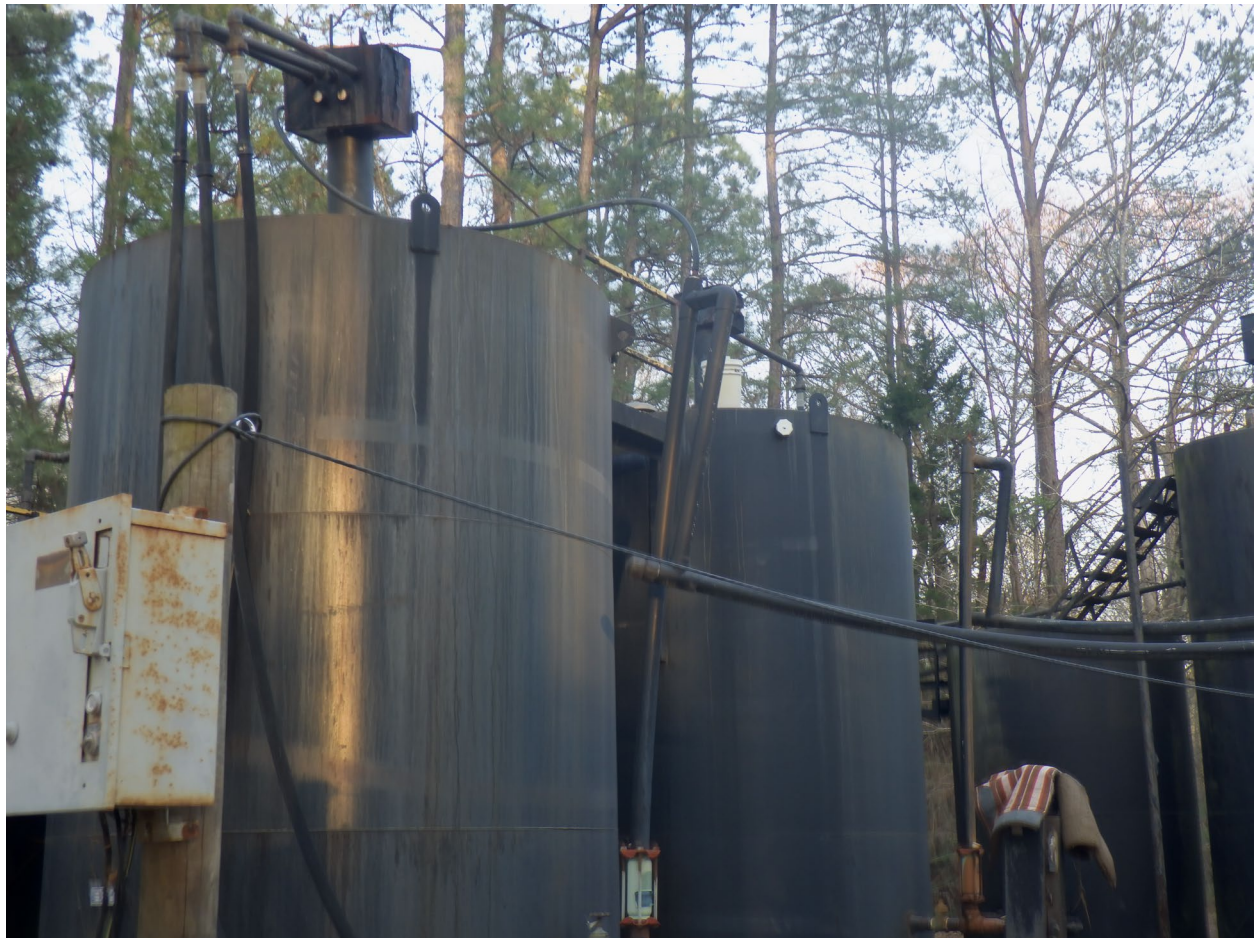
Photo No. 12

**Description:** This photo was taken looking E showing a closeup of tanks with pipes without support sagging and pulling from the tanks in Photo No. 11.

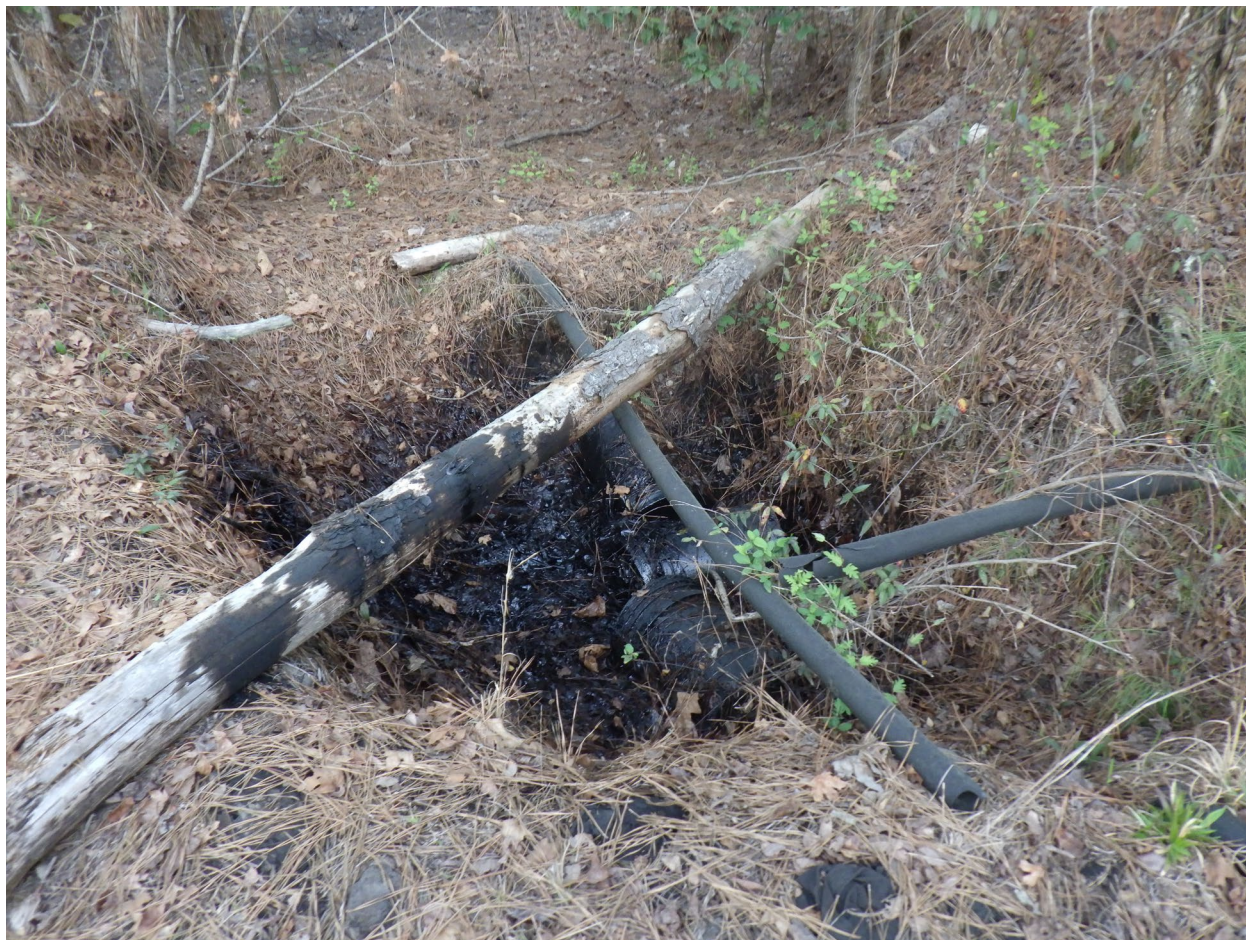
Photo No. 13

Looking E outside of the secondary containment, I observed an excavated pit used for dumping loose oil and solid waste; see Photo No. 13.

**Description:** This photo was taken looking E showing a pit, outside secondary containment, used for solid waste and loose oil.
