## Region 6 - Enforcement & Compliance Assurance Division

### INSPECTION REPORT

| Company Name: | <b>C12: Arkansas Oil, LLC</b> | |
| Facility Name: | <b>Midway Smackover Unit Tract #17 Tank Battery</b> | |

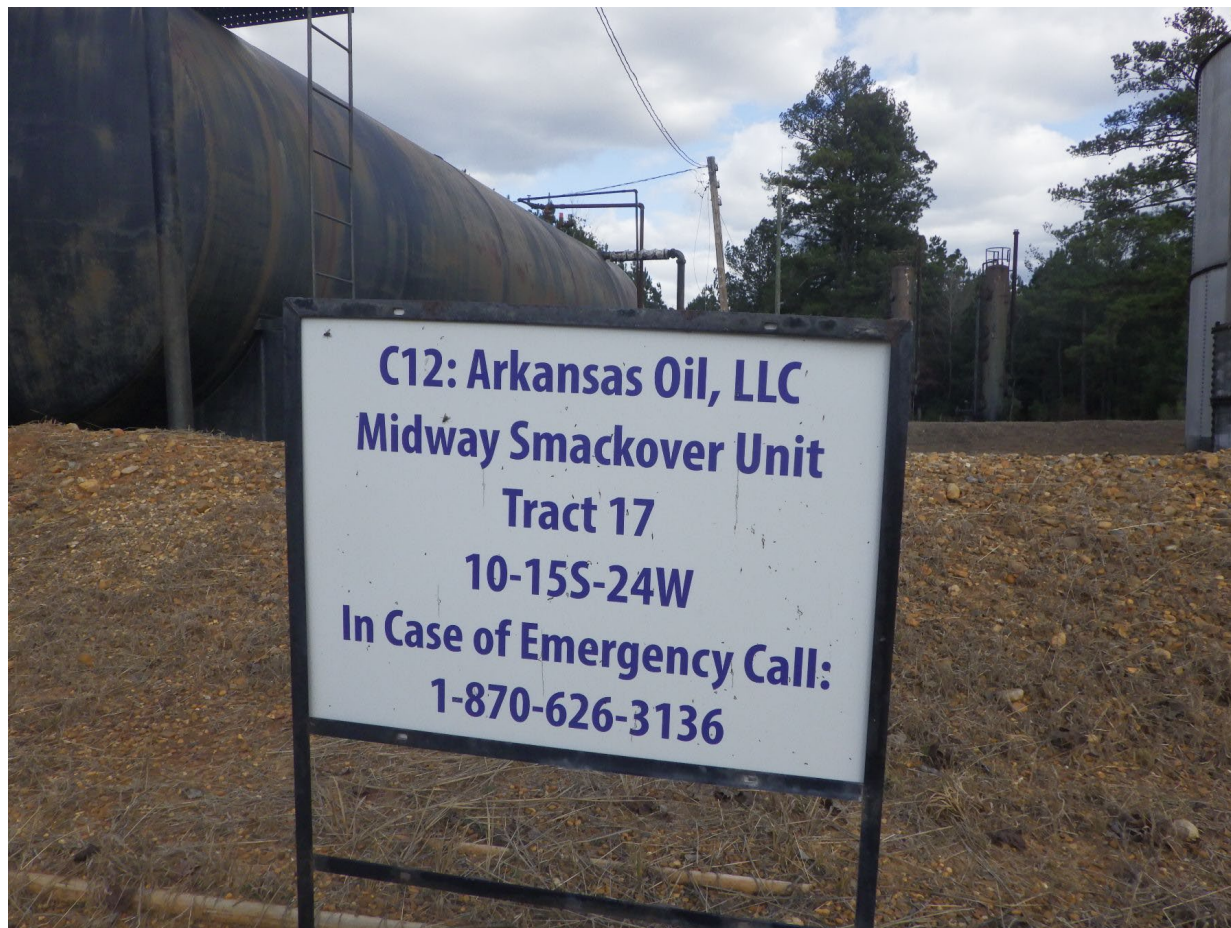
Photo No. 1

| Description: | Looking SSW, this photo shows the signage for the Midway Smackover Unit Tract 17 Tank Battery ("facility"). | | |

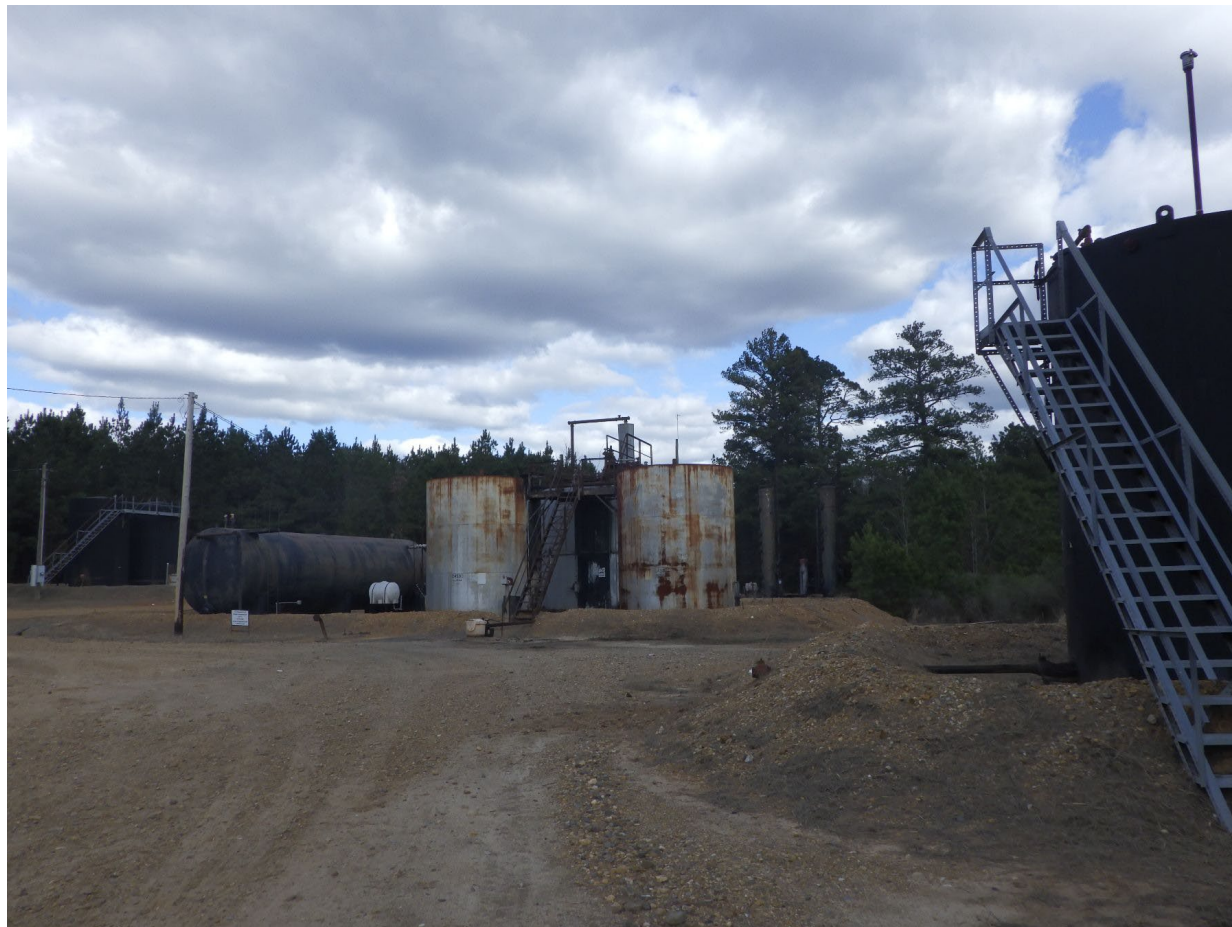
Photo No. 2

- Load line for “test” tank outside secondary containment, 40 CFR §112.7(c) (Photos No. 2 through No. 4), and
- Loose oil inside the oil storage tank battery (Area 1), 40 CFR §112.9(b)(1) (Photo No. 5); C12: Arkansas Oil, LLC personnel remediated the loose oil during the inspection (Photos No. 10 and No. 11).

| Description: | Looking SSW, this photo shows an overview of the facility. | | |

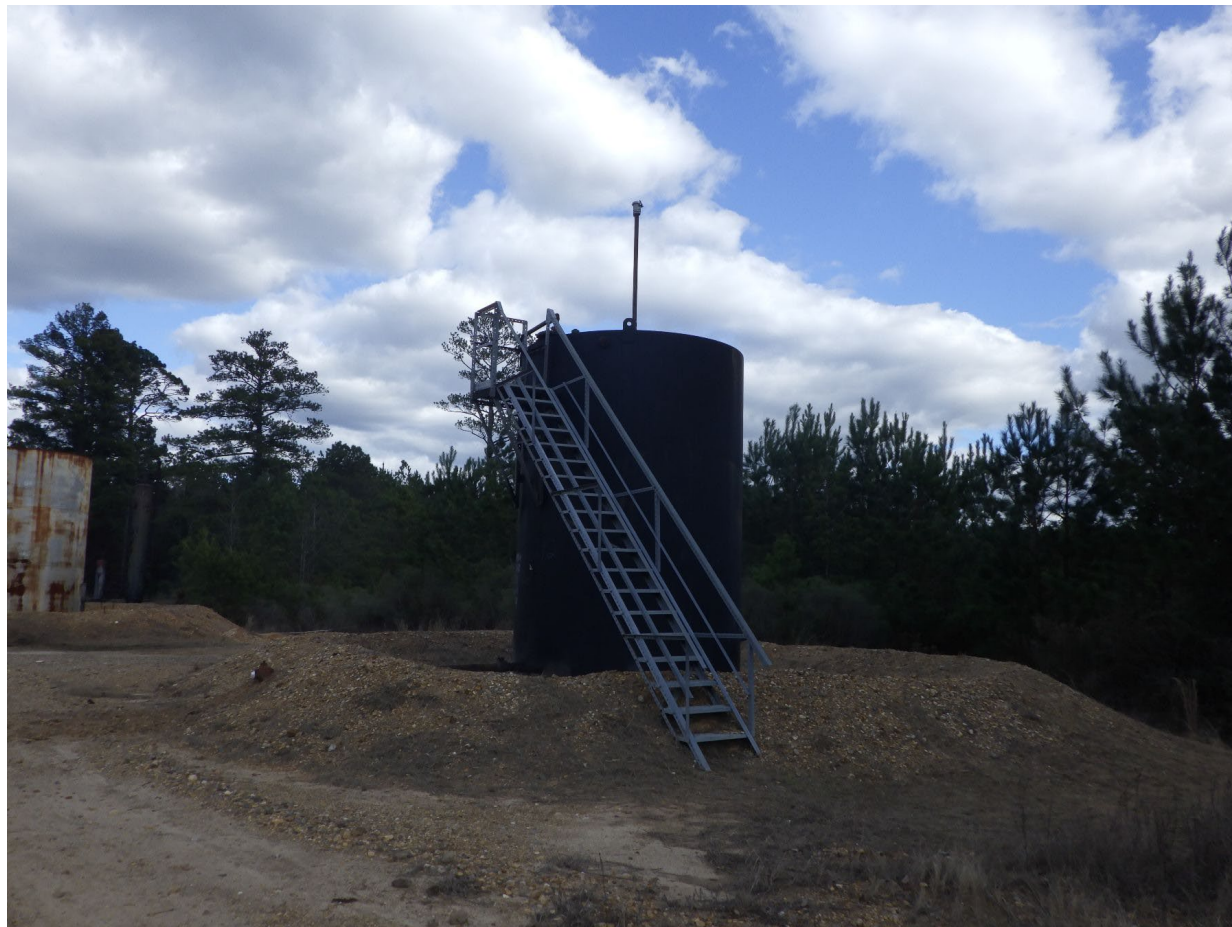
Photo No. 3

I observed a tank battery with a “test” tank and the associated load line, see Photos No. 3 and No. 4.

| Description: | Looking S, this photo shows the tank battery for a "test" tank. | | |

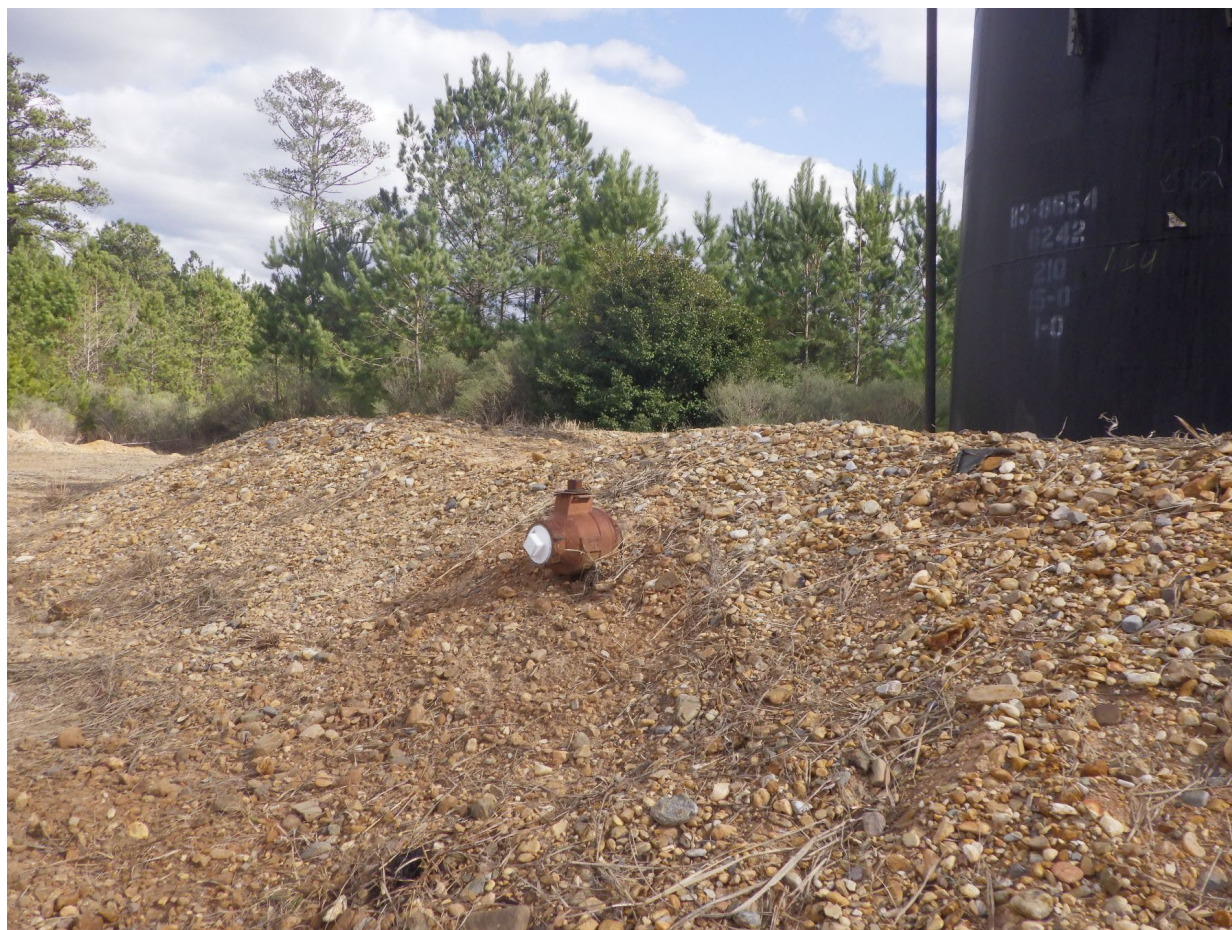
Photo No. 4

| Description: | Looking S, this photo shows the load line for the "test" tank battery without a secondary containment. | | |

Inspector will conduct follow-up phone calls with the company representative(s) over the coming weeks and months to ensure areas of concern are properly addressed. SEE Inspector Tom McKay will address SPCC rule concerns.

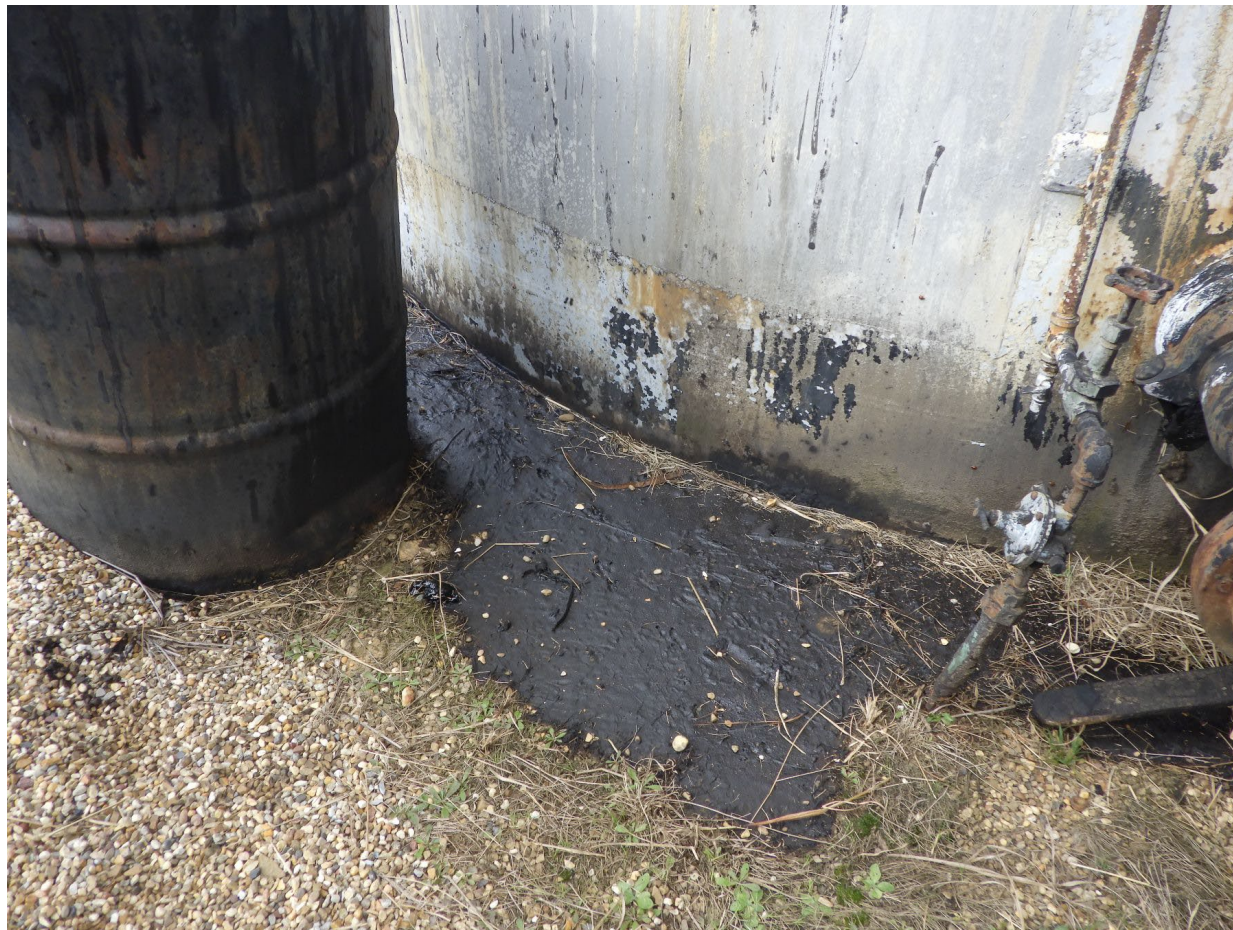
Photo No. 5

I observed loose oil inside the oil storage tank battery (Area 1), see Photo No. 5.

| Description: | Looking WSW, this photo shows loose oil inside the FWKO tank battery. | | |

I observed C12: Arkansas Oil, LLC personnel remediate the loose oil in the oil storage tank battery (Area 1), see Photos No. 10 and No. 11.

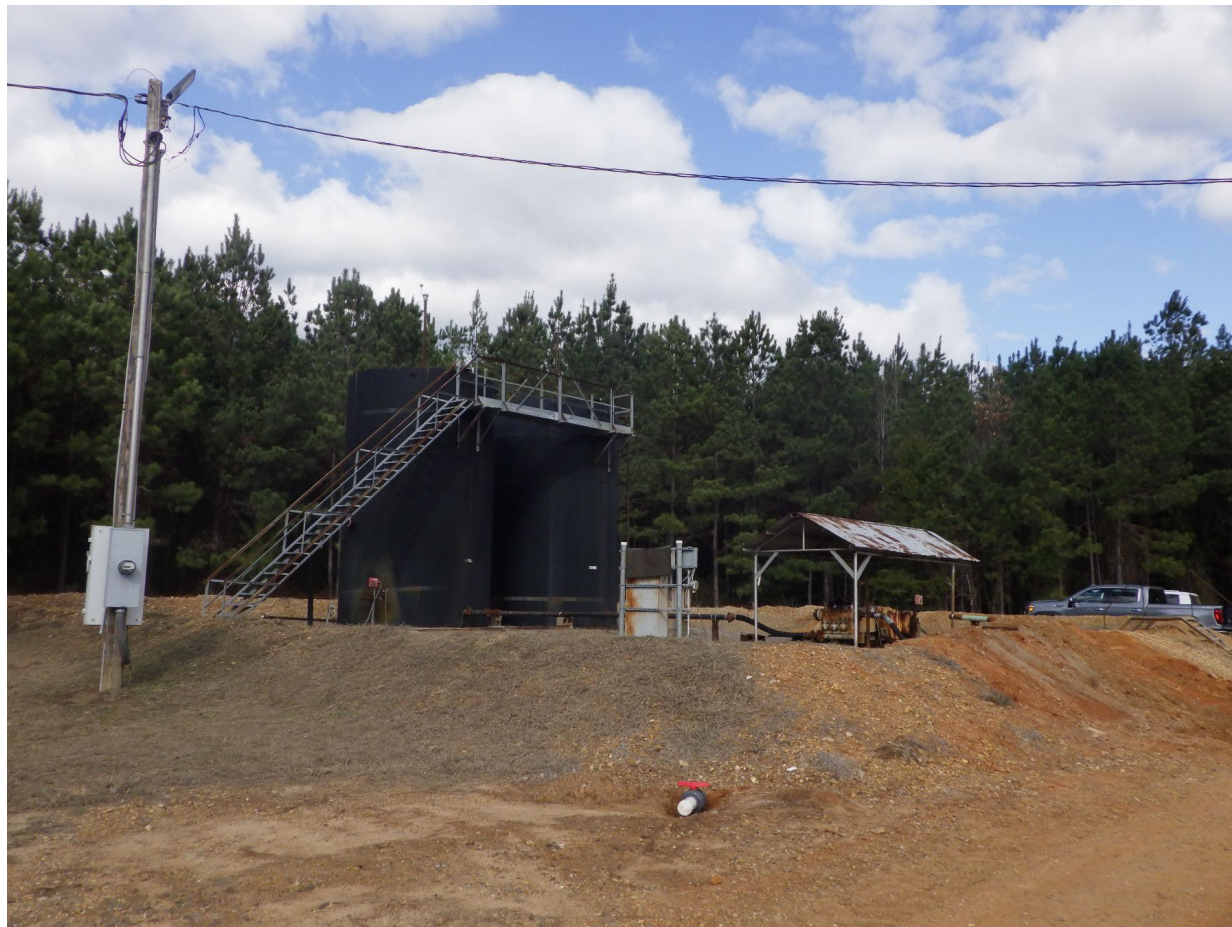
Photo No. 6

I observed the saltwater disposal (SWD) tank battery (Area 2) and drainpipe, see Photos No. 6 and No. 7.

| Description: | Looking SW, this photo shows an overview of the saltwater disposal (SWD) injection well tank battery with a repaired containment berm. | | |

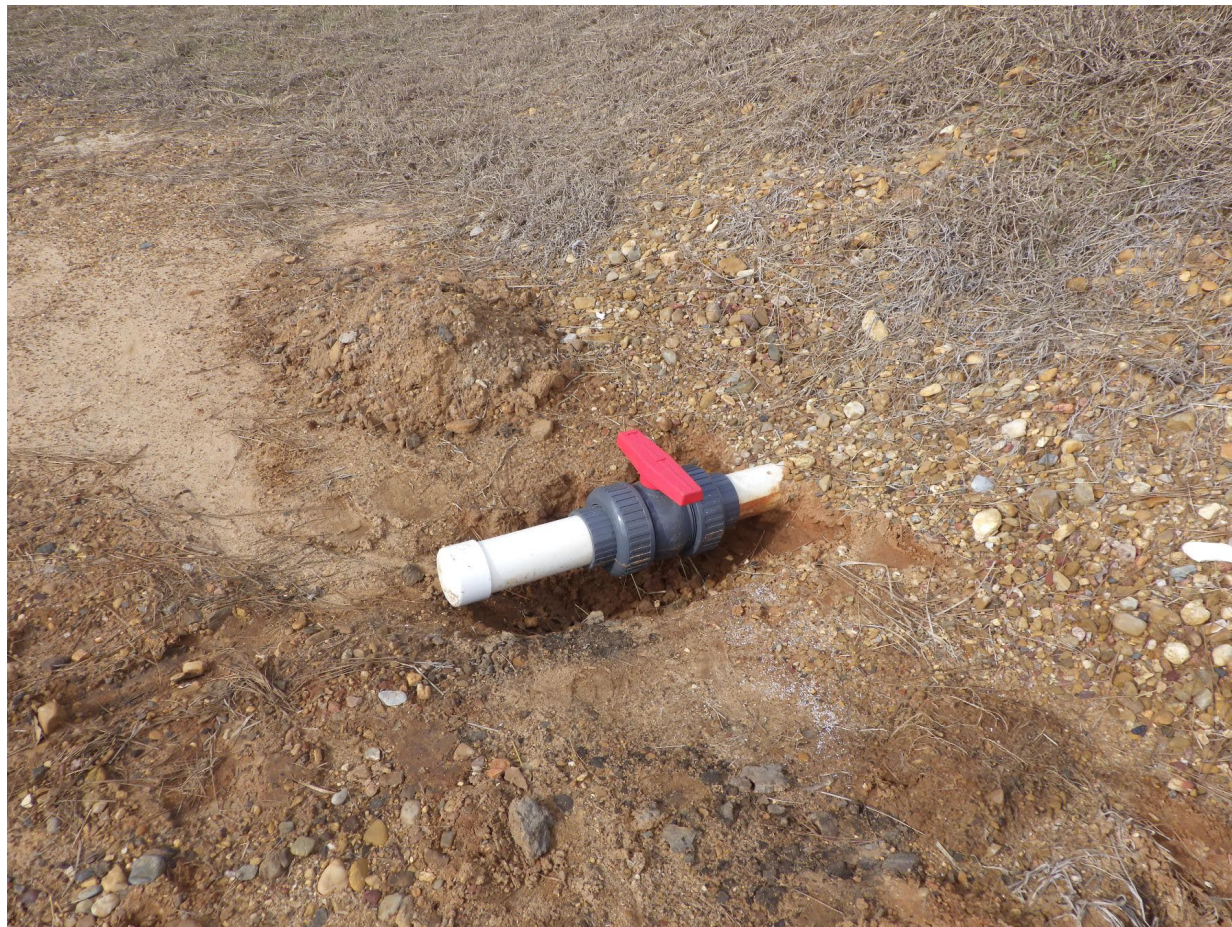
Photo No. 7

| Description: | Looking WSW, this photo shows the drainpipe for the SWD tank battery with closed valve and cap. | | |

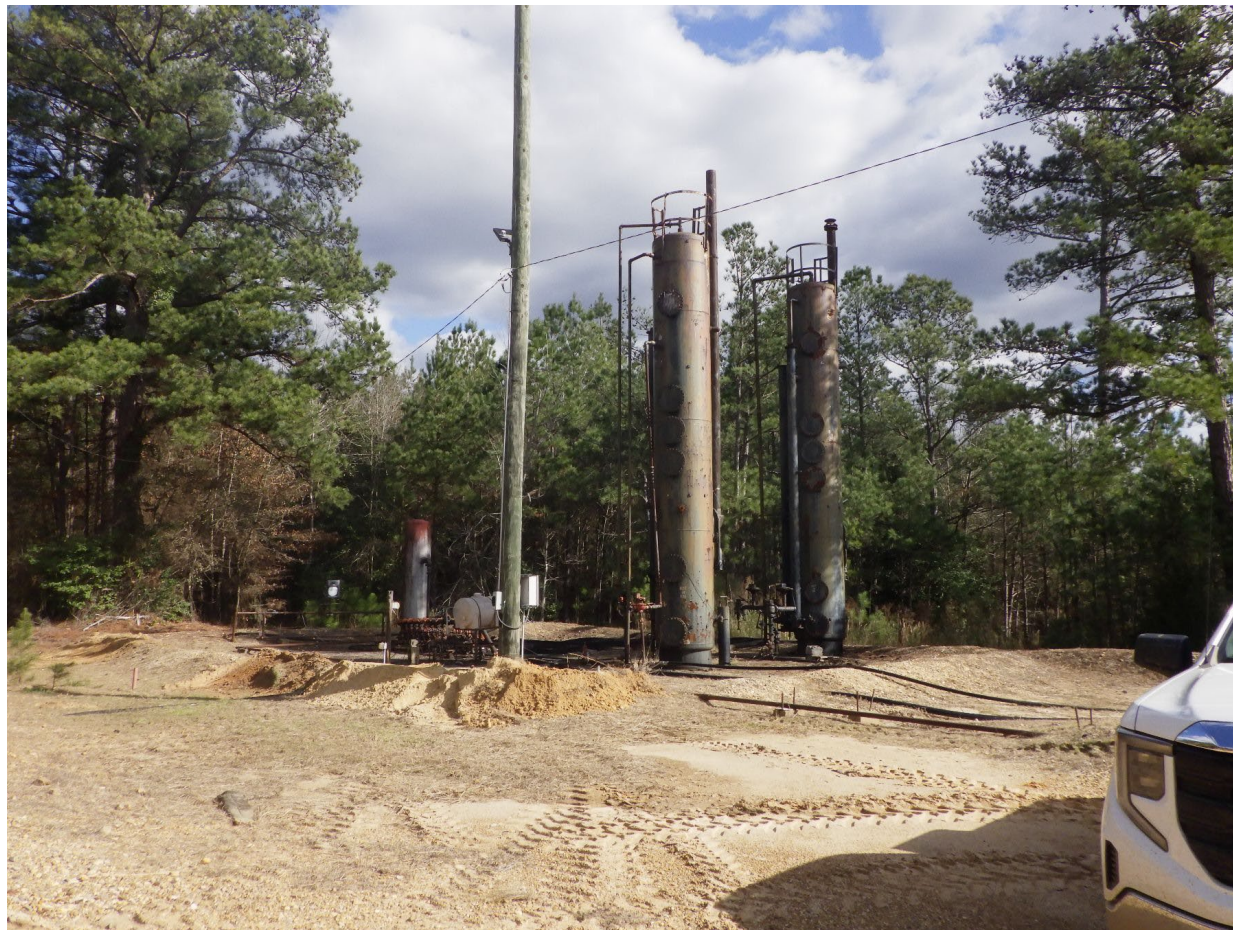
Photo No. 8

I observed the separator tank battery (Area 3) and berm that C12: Arkansas Oil, LLC personnel repaired since the 04/17/2025 inspection, see Photos No. 8 and No. 9.

| Description: | Looking S, this photo shows the tank battery for the separators with a repaired containment berm. | | |

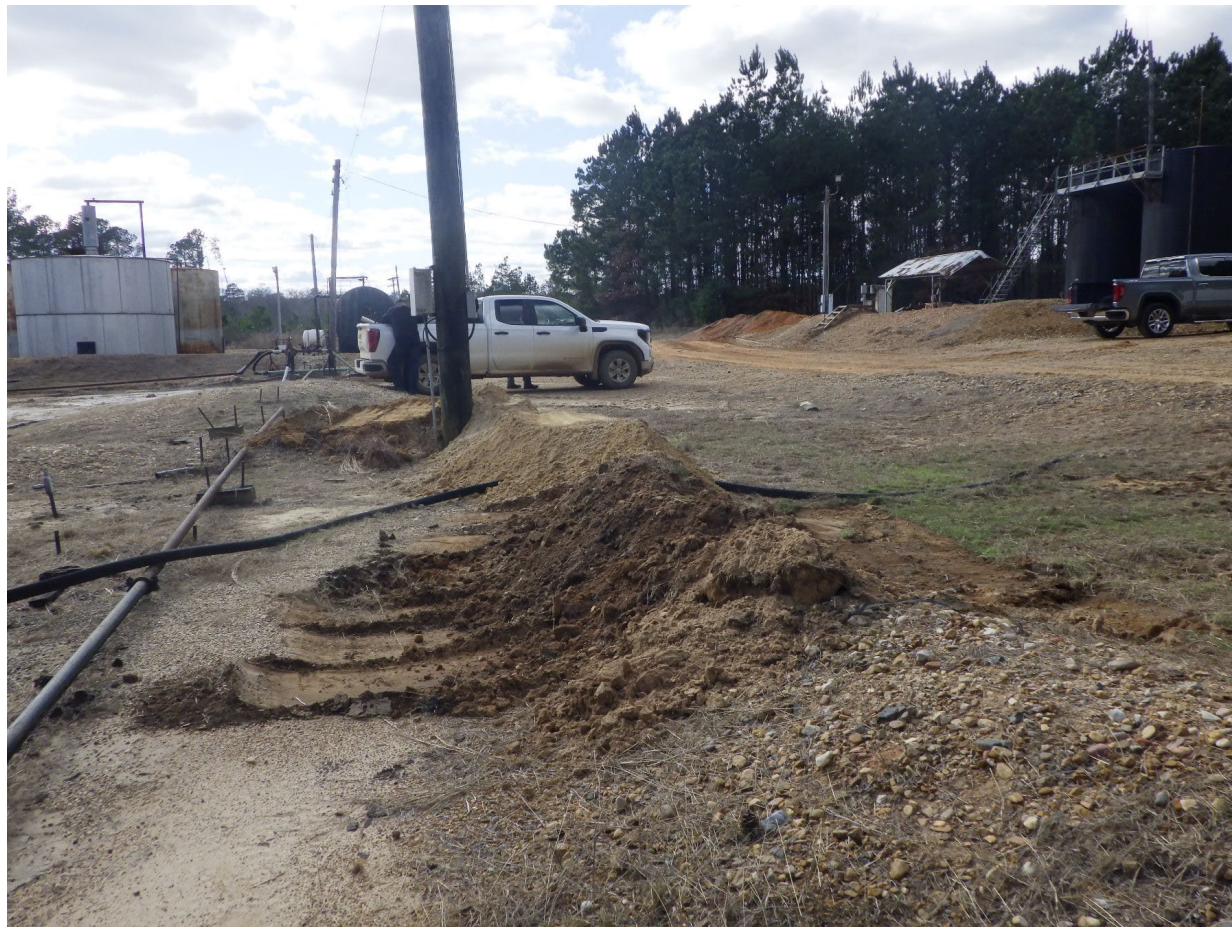
Photo No. 9

| Description: | Looking SW, this photo shows a closeup of the containment berm repairs for Photo No. 8. | | |

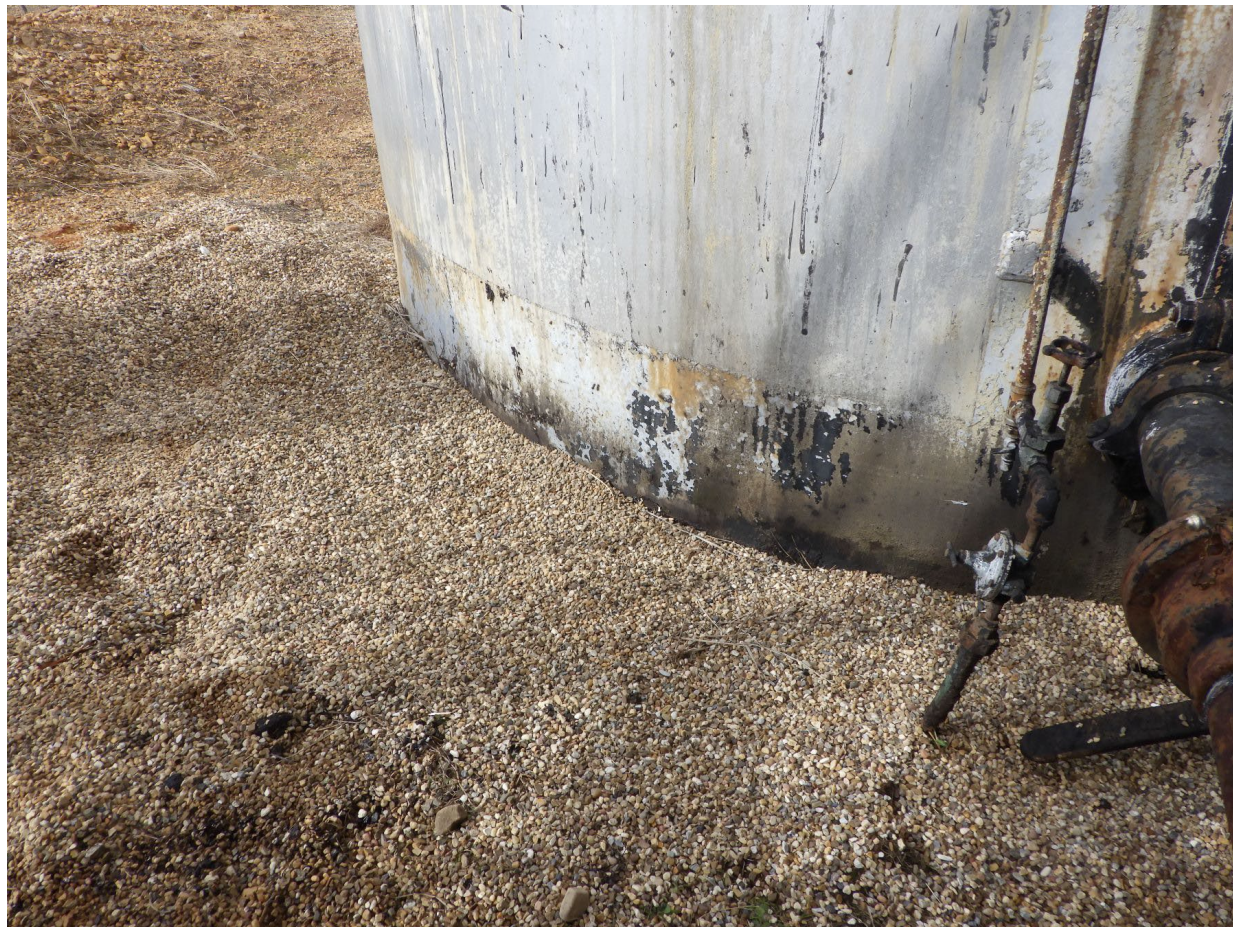
Photo No. 10

| Description: | Looking WSW, this photo shows the loose oil from Photo No. 5 removed by C12: Arkansas Oil, LLC personnel during the inspection. | | |

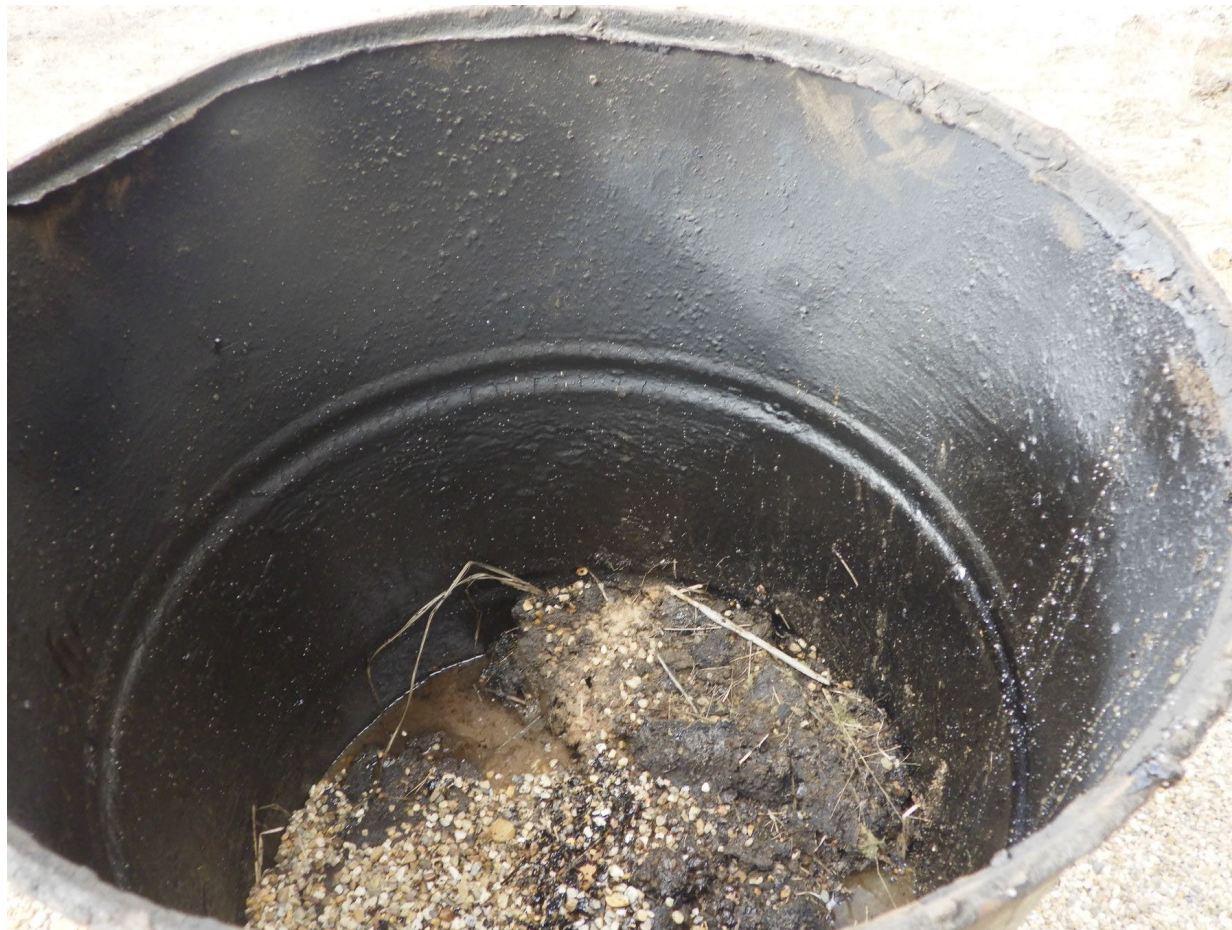
Photo No. 11

| Description: | Looking WSW, this photo shows the loose oil from Photo No. 5 placed in a drum for proper disposal. | | |
