## RCRA Compliance Evaluation Inspection Report

Induron Coatings, LLC  
3333 Richard Arrington Jr. Boulevard North  
Birmingham, Alabama 35234  
County: Jefferson  
Latitude: 33.533022  
Longitude: -86.794089

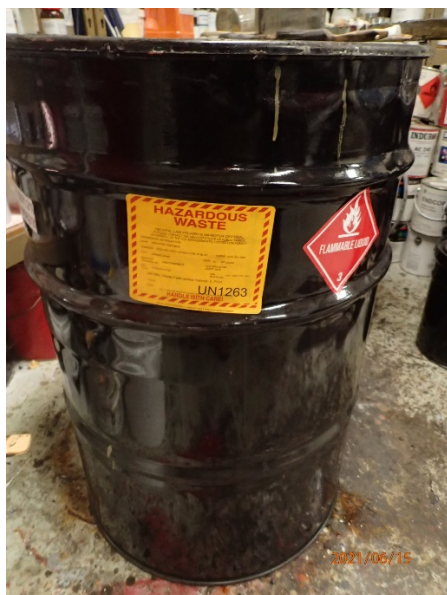
There were two 55-gallon open satellite accumulation containers of paint and solvent waste staged in the Chemical Lab. Both drums were open during the inspection. According to the facility representatives, the 55-gallon containers contained two separate waste streams, "Part A" and "Part B" generated in the Chemical Lab. The first 55-gallon container contained "Part A" waste, marked with the words "Hazardous Waste" and "Flammable Liquid" (Photograph #1). The second 55-gallon container contained "Part B" coatings waste but was not marked "Hazardous Waste" and with an indication of the hazards of the contents (Photograph #2). The facility personnel placed "Hazardous Waste" and "Flammable Liquid" label on the "Part B" drum prior to the conclusion of the inspection.

Photo #1 – Open satellite accumulation container in the Chemical Lab.

**Pursuant to ADEM Admin. Code r. 335-14-3-.01(5)(a)4. [40 C.F.R. § 262.15(a)(4)], which is a condition of the SAA Permit Exemption, a generator is required to keep containers of hazardous waste closed at all times during accumulation, except when adding, removing, or consolidating waste; or when temporary venting of a container is necessary for the proper operation of equipment, or to prevent dangerous situations, such as build-up of extreme pressure.**

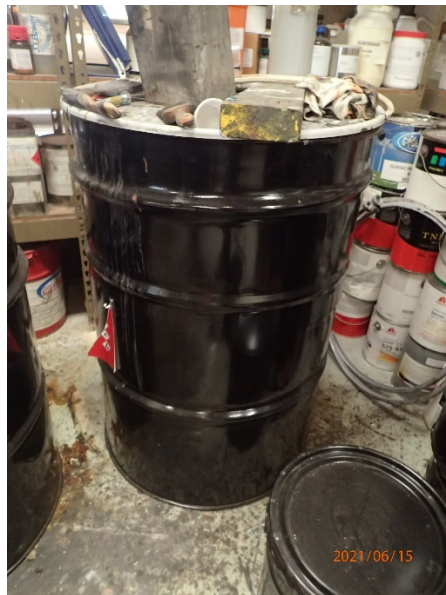
Photo #2 – Open and unlabeled satellite accumulation container in the Chemical Lab.

**Pursuant to ADEM Admin. Code r. 335-14-3-.01(5)(a)5. [40 C.F.R. § 262.15(a)(5)], which is a condition of the SAA Permit Exemption, a generator is required to mark or label its containers (i) with the words “Hazardous Waste” and (ii) with an indication of the hazards of the contents.**

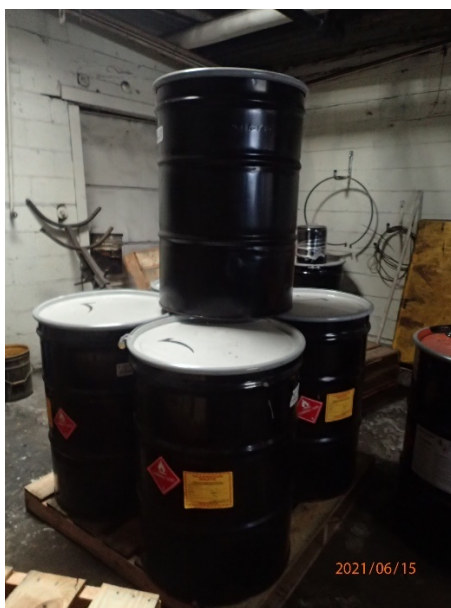
- Five 55-gallon containers of waste paint related materials from cleaning tub (D001, D035, F003, and F005) were staged on plastic spill control pallets (Photograph #3). The drums were closed, marked with the words “Hazardous Waste,” an indication of the hazards of the contents, and marked with an accumulation start date of June 10, 2021;

Photo #3 – Hazardous waste containers in the 90-Day Storage Area.

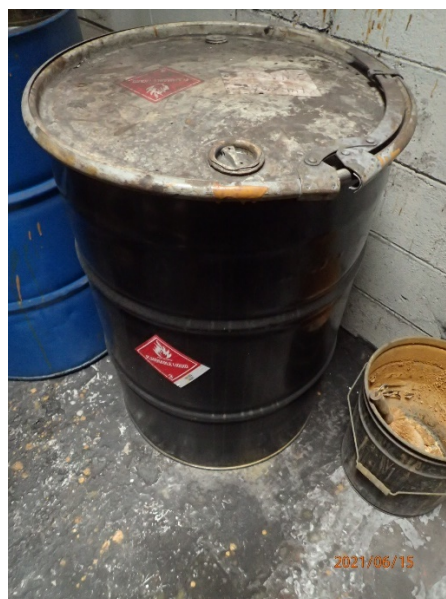
- One open-top 55-gallon metal container of wash solvent was staged in the central hazardous waste accumulation area. The container was open and unlabeled. According to the facility representative, the wash solvents are used to clean parts and equipment and is not a waste. The facility indicated that once the wash solvents become unusable and/or contaminated with impurities then the spent solvent waste is managed as hazardous waste;
- One 55-gallon container and three 5-gallon containers were stored in the back wall of the 90-day storage area (Photograph #4). The facility representative couldn't identify the waste materials in the containers. The inspectors instructed the facility to conduct a waste determination on the four containers and dispose of it accordingly.

Photo #4 – A 55-gallon container of unknown waste stored in the 90-Day Storage Area.

**Pursuant to ADEM Admin. Code r. 335-14-3-.01(2) [40 C.F.R. § 262.11], a person who generates a solid waste, as defined in ADEM Admin. Code r. 335-14-2-.01(2) [40 C.F.R. § 261.2], must make an accurate determination as to whether that waste is a hazardous waste in order to ensure wastes are properly managed according to applicable RCRA regulations articulated in ADEM Admin. Code r. 335-14-3-.01(2) [40 C.F.R. § 262.11].**
