## RCRA Compliance Evaluation Inspection Report

Peninsula Metal Finishing Inc.  
2550 Dinneen Avenue  
Orlando, FL 32804

July 14, 2021, 10:00 a.m.

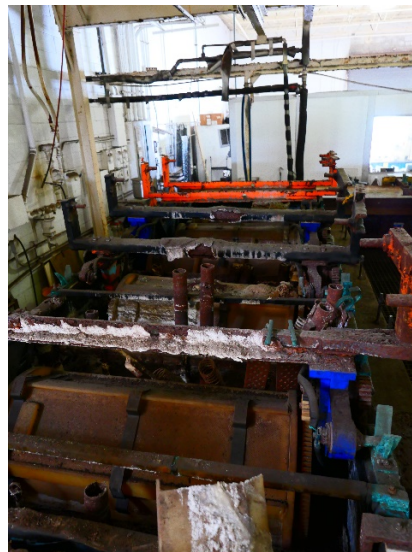
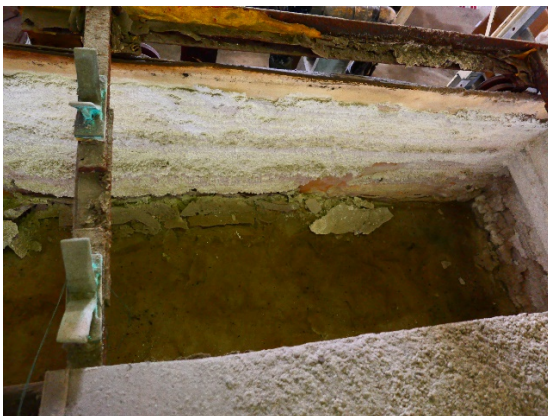
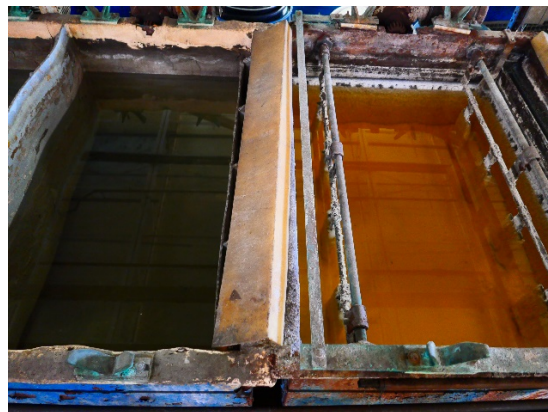
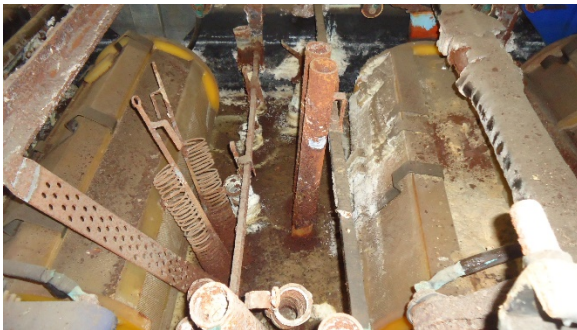
During the inspection, the small barrel line was in operation. According to Mr. Coachman, the large barrel line has been out of service for approximately two years. The inspectors observed rusted plating equipment and tanks in the large barrel line area. The equipment and open plating tanks contained plating solutions and dried up plating chemicals (Photos #1-13). The inspectors

Photo #1 – Out of service zinc plating large barrel line tanks.

Photo #2 – Out of service zinc plating large barrel line tank.

Photo #3 – Out of service zinc plating large barrel line tanks.

Photo #4 – Out of service/rusted zinc plating large barrel line tanks.

Photo #5 – Out of service zinc plating large barrel line tank.

Photo #6 – Out of service zinc plating solutions stored in the large barrel line tanks.

Photo #7 – Rusted out of service zinc plating large barrel line equipment.

Photo #8 – Out of service zinc plating large barrel line tanks.

Photo #9 – Out of service zinc plating solutions stored in the large barrel line tanks.

Photo #10 – Out of service zinc plating solutions stored in the large barrel line tank.

Photo #11 – Out of service zinc plating large barrel line tank.

Photo #12 – Out of service zinc plating large barrel line tank.

Photo #13 – Out of service zinc plating solutions stored in the large barrel line tanks.

informed Mr. Coachman to make waste determination of the plating solutions/materials left in the large barrel line tanks and dispose of the wastes accordingly.

**Pursuant to Fla. Admin. Code Ann. r. 62-730.160(1) [40 C.F.R. § 262.11], a person who generates a solid waste, as defined in Fla. Admin. Code Ann. r. 62-730.030(1) [40 C.F.R. § 261.2], must make an accurate determination as to whether that waste is a hazardous waste in order to ensure wastes are properly managed according to applicable RCRA regulations articulated in Fla. Admin. Code Ann. r. 62-730.160(1) [40 C.F.R. § 262.11].**

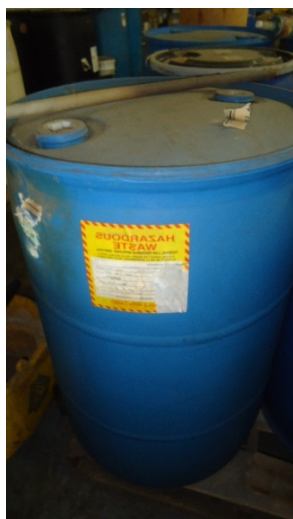
The chemical inventory area was located near the smaller plating lines. There were several rusty containers noted in this area. The inspector informed Mr. Coachman to assess the containers for usability and make a proper waste determination. There was one 55-gallon drum of hazardous waste ammonium nitrate waste. The drum was closed, labeled "Hazardous Waste" but was not marked with the hazards of the contents and not marked with an accumulation start date (Photos

Photo #41 – Hazardous waste drum in SAA.

Photo #42 – Close up of Photo #41.

**Pursuant to Fla. Admin. Code Ann. r. 62-730.160(1) [40 C.F.R. § 262.17(a)(5)(i)(B-C)], which is a condition of the LQG Permit Exemption, a generator must mark or label its containers with the following: (B) an indication of the hazards of the contents (examples include, but are not limited to, the applicable hazardous waste characteristic(s) (i.e., ignitable, corrosive, reactive, toxic); hazard communication consistent with the Department of Transportation requirements at 49 C.F.R. part 172 subpart E (labeling) or subpart F (placarding); a hazard statement or pictogram consistent with the Occupational Safety and Health Administration Hazard Communication Standard at 29 C.F.R. 1910.1200; or a chemical hazard label consistent with the National Fire Protection Association code 704); and (C) the date upon which each period of accumulation begins clearly visible for inspection on each container.**

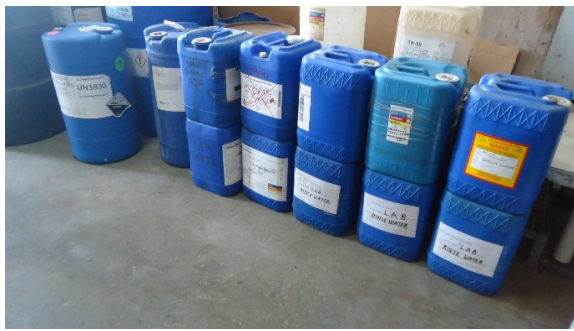
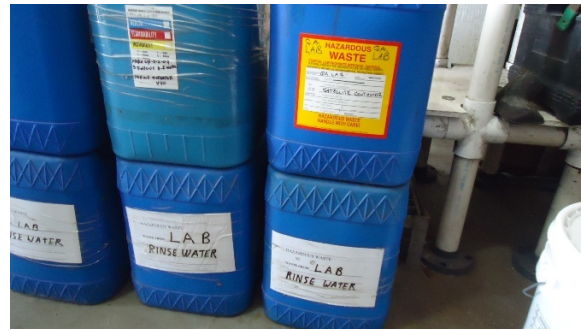
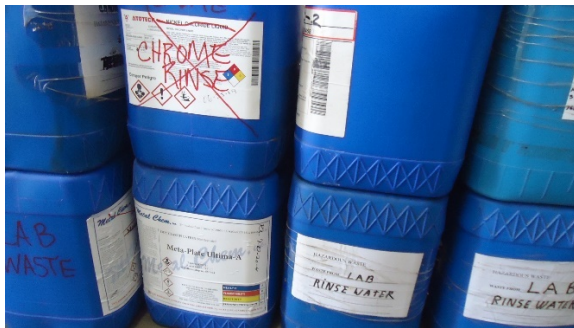
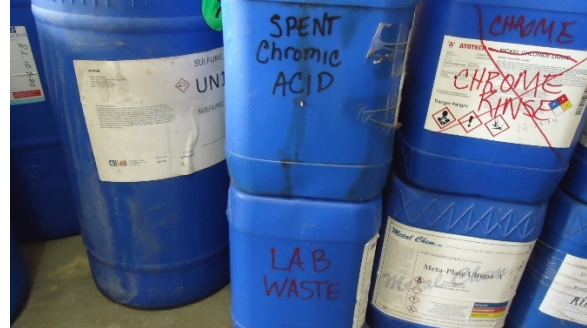
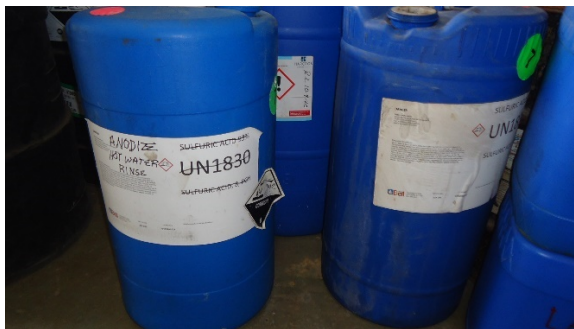
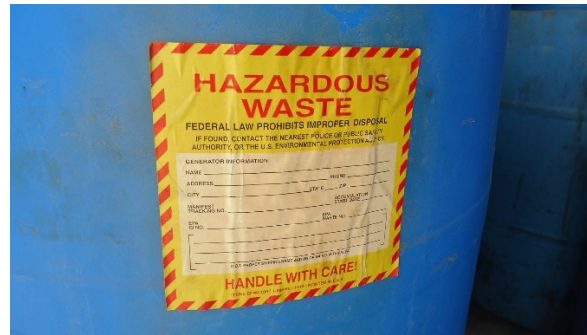
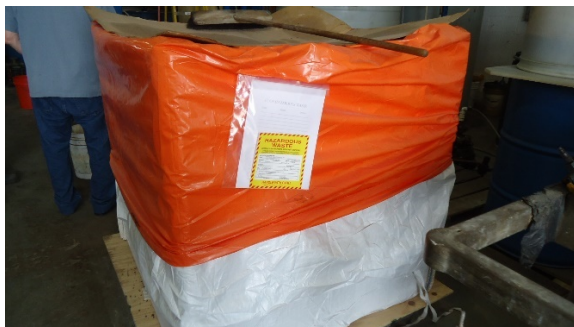
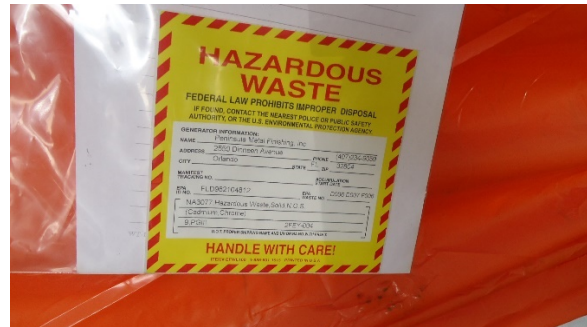
- There were ten 5-gallon containers, two 15-gallon containers, and three 55-gallon poly drums (Photos #43-48). Four of ten 5-gallon containers, two 15-gallon containers, and two of three 55-gallon poly drums were not marked with the words “Hazardous Waste.” Ten 5-gallon containers, one of two 15-gallon container, and three 55-gallon poly drums were not marked with the hazards of the contents. Ten 5-gallon containers, two 15-gallon containers, and three 55-gallon poly drums were not marked with an accumulation start date; and
- One cubic yard box of plating filter cake/sludge marked “Hazardous Waste” but was not marked with the hazards of the contents and not marked with an accumulation start date (Photos #49-50).

Photo #43 – Hazardous plating waste containers in the wastewater treatment system area.

Photo #44 – Close up of containers Photo #43.

Photo #45 – Close up of containers Photo #43.

Photo #46 – Close up of containers Photo #43.

Photo #47 – Close up of containers Photo #43.

Photo #48 – Hazardous waste label of one of the containers in Photo #43.

Photo #49 – F006 filter cake sludge stored in a 250-gallon tote.

Photo #50 – Close up label of Photo #49.

**Pursuant to Fla. Admin. Code Ann. r. 62-730.160(1) [40 C.F.R. § 262.17(a)(5)(i)(A-C)], which is a condition of the LQG Permit Exemption, a generator must mark or label its containers with the following: (A) the words “Hazardous Waste;” (B) an indication of the hazards of the contents (examples include, but are not limited to, the applicable hazardous waste characteristic(s) (i.e., ignitable, corrosive, reactive, toxic); hazard communication consistent with the Department of Transportation requirements at 49 C.F.R. part 172 subpart E (labeling) or subpart F (placarding); a hazard statement or pictogram consistent with the Occupational Safety and Health Administration Hazard Communication Standard at 29 C.F.R. 1910.1200; or a chemical hazard label consistent with the National Fire Protection Association code 704); and (C) the date upon which each period of accumulation begins clearly visible for inspection on each container.**
