**Region 6 - Enforcement & Compliance Assurance Division**  
**INSPECTION REPORT**

| Company Name: | <b>Lion Copolymer Geismar, LLC</b> | |
| Facility Name: | <b>Lion Copolymer Geismar, LLC – Geismar Facility</b> | |

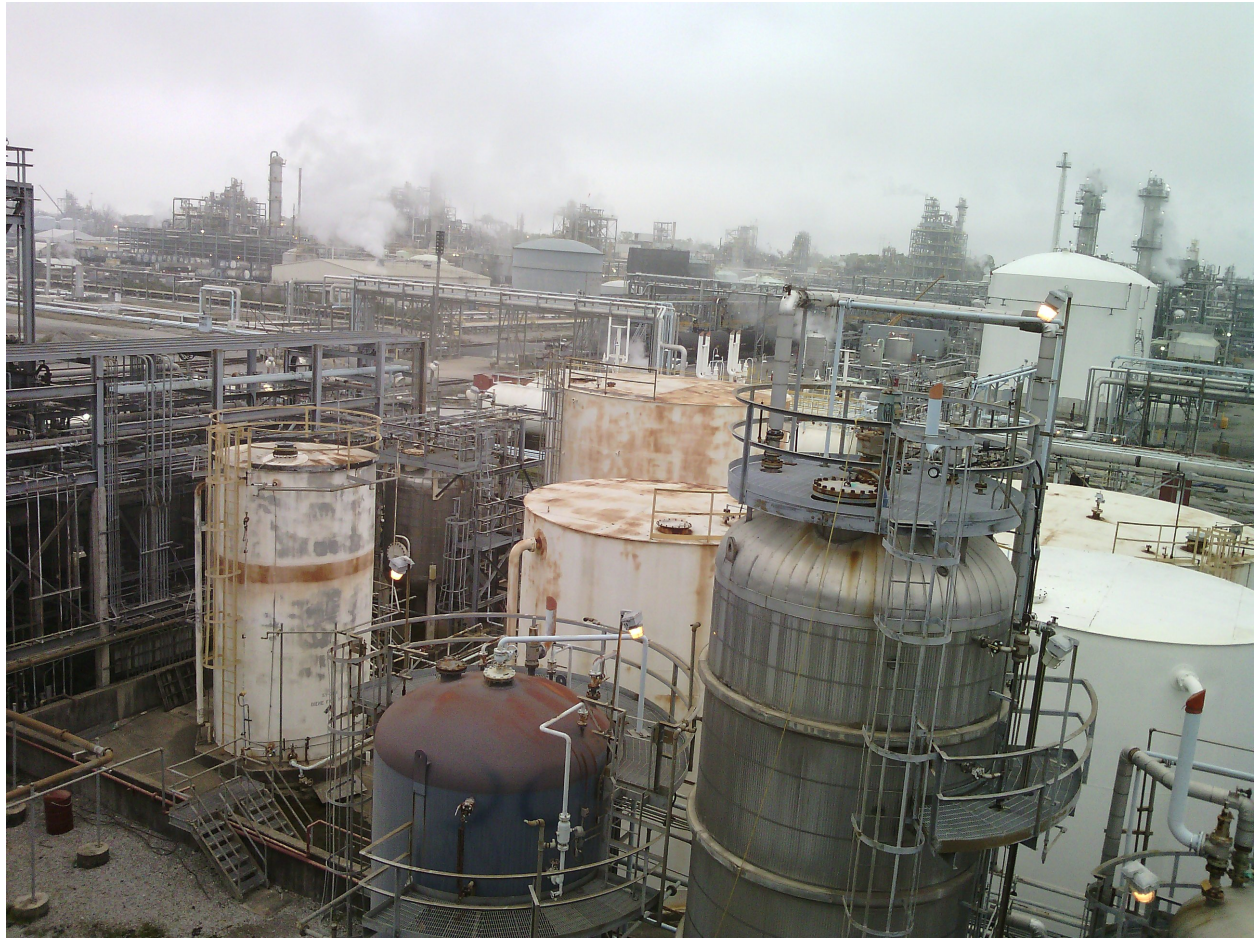
Photo File Name: FLIR0235.jpg

Description: Tank SV-105 IFR Dry Hexane Tank observed with emissions from hatch

- 4B) At Tank SV-105, an IFR dry hexane tank, EPA inspectors observed hydrocarbon emissions with the OGIC from the hatch. At Tank SV-100, an IFR dry solvent hexane tank that routes to a vent condenser, EPA inspectors measured over 700 ppm from the hatch. Group 1 storage vessels must route emissions to a closed vent system and control device per 40 CFR 63.119(a)(1).
