## Region 6 - Enforcement & Compliance Assurance Division

### INSPECTION REPORT

| Company Name: | <b>RCP Production, LLC</b> | |
| Facility Name: | <b>TD Murphy B-3 SWD Tank Battery</b> | |

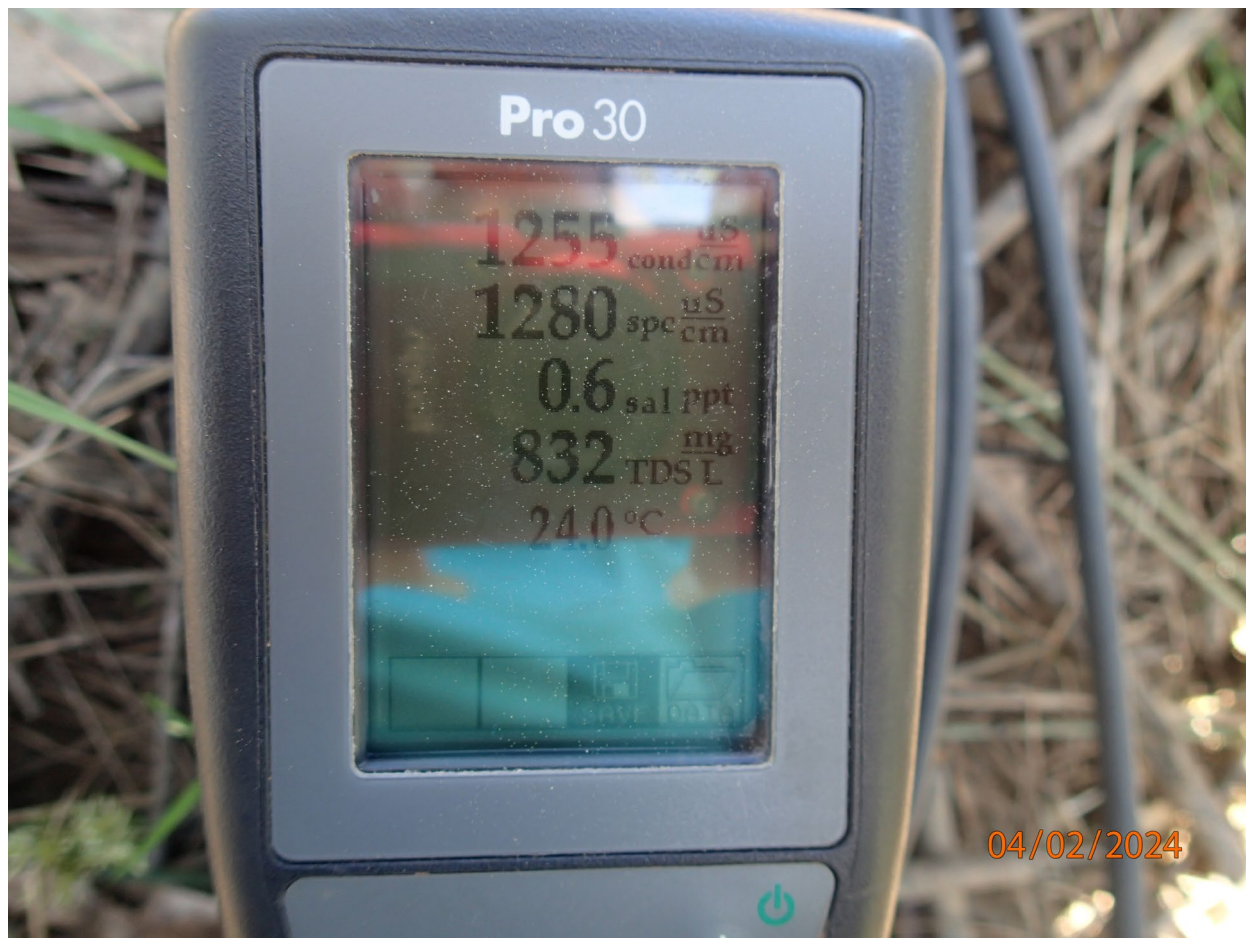
A Total Dissolved Solids (TDS) reading of 832 mg/L was taken in a pool at a wetland upstream of a culvert in an oil field lease road and downstream of the TD Murphy B-3 SWD tank battery release, see Appendix 1 (Photographs Log), Photo No. 1 through No. 3. For additional GPS location and photo metadata, see Appendix 1.

**Description:** Looking W, this photo showed the Total Dissolved Solids (TDS) reading at the pond off All Gulf Rd that is downstream from the TD Murphy B-3 SWD tank battery release.

| TSD / Temperature | 832 mg/L at 24.0 degC |

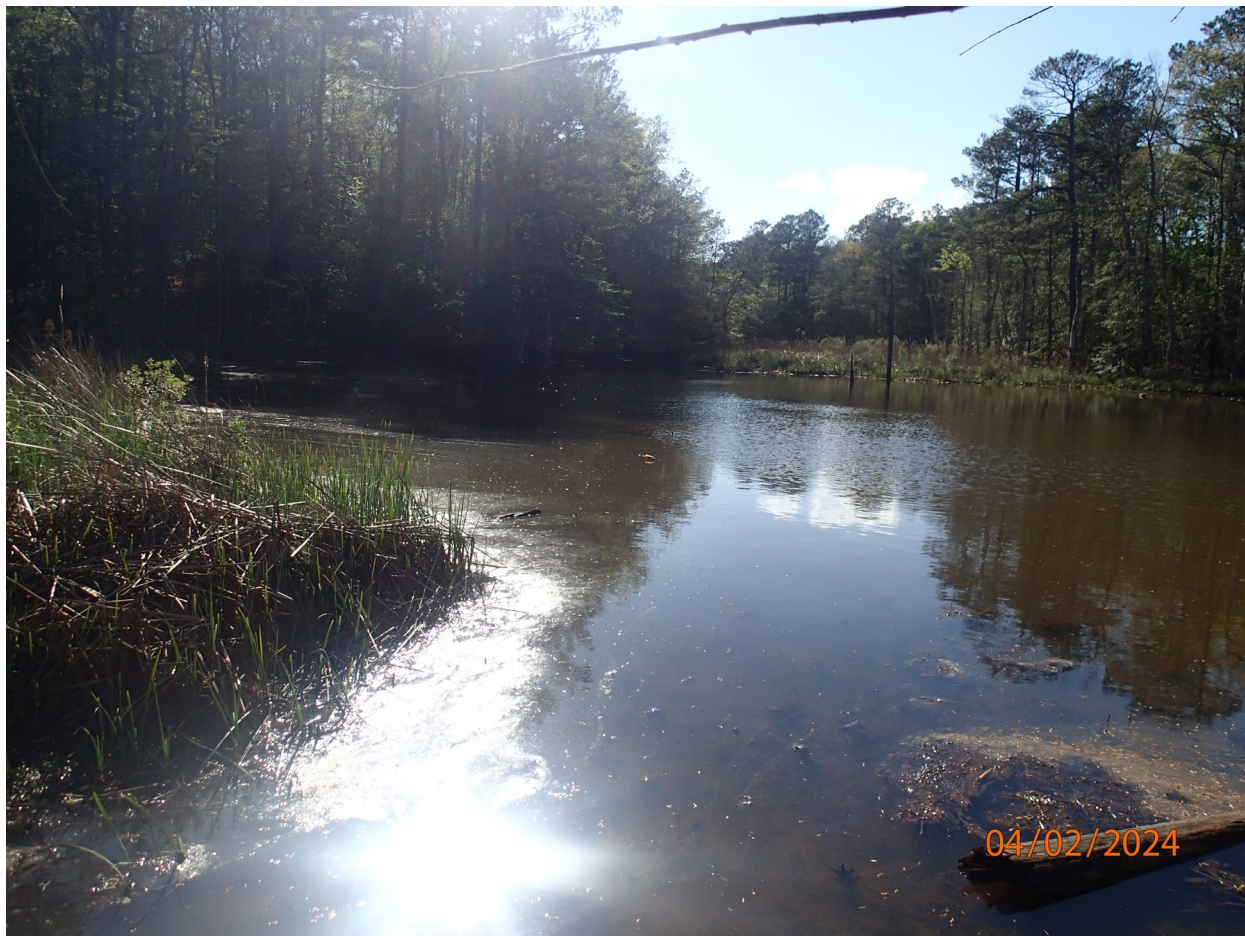
Photo No. 2

**Description:** Looking SE, this photo showed the upstream view at the TDS reading location in Photo No. 1.

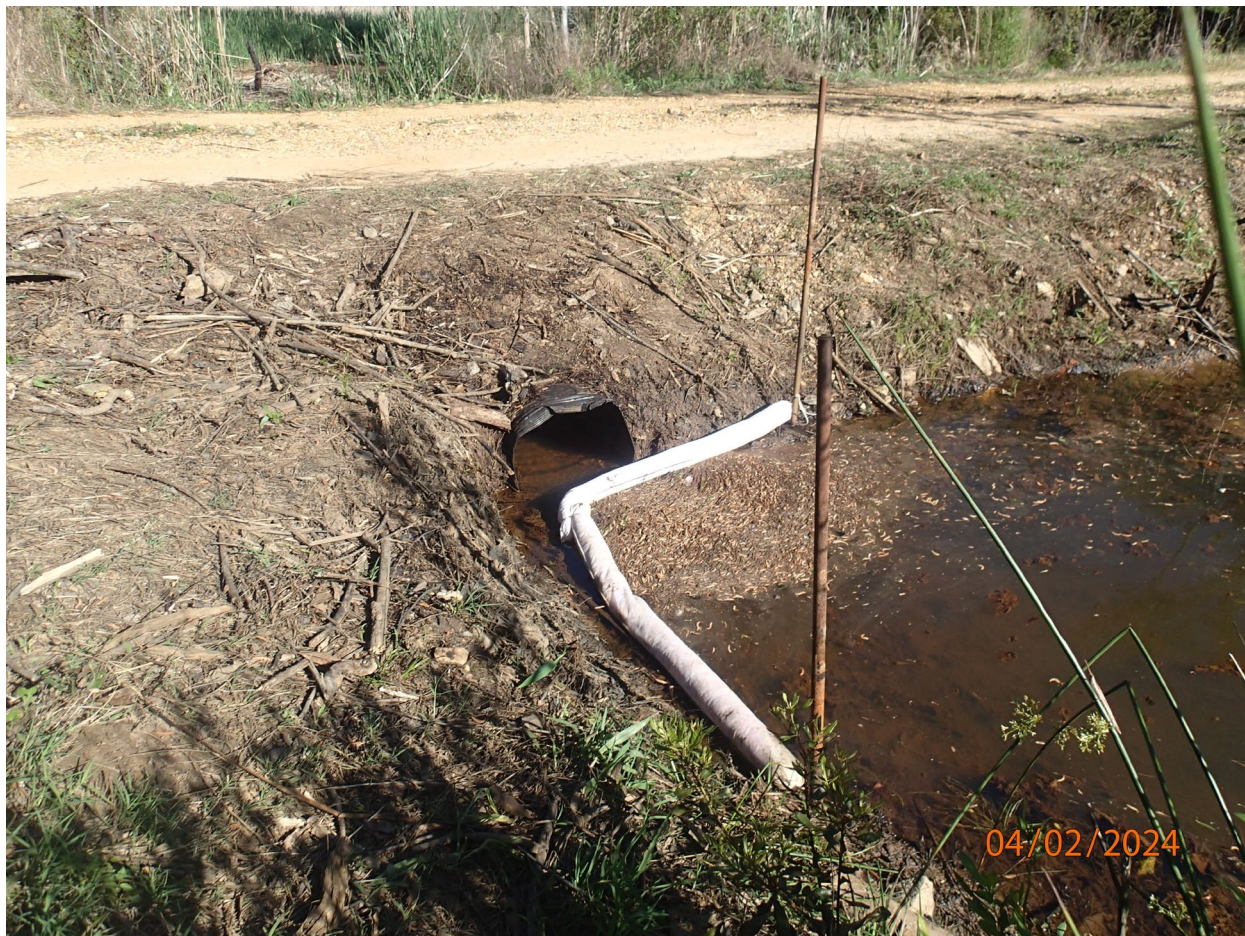
Photo No. 3

**Description:** Looking SW, this photo showed the downstream view at the TDS reading location in Photo No. 1.

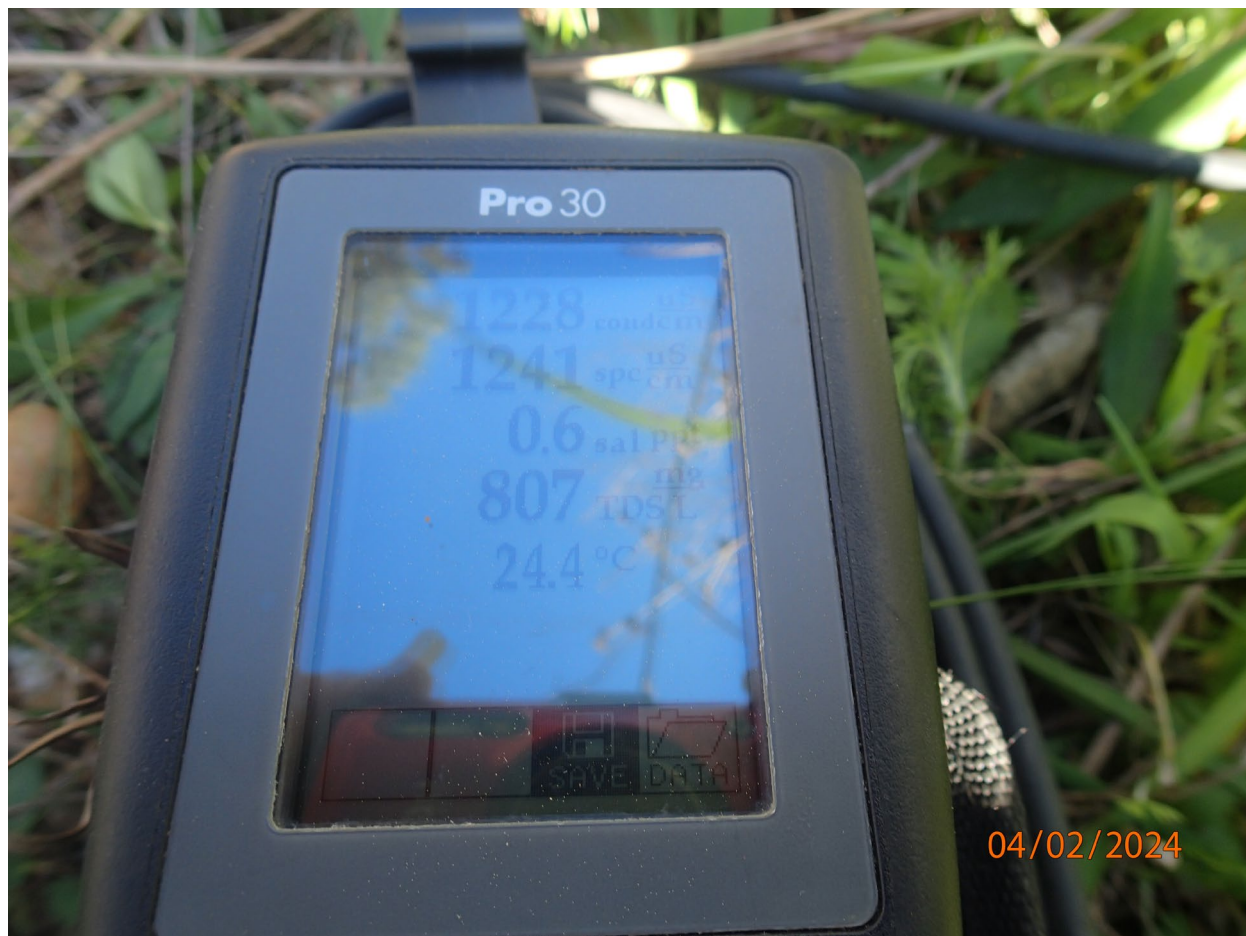
Another TDS reading of 807 mg/L was taken directly downstream of the pool and the culvert in the same conveyance as the first TDS reading, see Photo No. 4 through No. 6.

**Description:** Looking W, this photo showed the TDS reading directly downstream of the pond off All Gulf Rd that is downstream from the TD Murphy B-3 SWD tank battery release.

| TSD / Temperature | 807 mg/L at 24.4 degC |

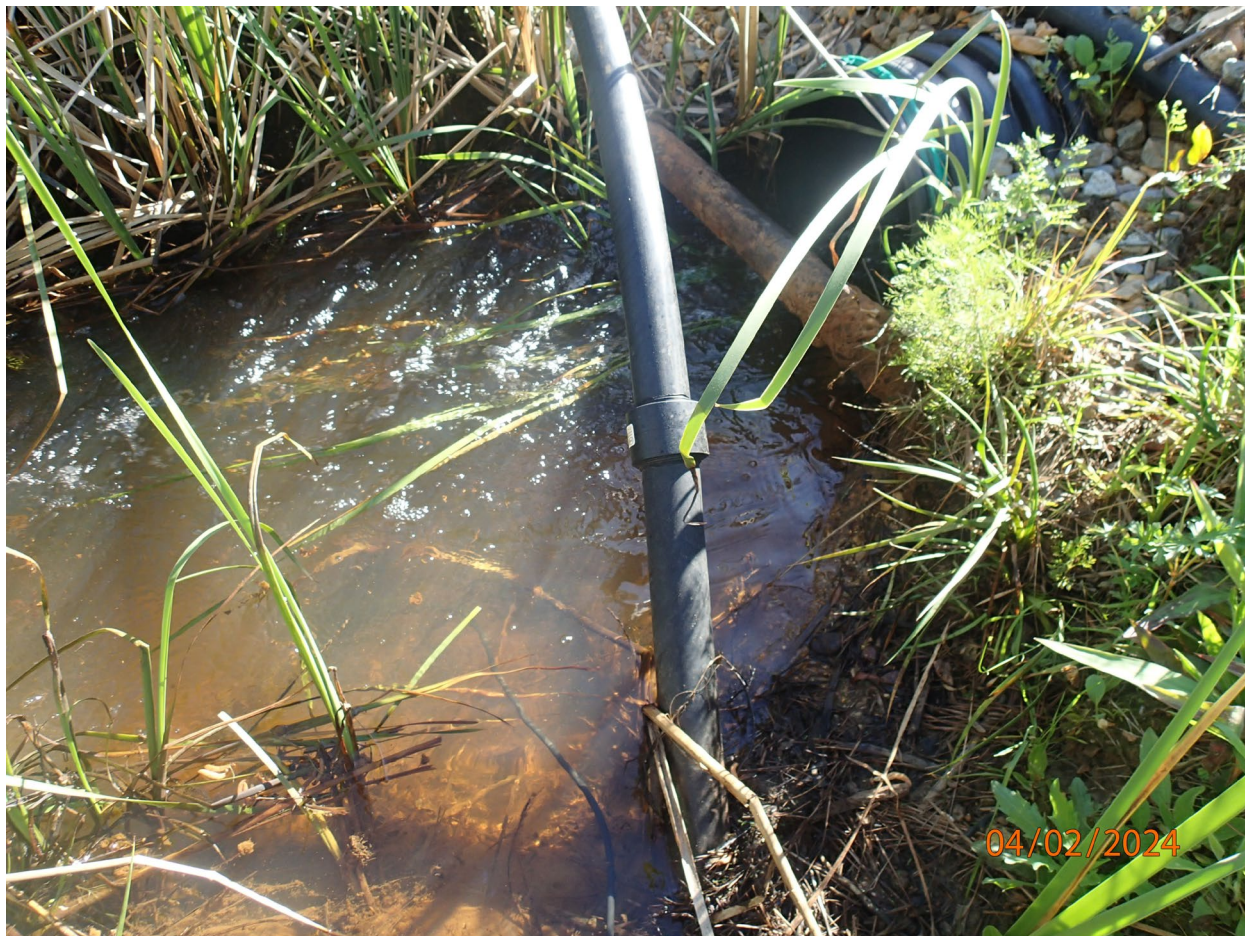
Photo No. 5

**Description:** Looking SE, this photo showed the upstream view at the TDS reading location in Photo No. 4.

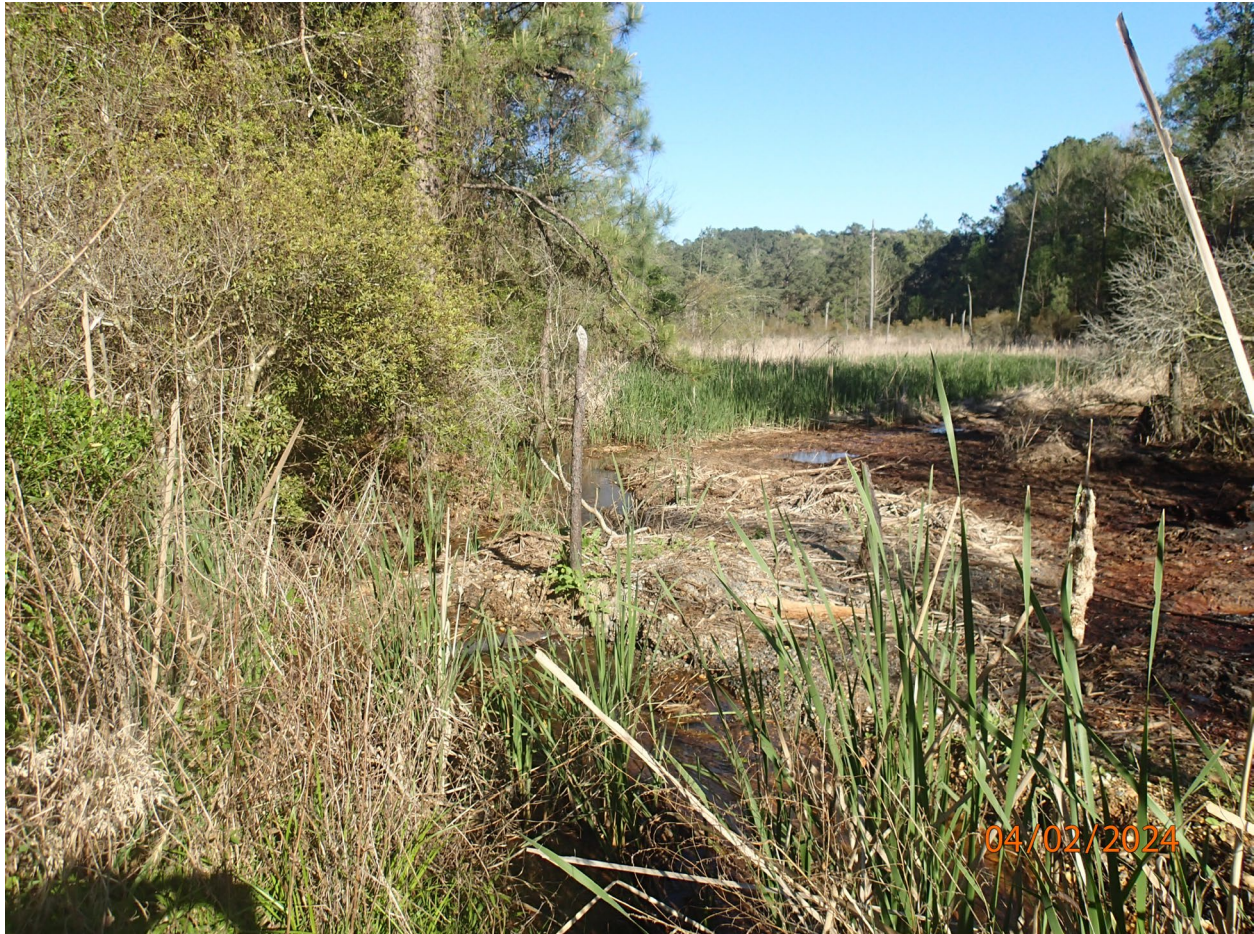
Photo No. 6

**Description:** Looking SW, this photo showed the downstream view at the TDS reading location in Photo No. 4.

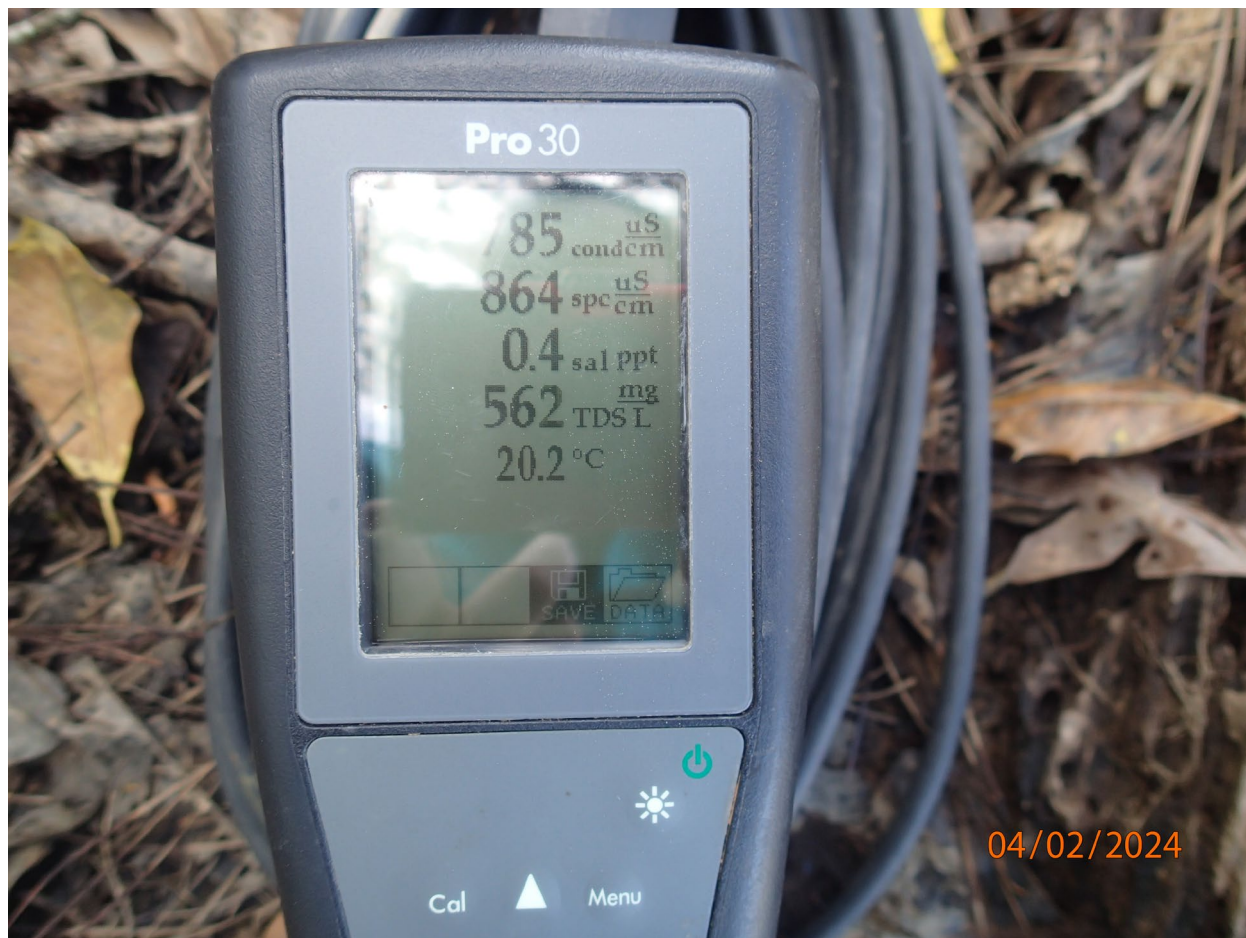
A TDS reading of 562 mg/L, for background comparison, was taken upstream of the pool, see Photo No. 7 through No. 9.

**Description:** Looking E, this photo showed the TDS reading upstream of the pond off All Gulf Rd that is downstream from the TD Murphy B-3 SWD tank battery release.

| TSD / Temperature | 562 mg/L at 20.2 degC |

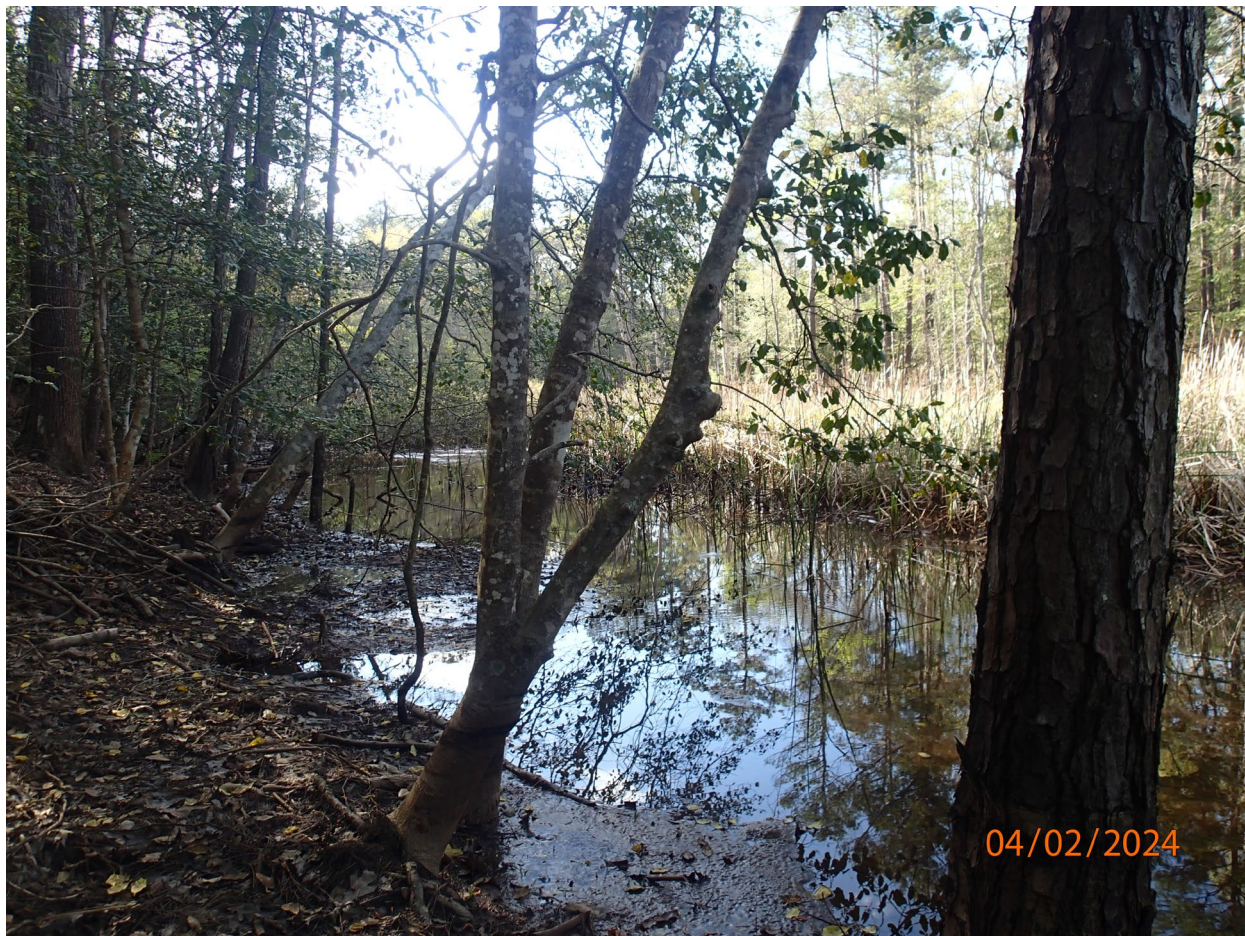
Photo No. 8

**Description:** Looking E-SE, this photo showed the upstream view at the TDS reading location in Photo No. 7.

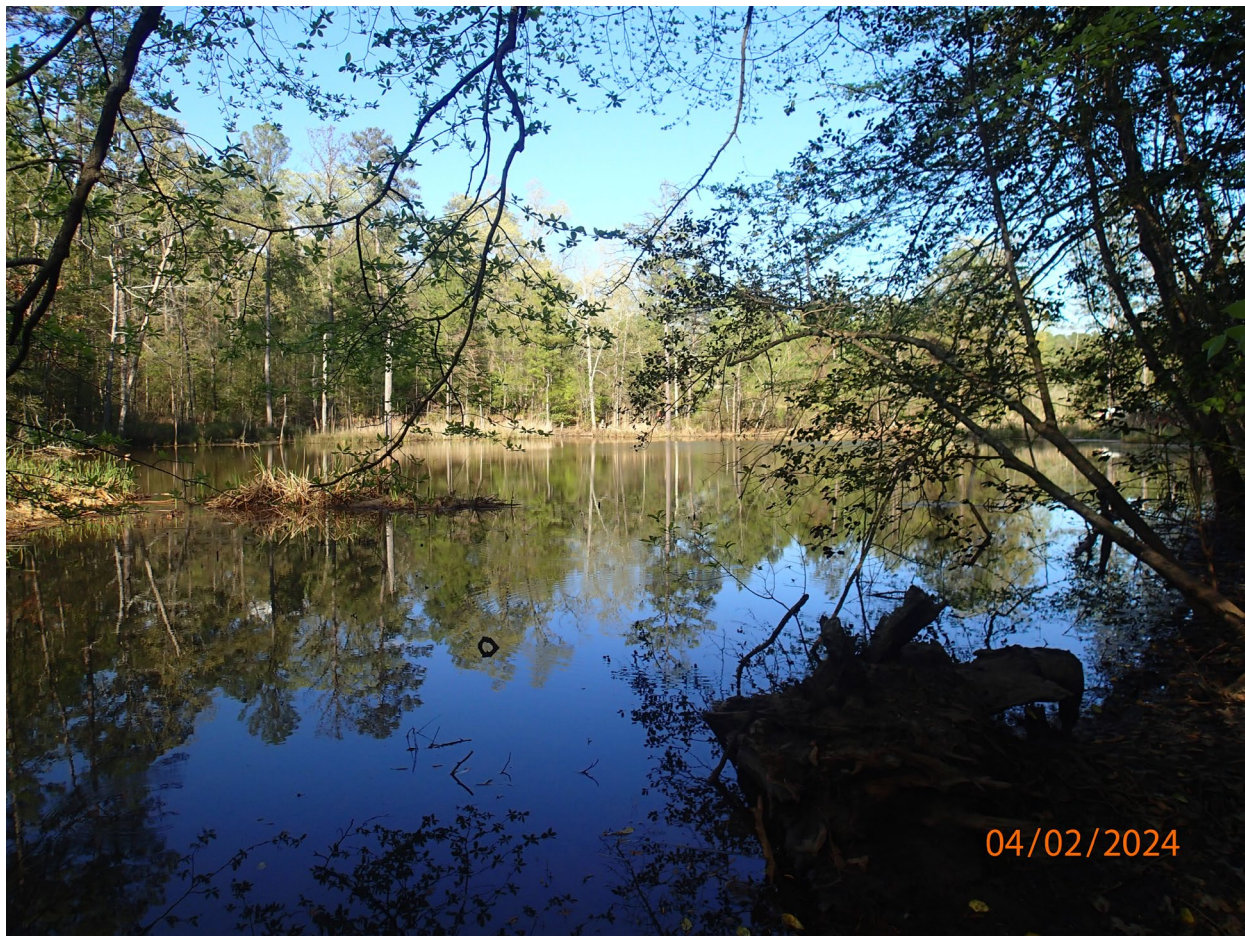
Photo No. 9

**Description:** Looking W, this photo showed the downstream view at the TDS reading location in Photo No. 7.

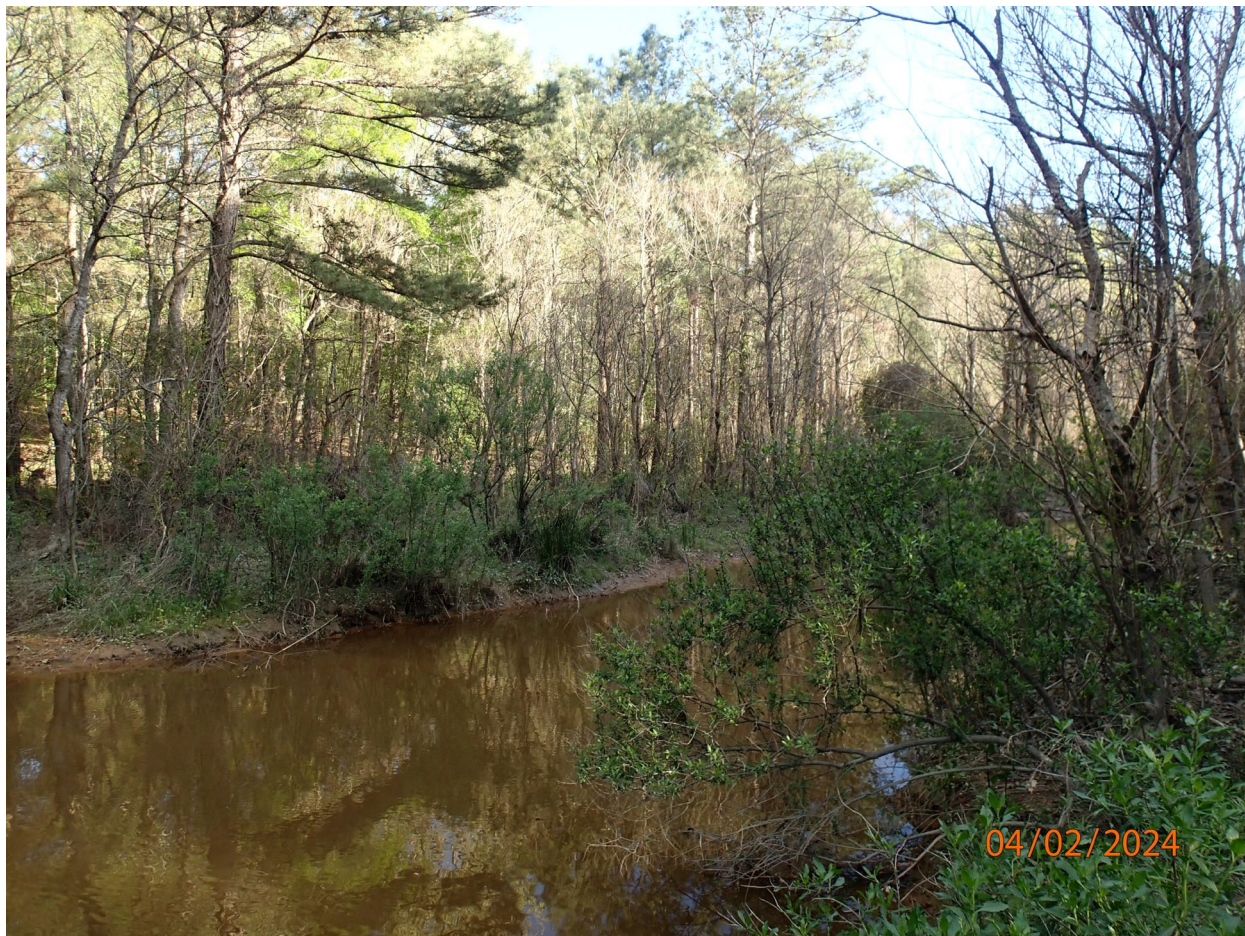
Photo No. 11

**Description:** Looking E-SE, this photo showed the upstream view at the TDS reading location in Photo No. 10.

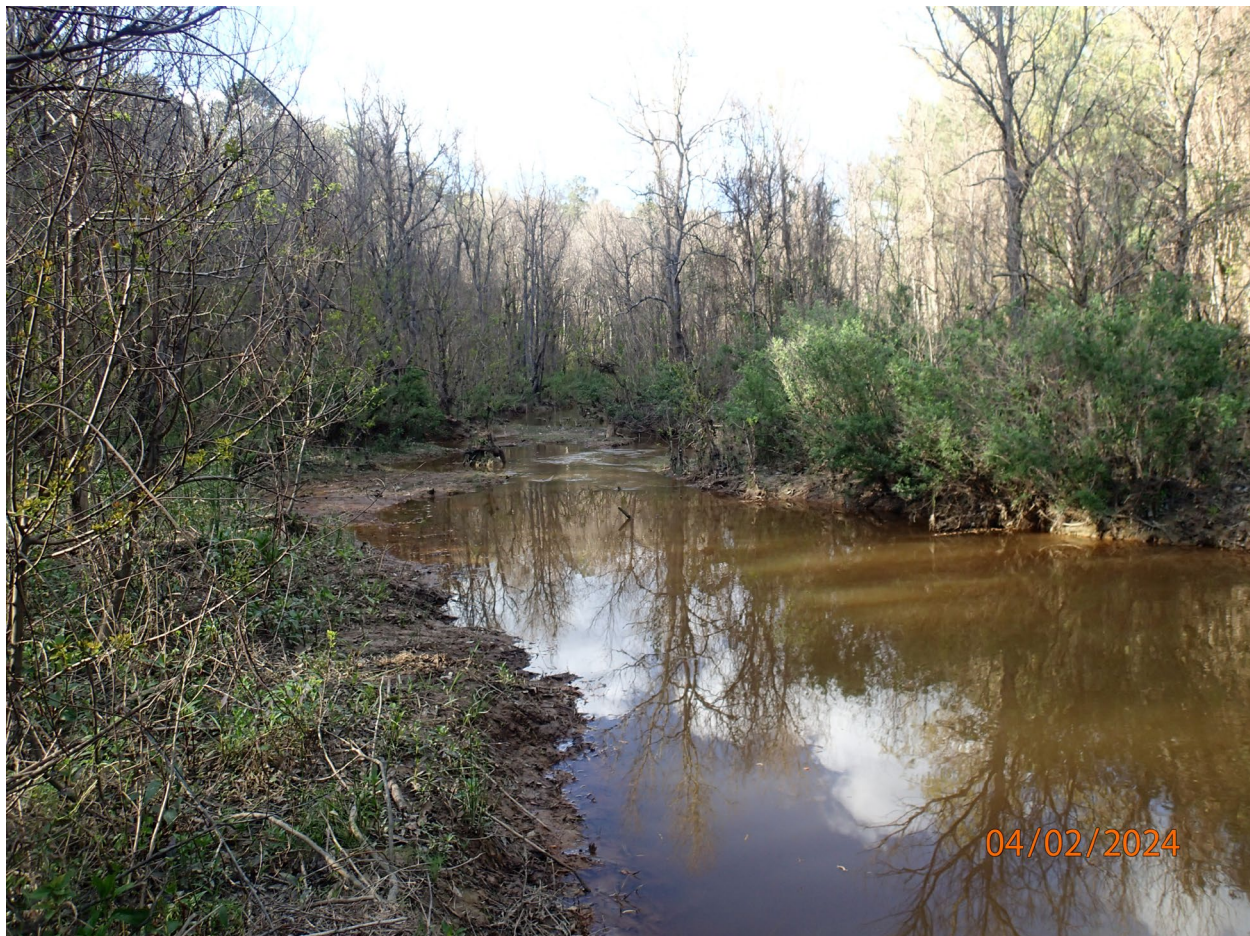
Photo No. 12

**Description:** Looking NW, this photo showed the downstream view at the TDS reading location in Photo No. 10.

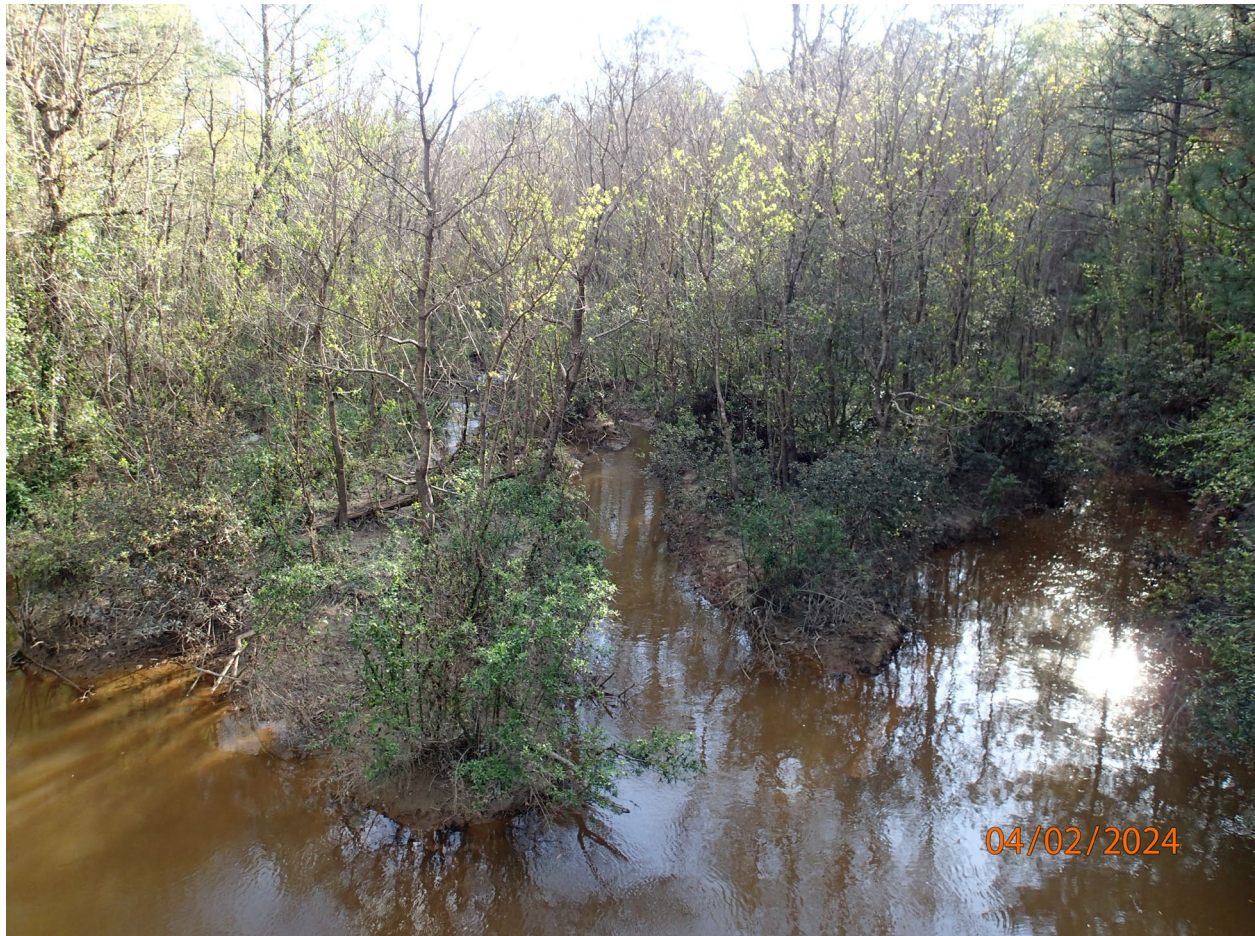
Photo No. 14

**Description:** Looking S-SE, this photo showed the upstream view at the TDS reading location in Photo No. 13.

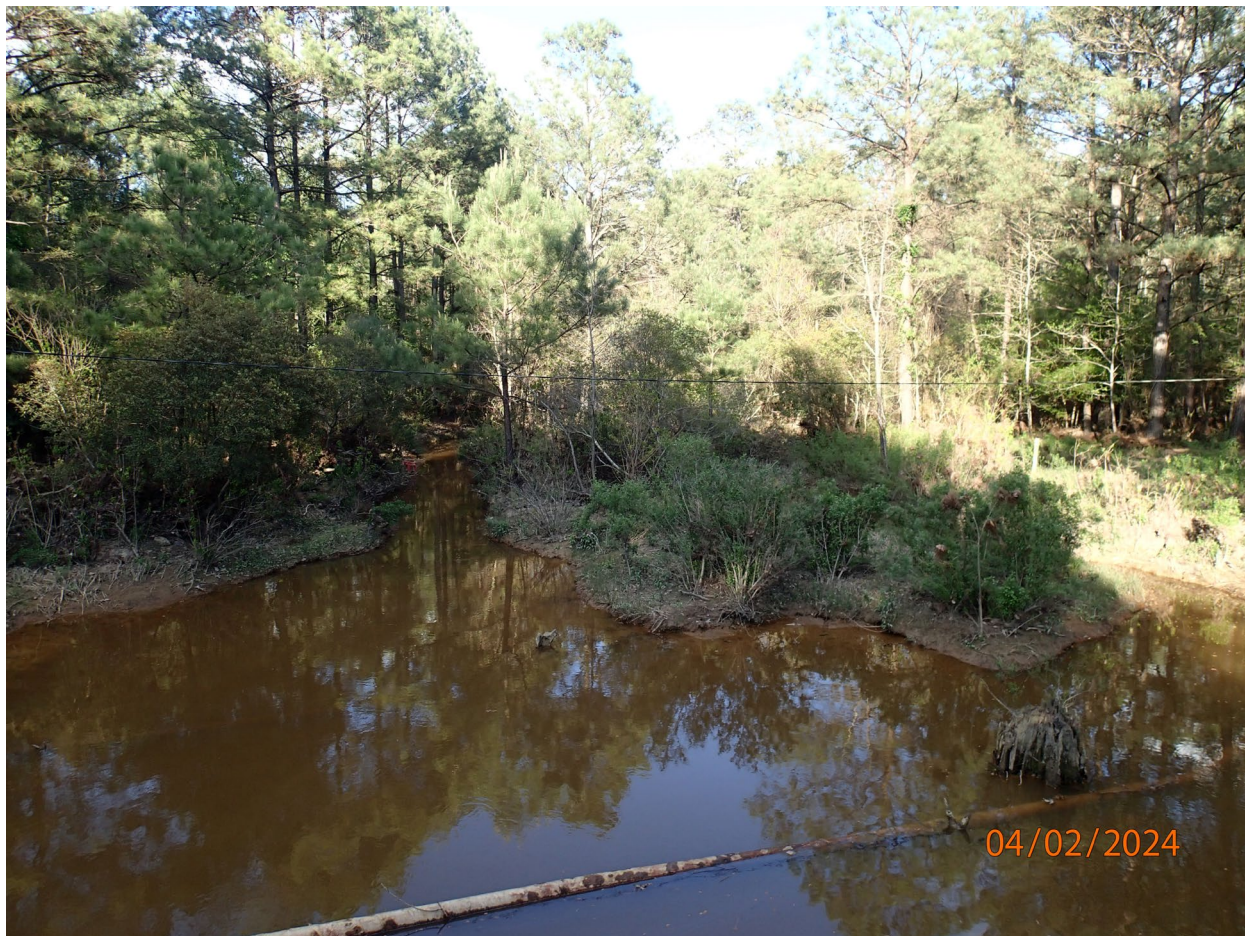
Photo No. 15

**Description:** Looking S-SW, this photo showed the downstream view at the TDS reading location in Photo No. 13.

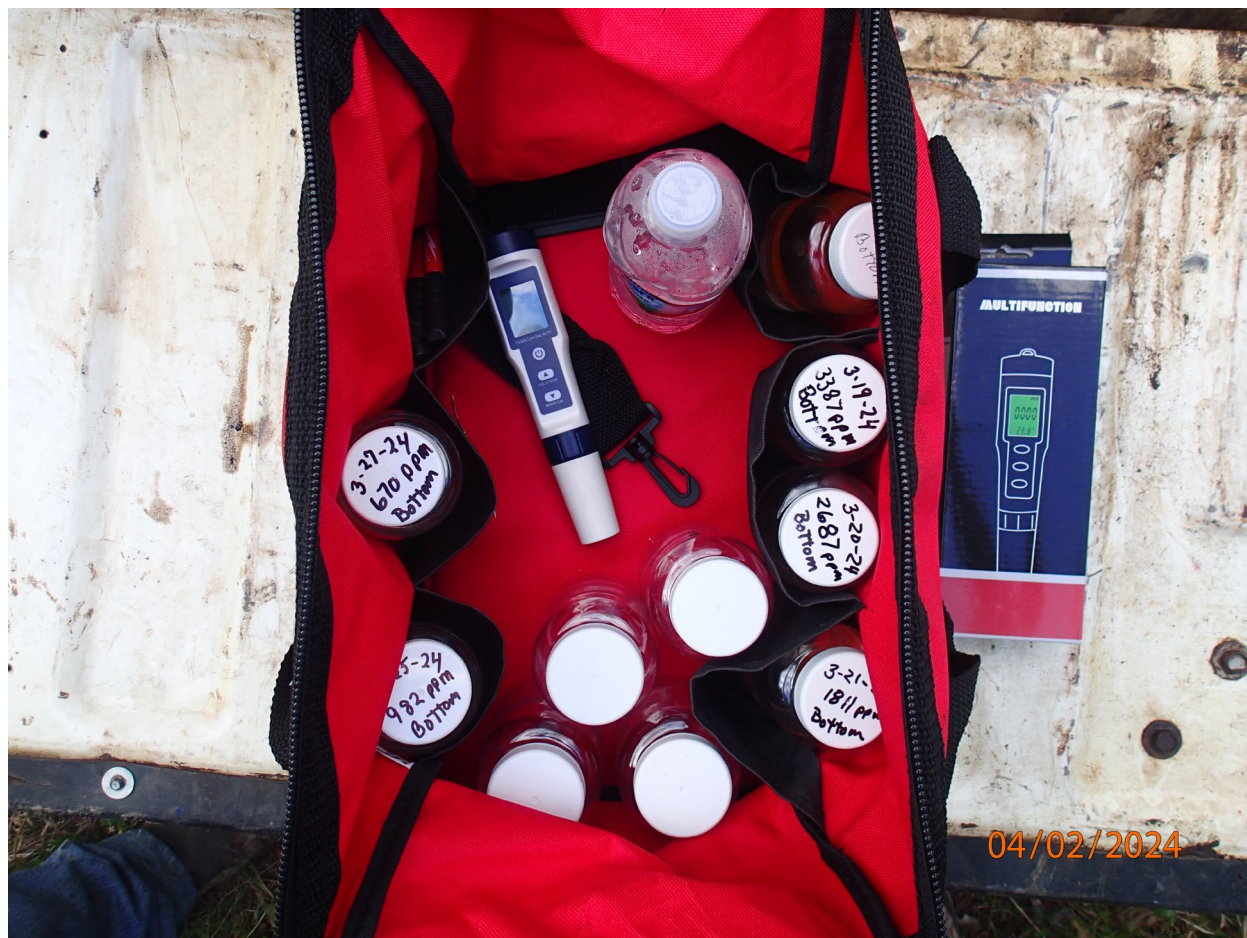
Photo No. 16

A comparison between the facility-owned meter and the Brine Program meter was conducted on samples collected by the operator throughout March 2024, see Photo No. 16.

**Description:** Looking N-NW, this photo showed the water samples collected by Mr. Rod Phillips of RCP Production, LLC.

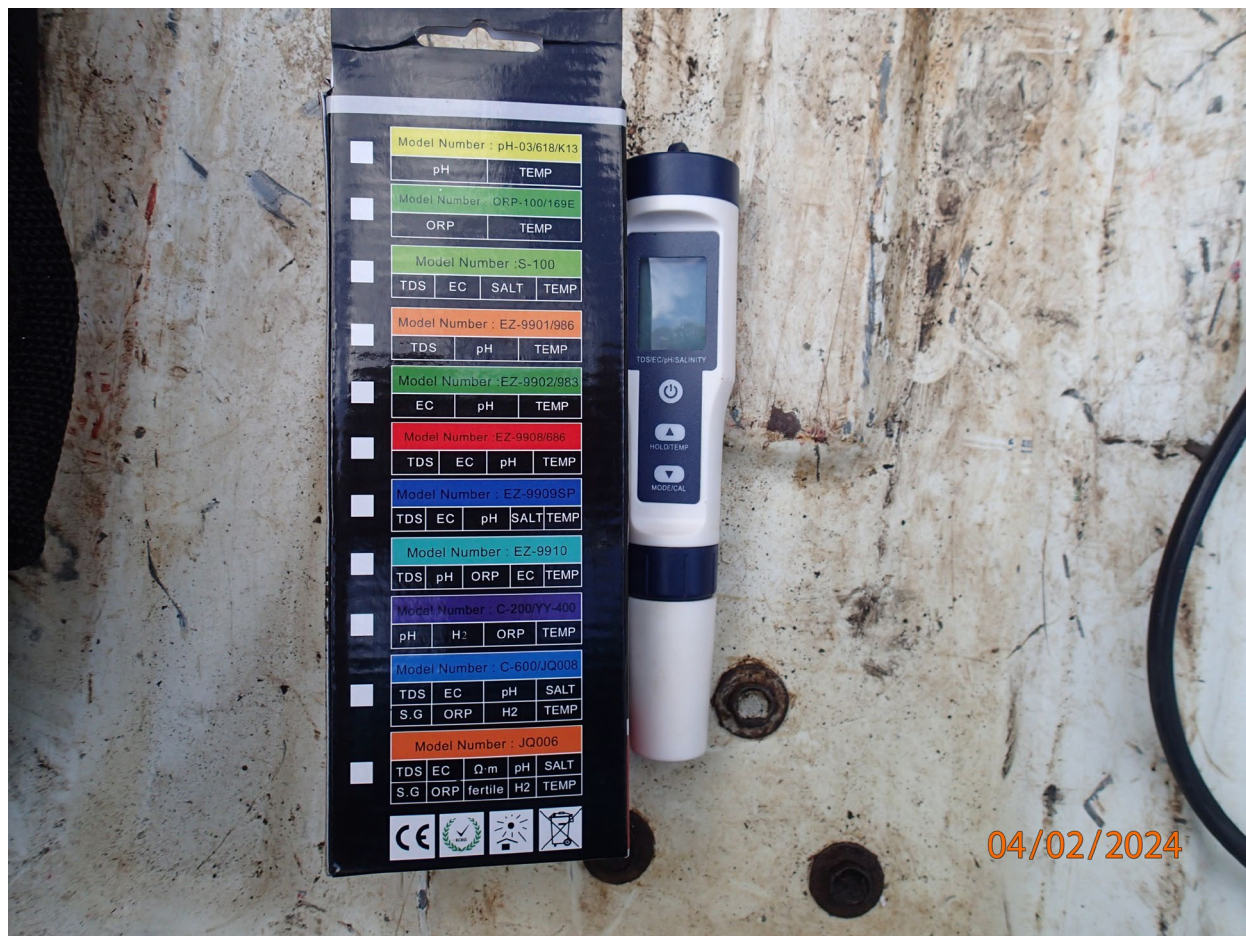
Photo No. 17

I observed the meter purchased and utilized by the operator, see Photo No. 17.

Description: Looking N, this photo showed the meter (Walfront Model No. EZ-9909SP) used by Mr. Rod Phillips of RCP Production, LLC.

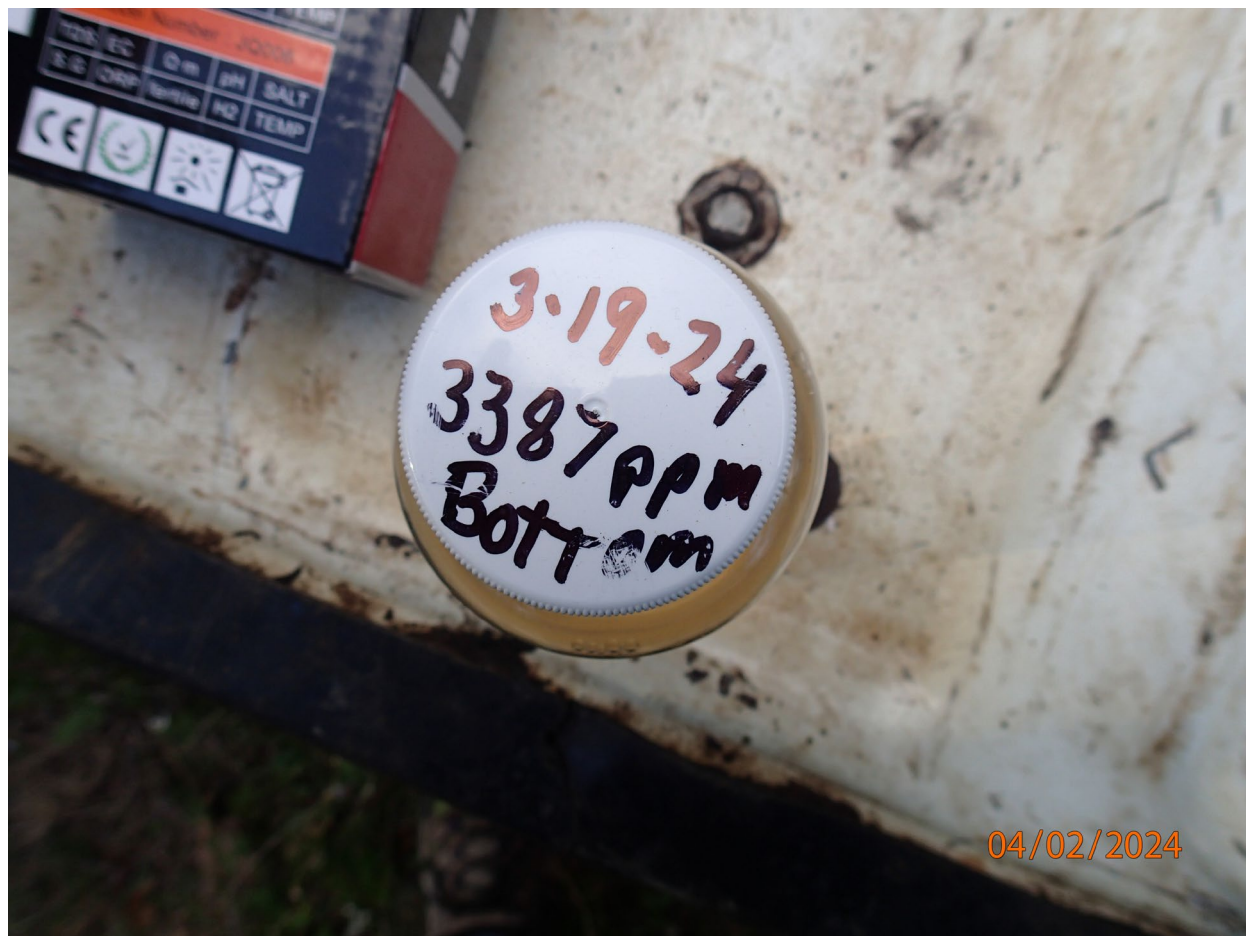
Photo No. 18

The sample used for analysis comparison was collected on 3/19/24 by the operator, see Photo No. 18.

**Description:** Looking N, this photo showed the March 19, 2024 sample (TDS reading is reported as 3,387 ppm) collected by Mr. Rod Phillips of RCP Production, LLC; this sample was used for meter comparison.

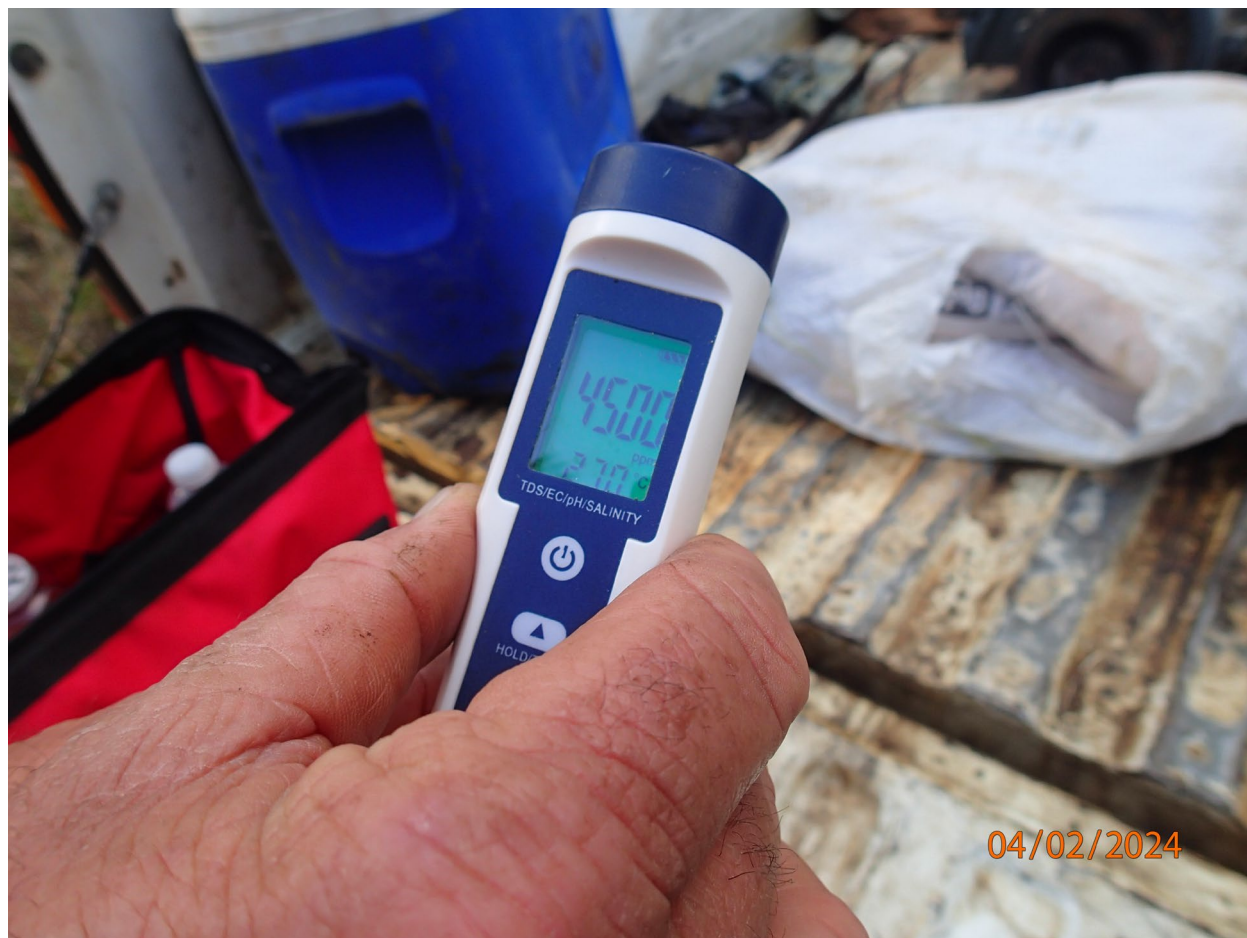
Photo No. 19

The TDS reading for the 3/19/24 sample reported from the facility-owned meter was 4,500 ppm, see Photo No. 19.

**Description:** Looking NW, this photo showed the TDS reading of the March 19, 2024 sample from the meter utilized by Mr. Rod Phillips of RCP Production, LLC.; TDS reading was 4,500 ppm.

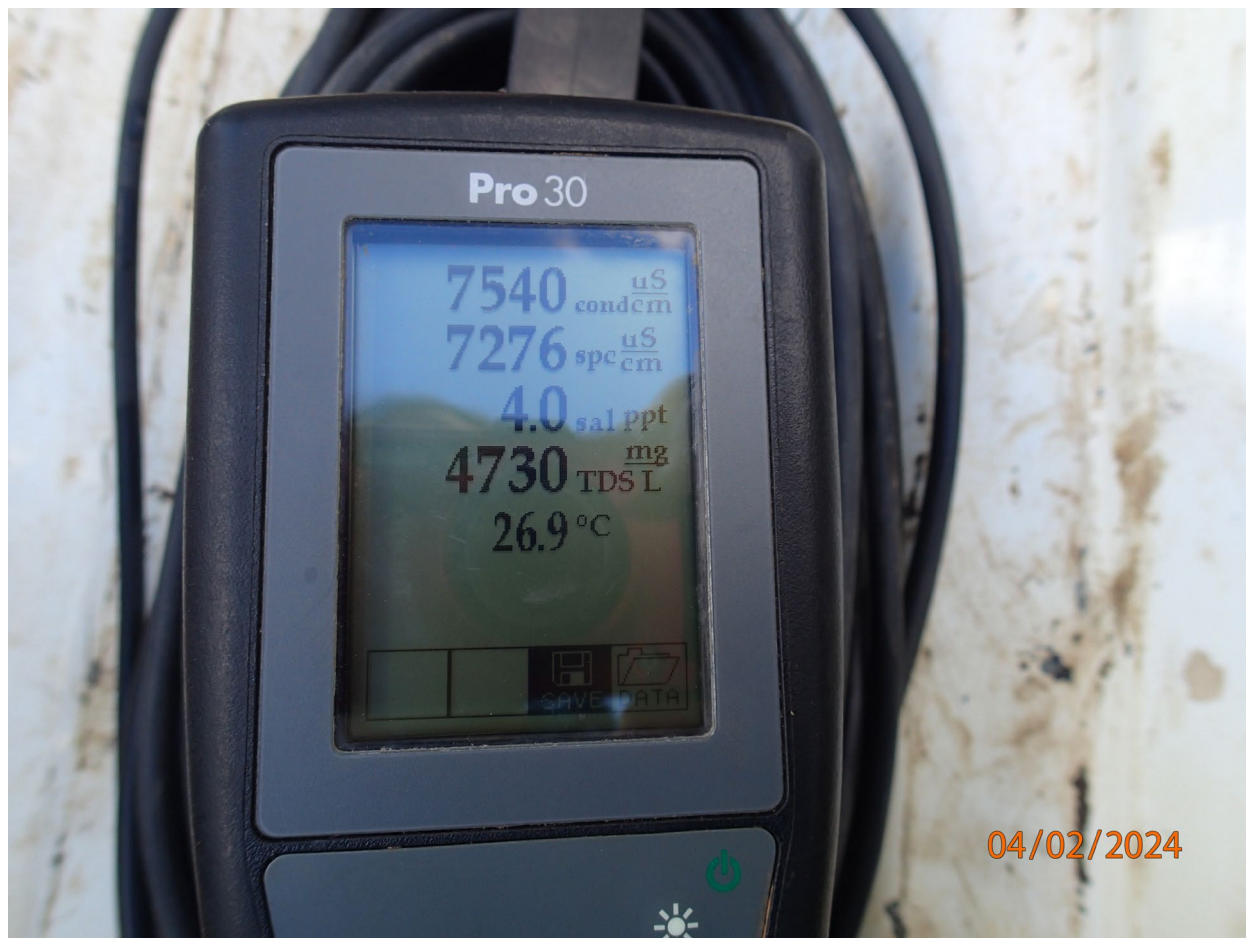
Photo No. 20

The TDS reading for the 3/19/24 sample reported from the Brine Program meter was 4,730 mg/L, see Photo No. 20.

**Description:** Looking NW, this photo showed the TDS reading of the March 19, 2024 sample from the meter utilized by USEPA Region 6; TDS reading was 4,730 mg/L.
