### INSPECTION REPORT

| Inspection Date(s): | 01/13/2022 | |
| Company Name: | <b>City of Santa Fe</b> | |
| Facility Name: | <b>Santa Fe Wastewater Treatment Plant</b> | |

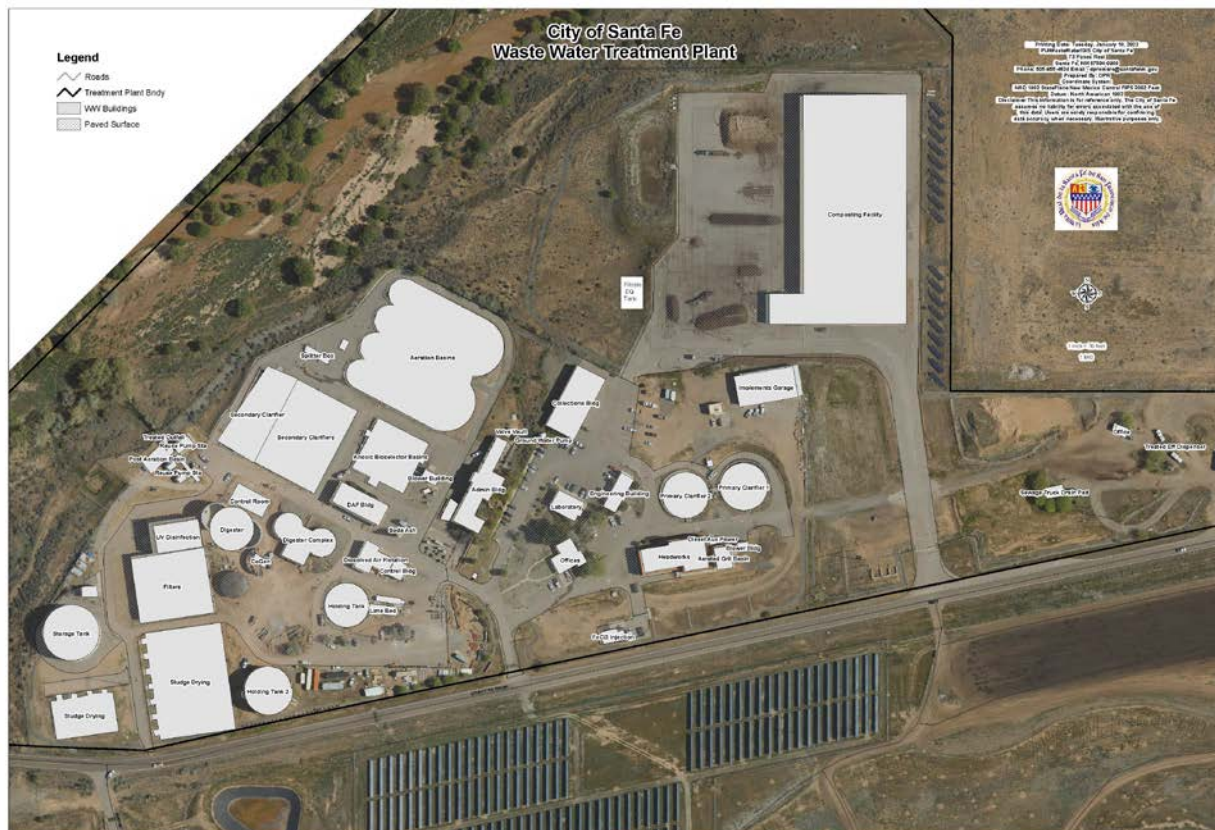
**Aerial Image #2:** Updated Site Map identifying all WWTP treatment processes and ancillary support facilities, or equipment. Provided by the City of Santa Fe. Aerial from Google Earth maps

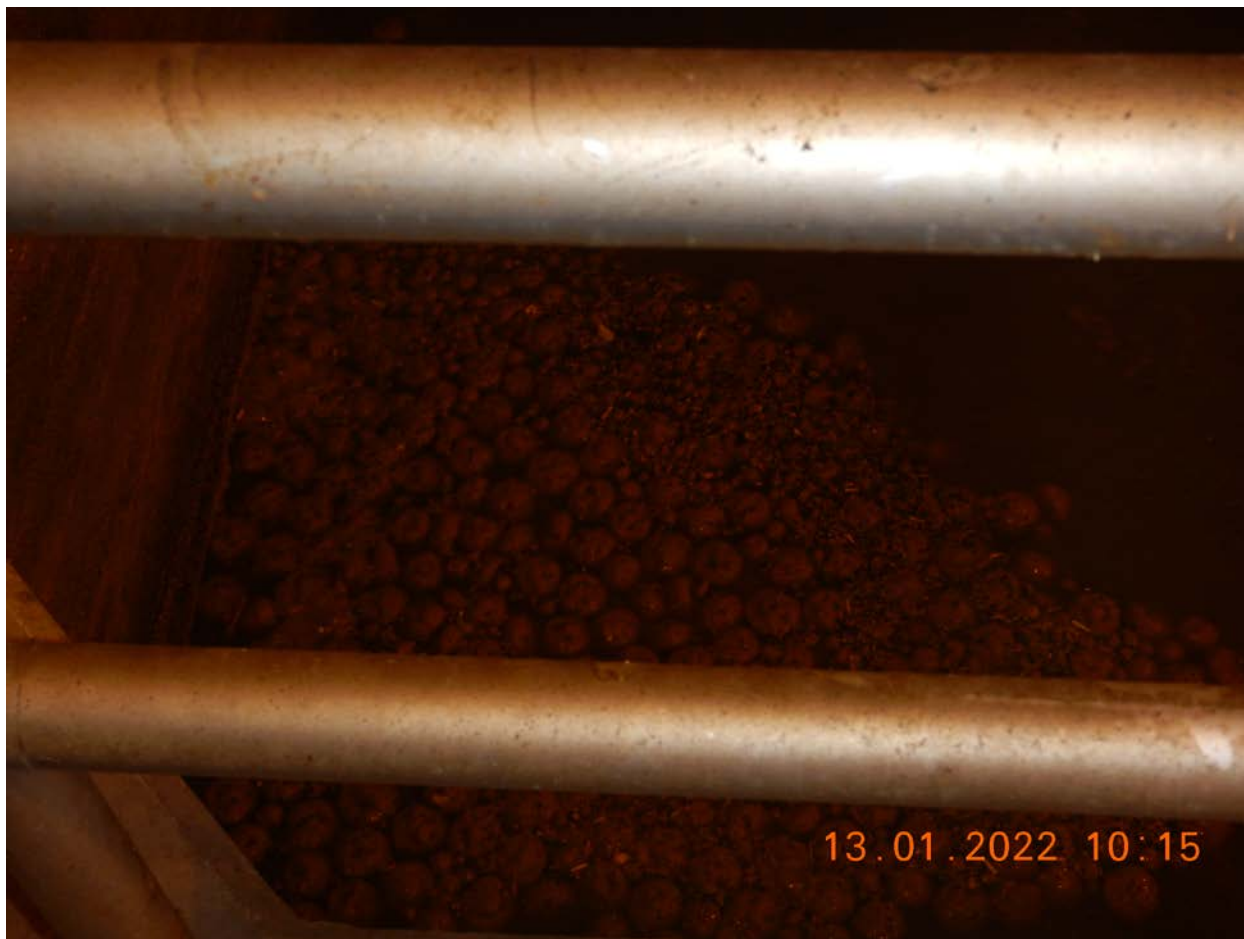
Photograph of the accumulated "grease balls" within the northside wet well. Note: these grease balls are removed by skimming the surface with a net. January 13, 2022. 10:15 AM (DSCN 2071). Photographed by D. Esparza.

- Evaluation of a procedure to alternate existing wet wells for preventative maintenance (PM), (i.e., cleaning, repair, or rehabilitation).

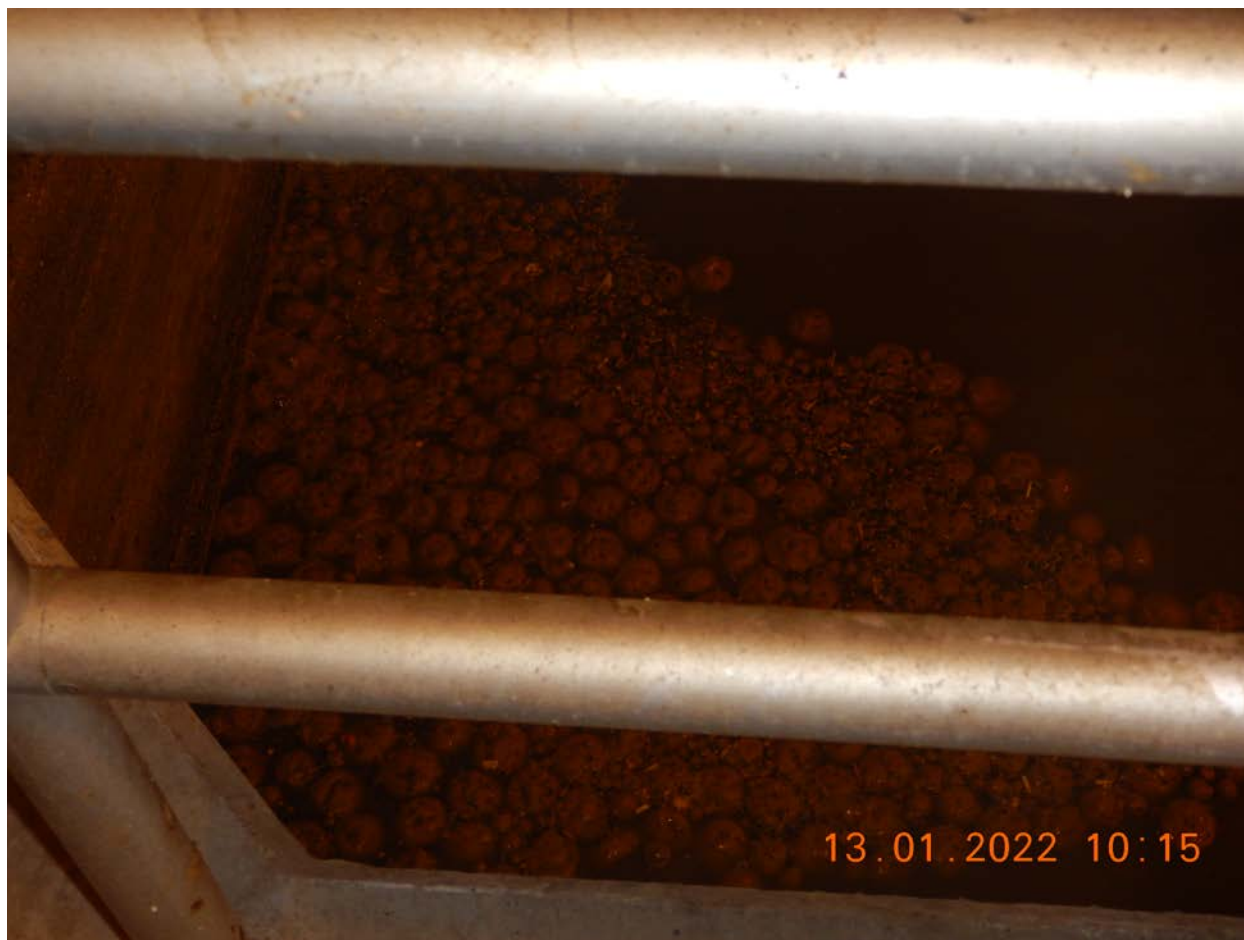
Another photograph of the accumulated "grease balls" within the northside wet well. Note: these grease balls are removed by skimming the surface with a net. January 13, 2022. 10:15 AM (DSCN 2072). Photographed by D. Esparza.

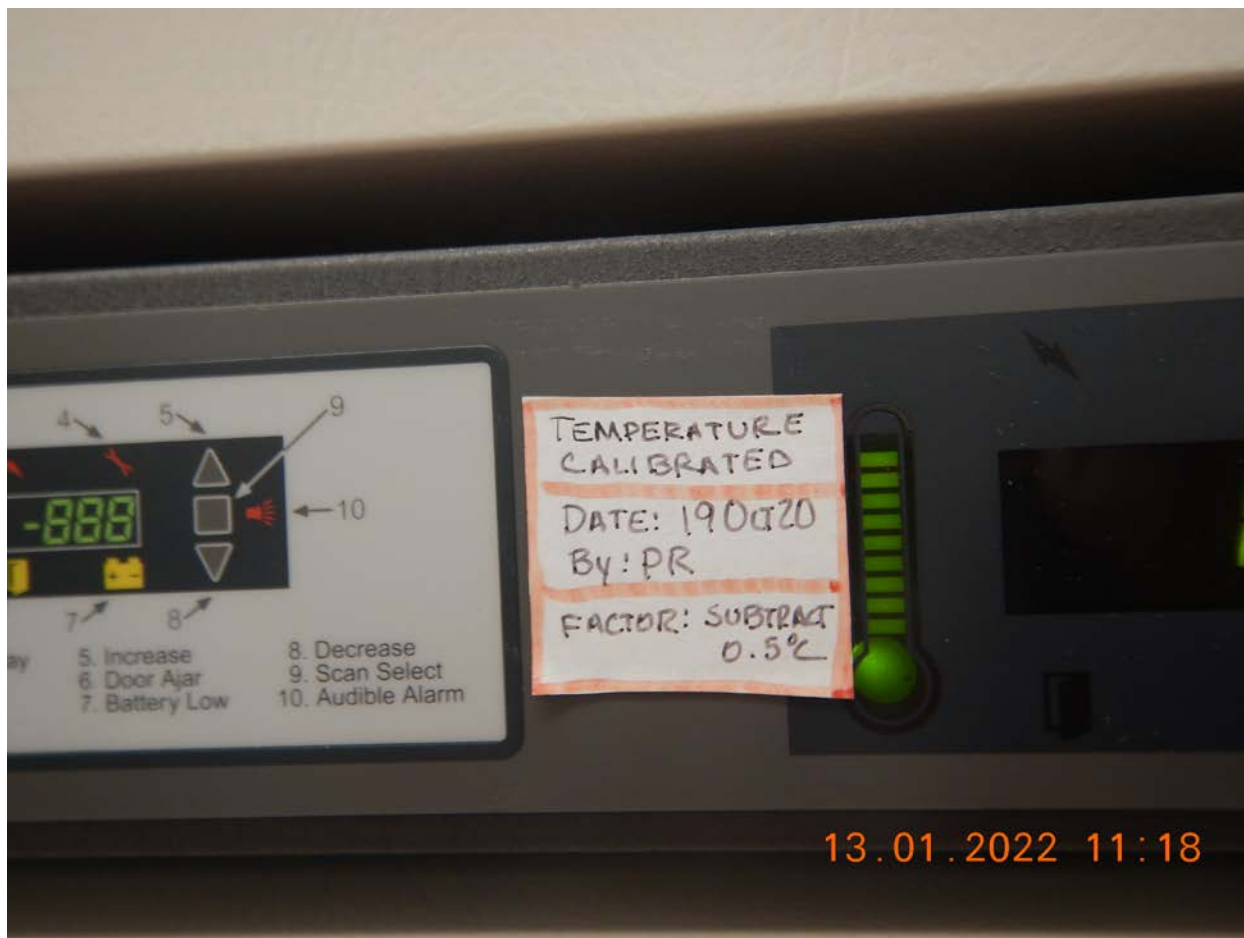
View of "calibration tag" affixed to the outside of the WWTP sample storage refrigerator inside the laboratory. Note: the date of the tag and there was no visible evidence of temperature recording devices (thermometers) inside the refrigerator. January 13, 2022. 11:18 AM (DSCN 20280). Photographed by D. Esparza.
