## **RCRA Inspection Report**

Graphic Packaging International, LLC–Stone Mountain  
5853 E Ponce De Leon Ave  
Stone Mountain, Georgia 30083  
DeKalb County  
EPA ID GAD003285665

May 18, 2022, 9:45am

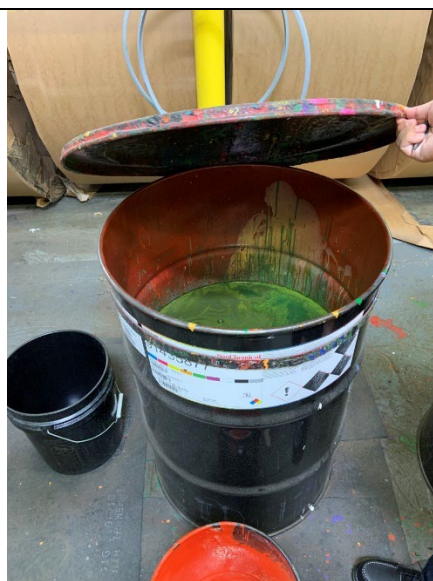
This water-based gravure press contains the ink cart with the cylinder, an ink pot, and a bucket to fill virgin ink into the ink pot (Photographs 1 and 2). Inspectors observed one 55-gallon container and one 35-gallon container for the accumulation of nonhazardous waste and waste rags, respectively. Facility representatives informed inspectors that the area was used to accumulate (hereinafter, “accumulation area”) water based nonhazardous waste and that each press had an accumulation area. Throughout the facility, underneath multiple pillars there are buckets with

Press 7293 with ink pot and bucket to fill ink pot.  
Photograph 1 taken at 10:56am.

Virgin ink drum near Press 7293. Photograph 2  
taken at 11:00am.

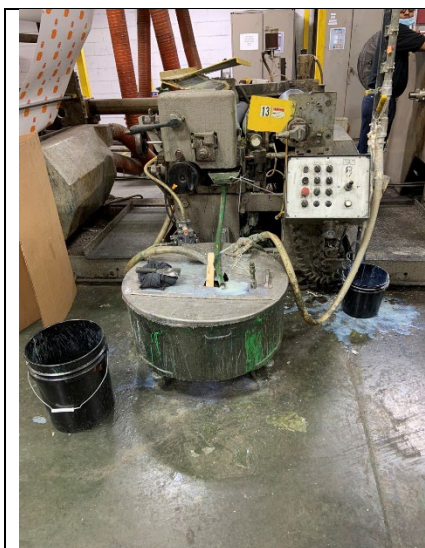
Press 7272 is a flexographic press that presses paperboard with a coating. The press sump, as well as the floor, was covered in dry coating (Photograph 3). Inspectors observed an open black 5-gallon bucket (Photograph 3) filled with the solidified coating, which facility representatives indicated would be discarded after being full. An accumulation area consisted of two 30-gallon containers for used mopheads and rags and one 55-gallon container for liquids. One Brute 75-gallon trash can was observed to hold an empty container of Anilox Renew. Todd Steele, Sun Chemical Ink Tech II, explained that Anilox Renew cleans the rubber cylinders in the press. Based on the inspectors review of the SDS, Anilox Renew is a hazardous waste when discarded.

Press 7272 with dry coating in bucket  
and on floor. Photograph 3 taken at  
11:14am

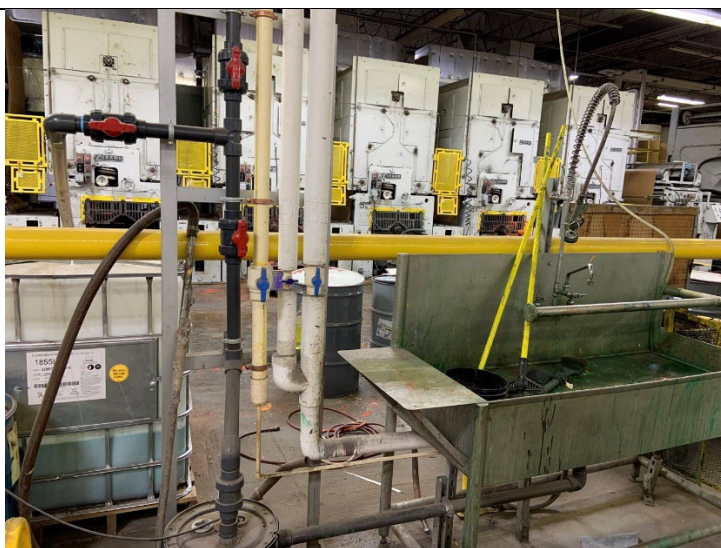
The wash station is fed with water for cleaning rags, mopheads, and press cylinders/sumps. A 275-gallon container designated for cleaner washout was observed (Photograph 4). When filled, the container is sent to the waste area where it is stored prior to offsite disposal via a bulk truck. Containers are reused. A 55-gallon container with a label of Nitro Non-Corrosive Heavy Duty Ink Dissolver (hereinafter, “Nitro”) was observed (Photograph 5). Nitro is used to clean the rags and mopheads.

Wash station with 275-gal container for cleaner washout.  
Photograph 4 taken at 11:27am

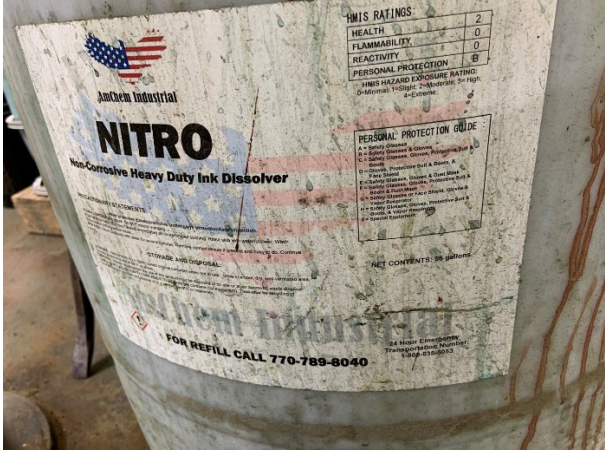
| <p>55-gal container with Nitro label near wash station. Photograph 5 taken at 11:28am</p> | <p>37-lb net weight container with 2-Dimethylaminoethanol near Press 7240 wash station. Photograph 6 taken at 11:45am</p> |

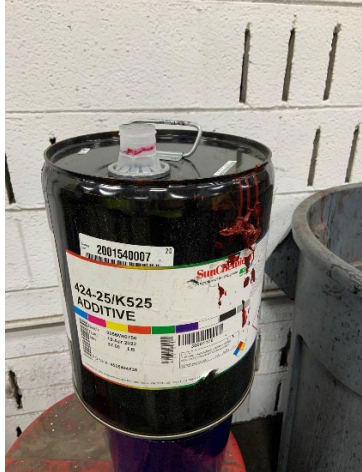
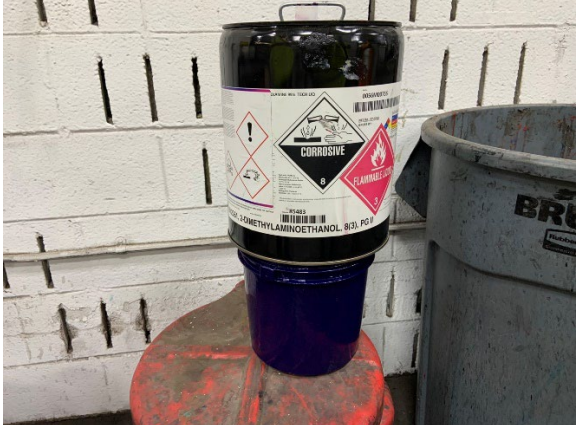
This flexographic press is more automatic regarding the cleaning and printing process. An empty 37-pound (lb) net weight container of 2-Dimethylaminoethanol was observed in a trash container near the Press 7240 wash station (Photographs 6 and 7). Todd Steele explained that the 2-Dimethylaminoethanol was an additive to prevent clotting of ink, which makes the printing clear and legible. The ink in Press 7240 is required to be 9.1-9.5 pH. Operators use the additive to achieve the correct pH. Three 55-gallon containers that accumulate runoff from the printing press were observed (Photograph 8 and 9). One 55-gallon container was observed holding used rags and waste ink, which was not properly labeled as nonhazardous waste or other words that would clearly convey the contents of the containers to emergency response personnel. The facility should properly label all containers, including non-hazardous waste.

| <p>37-lb net weight container with 2-Dimethylaminoethanol near Press 7240 wash station. Photograph 7 taken at 11:46am</p> | <p>Three 55-gal containers of Press 7240 runoff. Photograph 8 taken at 11:57am</p> |

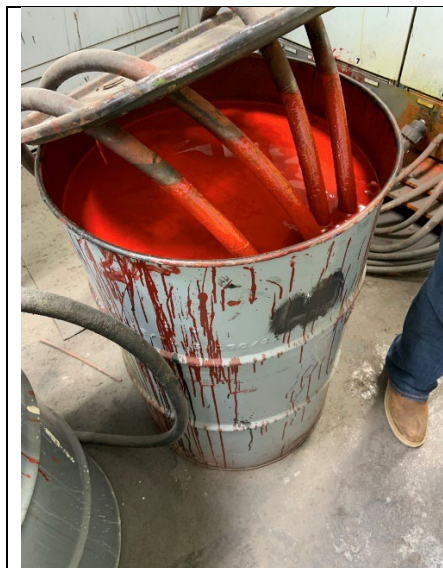
One of three 55-gal containers from Press 7240 runoff opened. Photograph 9 taken at 11:57am

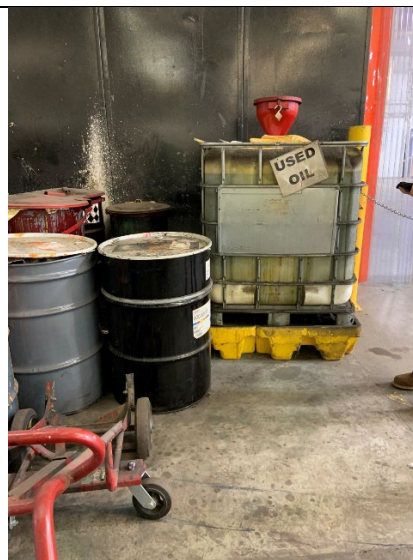
Used oil generated from preventative maintenance at the facility is stored in this area. A 275-gallon container was observed labeled “used oil” with an unlatched (not fully closed/locked) red funnel on top (Photograph 10). Nine (9) 55-gallon containers filled with single-use oil contaminated rags and seven (7) 30-gallon containers with unsecured (flappable) red tops filled with washable rags were observed. The room adjacent to the used oil area is the compressor room and was previously utilized as a Central Accumulation Area (CAA).

275-gal container with funnel labeled "Used Oil." Photograph 10 taken at 12:00pm

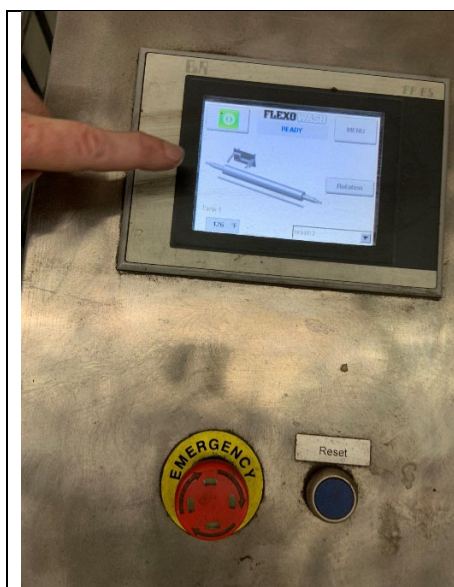
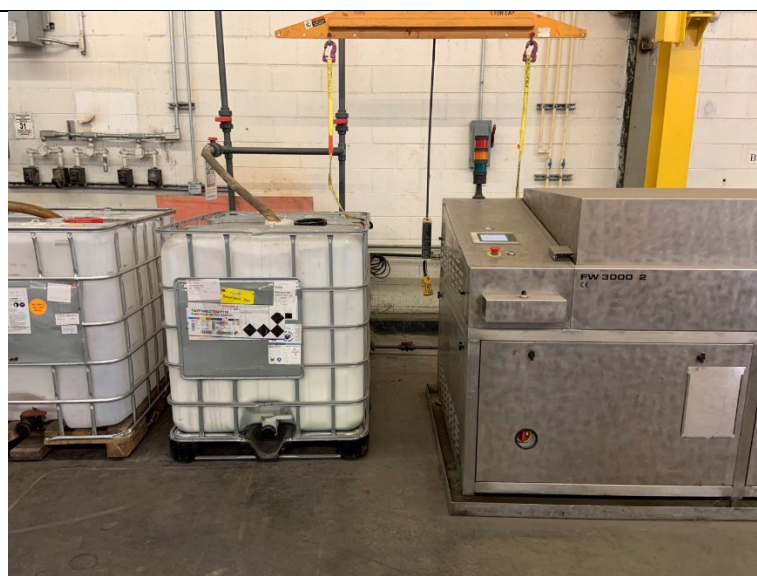
Flexowash (FW-3000-2) is a cleaning process for press cylinders (Photographs 11 and 12). Wash 3 is a wash option that uses Nitro as a surfactant with temperature at 126°F. Two (2) 275-gallon containers for accumulation of solid waste and wastewater were observed. Product Nitro and Anilox Renew were also observed.

Flexowash (FW-3000-2) with setting options for washing press cylinders. Photograph 11 taken at 12:14pm

Flexowash (FW-3000-2) with two 275-gal containers. Photograph 12 taken at 12:16pm

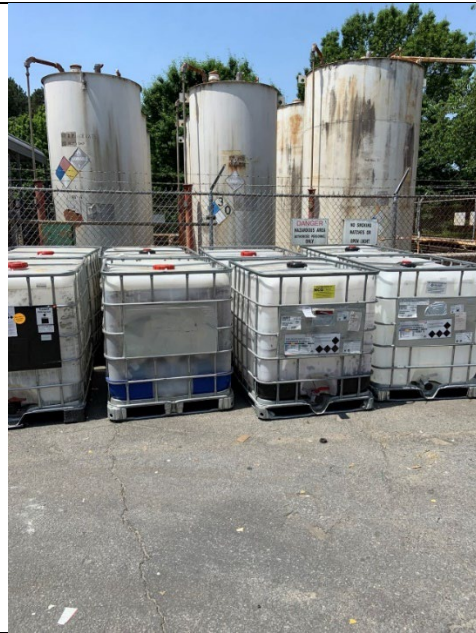
A total of eight (8) tanks were observed (Photographs 14 to 29), six (6) solvent tanks and two (2) diesel tanks. Facility representatives explained that the tanks were previously (more than 10 years) used to hold raw materials used in the manufacturing process. The inspectors observed the following vertical cylinder above ground tanks:

- 4) Tank 4 labeled 80% Normal Propyl (N.P.) Acetate 20% Heptane with sight glass measurement 1.5-ft. A Flammable label with an unwritten NFPA 704 label was found (Photograph 14).

The tanks did not appear to be fully/properly decommissioned, and had been out of service for more than 10 years. The inspectors requested documentation regarding the tanks closure certification, or/and decommissioning.

Graphic Packing personnel informed inspectors that the facility stopped using the tanks for manufacturing processes more than 10 years ago. Inspectors observed that the tanks did not appear to have been properly decommissioned and continued to hold waste. The Facility appears to have failed to make an accurate determination as to whether waste left in the tanks was hazardous waste. The waste in the tanks was not exempted from the waste determination because it remained in the tanks for more than 90 days from the date the tanks ceased to be operated.

Tank farm (8 tanks total). Photograph 14 taken at 12:21pm

Following the inspection Graphics Packing contracted Miller Environmental Group (Miller) to determine the closure status of the six (6) solvent tanks and two (2) diesel tanks. Miller arrived onsite on June 15, 2022.

On June 16, 2022, Miller completed the removal of approximately 270-gallons of flammable liquids from the solvent tanks, 2,000-gallon vertical above ground storage tanks. Miller generated approximately 2,800-gallon of petroleum contact water from the cleaning of the six (6) solvent tanks. A tank is considered empty when its contents have been drained to the fullest extent possible. It is impossible to determine how much solvent was remaining in the tanks when they were removed from the process. However, an accurate waste determination should have been made of the remaining solvent that was left after not properly decommissioning.

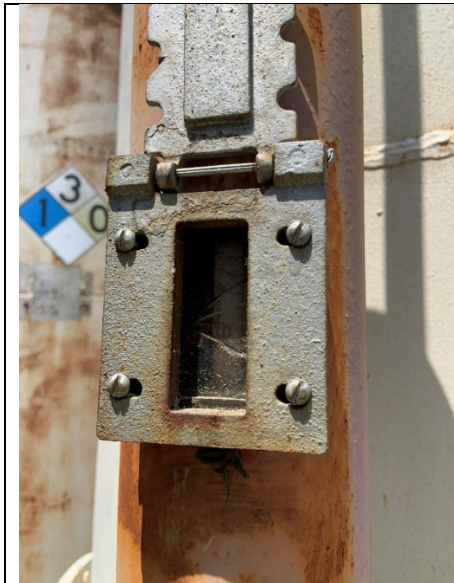
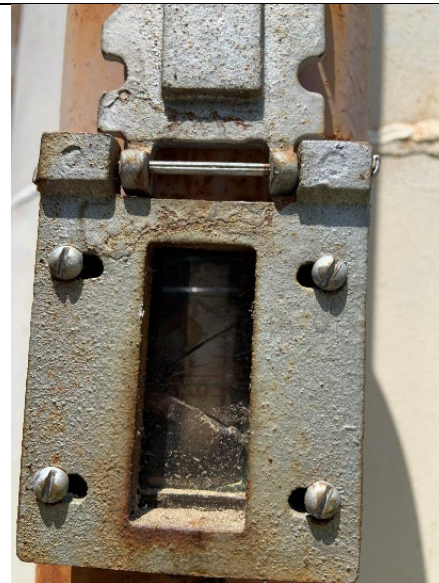
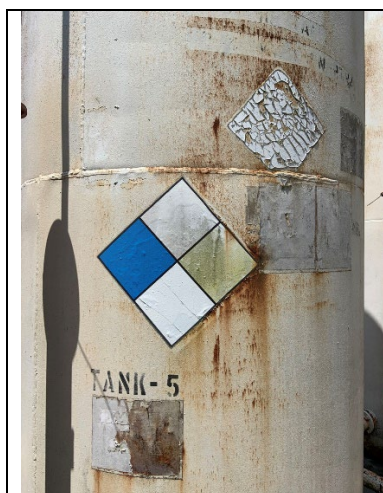
- 5) Tank 5 had an unwritten NFPA 704 label and a broken sight glass measurement of 6–7 ft (Photograph 15-17).
- 6) Tank 6 labeled “Ethyl Acetate” a NFPA 704 label with a Health Hazard (blue) of 1, Flammability Hazard (red) of 3, and Stability Hazard (yellow) of 0 (Photograph 18). A sight glass measurement read 4–5 ft (Photograph 19).

Tank 5 site glass measurement. Photograph 15 taken at 12:32pm

Tank 5 site glass measurement. Photograph 16 taken at 12:32pm

Tank 5 with labels. Photograph 17 taken at 12:32pm

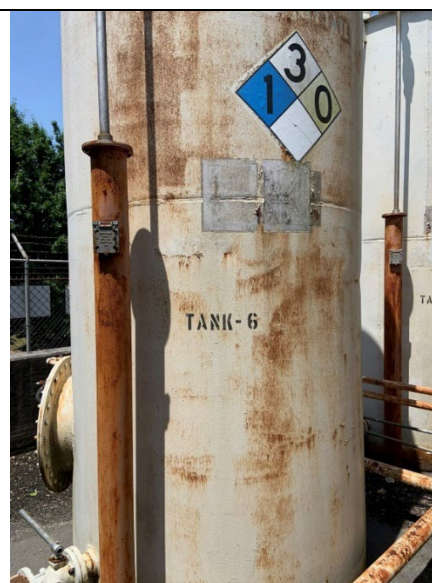
Tank 6 with labels. Photograph 18 taken at 12:33pm

Tank 6 site glass measurement. Photograph 19 taken at 12:34pm

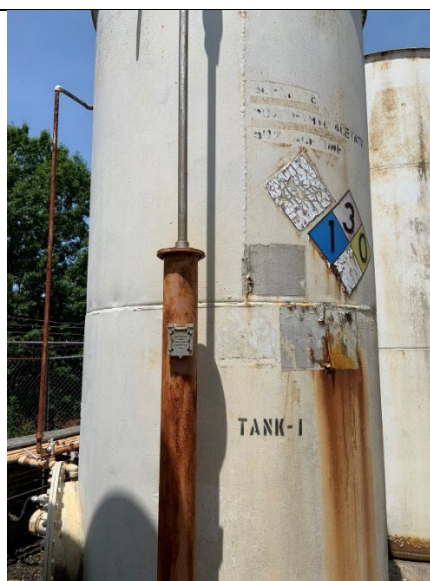
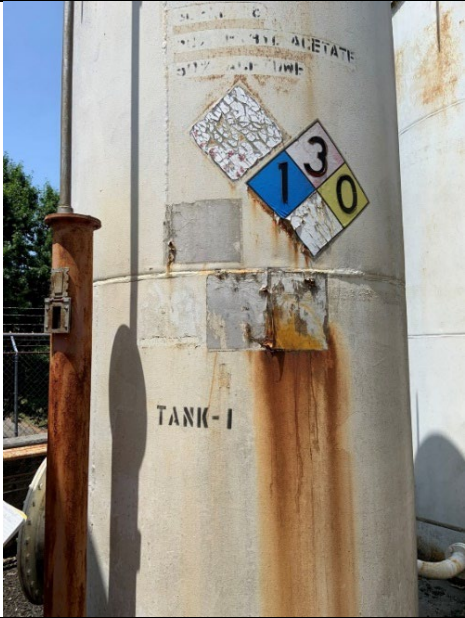
- 1) Tank 1 labeled “Blend #8 50% Acetone and 50% Ethyl Acetate.” Tank 1 was equipped with a sight glass, used to measure the height of its contents, which appeared to read 4.75 feet(ft). A National Fire Prevention Association (NFPA) 704 label included a Health Hazard (blue) of 1, Flammability Hazard (red) of 3, and Stability Hazard (yellow) of 0; from 0 being a minimal hazard to 4 being a severe hazard under the Occupational Safety and Health Administration (OSHA) Hazard Communication Standard (Photograph 20).

Tank 1 with labels. Photograph 20 taken at 12:35pm

| <p>Tank 1 with labels. Photograph 21 taken at 12:37pm</p> | <p>Tank 3 with labels. Photograph 22 taken at 12:40pm</p> |

Tank 1 with label. Photograph 28 taken at 12:44pm

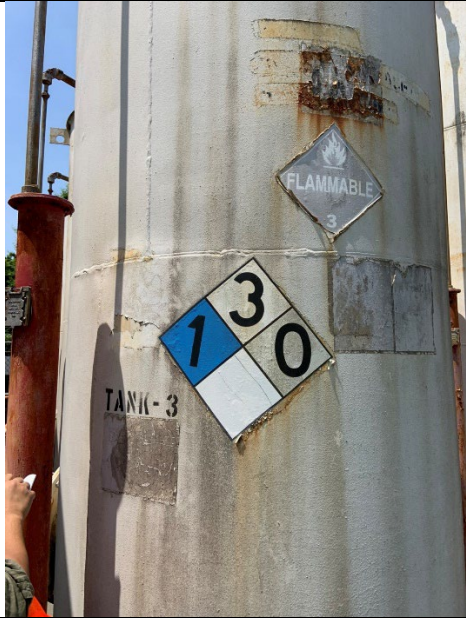
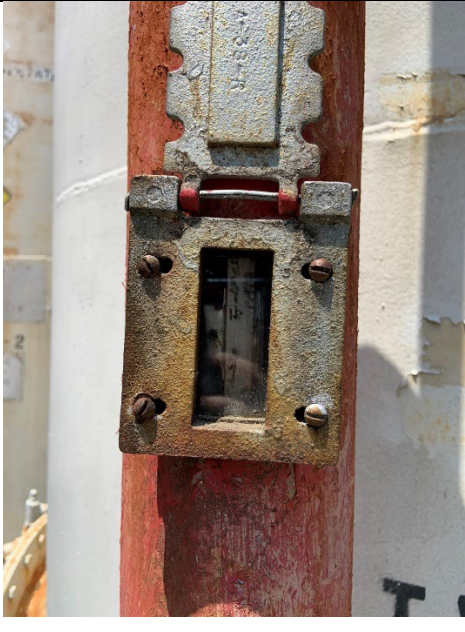
- 3) Tank 3 had a NFPA 704 label with a Health Hazard (blue) of 1, Flammability Hazard (red) of 3, and Stability Hazard (yellow) of 0 (Photograph 22). A sight glass measurement read 4–4.5 ft (Photograph 23).

| <p>Tank 3 site glass measurement. Photograph 23 taken at 12:40pm</p> | <p>Tank 8 with labels. Photograph 24 taken at 12:42pm</p> |

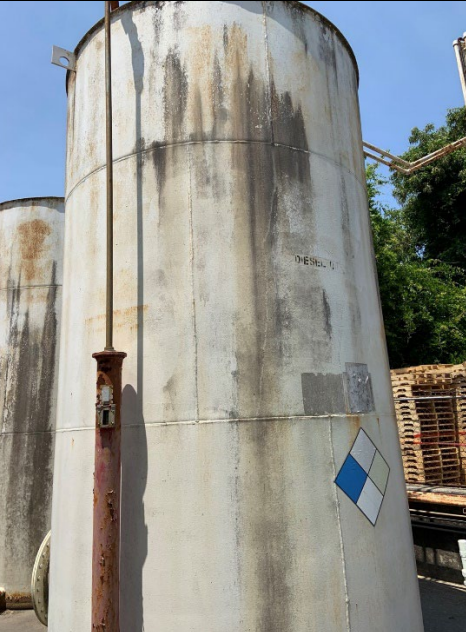
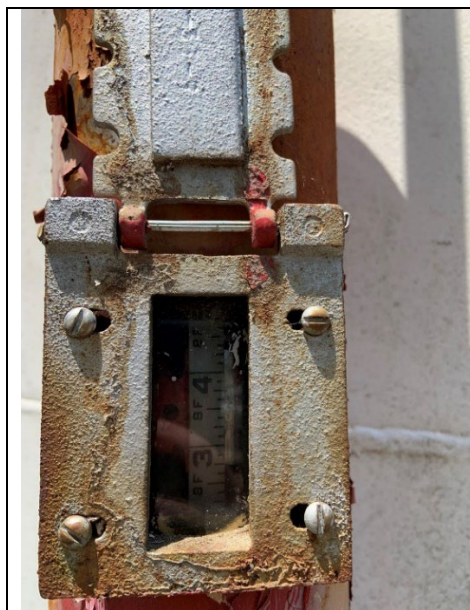
- 7) Tank 7 labeled “Tank Empty Out of Service” had an unwritten NFPA 704 label with no sight glass (Photograph 26).
- 8) Tank 8 labeled “Diesel” had an unwritten NFPA 704 label and a sight glass measurement of

8ft and 4-inches(in) (Photograph 24-25).

Tank 8 site glass measurement. Photograph 25 taken at 12:42pm

On June 17, 2022, Miller removed approximately 300-gallons of diesel from Tank 7. Miller reported Tank 8 empty upon opening. Miller collected 300 gallons of petroleum contact water from the two diesel tanks and 350 gallons of rinse water.

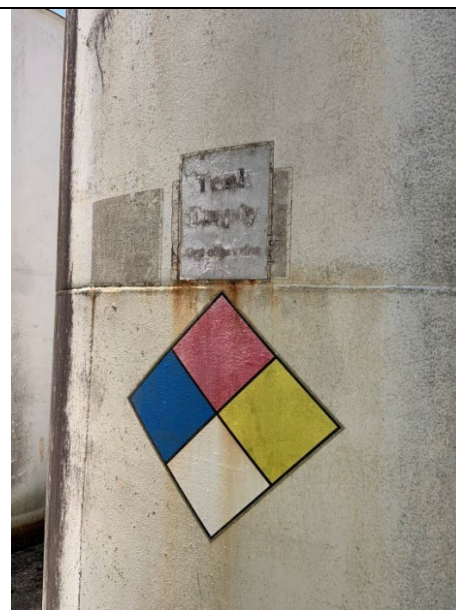
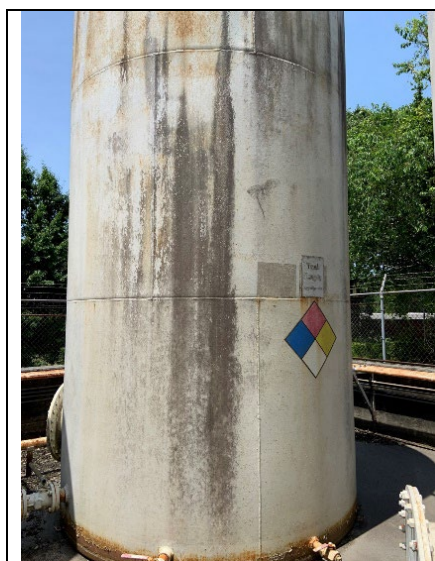
Tank 7 with labels. Photograph 26 taken at 12:43pm

Tank 7. Photograph 29 taken at 12:46pm

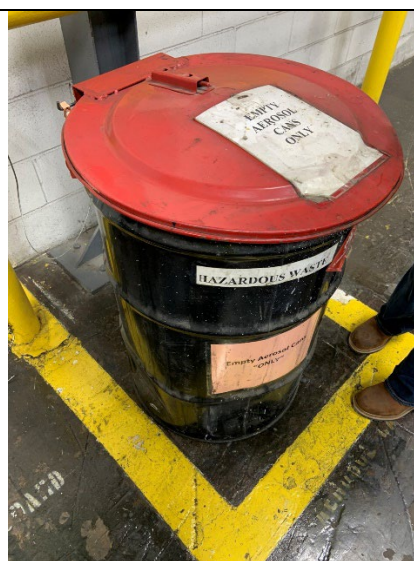
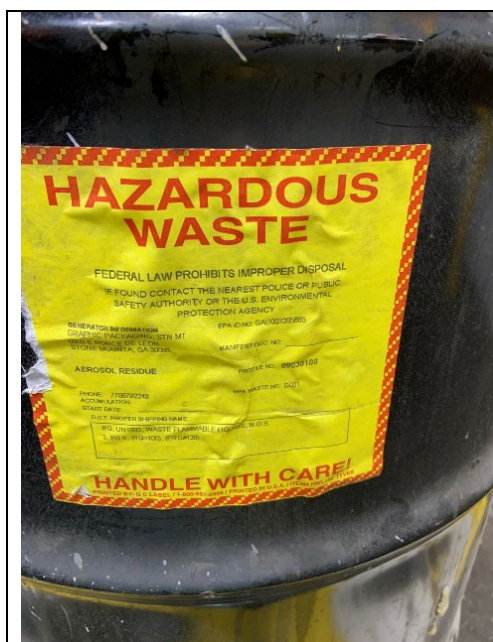
Outside the Maintenance Room, inspectors observed a 55-gallon container labeled hazardous waste “Empty Aerosol Cans Only” (Photograph 30 and 31). The container was not at or near the point of generation. However, facility representatives explained that they are managing the aerosol cans as universal waste until they are brought into the Maintenance Room. Inside the Maintenance Room, inspectors observed an aerosol can puncturing system that did not include

55-gal container outside maintenance room. Photograph 30 taken at 1:02pm

55-gal container hazardous waste label outside maintenance room. Photograph 31 taken at 1:04pm

The inspectors requested that the facility properly label aerosol cans as universal waste and discontinue the use of the aerosol can puncturing device, if they determined that they would not be managing the aerosols as hazardous waste. On June 10, 2022, the facility provided the inspectors evidence of their corrective actions.

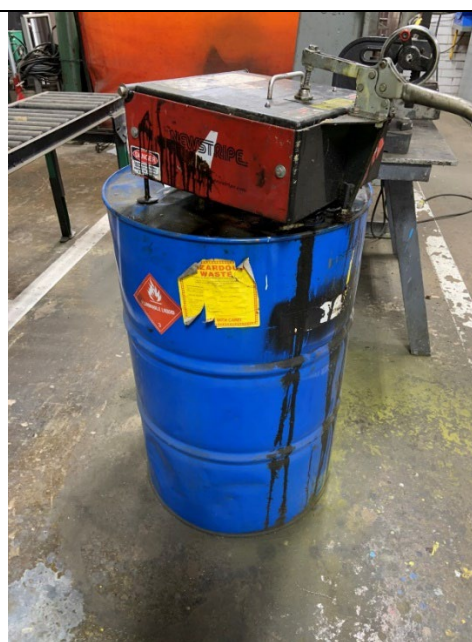
an air filter on top of a 55-gallon container labeled hazardous waste (Photograph 32).

Inspectors explained the universal waste rules and the limitations of large quantity generator's ability to treat hazardous waste in containers, which requires compliance with Organic Air Emission Standards. However, the facility was not operating as a large quantity generator at the time of the inspection.

55-gal container with aerosol can liquid remover inside maintenance room. Photograph 32 taken at 1:05pm

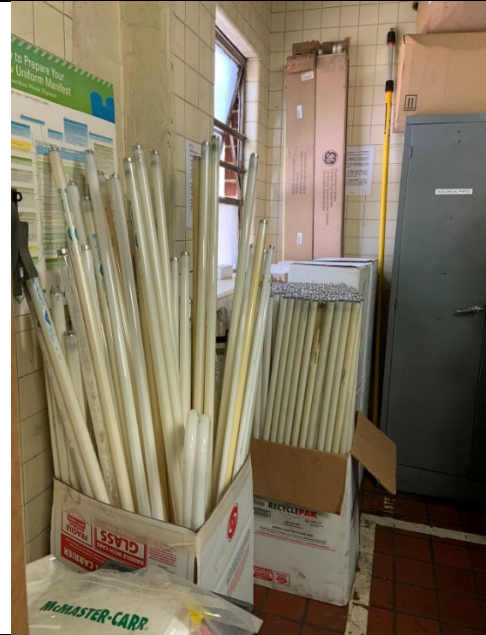
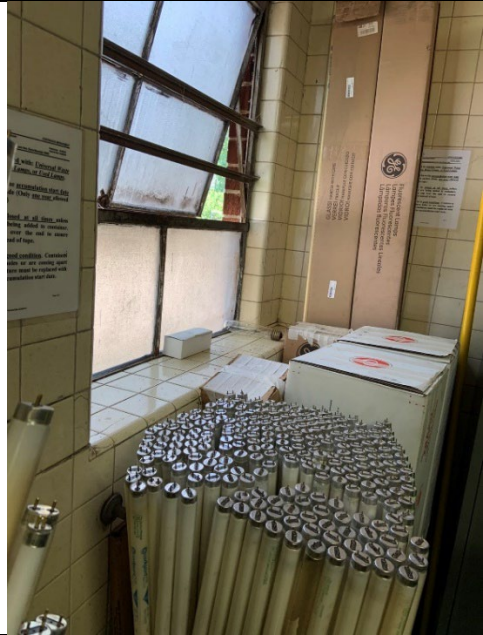
The inspectors observed nine (9) containers of universal waste lamps (Photographs 33 and 34). One unlabeled 4-ft box of used lamps, which was closed and not marked with an accumulation start date. One 4-ft box labeled universal waste lamps, which was closed and marked with an accumulation start date. Three (3) unlabeled 4-ft boxes of used lamps, which were closed and not marked with an accumulation start date. Two open unlabeled (2) small boxes of used lamps, which were not marked with an accumulation start date. Two (2) open unlabeled 8-ft boxes of used lamps, which were not marked with an accumulation start date. The inspectors observed six (6) containers of universal waste batteries in this area during the inspection. Four (4) closed labeled 5-gal containers of used batteries, which were not marked with an accumulation start date. Two closed labeled 5-gallon containers of used batteries, which were marked with an accumulation start date. The oldest date observed on any container of lamps was August 6, 2021, and any container of batteries was June 25, 2019. Since the most recent shipment of universal waste offsite was made in 2019, there is no clear way to demonstrate the length of time the following universal wastes had been stored onsite and available review at the time of the inspection.

**Pursuant to Ga. Comp. R. and Regs. 391-3-11-.18 [40 C.F.R. § 273.14(e)], a SQHUW must label or mark each lamp or container of lamps clearly with one of the following phrases: "Universal Waste-Lamp(s)," or "Waste Lamp(s)," or "Used Lamps."**

**Pursuant to Ga. Comp. R. and Regs. 391-3-11-.18 [40 C.F.R. § 273.15(a) and (c)], a SQHUW may accumulate universal waste no longer than one year and must be able to demonstrate the length of time that the universal waste has accumulated from the date that it became a waste or was received.**

**Pursuant Ga. Comp. R. and Regs. 391-3-11-.18 [40 C.F.R. § 273.13(d)], a SQHUW must manage universal waste lamps in a way that prevents releases of any universal waste or component of a universal waste to the environment.**

| <p>Universal waste lamps in utility room. Photograph 33 taken at 1:09pm</p> | <p>Universal waste lamps in utility room. Photograph 34 taken at 1:09pm</p> |
