## Clean Water Act Section 404: Site Visit/Case Development

| Site Name | Lankford Mine | | | | |

| Inspection Purpose | Initial site visit | | |

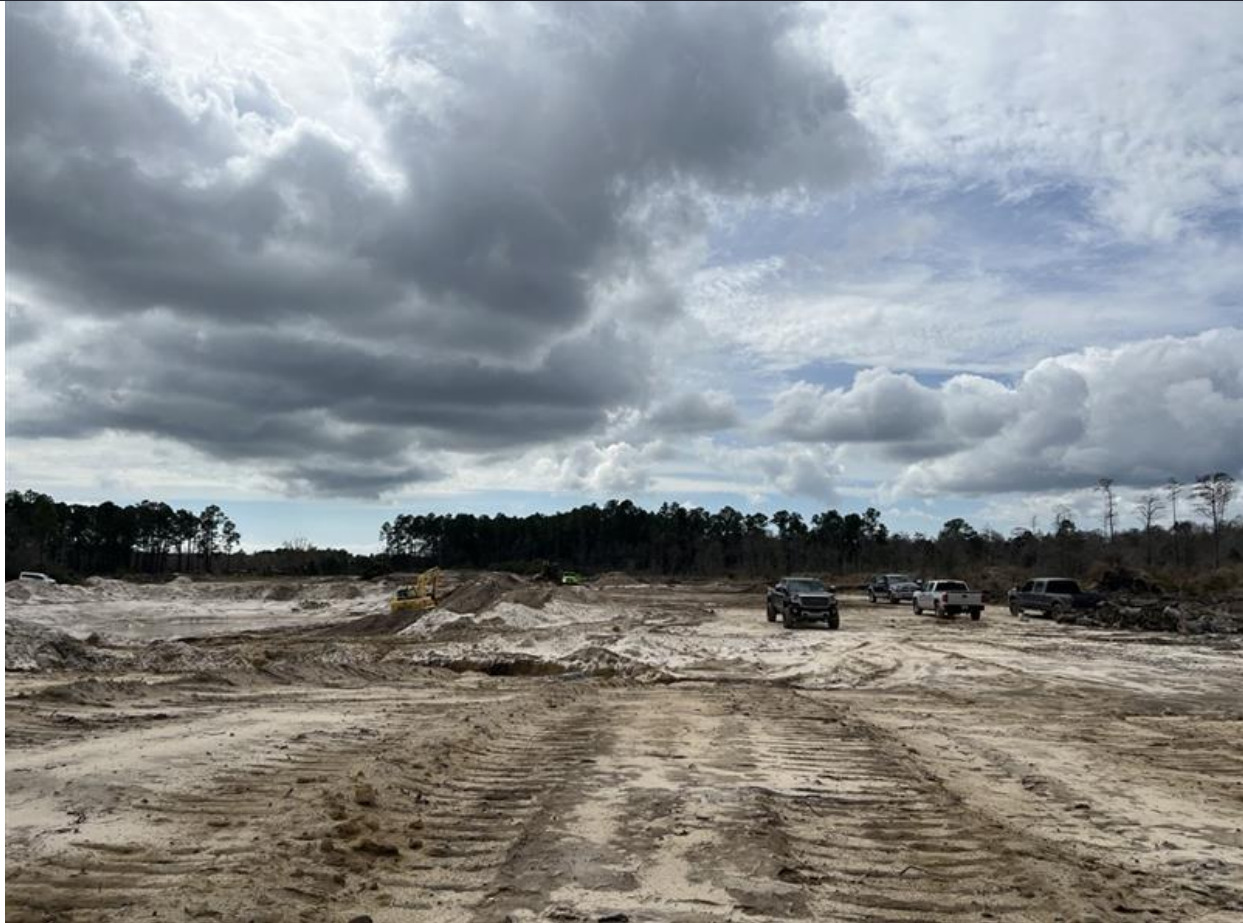
| File Name | 1.jpg |

| Description | striking south; toward the Corps No Permit Required (NPR) boundary. Lat 30.39793, Long -89.15462 |

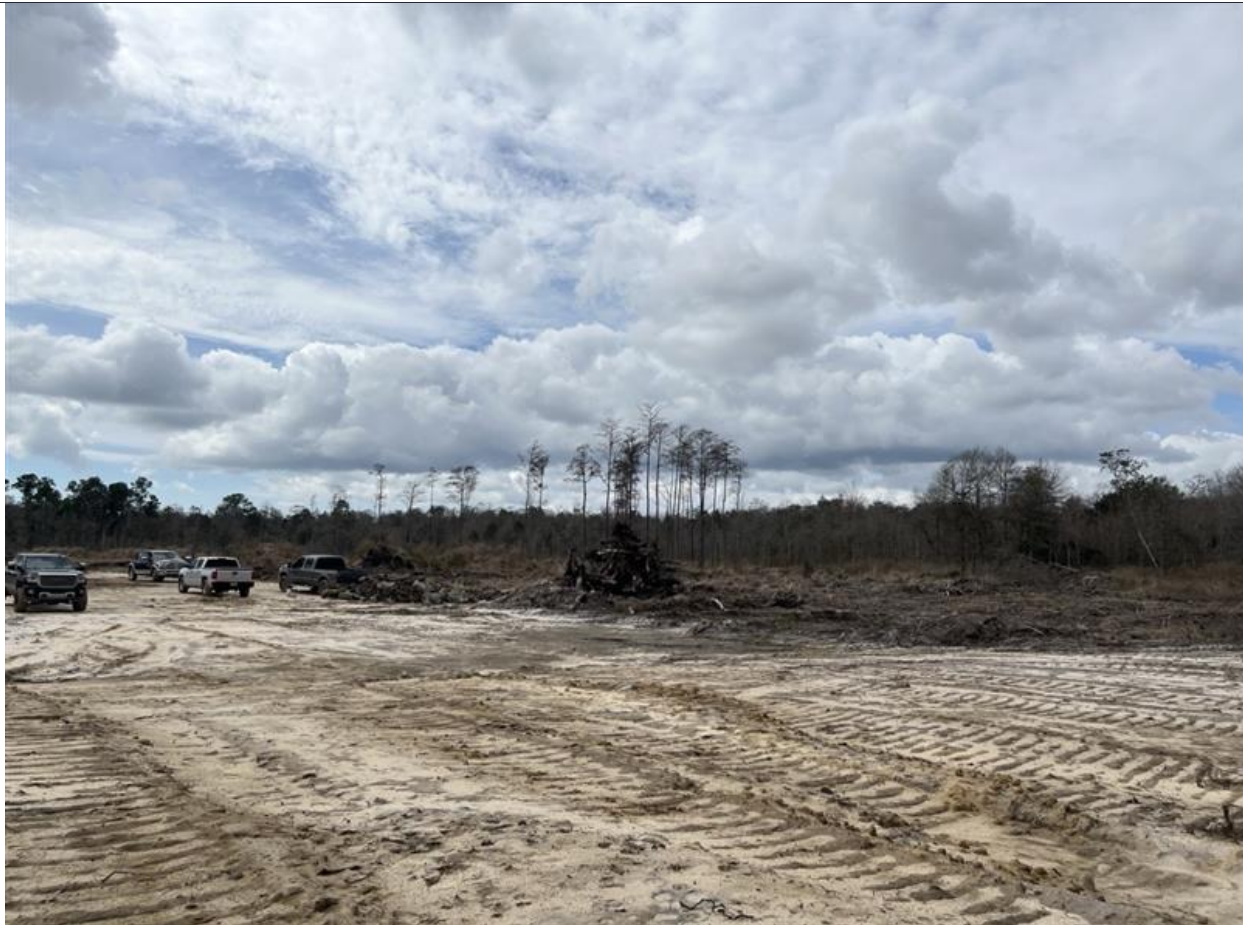
| File Name | 2.jpg |

| Description | striking southwest; disturbed wetlands outside of the NPR boundary. Lat 30.39792, Long -89.15462 |

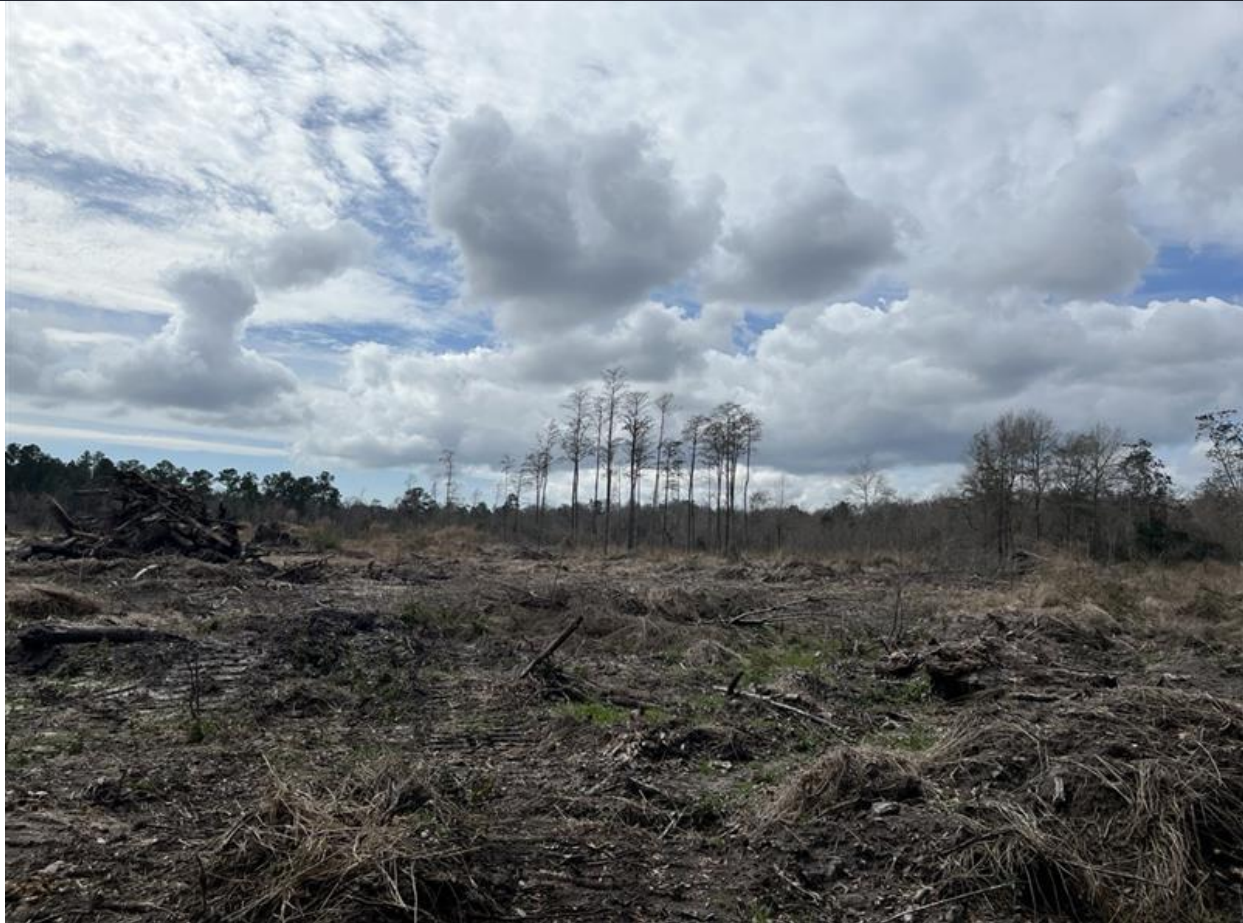
| File Name | 3.jpg |

| Description | striking southwest; standing to the west of Photo 3. Wetland connection to Turkey Creek is approximately 30 feet to the north of this location. Multiple discharges of soil and woody debris present. Lat 30.39796, Long -89.15493 |

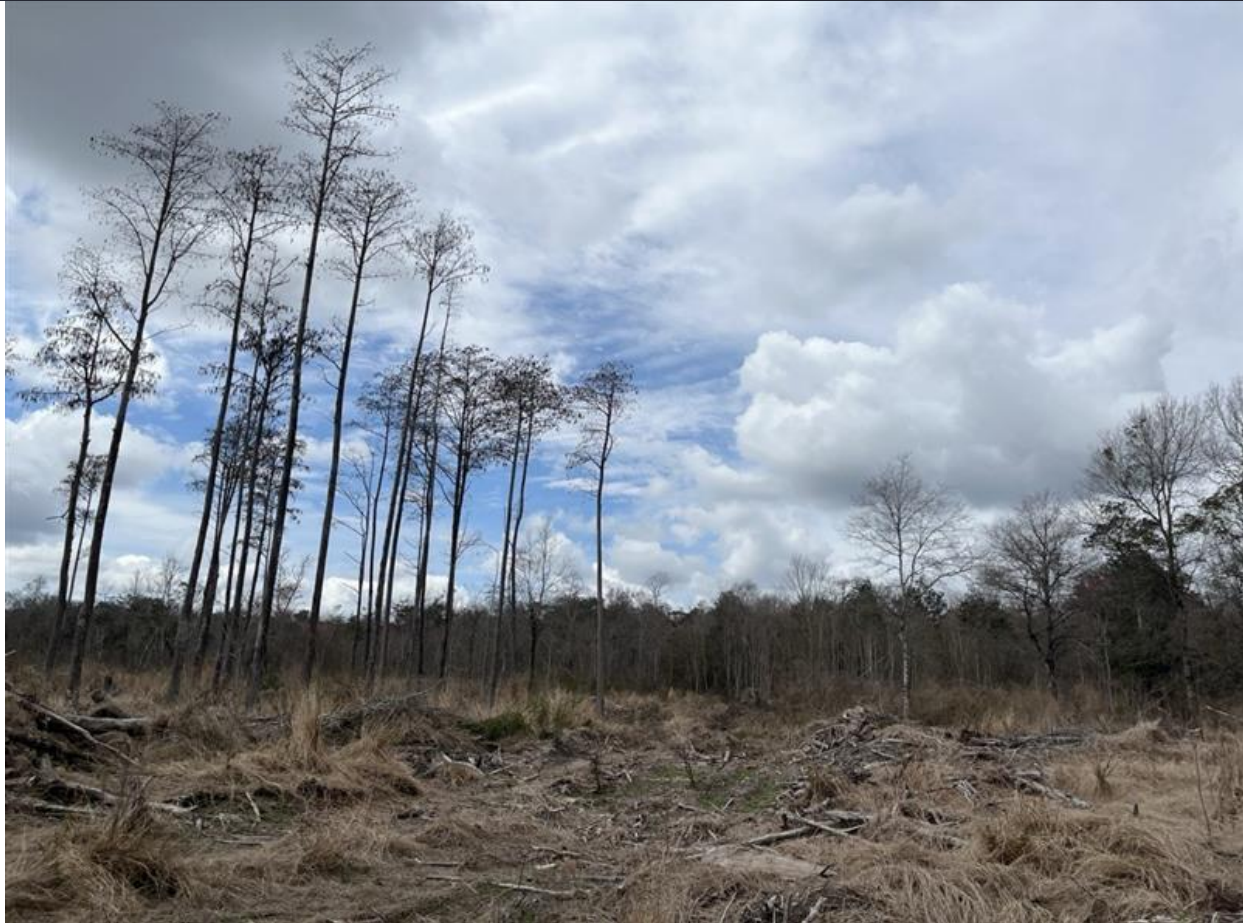
| File Name | 4.jpg |

| Description | striking southwest; cleared area. Notice the cypress (sp.) trees and spoil piles.<br>Lat 30.39746, Long -89.15518 |

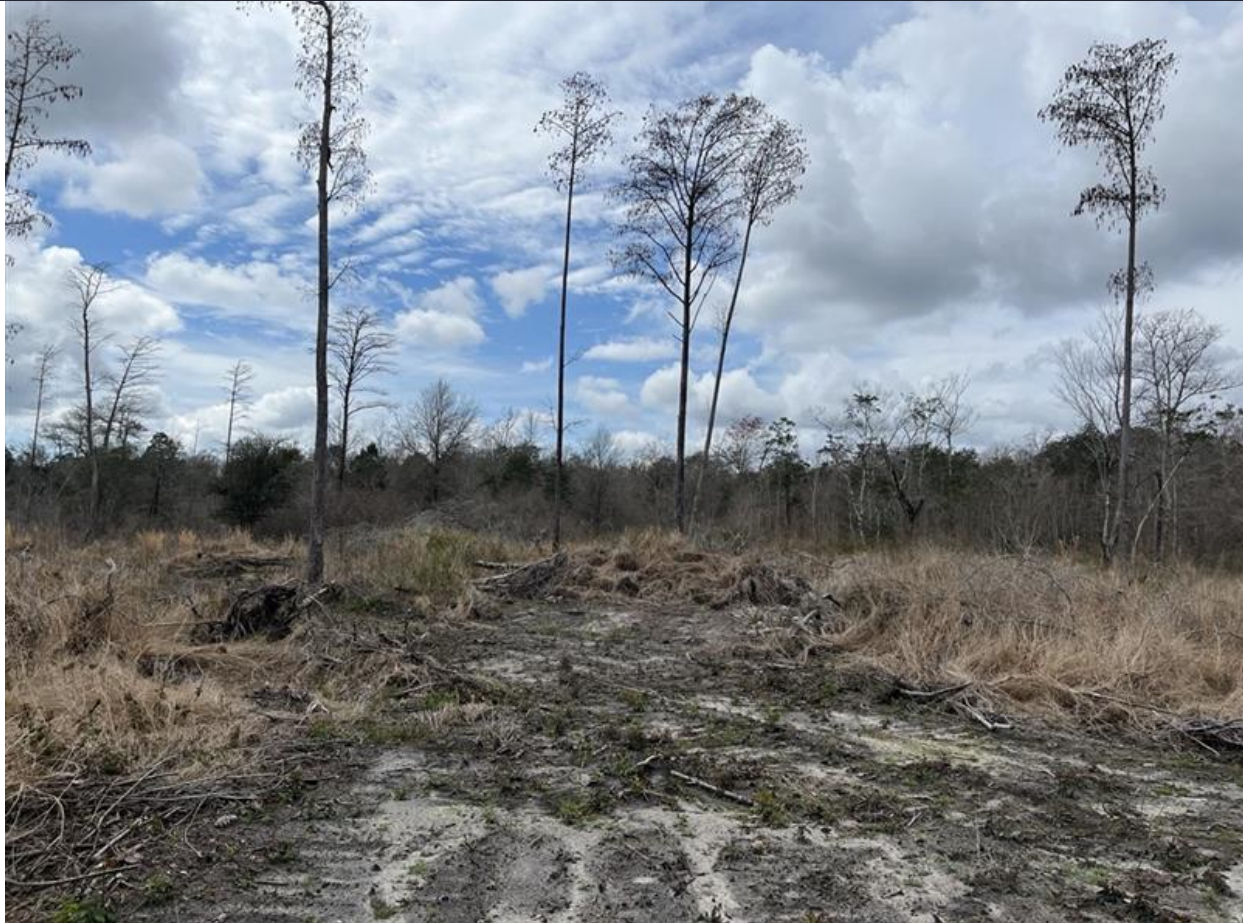
| File Name | 5.jpg |

| Description | striking southwest; location where mechanized equipment moved/<br>pushed material. Lat 30.396683, Long -89.1553 |

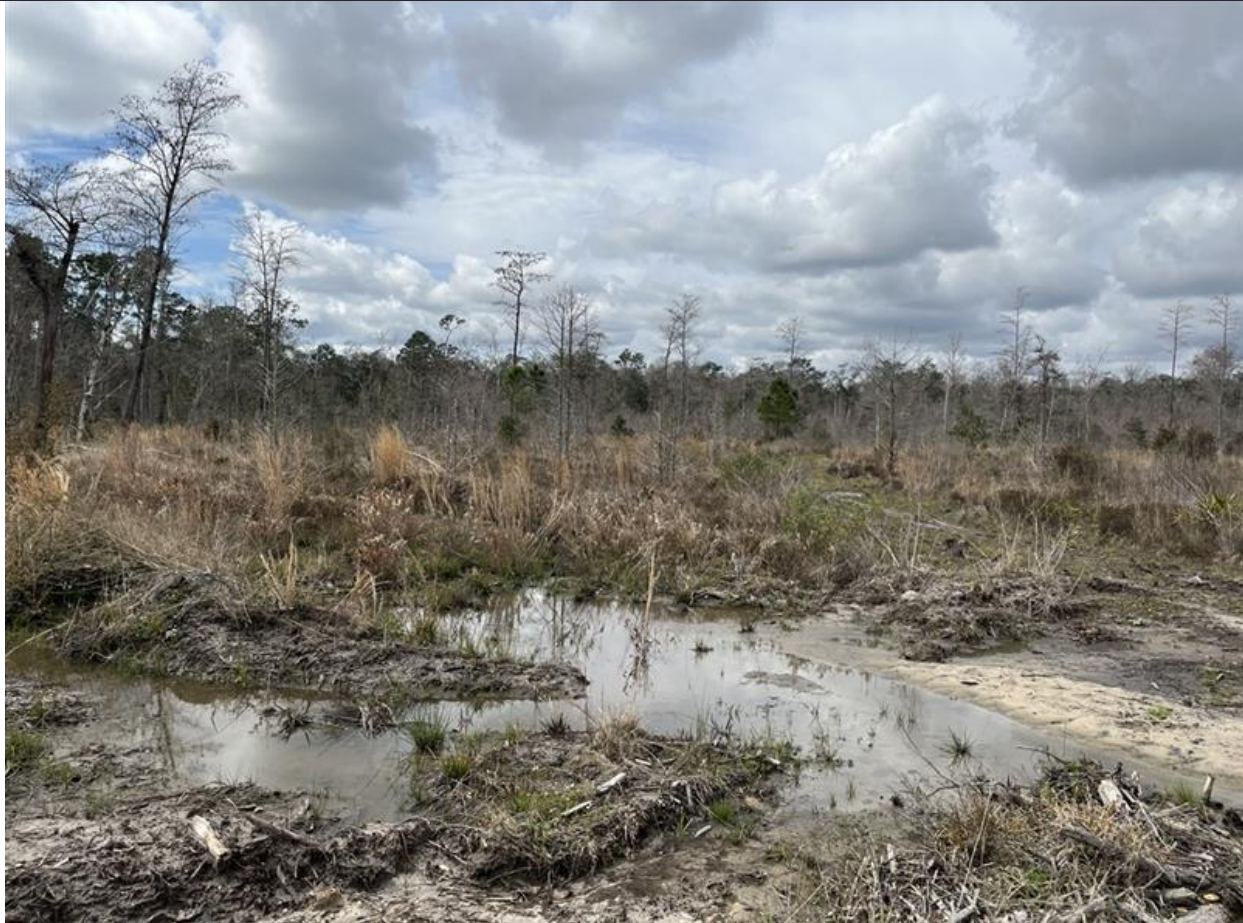
| File Name | 6.jpg |

| Description | striking toward the property's western boundary. One of the three paths leading to the wetland area is to the right of the photo. Additional discharges visible in the photo. Lat 30.39598, Long -89.15461 |

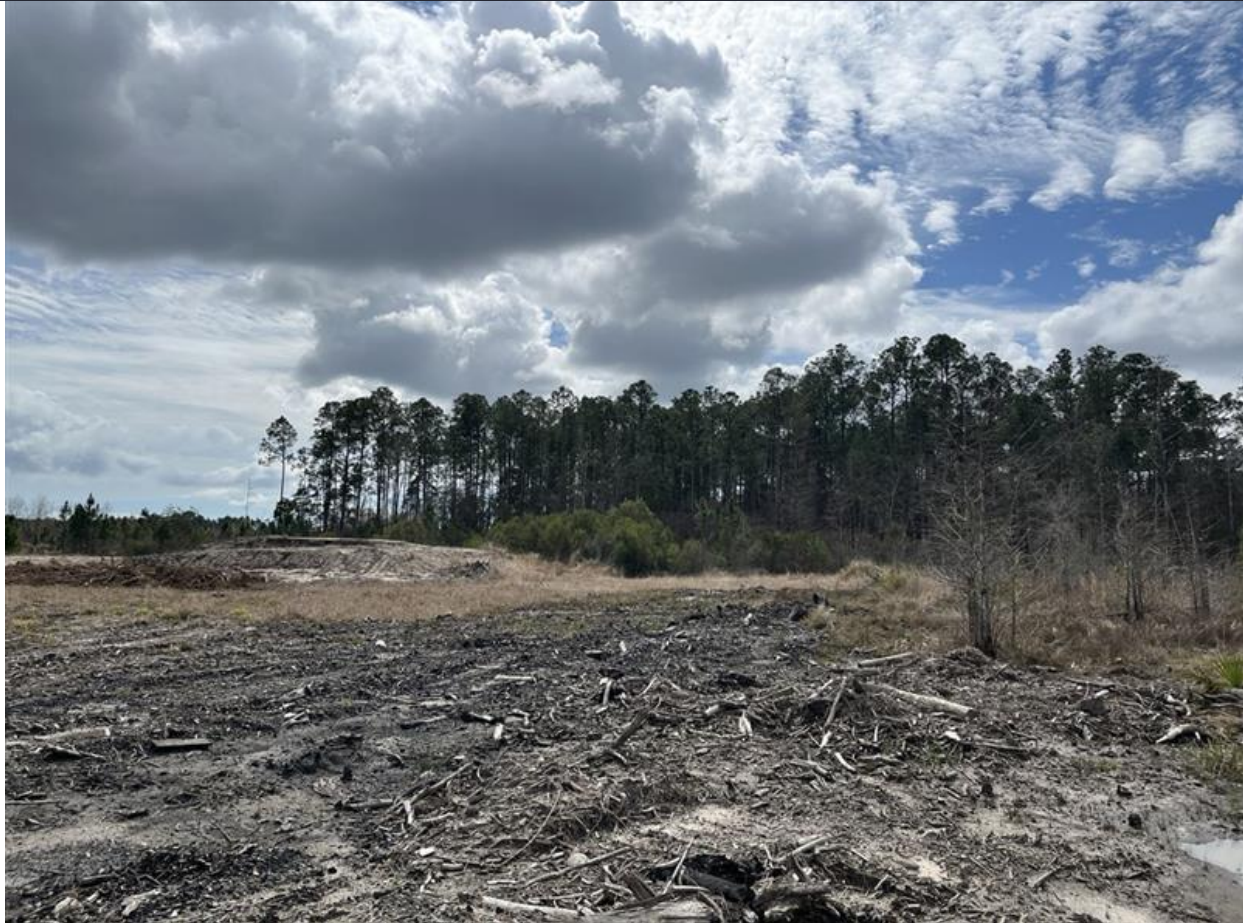
| File Name | 7.jpg |

| Description | striking southeast; viewing the wetland-upland transition. Lat 30.39598, Long -89.15461 |

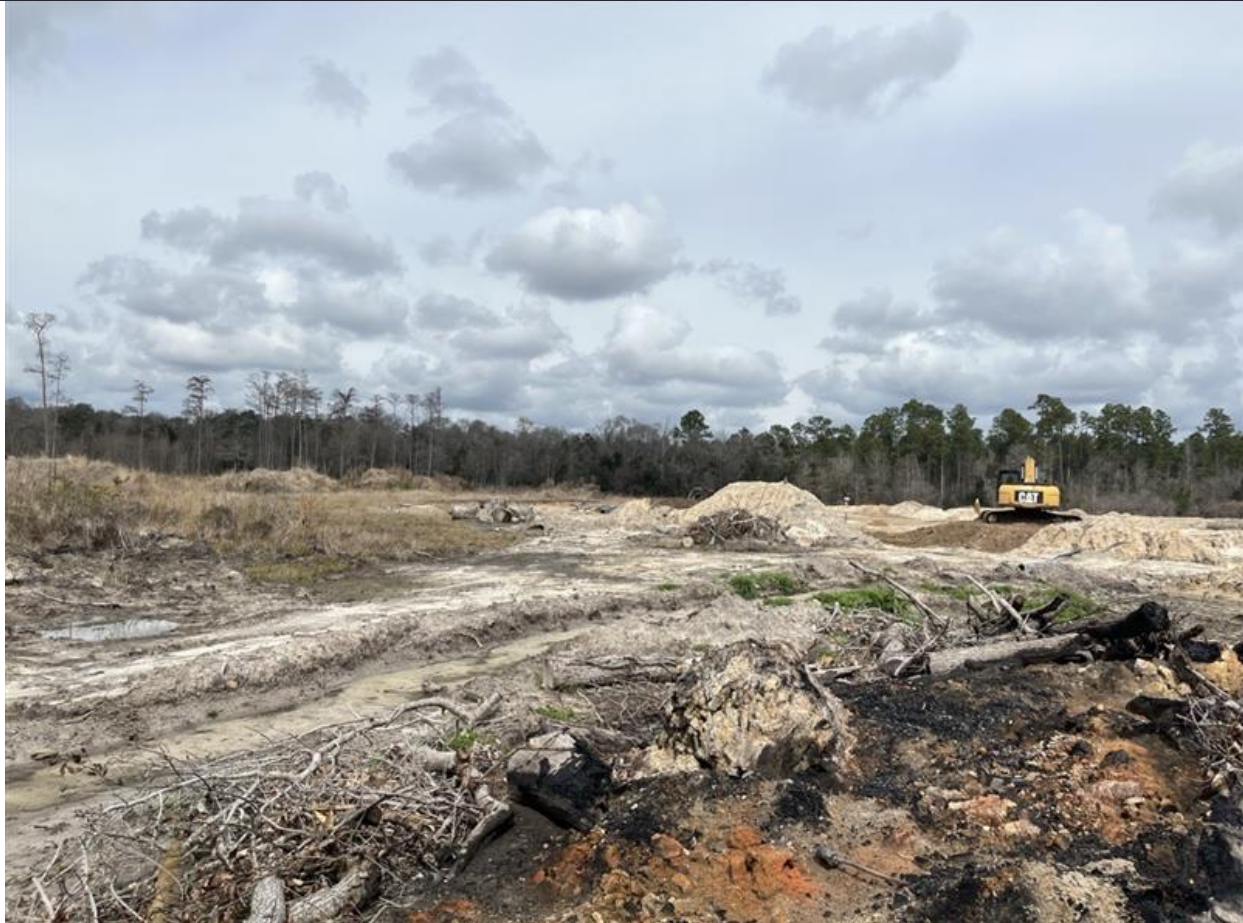
| File Name | 8.jpg |

| Description | striking northeast; viewing wetland (left) and upland (right) conditions toward the northern boundary of the property. Notice spoil piles in wetland. Lat 30.39592, Long -89.15466 |

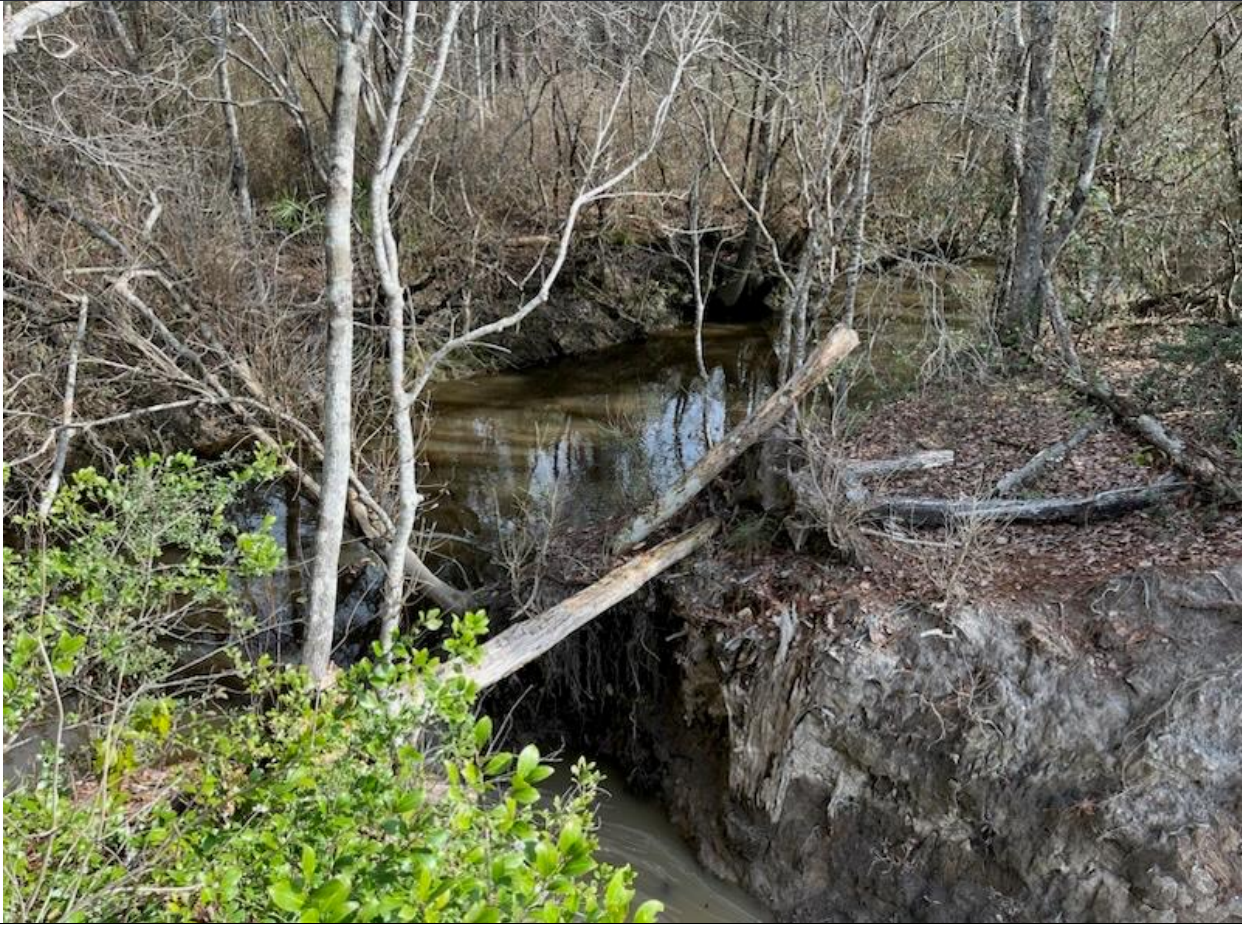
| File Name | 9.jpg |

| Description | striking northwest; Turkey Creek (downstream), which appears to be channelized in its reach that flows across the northern boundary of the property. Lat 30.39807, Long -89.15446 |
