## **RCRA Inspection Report**

Boston Gear  
701 Carrier Drive  
Charlotte, North Carolina 28216

EPA ID#: NCD083673590  
NAICS #: 333613 Mechanical Power  
Transmission Equipment Manufacturing

January 8, 2024, 9:00 AM – 4:45 PM

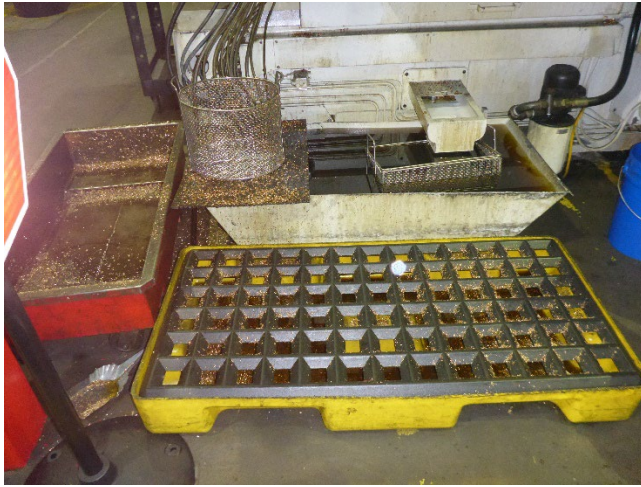
The inspection participants observed one of many similar manufacturing units in the Machining Area and another in the Large Gear Cut Cell Area. Each unit uses either water or oil as a cutting fluid to shape steel or bronze metal blanks into the desired gear shape. This process generates scrap metal chips or shavings which are accumulated in a straining basket at each unit (Photo 1). The cutting fluid drains from the scrap metal into a reservoir that recirculates cutting fluids

**Photo 1:** Manufacturing units use either water or oil as a cutting fluid, and each unit is equipped with a reservoir that recirculates the cutting fluids through the manufacturing unit. The process generates scrap metal chips or shavings which are accumulated in a straining basket at each unit.

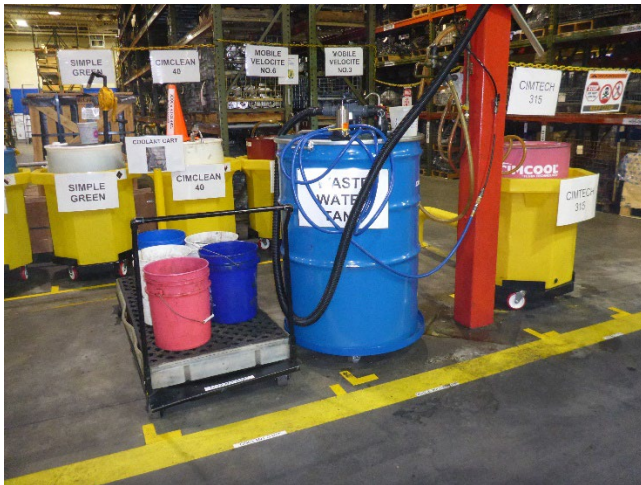
At Pillar P4 in the Open Gear Area, the inspection participants observed one 110-gallon container labeled “Waste Water Tank” (Photo 2). Facility personnel stated that this container is primarily used to accumulate used mop water generated during cleaning activities. Personnel stated that the contents of the 110-gallon container are transferred into the on-site wastewater tank and estimated that this transfer occurs approximately once every two weeks.

**Photo 2:** One 110-gallon container for accumulating used mop water at Pillar P4 in the Open Gear Area.

- **Pursuant to 15A NCAC 13A .0107(a) [40 C.F.R. § 262.11], a person who generates a solid waste, as defined in 15A NCAC 13A .0106(a) [40 C.F.R. § 261.2], must make an accurate determination as to whether that waste is a hazardous waste in order to ensure wastes are properly managed according to applicable RCRA regulations articulated in 15A NCAC 13A .0107(a) [40 C.F.R. § 262.11].**

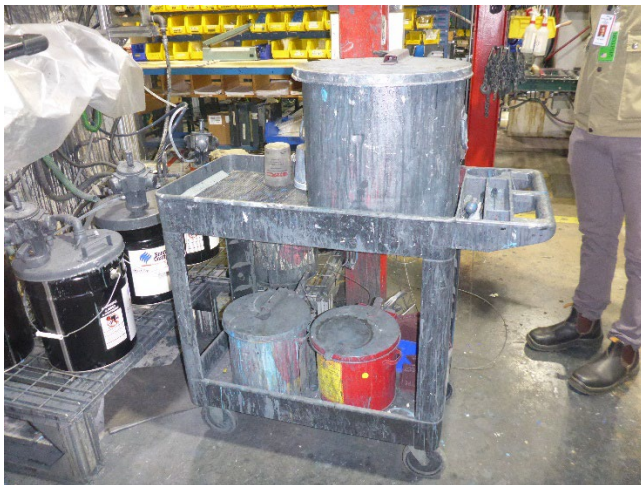
elevated platform (Photo 3). Although one of the 5-gallon containers of solvent liquids was labeled as hazardous waste, Facility personnel explained that the solvents in these containers are still in use. Dirty paint guns and covers that are used in the Main Paint Booth are placed into these containers where they are cleaned by soaking in the solvent liquids. When it becomes necessary to refresh the cleaning solvents in these containers, the spent solvents are disposed of as hazardous waste.

**Photo 3:** Three containers (two 5-gallon containers and one 10-gallon container) on a mobile cart next to the elevated platform. Each container is holding solvent liquids used to clean dirty paint guns and covers. One container is identified with a hazardous waste label.

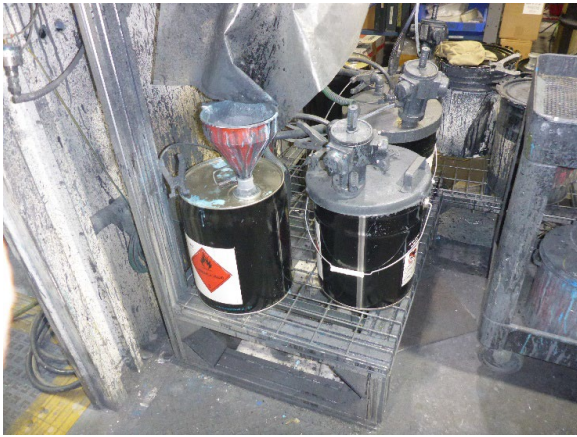
Liquid wastes that are generated when working with solvent-based paints and cleaning solvents have been identified as hazardous waste paint related material with the EPA codes D001, F003 and F005. Boston Gear manages one SAA at the Main Paint Booth for accumulating hazardous waste paint related material that is generated in this area. The inspectors observed one 5-gallon container in this SAA (Photo 4). The container, which was located on the elevated platform next to the four 5-gallon product containers, was identified with a flammable liquid DOT hazard placard, but it was not labeled with the words “hazardous waste” or marked with an indication that its contents are also toxic. The container was equipped with an open-top funnel fitted into the open bung.

**Photo 4:** One 5-gallon container in an SAA next to the Main Paint Booth for accumulating waste paint related material generated in and around this area. This container is shown on the left side of the photo on an elevated platform next to four 5-gallon containers of product materials. The container is equipped with an open funnel; it is identified with a flammable liquid DOT hazard placard; it is not labeled with the words “hazardous waste;” and it is not marked with an indication that the contents are toxic.

- **Pursuant to 15A NCAC 13A .0107(a) [40 C.F.R. § 262.15(a)(5)], which is a condition of the SAA Permit Exemption, a generator is required to mark or label its containers (i) with the words “Hazardous Waste” and (ii) with an indication of the hazardous of the contents.**
- **Pursuant to 15A NCAC 13A .0107(a) [40 C.F.R. § 262.15(a)(4)], which is a condition of the SAA Permit Exemption, a generator is required to keep containers of hazardous waste closed at all times during accumulation, except when adding, removing, or consolidating waste; or when temporary venting of a container is necessary for the proper operation of equipment, or to prevent dangerous situations, such as build-up of extreme pressure.**

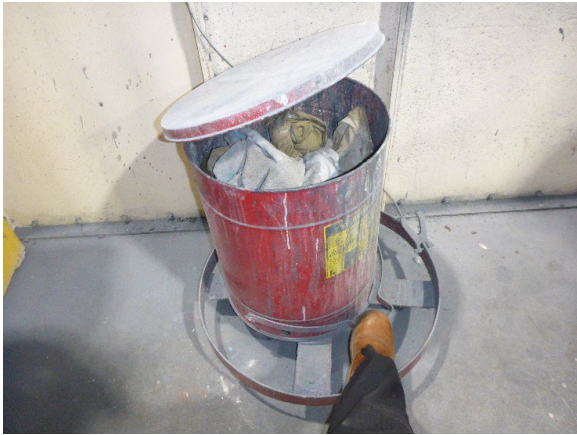
Used paint booth filters, contaminated rags, and floor sweepings have been identified as hazardous waste solids (methyl ethyl ketone/chromium) with the EPA waste codes D007, D035 and F005. Boston Gear manages one SAA at the Main Paint Booth for accumulating hazardous waste solids that are generated in and around this area. The inspectors observed one 20-gallon container (Photo 5) and one 55-gallon container (Photo 6) in this SAA. The 20-gallon container was located next to the wall just outside of the Main Paint Booth, and the 55-gallon container was located next to the sink just outside the opposite side of the Main Paint Booth. Neither container was labeled as hazardous waste or marked with an indication of the hazards of its contents.

**Photo 5:** One 20-gallon container in an SAA next to the Main Paint Booth for accumulating hazardous waste solids generated in and around this area. This container, which was observed in the corner just outside of the Main Paint Booth, was not labeled with the words “hazardous waste” and it was not marked with an indication of the hazards of its contents.

- **Pursuant to 15A NCAC 13A .0107(a) [40 C.F.R. § 262.15(a)(5)], which is a condition of the SAA Permit Exemption, a generator is required to mark or label its containers (i) with the words “Hazardous Waste” and (ii) with an indication of the hazardous of the contents.**

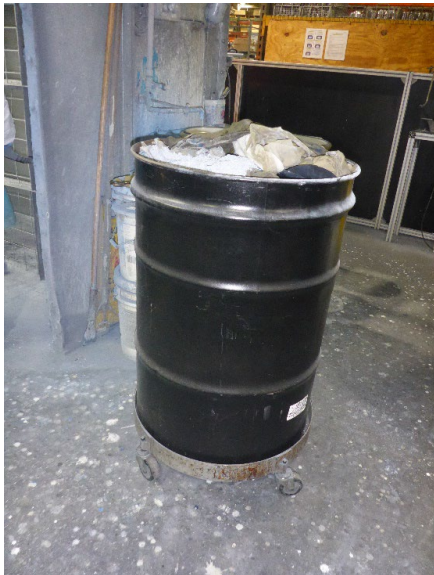
given time to be no more than 55 gallons. An employee working in the Main Paint Booth area was in the process of placing used paint booth filters and floor sweepings into the open 55-gallon drum, and it appeared that the combined volume of waste in both containers had reached or exceeded 55-gallons as a result of this activity. The employee stated that they can typically change the paint booth filters twice before filling the 55-gallon drum. Note that, with respect to any volume of hazardous waste that exceeds the 55-gallon limit for an SAA, 15A NCAC 13A .0107(a) [40 C.F.R. § 262.15(a)(6)] requires Boston Gear to mark or label the container(s) holding the excess hazardous waste with the date the excess amount began accumulating and to comply with 15A NCAC 13A .0107(a) [40 C.F.R. § 262.17(a)] or remove the excess hazardous waste within three consecutive calendar days.

**Photo 6:** One 55-gallon container in an SAA next to the Main Paint Booth for accumulating hazardous waste solids generated in and around this area. This container was not labeled with the words “hazardous waste;” and it was not marked with an indication of the hazards of its contents. An employee working in the Main Paint Booth area was in the process of placing used paint booth filters and floor sweepings into the open 55-gallon drum.

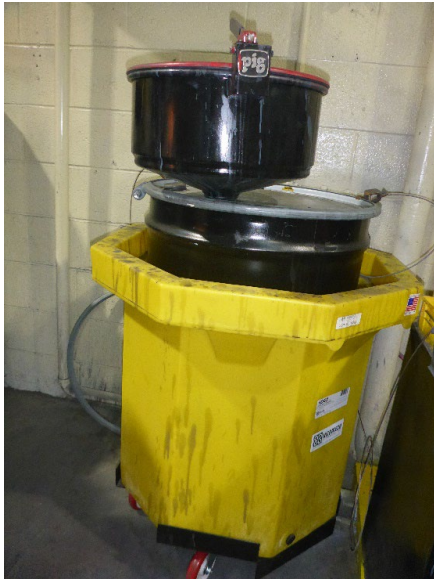
Boston Gear manages one SAA at the Flow Line Paint Booth for accumulating hazardous waste paint related material that is generated in this area. The inspectors observed one 55-gallon container inside a wheeled secondary containment caddy in this SAA (Photo 7). The container was equipped with a latched funnel, but it was not labeled with the words "hazardous waste" or marked with an indication of the hazards of its contents.

**Photo 7:** One 55-gallon container in an SAA next to the Flow Line Paint Booth for accumulating waste paint related material generated in and around this area. The container was equipped with latched funnel, but it was not labeled with the words “hazardous waste” or marked with an indication of the hazards of its contents.

- **Pursuant to 15A NCAC 13A .0107(a) [40 C.F.R. § 262.15(a)(5)], which is a condition of the SAA Permit Exemption, a generator is required to mark or label its containers (i) with the words "Hazardous Waste" and (ii) with an indication of the hazardous of the contents.**

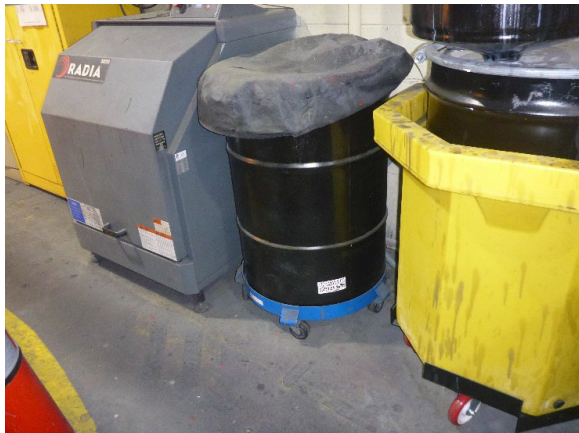
Boston Gear manages another SAA at the Flow Line Paint Booth for accumulating hazardous waste solids that are generated in and around this area. The inspectors observed one 55-gallon container on a wheeled base in this SAA (Photo 8). The container was closed, but it was not labeled with the words "hazardous waste" or marked with an indication of the hazards of its contents.

**Photo 8:** One 55-gallon container in an SAA next to the Flow Line Paint Booth for accumulating hazardous waste solids generated in and around this area. This container was not labeled with the words “hazardous waste,” and it was not marked with an indication of the hazards of its contents.

- **Pursuant to 15A NCAC 13A .0107(a) [40 C.F.R. § 262.15(a)(5)], which is a condition of the SAA Permit Exemption, a generator is required to mark or label its containers (i) with the words "Hazardous Waste" and (ii) with an indication of the hazardous of the contents.**

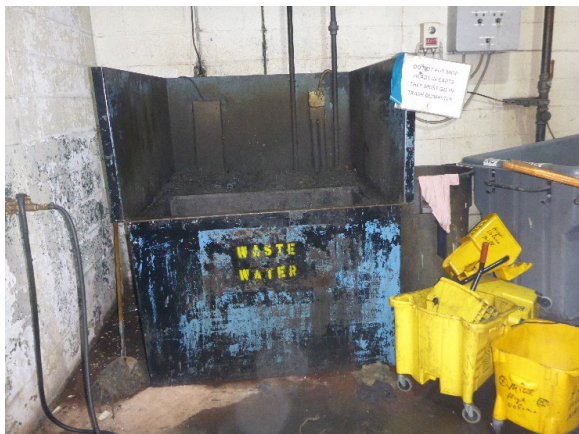
large open vat labeled “waste water” in this area (Photo 9). Facility personnel explained that dirty mop water, including the dirty mop water that is accumulated in the 110-gallon container that was observed at Pillar P4 in the Open Gear Area, is poured into this vat. The dirty mop water is then transferred via hard-piping into a 2,000-gallon vertical storage tank, which is located on the other side of the cinderblock wall behind the vat. The inspectors observed several empty mop buckets on the floor next to the vat, and dirty liquids inside of the vat (Photo 10).

**Photo 9:** Large open vat labeled “waste water” in the Chip Dock Area. Dirty mop water, including the dirty mop water that is accumulated in the 110-gallon container shown in Photo 2, is poured into this vat. The dirty mop water is then transferred into a 2,000-gallon vertical storage tank, which is located on the other side of the cinderblock wall behind the vat.

- **Pursuant to 15A NCAC 13A .0107(a) [40 C.F.R. § 262.11], a person who generates a solid waste, as defined in 15A NCAC 13A .0106(a) [40 C.F.R. § 261.2], must make an accurate determination as to whether that waste is a hazardous waste in order to ensure wastes are properly managed according to applicable RCRA regulations articulated in 15A NCAC 13A .0107(a) [40 C.F.R. § 262.11].**

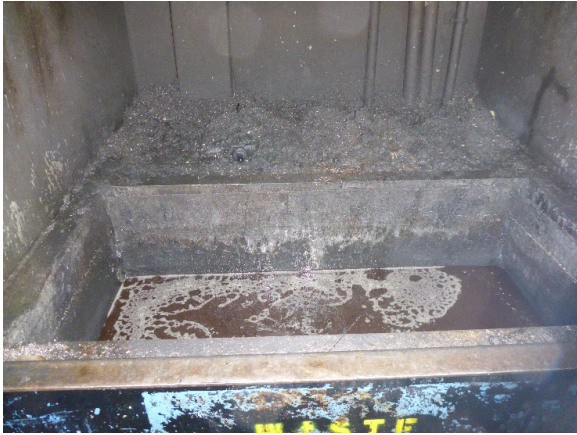
**Photo 10:** Liquids observed inside the open vat shown in Photo 9.

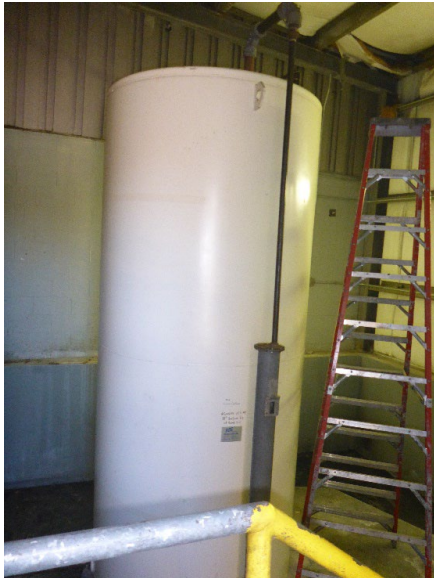
The inspectors entered the room on the opposite side of the cinderblock wall and observed the 2,000-gallon vertical storage tank on an elevated concrete pad (Photo 11). The tank was not labeled. The inspectors observed liquids on the floor surrounding the concrete pad (Photo 12) and in a sump in the corner of the room. This sump is one of two blind sumps that are connected to another. The second sump is located just outside of this building next to the 2,500-gallon metal fabricated tank under the chip bins. Personnel explained that, when the transporter comes to transport liquids from the 2,000-gallon and 2,500-gallon tanks, liquids are also pumped from the sumps. Terry Jones stated that the liquid was rainwater that had entered the room through the damaged roof, but the inspectors observed discoloration indicating contamination of the liquids inside the 2,000-gallon tank room.

**Photo 11:** 2,000-gallon vertical storage tank inside the room on the opposite side of the cinderblock wall shown in Photo 9. Dirty mop water is transferred into this tank from the wastewater vat shown in Photo 9.

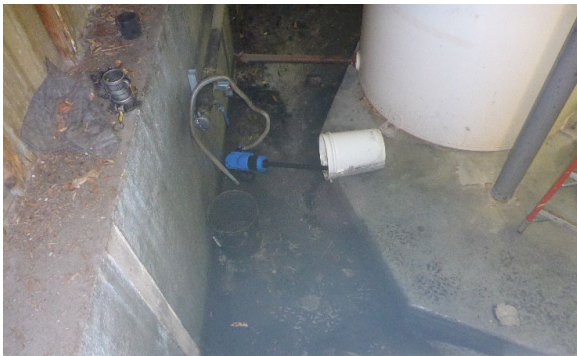
**Photo 12:** Dirty liquids observed on the floor surrounding the concrete pad beneath the 2,000-gallon vertical storage tank.

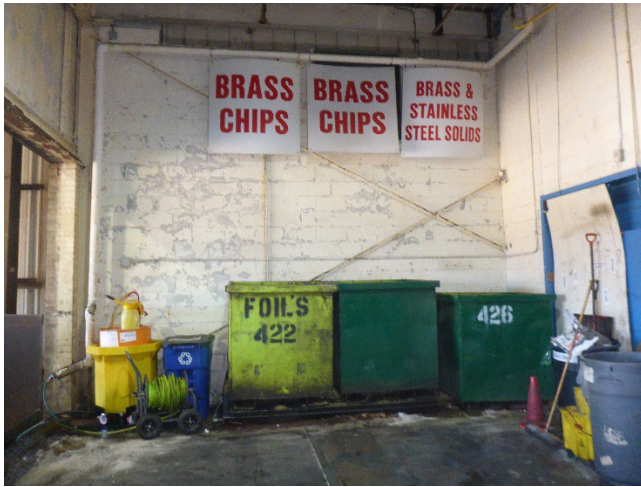
**Photo 13:** Three bins along the wall at the far end of the Chip Dock. Signs on the wall identify two bins for storing brass chips and the third for storing brass and stainless-steel solids. Cutting fluids drain from these bins onto a secondary containment tray that is connected through a pipe into the 2,500-gallon metal fabricated storage tank.

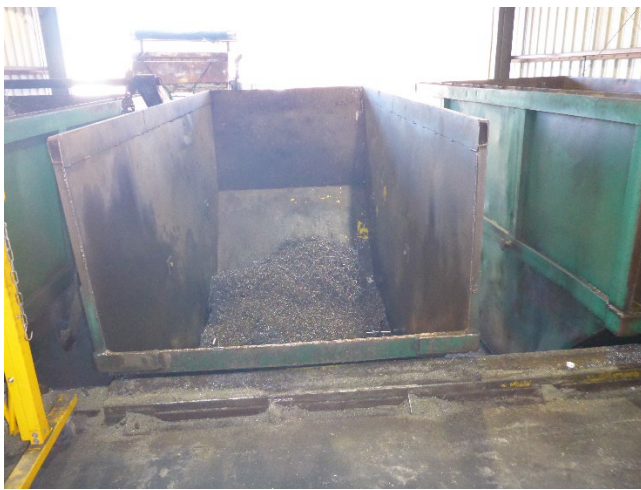
**Photo 14:** The middle one of three large hoppers just off the edge of the loading dock floor in the Chip Dock. This hopper is in use to accumulate and store metal chips and shavings that do not contain brass.

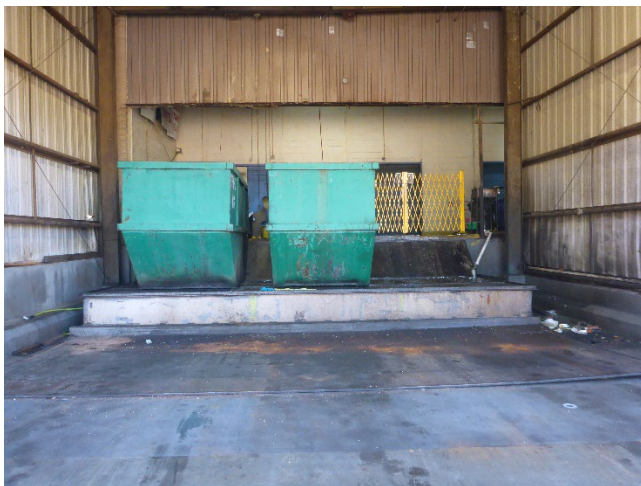
**Photo 15:** Two of three large hoppers staged above the 2,500-gallon metal fabricated storage tank at the Chip Dock. The funnel and PVC pipe shown in Photo 17 can be seen to the right at the far side of the tank. The blind sump shown in Photo 18 can be seen to the right at the near side of the tank.

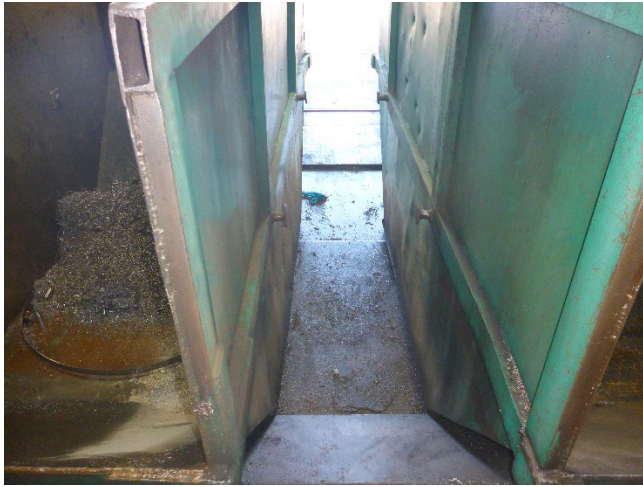
**Photo 16:** The top of the 2,500-gallon metal fabricated storage tank located below the three large hoppers just off the edge of the loading dock at the Chip Dock.

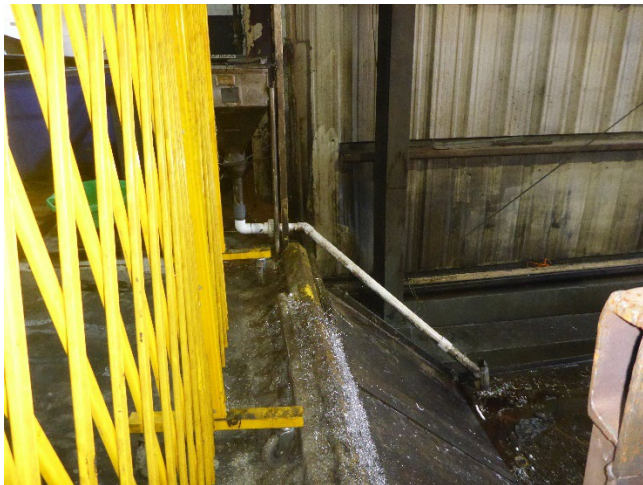
**Photo 17:** Funnel that is connected through PVC piping into the 2,500-gallon metal fabricated storage tank beneath the three large hoppers at the Chip Dock.

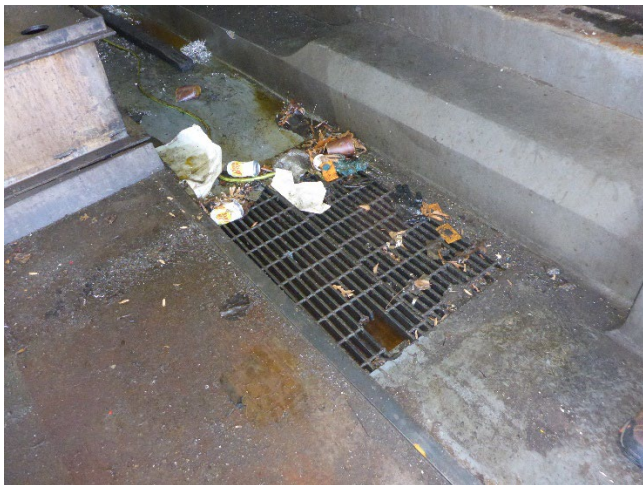
**Photo 18:** Blind sump located next to the 2,500-gallon metal fabricated storage tank at the Chip Dock. Facility personnel stated that this sump is connected to the sump observed inside the room with the 2,000-gallon storage tank, but that liquids do not drain from the sumps. Instead, when the transporter comes to transport liquids from the 2,000-gallon and 2,500-gallon tanks, liquids are also pumped from the sumps and shipped with the tank contents.

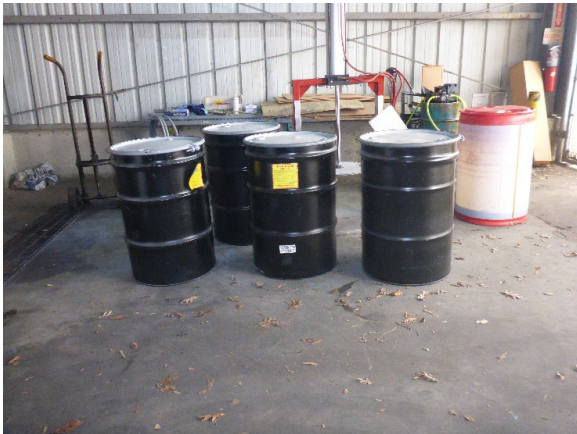
**Photo 20:** Four 55-gallon drums of hazardous waste next to a drum compactor unit in the center of the CAA.

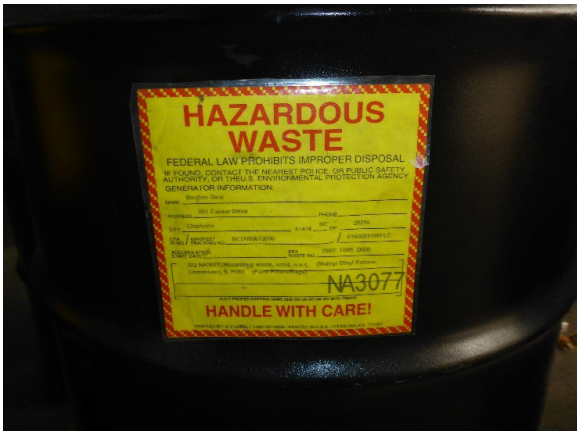
**Photo 21:** One of two labels identifying the contents of two 55-gallon drums in the CAA as D007, D035, F005 hazardous waste solid paint filters and rags containing methyl ethyl ketone and chromium. The containers were not marked with an accumulation start date.

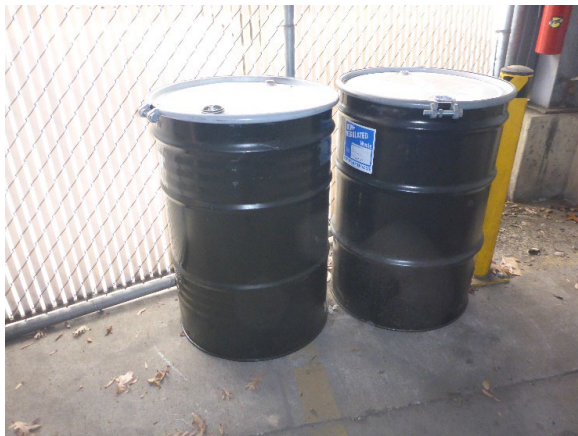
**Photo 23:** Two drums of used oil near the entrance of the CAA. The containers were closed and identified with the words “used oil” written on a non-regulated waste label.

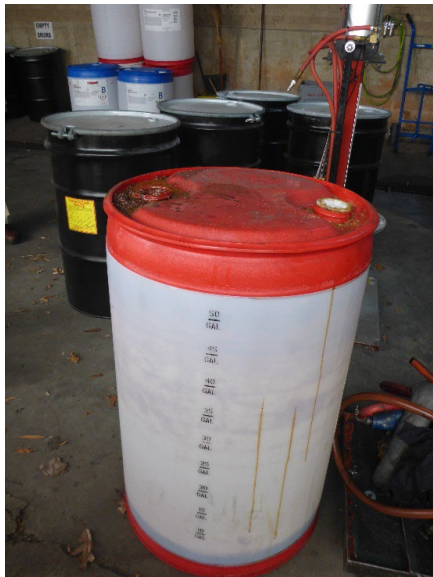
**Photo 24:** One 55-gallon drum containing a small amount of SmartFOAM A, which had reacted and could not be used.

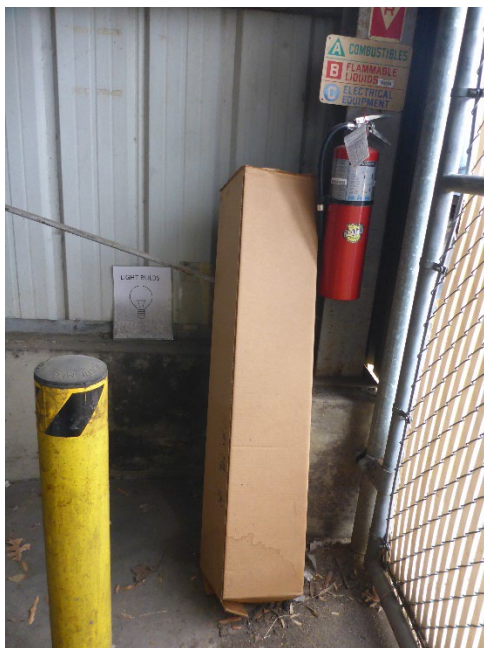
**Photo 25:** One cardboard box of universal waste lamps near the chain link fence in the far-right corner just inside the CAA. The container was open, and it was not labeled as universal waste lamps.
