## INSPECTION REPORT

| Type of Inspection | Compliance Evaluation Inspection (CEI) | |
| Company Name | Bartlett Regional Hospital | |
| Facility/Site Physical Address | 3260 Hospital Dr. | |

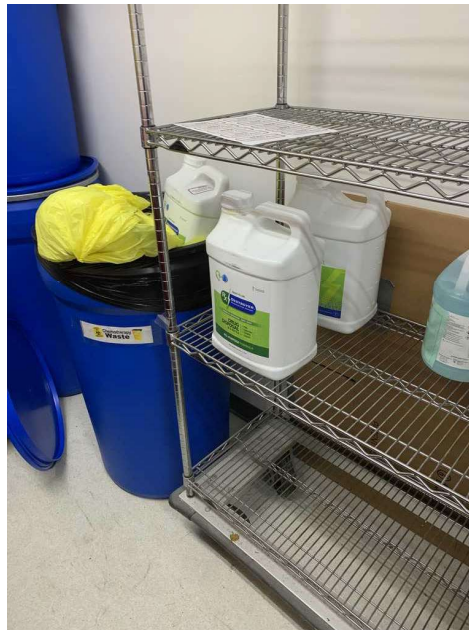
| [Title] | | | IMG_1681.jpg |

| <p>While at the CAA, we observed containers of non-RCRA waste, including sharps, red bag waste, non-hazardous waste, and chemotherapy waste. We also observed three, 2.5 - gallon "Rx Destroyer" containers. There were two "Rx Destroyer" containers on a shelf that were not labeled with the words "Hazardous Waste" and were not dated. There was one "Rx Destroyer" container that was labeled with the words "Hazardous Waste," a hazard indicator, but not dated, and in an open blue, poly container that was adjacent to the shelf where the other two "Rx Destroyer's" were located. According to the "Rx Destroyer" website which I researched following the inspection, these containers are for pharmaceuticals that are controlled substances. The "Rx Destroyer" renders pharmaceuticals non-retrievable. At the time of the inspection, the facility was managing the "Rx Destroyer" containers as hazardous waste. I suggested to Mr. Nolan that he take a closer look at the "Rx Destroyer's" to make a waste determination, as this waste might not be hazardous.</p> <p>We also saw a one-gallon container that was labeled with the words "Ethyl Alcohol Waste," with trace amounts of xylene and a one-gallon container that was labeled with the words "Paraffin Wax Waste," with trace amounts of xylene on the same shelf. Both containers were marked with hazard indicators. According to Mr. Nolan, the ethyl alcohol and paraffin wax wastes were being managed by the facility as flammable/toxic waste.</p> | | | |

| View of Rx Destroyer containers in the CAA. | | | |

| Building: Main Building | Area: Central Accumulation Area (CAA) | Sub-area: Rm #1115 Medical Waste Storage |
|---|---|---|
| At the time of the inspection, the facility was managing the "Rx Destroyer" containers as hazardous waste. I suggested to Mr. Nolan that he take a closer look at the "Rx Destroyer's" to make a waste determination, as this waste might not be hazardous. | <b>Regulation:</b> | <b>Sections:</b> |

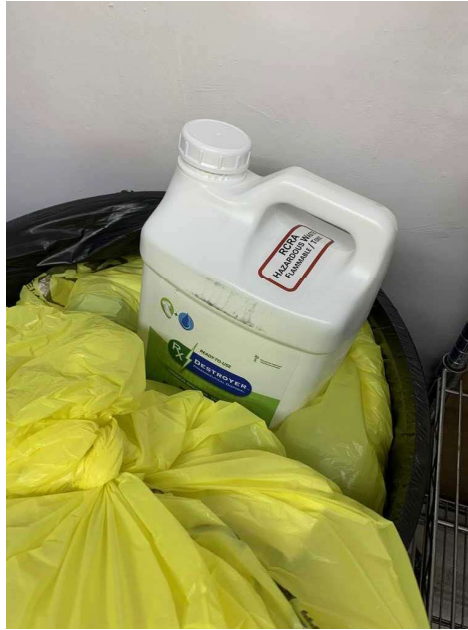
| [Title] | | | IMG_1682.jpg |

| View of an Rx Destroyer container that has been labeled as "RCRA Hazardous Waste Flammable/Toxic." | | | |

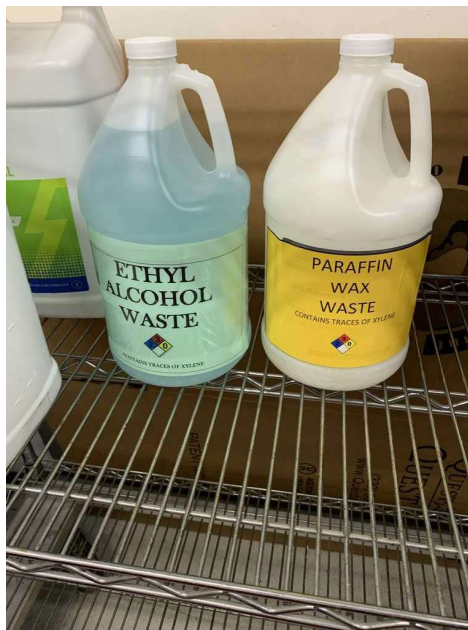
| [Title] | | | IMG_1683.jpg |

| View of two, one-gallon containers of waste. One containing "Ethyl Alcohol Waste" and one containing "Paraffin Wax Waste" that contains traces of xylene. | | | |

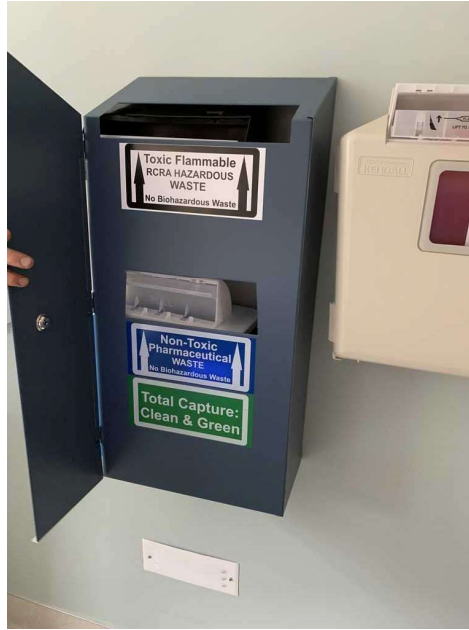
| [Title] | | | IMG_1684.jpg |

| View of wall mounted waste collection container in a patient room within the facility's CCU. | | | |

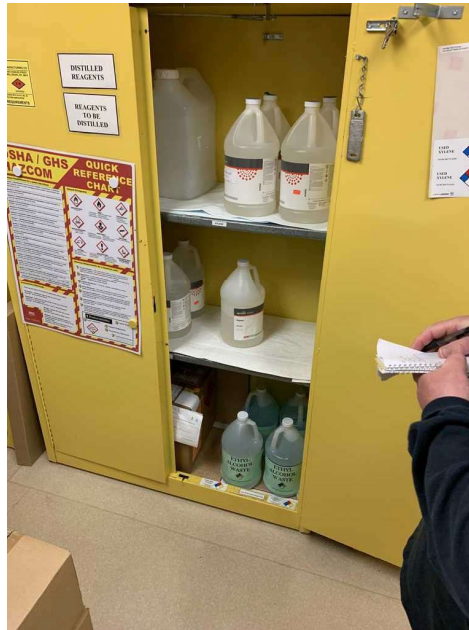
| [Title] | | | IMG_1690.jpg |

| View of four, one-gallon containers of Ethyl Alcohol waste (these were the same wastes seen in the CAA). | | | |

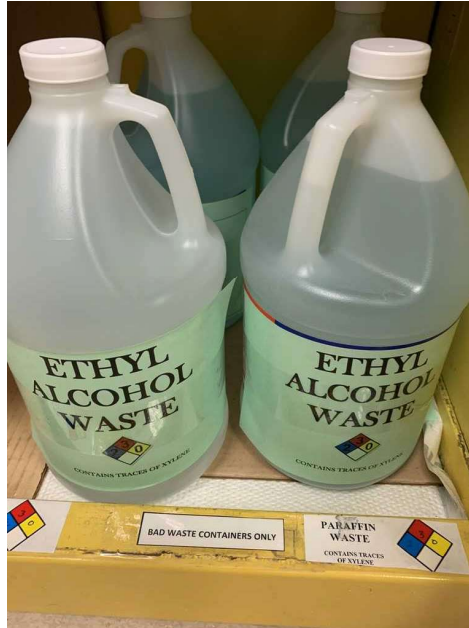
| [Title] | | | IMG_1692.jpg |

| Another close-up view of four, one-gallon containers of Ethyl Alcohol waste. | | | |

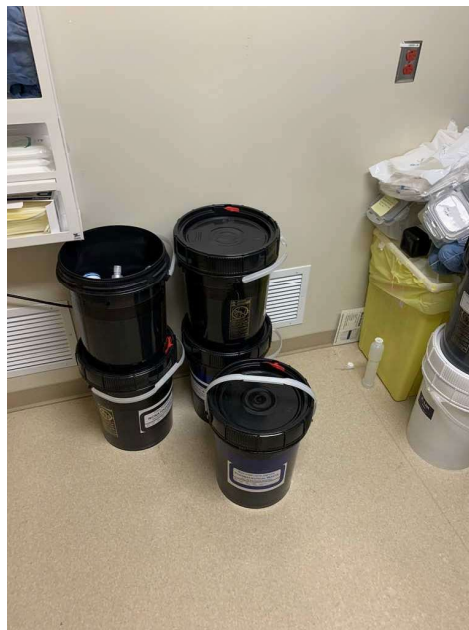
- Two full, black, five-gallon containers of flammable/toxic waste which, according to facility personnel, were ready to be transferred the CAA. These two containers were labeled with the words "Hazardous Waste" and hazard indicators, but no accumulation start date (ASD).

- Two, black, five-gallon containers labeled with the words "Non-Toxic Pharmaceutical Waste."
- One, black, five-gallon SAA container of flammable/toxic waste which waste was still be accumulated. The container was labeled with the words "Hazardous Waste" and marked with a hazard indicator.

| View of two, black, five-gallon containers of flammable/toxic waste which were ready to be transferred to the CAA. Two, black, five-gallon containers of non-toxic pharmaceutical waste, and one, black, five-gallon container of flammable/toxic waste which an active SAA container. | | | |

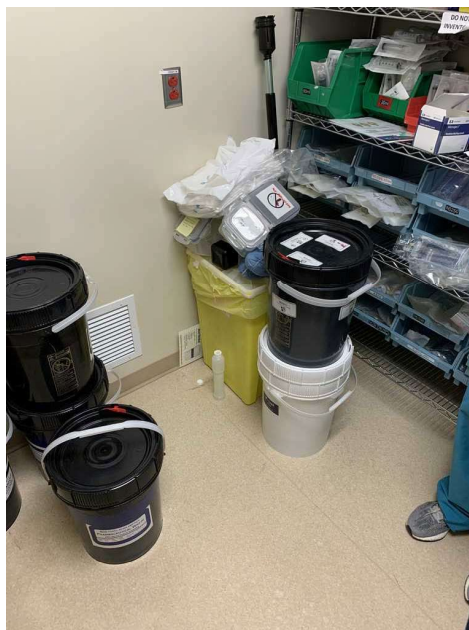
- One, black, five-gallon container of waste aerosols (almost full and was estimated to be a 6-month accumulation). This container was labeled with the words "Aerosols: (Anything that is propelled)." The container was neither labeled with the words "Hazardous Waste" and marked with a hazard indicator nor was it being managed as universal waste and labeled with either the phrase, "Universal Waste - Aerosols," "Waste Aerosols," or "Used Aerosols."

- One, white, five-gallon container of waste nicotine products (2/3 full estimated to be a 1-year accumulation) and labeled with the words "P-List." The container was not labeled with the words "Hazardous Waste" or marked with a hazard indicator.

| Another view of the containers seen in IMG_1693.jpg, and a black, five-gallon container of waste aerosols (almost full and estimated to be a 6-month accumulation) can be seen here on the right and on top of a white, five-gallon container of P-List nicotine products (2/3 full estimated to be a 1-year accumulation). | | | |

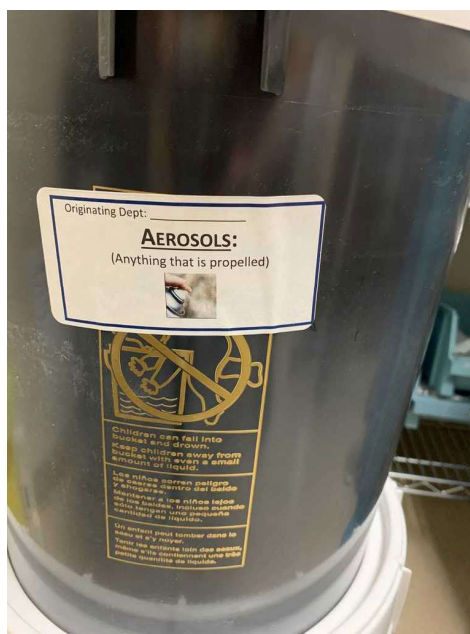
| [Title] | | | IMG_1695.jpg |

| Close-up view of the label on the waste aerosol container. | | | |

I told them they needed to manage their waste lamps, batteries, and aerosols as universal waste as this would reduce the amount of hazardous waste they generate. I also told them they needed to do better waste determinations because some of the hazardous wastes they think they're generating might turn out to be non-hazardous, like the "Rx Destroyer's." I explained that once that's done, if they were still a VSQG, counting both pharmaceutical and nonpharmaceutical waste, they would not have to opt into Subpart P for managing their hazardous waste pharmaceuticals.

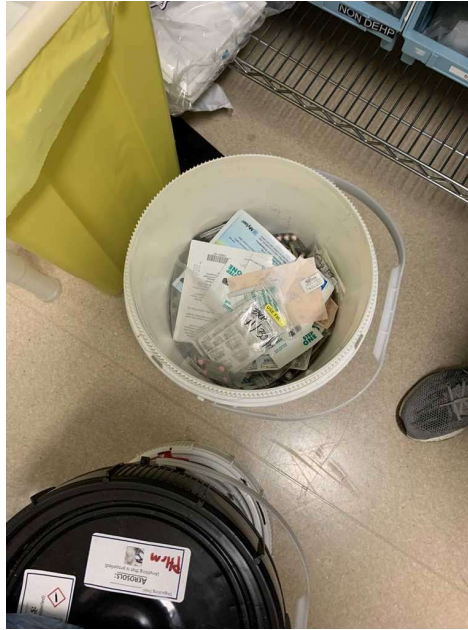
| [Title] | | | IMG_1696.jpg |

| View of the contents in the container labeled as "P-list waste." | | | |

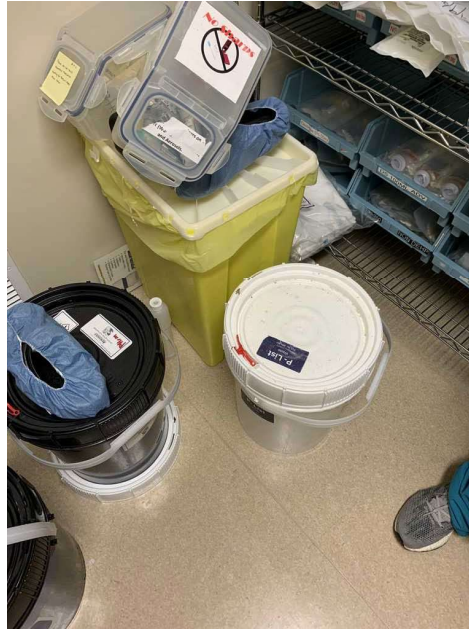
| [Title] | | | IMG_1698.jpg |

| Another view of the white, five-gallon container, labeled as containing P-listed waste. | | | |

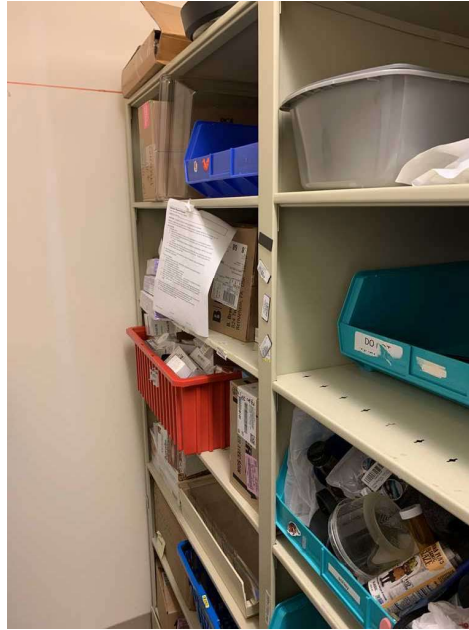
| [Title] | | | IMG_1702.jpg |

Mr. Rip showed us a shelving unit of potentially creditable pharmaceuticals for reverse distribution. According to Mr. Rip, the reverse distributor (Inmar) makes the determination as to what pharmaceuticals they will take for credit, and anything not taken gets wasted. The reverse distributor comes every three months and according to Mr. Rip, on average 2% of what the pharmacy deems as potentially creditable isn't taken by Inmar and ends up leaving the facility as hazardous waste.

| View of the area where the potentially creditable HWPharms are accumulated prior to being picked up by the reverse distributor. | | | |

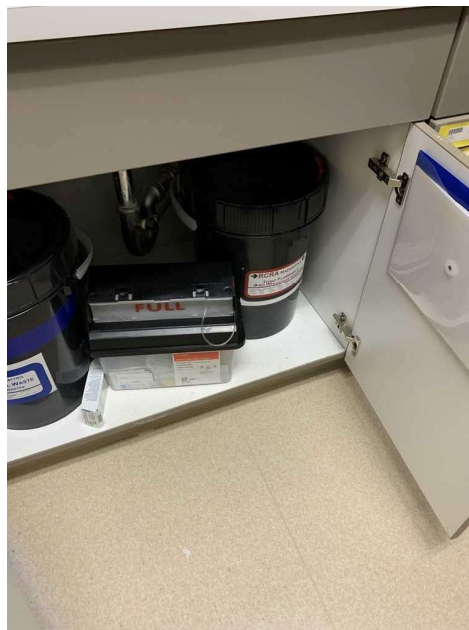
| [Title] | | | IMG_1705.jpg |

| View of black, five-gallon container holding non-toxic pharmaceutical waste on the left, a three-gallon container of P-listed waste, and a black, five-gallon container of flammable/toxic waste. | | | |

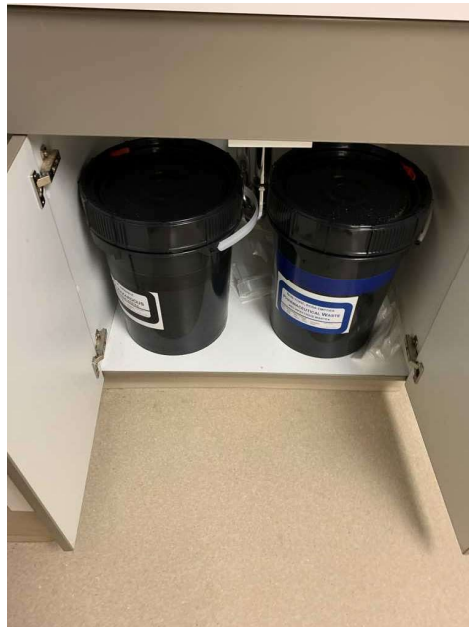
| [Title] | | | IMG_1707.jpg |

| View of black, five-gallon container holding non-toxic pharmaceutical waste on the right, and a black, five-gallon container holding flammable/toxic waste on the left. | | | |

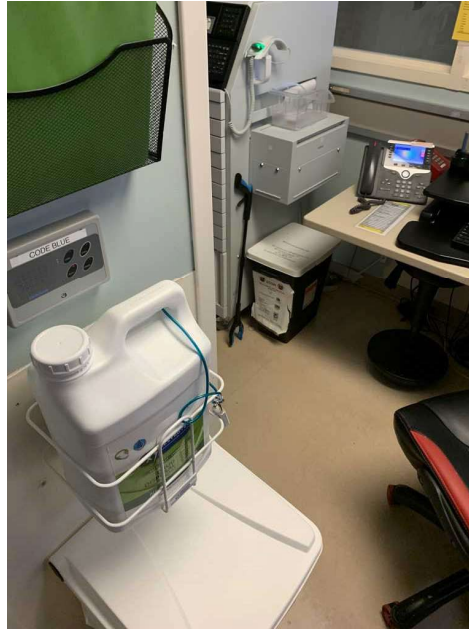
| [Title] | | | IMG_1708.jpg |

While at the Nurses Station, we saw another 2.5 gallon "Rx Destroyer" and a seven-gallon SAA container being used to accumulate flammable/toxic waste. At the time of the inspection, the SAA container was labeled with the words "Hazardous Waste," but was not marked with a hazard indicator.

| View of 2.5-gallon Rx Destroyer on the left, and a black, seven-gallon container of flammable/toxic waste seen on the floor. | | | |

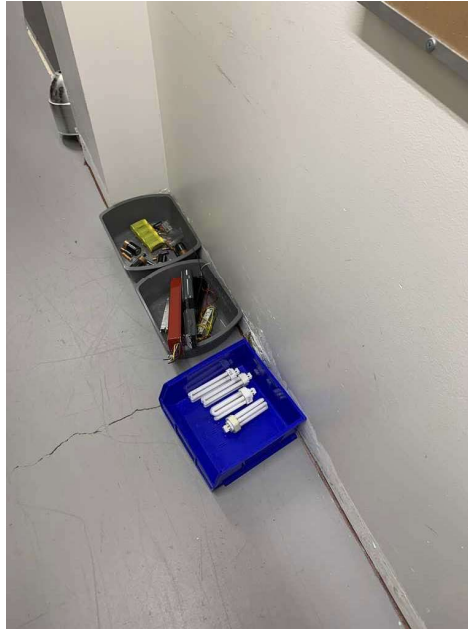
| [Title] | | | IMG_1712.jpg |

| View of fluorescent (compact type) bulbs in a blue unmarked tray, and NiCad batteries in a gray unmarked tray. | | | |

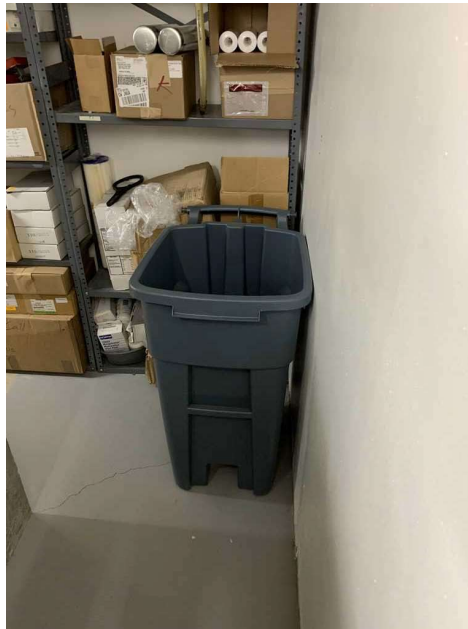
| [Title] | | | IMG_1713.jpg |

| Another view of a trash receptacle being used to accumulate waste lamps. | | | |

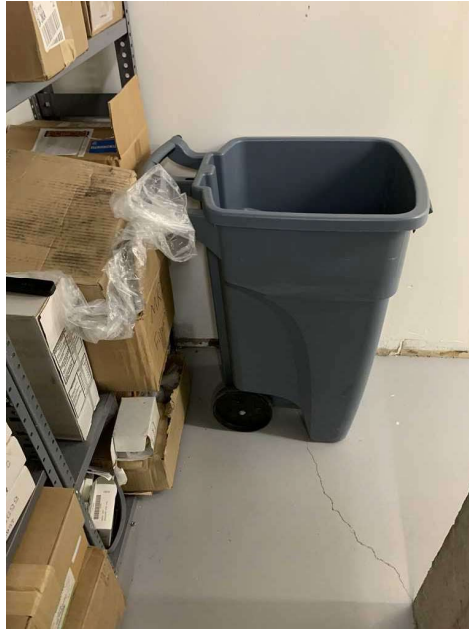
| [Title] | | | IMG_1715.jpg |

| View of a trash receptacle being used to accumulate waste lamps. | | | |
