## Clean Water Act Section 404: Site Visit/Case Development

| Site Name | Mountain Fork River, Mr. Bridges | | | | |

| We assessed the restoration work that was conducted as required by the Administrative Order on Consent that was issued. We inspected the boat ramp, banks, and stream bed. | | | |

### Photograph Log

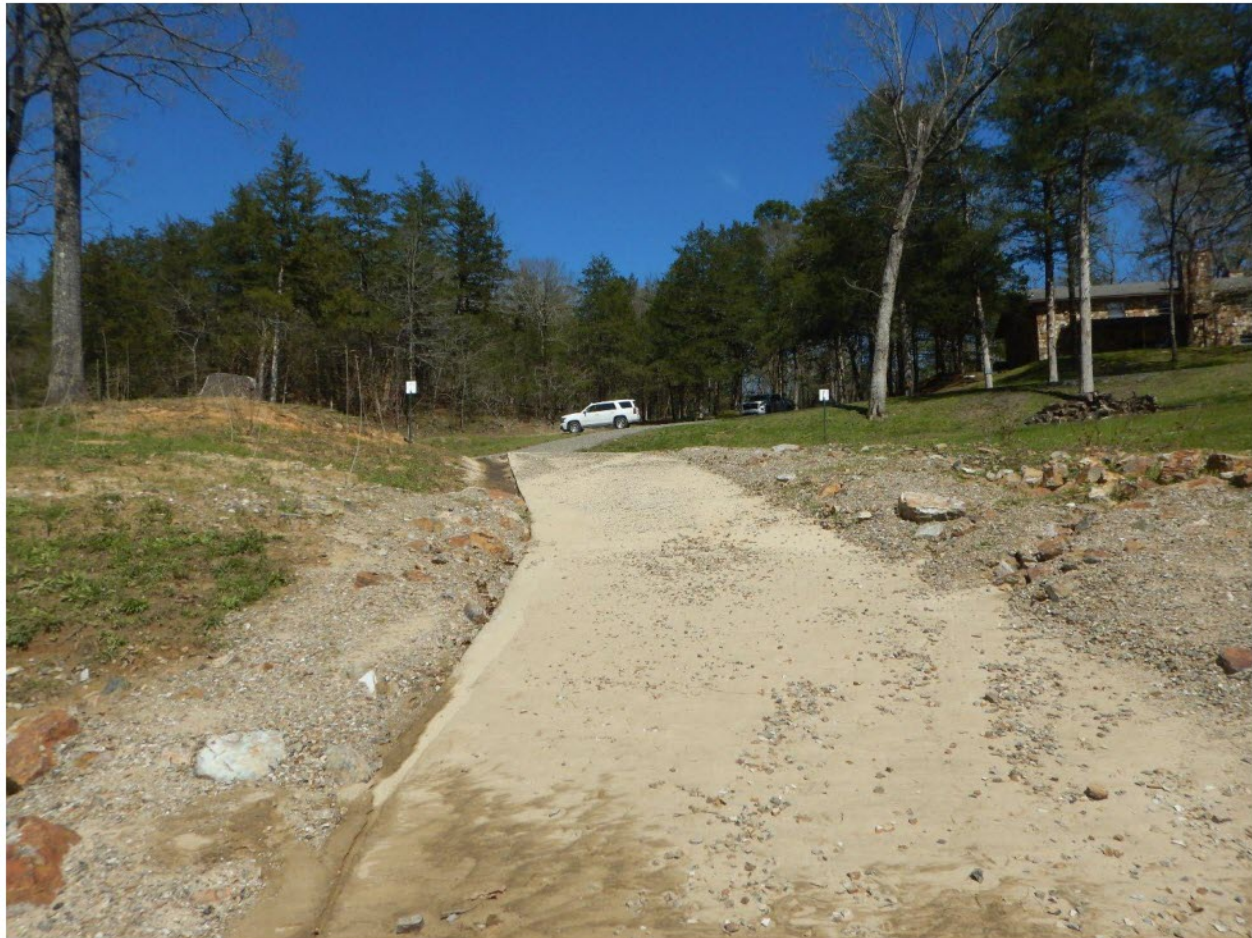
Photo No. 1

| Photo File Name | Date and Time of Photo | Photographer | Description |
|---|---|---|---|
| DSCN6385 | 03/27/2024, 1:56 PM | Chelsey Sherwood | Showing restoration of boat ramp. Note sides along boat ramp are beginning to wash out and lots of sediment deposition and gravel on boat ramp. Picture taken facing east. |

| This inspection was done to assess the restoration and determine compliance with the Administrative Order on Consent. Restoration was completed. See photos for reference. Note - for repairs in the future to use larger gravel (such as 3 in or greater) as we observed some areas around the boat ramp already getting washed out. | | | |

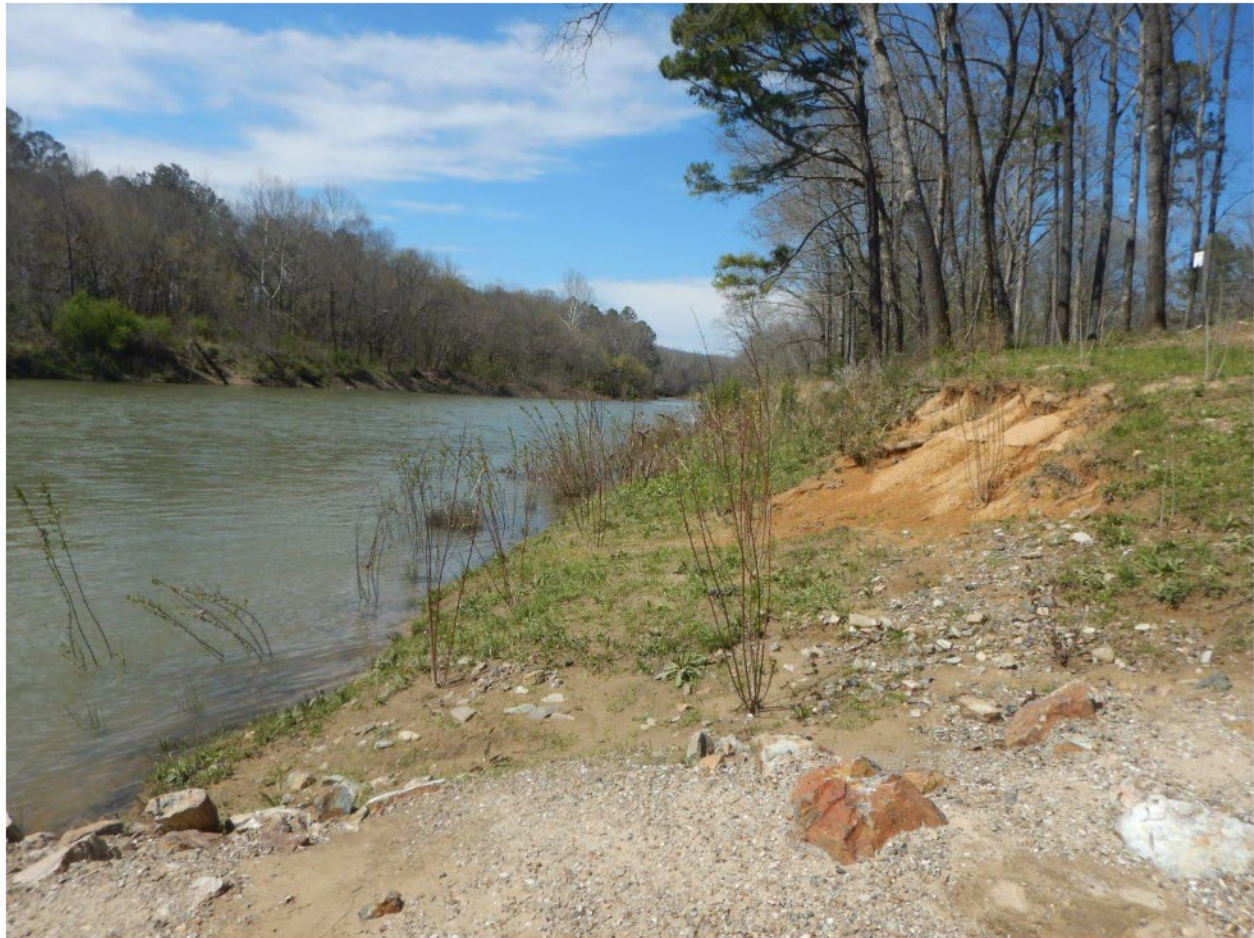
Photo No. 2

| Photo File Name | Date and Time of Photo | Photographer | Description |
|---|---|---|---|
| DSCN6386 | 03/27/2024, 1:56 PM | Chelsey Sherwood | Showing restoration on stream bank. Note all the shrubs planted. Picture taken facing north. |

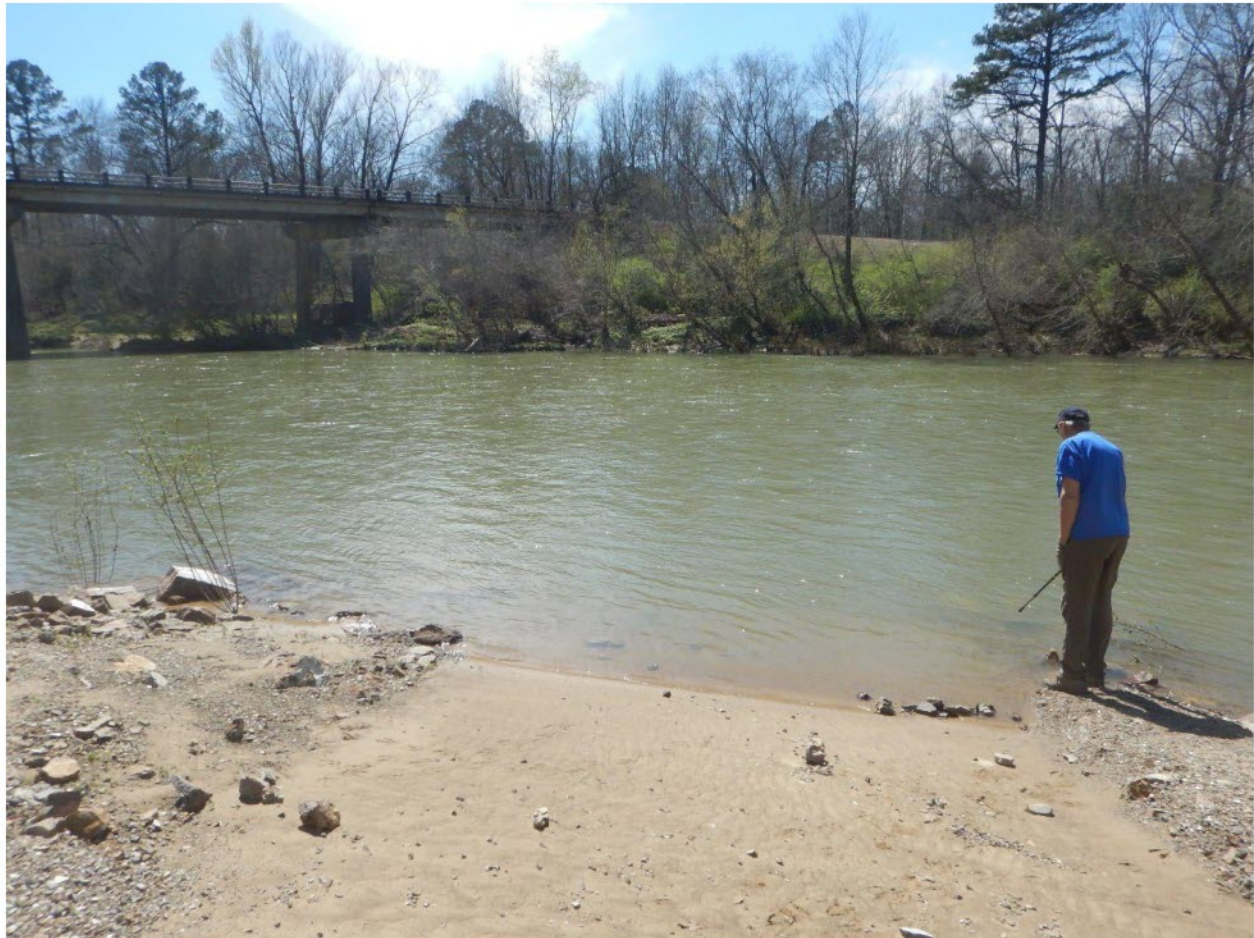
Photo No. 3

| Photo File Name | Date and Time of Photo | Photographer | Description |
|---|---|---|---|
| DSCN6387 | 03/27/2024, 1:57 PM | Chelsey Sherwood | Showing restoration area along boat ramp. Picture taken facing west. |

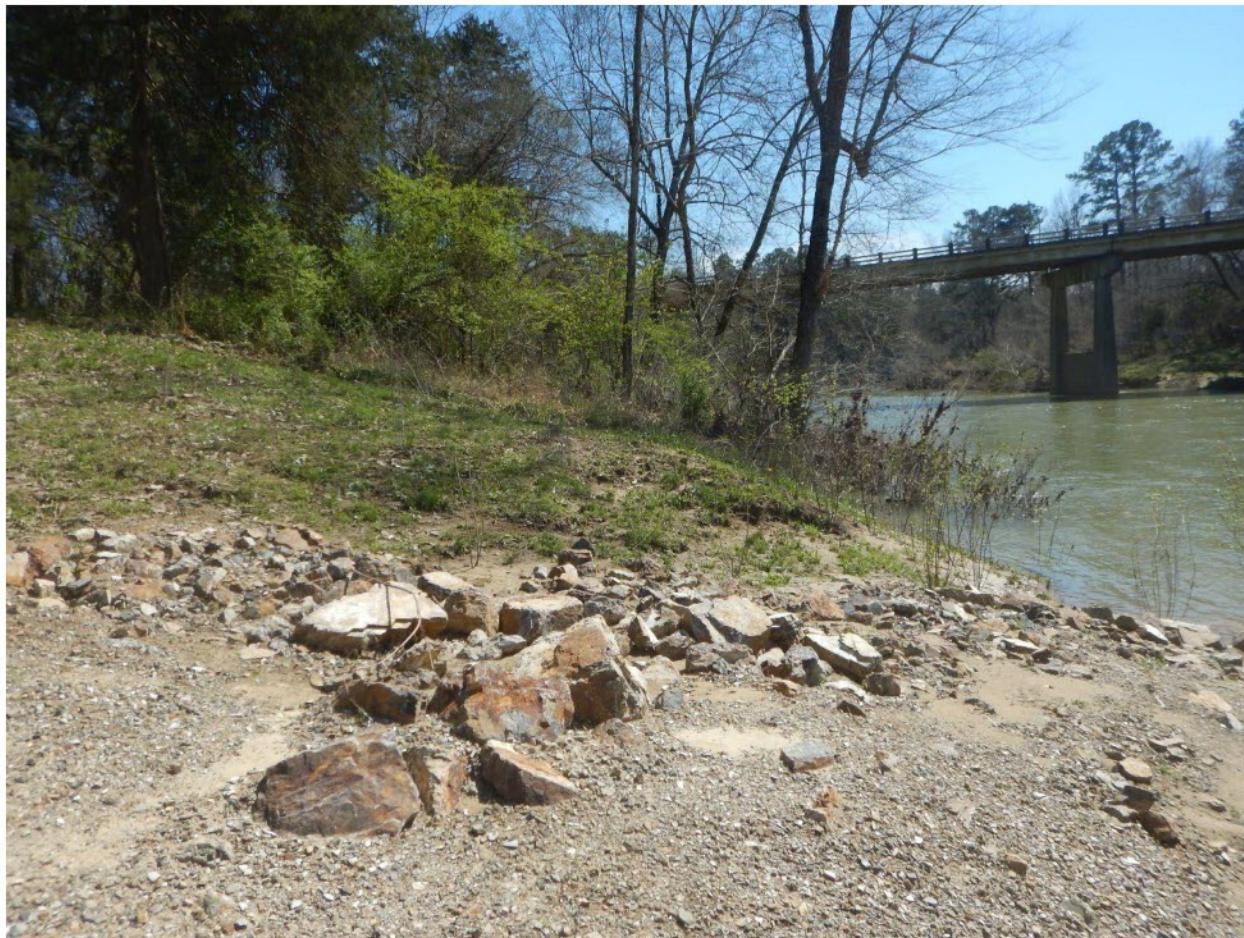
Photo No. 4

| Photo File Name | Date and Time of Photo | Photographer | Description |
|---|---|---|---|
| DSCN6388 | 03/27/2024, 1:57 PM | Chelsey Sherwood | Showing restoration area along boat ramp and stream bank. Note shrubs planted and mixed rock. Picture taken facing south. |

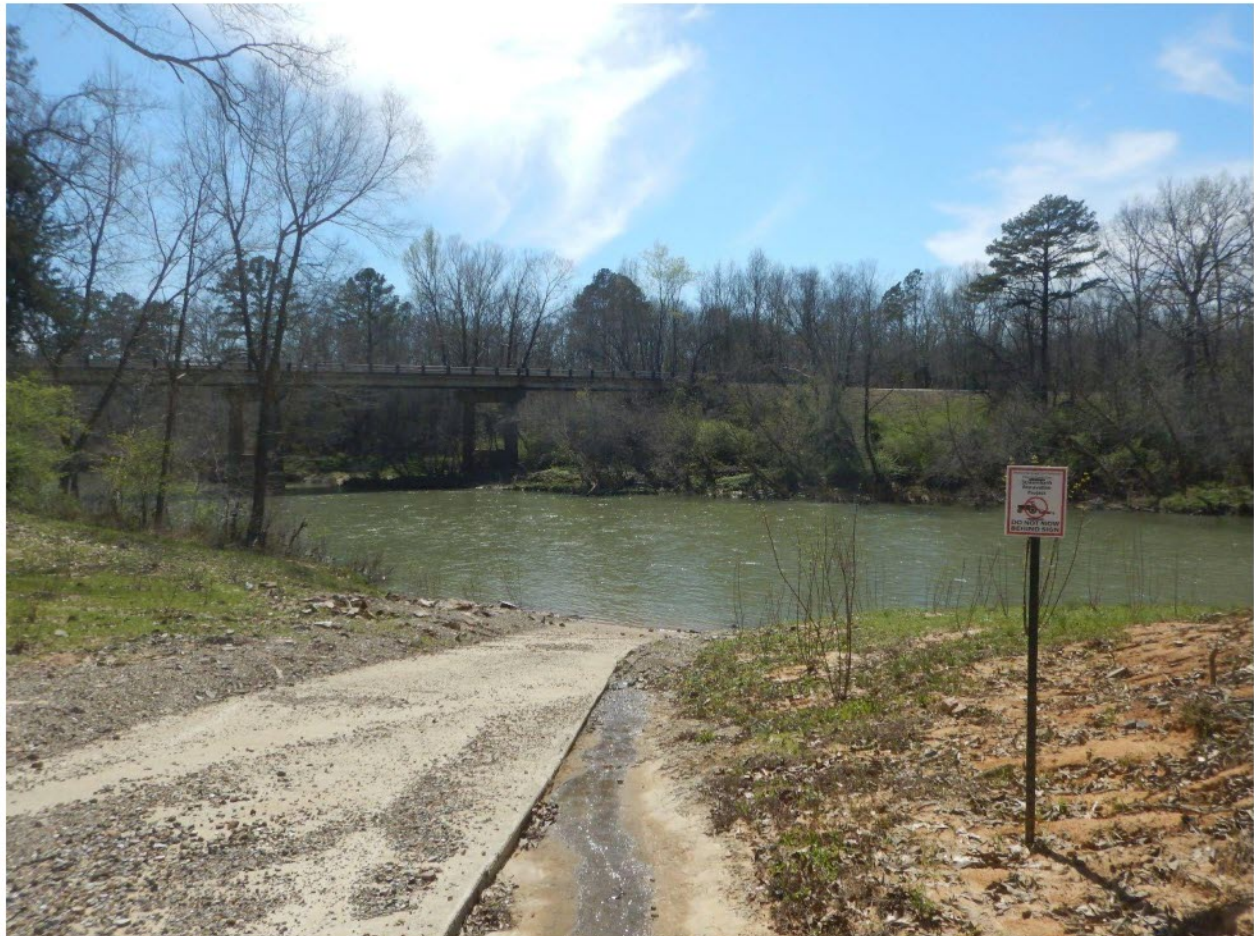
Photo No. 5

| Photo File Name | Date and Time of Photo | Photographer | Description |
|---|---|---|---|
| DSCN6389 | 03/27/2024, 2:02 PM | Chelsey Sherwood | Showing restoration area along boat ramp and stream bank. Picture taken facing west. |
