## **RCRA Inspection Report**

Honeywell International  
1 Cliff Garrett Drive  
Oxford, Alabama 36203  
Calhoun County

EPA ID No.: ALR000043340

August 19, 2020, at 9:00 a.m.

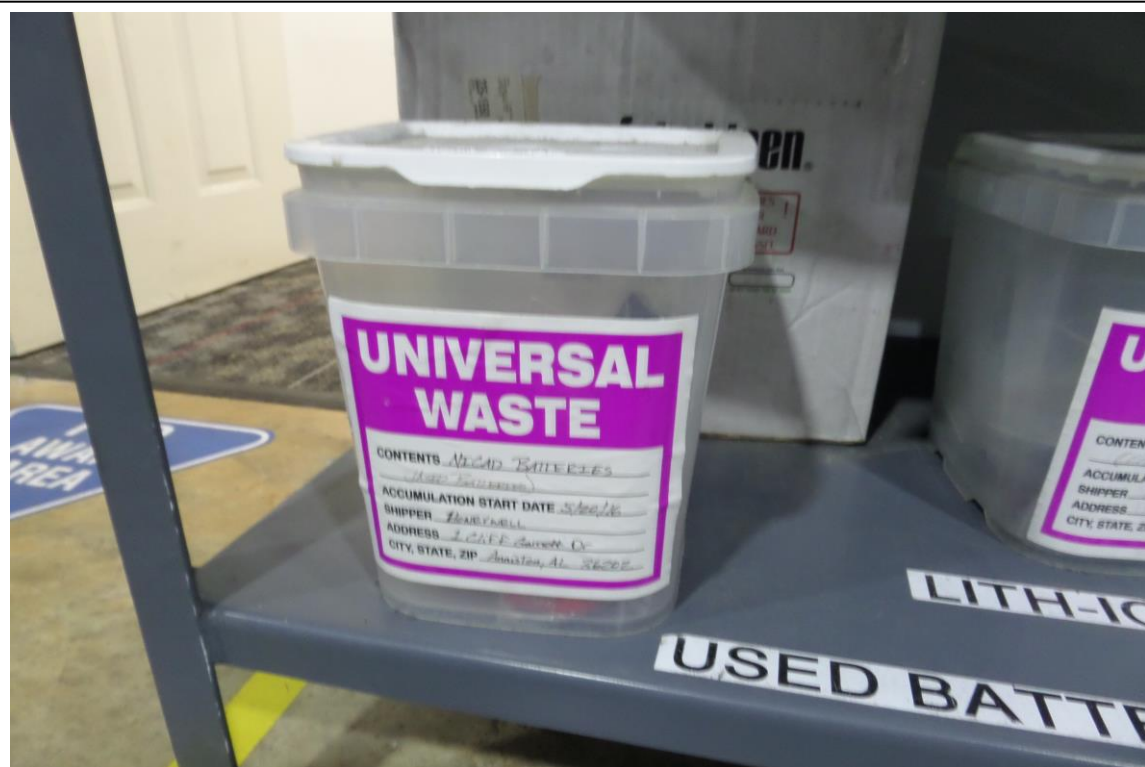
This area is in Honeywell's main production floor. Inspectors observed three 1.5-gallon containers accumulating waste lithium, alkaline, and NiCad batteries. The containers were approximately one-quarter to one-half full, closed, in good condition, labeled with the words universal waste, and marked with the dates January 26, 2016, May 19, 2016, or May 20, 2016 (photographs 1 and 2). Mr. Schmit explained that the operator of this area had not changed the date on the containers and that universal waste is shipped about every three months. A review of the facility's universal waste records found universal waste is shipped approximately every three to four months. On August 19, 2020, Honeywell provided several pictures in an email to EPA showing the universal waste batteries were packaged for shipping to a destination facility and the three 1.5-gallon containers were marked with new universal waste labels and marked with the date August 19, 2020.

Honeywell International. Turbine Area. Inspectors observed three 1.5-gallon containers accumulating waste lithium, alkaline, and NiCad batteries. The containers were approximately one-quarter to one-half full, closed, in good condition, labeled with the words universal waste, and marked with the date January 26, 2016, May 19, 2016, or May 20, 2016. The facility shipped the universal waste to an off-site destination facility. Photograph 2 taken at 11:40 a.m.
