## Region 6 - Enforcement & Compliance Assurance Division

### INSPECTION REPORT

| Company Name: | LBOC, LLC | |
| Facility Name: | Baker Sand Unit Tank Battery | |

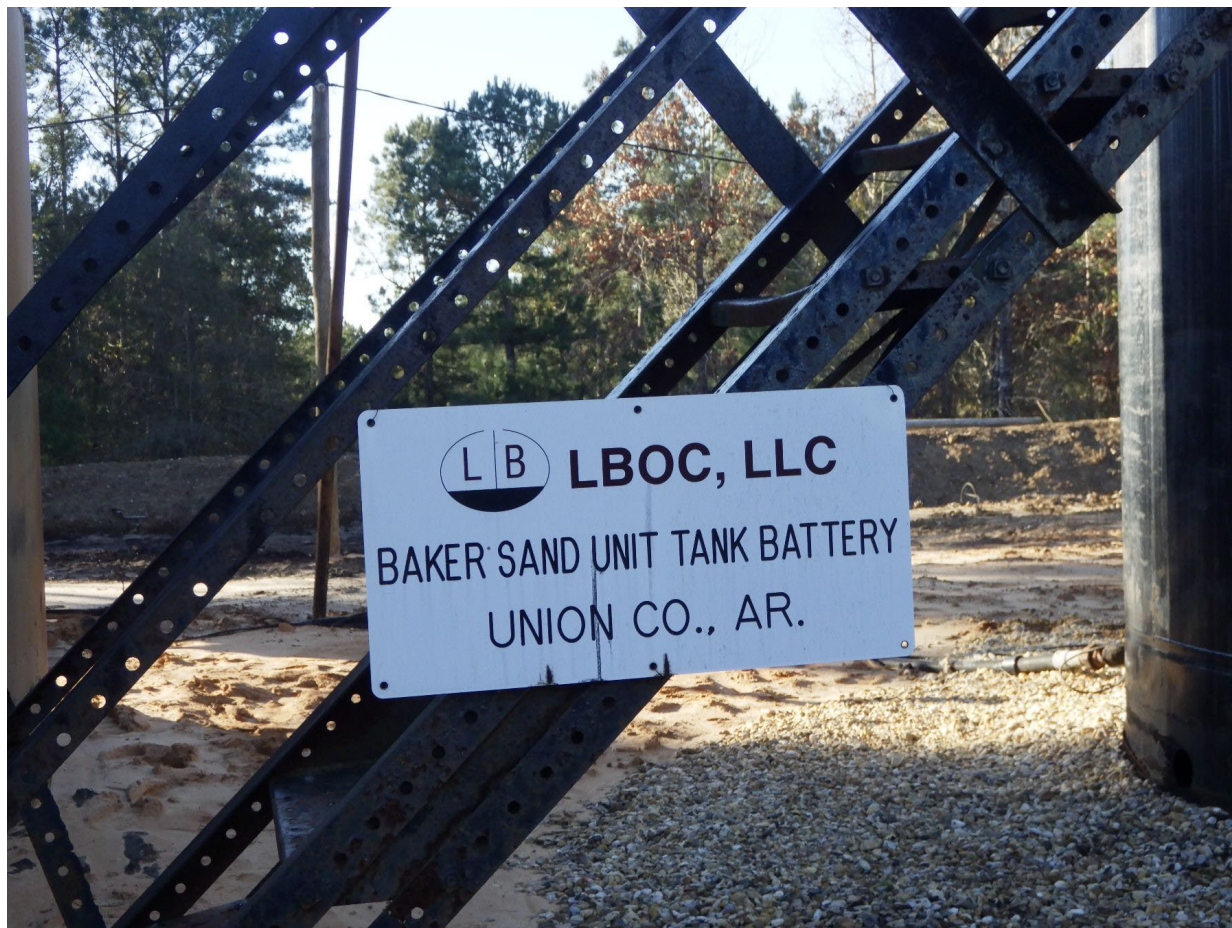
Photo No. 1

| Description: | Looking SSW, this photo shows the signage at the Baker Sand Unit Tank Battery ("facility"). | | |

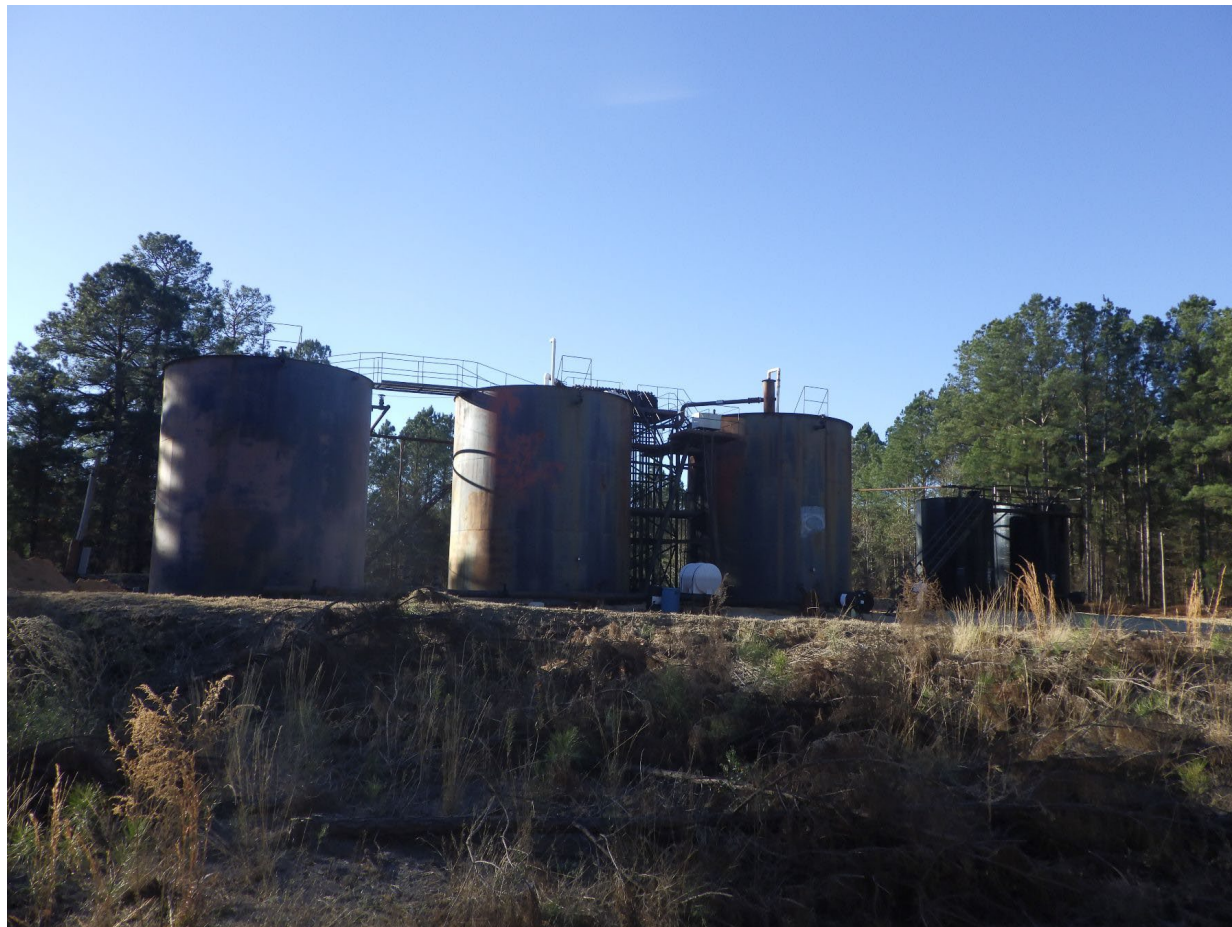
Photo No. 2

| Description: | Looking SSW, this photo shows an overview of the facility. | | |

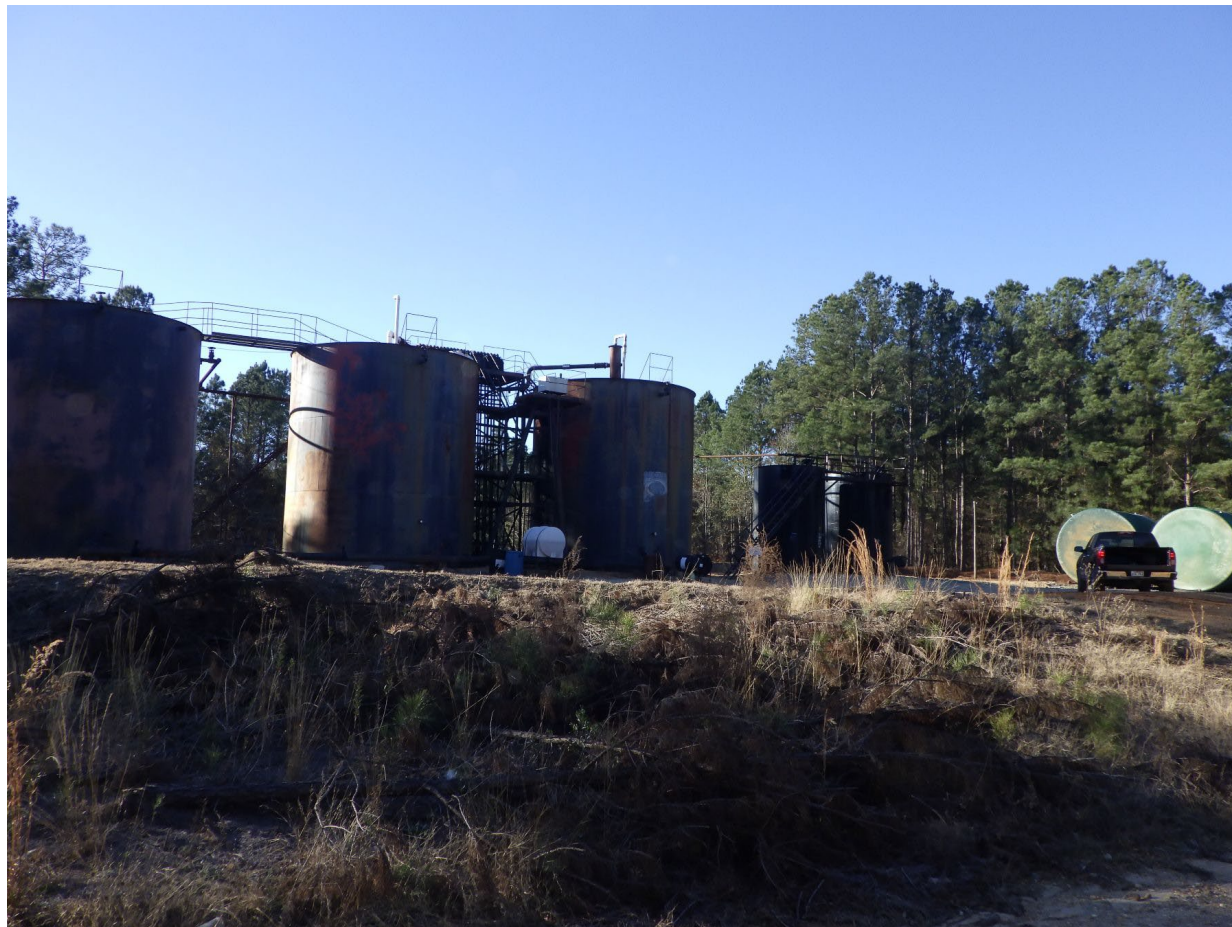
Photo No. 3

| Description: | Looking SSW, this photo shows an additional overview of the facility. | | |

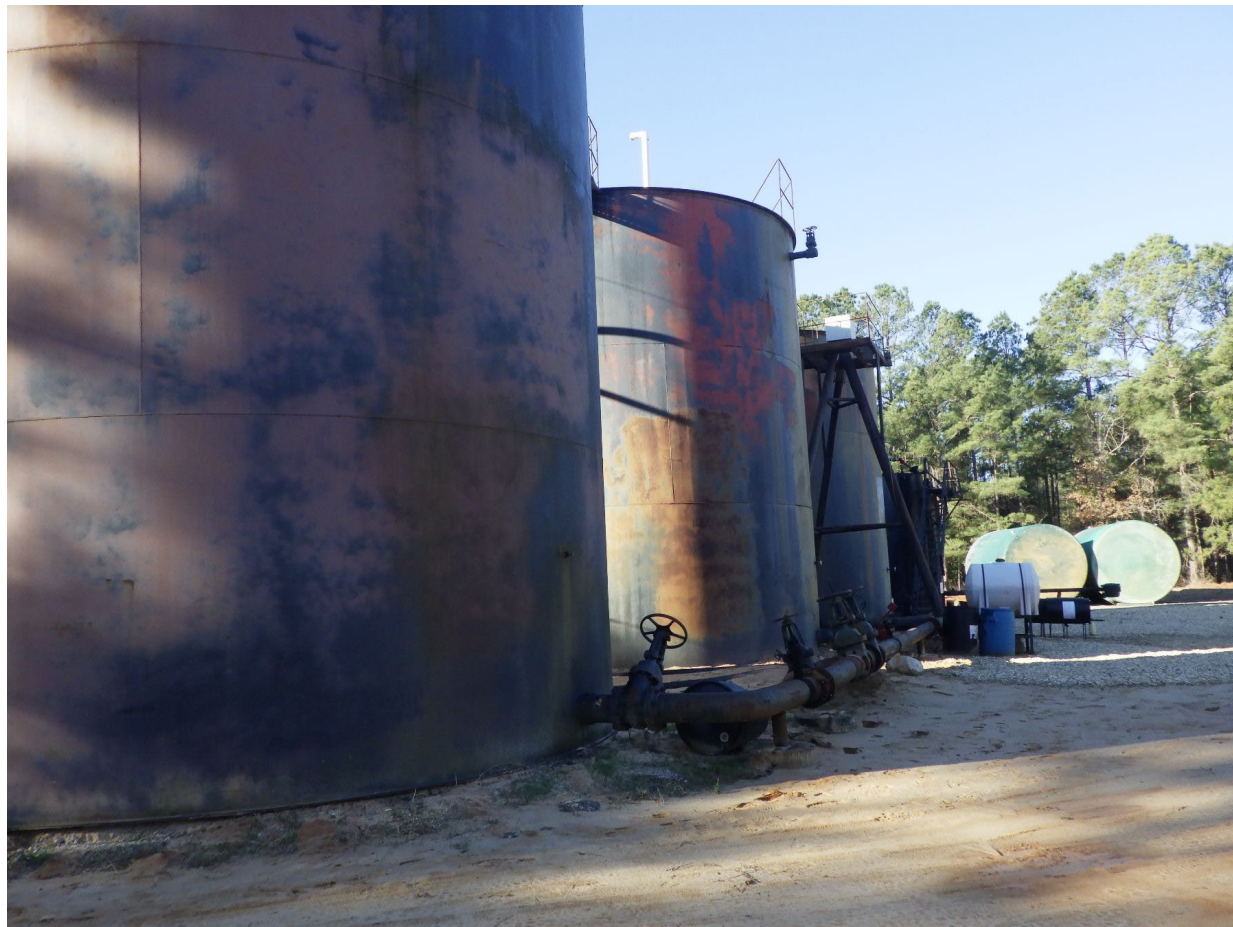
Photo No. 4

| Description: | Looking SSW, this photo shows the front view of the storage tanks for the battery. | | |

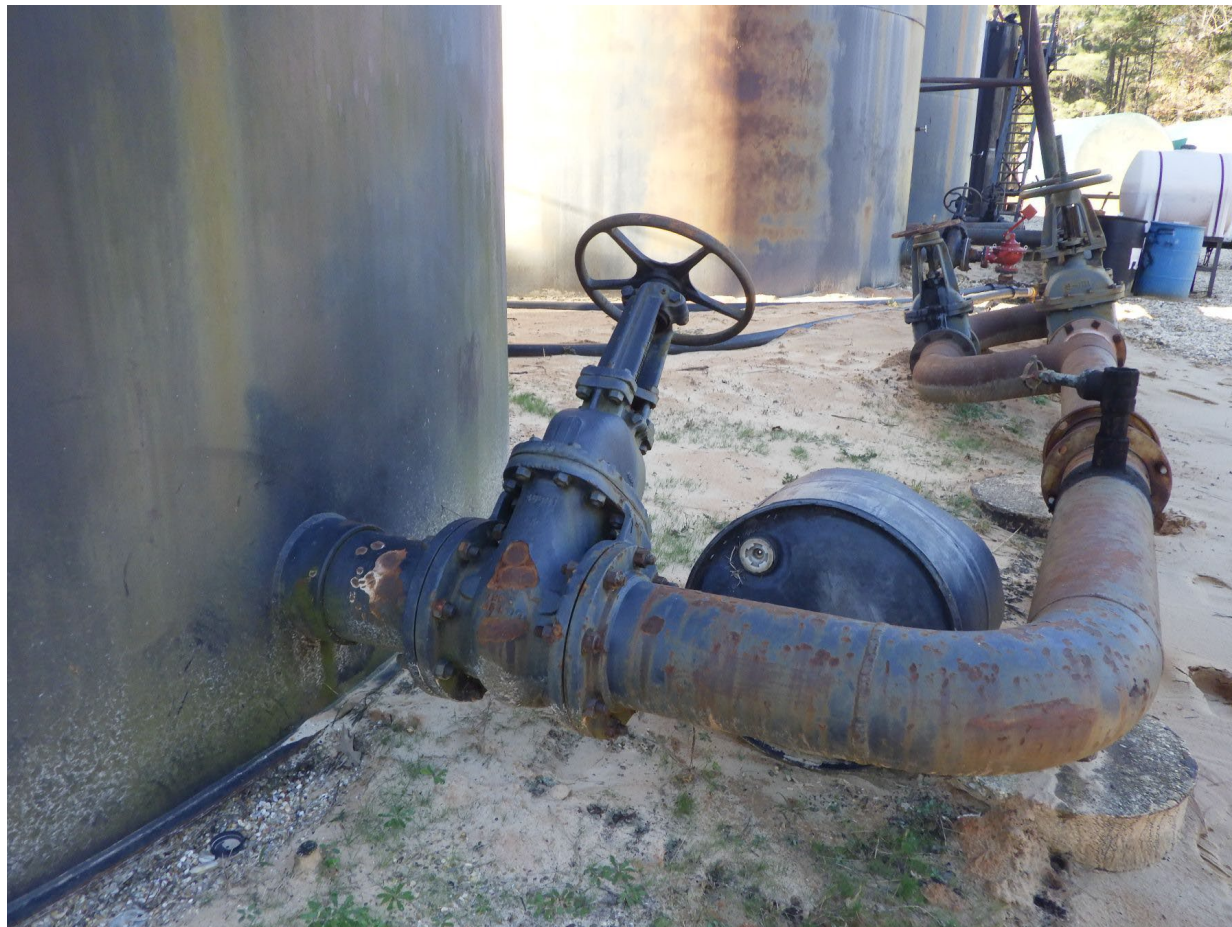
Photo No. 5

I observed a valve at one of the tanks that had been repaired, see Photo No. 5.

| Description: | Looking SW, this photo shows a repaired valve at one of the storage tanks. | | |

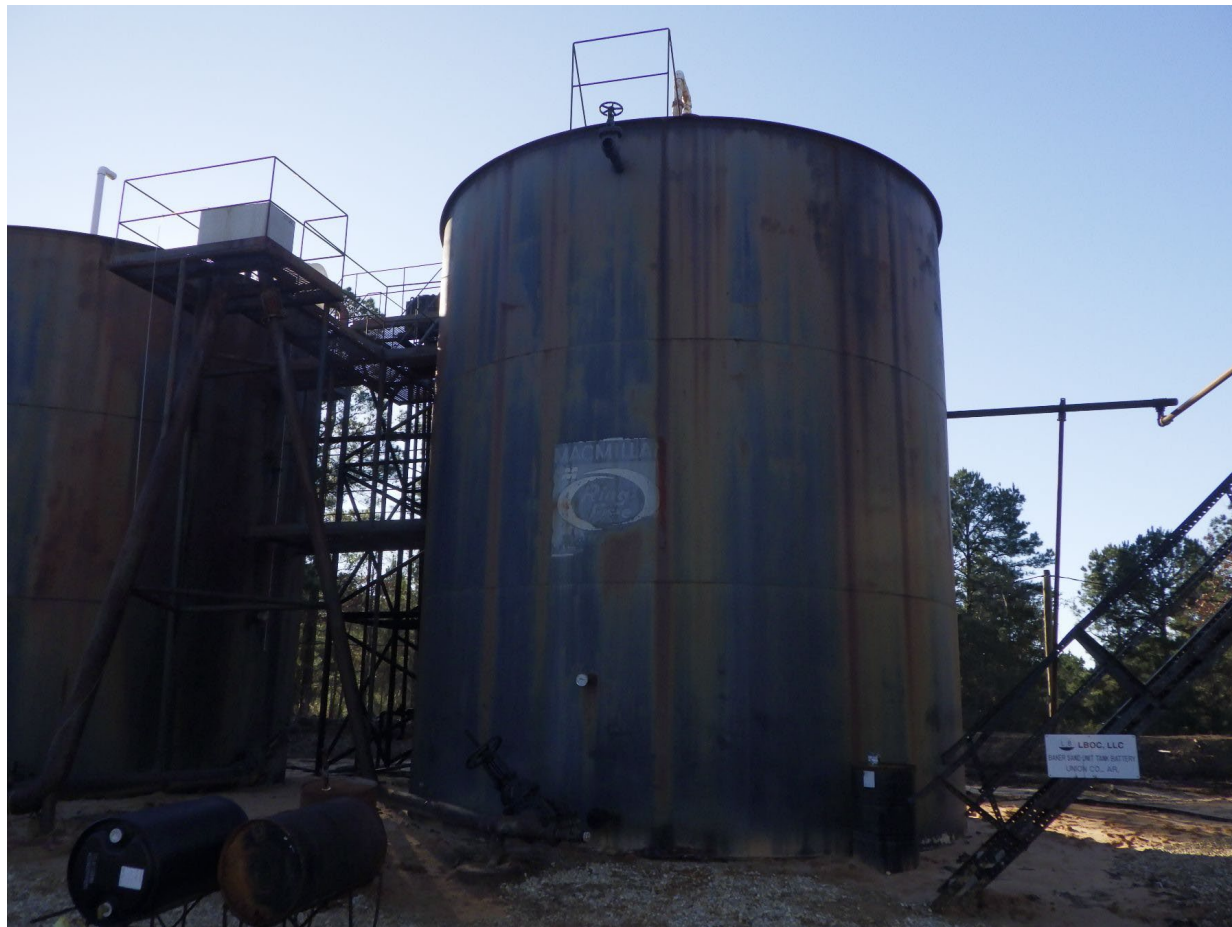
Photo No. 6

I observed the gun barrel tank with exterior corrosion to the sides and bottom of the tank, see Photos No. 6 and No. 7.

- Exterior and bottom corrosion of the gun barrel tank, 40 CFR §112.9(c)(1) (Photos No. 6 and No. 7), and
- Overhead pipes without support/bracing, 40 CFR §112.9(d)(1) (Photo No. 9).

| Description: | Looking S, this photo shows a gun barrel/separator with exterior corrosion. | | |

Inspector will conduct follow-up phone calls with the company representative(s) over the coming weeks and months to ensure areas of concern are properly addressed. SEE Inspector Tom McKay will address SPCC rule concerns.

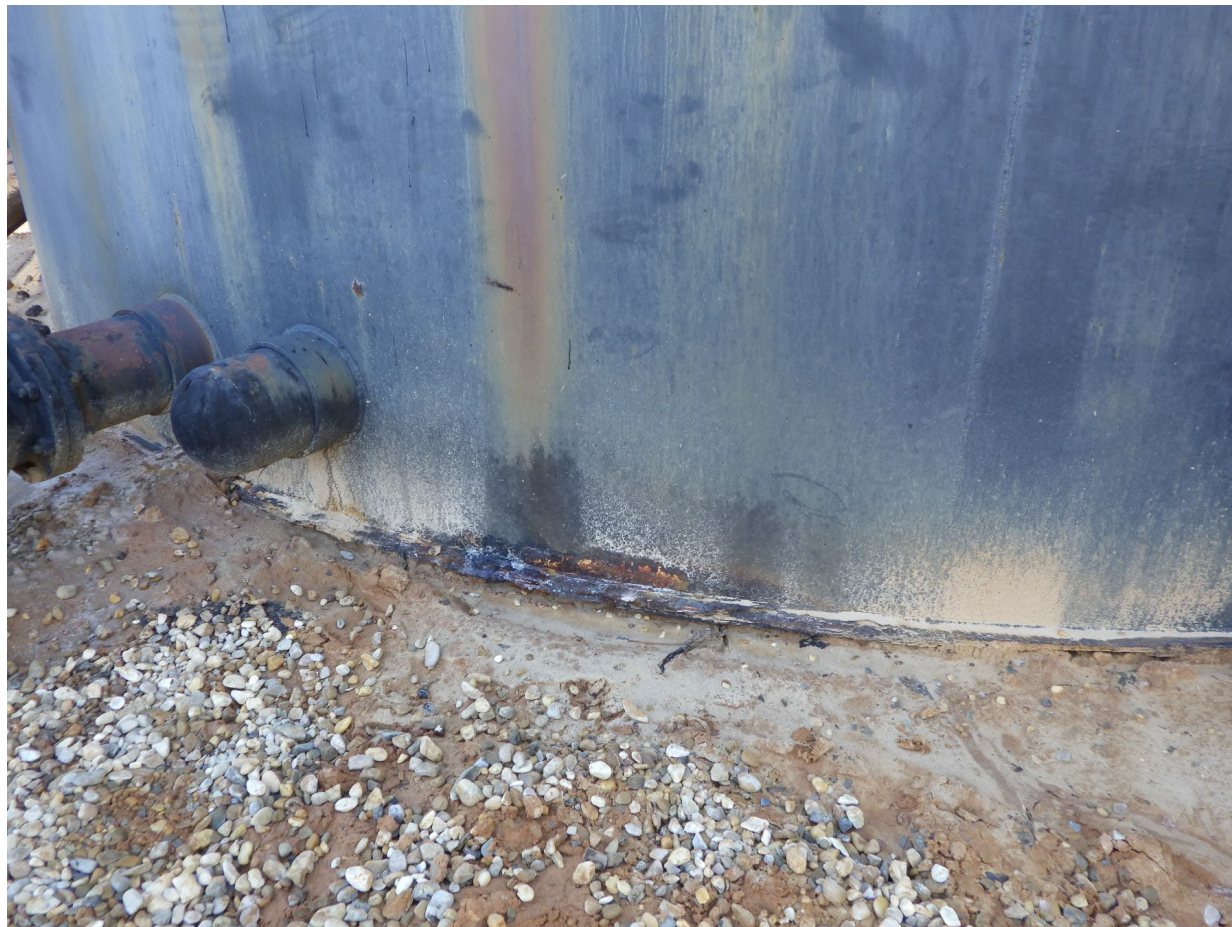
Photo No. 7

| Description: | Looking S, this photo shows corrosion at the bottom of the gun barrel/separator for the tank in Photo No. 6. | | |

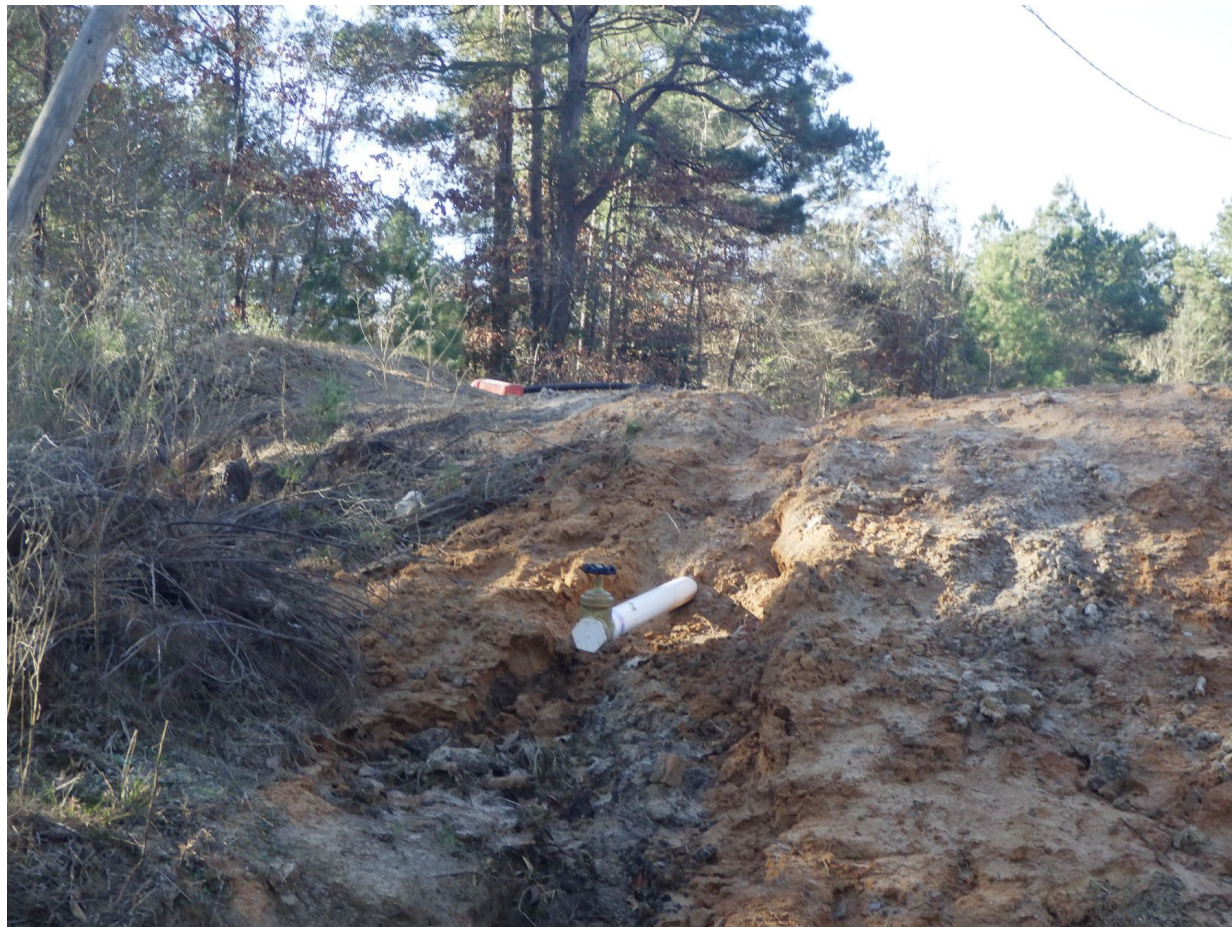
Photo No. 8

I observed the drainpipe for secondary containment that had been replaced since the 12/03/2025 inspection, see Photo No. 8.

| Description: | Looking SSW, this photo shows the repaired drainpipe for the containment berm with valve/cap. | | |

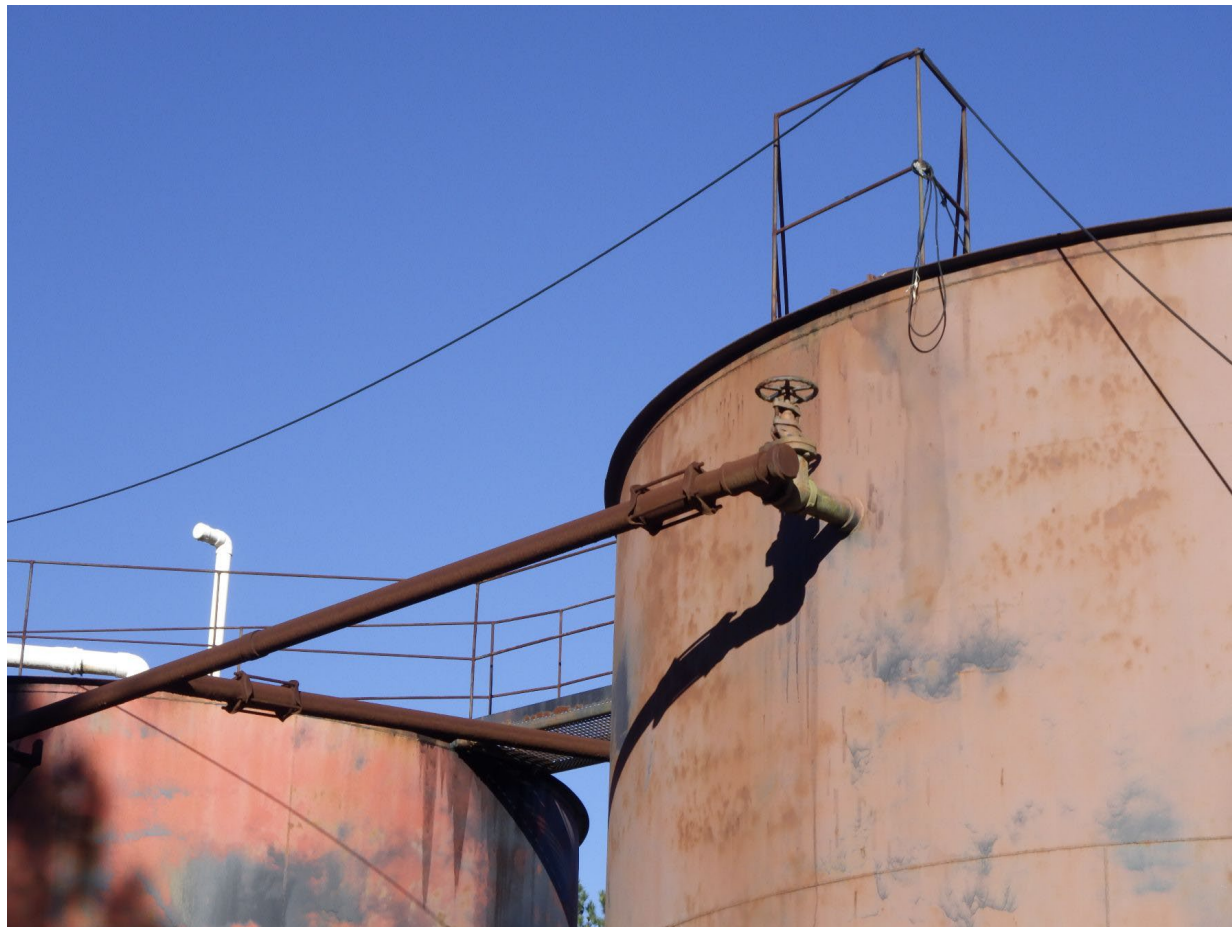
Photo No. 9

I observed overhead piping that did not have support/bracing, see Photo No. 9.

| Description: | Looking SW, this photo shows overhead piping without support/bracing. | | |

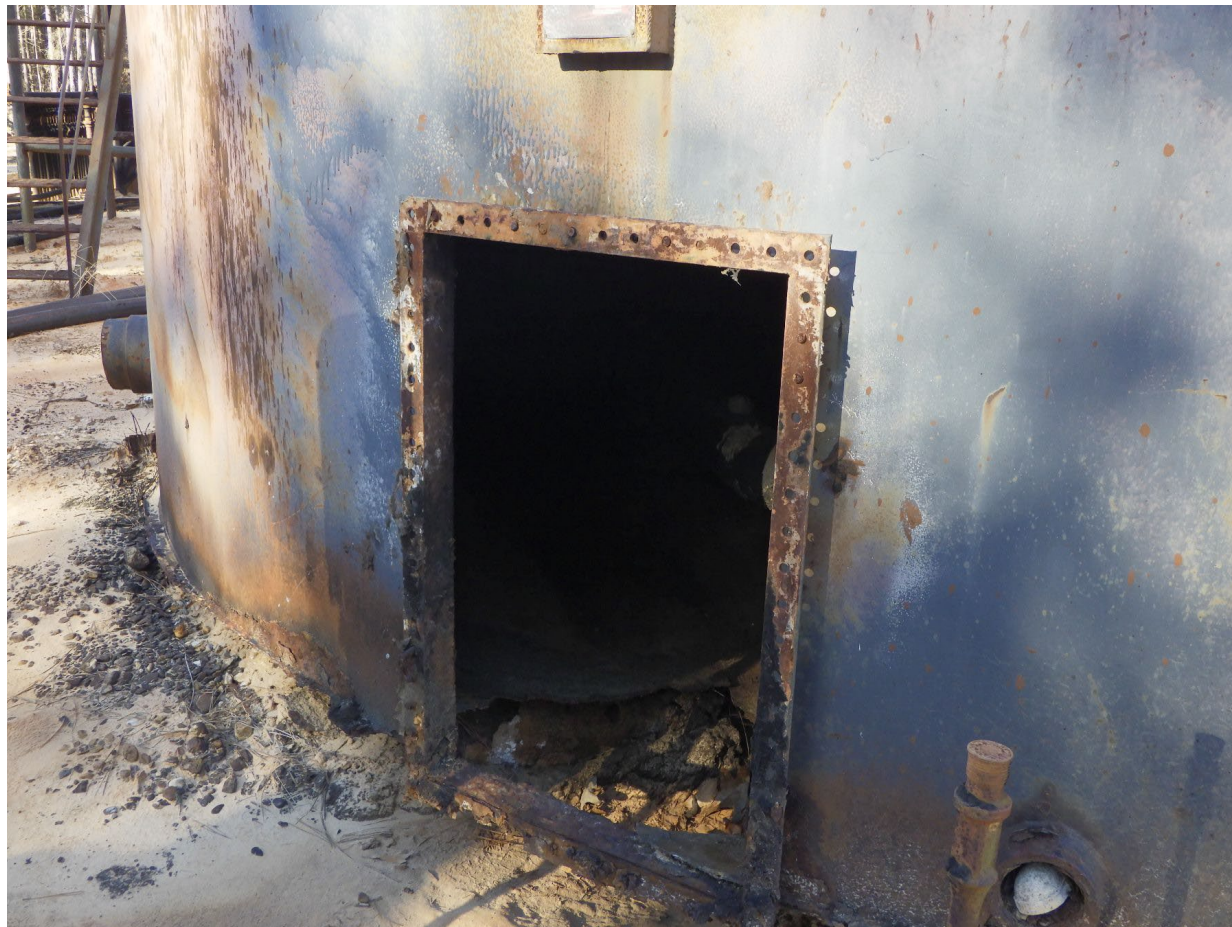
Photo No. 10

I observed a tank plated (i.e. with the manway removed) in preparation for permanent closure, see Photo No. 10.

| Description: | Looking SSW, this photo shows a tank that LBOC, LLC plated (i.e., removed the manway) in preparation for permanent closure. | | |
