## RCRA Inspection Report

Delta Flight Products, LLC ATL Operations (DFP)  
3980 Tradeport Boulevard  
Building 1200  
Atlanta, Georgia 30354

June 22, 2021

**COMPLIANCE EVALUATION INSPECTION**

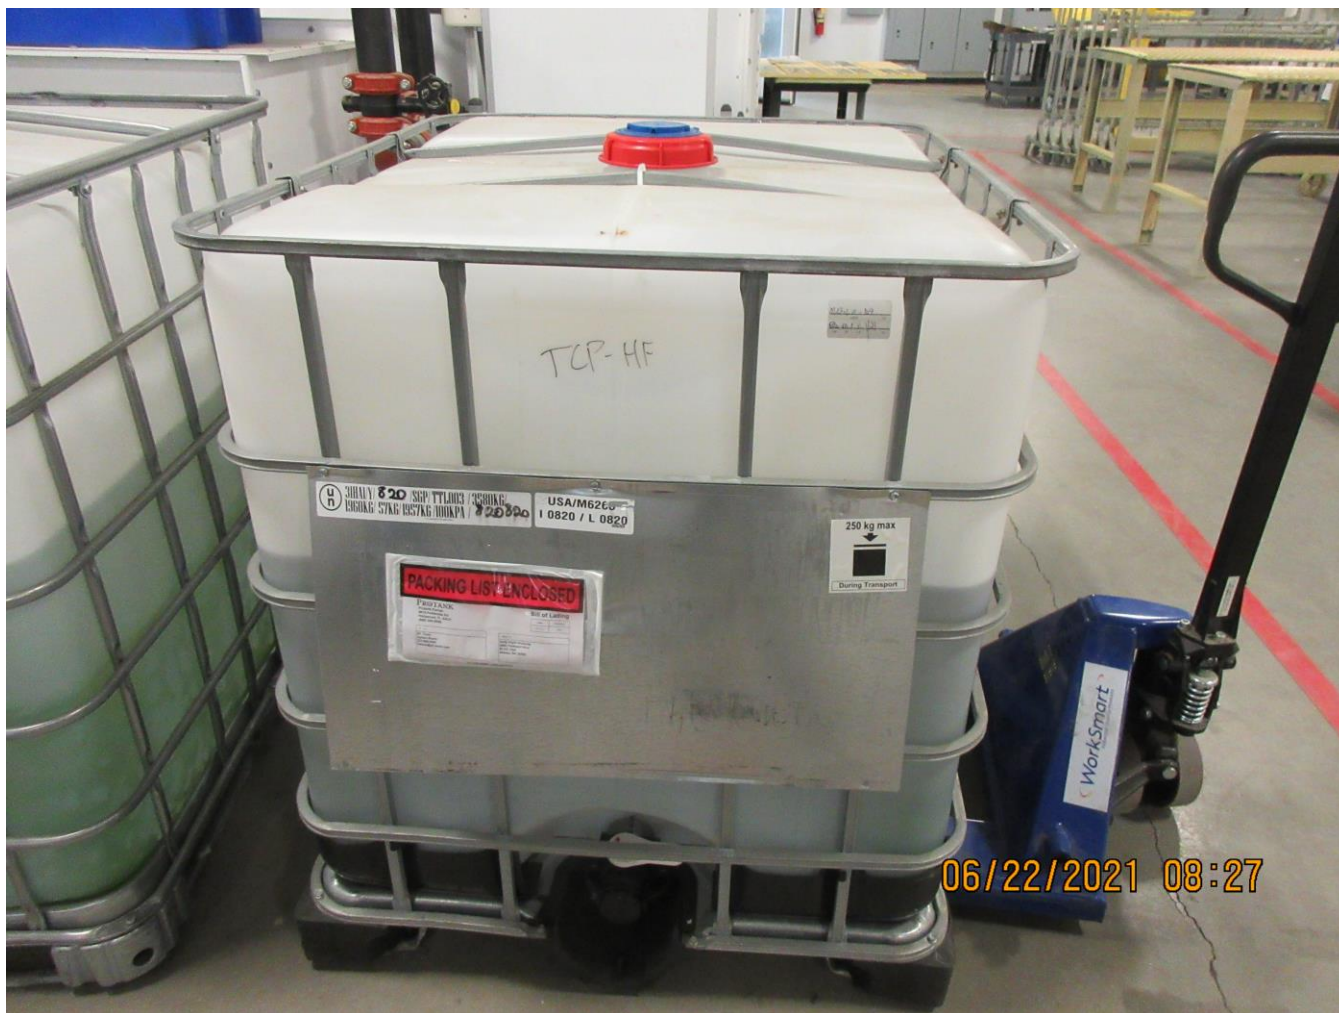
At the time of the inspection, the two 275-gallon totes containing hazardous wastes from the baths discussed above were observed in an area close to the paint booth used to perform the metal finishing operations. One of the totes contained 23 inches of spent chemical conversion coating solution (Photos 1 & 2). One tote contained 5 inches of spent sodium hydroxide passivation solution (less than 55 gallons) (Photos 2 and 3). Neither of the two totes were labeled with the words "Hazardous Waste" or an indication of the hazard for either solution. The tote containing 23" inches of spent chemical conversion coating solution was not marked with an accumulation start date. A third tote containing a nonhazardous cleaning solution was also located in this area between the other two totes (Photos 1, 2 and 3). At the time of the inspection facility personnel stated that they thought the containers did not need to be labeled or dated until they were full.

Photo 1 – Tote of spent chemical conversion coating solution.

**Pursuant to Ga. Comp. R. and Regs. 391-3-11-.08(1) [40 C.F.R. § 262.17], a LQG may accumulate hazardous waste on-site for 90 days or less without a permit or without having interim status, as required by Section 12-8-66 of the GHWMA, Ga. Code Ann. § 12-8-66 [Section 3005 of RCRA, 42 U.S.C. § 6925], provided that the generator complies with the conditions listed in Ga. Comp. R. and Regs. 391-3-11-.08(1) [40 C.F.R. § 262.17] (hereinafter referred to as the "LQG Permit Exemption").**

**Pursuant to Ga. Comp. R. and Regs. 391-3-11-.08(1) [40 C.F.R. § 262.17(a)(5)(i)(A)((B)(C)], which is a condition of the LQG Permit Exemption, a generator must mark or label its containers with the following: the words "Hazardous Waste"; an indication of the hazards of the contents; and the date upon which each period of accumulation begins clearly visible for inspection on each container, respectively.**

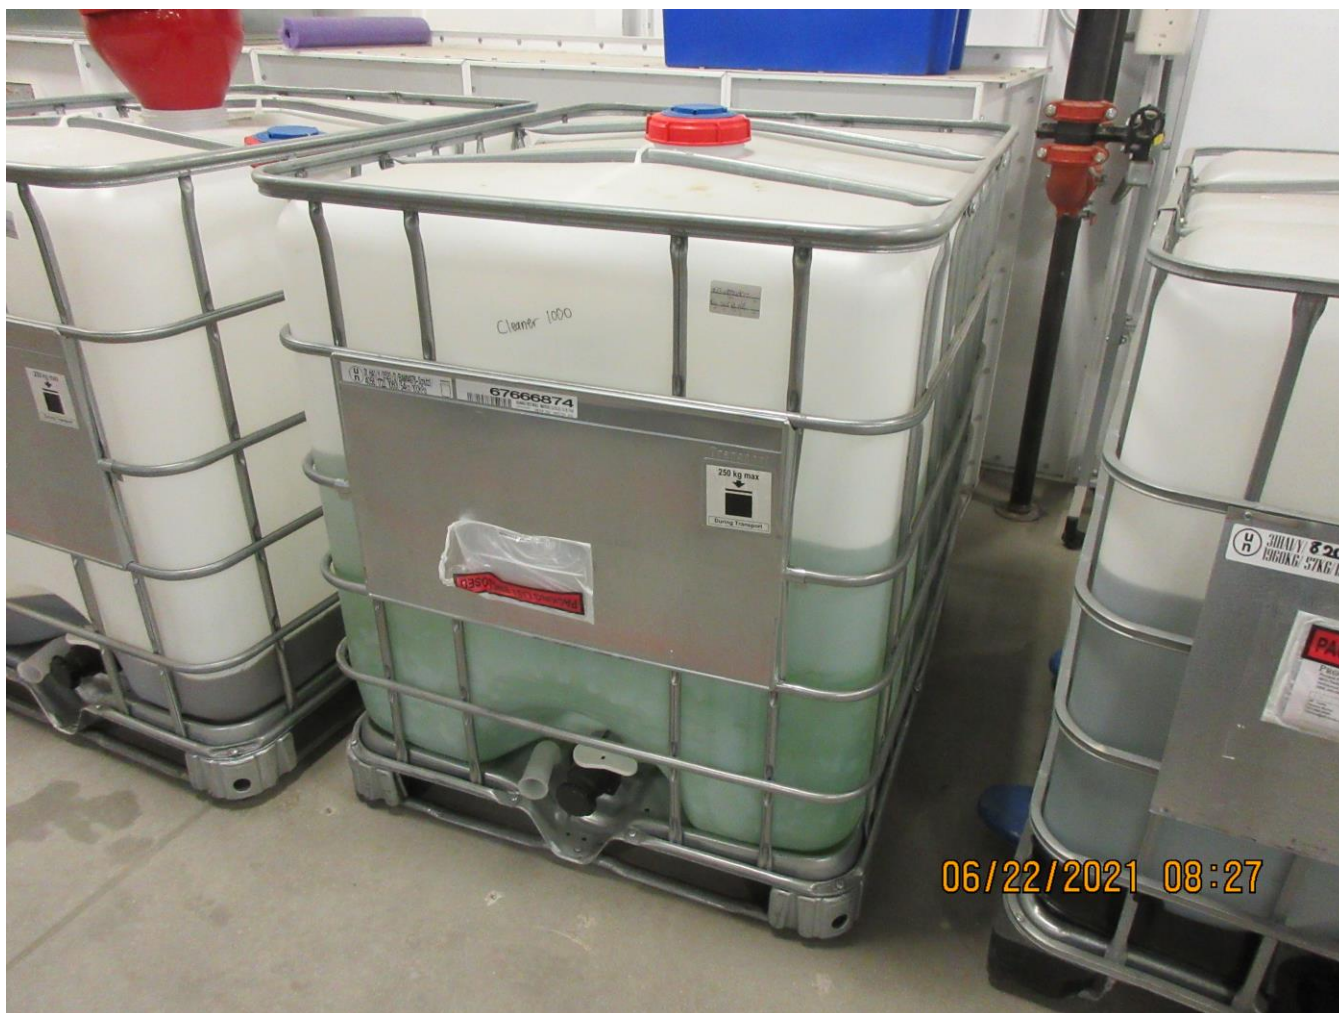
Photo 2 – Tote of spent chemical conversion coating solution (on right) and tote of nonhazardous cleaning solution (center).

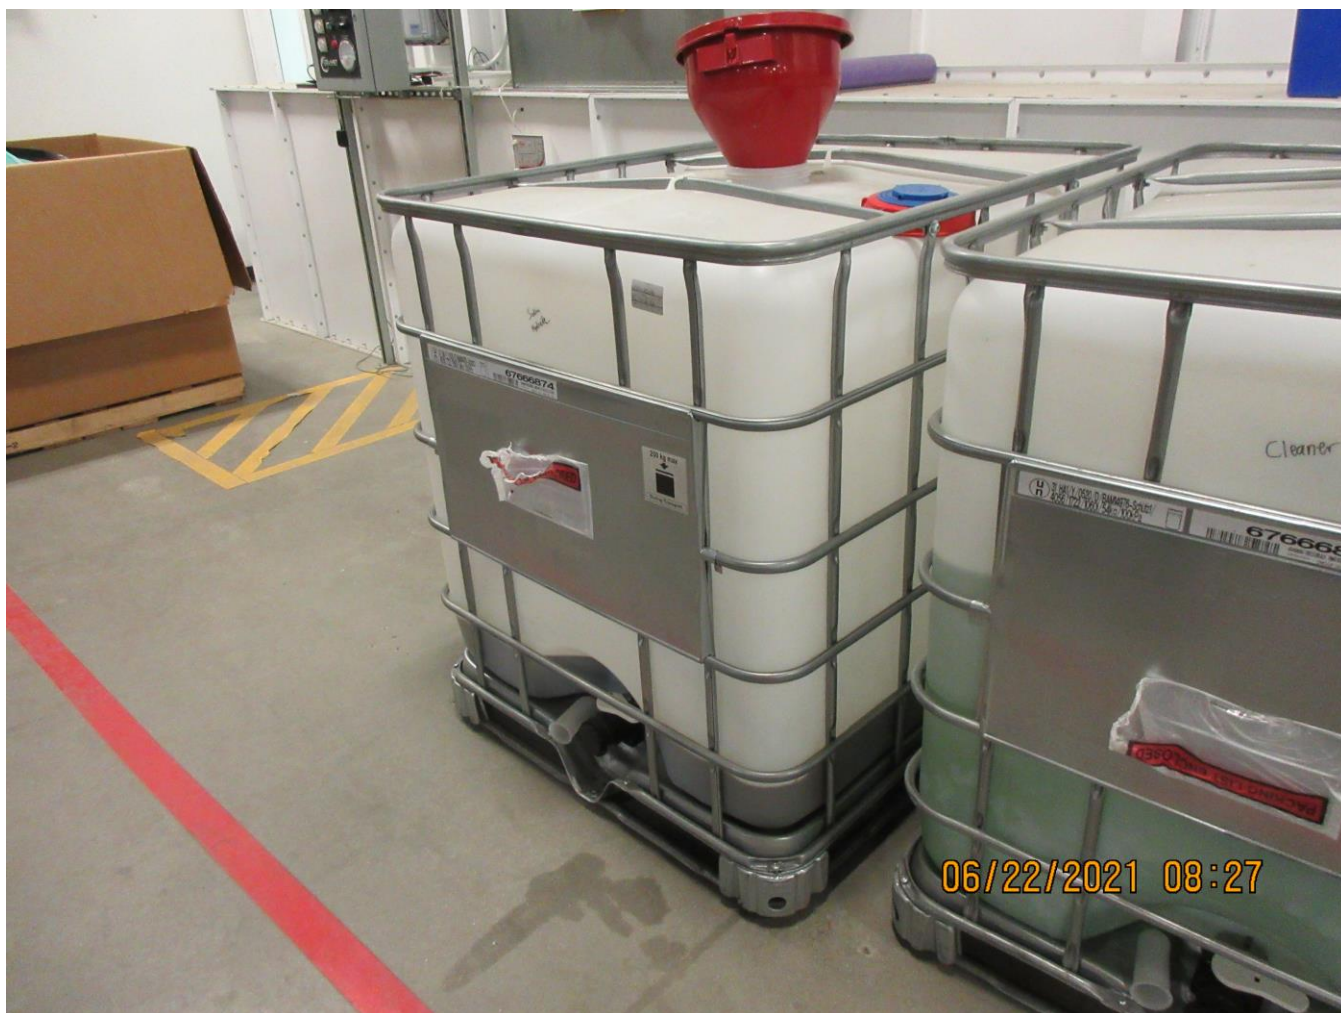
Photo 3 – Tote of spent sodium hydroxide passivation solution (on left) and tote of nonhazardous cleaning solution (on right).

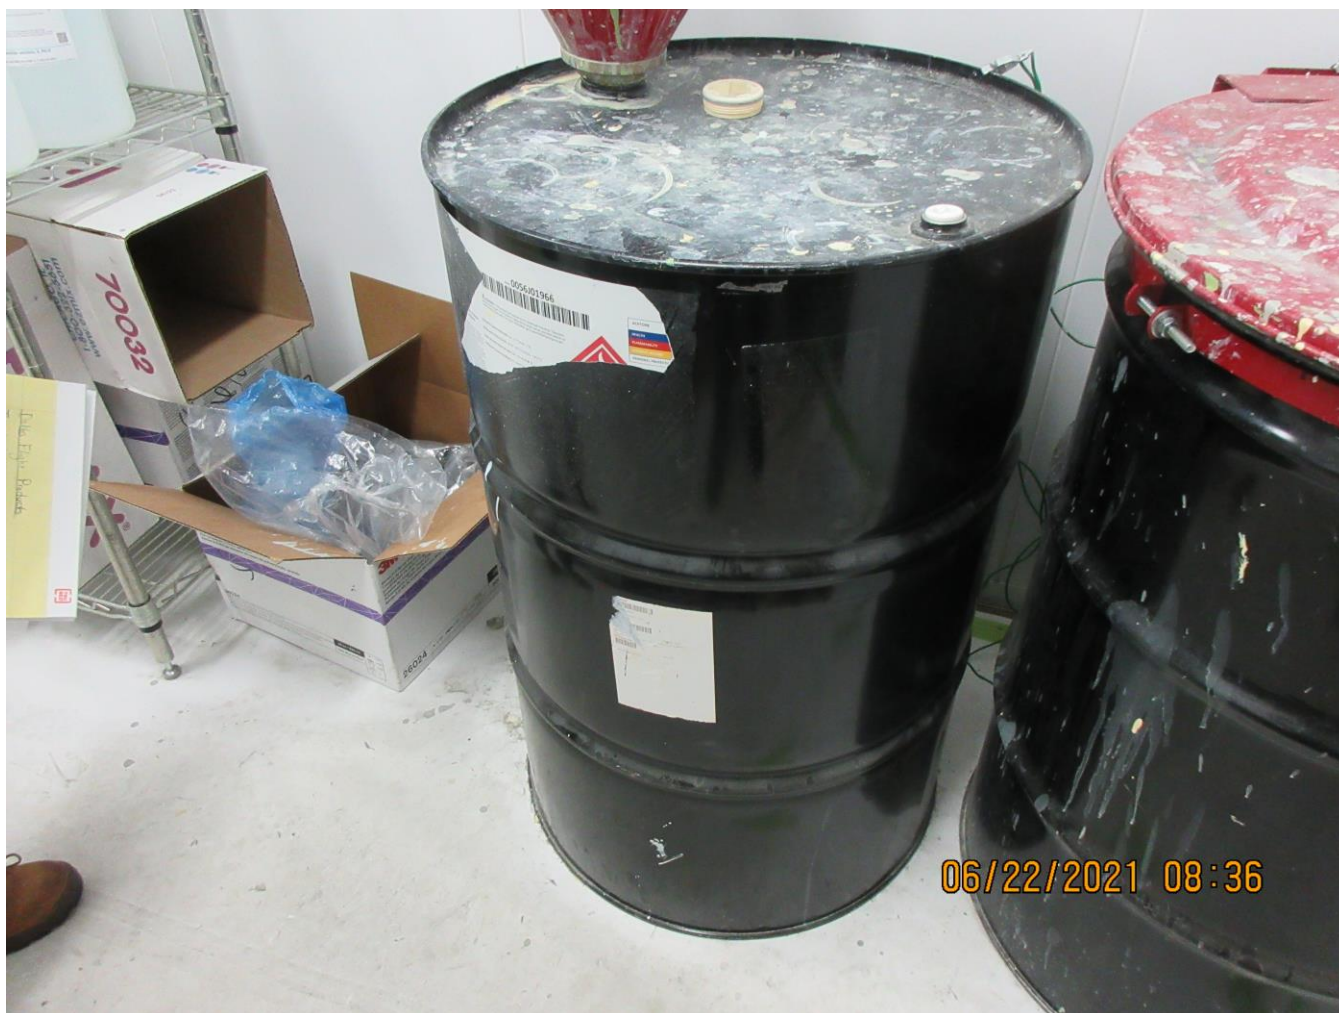
One SAA was used for the collection of paint waste containing acetone. A 55-gallon drum with a funnel screwed into the bung hole was observed in this SAA. The funnel’s lid was fully open at the time of the inspection. The container also lacked any labels at the time of the inspection (Photo 4).

Photo 4 – Container of Paint Waste in Paint Booth on the Metal Shop Side

**Pursuant to Ga. Comp. R. and Regs. 391-3-11-.08(1) [40 C.F.R. § 262.15(a)(4)], which is a condition of the SAA Permit Exemption, a generator is required to keep containers of hazardous waste closed at all times during accumulation, except when adding, removing, or consolidating waste; or when temporary venting of a container is necessary for the proper operation of equipment, or to prevent dangerous situations, such as build-up of extreme pressure.**

**Pursuant to Ga. Comp. R. and Regs. 391-3-11-.08(1) [40 C.F.R. § 262.15(a)(5)], which is a condition of the SAA Permit Exemption, a generator is required to mark or label its containers (i) with the words “Hazardous Waste” and (ii) with an indication of the hazards of the contents.**

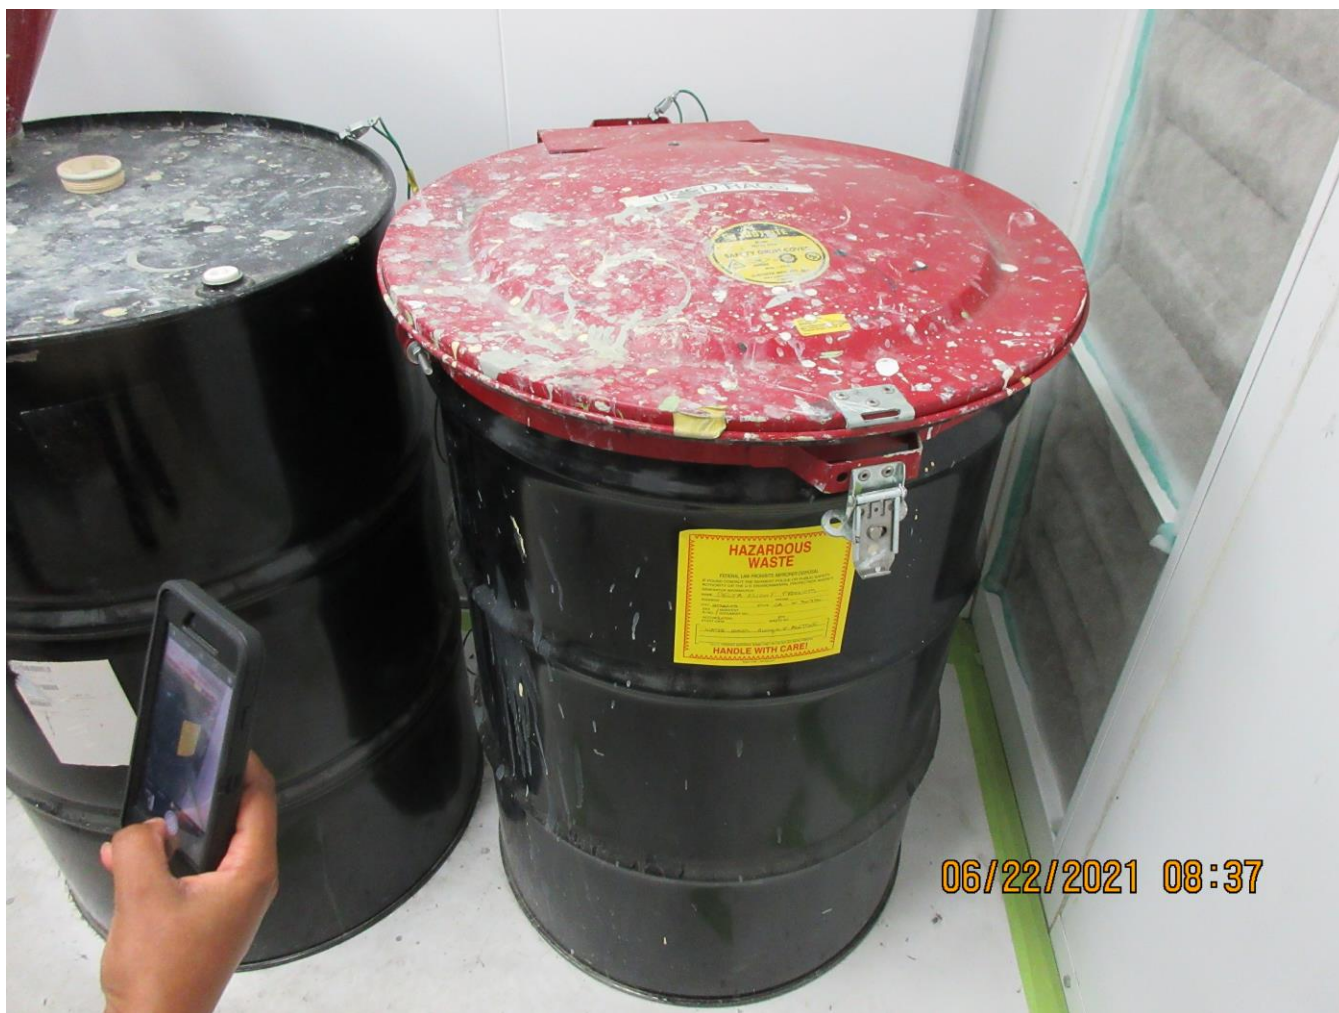
The second SAA was used for the collection of acetone and alcohol paint wastes. A 55-gallon drum with a funnel screwed into the bung hole was observed to have the funnel’s lid slightly ajar

and not latched at the time of the inspection (Photo 5). The container was labeled with the words “Hazardous Waste” and the waste code associated with the waste at the time of the inspection.

Photo 5 – Container of Paint Waste in Paint Booth on the Metal Shop Side

**Pursuant to Ga. Comp. R. and Regs. 391-3-11-.08(1) [40 C.F.R. § 262.15(a)(4)], which is a condition of the SAA Permit Exemption, a generator is required to keep containers of hazardous waste closed at all times during accumulation, except when adding, removing, or consolidating waste; or when temporary venting of a container is necessary for the proper operation of equipment, or to prevent dangerous situations, such as build-up of extreme pressure.**

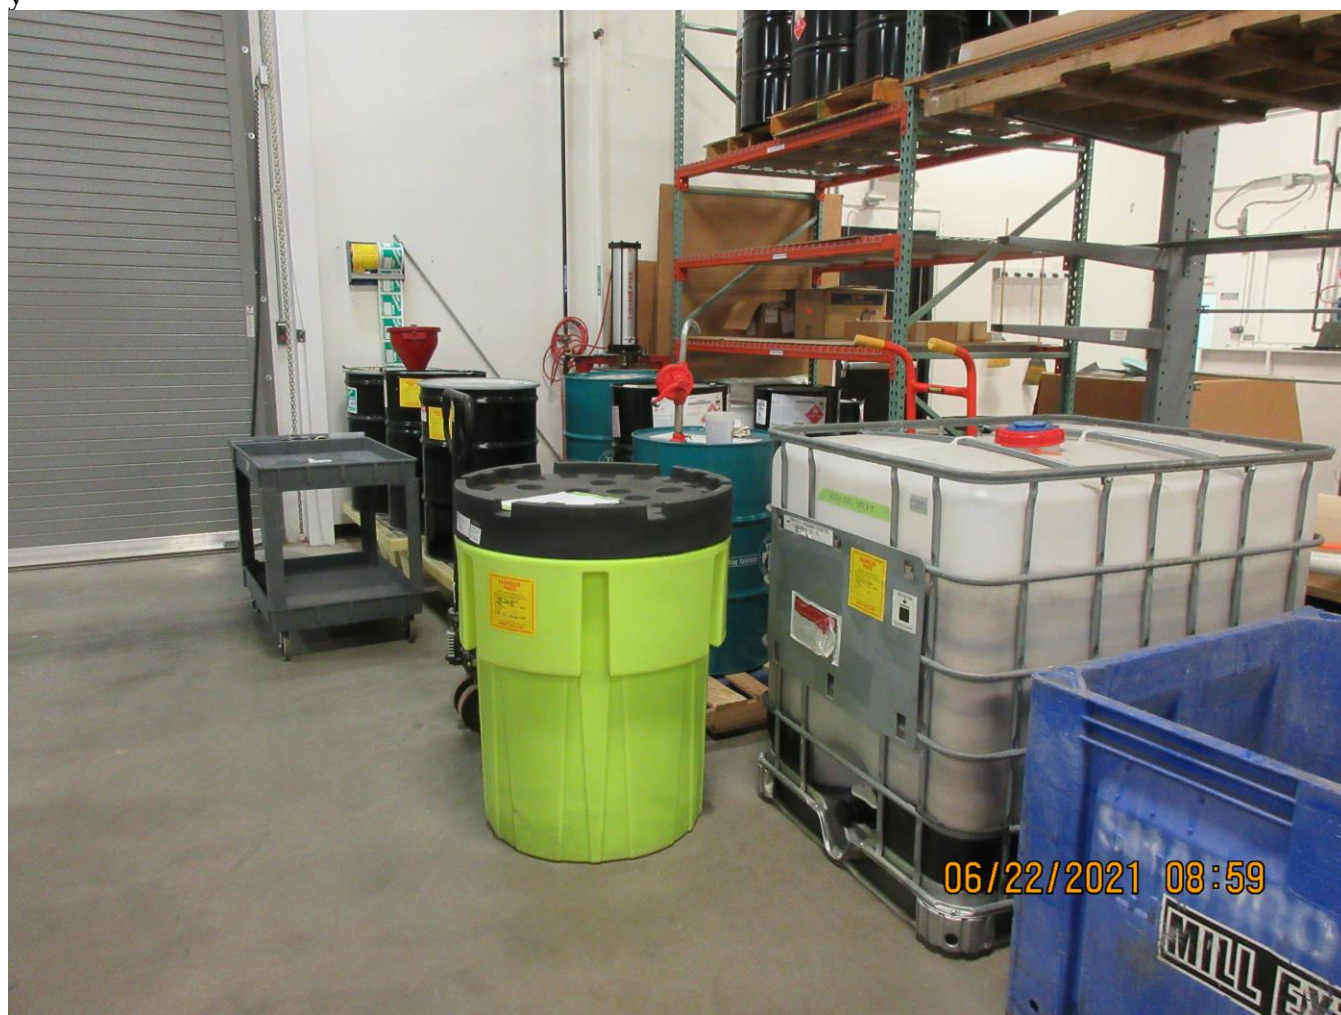
#### 90-Day Hazardous Waste Accumulation Area (Photo 6)

Photo 6 – 90-Day Hazardous Waste Accumulation Area

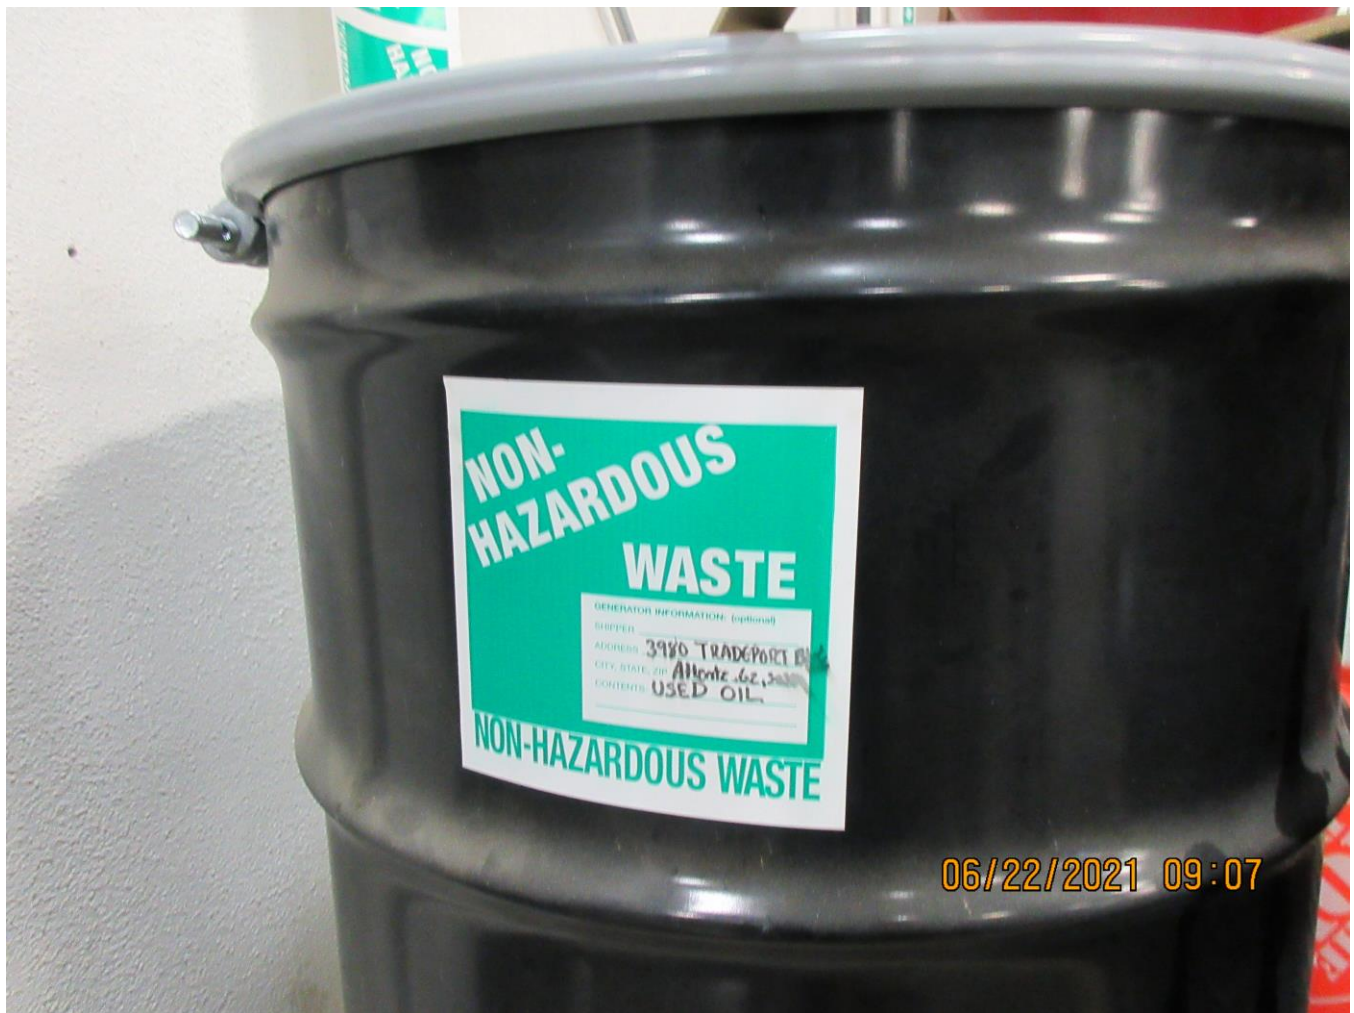
One 55-gallon drum of used oil labeled with a nonhazardous waste label with the words “Used Oil” written on the label was observed in this area (Photo 7)

Photo 7 – Photo of Used Oil drum in 90-Day Hazardous Waste Accumulation Area

**Pursuant to Ga. Comp. R. and Regs. 391-3-11-.17(1) [40 C.F.R. § 279.22(c)(1)], containers and aboveground tanks used to store used oil at generator facilities must be labeled or marked clearly with the words “Used Oil.”**

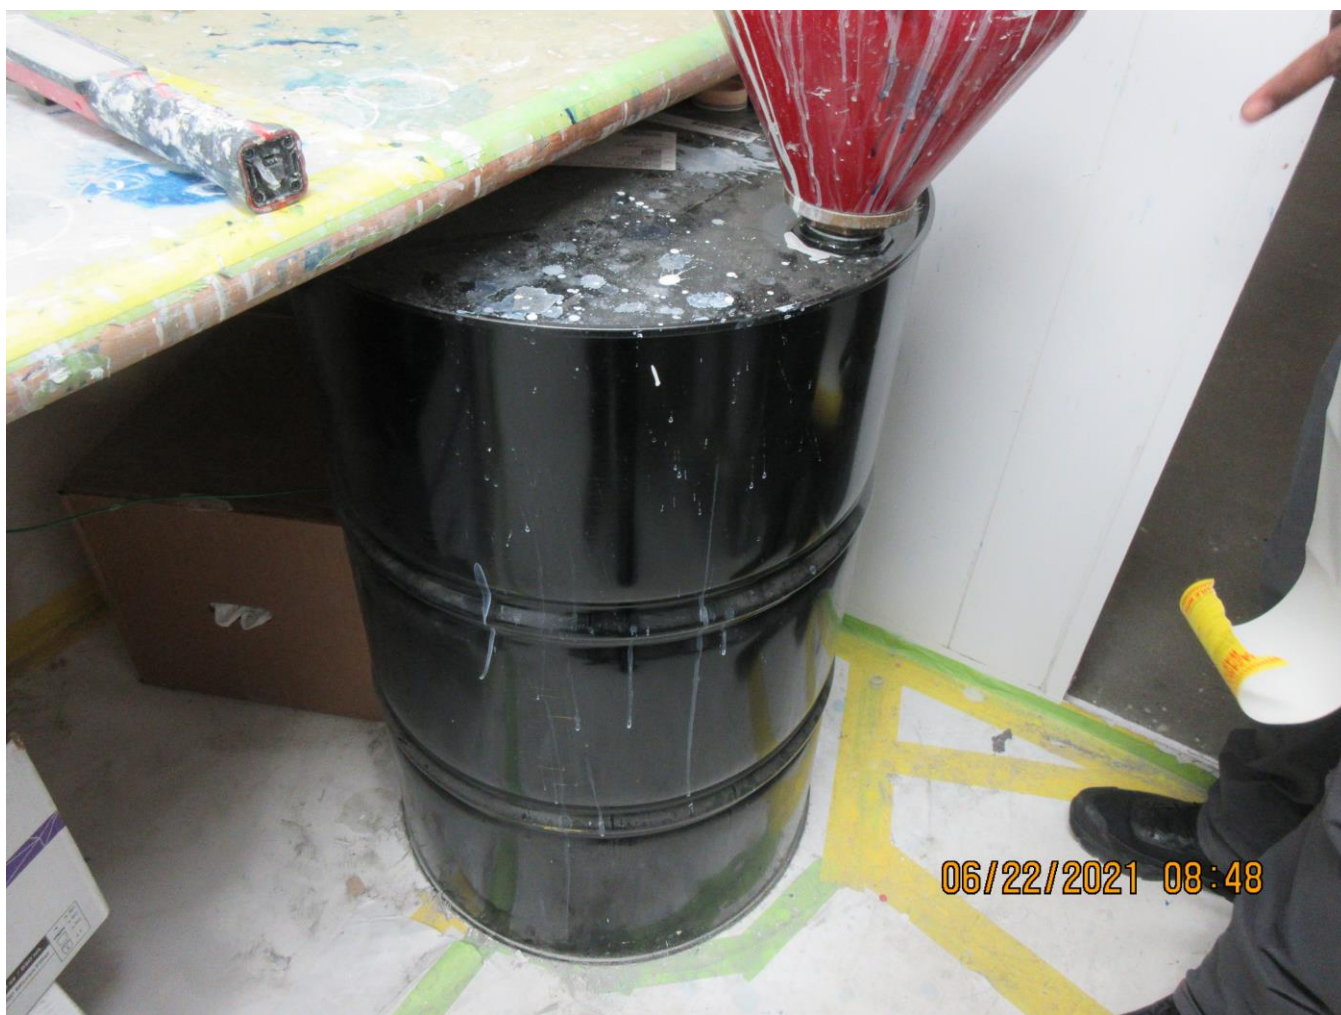
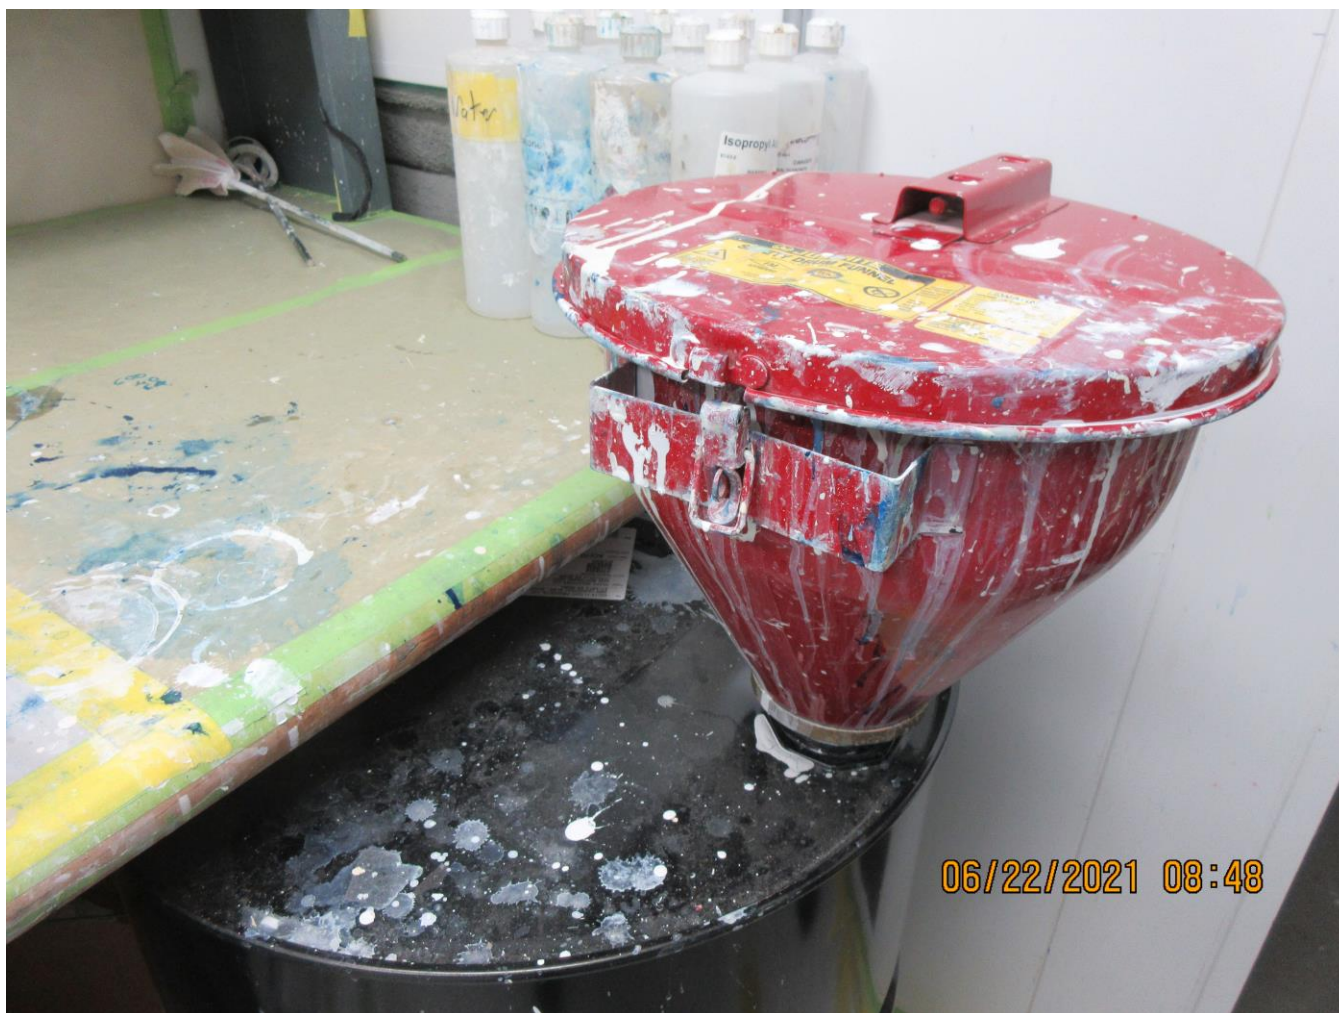
At the time of the inspection, one SAA was observed within the paint booth. The SAA contained one 55-gallon drum for the accumulation of paint waste. The drum was not closed as the lid to the funnel was not latched and ajar. The container was not labeled with the word “Hazardous Waste” or marked a hazard code or placard identifying the hazard associated with the waste (Photos 11 and 12).

Photo 11 – Hazardous Waste Container in Paint Booth on Composites Site

Photo 12 – Hazardous Waste Container in Paint Booth on Composites Site

**Pursuant to Ga. Comp. R. and Regs. 391-3-11-.08(1) [40 C.F.R. § 262.15(a)(4)], which is a condition of the SAA Permit Exemption, a generator is required to keep containers of hazardous waste closed at all times during accumulation, except when adding, removing, or consolidating waste; or when temporary venting of a container is necessary for the proper operation of equipment, or to prevent dangerous situations, such as build-up of extreme pressure.**

**Pursuant to Ga. Comp. R. and Regs. 391-3-11-.08(1) [40 C.F.R. § 262.15(a)(5)], which is a condition of the SAA Permit Exemption, a generator is required to mark or label its containers (i) with the words “Hazardous Waste” and (ii) with an indication of the hazards of the contents.**
