## **RCRA Inspection Report**

MKC Enterprises, Inc.  
5856 New Peachtree Road  
Doraville, Georgia 30340  
DeKalb County

February 15, 2023; 9:00 a.m. – 4:00 p.m.

The purpose of this inspection was to conduct an unannounced compliance evaluation inspection to determine MKC Enterprises, Inc. compliance with the conditions of its RCRA Hazardous Waste Facility Operating Permit HW-005(S&T)-2 the applicable requirements of RCRA and the corresponding Georgia regulations. This was an EPA lead inspection.

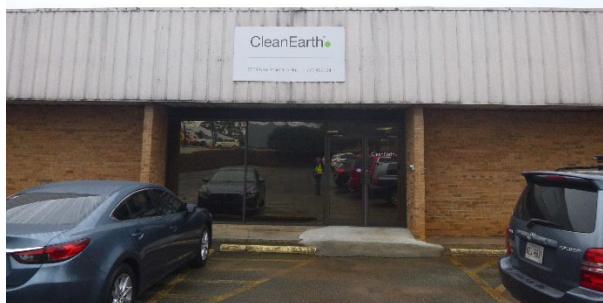
Photograph 1: Exterior of Building 1.

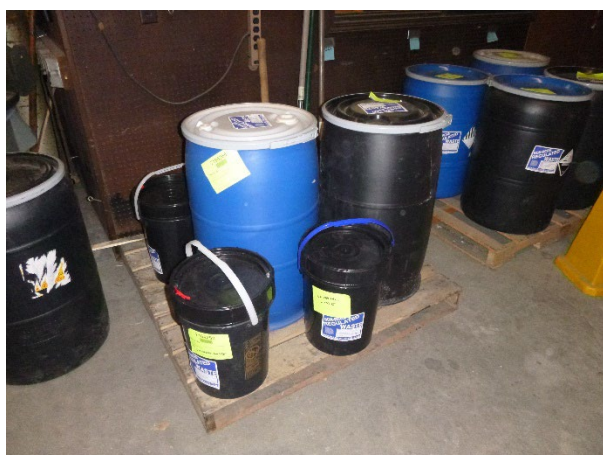
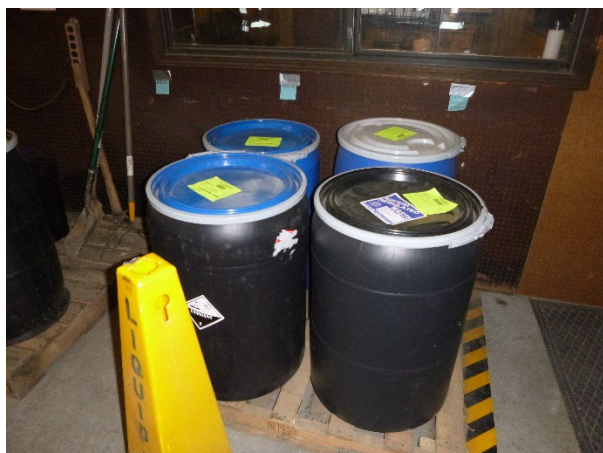
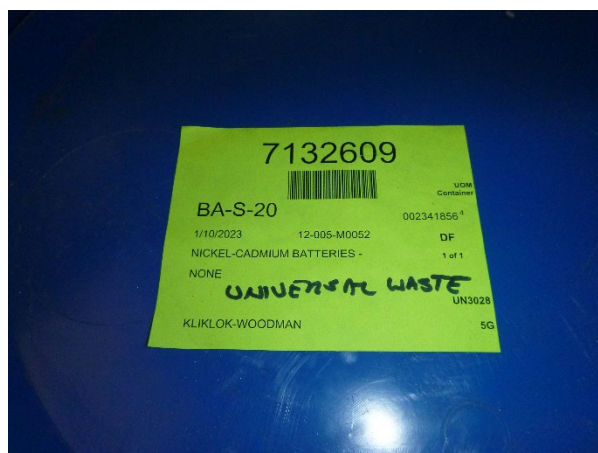
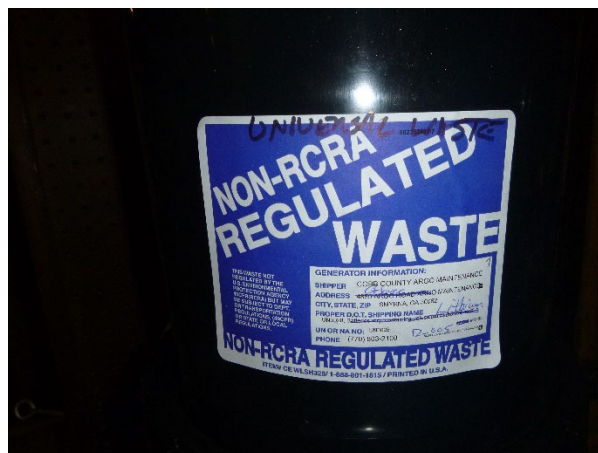
There were six 30-gallon and four 5-gallon containers of used batteries in storage in the warehouse on the day of the inspection (Photographs 2-6). Four of the 30-gallon containers and one of the 5-gallon containers stored alkaline batteries. One 30-gallon and two 5-gallon containers stored Lithium batteries. One 30-gallon container stored Nickel-Cadmium (Ni Cad) batteries. One 5-gallon container stored lead acid batteries. None of the containers of Lithium batteries, lead acid batteries, or Ni Cad batteries were labeled with one of the following phrases: "Universal Waste - Battery(ies)," or "Waste Battery(ies)," or "Used Battery(ies)." Facility personnel labeled each container during the inspection.

Photograph 4: Universal Waste Batteries.

Photograph 2: Universal Waste Batteries.

Photograph 5: Universal Waste Batteries.

Photograph 3: Universal Waste Batteries.

Photograph 6: Universal Waste Batteries.

**Pursuant to Ga. Comp. R. and Regs. 391-3-11-.18 [40 C.F.R. § 273.34(a)], a LQHUW must label or mark each Universal Waste battery or container or tank in which the batteries are contained clearly with one of the following phrases: "Universal Waste - Battery(ies)," or "Waste Battery(ies)," or "Used Battery(ies)."**

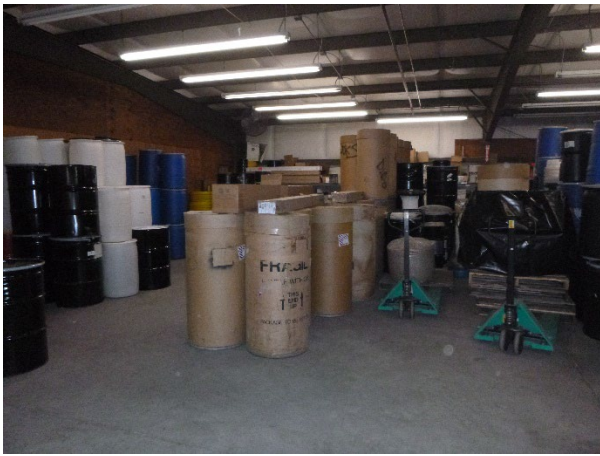
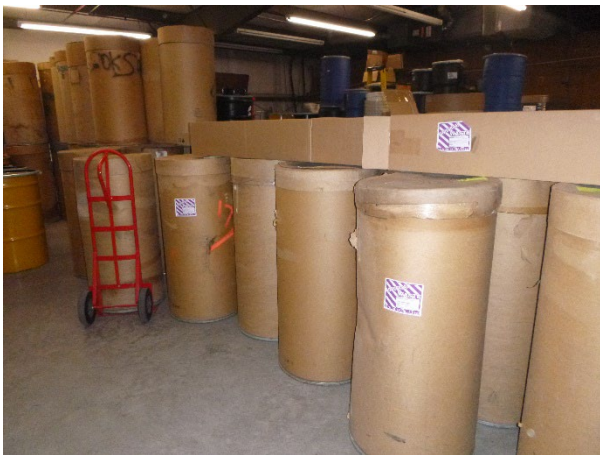
There were ten (10) 4-foot cylindrical cardboard containers and three long cardboard boxes used to store universal waste lamps (Photographs 7-8). There was one 4-foot cylinder and three long boxes that were not dated. Facility personnel stated that all lamps were shipped off site on January 16, 2023, and that all batteries were shipped off site on January 19, 2023. The recent pick up on February 8, 2023 was unable to accommodate the volume of universal waste present at that time. A follow-up shipment on February 20, 2023 was able to accommodate the remaining volume.

Photograph 7: Universal Waste Lamps.

Photograph 8: Universal Waste Lamps.

**Pursuant to Ga. Comp. R. and Regs. 391-3-11-.18 [40 C.F.R. § 273.34(e)], a LQHUW must label or mark clearly each lamp or a container or package in which such lamps are contained with any one of the following phrases: “Universal Waste - Lamp(s),” or “Waste Lamp(s),” or “Used Lamp(s)”.**

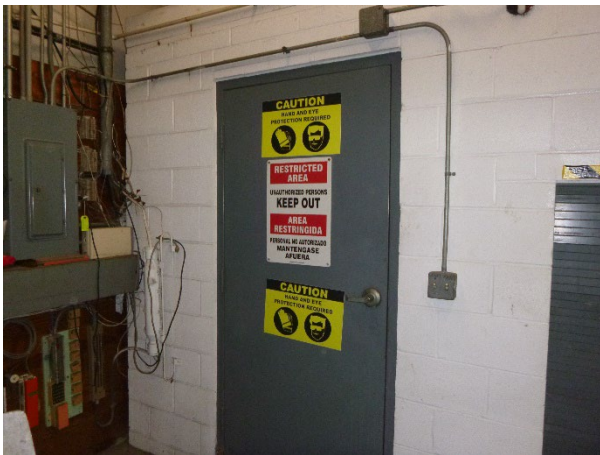
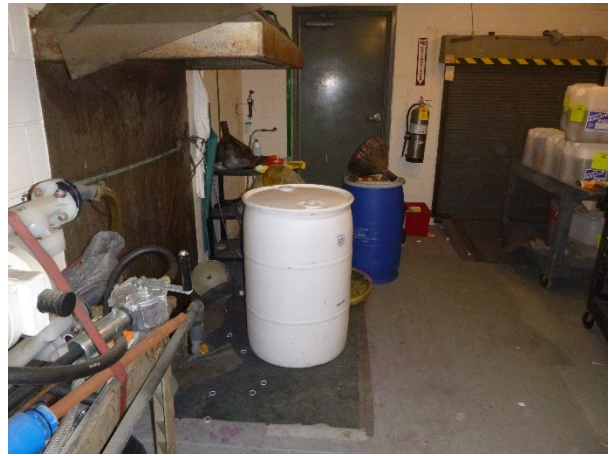
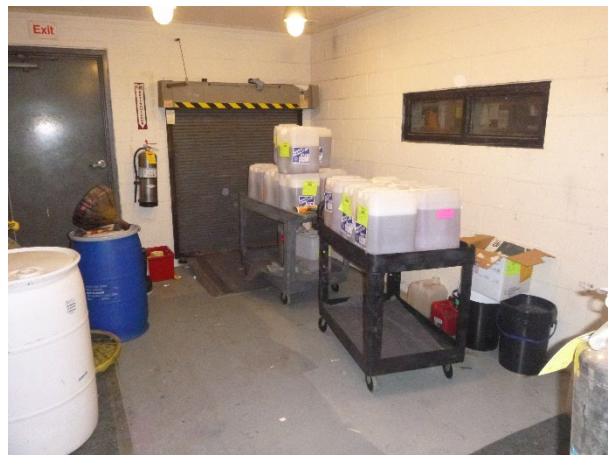
Facility personnel use the consolidation room to combine like chemicals into larger containers (Photographs 9-11). Facility personnel stated that combined containers are labeled with the oldest accumulation start date. At the time of the inspection there were four 5-gallon containers of hazardous waste and thirteen 5-gallon containers of non-hazardous waste. Each container was labeled, closed, and in good condition.

Once MKC consolidates waste from multiple containers into one, the standard operating procedure is to label the accumulation start date on the combined containers with the oldest date of accumulation. The inspection team noted the accumulation start dates on some of the consolidation containers were incorrect, however the database that tracked the containers was correct. MKC stated they would rectify this inconsistency with training.

Photograph 10: Containment Room in Building 1.

Photograph 11: Containment Room in Building 1.

Photograph 9: Containment Room in Building 1.

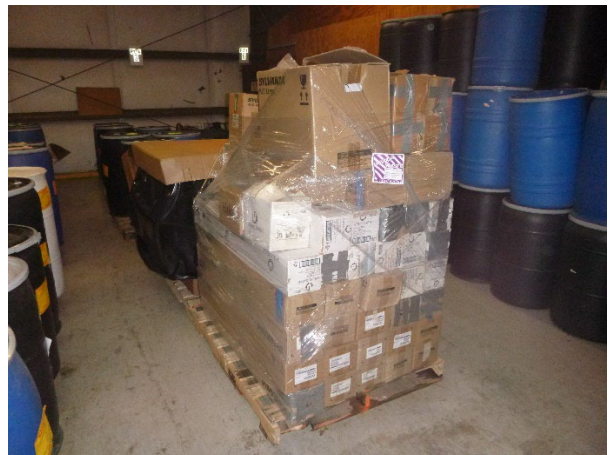
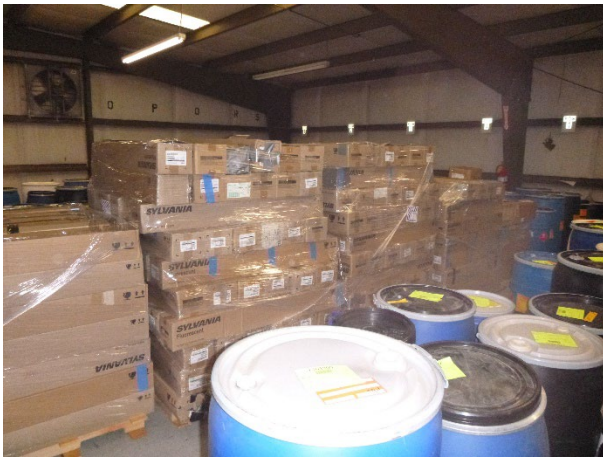
Photograph 12: Universal Waste Lamps.

Photograph 13: Universal Waste Lamps.

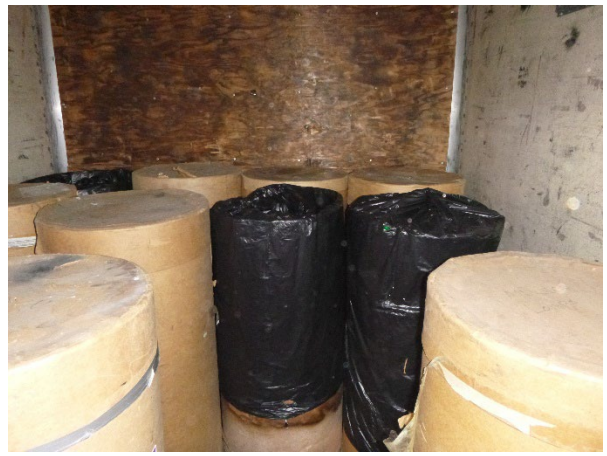
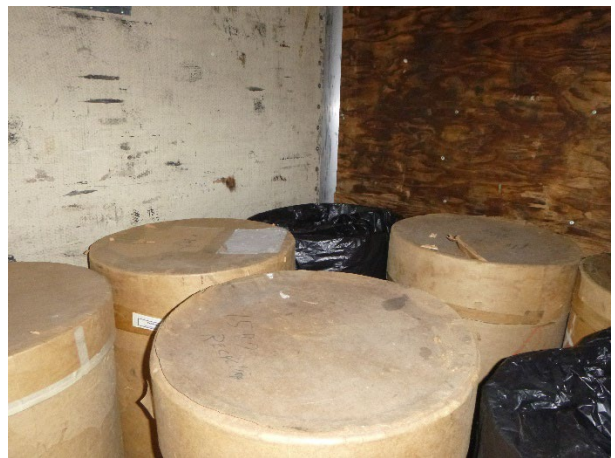
MKC parks transport trucks in a fenced area beside Building 2. There were two trucks located in this parking area on the day of the inspection. One truck was empty and the other was storing approximately eleven 4-foot cylindrical cardboard containers of universal waste lamps (Photographs 20-21). Three of the containers were covered with black plastic. The inspection team considered these to be open containers. Facility personnel closed these containers during the inspection.

Photograph 20: Trailer storing universal waste lamps in open containers.

Photograph 21: Trailer storing universal waste lamps in open containers.

**Pursuant Ga. Comp. R. and Regs. 391-3-11-.18 [40 C.F.R. § 273.33(d)(1)], a LQHUW must manage universal waste lamps in a way that prevents releases of any universal waste or component of a universal waste to the environment. (1) A large quantity handler of universal waste must contain any lamp in containers or packages that are structurally sound, adequate to prevent breakage, and compatible with the contents of the lamps. Such containers and packages must remain closed and must lack evidence of leakage, spillage or damage that could cause leakage under reasonably foreseeable conditions.**

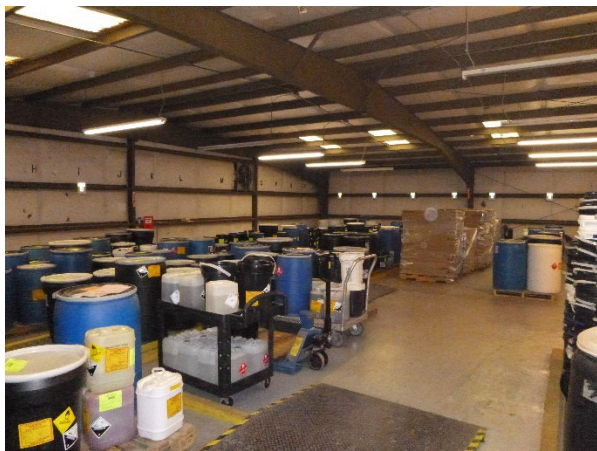
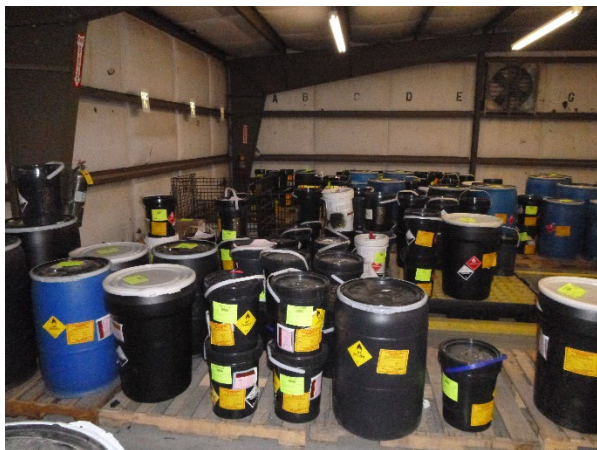
Containers of waste are stored in Bays 4, 5, and 6 in this area (Photographs 12-19). On the day of the inspection, there were 456 containers totaling 9,927 gallons. The inspection team requested information on the ten containers in storage with the oldest accumulation start dates. Each of the oldest containers were in Building 1 Area C. The inspection team was able to locate nine of the ten containers during the inspection. The tenth container identified with container number 6576106 was described as a 30-gallon fiber drum in Bay 6 Row #2. This container was not located in this area. Neither the facility personnel nor the inspection team were able to locate this during the inspection. On March 6, 2023, MKC personnel documented that this container was consolidated with other lab packs into container number 7111387C and shipped to the Clean Earth of Alabama Facility in Glencoe, Alabama on January 3, 2023. The inspection team noted multiple pallets of universal waste lamp containers that were shrink-wrapped together. There was one label on the shrink-wrap. MKC had not labeled each container when it arrived. MKC personnel documented that each container of waste was labeled in an email dated March 6, 2023.

Photograph 17: Building 1 permitted storage containers.

Photograph 18: Building 1 Area C.

Photograph 19: Building 1 Area C.

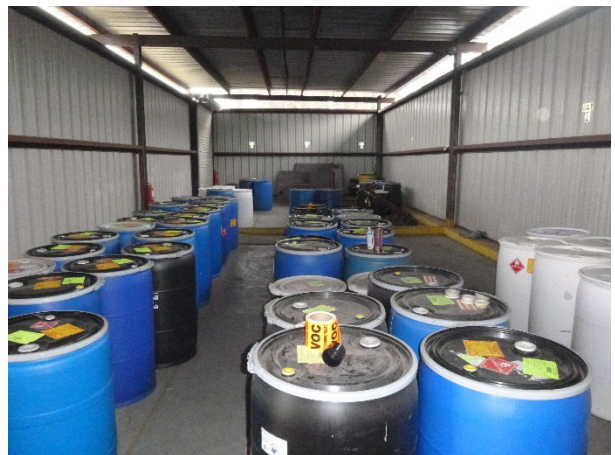
The inspection team noted multiple containers in Building 2 (Photographs 22-23). On the day of the inspection, there were 116 containers totaling 5,655 gallons. Each container was labeled, in good condition, and closed. Spill kits and fire control equipment were present.

Photograph 22: Building 2 Area A.

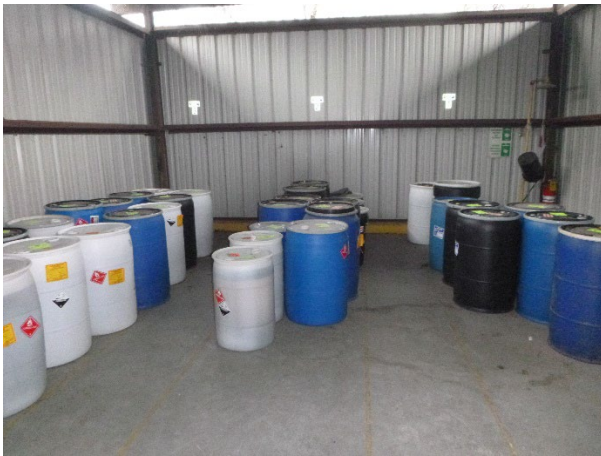
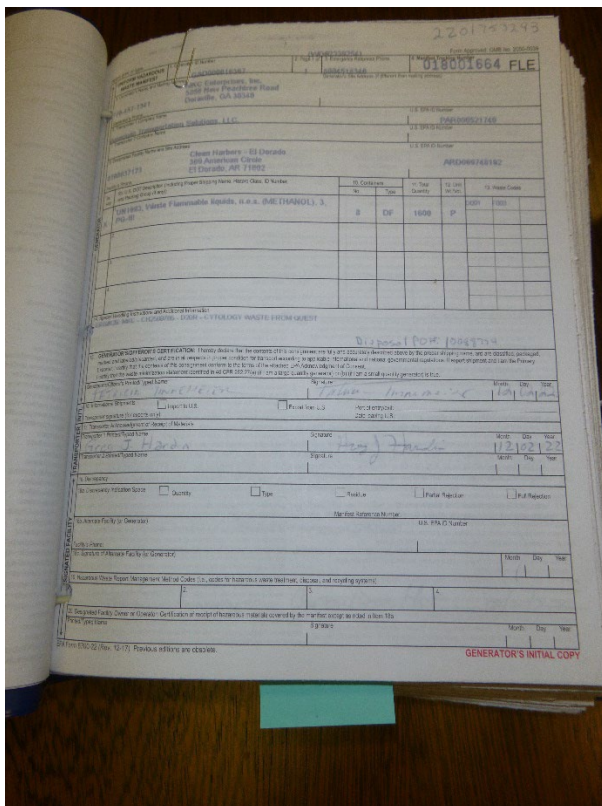
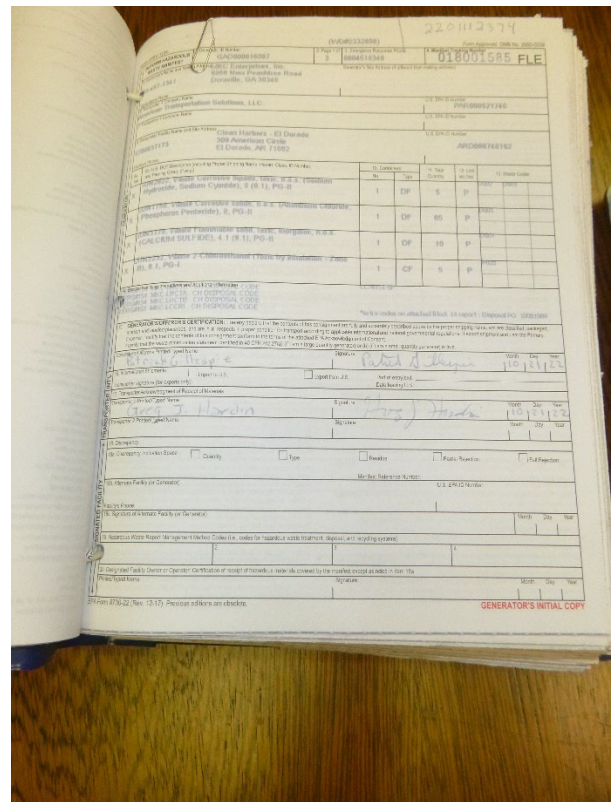
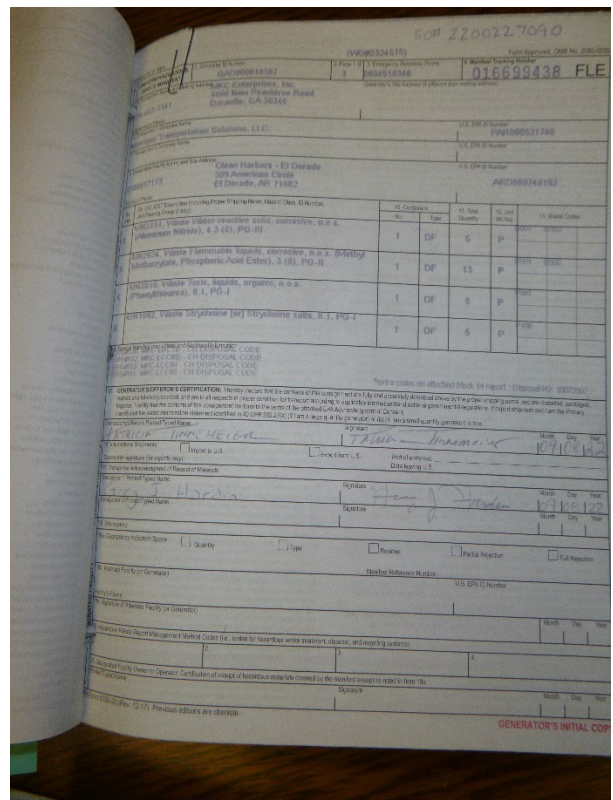
| <b>Manifest Number</b> | <b>Waste Codes</b> | <b>Waste Description</b> | <b>Waste Destination</b> | <b>Date of Shipment/ Receipt</b> |
|---|---|---|---|---|
| 018001664<br>FLE | D001/F003 | Eight containers of Waste Flammable Liquids (Photograph 24) | Clean Harbors – El Dorado (ARD069748192) | 12/2/2022<br>2/27/2023 |
| 018001585<br>FLE | D001/D002/D003<br>P023 | Sixteen containers of various waste (Photograph 25) | Clean Harbors – El Dorado (ARD069748192) | 10/21/2022<br>10/31/2022 |
| 016699438<br>FLE | D001/D002/D003/<br>D004/D005/D006/<br>D007/D008/D011<br>/P039/P087/P105 | Seventeen containers of various wastes (Photograph 26) | Clean Harbors – El Dorado (ARD069748192) | 9/8/2022<br>9/25/2022 |

| <b>Manifest Number</b> | <b>Waste Codes</b> | <b>Waste Description</b> | <b>Waste Destination</b> | <b>Date of Shipment/ Receipt</b> |
|---|---|---|---|---|
| 016680880<br>FLE | D001/D002 | Two containers of Waste Sodium Hydroxide and two containers of Waste Organic Peroxide (Photograph 27) | Clean Harbors – El Dorado (ARD069748192) | 2/25/2022<br>3/11/2022 |

No records were provided to show that MKC contacted the transporter or the owner or operator of the designated facility to determine the status of this waste, and MKC did not submit exception reports for these missing manifests. MKC documented that they had obtained final copies of each of the manifest above on March 6, 2023, and March 24, 2023.

**Pursuant to Ga. Comp. R. and Regs. 391-3-11-.08(1) [40 C.F.R. 262.42(a)(1-2)], (a) (1) A generator of 1,000 kilograms or greater of hazardous waste in a calendar month, or greater than 1 kg of acute hazardous waste listed in § 261.31 or § 261.33(e) in a calendar month, who does not receive a copy of the manifest with the handwritten signature of the owner or operator of the designated facility within 35 days of the date the waste was accepted by the initial transporter must contact the transporter and/or the owner or operator of the designated facility to determine the status of the hazardous waste and (2) A generator of 1,000 kilograms or greater of hazardous waste in a calendar month, or greater than 1 kg of acute hazardous waste listed in § 261.31 or § 261.33(e) in a calendar month, must submit an Exception Report to the EPA Regional Administrator for the Region in which the generator is located if he has not received a copy of the manifest with the handwritten signature of the owner or operator of the designated facility within 45 days of the date the waste was accepted by the initial transporter. The Exception Report must include: (i) A legible copy of the manifest for which the generator does not have confirmation of delivery; (ii) A cover letter signed by the generator or his authorized representative explaining the efforts taken to locate the hazardous waste and the results of those efforts.**
