INSPECTION REPORT

| Type of Inspection | Focused Compliance Inspection (FCI) | | | |
| Facility or Site Name | Sun Coast Resources | | | |
| Type of Operation | Sun Coast Resources is a fuel delivery company and transfer facility for used oil. | | | |

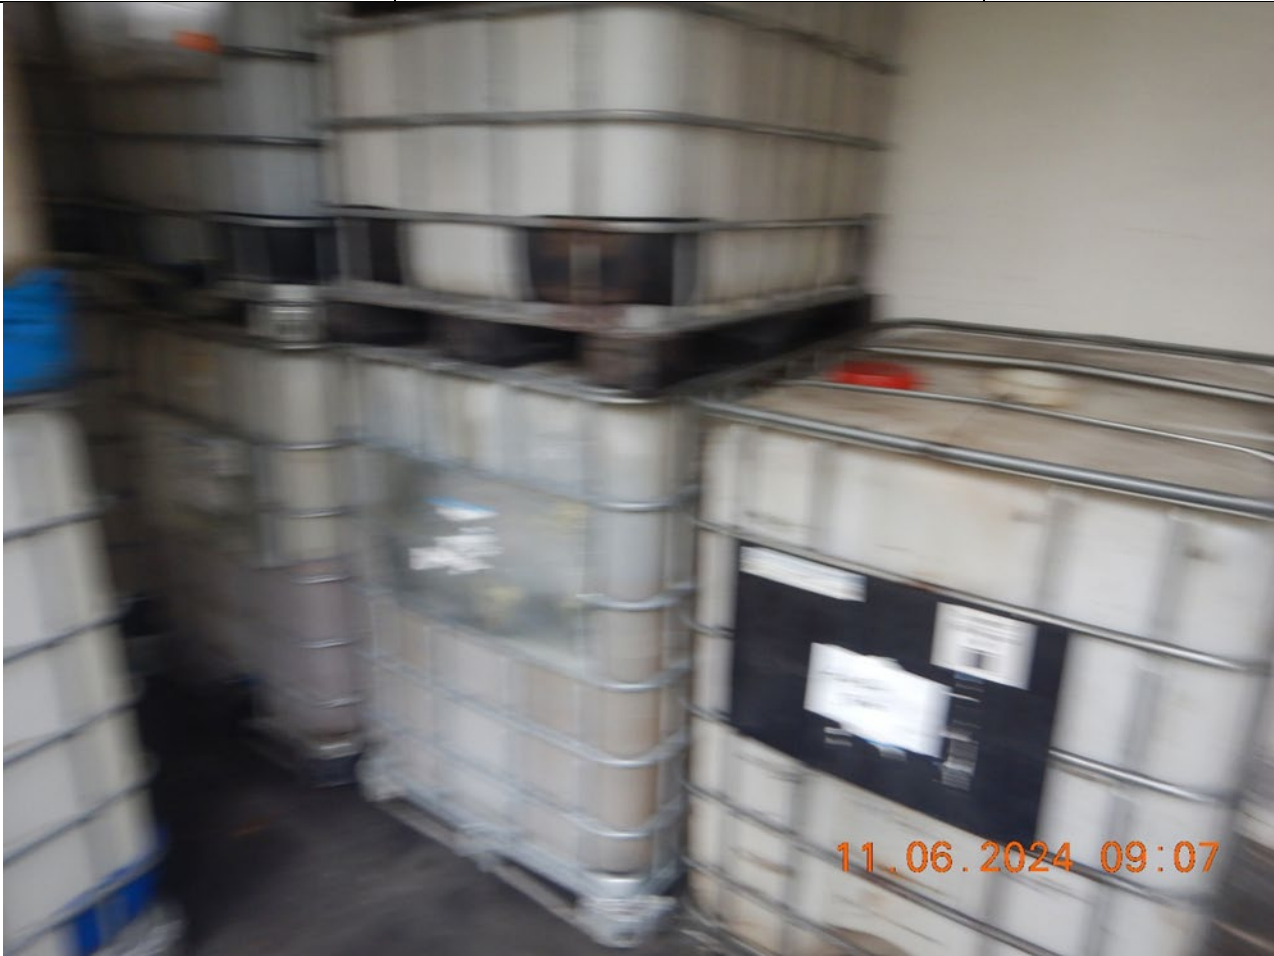
Photo No. 1

Description: View of four 300-gallon totes (far right tote is empty) storing used oil on SCR's used oil storage area located on its loading dock.

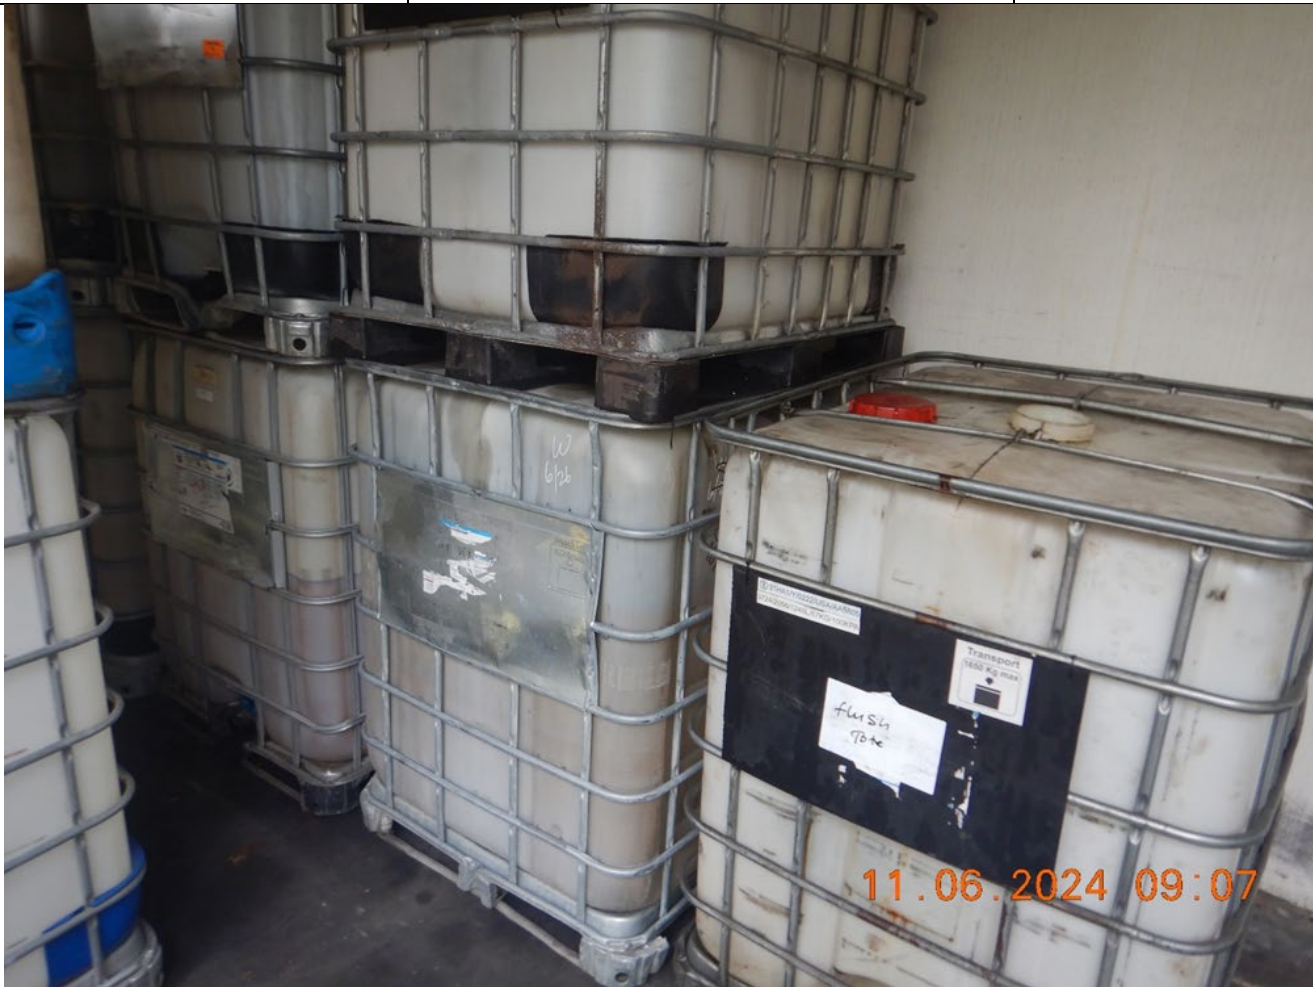
**Photo No. 2**

Description: View of four 300-gallon totes (far right tote is empty) storing used oil on SCR's used oil storage area located on its loading dock.

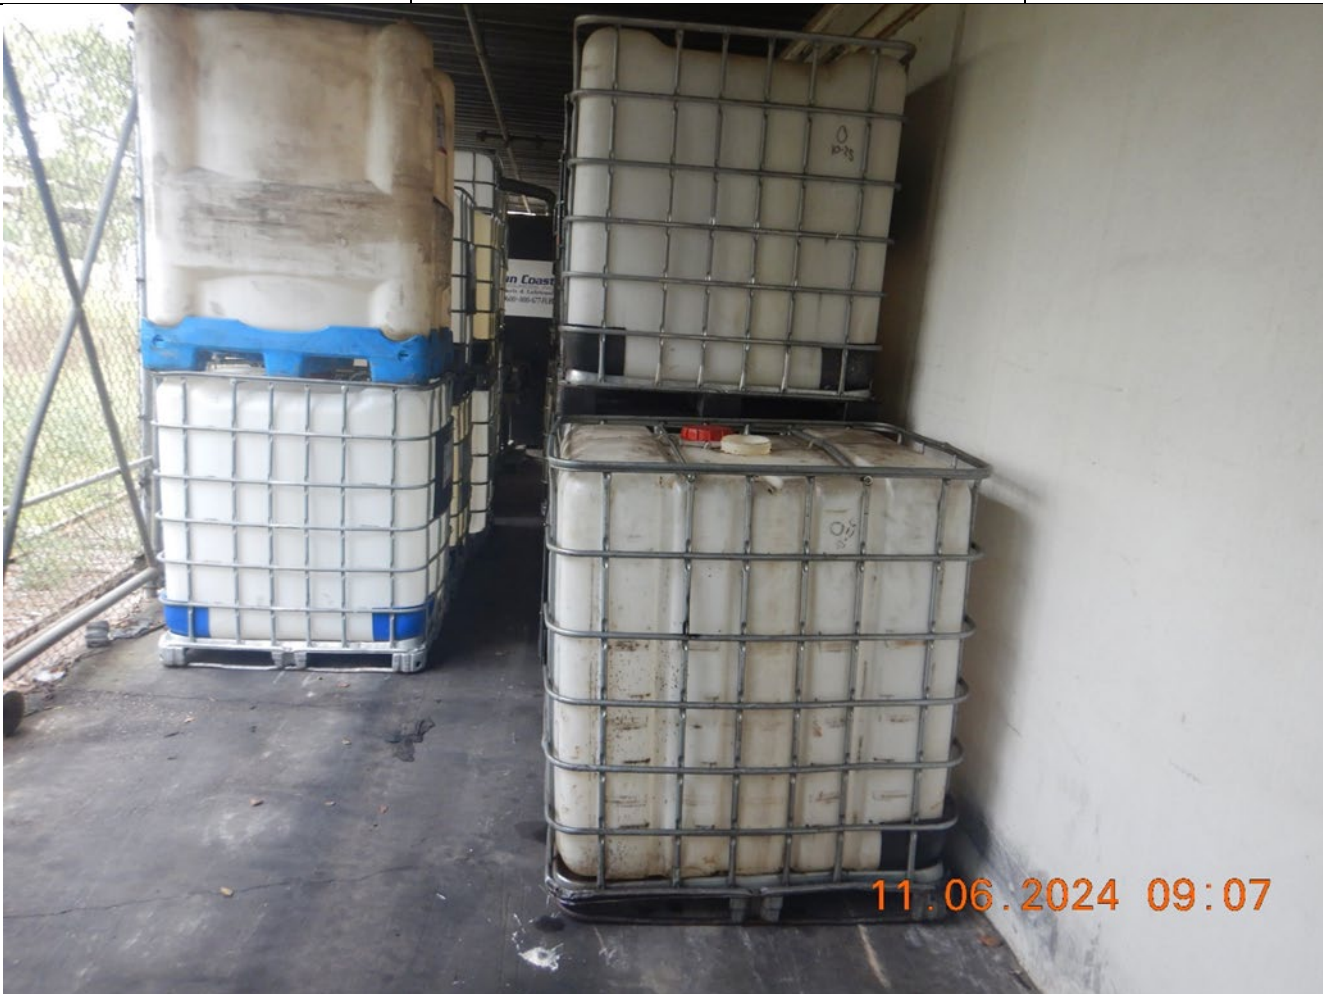
Photo No. 3

Description: Overview of used oil storage loading dock. The totes on the left side of the photos and the totes on the right side are storing used oil.

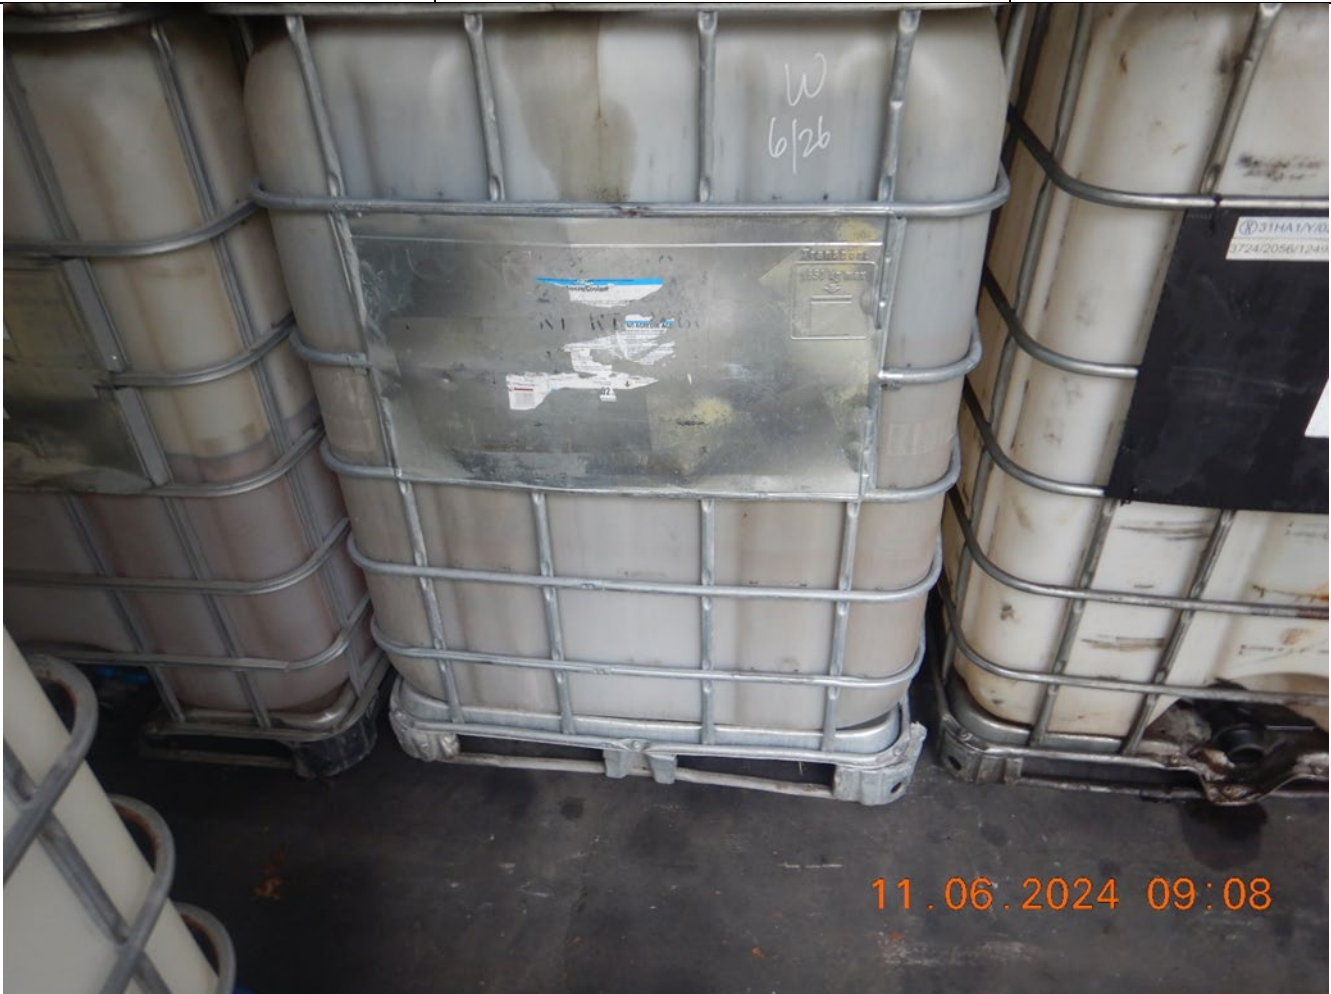
**Photo No. 4**

Description: View of a half-full 300-gallon tote in the used oil storage dock that was not labeled as "Used Oil."

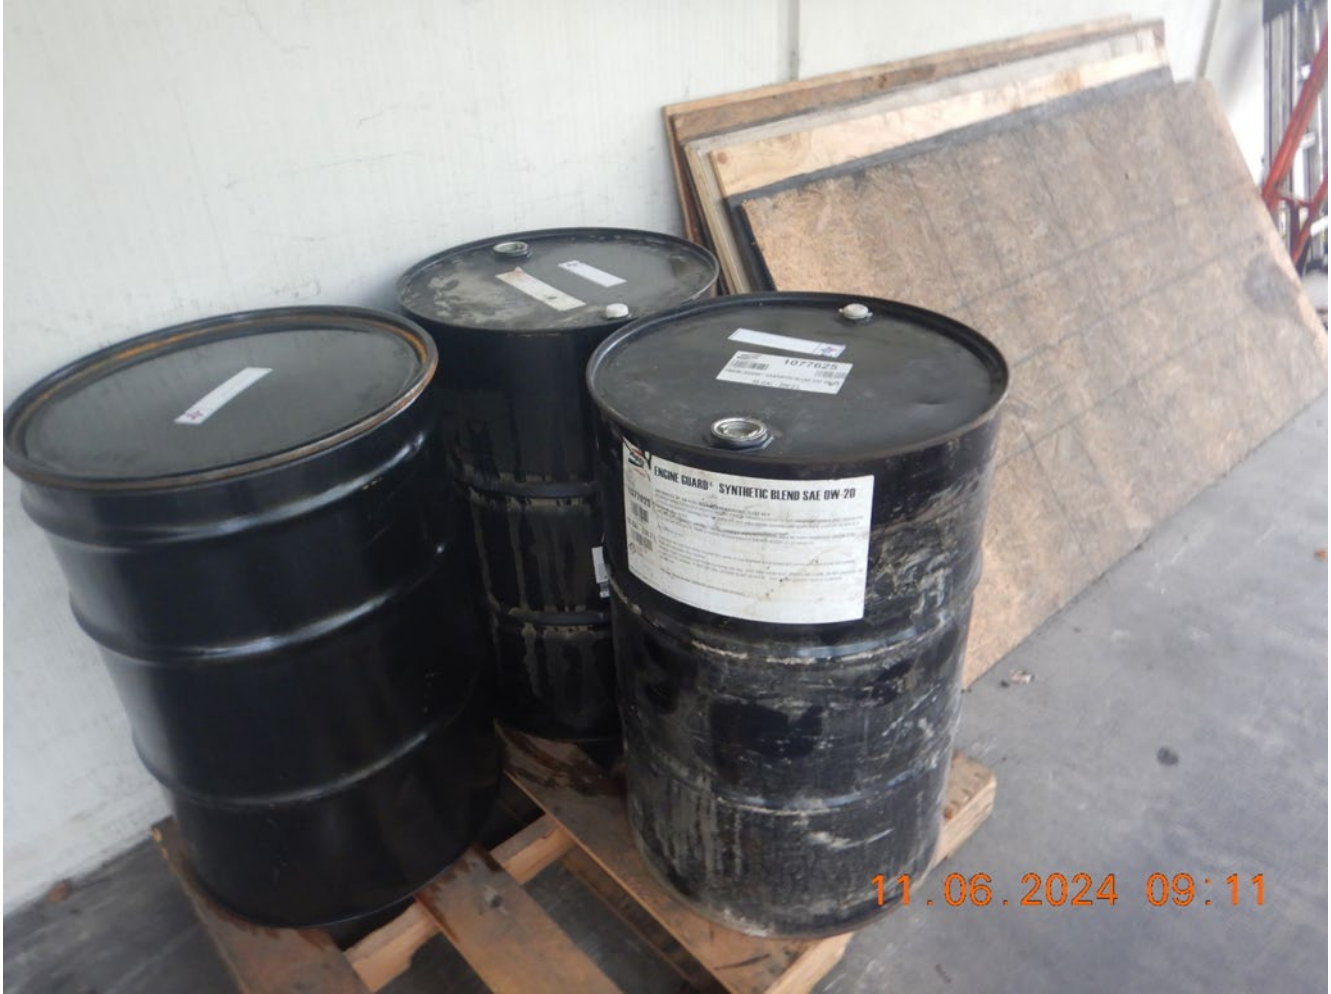
Photo No. 6

Description: View of three 55-gallon drums found on the loading dock that were labeled as empty. However, the drums on the right and left of the photo were half-full of an unknown liquid.

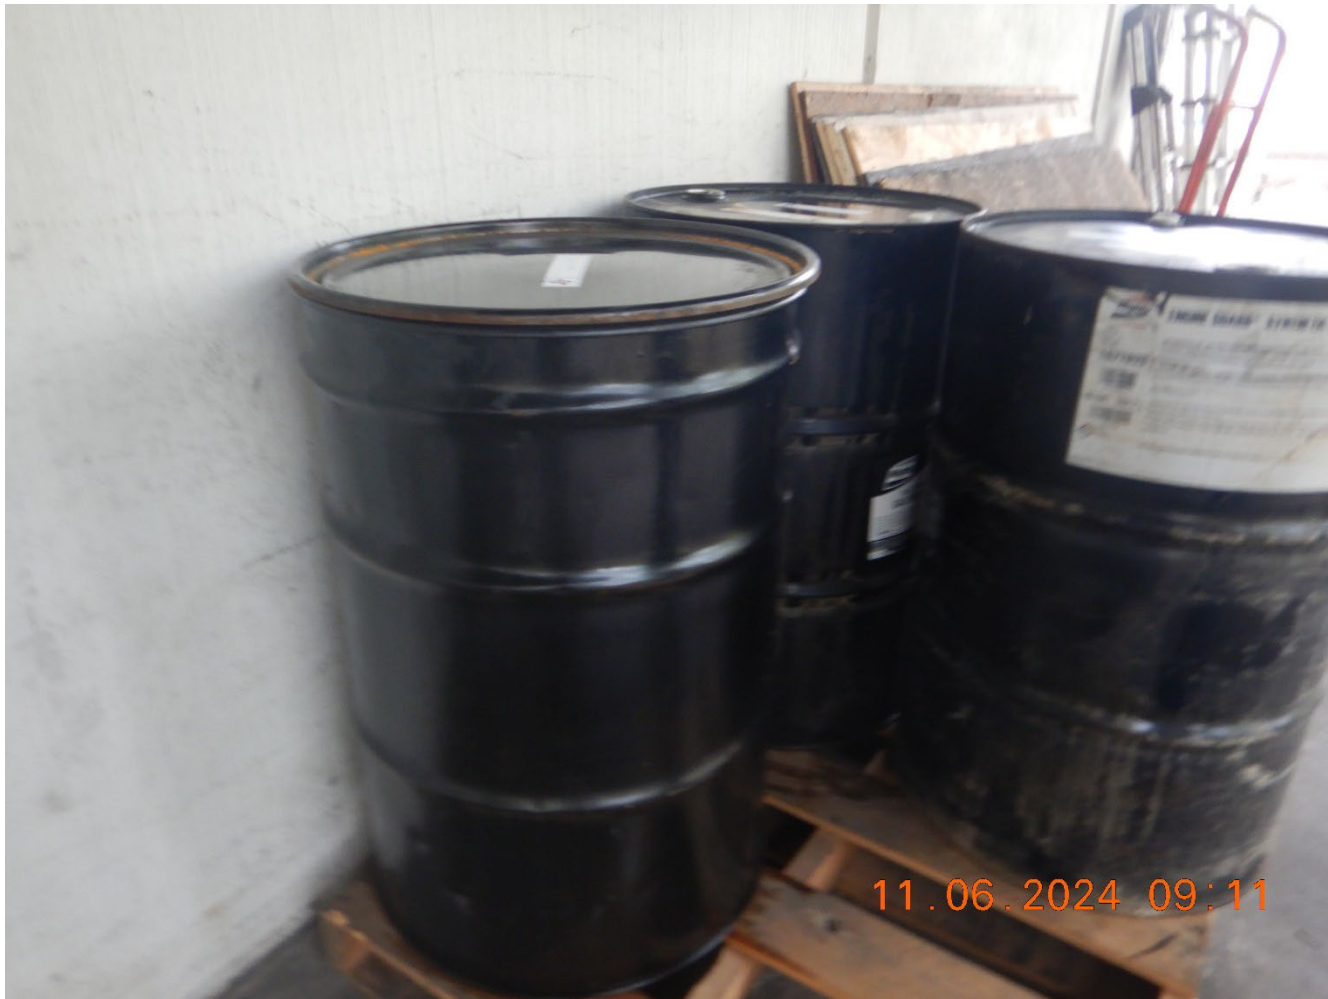
Photo No. 9

Description: Overview of three 55-gallon drums found on the loading dock that were labeled as empty. However, the drums on the right and left of the photo were half-full of an unknown liquid.

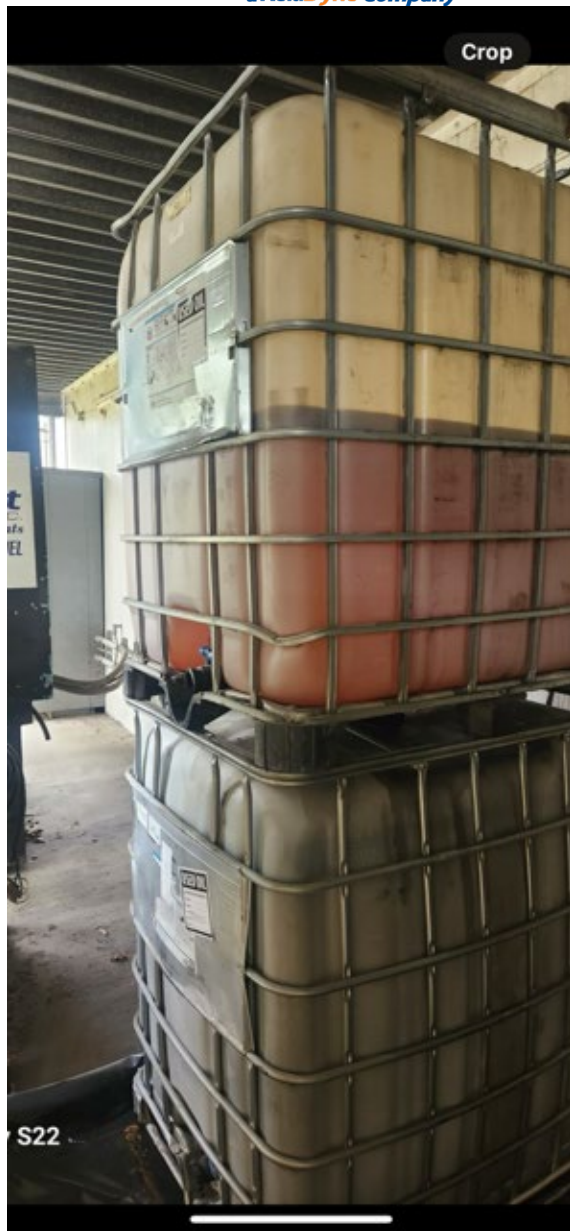
Area of Concern 1: Some used oil totes were not visibly labeled (side facing out) as used oil.

Corrective action- SCR has placed outward facing labels on all used oil totes that required them. Please see below for photographic documentation.

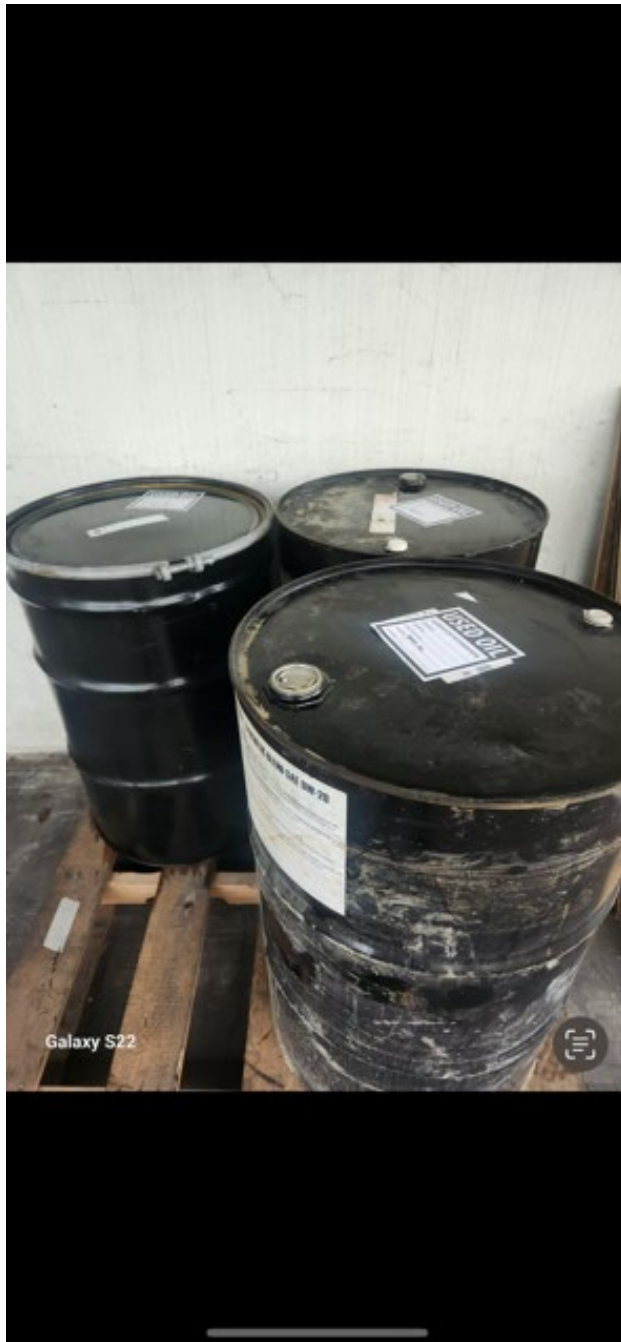
Area of Concern 2: Two drums were mistakenly labeled as empty; one filter drum did not have a lock ring securing the lid.

Corrective action- Labels were placed on the two unlabeled drums and a lock ring was installed on the third drum securing the lid. Please see below for photographic documentation.

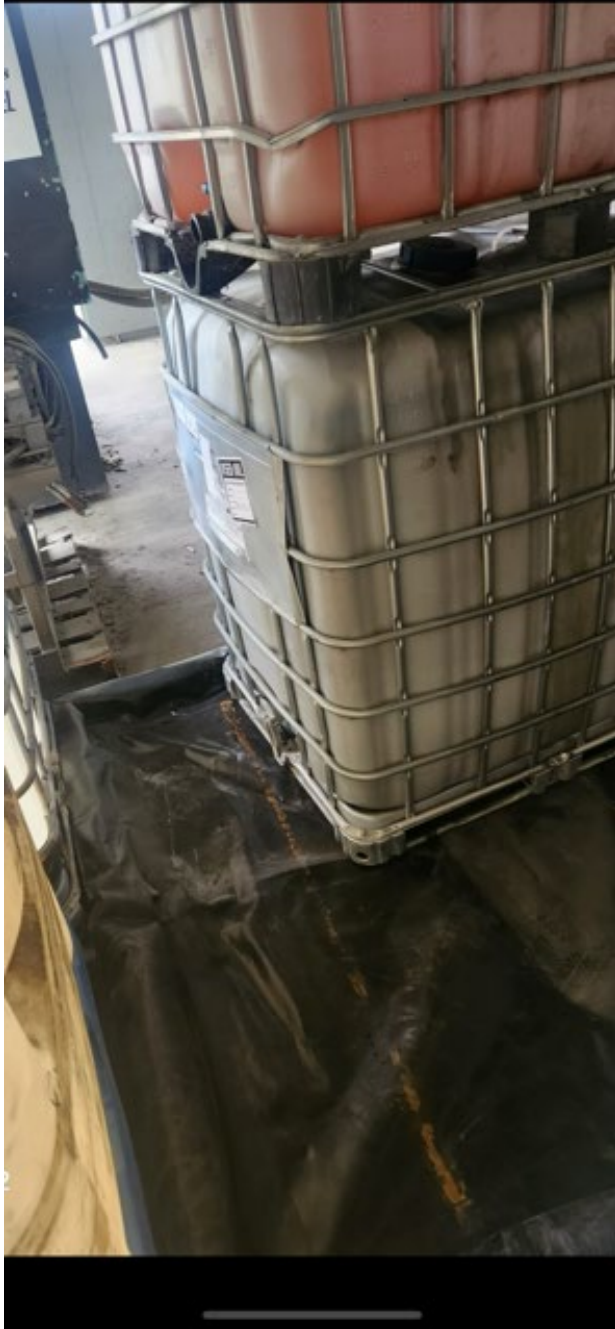
Area of Concern 3: Used oil tote storage area did not have secondary containment.

Corrective action- Used oil totes were moved inside an expandable soft berm on the loading dock.
