## Region 6 - Enforcement & Compliance Assurance Division

### INSPECTION REPORT

| Company Name: | Nevada Oil, LLC | |
| Facility Name: | Duke Tank Battery | |

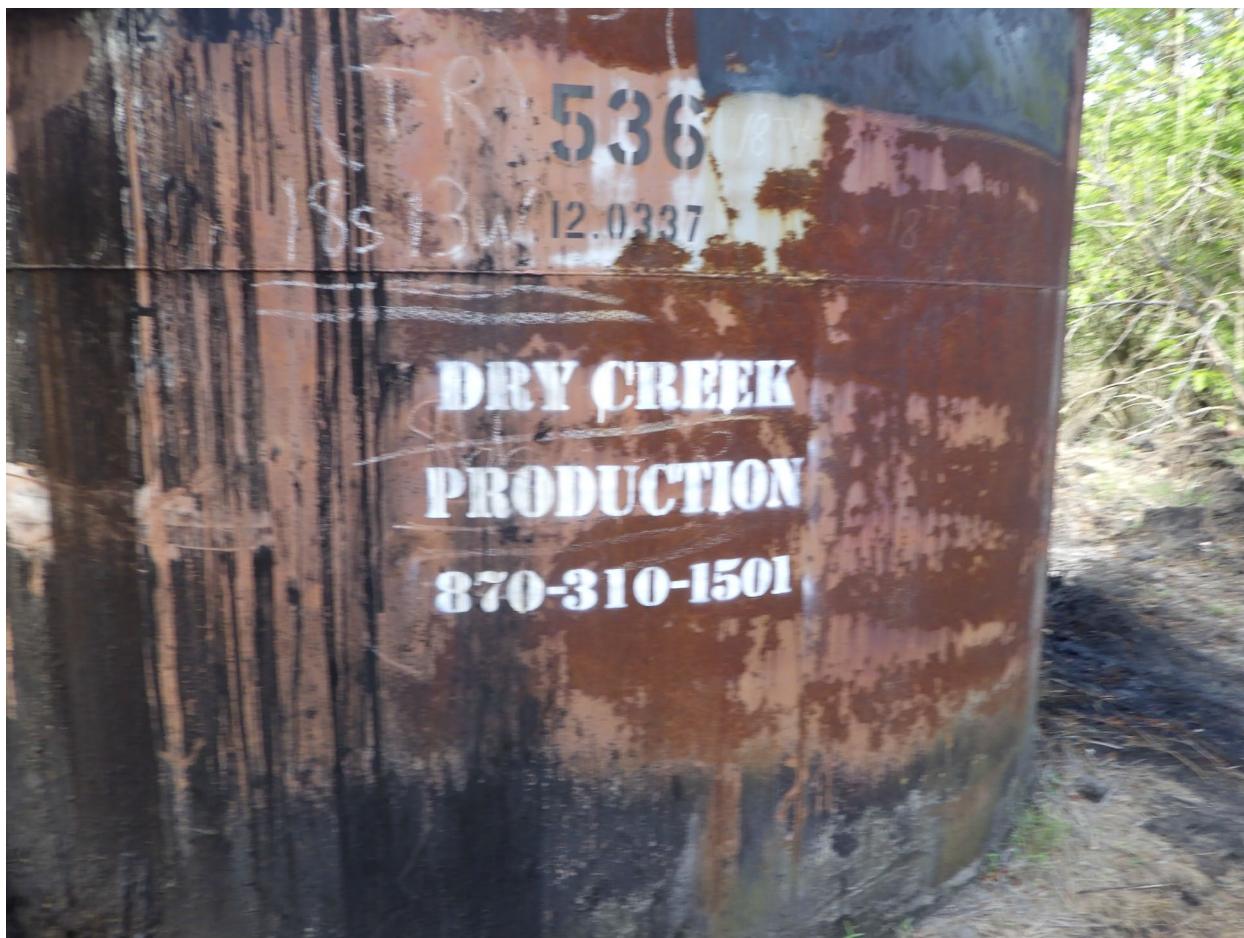
Photo No. 1

I observed the facility signage, secondary containment, pipes and valves, storage tank, and the separator/heater treater; see Appendix 1 (Photographs Log), Photos No. 1 and No. 2. For additional GPS location and photo metadata, see Appendix 1.

**Description:** Looking NNE, this photo shows the former operator's contact information on one of the storage tanks. This facility is being labeled "Nevada Oil, LLC – Duke Tank Battery" for reporting purposes.

- No updated contact information for the facility (Photo No. 1), and
- Residual, loose crude oil inside the secondary containment (Photo No. 6).

Inspector will conduct follow-up phone calls with the company representative(s) over the coming weeks and months to ensure areas of concern are properly addressed.

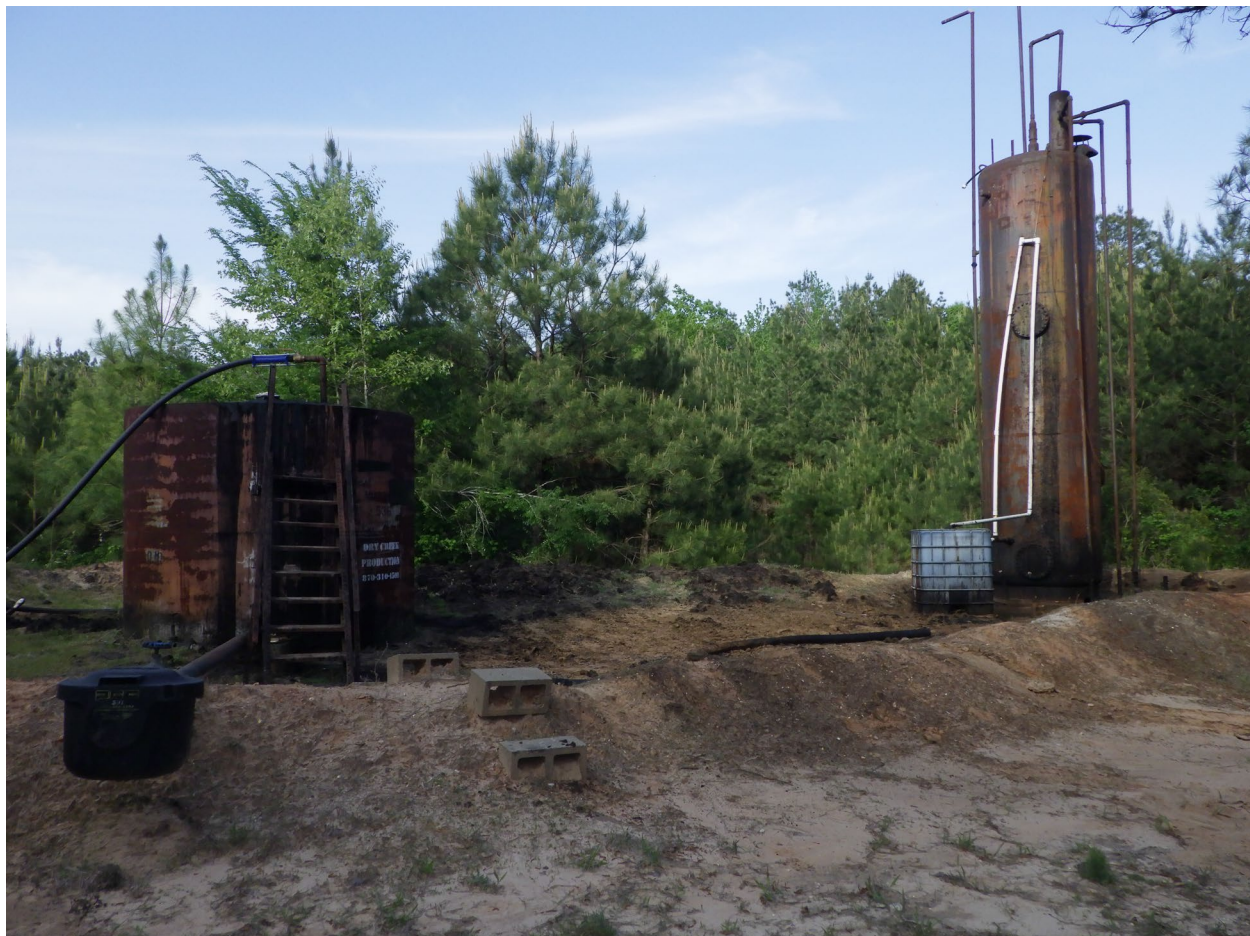
Photo No. 2

**Description:** Looking NE, this photo shows an overview of the facility.

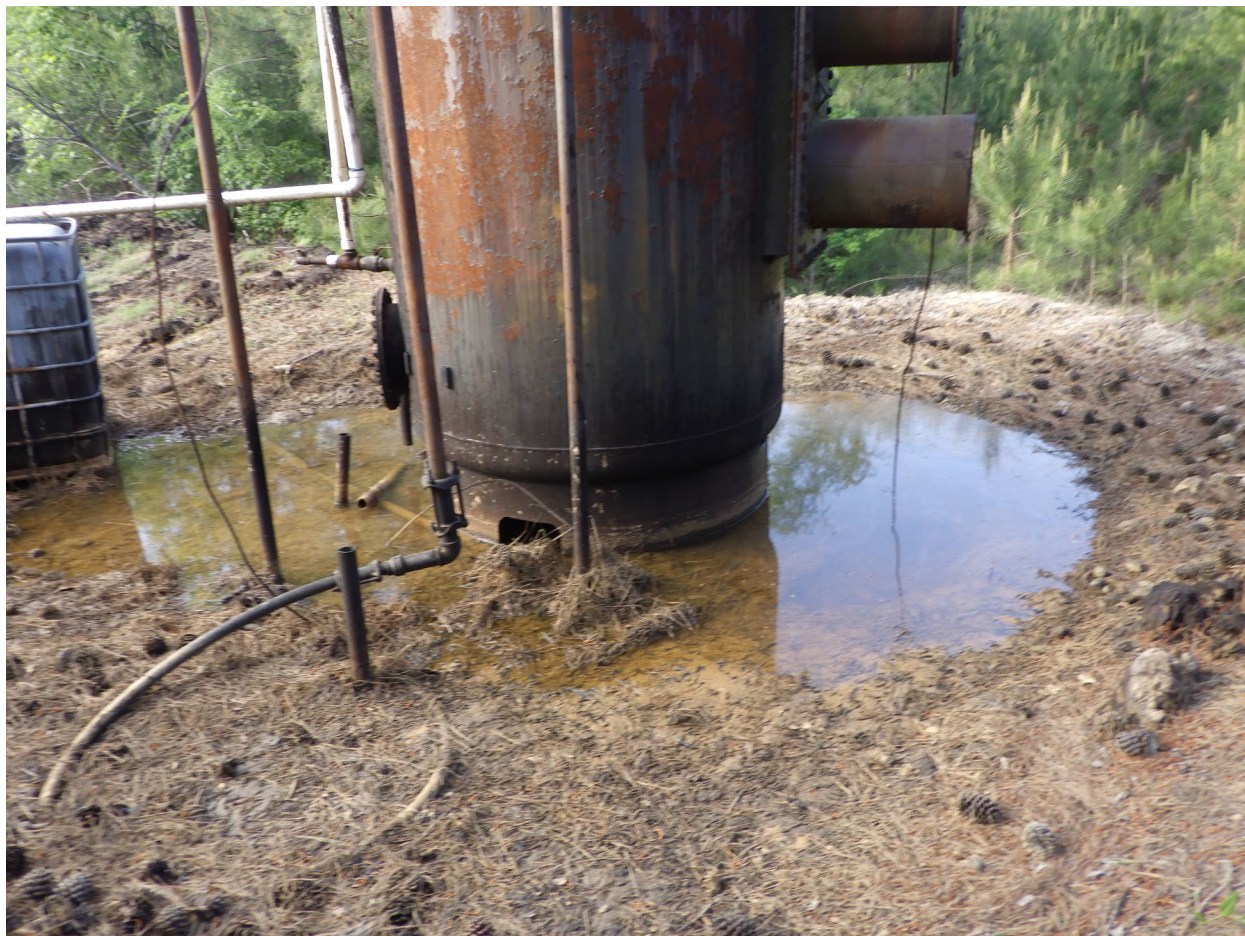
Photo No. 3

I observed the heater treater, a tote tank used for oil skimming, and accumulated stormwater with iron staining and minor sheening inside the secondary containment, see Photos No. 3 and No. 4.

**Description:** Looking NNE, this photo shows a tote tank for skimming oil and a treater heater.

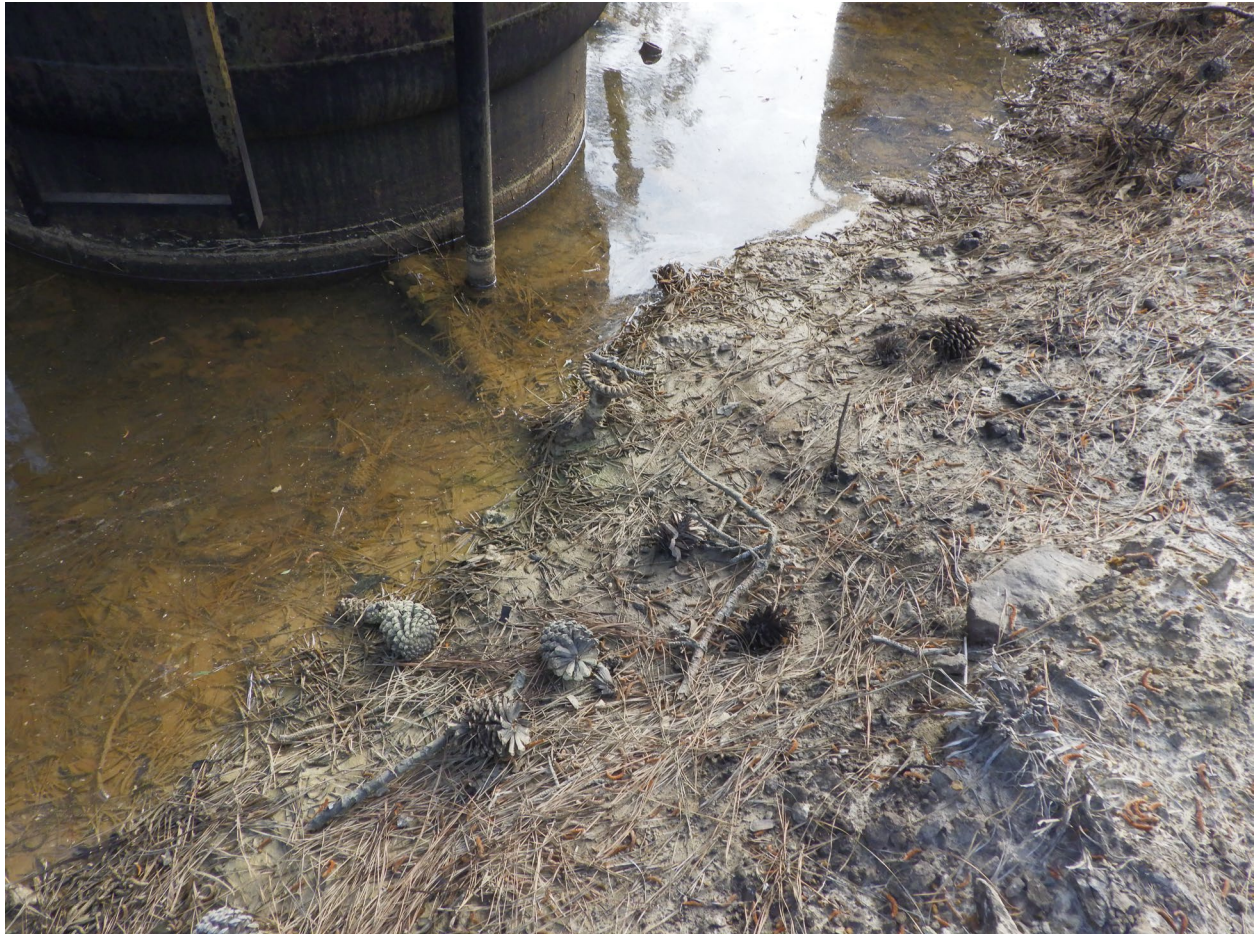
Photo No. 4

**Description:** Looking SW, this photo shows stormwater with iron staining and a slight sheen. No drainpipe was observed for the tank battery.

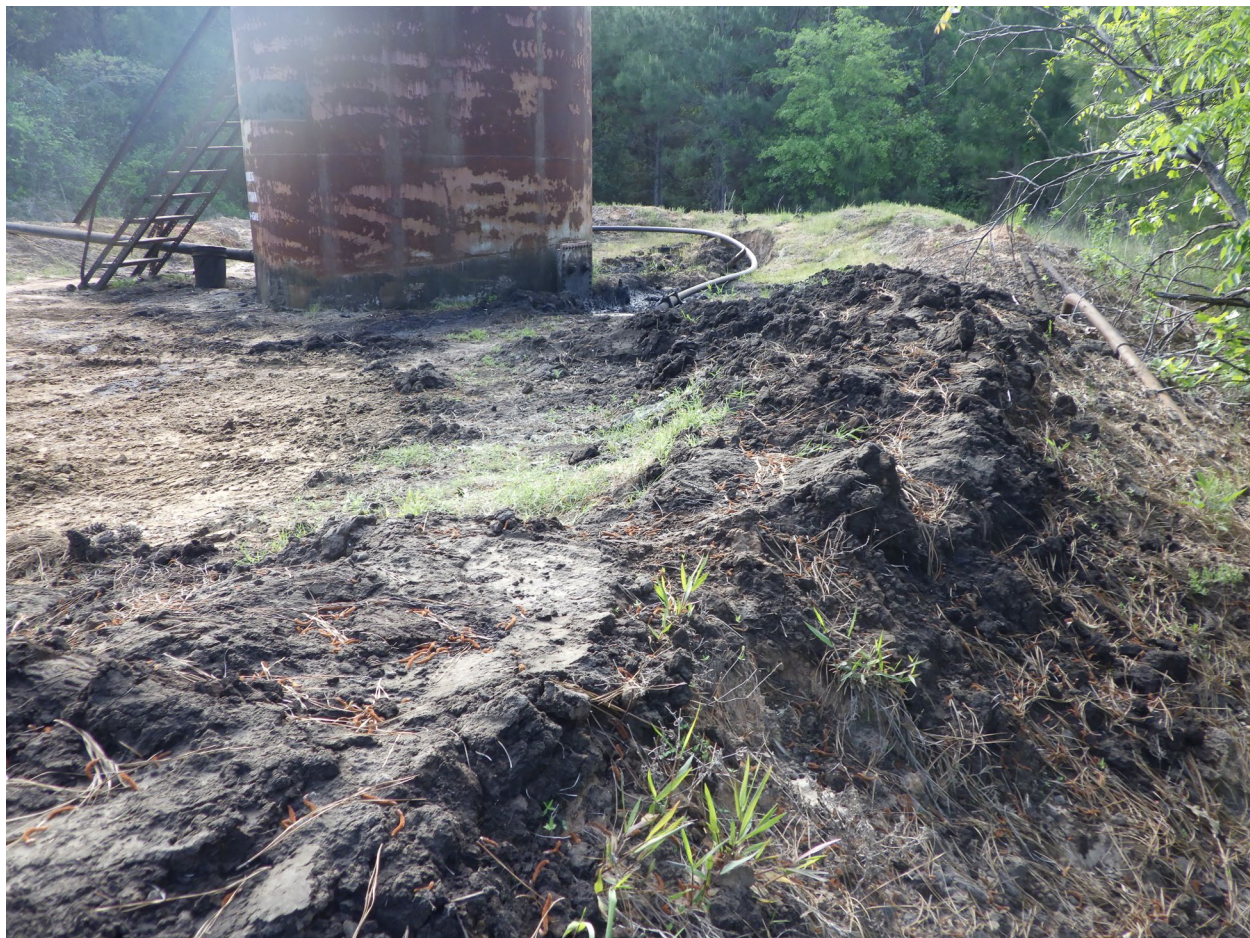
Photo No. 5

I observed dirt work inside secondary containment and along the berm, see Photo No. 5.

**Description:** Looking NNW, this photo shows dirt work that had occurred inside the tank battery and berm.

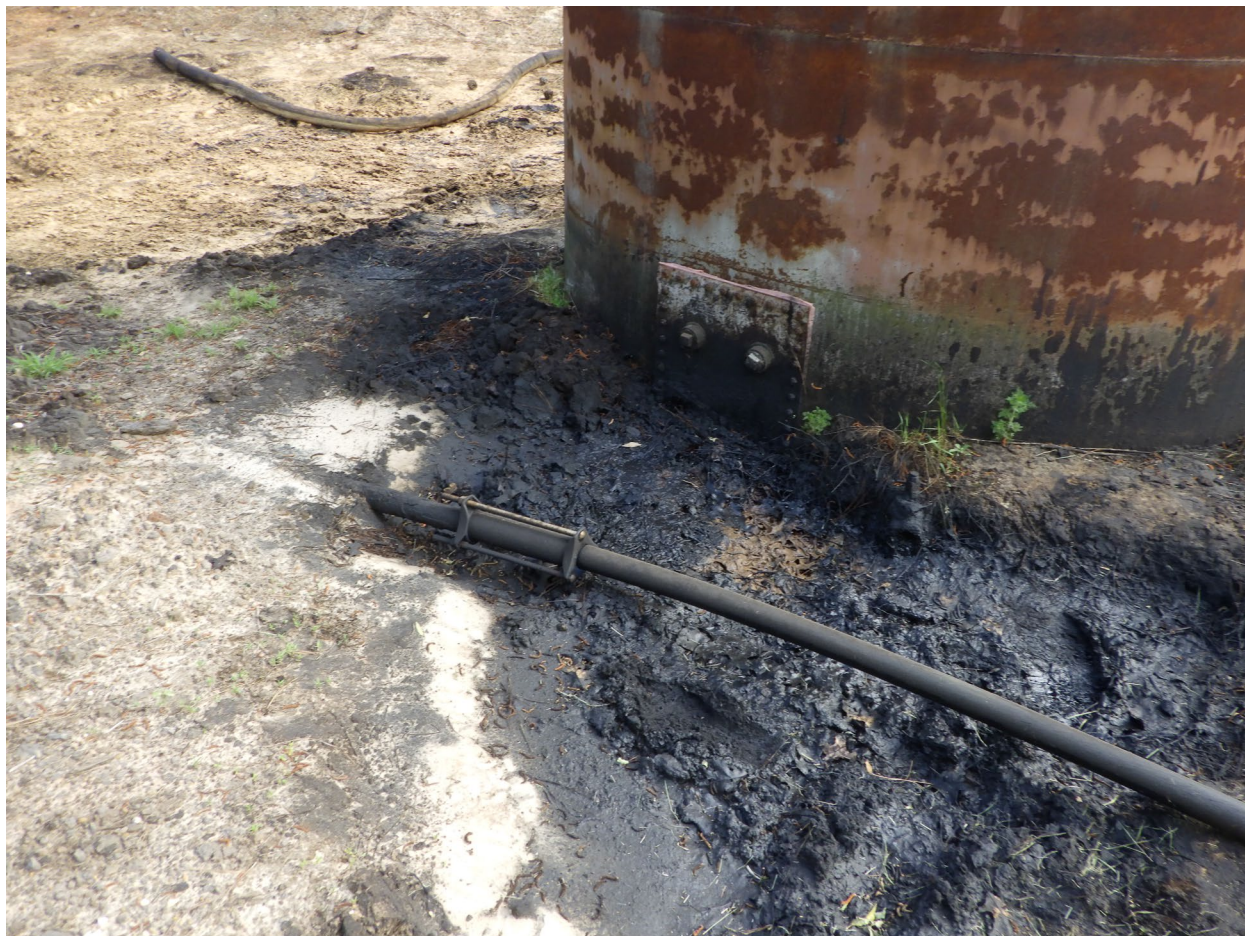
Photo No. 6

I observed residual, loose crude oil inside secondary containment, see Photo No. 6.

**Description:** Looking SE, this photo shows loose crude oil inside the tank battery.

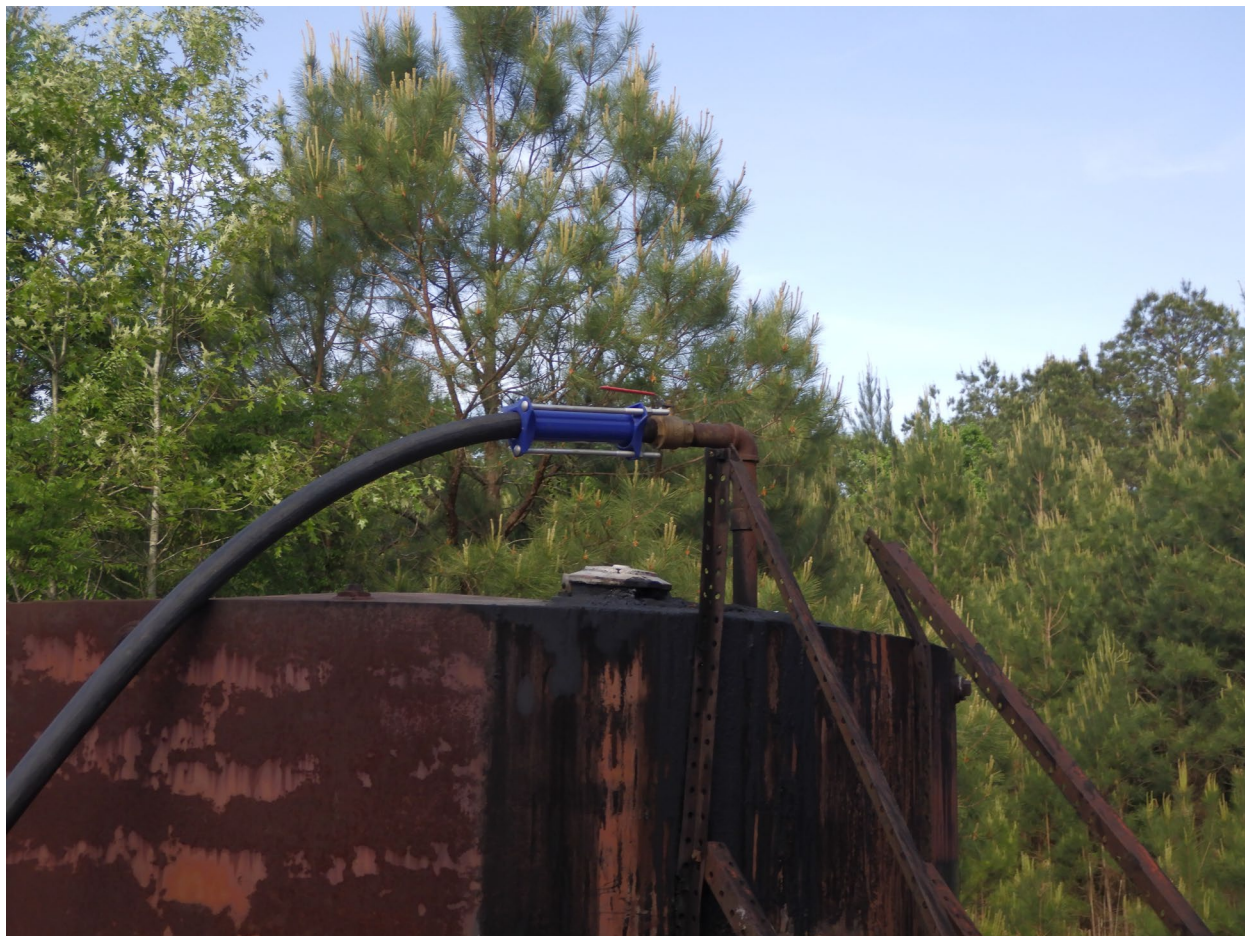
Photo No. 7

I observed a new coupling used to repair a flowline at the crude oil storage tank, see Photo No. 7.

**Description:** Looking NE, this photo shows a new coupling that had been installed on a flowline for the crude oil storage tank.
