## INSPECTION REPORT

| Type of Inspection | Compliance Evaluation Inspection (CEI) | |
| Facility or Site Name | Alaska Department of Environmental Conservation Environmental Health Laboratory (ADEC EHL) | |

APPENDIX 1: PHOTO LOG

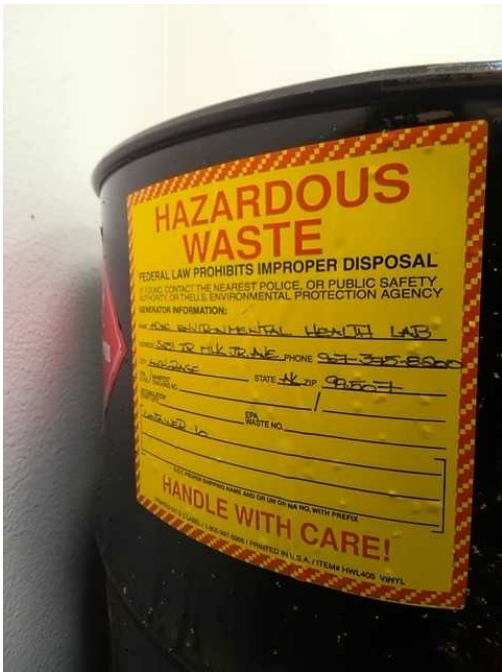
| 55-gallon drum of solvent waste | | | IMG-20240710093650365078651.jpg |

| Drum not labeled with accumulation start date. | | | |

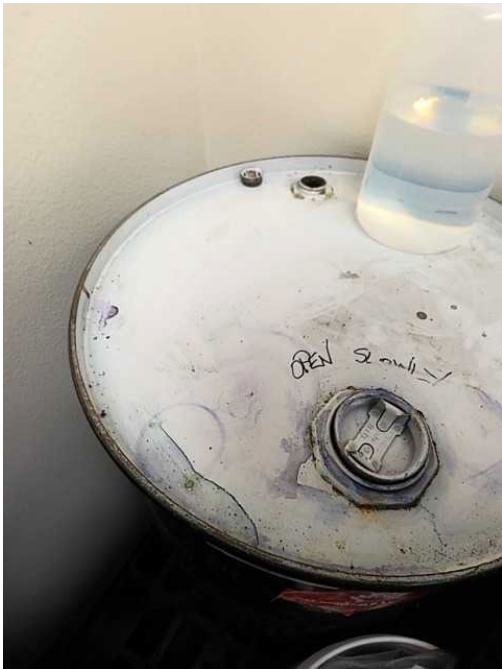
| 55-gallon drum of organic waste | | | IMG-2024071009400640658618.jpg |

| Bung not secured into container. | | | |

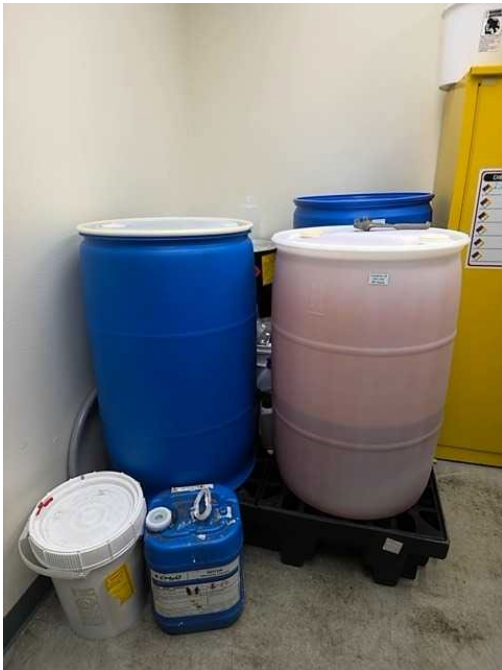
| Central accumulation area | | | IMG-20240710094110411055416.jpg |

| Storage of hazardous waste and used oil containers. | | | |

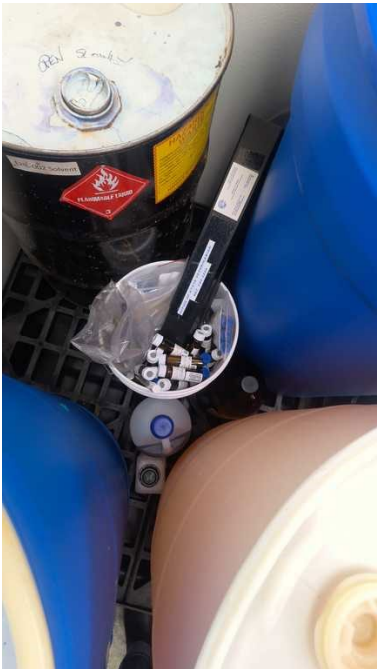
| Central accumulation area | | | IMG-202407100944104410860907.jpg |

| Storage of hazardous waste and used oil containers. | | | |

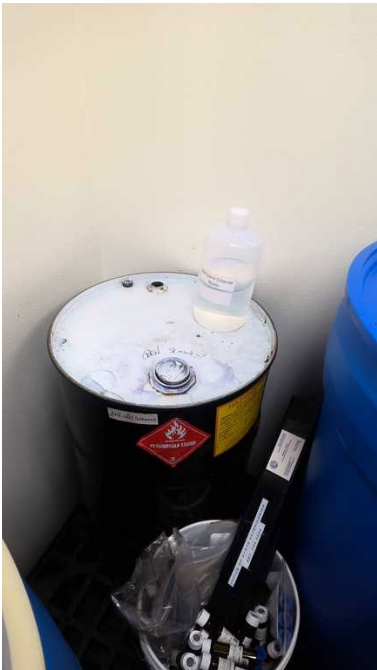
| Central accumulation area | | | IMG-202407100944224422908461.jpg |

| Bung not secured into container. | | | |

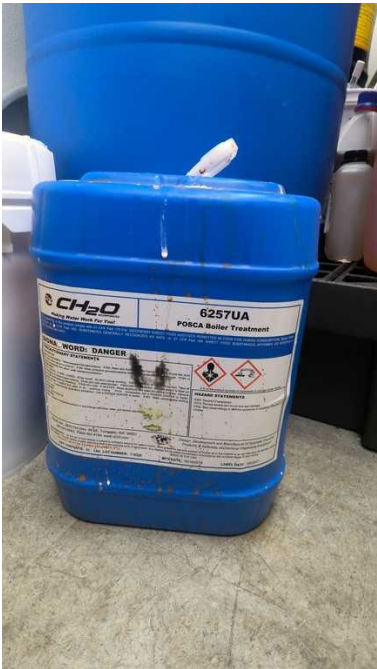
| PSCOA boiler treatment | | | IMG-2024071009445444541366236.jpg |

| Container of hazardous waste not labeled with the words "Hazardous Waste" or with an indication of the hazards of the contents. | | | |

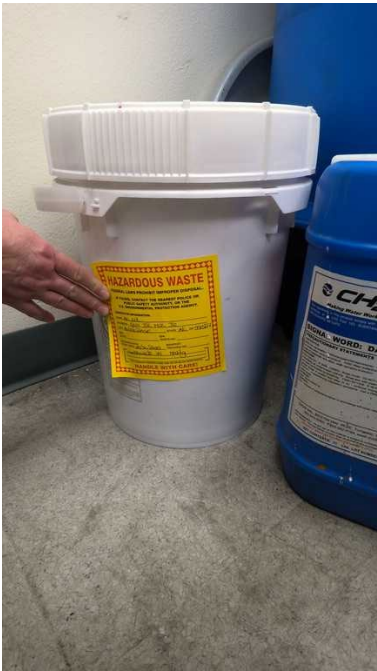
| 5-gallon container labeled as "Mehg" | | | IMG-2024071009451245121368435.jpg |

| <p>A 5-gallon container of waste Mehg was not marked with a hazard indicator but was marked with an ASD of 8/30/22 indicating that it had been in accumulation for more than 270 days.</p> <p>A 55-gallon container of waste solvent was not closed or marked with an ASD.</p> <p>Three additional 55-gallon containers of liquid organic waste were not labeled "Hazardous Waste," marked with a hazard indicators or an ASDs.</p> <p>Failure to make a hazardous waste determination for a cart full of individually contained hazardous waste materials collected and stored over the last ten years.</p> | | |

| Accumulation start date of 8/30/2022. | | | |

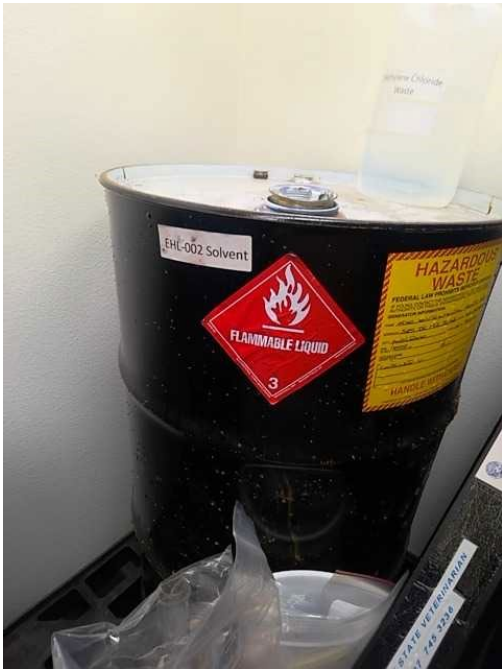
| Hazardous waste container | | | IMG-20240710094534453471016.jpg |

| Bung not secured into container. | | | |

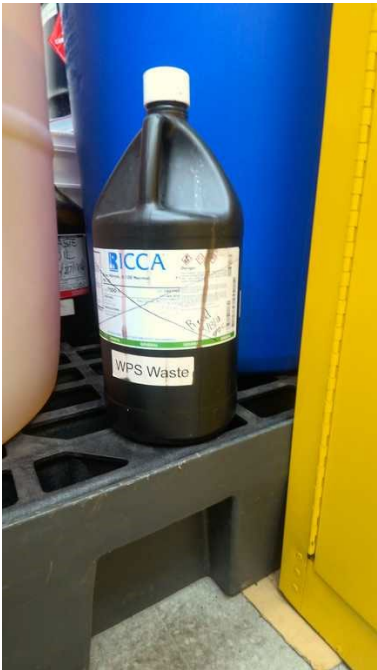
| Hazardous waste container | | | IMG-202407100946454645828924.jpg |

| WPS waste container not labeled with the words "Hazardous Waste" or with an indication of the hazards of the contents. | | | |

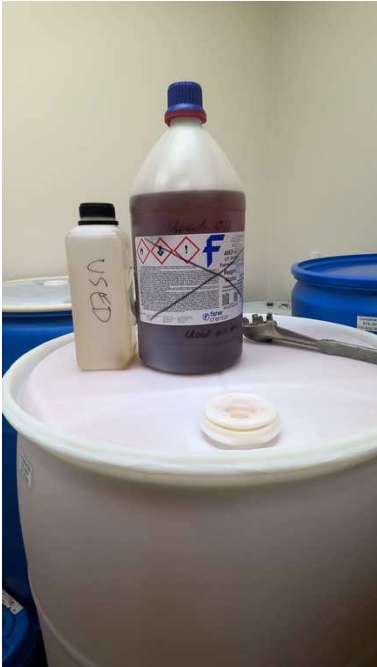
| Used oil containers | | | IMG-202407100947284728967178.jpg |

| Containers of used oil, 4L and 1L, not labeled with the words "Used Oil." | | | |

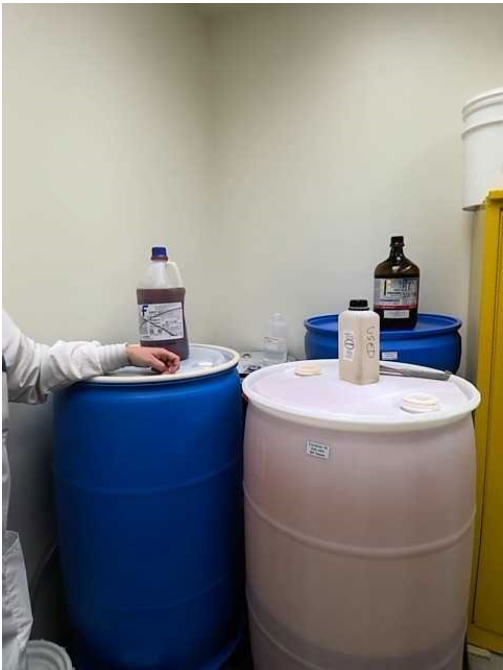
| Used oil containers | | | IMG-2024071009490249241349.jpg |

| Containers of used oil, 4L and 1L, not labeled with the words "Used Oil." | | | |

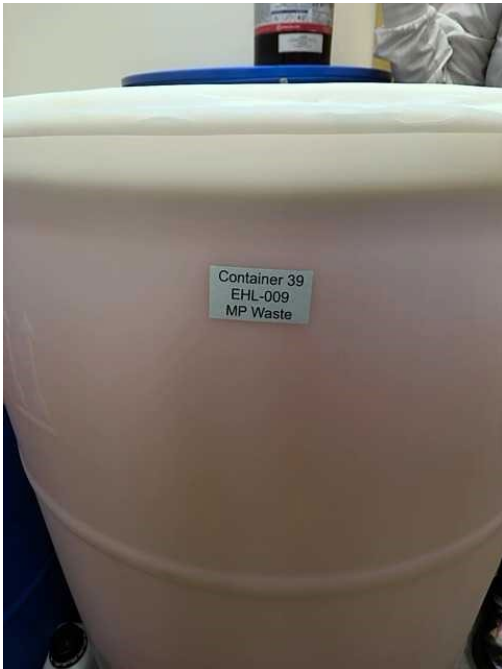
| 55-gallon drum of labeled with an internal label | | | IMG-20240710094951495130324.jpg |

| Container of hazardous waste not labeled with the words "Hazardous Waste", an indication of the hazards of the contents, or accumulation start date. | | | |

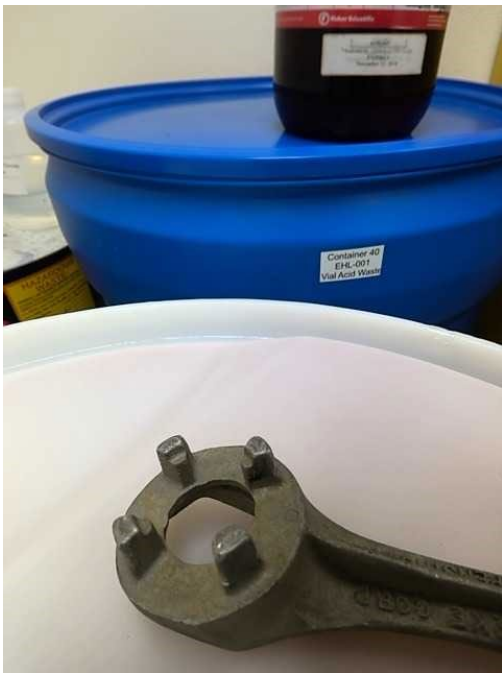
| 55-gallon drum of labeled with an internal label | | | IMG-20240710094955495545878.jpg |

| Container of hazardous waste not labeled with the words "Hazardous Waste", an indication of the hazards of the contents, or accumulation start date. | | | |

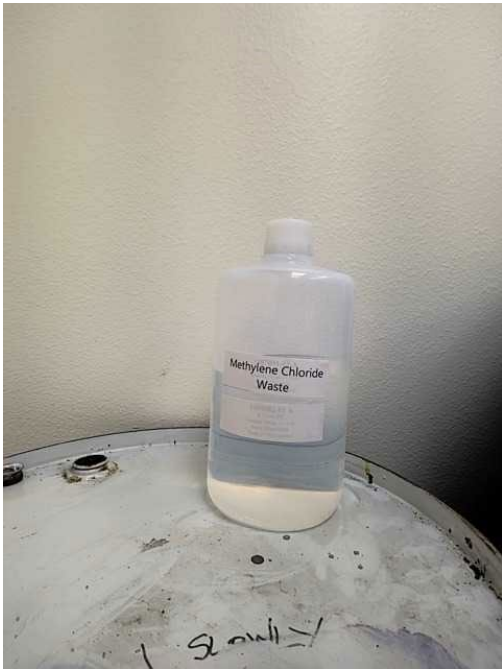
| Container of methylene chloride | | | IMG-20240710095435543567748.jpg |

| Various containers in this area were identified as having the following deficiencies:<br><br>A ~1 Liter container of waste methylene chloride was not labeled “Hazardous Waste,” marked with a hazard indicator or an ASD.<br><br>A 1-gallon container of WPS waste was not labeled “Hazardous Waste,” marked with a hazard indicator or an ASD.<br><br>A 5-gallon container of Boiler Treatment waste was not labeled “Hazardous Waste,” marked with a hazard indicator or an ASD. | Regulation: | Sections: |

| Container of hazardous waste not labeled with the words "Hazardous Waste", an indication of the hazards of the contents, or accumulation start date | | | |

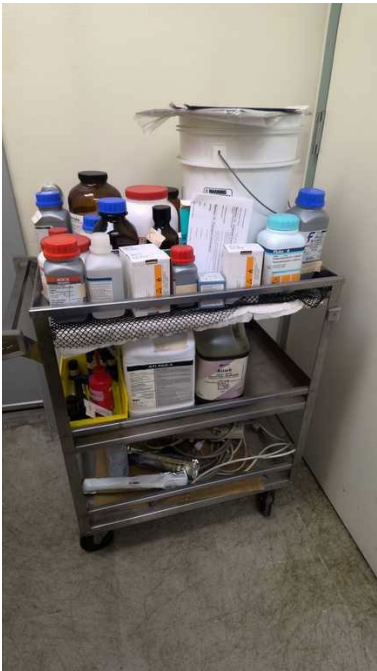
| Expired and/or waste chemical storage | | | IMG-2024071009584858481159253.jpg |

| Both acute and non-acute hazardous waste exceeding ten years of storage, not labeled with the words "hazardous waste", or an indication of the hazards of the contents. | | | |

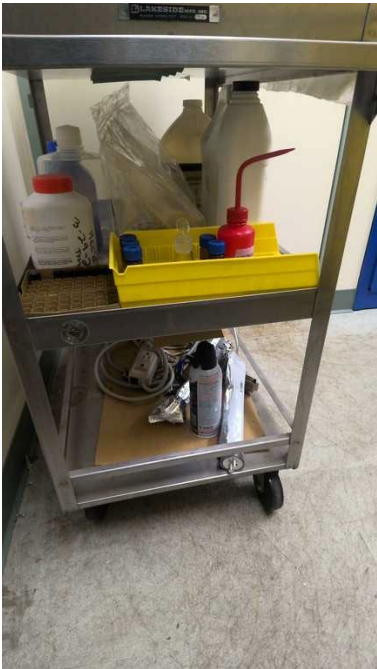
| Expired and/or waste chemical storage | | | IMG-202407100959005901293824.jpg |

| Both acute and non-acute hazardous waste exceeding ten years of storage, not labeled with the words "hazardous waste", or an indication of the hazards of the contents. | | | |

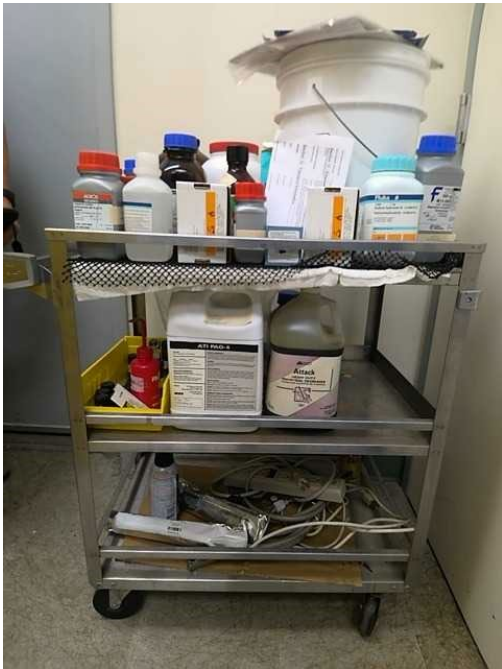
| Expired and/or waste chemical storage | | | IMG-20240710095947594782375.jpg |

| Both acute and non-acute hazardous waste exceeding ten years of storage, not labeled with the words "hazardous waste", or an indication of the hazards of the contents. | | | |

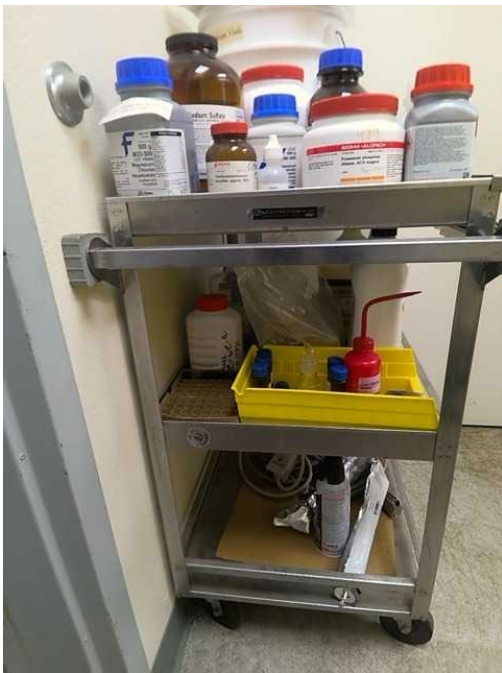
| Expired and/or waste chemical storage | | | IMG-2024071010014214277593.jpg |

| Both acute and non-acute hazardous waste exceeding ten years of storage, not labeled with the words "hazardous waste", or an indication of the hazards of the contents. | | | |

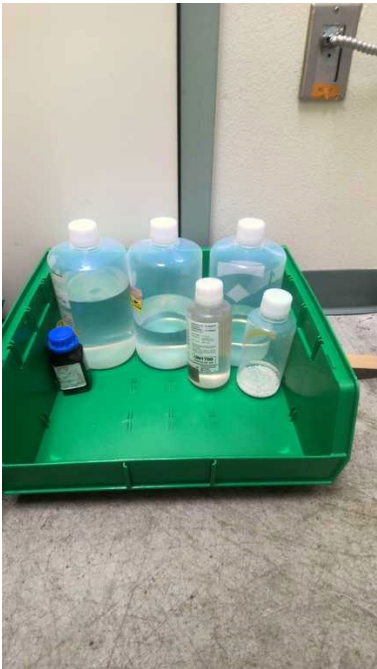
| Expired and/or waste chemical storage | | | IMG-202407101001571571185490.jpg |

| Both acute and non-acute hazardous waste exceeding ten years of storage, not labeled with the words “hazardous waste”, or an indication of the hazards of the contents. | | | |

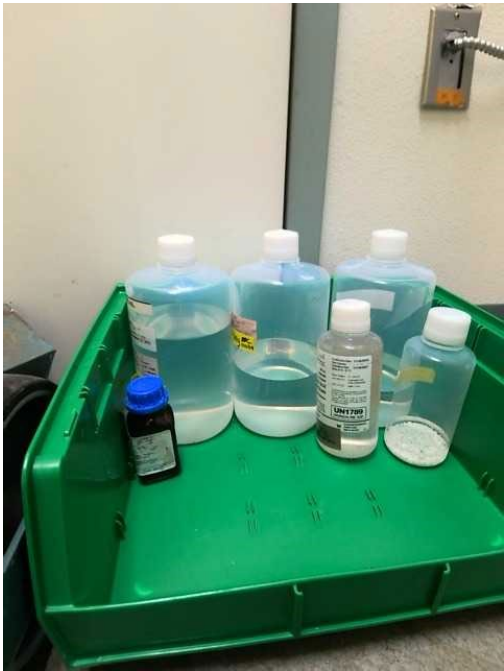
| Expired and/or waste chemical storage | | | IMG-2024071010022122160127.jpg |

| Both acute and non-acute hazardous waste exceeding ten years of storage, not labeled with the words “hazardous waste”, or an indication of the hazards of the contents. | | | |

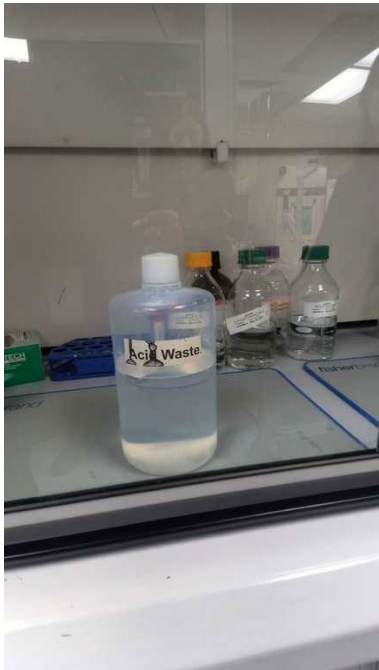
| Container of acid waste in fume hood | | | IMG-202407101011291129795151.jpg |

| I observed a partially filled 2 Liter SAA container of acid waste located in the fume hood not labeled with the words "Hazardous Waste" or with an indication of the hazards of the contents. The contents were determined to be a hazardous waste by EHL staff. | | | |

| Container of hazardous waste not labeled with the words "Hazardous Waste" or with an indication of the hazards of the contents. | | | |

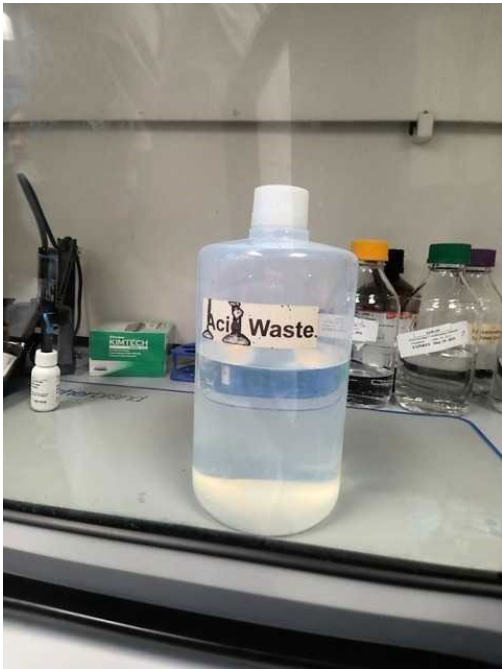
| Container of acid waste in fume hood | | | IMG-20240710101159115958986.jpg |

| Container of hazardous waste not labeled with the words "Hazardous Waste" or with an indication of the hazards of the contents. | | | |

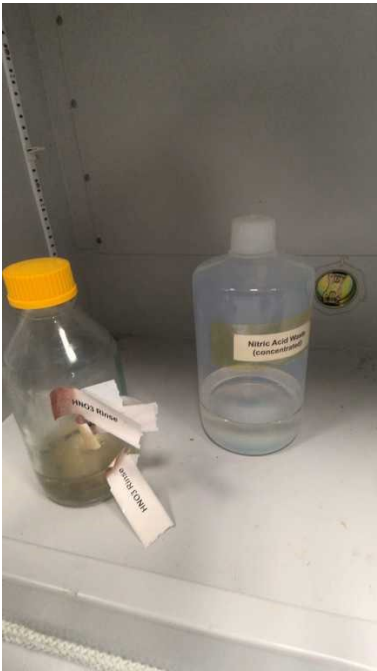
| Container of acid waste in fume hood storage cabinet | | | IMG-202407101012311231827278.jpg |

| I observed two partially filled SAA containers of waste nitric acid located below the fume hood not labeled with the words "Hazardous Waste" or with an indication of the hazards of the contents. The contents were determined to be a hazardous waste by EHL staff. | | | |

| Containers of hazardous waste not labeled with the words "Hazardous Waste" or with an indication of the hazards of the contents. | | | |

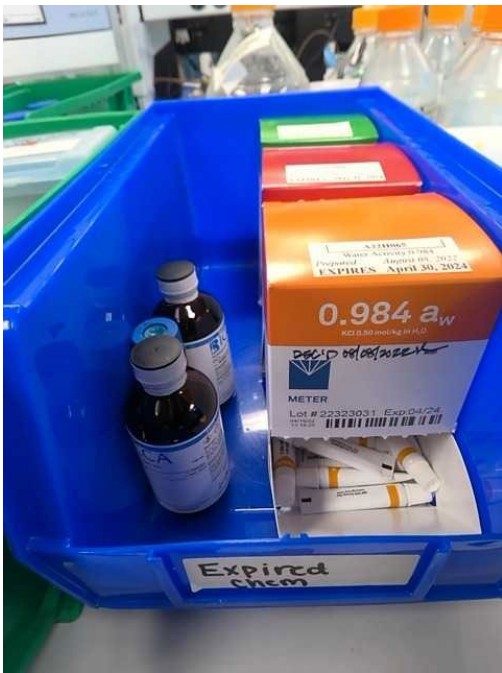
| Expired chemical storage cubby | | | IMG-20240710101638163874265.jpg |

| I observed a cubby of expired chemicals intended for disposal via trash (if determined to be non-hazardous) or awaiting logging prior to being moved to the CAA in Room 179 (if determined to be hazardous). The containers were not labeled with the words "Hazardous Waste" or with an indication of the hazards of their contents. The expired chemicals required a hazardous waste determination. | | | |

| Failure to make a hazardous waste determination for containers of expired chemicals. | <b>Regulation:</b> | <b>Sections:</b> |

| Containers of hazardous waste not labeled with the words "Hazardous Waste" or with an indication of the hazards of the contents. | | | |

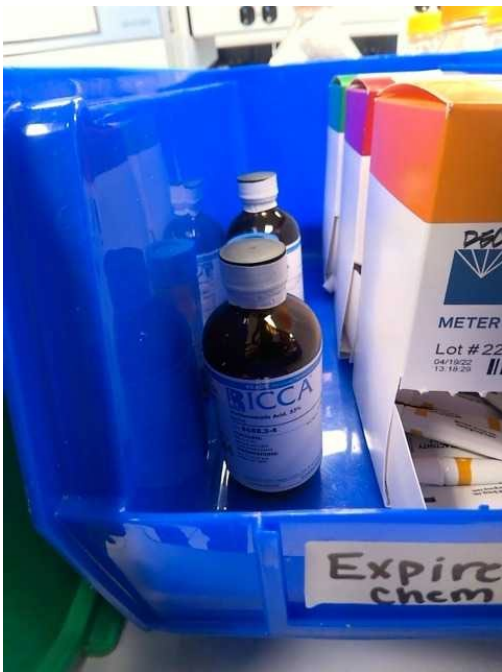
| Expired chemical storage cubby | | | IMG-20240710101826182666708.jpg |

| Containers of hazardous waste not labeled with the words "Hazardous Waste" or with an indication of the hazards of the contents. | | | |

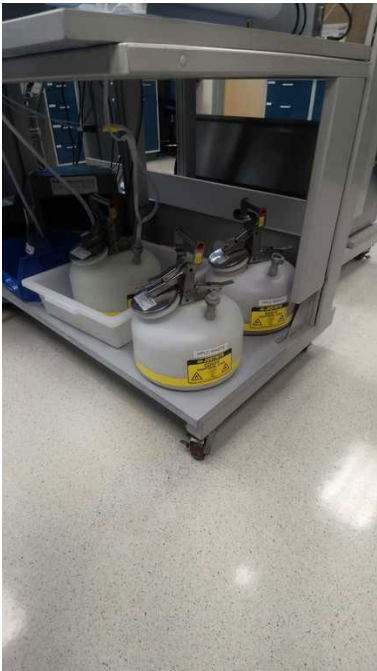
| Machinery liquid collection of HPLC waste | | | IMG-2024071010212121211291952.jpg |

| Room 177 houses multiple machines that excrete waste fluid via gravity fed hoses into bottles. Ms. McKinney informed us that the liquids collected from these machines are a hazardous waste. The bottles contained varying levels of liquids. | | | |

| Containers of hazardous waste not labeled with the words "Hazardous Waste" or with an indication of the hazards of the contents. | | | |

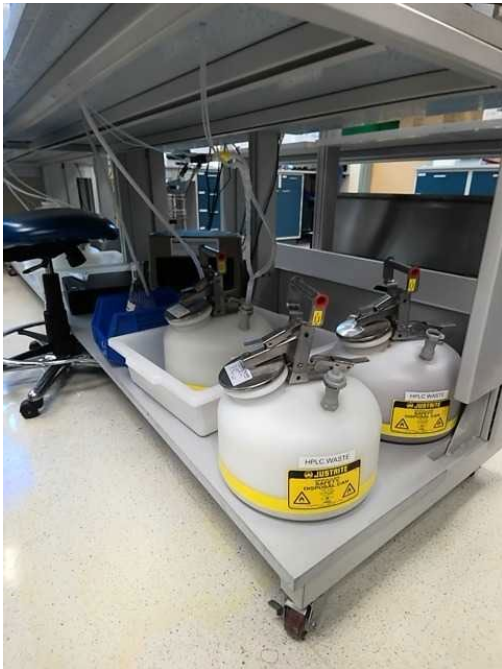
| Machinery liquid collection of HPLC waste | | | IMG-20240710102218221886275.jpg |

| Containers of hazardous waste not labeled with the words "Hazardous Waste" or with an indication of the hazards of the contents. | | | |

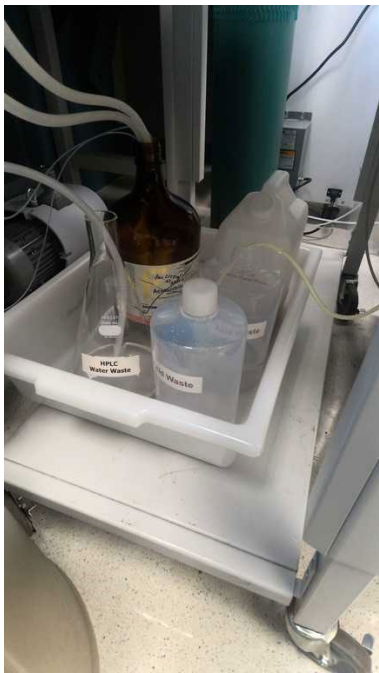
| Machinery liquid collection of HPLC, acid waste | | | IMG-202407101024262426995068.jpg |

| Containers of hazardous waste not labeled with the words "Hazardous Waste" or with an indication of the hazards of the contents. Container(s) not closed. | | | |

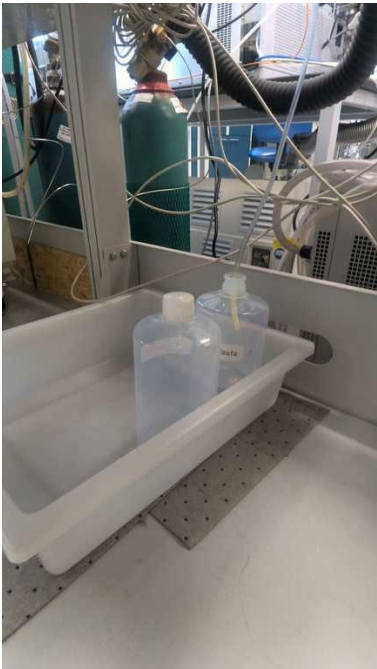
| Containers of acid waste | | | IMG-2024071010244324431035095.jpg |

| I observed several partially filled containers of acid waste, determined to be a hazardous waste by ADEC EHL staff, not labeled with the words "Hazardous Waste" or with an indication of the hazards of the contents. The contents were determined to be a hazardous waste by EHL staff. | | | |

| Containers of hazardous waste not labeled with the words "Hazardous Waste" or with an indication of the hazards of the contents. Container(s) not closed. | | | |

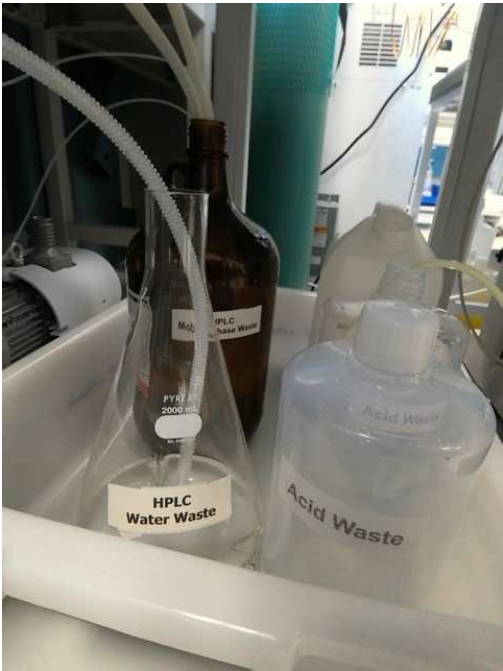
| Machinery liquid collection of HPLC, acid waste | | | IMG-20240710102738273864657.jpg |

| Containers of hazardous waste not labeled with the words "Hazardous Waste" or with an indication of the hazards of the contents. Container(s) not closed. | | | |

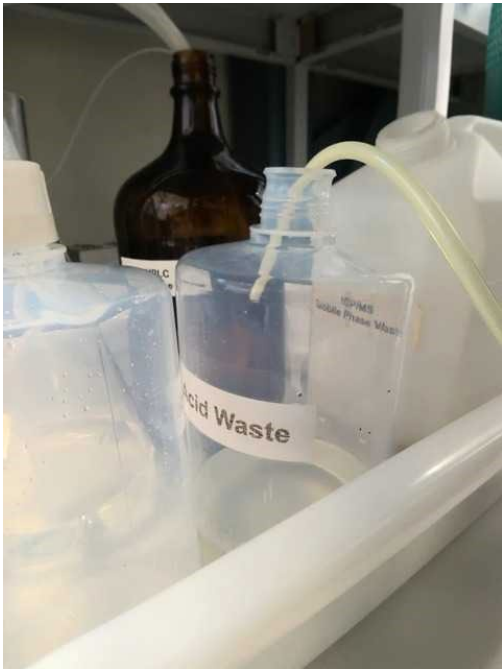
| Machinery liquid collection of acid waste | | | IMG-20240710102744274444720.jpg |

| Containers of hazardous waste not labeled with the words "Hazardous Waste" or with an indication of the hazards of the contents. Container(s) not closed. | | | |

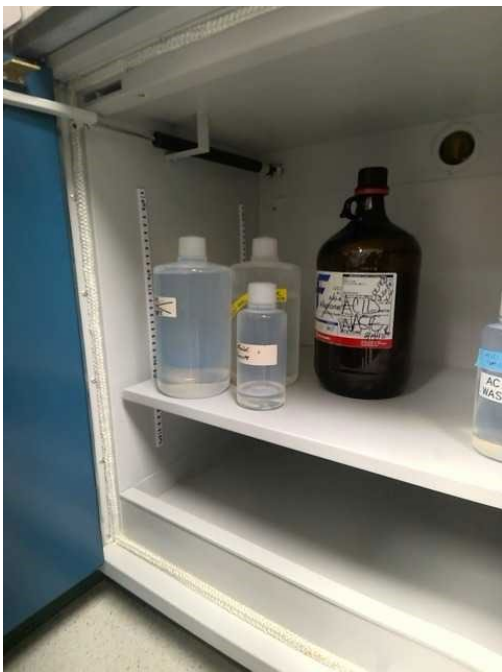
| Containers of acid waste | | | IMG-20240710103017301753253.jpg |

| Containers of hazardous waste not labeled with the words "Hazardous Waste" or with an indication of the hazards of the contents. | | | |

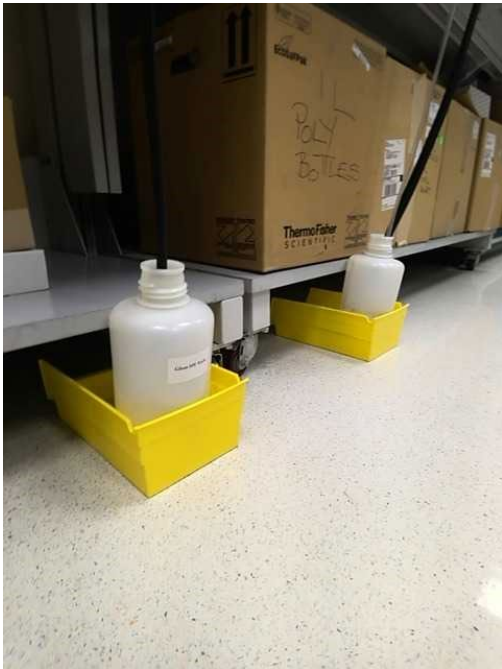
| Gilson solid phase extraction (SPE) liquid collection | | | IMG-20240710103145314567283.jpg |

| I observed a Gilson solid phase extraction (SPE) system collecting hazardous waste discharge from machinery via a plastic hose into a small open container. The containers were not labeled with the words "Hazardous Waste" or with an indication of the hazards of the contents. The contents were determined to be a hazardous waste by EHL staff. The employee covered the top of the container with plastic wrap at the time of inspection. | | | |

| SAA containers collecting Gilson solid phase extraction (SPE) system waste discharge from machinery via a plastic hose were not closed, not labeled with the words "Hazardous Waste," or marked with a hazard indicator. | <b>Regulation:</b> | <b>Sections:</b> |

| Containers of hazardous waste not labeled with the words "Hazardous Waste" or with an indication of the hazards of the contents. Container(s) not closed. | | | |

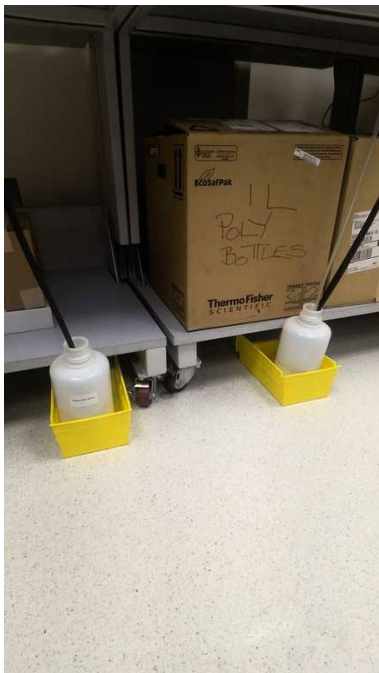
| Gilson solid phase extraction (SPE) liquid collection | | | IMG-2024071010315431541090812.jpg |

| Containers of hazardous waste not labeled with the words "Hazardous Waste" or with an indication of the hazards of the contents. Container(s) not closed. | | | |

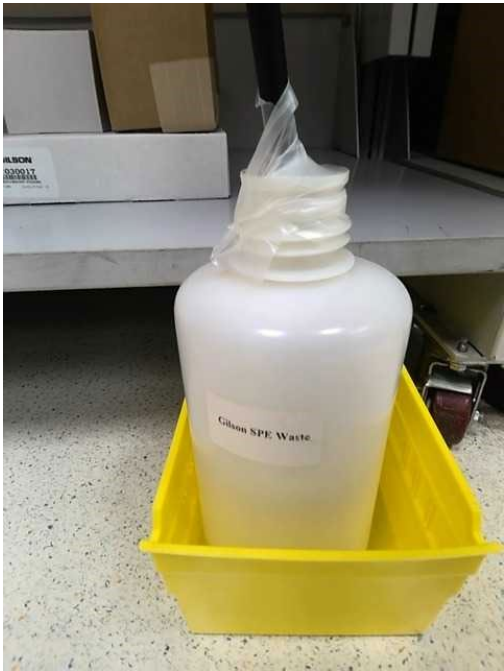
| Gilson solid phase extraction (SPE) liquid collection | | | IMG-20240710103542354260666.jpg |

| Containers of HPLC waste, closed by staff at time of inspection. | | | |
