## **RCRA Inspection Report**

Greenwood Fabricating and Plating Inc.  
215 Mill Avenue  
Greenwood, South Carolina 29646  
Greenwood County

**COMPLIANCE EVALUATION INSPECTION PHOTOGRAPHS**

**April 2, 2024**

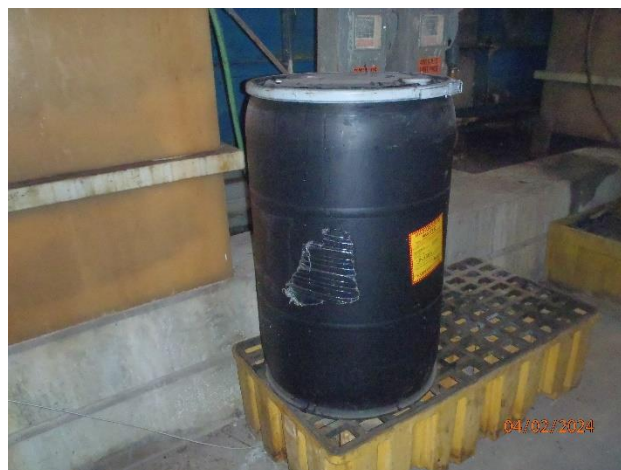
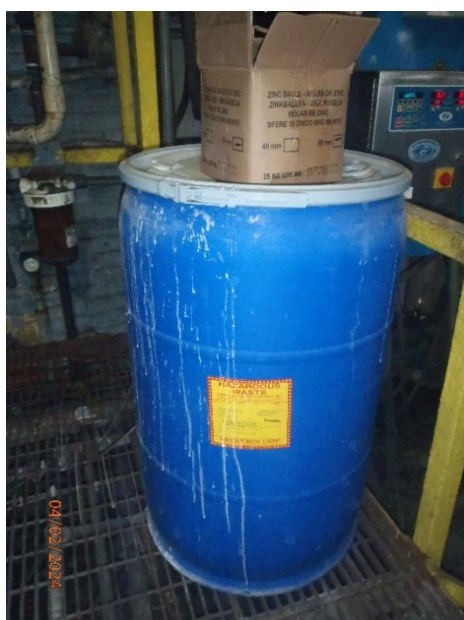
two pumps that pump directly to the on-site wastewater treatment plant. The inspectors walked through the Line 7 and observed the plating process. A blue plastic 55-gallon container of hazardous waste caustic cleaner and debris was observed in a satellite accumulation area (SAA) at the end of the line (Pictures 2-3). The container was observed closed and labeled. In addition, the air around the container was very caustic due to the process and difficult to breathe.

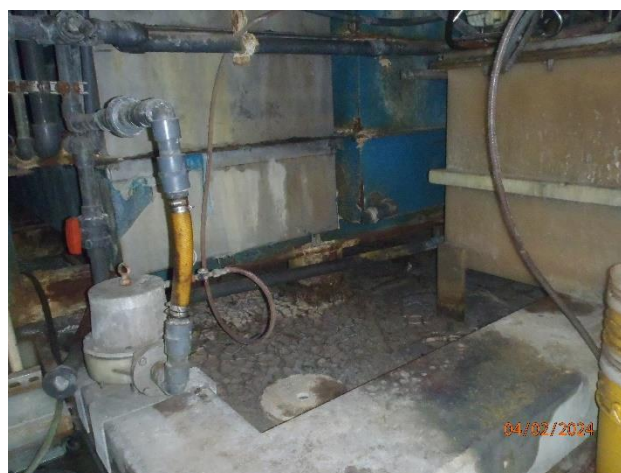
- Solids were noted in a non-cyanide concrete secondary containment area; this area needed a cleanout (Picture 6). Mr. Tucker stated that the solid material built up over time and that corrosive spillover periodically occurred in the past. The inspectors stated that the contents of the secondary containment area required a hazardous waste determination prior to disposal.

**Pursuant to S.C. Code Ann. Regs. 61-79.262.11 [40 C.F.R. § 262.11], a person who generates a solid waste, as defined in S.C. Code Ann. Regs. 61-79.262.2 [40 C.F.R. § 261.2], must make an accurate determination as to whether that waste is a hazardous waste in order to ensure wastes are properly managed according to applicable RCRA regulations articulated in S.C. Code Ann. Regs. 61-79.262.11 [40 C.F.R. § 262.11].**

1. Photo of all applicable hazards are labeled on the yellow labels;
2. Email attached showing the timeline of Line 8 pit clean out;
3. Photos showing housekeeping at the sandblaster and corrected label on the used sand;

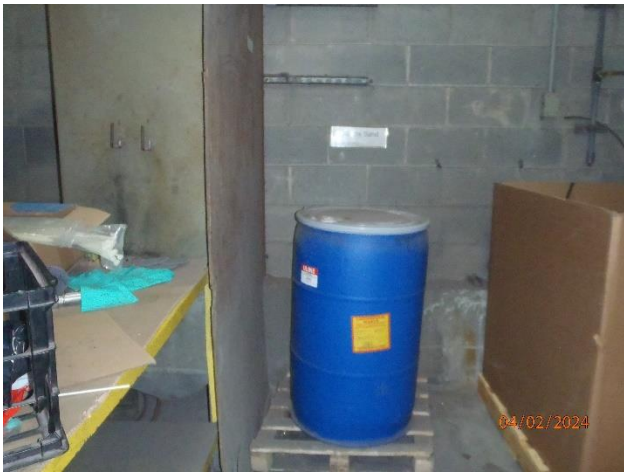
Picture 7 – Spent sand blast media SAA

The central accumulation area (CAA) was located between the plating lines and the wastewater treatment plant. A blast media booth with an SAA for accumulating hazardous waste generated in the booth was observed in this area. A blue 55-gallon container of hazardous waste spent copper/silver sand blast sat on a wooden pallet (Pictures 7-8) in this SAA. Spent copper/silver sand blast is expected to exhibit the hazardous waste characteristic of toxicity. The container, which was closed, was marked with an indication that the contents are Reactive, but not with an indication that the contents are Toxic. The inspectors observed the spent blast media was released to the ground underneath the sand blaster outlet (Pictures 9-10). In addition, clean, unused sand blast media was spilled on the ground near the sand blaster inlet (Pictures 11-12). To minimize the possibility of a release, both the clean and spent media needed to be swept up and disposed of.

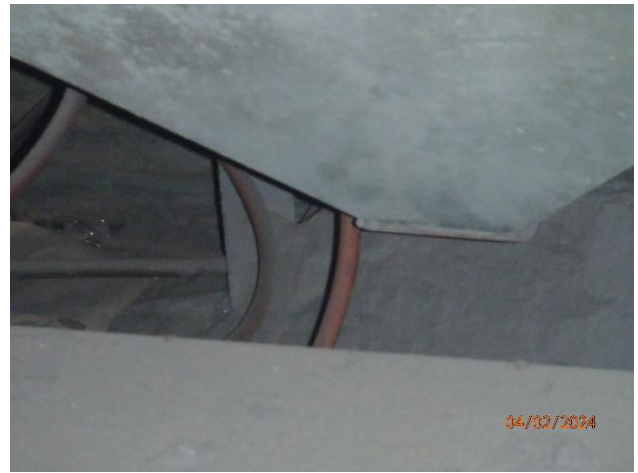
Picture 10 – Spent sand blast media released to ground

**Pursuant to S.C. Code Ann. Regs. 61-79.262.17(a)(6) [40 C.F.R. § 262.17(a)(6)], which incorporates S.C. Code Ann. Regs. 61-79.262.251 [40 C.F.R. § 262.251], and is a condition of the LQG Permit Exemption, a generator is required to maintain and operate its facility to minimize the possibility of a fire, explosion, or any unplanned sudden or non-sudden release of hazardous waste or hazardous waste constituents to air, soil, or surface water which could threaten human health or the environment.**

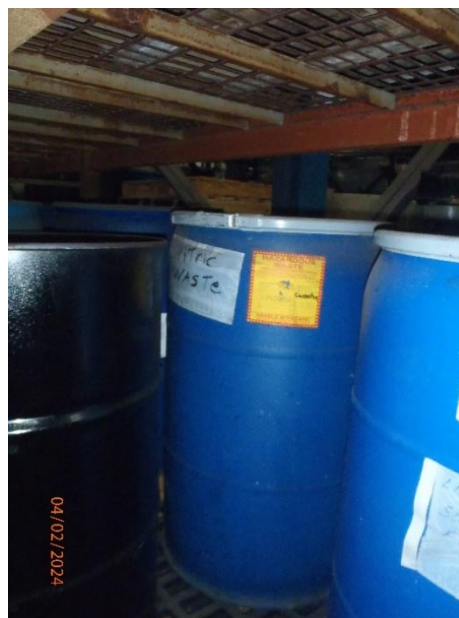
Picture 16 – Spent Nitric Acid SAA near CAA

Also, in the rear of the CAA was an SAA for accumulating hazardous nitric waste (Picture 16). The inspectors observed a blue 55-gallon container, which was closed and labeled Hazardous Waste, Nitric Acid, Corrosive, in this SAA. The inspectors also observed a single 25-cubic yard supersack of hazardous waste wastewater treatment plant sludge closed, labeled, and dated March 20, 2024 (Picture 17).

6. Photo of labeled used oil drums and manifests;
7. Photo of oil soaked up on the floor;
8. Purchase order for an oil/water separator;
9. Revised contingency plan including satellite nitric drum, supersacks, and max quantities of all hazardous waste;

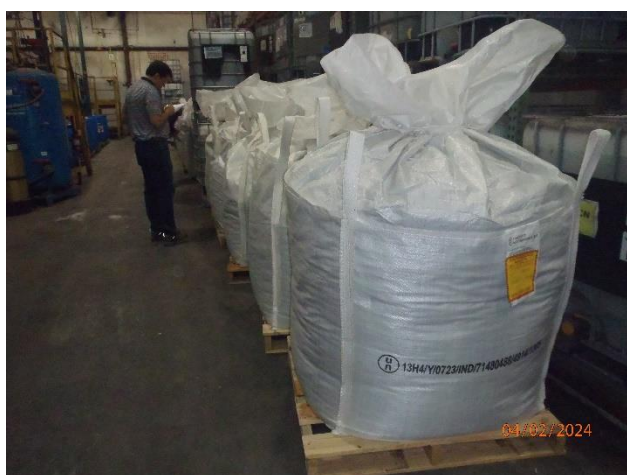
Picture 14 – CAA WWTP Sludge supersacks

The inspectors observed nine 25 cubic yard supersacks of hazardous waste wastewater treatment plant sludge (Pictures 13-14). Each supersack was labeled Wastewater Treatment Sludge, Toxic and marked with an accumulation start date. The oldest date was January 28, 2024. Two of the supersacks were closed, however, the remaining six were not closed. The EPA inspector recommended taping or zip tying the supersacks closed.

**Pursuant to S.C. Code Ann. Regs. 61-79.262.17(a)(1)(iv) [40 C.F.R. § 262.17(a)(1)(iv)], which is a condition of the LQG Permit Exemption, (A) a container holding hazardous waste must always be closed during accumulation, except when it is necessary to add or remove waste; and (B) A container holding hazardous waste must not be opened, handled, or stored in a manner that may rupture the container or cause it to leak.**

4. Photos showing closed super sacks with a different method used;
5. Photo of aerosol drum closed and labeled. The old aerosol satellite drum is being profiled and will be shipped out upon profile approval;

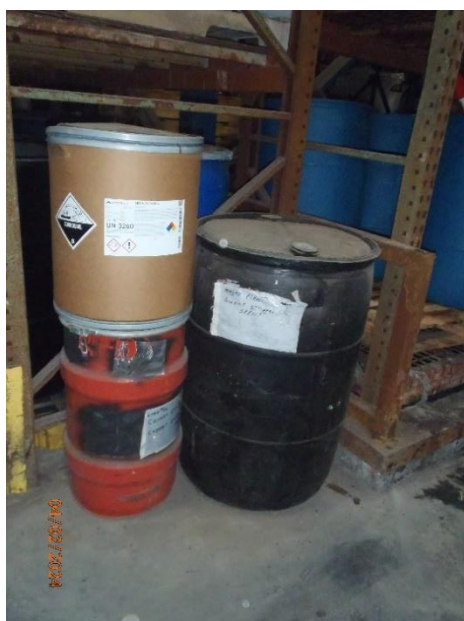
Picture 15 – Hoges Plant spent silver stripper - full

The CAA contained a black 55-gallon container of spent silver stripper from Greenwood Fabricating and Plating Inc.'s Hodges Plant (Picture 15). The wastewater treatment plant staff were not aware when the container arrived or what it would be used for. The inspectors requested the manifest, bill of lading and/or the shipping papers for this container. On April 15, 2024, Mr. Tucker stated via email that the facility did not have transportation paperwork for the drum of silver strip from Hodges, and that the drum was being treated in house. Because the container could not be tracked and the use of the contents could not be ascertained, a hazardous waste determination is required to prior to any processing or shipment.

**Pursuant to S.C. Code Ann. Regs. 61-79.262.11 [40 C.F.R. § 262.11], a person who generates a solid waste, as defined in S.C. Code Ann. Regs. 61-79.262.2 [40 C.F.R. § 261.2], must make an accurate determination as to whether that waste is a hazardous waste in order to ensure wastes are properly managed according to applicable RCRA regulations articulated in S.C. Code Ann. Regs. 61-79.262.11 [40 C.F.R. § 262.11].**

15. We do not have transportation paperwork for the drum of silver strip from Hoges. This drum is being treated in house.

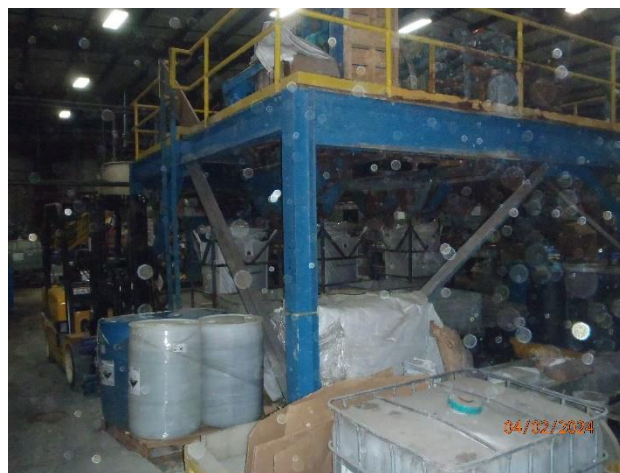
Picture 18 –WWTP

The wastewater treatment plant (WWTP) is managed by Operators Unlimited. The rinsewater, which contains acids and cyanide, is sent to batch tanks that are pH adjusted to drop out the metals. The water is fed back to the front of the waste stream for additional treatment. The hazardous waste solids are filter pressed and discharged into 25-cubic yard supersacks for shipment and disposal to US Ecology. At the time of the inspection, the inspectors observed three 25-cubic yard supersacks under the hoppers (Pictures 18-21). The supersacks were labeled Hazardous Waste, Wastewater Treatment Sludge, Toxic, dated but not closed and not actively being filled. Mr. Turner explained that the bags take one to two days to fill. The inspectors stated that supersacks must be covered/closed when not actively filling. The inspectors recommended covering the supersacks with a board or plank until ready to fill. A floor press that is used once a week was observed beside the WWTP (Picture 22).

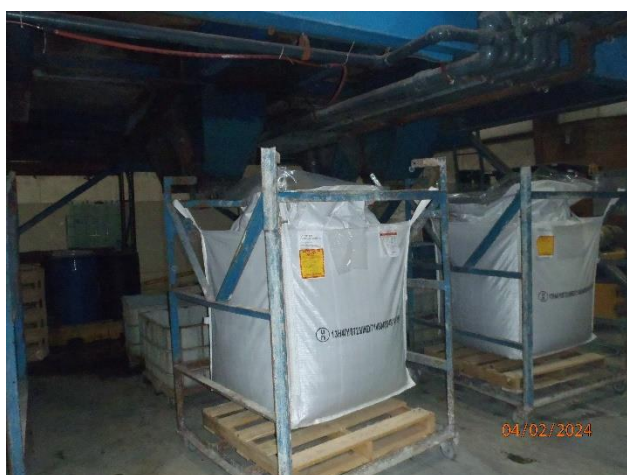
Picture 20 – WWTP CAA open supersacks

**Pursuant to S.C. Code Ann. Regs. 61-79.262.17(a)(1)(iv) [40 C.F.R. § 262.17(a)(1)(iv)], which is a condition of the LQG Permit Exemption, (A) a container holding hazardous waste must always be closed during accumulation, except when it is necessary to add or remove waste; and (B) A container holding hazardous waste must not be opened, handled, or stored in a manner that may rupture the container or cause it to leak.**

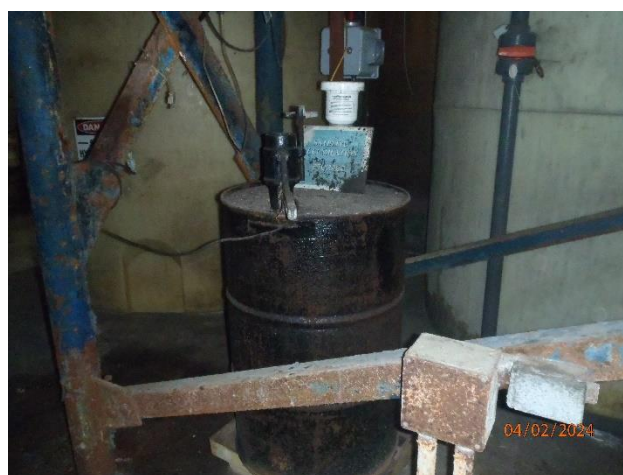
Picture 23 – WWTP aerosol can puncture SAA not labeled

A 55-gallon container of hazardous waste was observed in an SAA for accumulating the contents of used aerosol cans at the WWTP (Picture 23). The container, which was not closed or labeled, was equipped with an aerosol can puncture system.

**Pursuant to S.C. Code Ann. Regs. 61-79.262.15(a)(4) [40 C.F.R. § 262.15(a)(4)], which is a condition of the SAA Permit Exemption, a generator is required to keep containers of hazardous waste closed at all times during accumulation, except when adding, removing, or consolidating waste; or when temporary venting of a container is necessary for the proper operation of equipment, or to prevent dangerous situations, such as build-up of extreme pressure.**

**Pursuant to S.C. Code Ann. Regs. 61-79.262.15(a)(5) [40 C.F.R. § 262.15(a)(5)], which is a condition of the SAA Permit Exemption, a generator is required to mark or label its containers (i) with the words “Hazardous Waste” and (ii) with an indication of the hazards of the contents.**

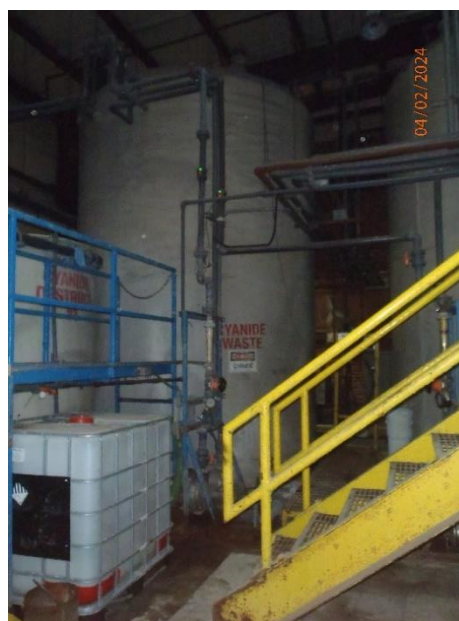
Picture 24 – Cyanide waste tank

Two 15,000-gallon wastewater treatment process tanks were observed near the WWTP. The tanks were labeled Cyanide Waste and Non-Cyanide Waste (Pictures 24-25).

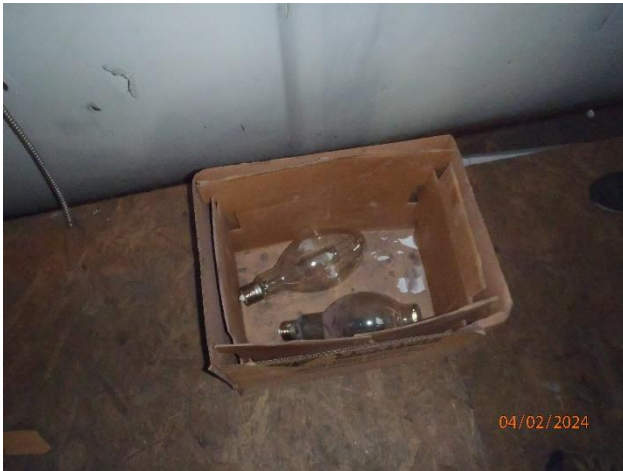
Picture 26 – Universal waste HID lamps

The universal waste lamps were stored in the shipping attic. The inspectors observed four cardboard boxes that were closed, labeled “Waste Lamps”, and dated (Pictures 27-28). The oldest date was April 24, 2023. A box with two spent high intensity discharge lamps was observed not closed, not labeled, and the facility was not able to demonstrate the waste was accumulated less than one year (Picture 26). Mr. Forest Dove removed the box and took it with him to be properly managed.

Pursuant S.C. Code Ann. Regs. 61-79.273.13(d) [40 C.F.R. § 273.13(d)], a SQHUW must manage universal waste lamps in a way that prevents releases of any universal waste or component of a universal waste to the environment.

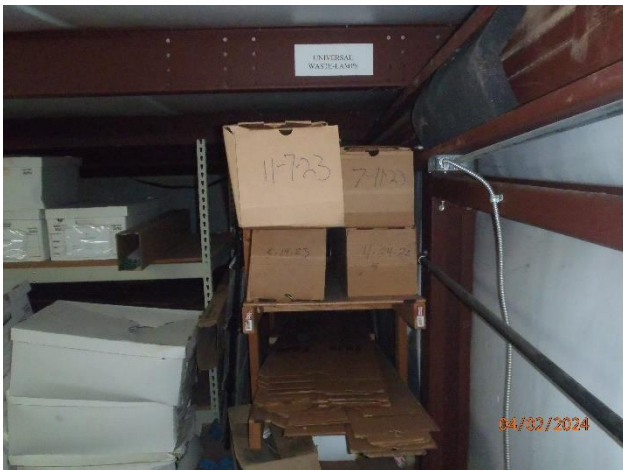
Picture 27 – Universal waste lamp boxes

Pursuant to S.C. Code Ann. Regs. 61-79.273.14(e) [40 C.F.R. § 273.14(e)], a SQHUW must label or mark each lamp or container of lamps clearly with one of the following phrases: "Universal Waste-Lamp(s)," or "Waste Lamp(s)," or "Used Lamps."

Pursuant to S.C. Code Ann. Regs. 61-79.273.15(a) and (c) [40 C.F.R. § 273.15(a) and (c)], a SQHUW may accumulate universal waste no longer than one year and must to be able to demonstrate the length of time that the universal waste has accumulated from the date that it became a waste or was received.

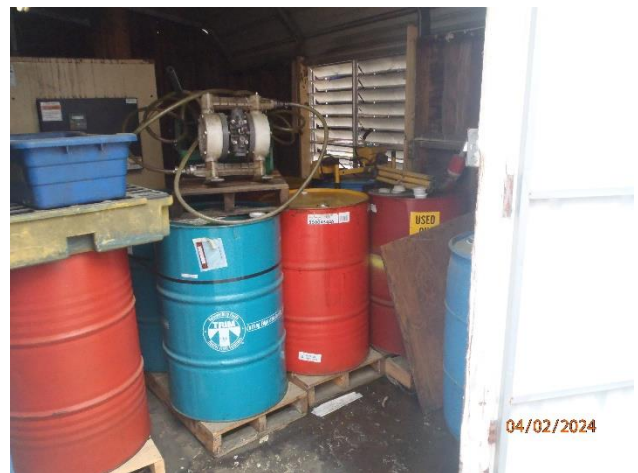
Picture 29 – Air Compressor Room used oil containers

Seven 55-gallon used oil containers and four 55-gallon used coolant containers were stored in the Air Compressor Room (Picture 29). The inspectors observed only one of the used oil containers was labeled and an oil release to ground was spreading across the floor (Pictures 30-31). The inspectors identified that the release was compressor oil blow off from an adjoining building.

Pursuant to S.C. Code Ann. Regs. 61-79.279.22(c)(1) [40 C.F.R. § 279.22(c)(1)], containers and aboveground tanks used to store used oil at generator facilities must be labeled or marked clearly with the words "Used Oil."

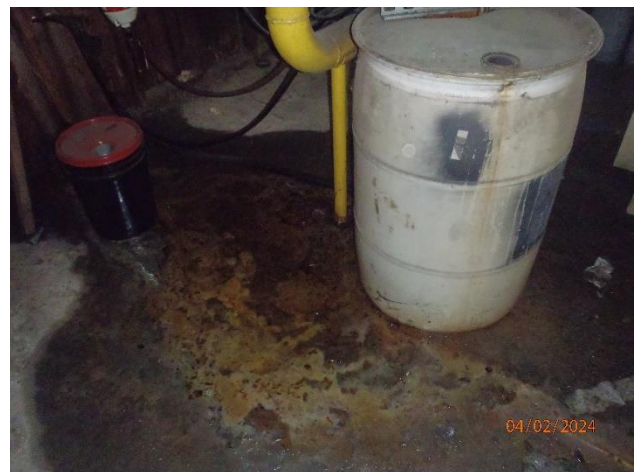
Picture 30 – Air Compressor Room used oil released to ground

Pursuant to S.C. Code Ann. Regs. 61-79.279.22(d) [40 C.F.R. § 279.22(d)], upon detection of a release of used oil to the environment, the facility must clean up and manage properly the released used oil and other materials.
